**INTERSTATE AVIATION COMMITTEE  
AIR ACCIDENT INVESTIGATION COMMISSION**

**INTERIM REPORT  
(PRELIMINARY REFERENCE INFORMATION)  
ON ACCIDENT INVESTIGATION**

Type of occurrence	Accident
Type of aircraft	RRJ-95 (RRJ-95B)
Registration	RA-89098
Owner	JSC «VEB-Leasing»
Operator	«Aeroflot » PJSC
Aviation authority	Federal Air Transport Agency (Rosaviatsiya)
Place of occurrence	Russia, Moscow region, Sheremetyevo airport, coordinates: 55°58'06.20" N, 37°24'07.20" E.
Date and time of occurrence	05.05.2019, 18:30 local time (15:30 UTC), daytime

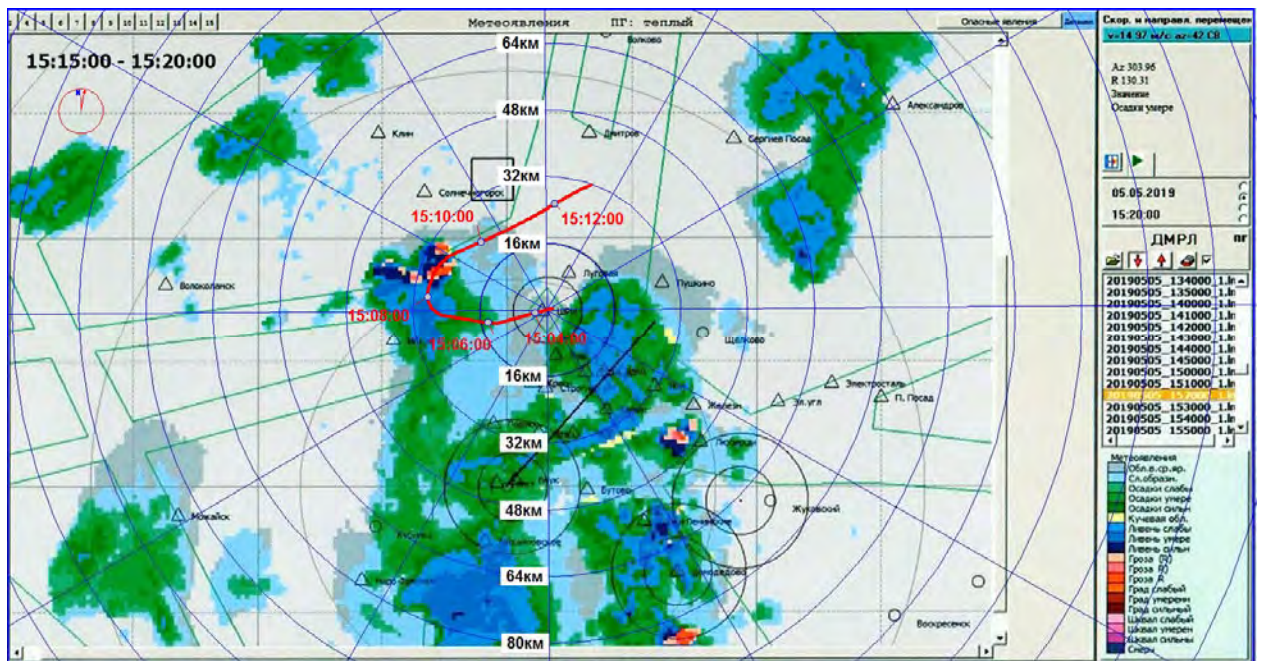
Fig. 3. Flight path combined with the DMRL-C Vnukovo weather radar for the time 15:15 – 15:20

At 15:07:10, the «HEADING» / «HDG» mode was engaged in the lateral control channel, and the selected heading was set to  $327^\circ$ . According to the Vnukovo<sup>7</sup> doppler weather radar, the aircraft was flying through the active thunderstorm area (Fig. 3), that was moving from the south-west to north-east with the speed of 40-45 km/h. The transition to the selected heading mode caused the aircraft to initiate the right turn earlier than it is prescribed by SID KN 24E (Fig. 4). The crew did not requested the active thunderstorm area avoidance clearance. Section 1.18.1 of the present

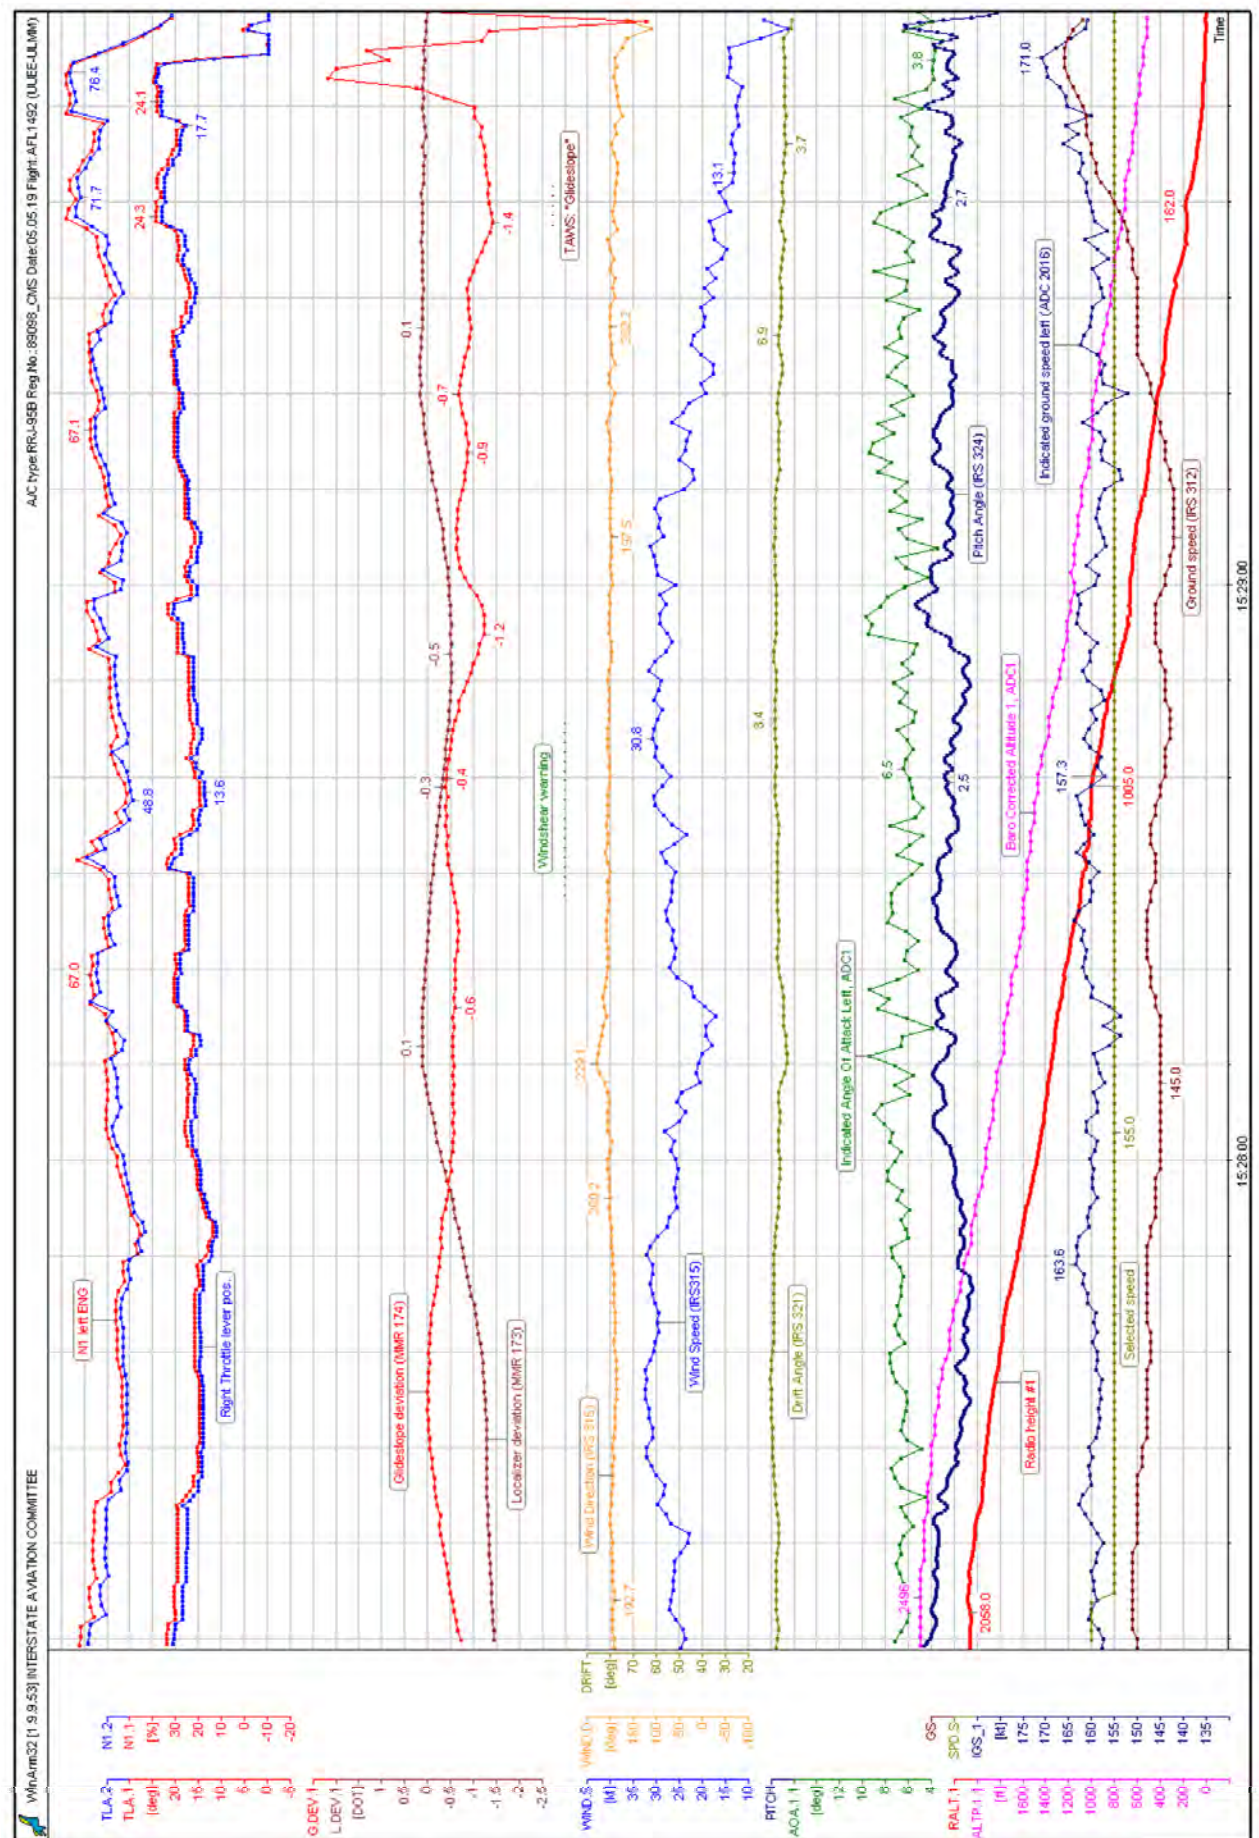
Fig. 6. Flight parameters while approach at the glide path

At 15:27:20, the glideslope descent was initiated. The go-around altitude was not set by the crew. The flight parameters during the glideslope descent are provided in Fig. 6 and Fig. 7.

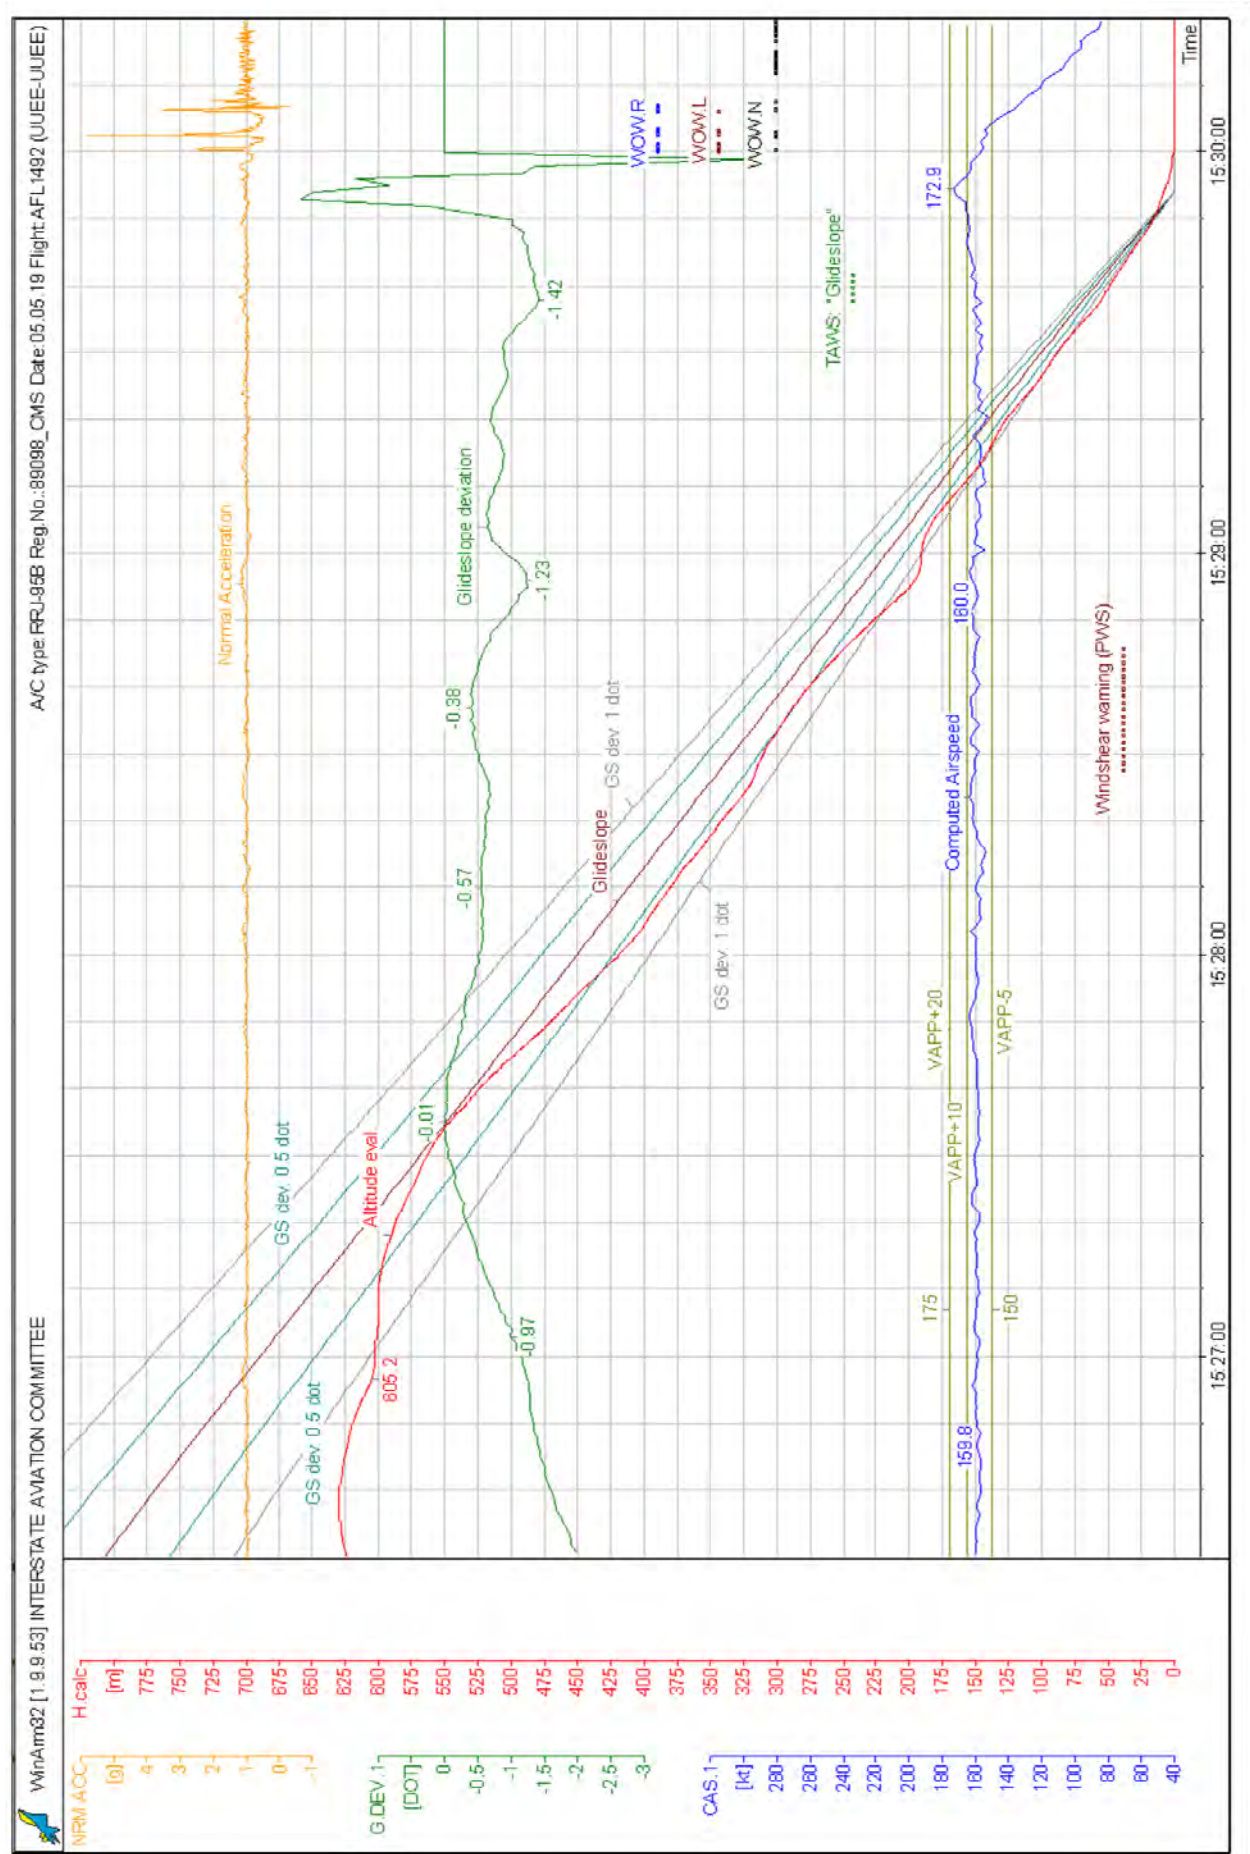
Fig. 7. Vertical approach profile via the glideslope

The descent was performed at the indicated air speed of 155...160 kt (287...296 km/h) parallel to (lower) the prescribed glideslope (Fig. 7). The heading deviation did not exceed 0.5 dot.

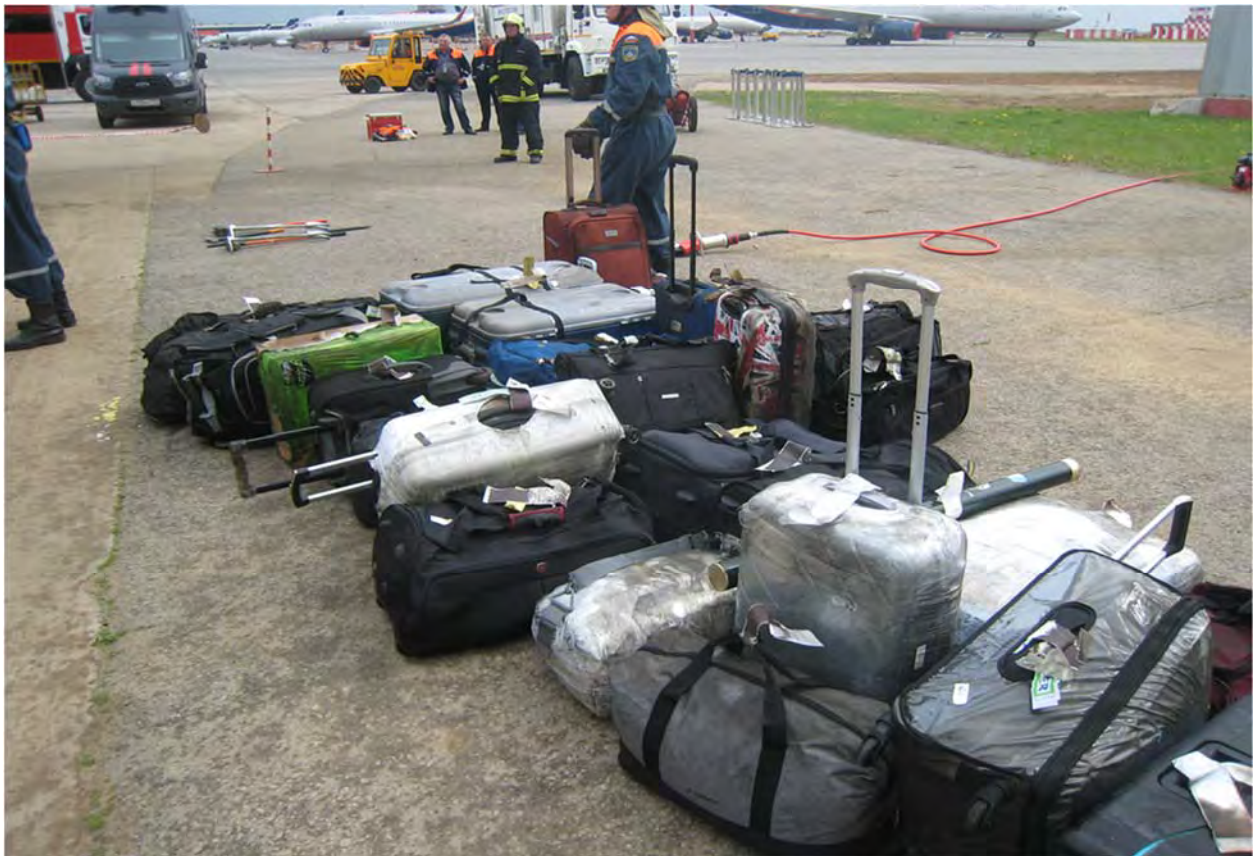
Rear baggage compartment damaged partially, there are no signs of open fire in the compartment. There is soot on the front wall of the compartment and the baggage of the passengers (Fig. 18). The access to the rear baggage compartment after the accident was carried out through the upper hatch with no mechanical damage (Fig. 19).

**Fig. 18. Passenger baggage from the rear baggage compartment after the accident**

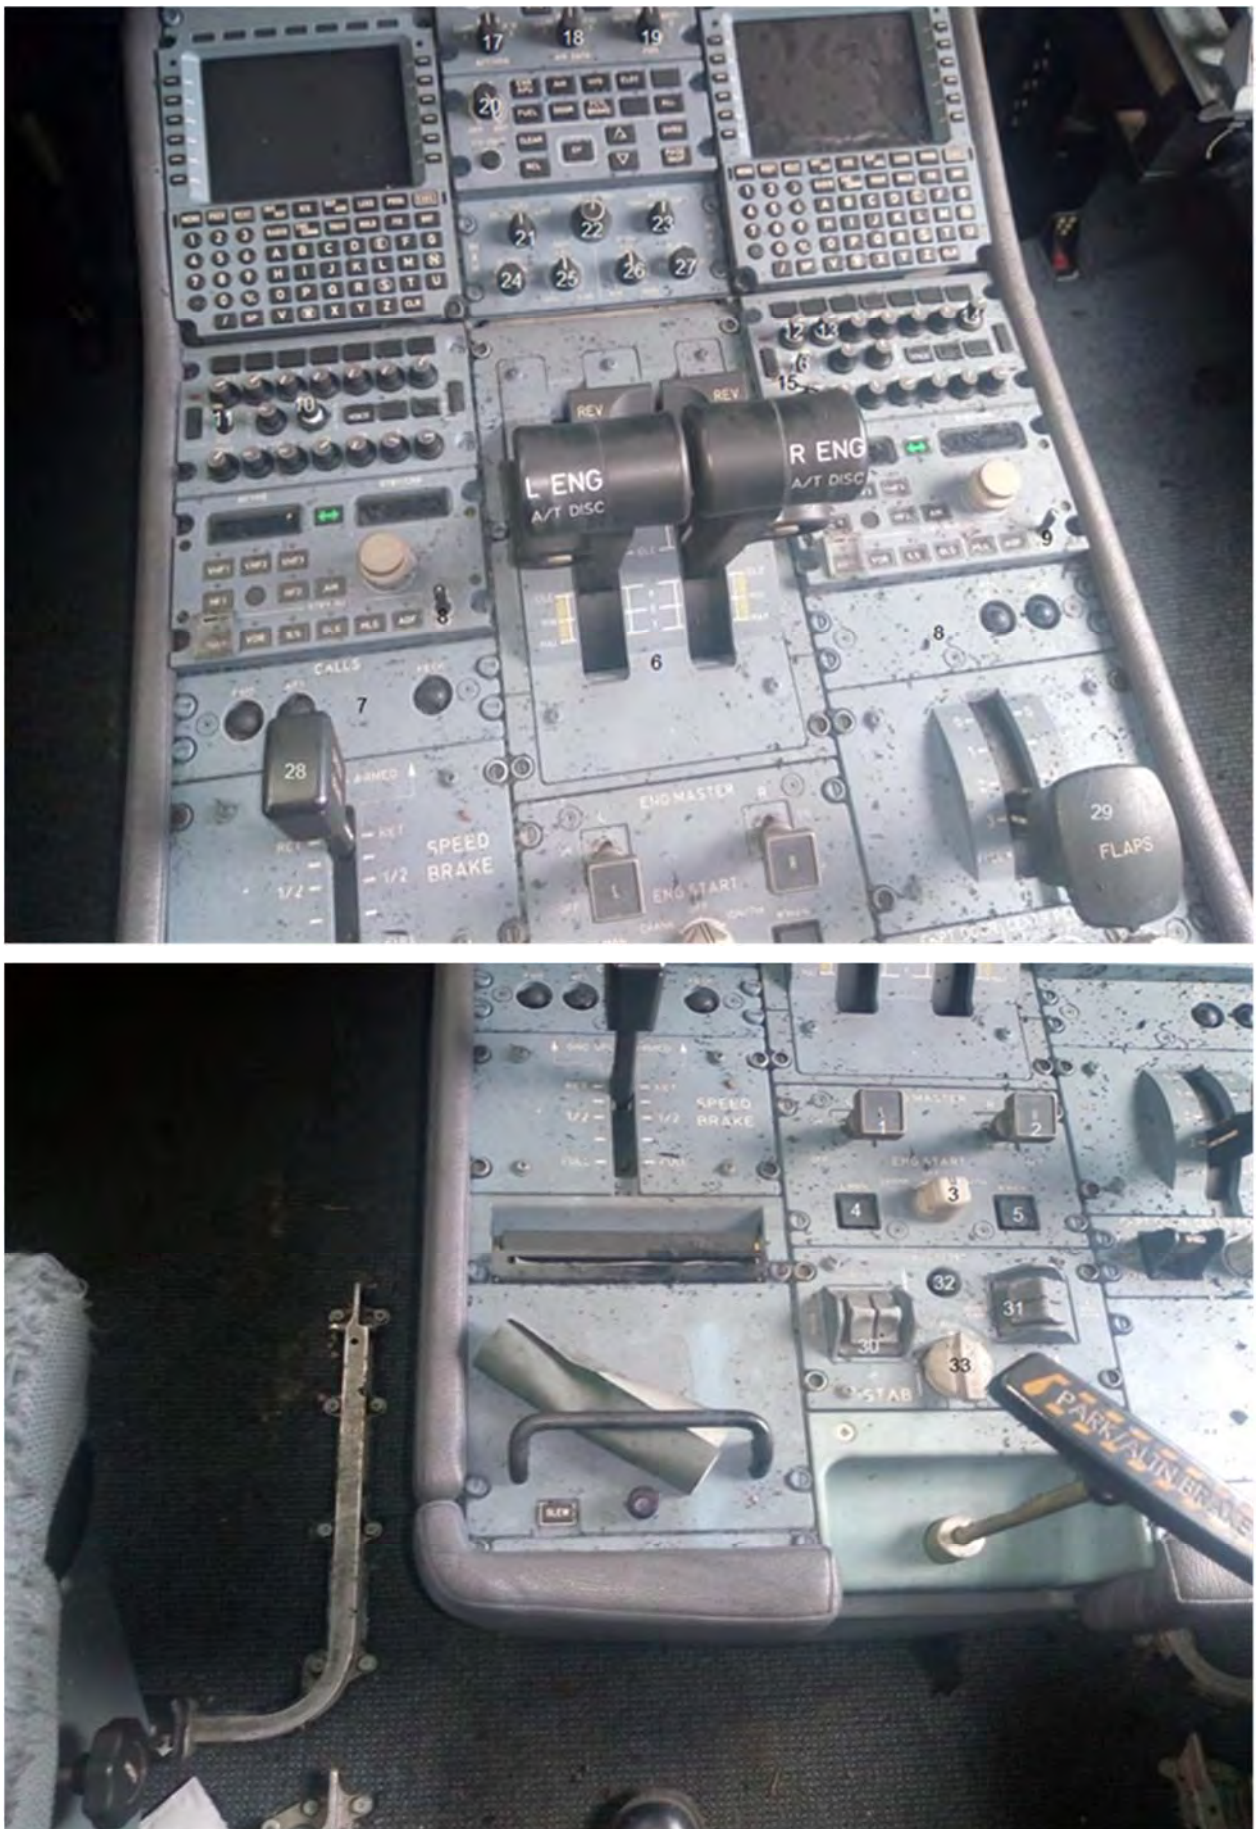
The following position of engine start switch (Fig. 20), electrical battery control and fire extinguish systems set.

Fig. 20. Engine control switch after the accident

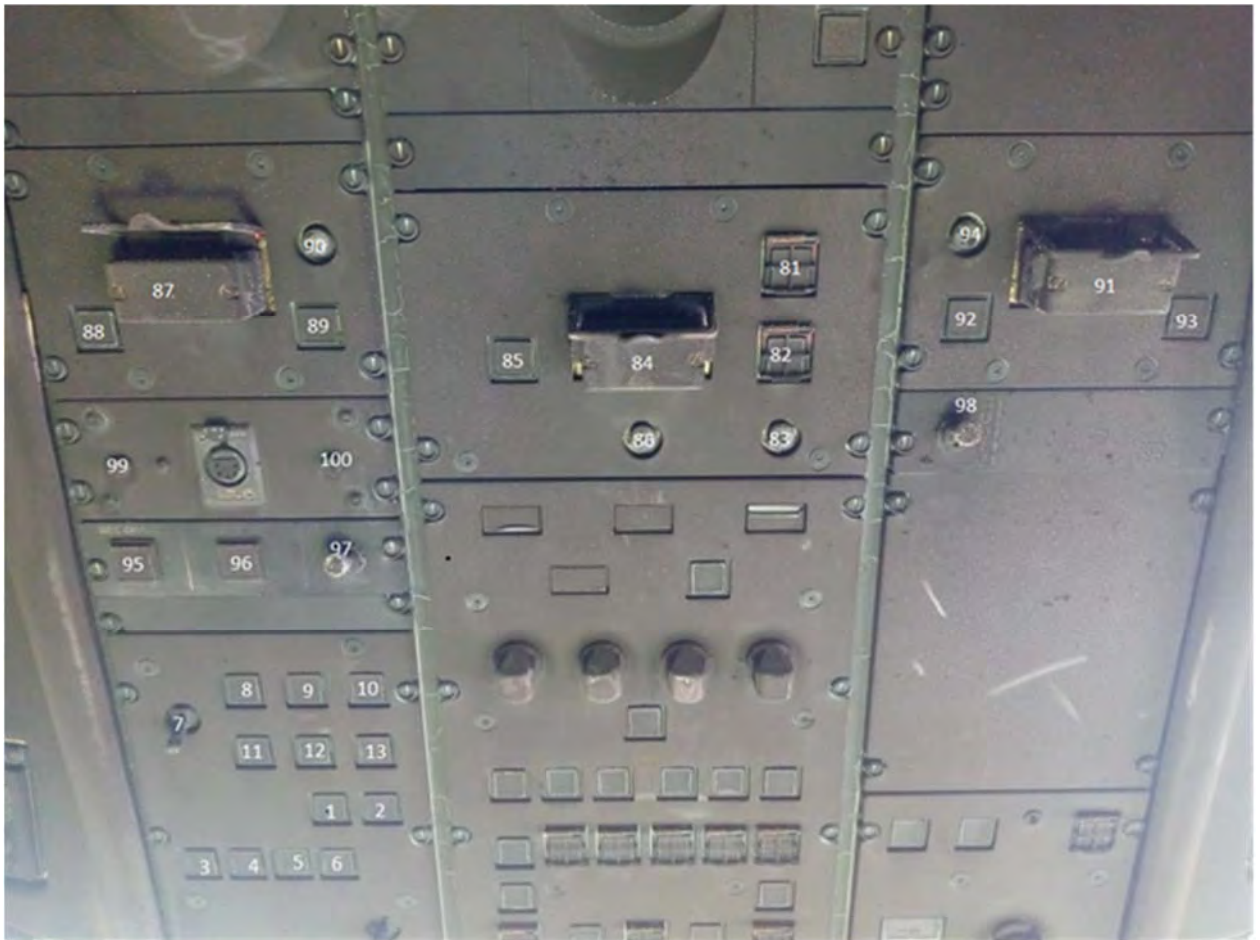
The examination of the cockpit equipment after the accident showed that APU FIRE (APU fire protection system, Fig. 21, position № 84), L ENG FIRE (left engine fire protection system, Fig. 21, position № 87) and R ENG FIRE (right engine fire protection system, Fig. 21, position № 91) were «Activated».

The fire extinguish system containers were weighted in order to determine whether they were used during the last flight. It was determined that all the containers were full. The APU fire extinguish system container was not detected.

**Fig. 21. Engines and APU fire extinguish systems switch condition after the accident**

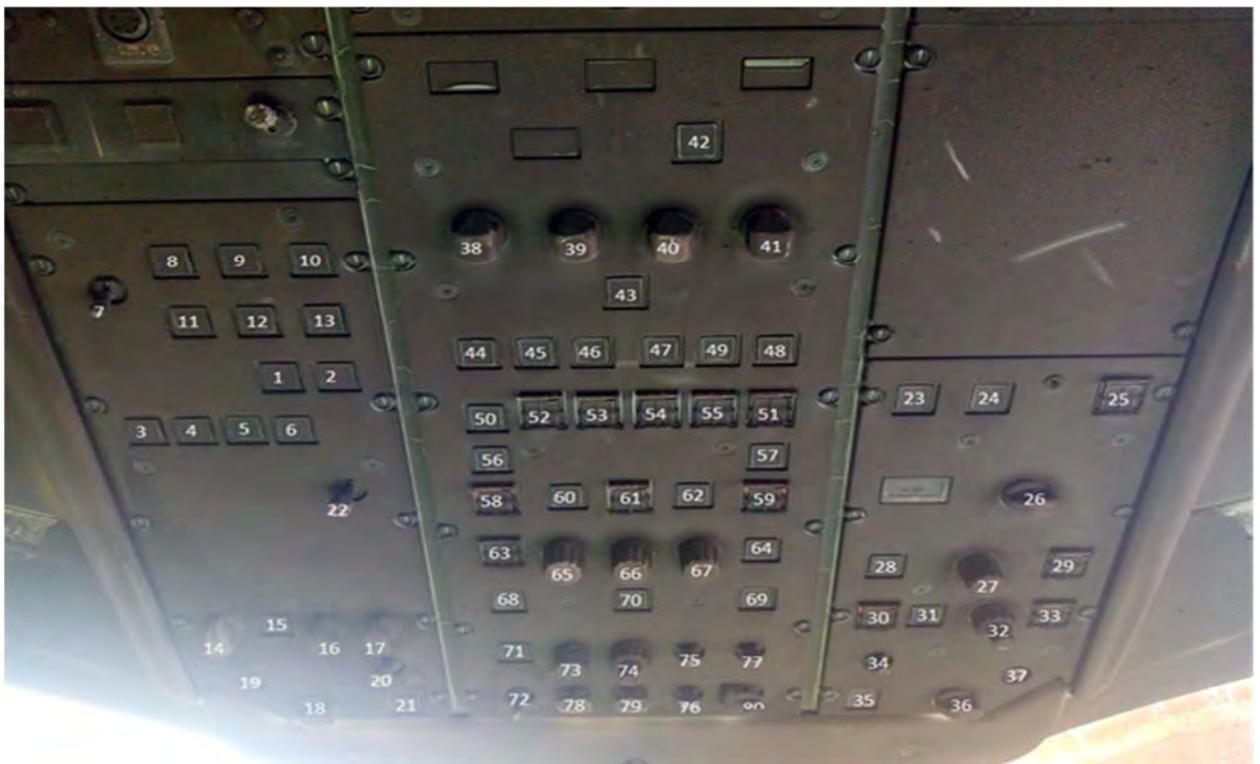
The buttons of all the for electrical batteries are off. (Fig. 22, positions №№ 52, 53, 54, 55).

**Fig. 22. Electrical batteries buttons condition after the accident**

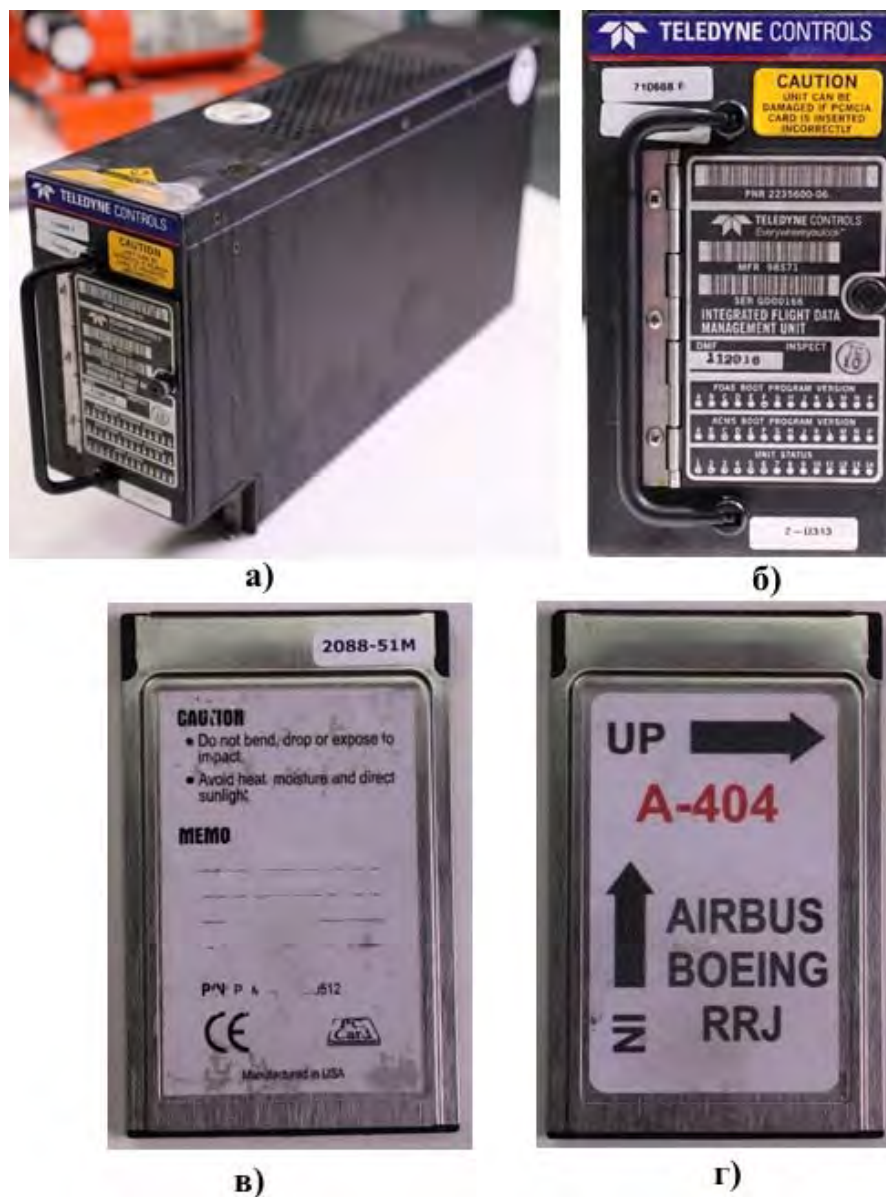
- CVR L3 FA2100 PNR 2100-1025-12 was damaged, its housings and protected memory module are covered with soot, no deformation (Fig. 31);
- Integrated Data Management Unit (iDMU) PNR 223560006 with a PCMCIA Flash-card s/n 2088-51M. The body of the iDMU is not damaged, was not exposed to fire, is in satisfactory condition (Fig. 32).

Fig. 32. Integrated Data Management Unit (iDMU) with Flash-card PCMCIA №2088-51M: a) general view of the unit; б) device label; в, г) Flash-card PCMCIA №2088-51M

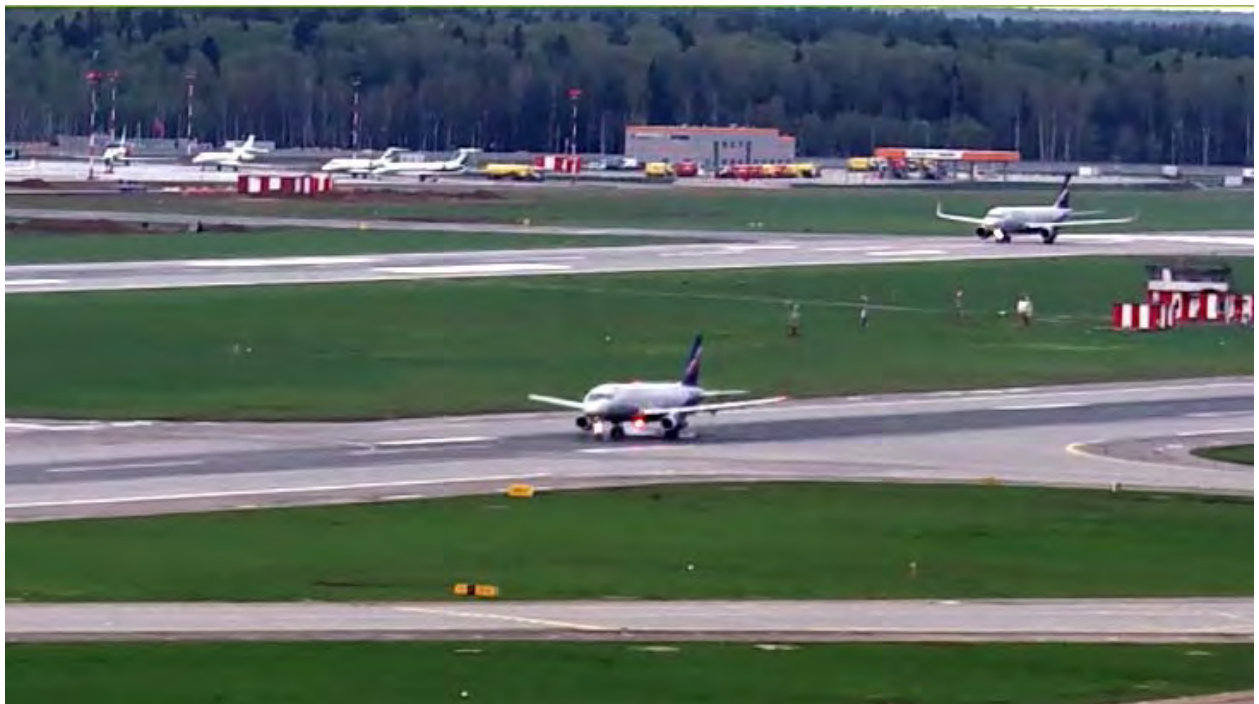
As per the records of the Sheremetyevo CCTV the first touchdown occurred with all the three landing gear legs at once at the A8 TWY at a distance  $\approx 890$  m off the RWY 24L threshold (Fig. 33), the aircraft bounce off the RWY occurred afterwards (Fig. 34).

**Fig. 33. First touchdown point**

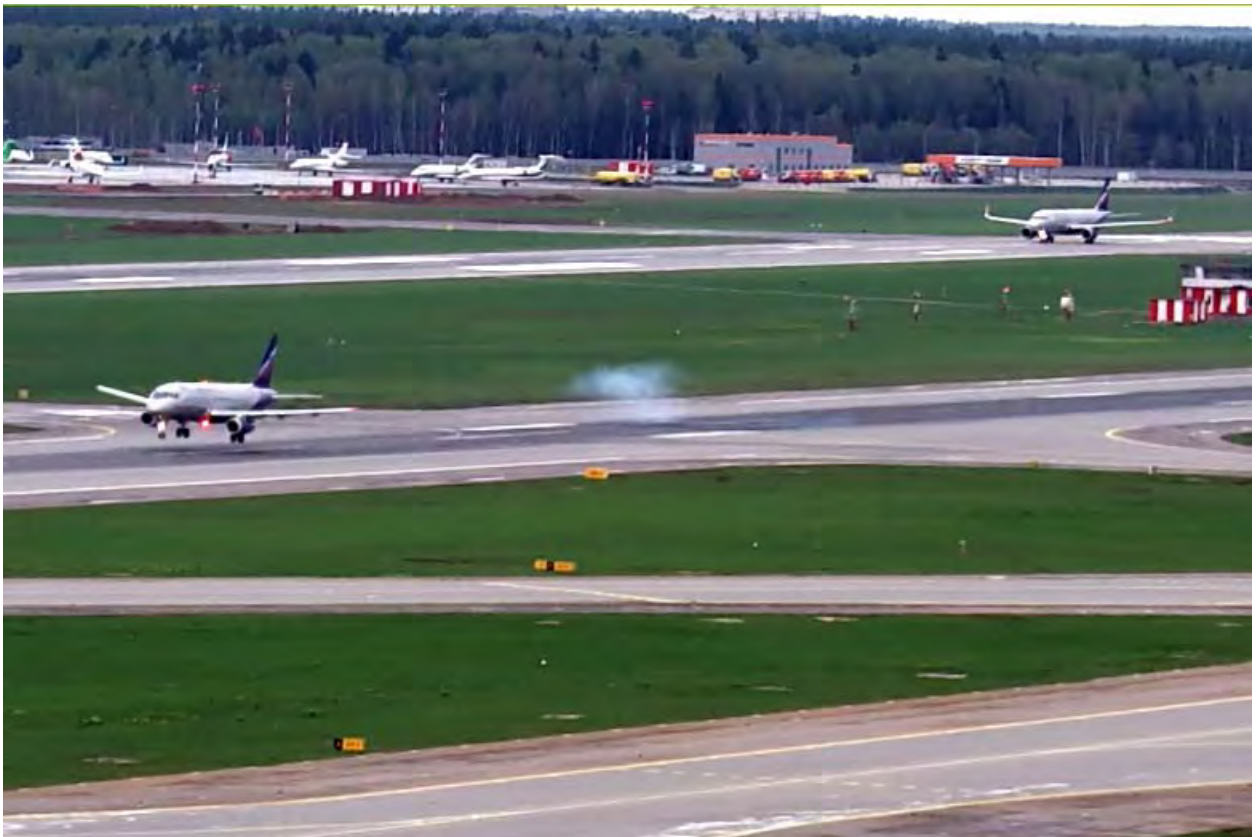
**Fig. 34. The bounce after the first touchdown**

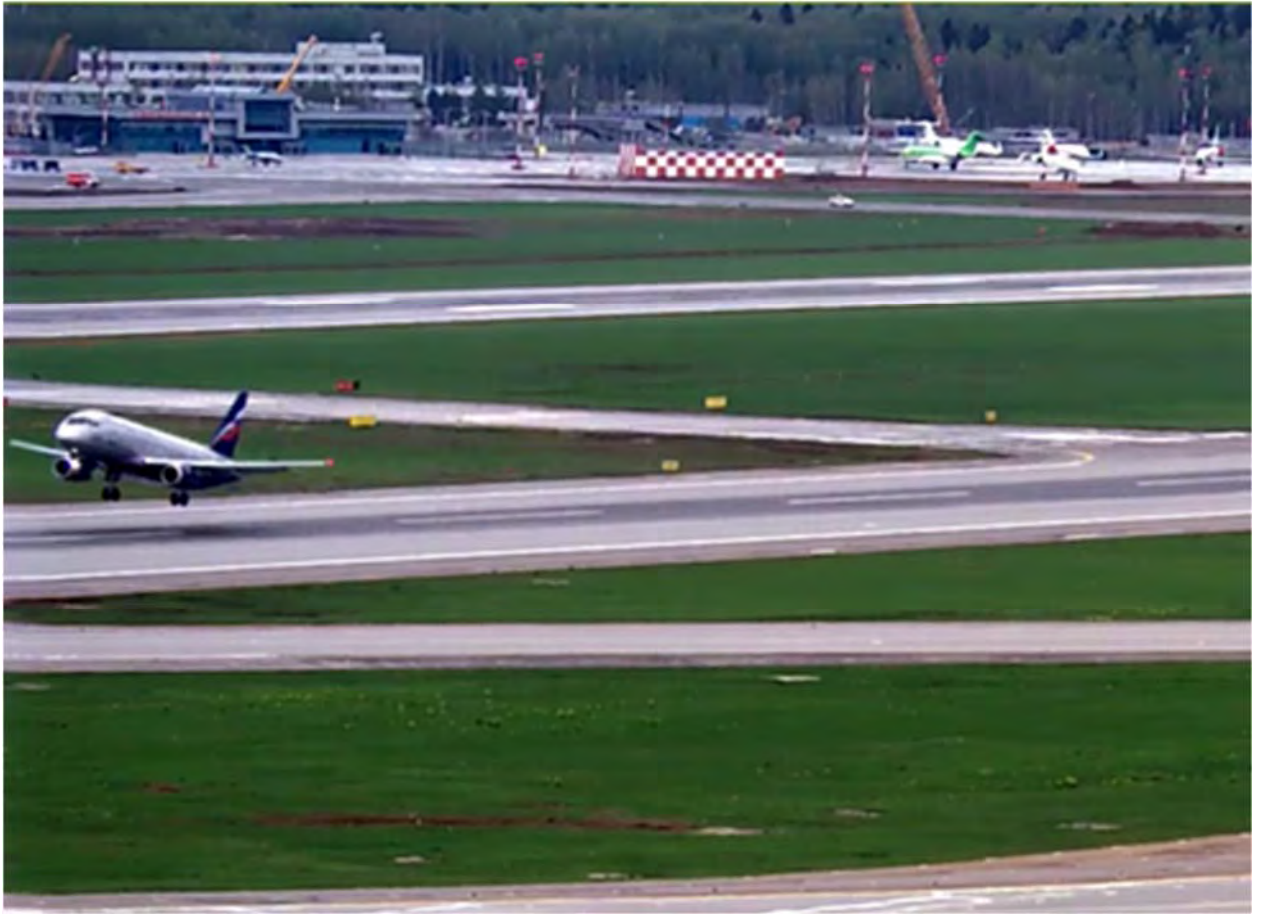
The second touchdown occurred at the distance of  $\approx 1070$  m from the RWY 24L threshold, first by the nose gear leg with the further main gear legs impact with the RWY (Fig. 35), another bounce off the RWY occurred afterwards (Fig. 36). At the area of the second impact there were no fuel traces or aircraft fragments found.

**Fig. 36. The aircraft bounce after the second touchdown**

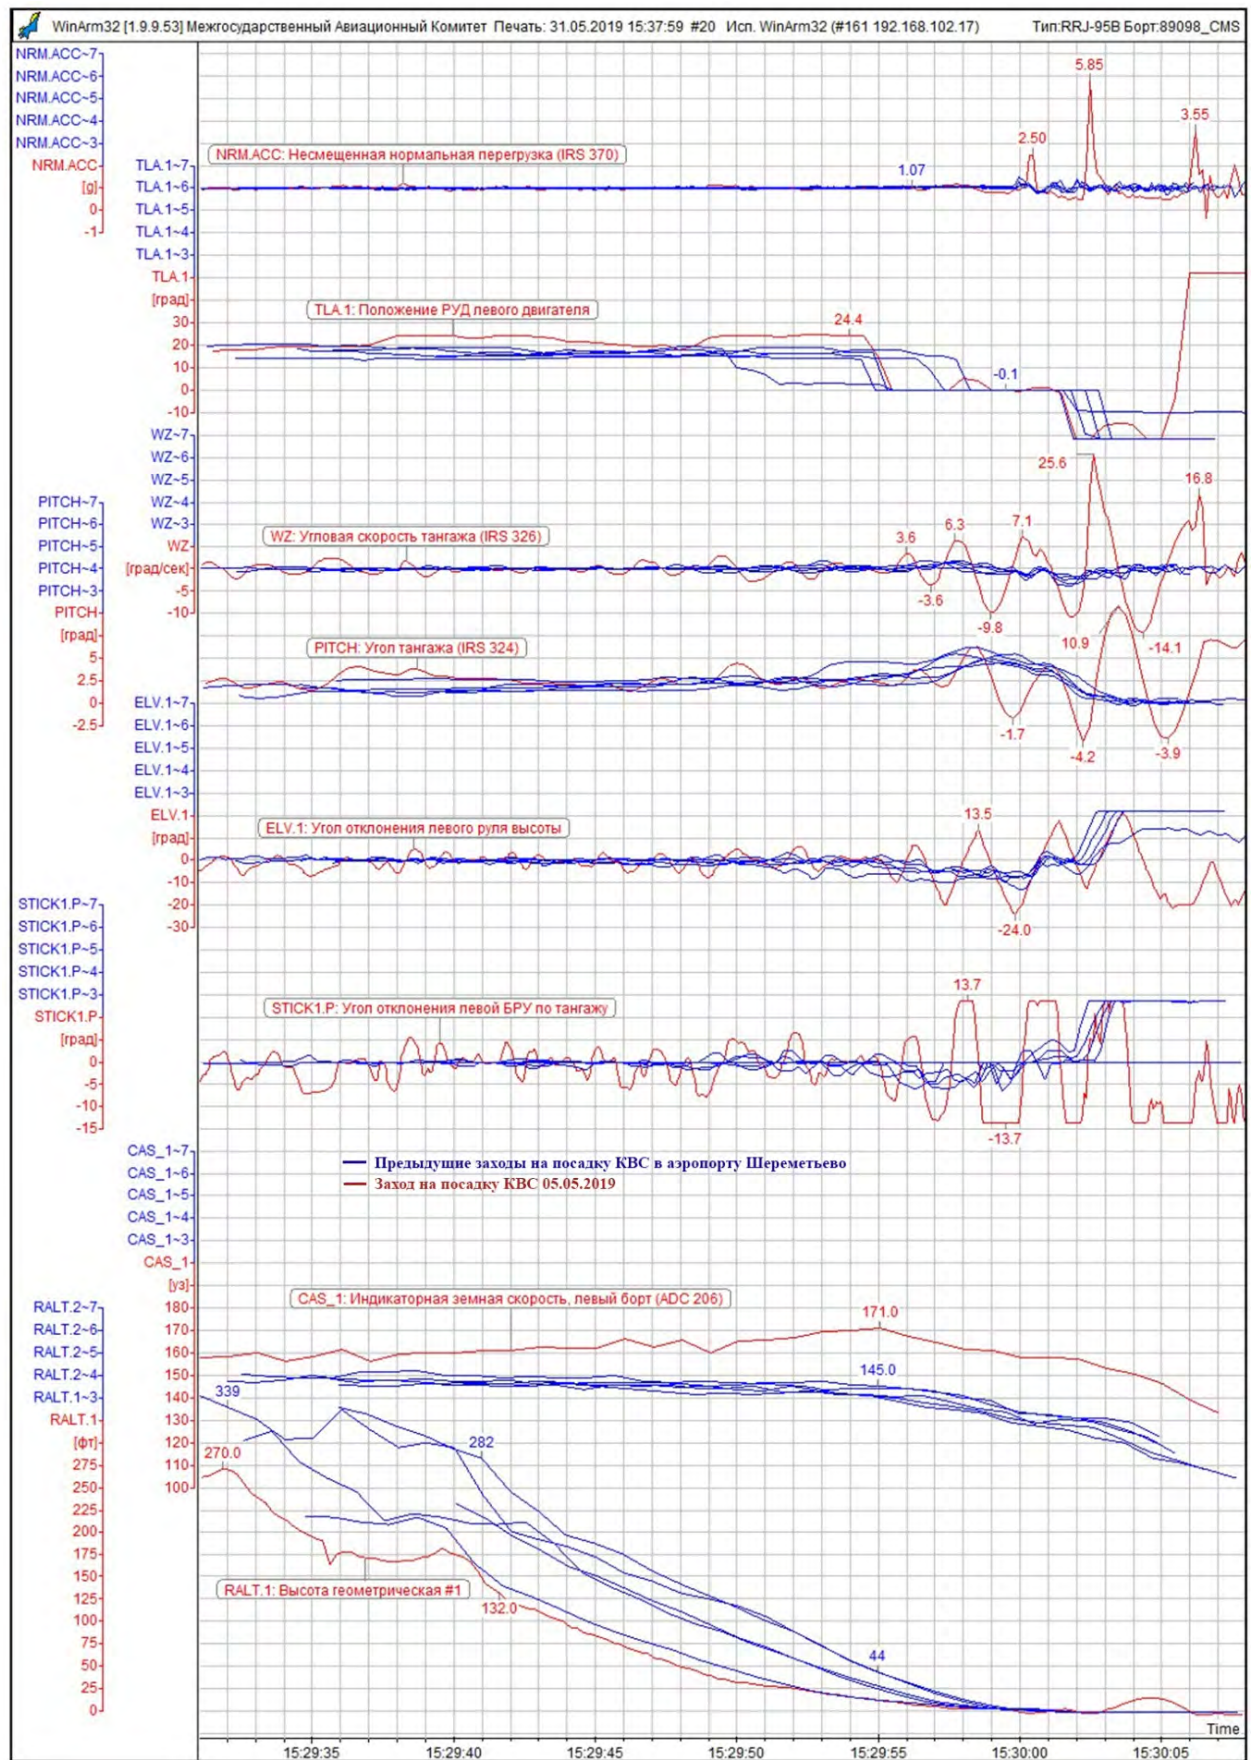
Fig. 42. PIC approach comparative analysis

The Commission carried out preliminary comparative analysis of the approaches performed by the PIC manually (with disengaged autopilot) in «NORMAL MODE», with the emergency flight (Fig. 42). The figure shows that the sidestick movements for the pitch in the emergency flight are characterized by significantly wider amplitude, and are oscillatory, which caused significant changes of longitudinal motion parameters.

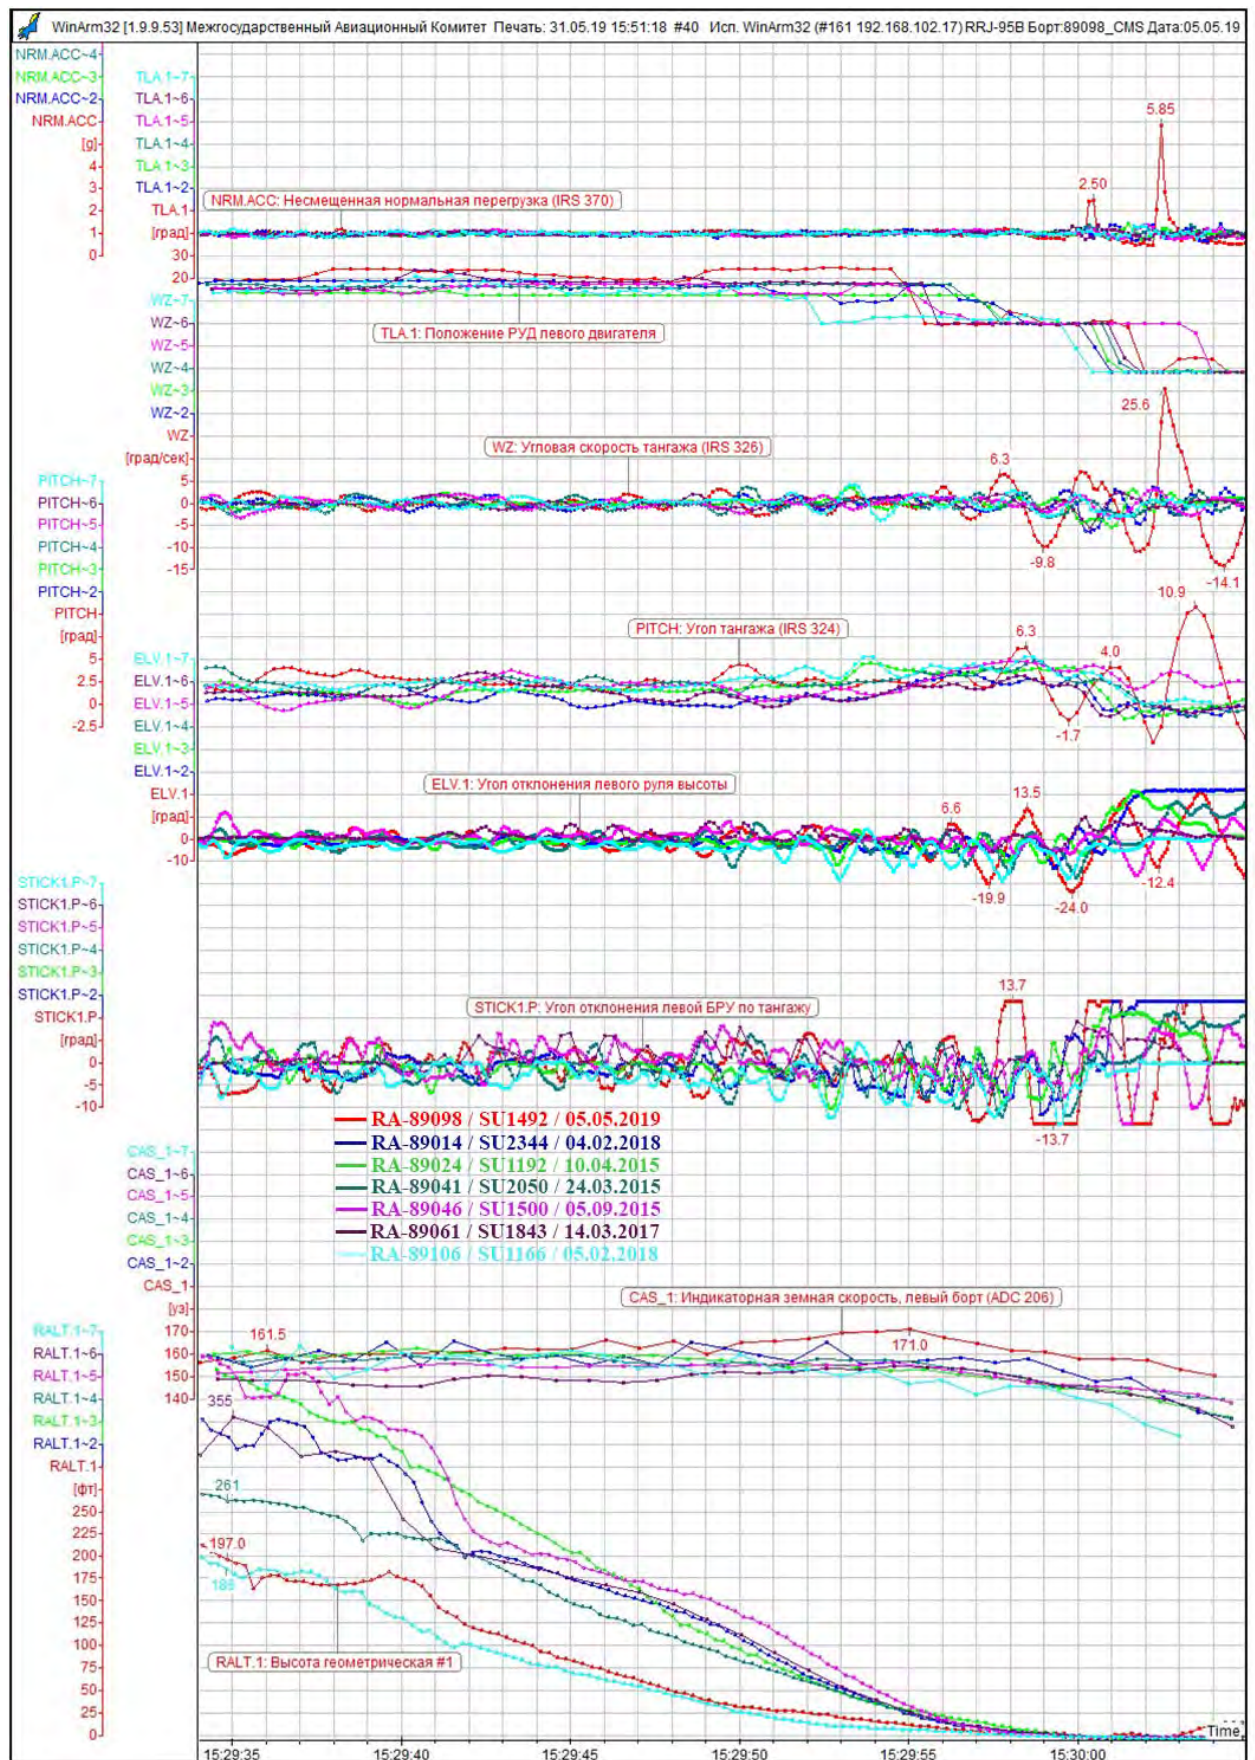
Fig. 43. Approach comparative analysis performed in DIRECT MODE

Similar "sweeping" movements were observed during landing performed in «DIRECT MODE» by other crews of the airline (Fig. 43). Reasons of these peculiarities are being analyzed.
