# Report

Accident on **16 October 2012**  
at **Lorient Lann Bihoué (56) Aerodrome**  
to the **the Bombardier CRJ-700**  
registered **F-GRZE**  
operated by **Brit Air**

**BEA**

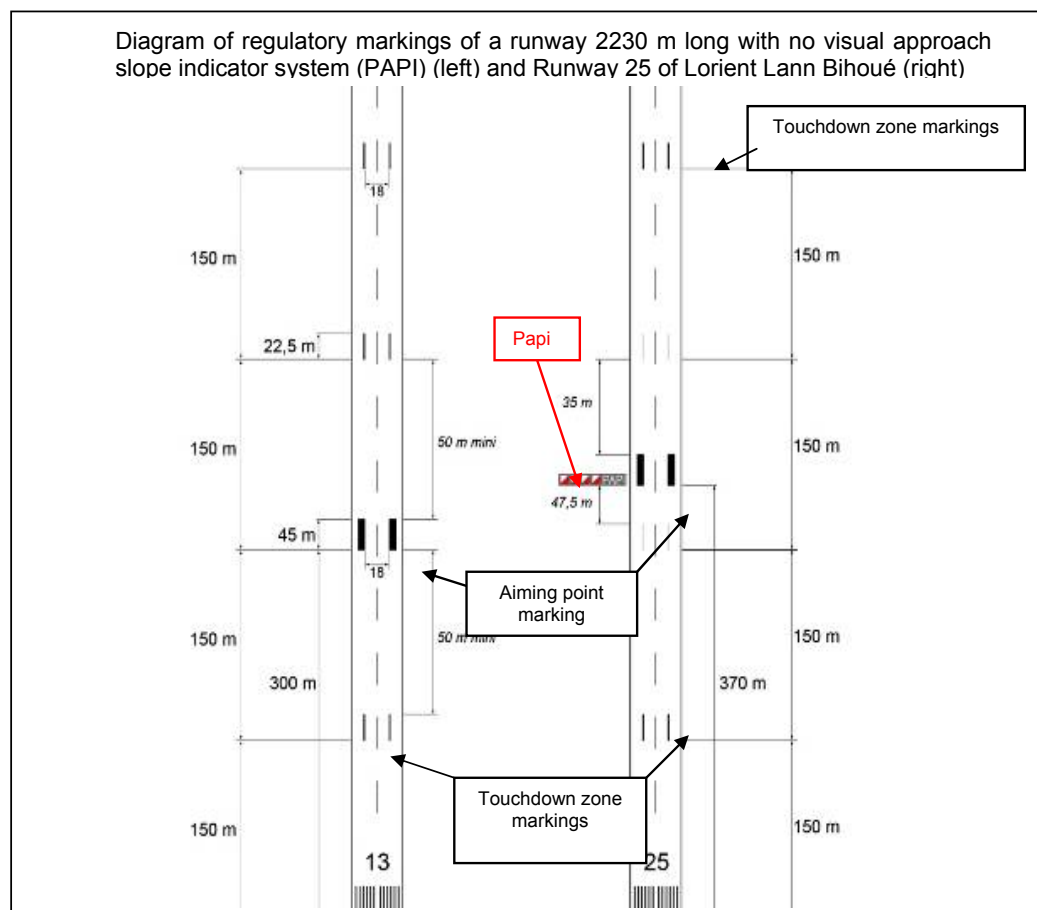
At Lorient Lann Bihoué, the PAPI is located 370 m from the threshold of runway 25. The aiming point markings are therefore also located in the same place. Touchdown zone markings are placed 150 and 600 m from the runway threshold. The other touchdown zone markings (theoretically 300 and 450 m from the runway threshold) are not apparent due to their proximity to the aiming point markings.

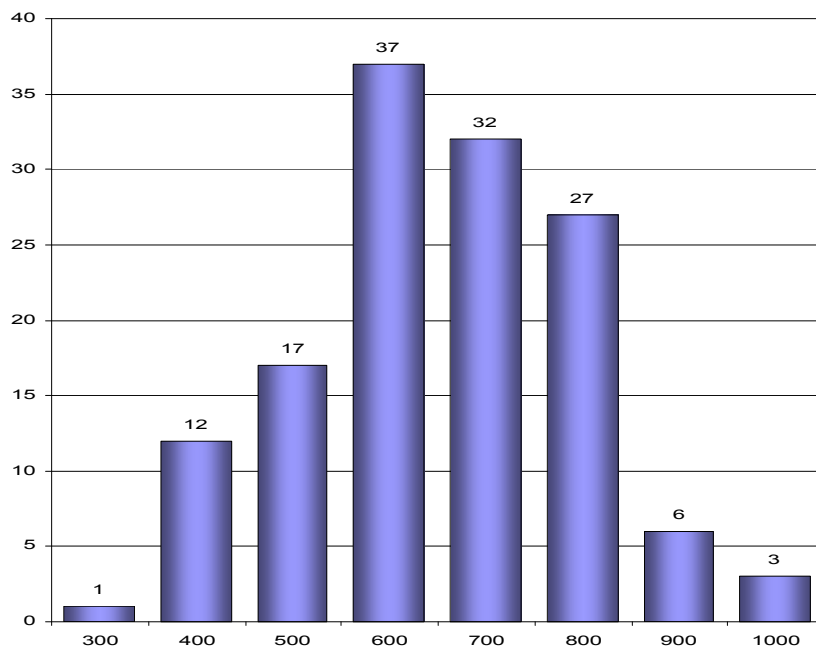
- Long landings in CRJ-1000 from May 2011 to December 2011 (Lyon Saint-Exupéry) runway 36 L (LDA: 4000 m)

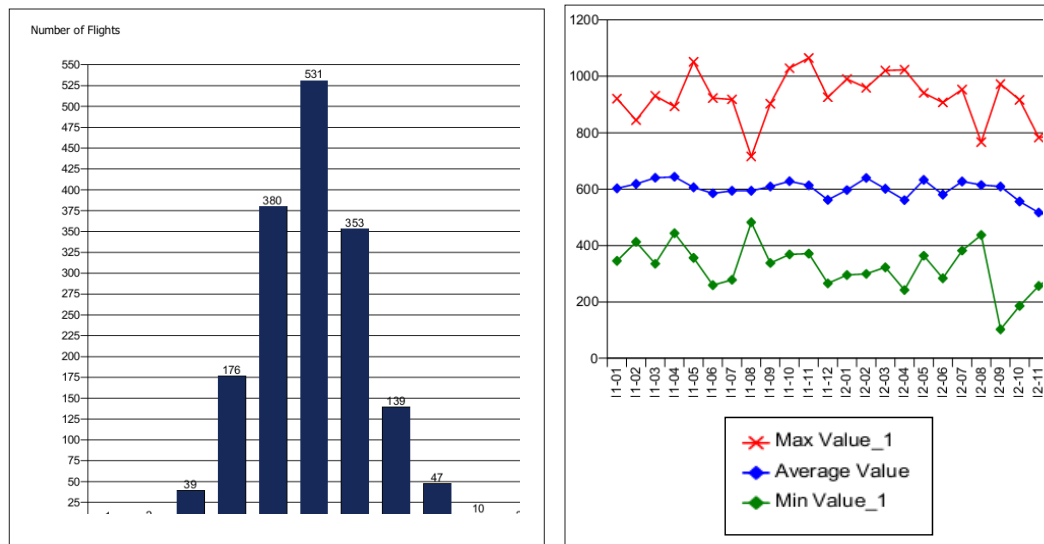
- Number of CRJ-700 long landings compared to the total number of CRJ-700 landings on runway 25 at Lorient Lann Bihoué from January 2011 to December 2012.
