**FINAL REPORT**

**AIC 18-1004**

**AIR NIUGINI LIMITED**

**Boeing 737-8BK**

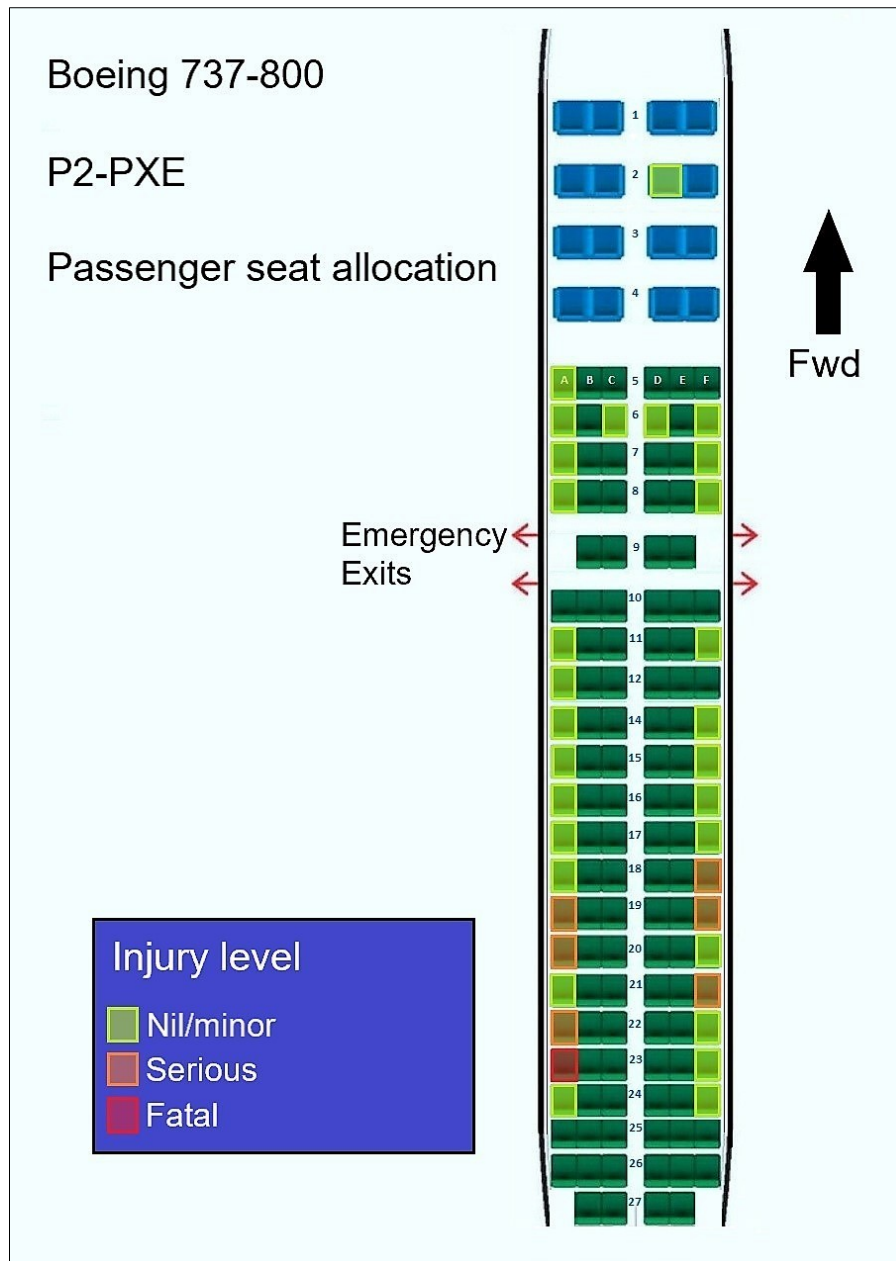
Figure 2: Passenger seating allocation showing injury status.

The nationalities of the seriously injured passengers were: two Chinese, three Vietnamese, and one from the Philippines (See Figure 2 for seat positions).

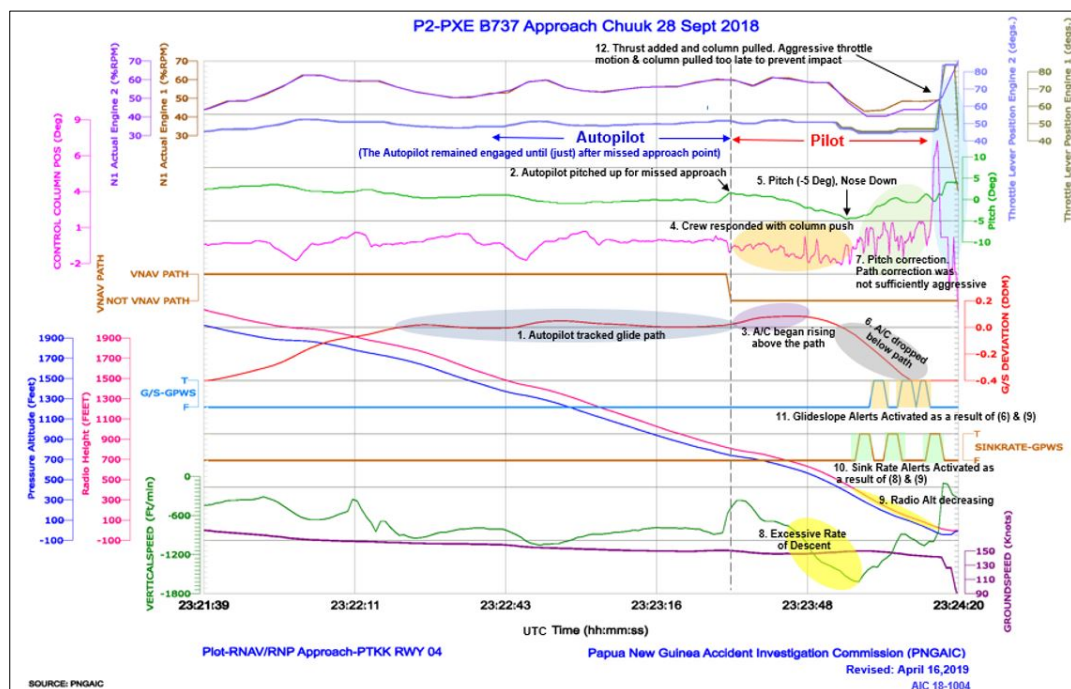
Figure 6: FDR data plot

The SSFDR data revealed that during the approach from 1,000 ft amsl, with the auto-pilot engaged, the aircraft flight path was relatively constant and consistent with the RNAV profile. The rate of descent was around 600 to 800 ft/min and the groundspeed remained between 149 and 151 kts. The approach was stable.

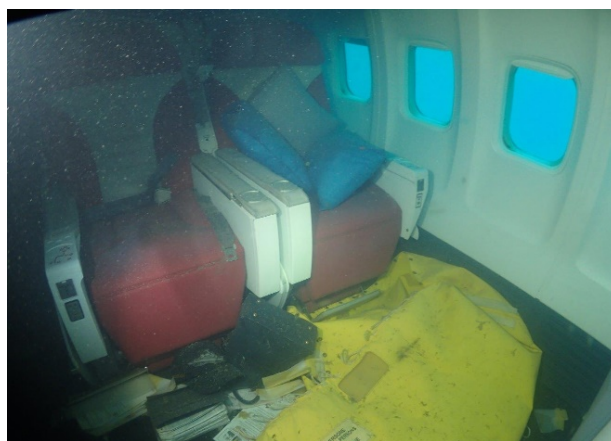
**Figure 22: 56-person life raft cover on the floor in front of Business Class Seats 1A and 1B.**  
(Photo taken by FSM diver)

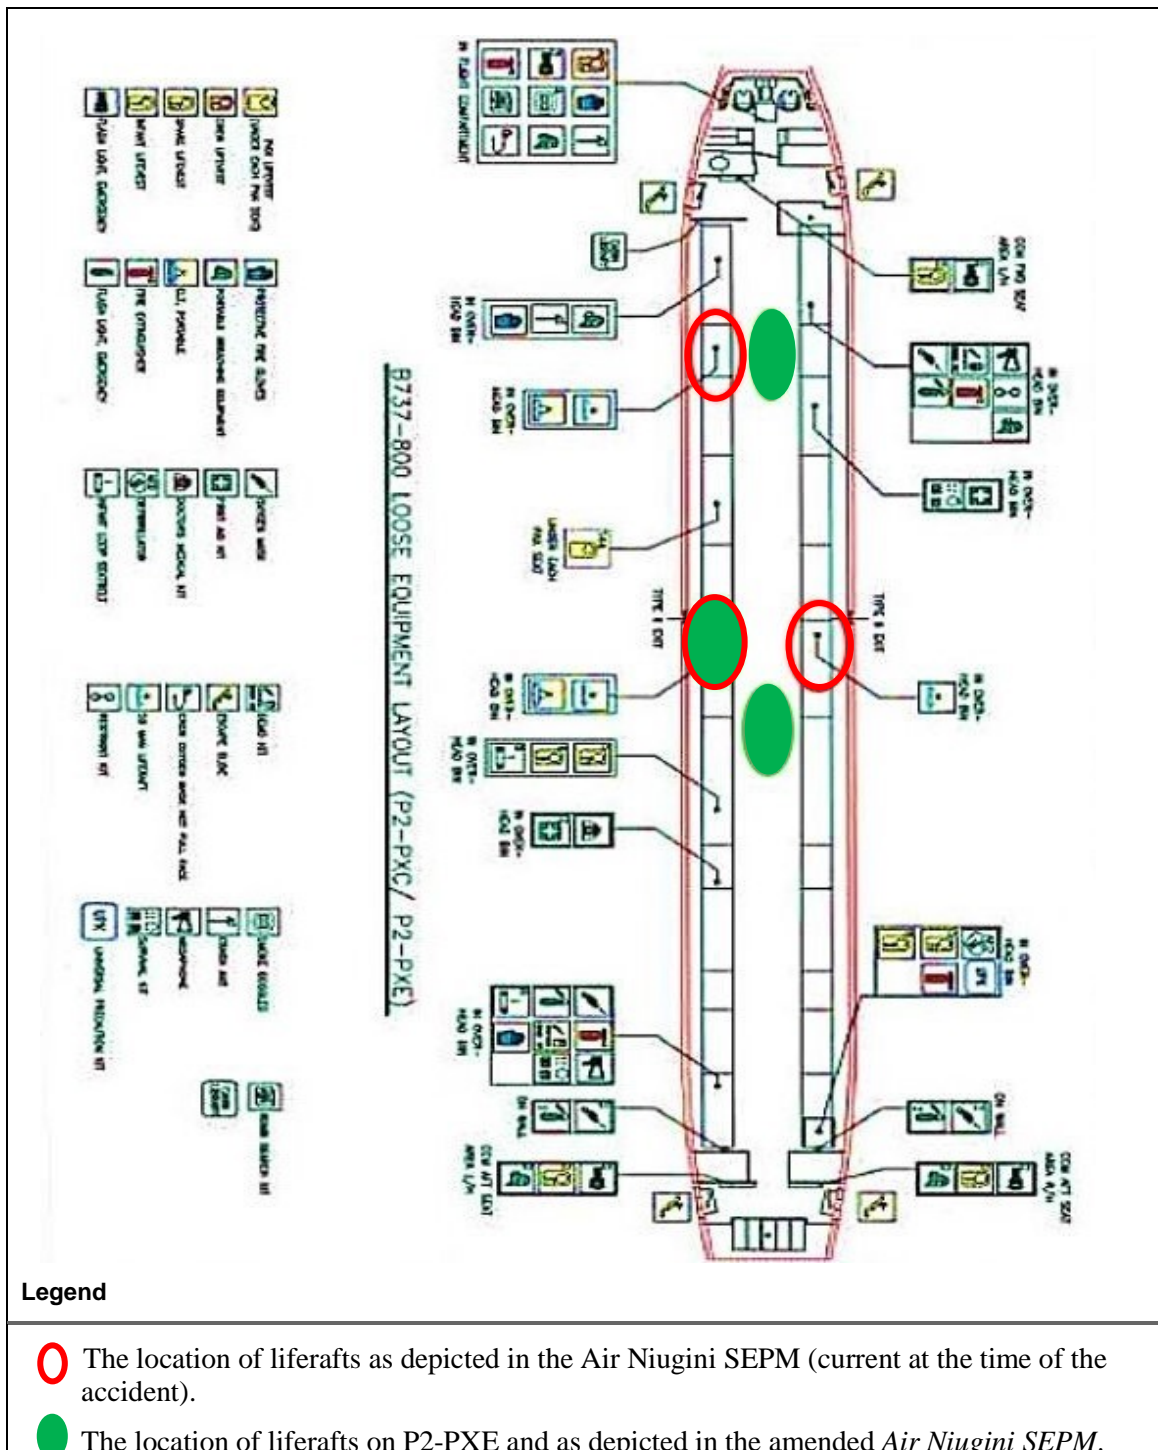
The actual life raft stowage locations on Air Niugini's Boeing 737's PXE and PXC are as follows:

- The Business Class life raft is stowed in the cabin ceiling between seat rows 1 and 2.
- One Economy Class life raft is stowed in the ceiling between rows 12 and 14, behind the over wing exit row; and the other life raft is stowed in the left overhead locker above the exit rows 9 and 10.

**Figure 24: Diagram modified from Air Niugini SEPM – Volume 6 (B737) Section 3.2.2.**

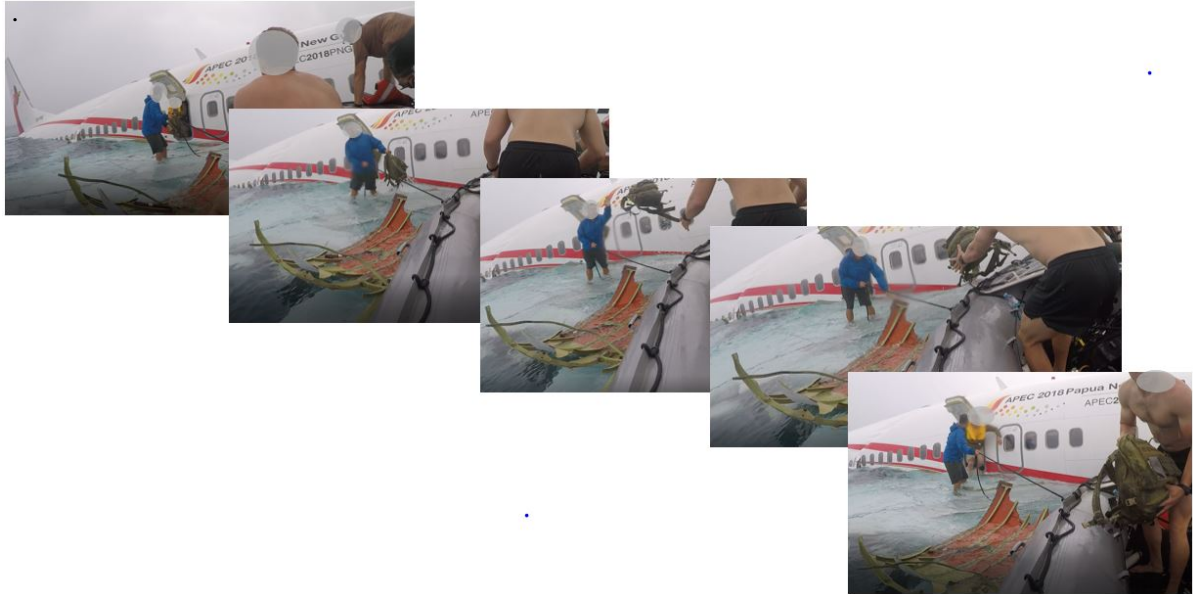
One passenger stopped inside the aircraft and leaned out the right aft over-wing exit to pass a carry-on bag to a US Navy diver standing on the wing assisting the evacuation. That diver first threw the bag to the divers in the rubber inflatable boat before assisting the passenger from the aircraft.

**Figure 26: The first passenger exiting via the right aft over-wing exit after passing a bag to US Navy diver who threw it to divers in the boat.**

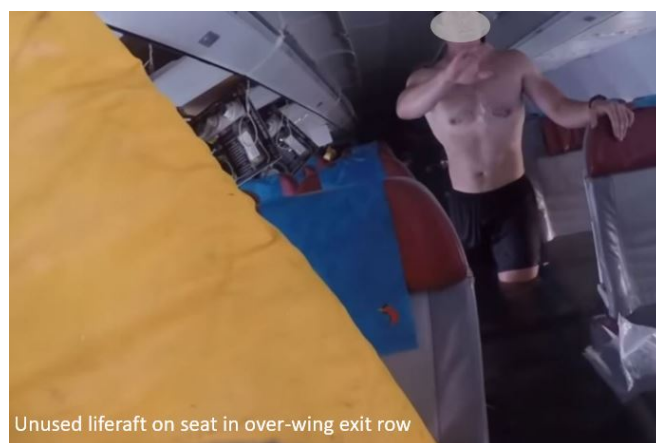
Video footage also showed a US Navy diver standing in thigh deep water two rows behind the over-wing exit in the cabin cautioning fellow rescuers and aircraft crew standing at the exit not to go further aft. He also exclaimed for them all to be careful as he did not know the depth of the water.

**Figure 27: US Navy diver cautioning not to go aft due unknown water depth**

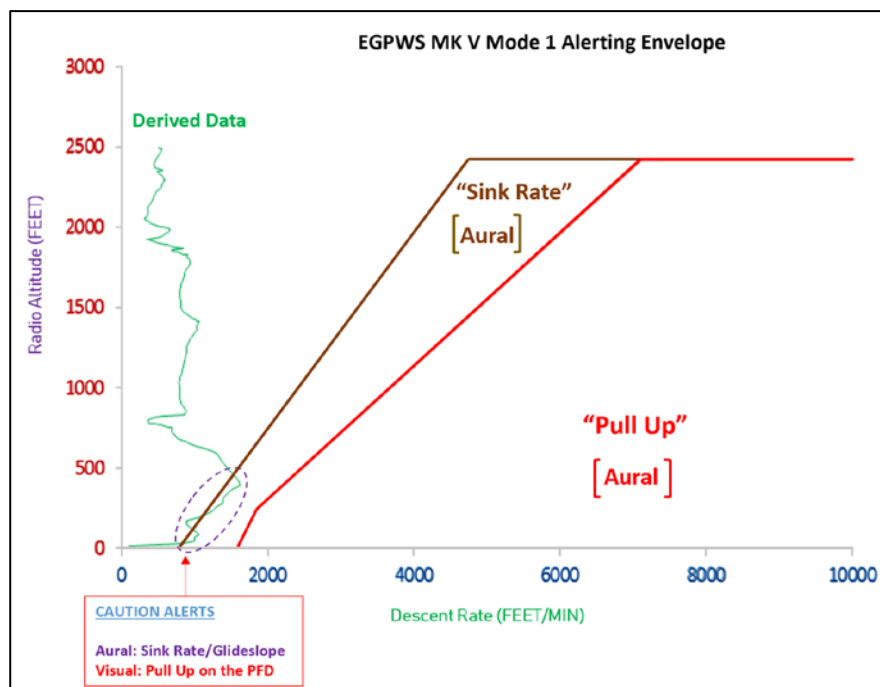
Figure 32: Derived Data plotted against Honeywell EGPWS MK V Mode 1 Graph

The investigation found that the crew did not take any remedial action in response to the *Glideslope* and *Sink Rate Caution*<sup>64</sup> alerts (aural alerts). The EGPWS additionally issued the red **PULL UP** visual alert on the PFD at 307 ft (**364 ft**) when the aircraft penetrated the *Sink Rate Envelope* of the *Honeywell EGPWS MK V Mode 1 Graph*. (See Figure 32).

The PNG Accident Investigation Commission recommends that Honeywell Aerospace should ensure that the Honeywell EGPWS MK V Computer should provide timely and continuous hard aural warning “*WHOO PULL UP*”, simultaneously with the Visual Display of **PULL UP** on the Primary Flight Display, which requires immediate action from the crew, when encountering an excessive Rate of Descent at very low Radio Altitude similar to that flown by the crew of P2-PXE as shown in Figure 1 (*In the stand-alone recommendation AIC 91-R02/18-1004, and Figure 32 of this report*).

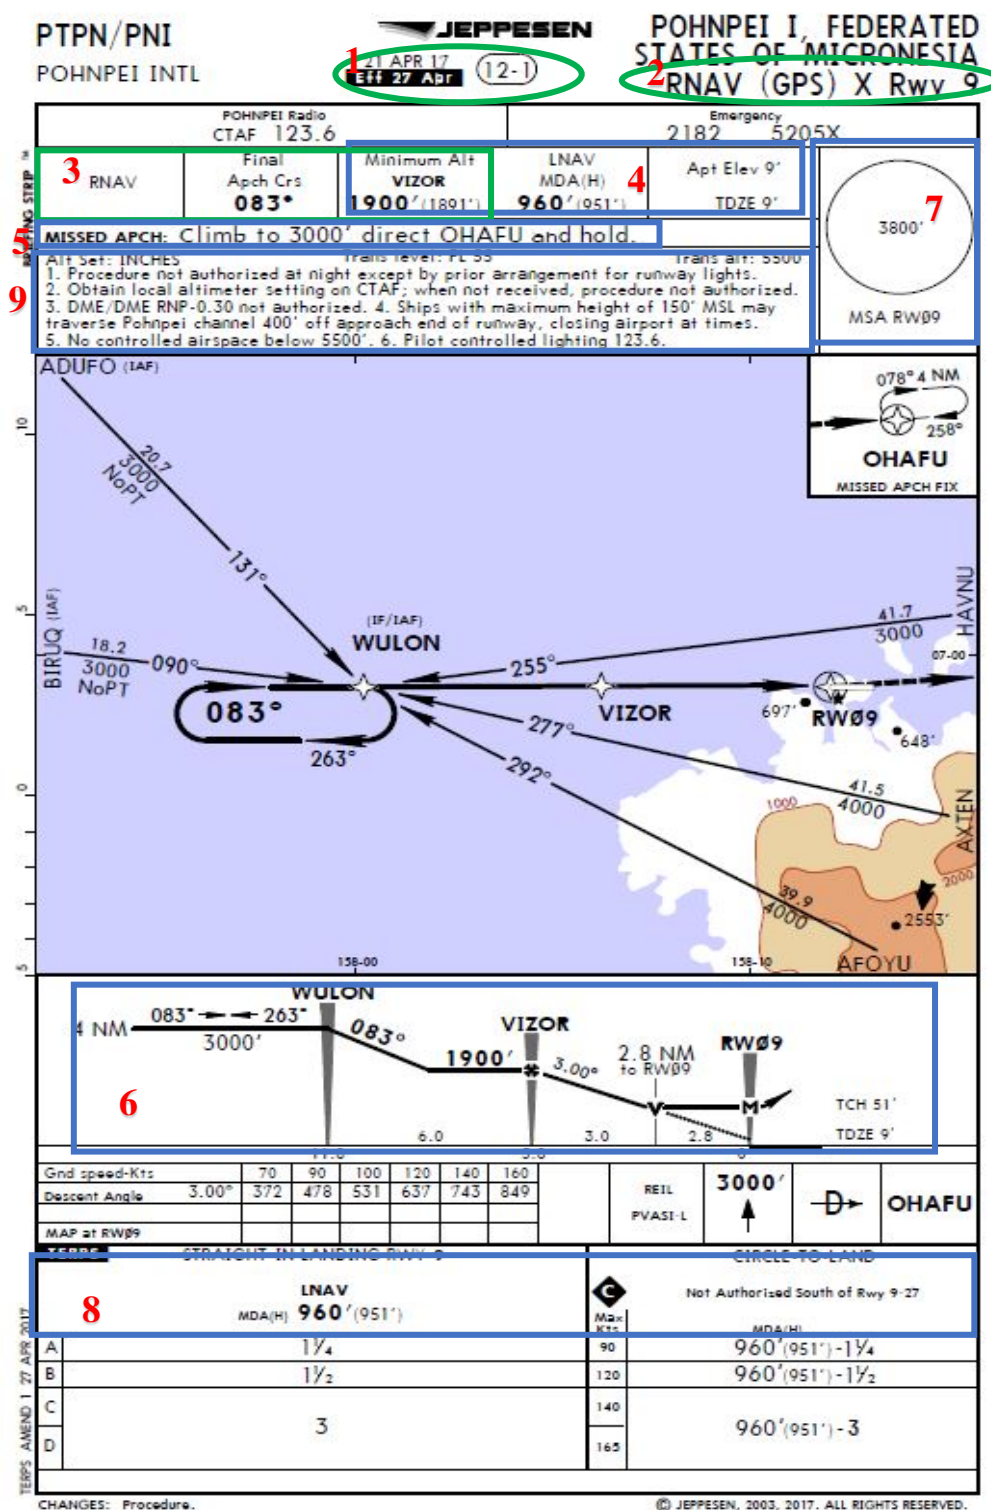
Figure 40: PIC's brief on the PTPN RNAV (GPS) Rwy 9 approach chart
