**KOMITE NASIONAL KESELAMATAN TRANSPORTASI
REPUBLIC OF INDONESIA**

KNKT.18.10.35.04

Aircraft Accident Investigation Report

**PT. Lion Mentari Airlines
Boeing 737-8 (MAX); PK-LQP
Tanjung Karawang, West Java
Republic of Indonesia
29 October 2018**

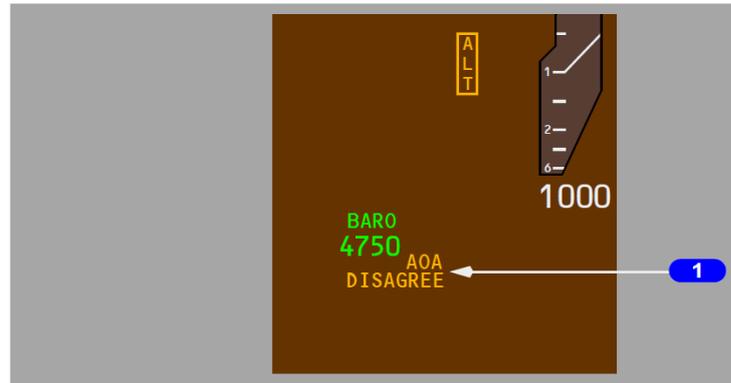
Figure 9: AOA Disagree message on the PFD

As shown in figure 9 the “AOA DISAGREE” message appears on the Captain and First Officer PFD when the values of the left and right AOA transmitted by the ADIRUs differ by 10° or more for 10 continuous seconds. The annunciation is only displayed in the air because AOA values are unreliable when the aircraft is stationary on the ground.

Lion Air did not select the optional AOA indicator feature on the PFD of their 737-8 (MAX) aircraft. As a result, the AOA DISAGREE did not appear on PK-LQP aircraft, even though the necessary conditions were met.

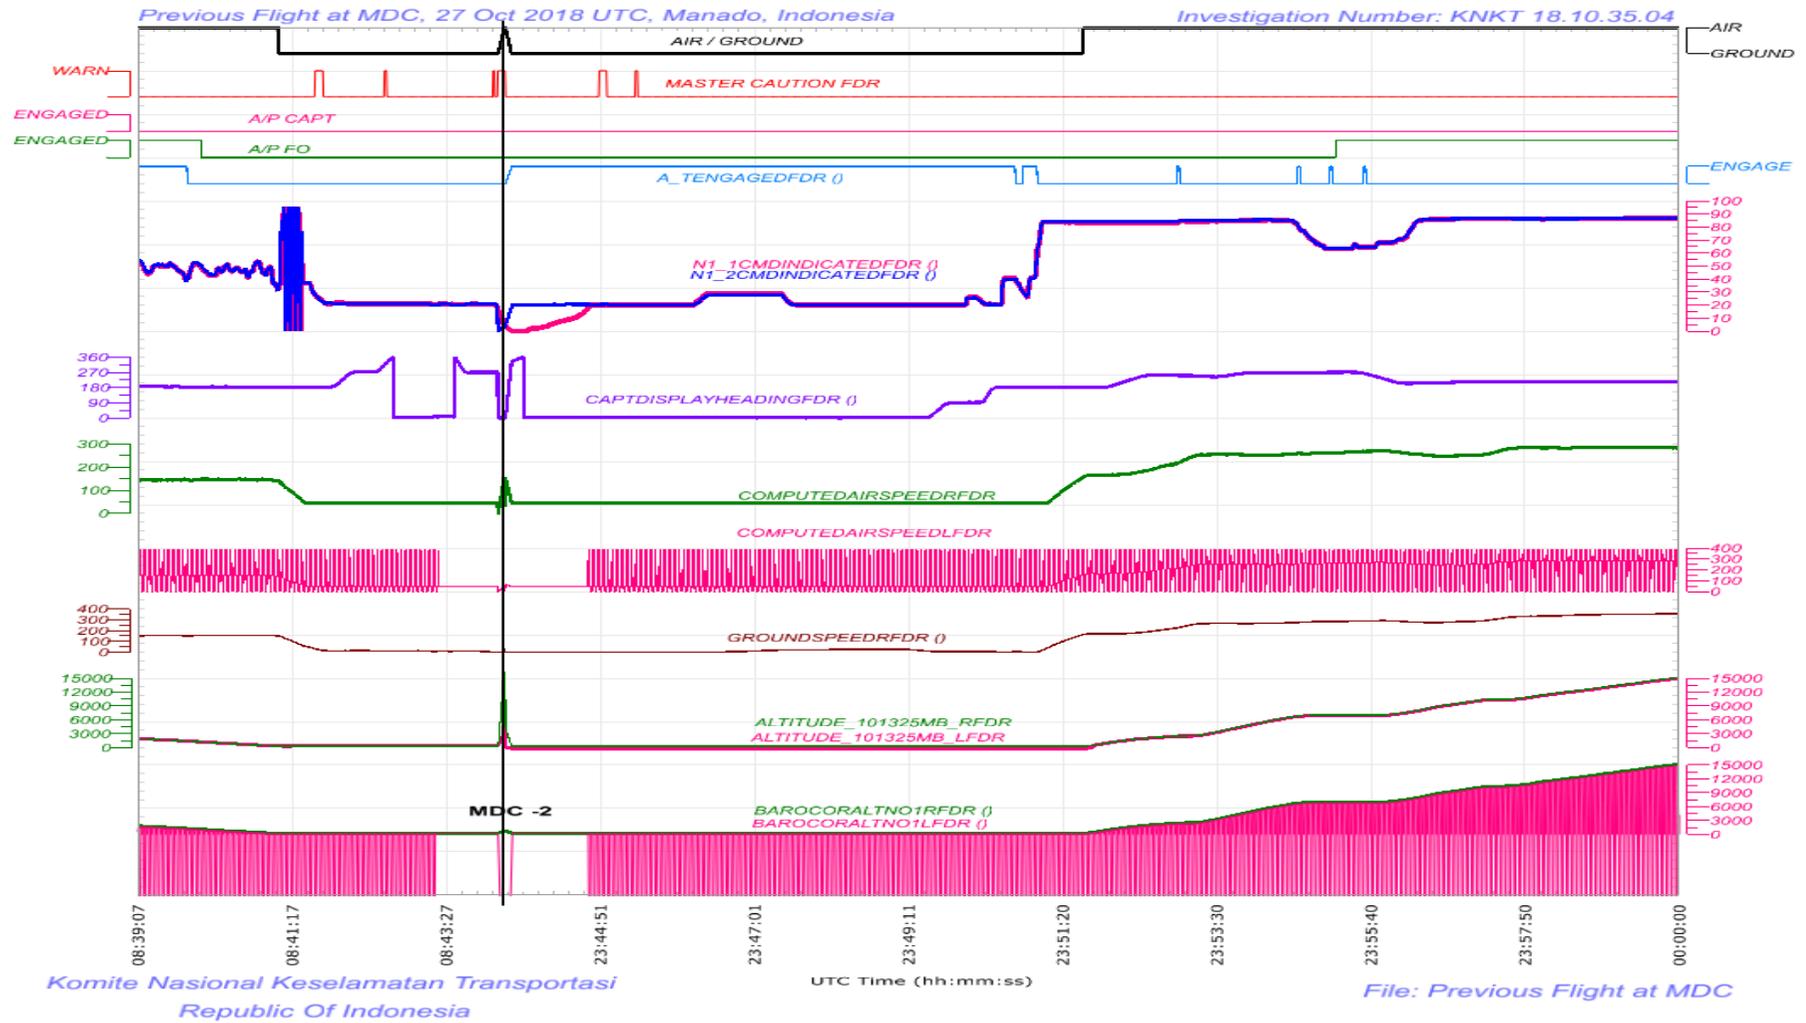
Figure 26: The FDR parameters of the flight from Manado to Denpasar on 28 October 2018 (MDC-2)

The DFDR parameters graphs of the flight from Manado to Denpasar on 28 October 2018 (MDC-2) on figure 26 showed:

6. When the aircraft altitude reached about 7,000 feet (refer to parameters labeled right Barometric Corrected Altitude (BAROCORALTNO1RFDR) and Altitude 101325MBFDR) the first officer autopilot (A/PFO) engaged. Other than the engagement of the autopilot, the DFDR graph did not show any invalid data change.

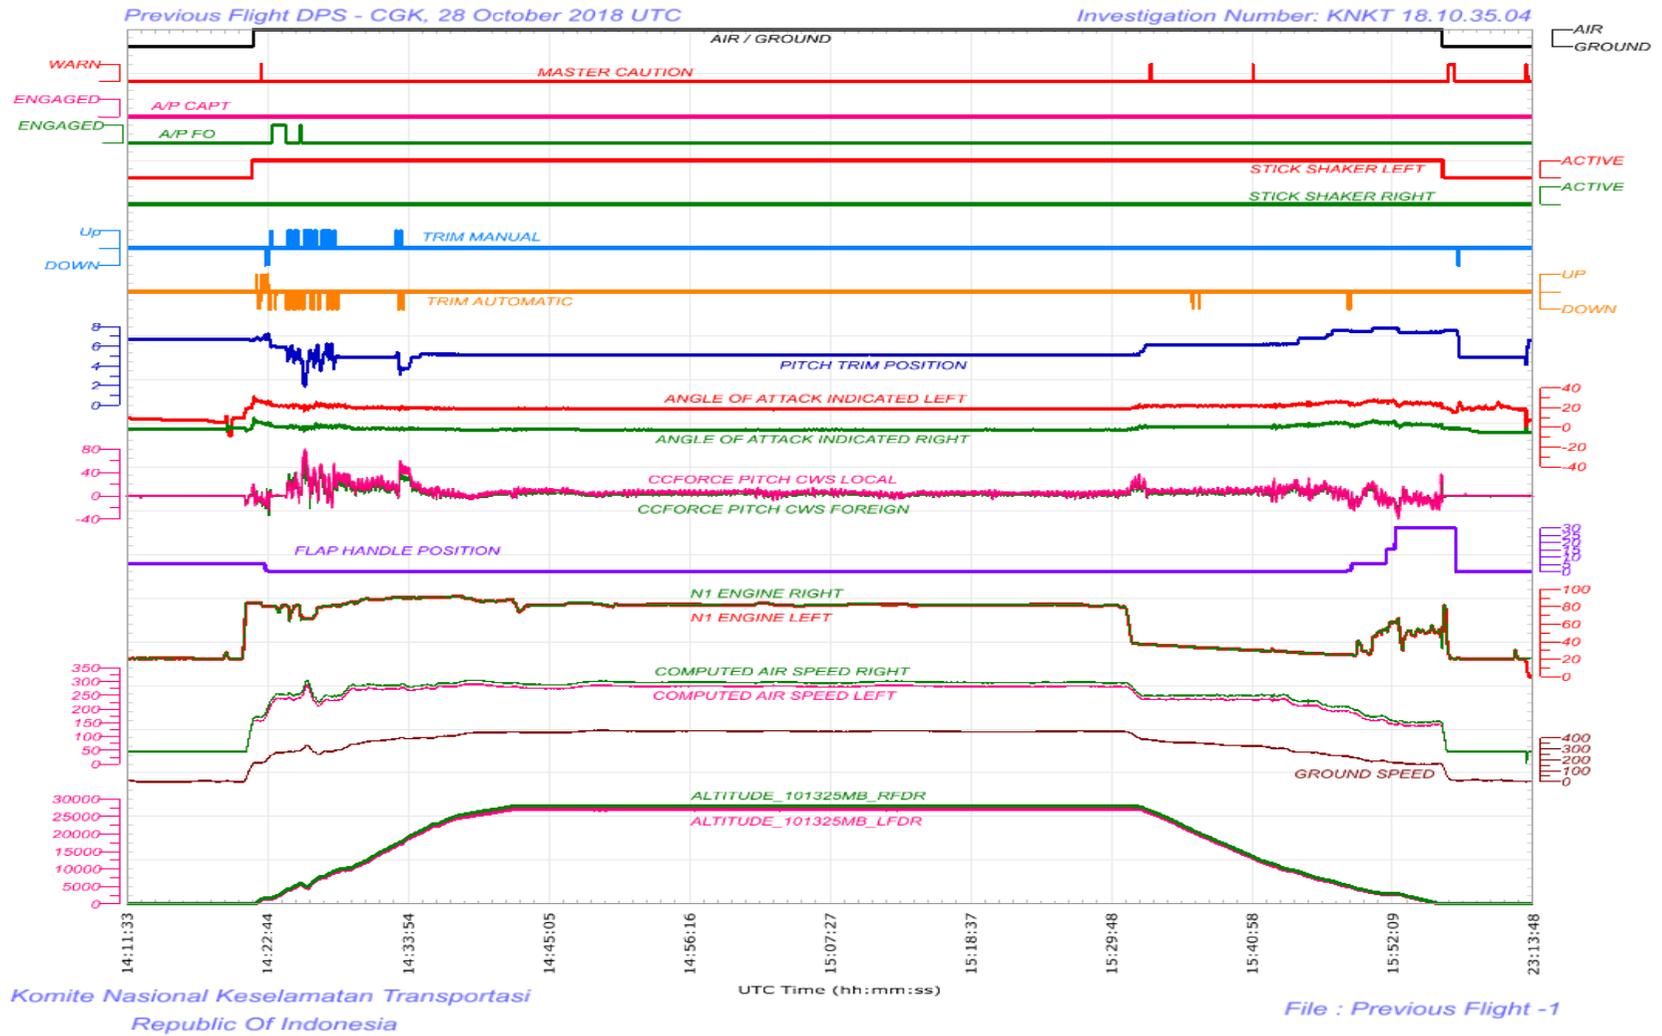
Figure 27: FDR parameters of the flight from Denpasar to Jakarta (DPS-1)

The DFDR parameters of the flight from Denpasar to Jakarta (DPS-1) plotted on figure 27 and 28 showed:

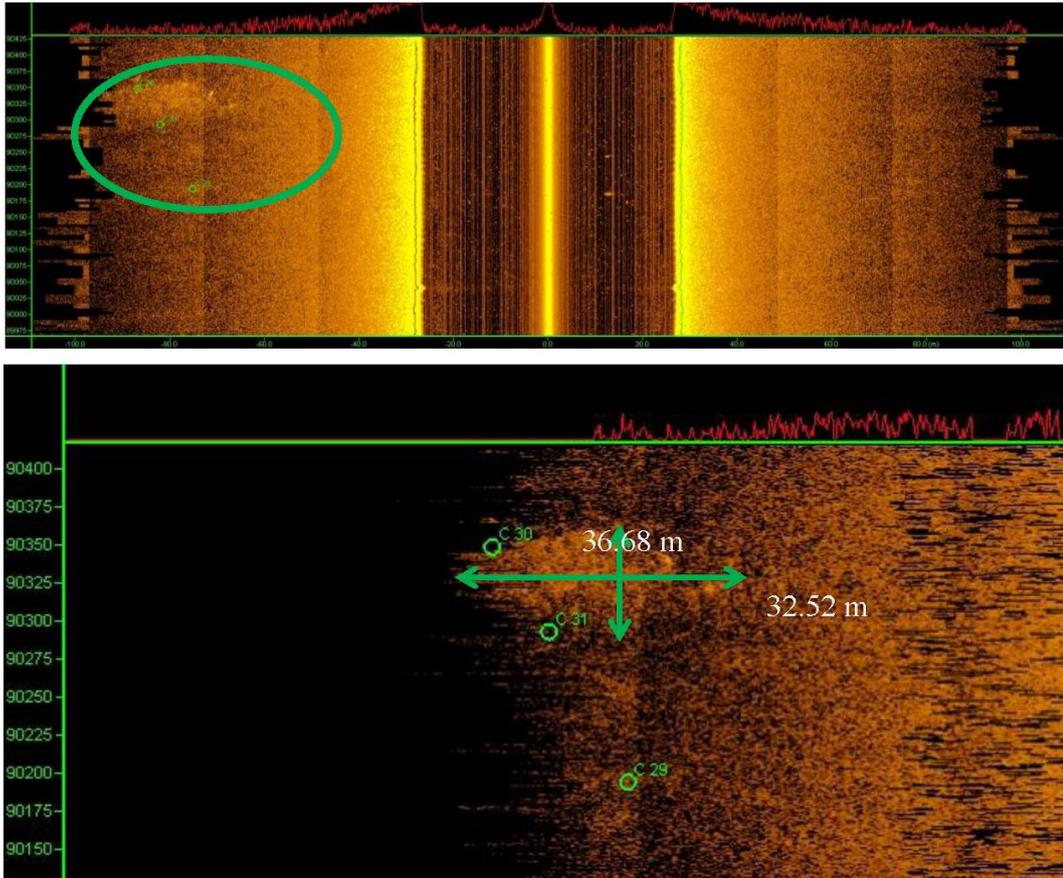
Figure 3 : Scan result using Side Scan Sonar

The team determined eight points at approximately two kilometers surrounding the last position recorded by ADSB. According to these positions the survey vessel scanned the area using Multibeam Echo Sounder and Side Scan Sonar. The sonar detected high reflectivity area around 36 meters by 32 meters, which was suspected from metal debris. The area was named as point C30-C31. Multibeam echo sounder identified the small different amount of depth which was consider not significant.

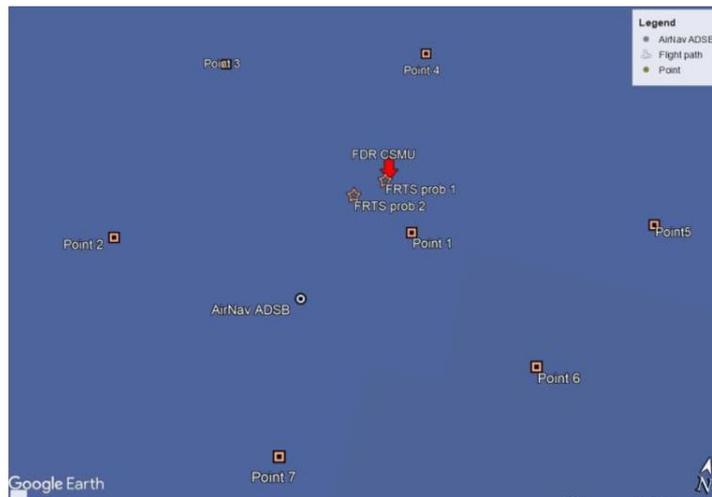
Figure 7 : The location of FDR CSMU

On the 1 November 2018 (the 3rd day of the search), a smaller team deployed to the first possible location using ping locator to narrow the search area. The team determined new possible location. The divers directed to the new possible location and about 1000 LT, the divers found the flight data recorder (FDR) CSMU with attached ULB. The CSMU FDR found approximately 10 meters from new possible location.

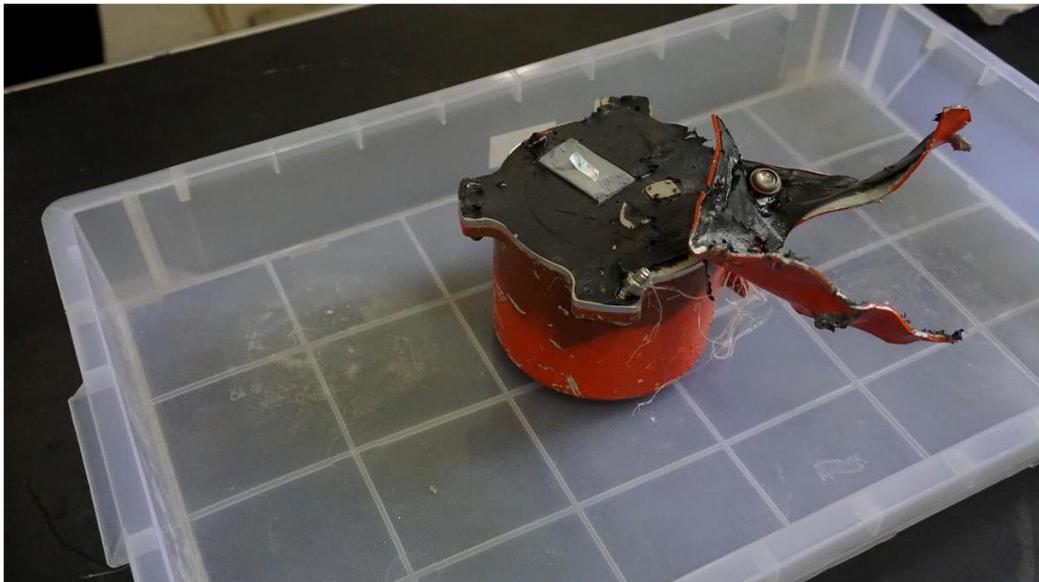
Figure 10 : The CVR CSMU at the KNKT recorder facility

The CVR CSMU condition was good with small discoloration on the metal case of the CSMU. The ULB was detached from the CVR CSMU which might be due to high impact force.
