Estonian
Safety
Investigation
Bureau

INVESTIGATION REPORT

ACCIDENT, LOSS OF CONTROL WITH AIRBUS A320-214
NEAR TALLINN AIRPORT ON 28.02.2018

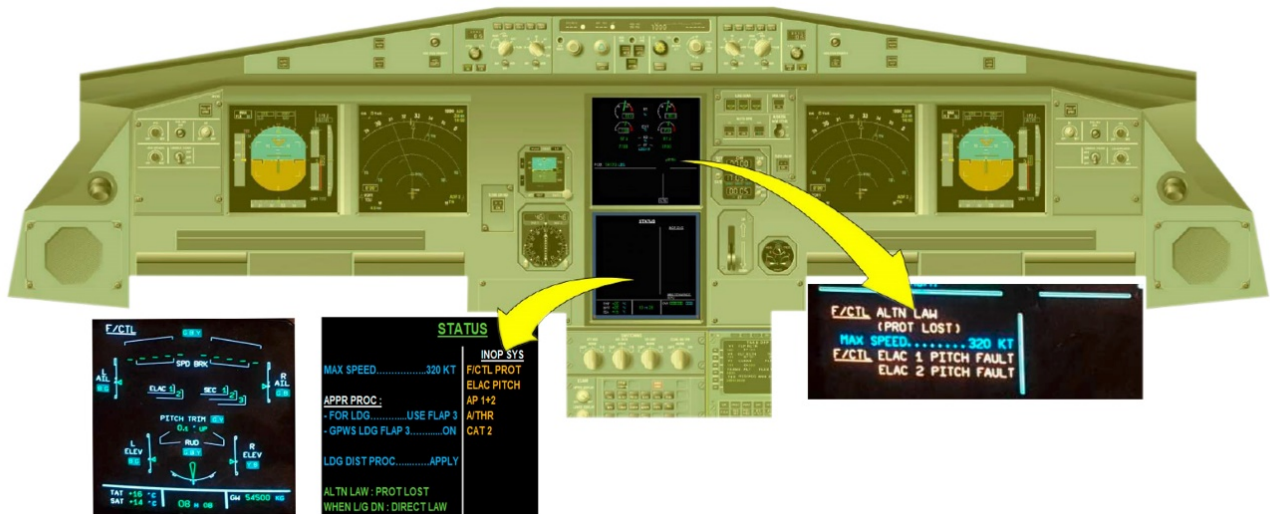
During the flight with the first student, two ELAC1 + ELAC2 PITCH FAULTs were triggered (the first and third touch-down, see Appendix I) at the moment when the instructor was manually stopping the trim wheel at around 1° Nose Up when the THS was returning to 0° after touch down (ground setting). Flight control (FLT CTL) pitch normal LAW switched to alternate 1 law. Due to the fact that ELAC PITCH FAUT message is inhibited by the system in flight phases 4, 5, 7 and 8 (see Figure 21), these failure messages were not displayed on the ECAM display until the aircraft reached 1500 ft. As for this flight with the first student, each time when the aircraft reached 1500ft the ECAM alert F/CTL ELAC 1(2) PITCH FAULT were displayed on the Engine Warning Display (see Figure 1), and a single chime (SC) was triggered related to the reversion of the F/CTL LAW in Alternate. Both ELAC-s were then reset by the crew according to the manufacturers' operational documentation during the following level flight of the flight pattern. FLT CTL pitch normal law was recovered each time after the reset.

Figure 1. Messages displayed on ECAM on F/CTL ELAC 1 and 2 PITCH FAULT - ECAM F/CTL system page, ECAM status page, ECAM Engine/Warning display

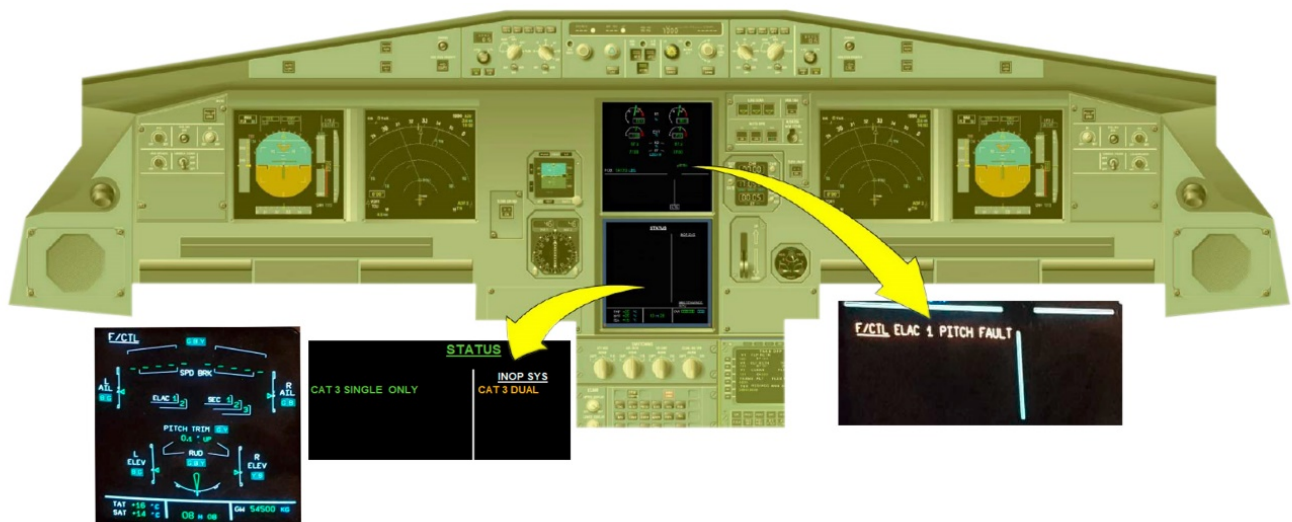
During the flight with the second student, one single ELAC1 PITCH FAULT was triggered while the instructor was manually stopping the trim wheel at around 1° Nose Up as the THS ground setting was returning to 0°, as it had happened previously. The fault was displayed again on the ECAM FLT CTL display as the aircraft reached 1500 ft, only this time, as there was only a single ELAC PITCH FAULT, there was no degradation of flight LAW, and therefore no SC was triggered by the system (see Figure 2). ELAC1 was then reset by the crew after it was displayed on the ECAM display during the following level flight of the flight pattern. The rest of the session with the second student was uneventful.

Figure 2. ECAM FC CTL system page, ECAM status page, ECAM Engine/Warning display on the event of ELAC 1 PITCH FAULT

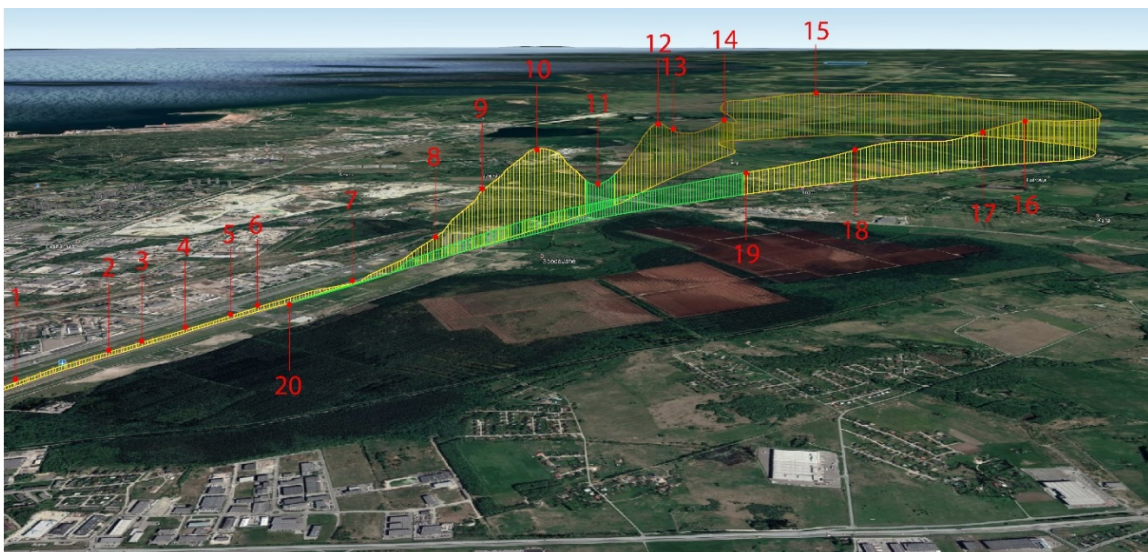
¹(see Figure 3). During the third touch-and-go at 15:05:05, an ELAC2 PITCH FAULT was again triggered in the same conditions. FLT CTL pitch normal LAW reverted to alternate 1 LAW, but stayed engaged only for 1 second². As the ELAC2 PITCH FAULT failure message is inhibited during this phase of a flight, so that the flight crew had no indication by the aircraft systems of the aircraft condition at this moment. As the aircraft was reaching rotation speed the instructor asked the student to rotate, after which the student initiated the rotation by pulling the sidestick, and by putting the thrust levers in the TOGA detent. The elevator position was 6.5° Nose Down and started to move towards 0°, the THS position was 3.5° Nose Up and the airspeed was 130 kt. As the instructor noticed the aircraft not rotating, the instructor commanded "Rotate! Rotate!", to which the student replied that he is Rotating (see Figure 4).

Figure 3. Final flight path. The yellow hatched part of the flightpath is derived from the FDR data. Green parts are reconstructed on the base of aerodrome camera footage, witness statements and CVR recordings. FDR data is lost when both of the engines spooled down.

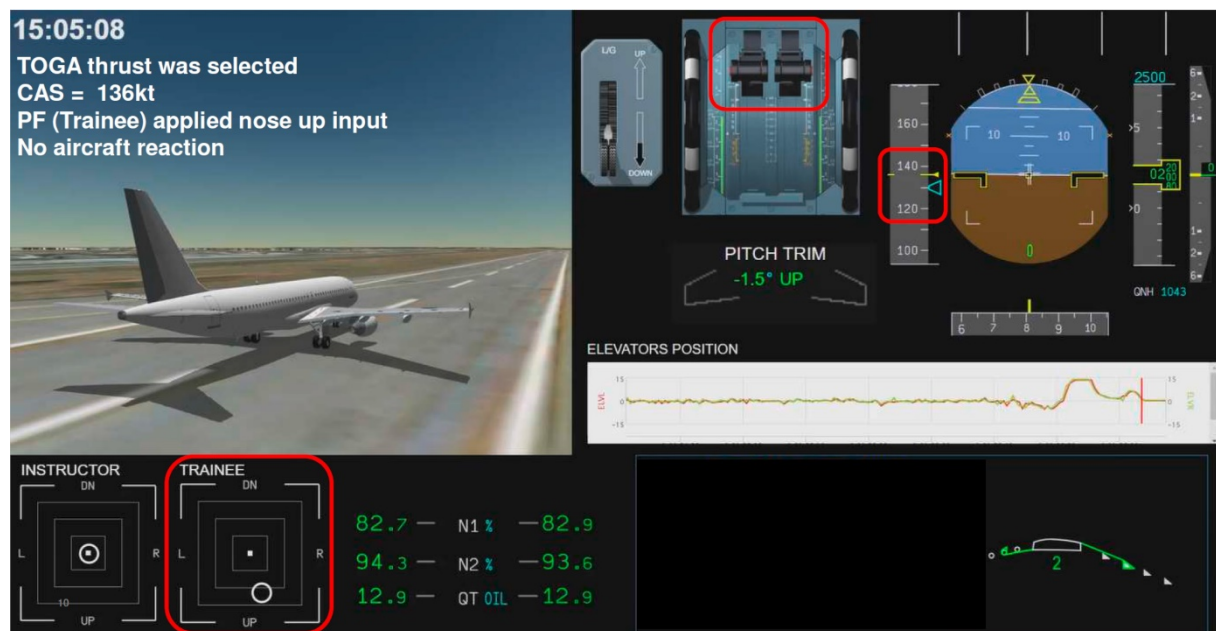
Figure 4. Cockpit inputs and indications at 15:05:08

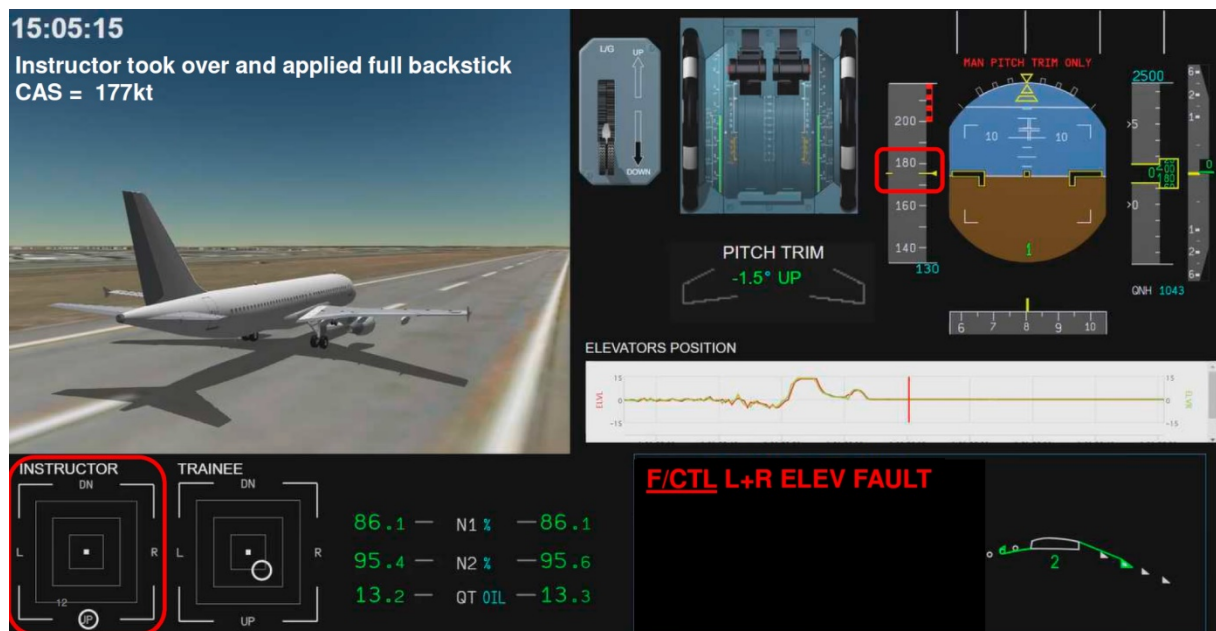
4. At 15:05:15, the student released the orders on the sidestick while pitch attitude was still 0.3° Nose Up and the aircraft was airborne. The instructor was close to full Nose Up sidestick deflection (this position was kept for 14 seconds) and giving side stick roll position commands +5 and -5 degrees (Figure 5).

Figure 5. Cockpit inputs and indications at 15:05:15

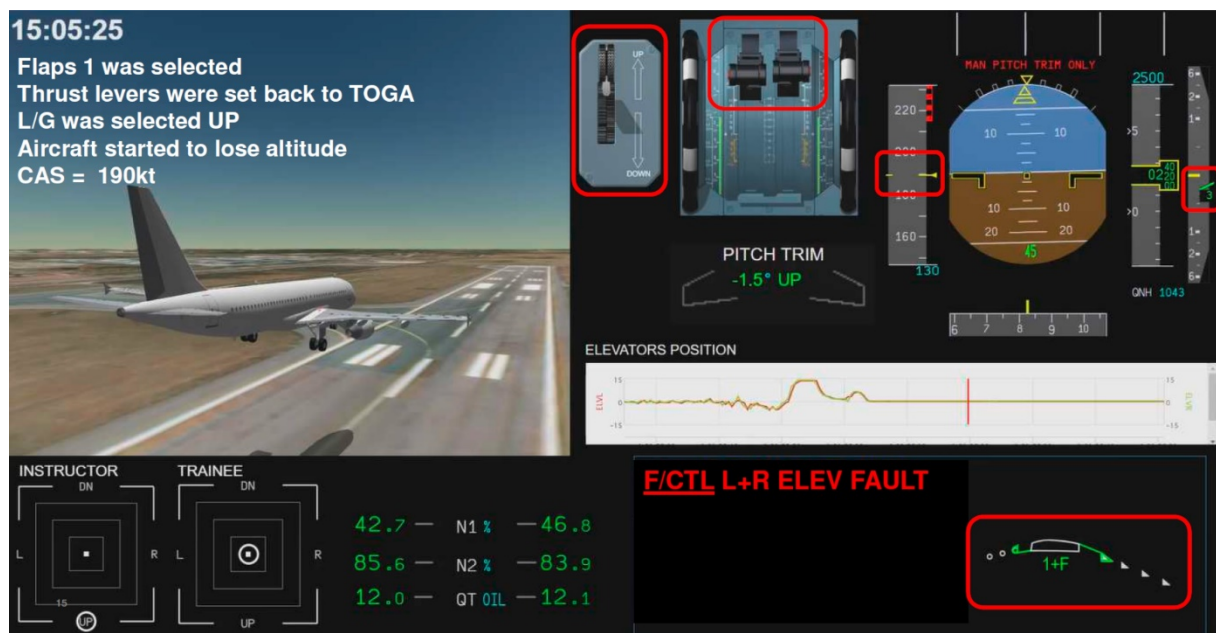
6. At 15:05:21 the instructor commanded “gear up” and the gear lever was selected to GEAR UP position. Two seconds later the aircraft reached its maximum altitude over the runway – 48ft and started to descend. The pitch attitude was 0.3° Nose Up, THS remained in 1.5° Nose Up position, and thrust levers were set back to TOGA (Figure 6).

Figure 6. Cockpit inputs and indications at 15:05:25

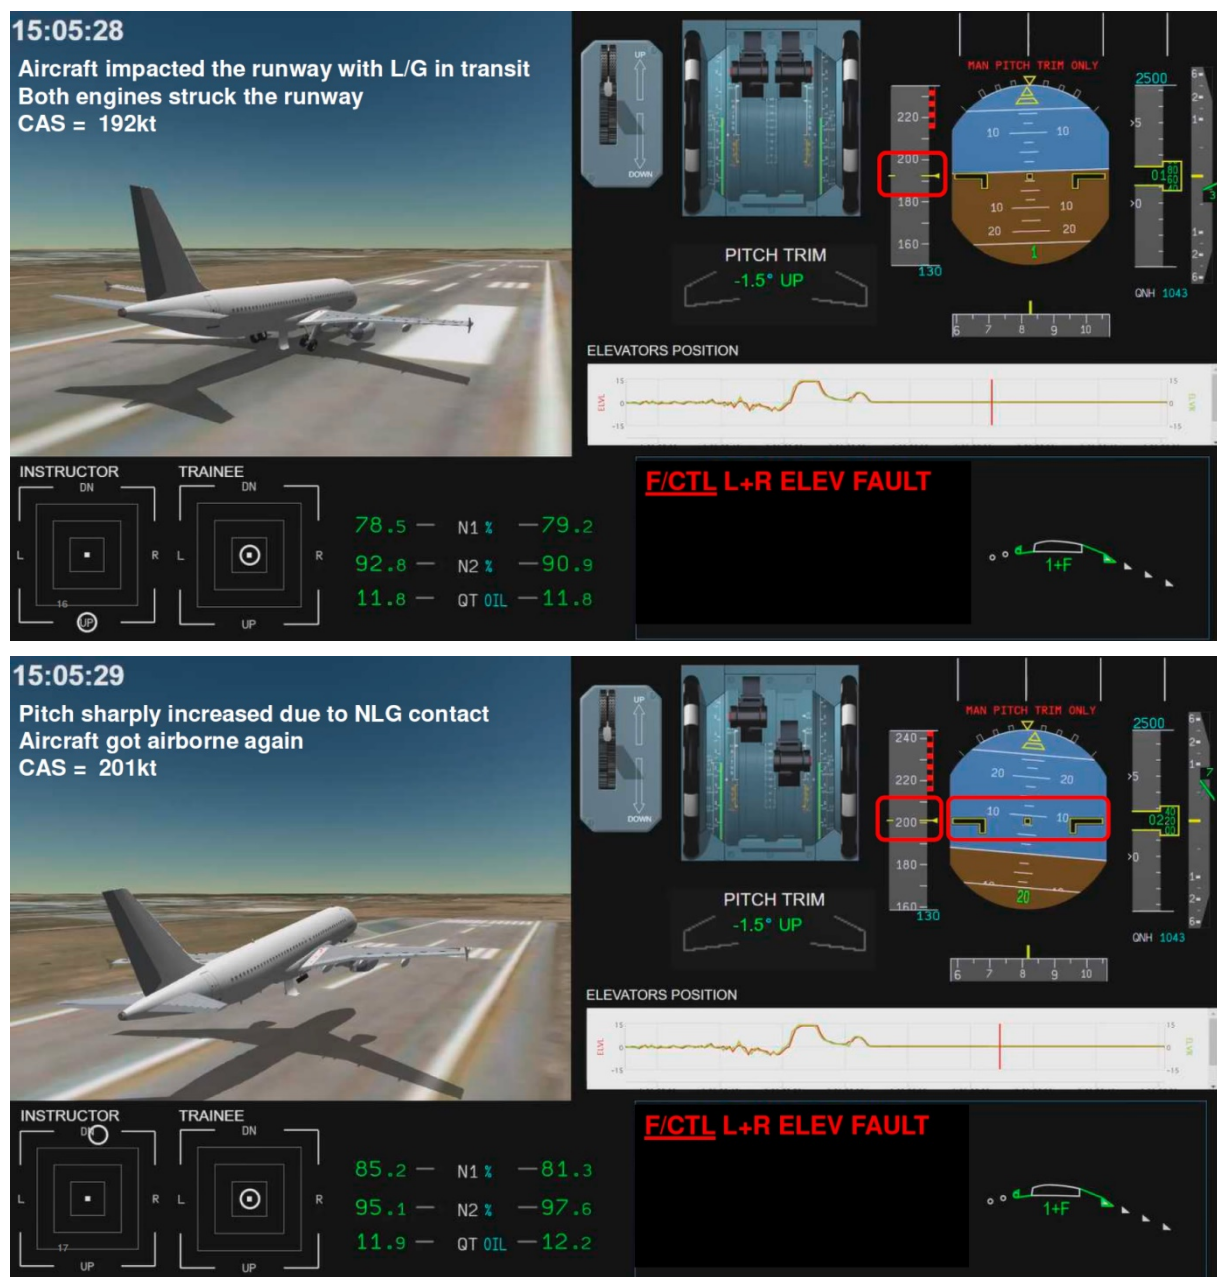
7. While the landing gear was in transit, the aircraft hit the ground with aircraft engines approximately 200m from the end of the runway at 15:05:28 with the vertical acceleration of 2,85 g (see Figures 7 and 8). The pitch attitude was 0.7° Nose Up. The airspeed was 192 kt. Two seconds after the impact, the airspeed increased to 206 kt, the pitch attitude to 9,1° Nose Up and the aircraft started to gain altitude at 6000 ft/min.

Figure 7. Cockpit inputs and indications at 15:05:28 and 15:05:29

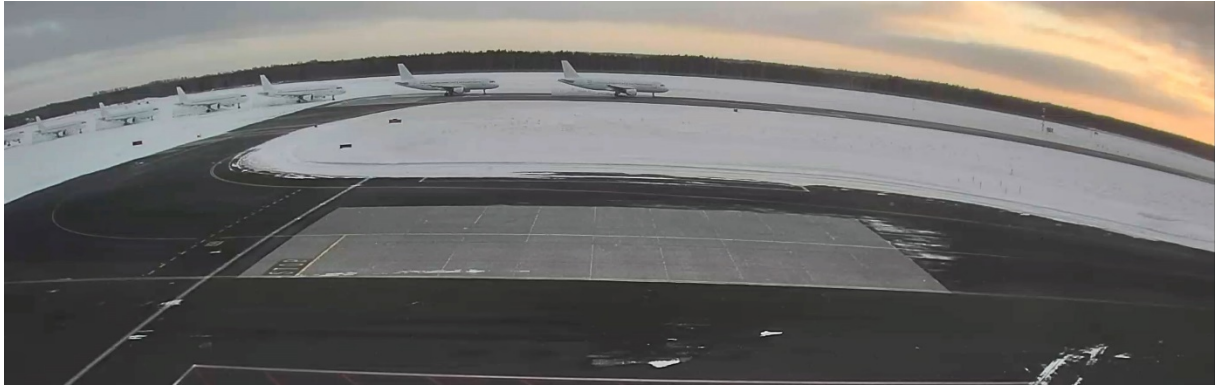
Approximately 15:10:12 the aircraft touched down hardly 150m before the runway threshold, burst all tires, decelerated on the runway and veered off stopping close to the left runway edge (20) (see Figures 10 and 11). During the impact, safety officer and one student suffered minor impact trauma.

Figure 10. Aircraft touching down (screenshots from the recordings of Tallinn Airport surveillance cameras)

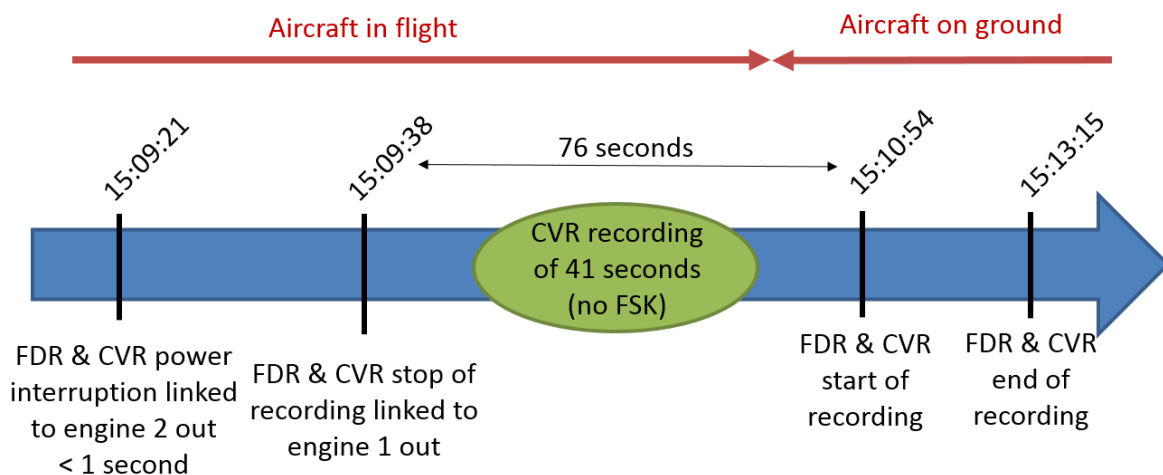
- Around 15:09:21, engine 2 spools down in flight
 - a power interruption of the FDR was observed between 15:09:21.125 and 15:09:22.124 (1 second letting the reconfiguration of the 115VAC NORM BUS from AC BUS 2 to AC BUS 1).
- Around 15:09:38 (end of FDR valid data), engine 1 spool down in flight (Figure 29),
 - a power interruption of the FDR was observed at 15:09:38.125.
 - a power interruption of the CVR was also observed at that time.

- Between 15:09:38 and 15:10:54 (76 seconds duration),
 - CVR was powered and was recording for 41 seconds, but no time signal was available (airplane in flight – FDR not powered).
- At 15:10:54 till 15:13:15 (end of data)
 - FDR and CVR were powered (airplane on ground and APU was running).

Figure 29 Power interruption of FDR and CVR

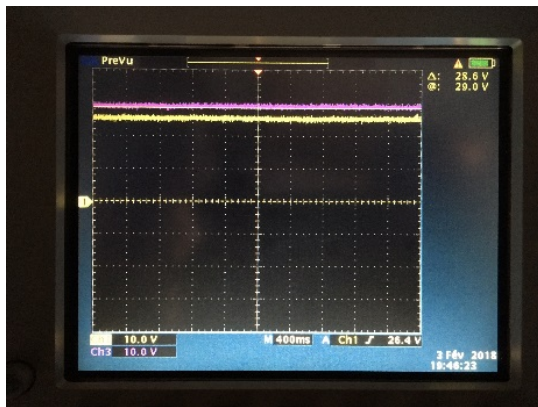
Several electronic signatures coming from the PTA were observed:

Figure 46 No signal
(SEC active on ground setting)

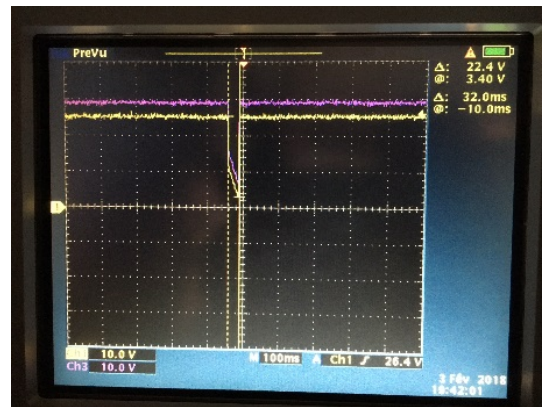
Figure 47 Single spike
(ELAC active on ground setting)

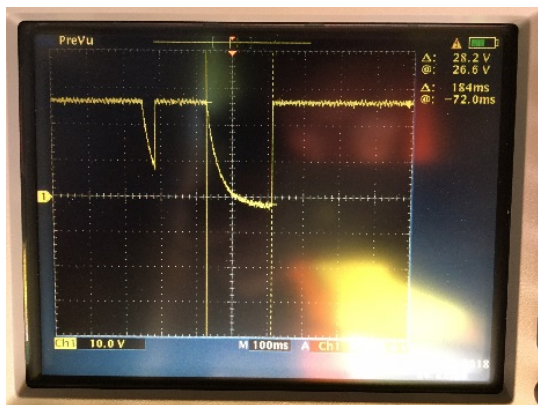
Figure 48 Spike and a step
(ELAC active on ground setting)

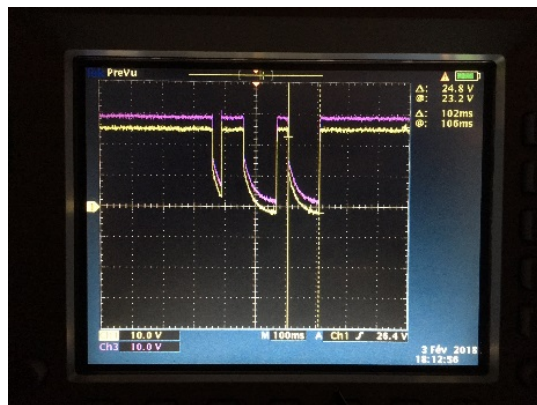
Figure 49 Multiple spikes
(SEC active on ground setting)

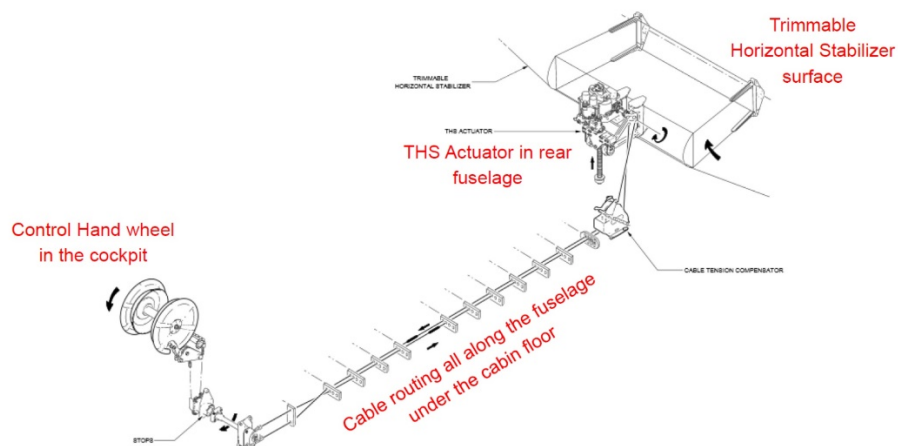
Figure 50 THSA mechanical control linkage

To rule out any mechanical linkage related sources that could contribute to the PTA signal anomalies the THS mechanical control linkage inspection was carried out. The correct routing and tensioning of the cable loop, correspondence for the trim wheel position with input THSA position and the general state of the cable-chain loop was checked (Figure 50).

No hardware (servo controls, wires and flight controls) malfunction was observed.

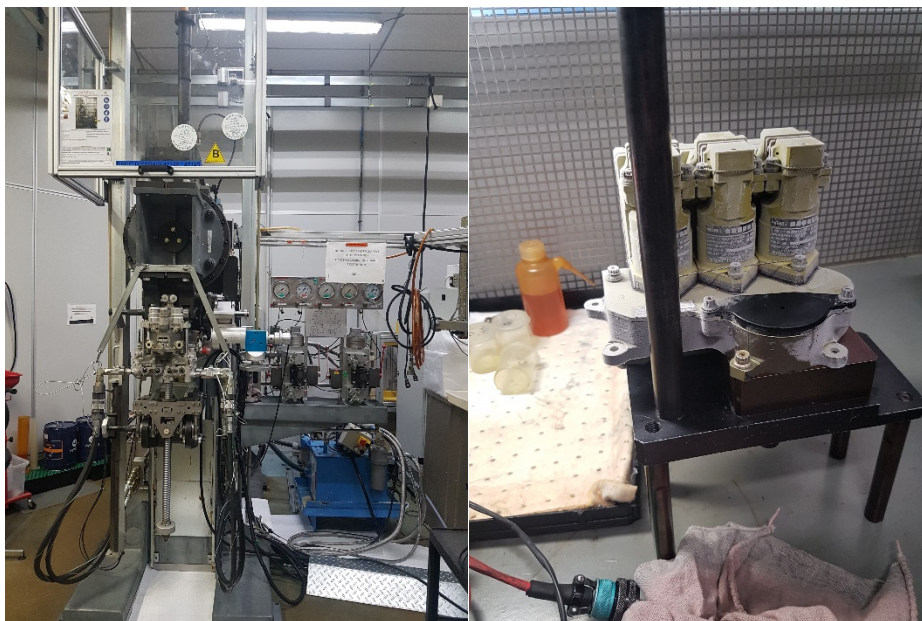
Figure 51 THSA at a test bench; PTA being chilled

Several tests of the THSA were carried out with the PTA at ambient temperature and below 0°C. During the tests, erratic triggering of the micro-switches of the PTA at ambient and cold temperature was observed on several test runs, even if the mechanical overriding function was reached (Figures 52, 53, 54).

During these erratic signal phases non-standard displacement of the OVM output piston was observed. The OVM finger stroke was not sufficient to allow the correct triggering of the PTA micro-switches.

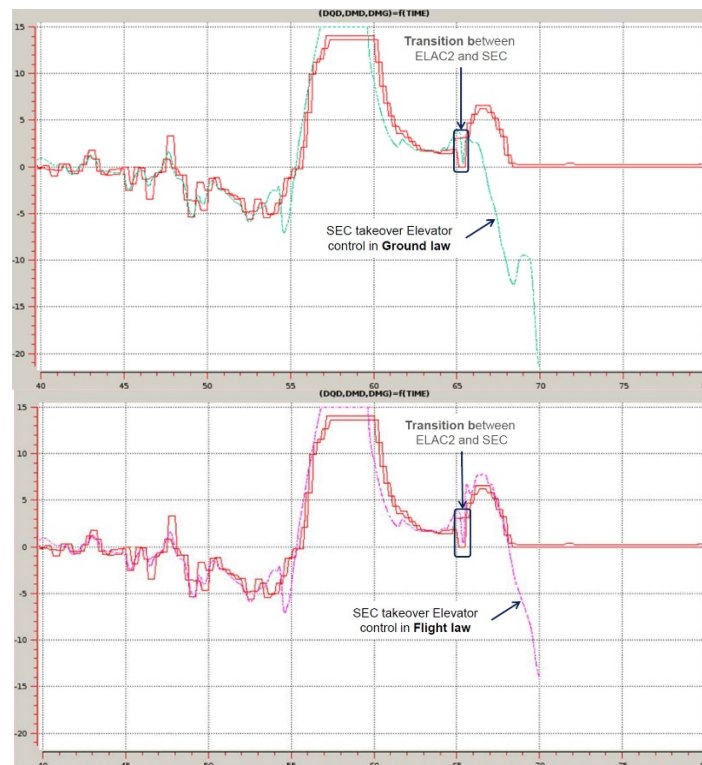
- During the event, SEC2 took over in Flight law (Evolution of the elevator positions of the simulation line in magenta is similar to the event up to the re-centering at 0°)
- Evolutions of the elevator positions in Flight and Ground law are different and sometimes opposite.

Figure 58 Spike from SEC takeover, initial opposite surface deflection in SEC flight and ground law. On the graph, red lines represent the event, green and magenta lines simulator replay

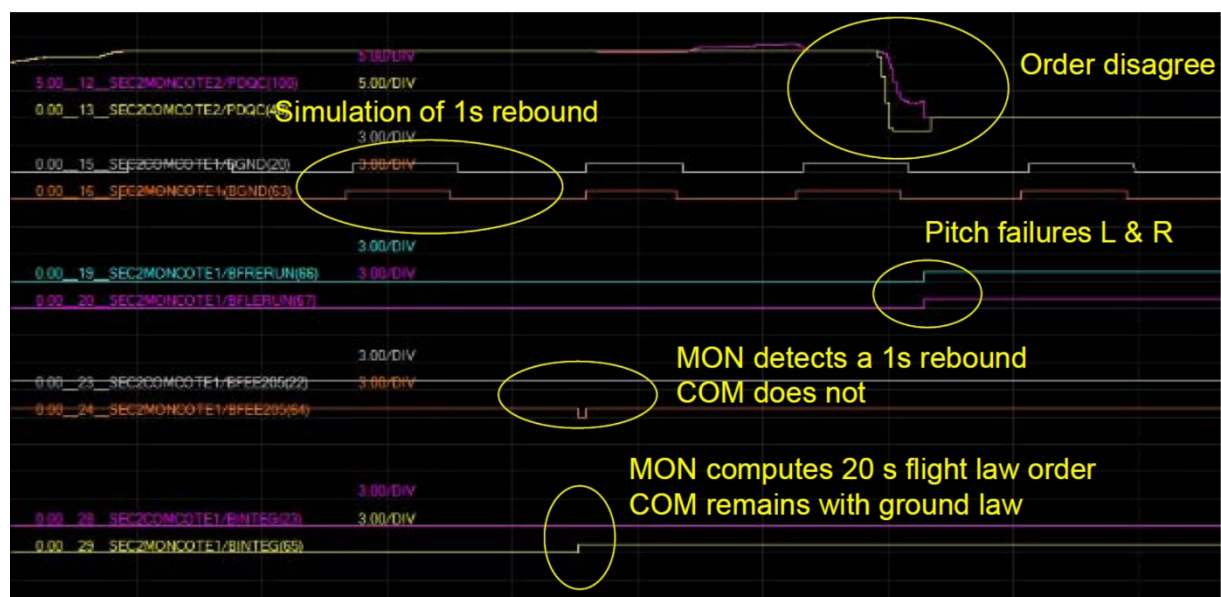
Figure 61 SEC behaviour simulation. COM remains in Ground law, MON reverts in Flight law

Loss of SEC by the discrepancy between COM and MON in the ground/flight condition was reproduced and confirmed in a simulator.

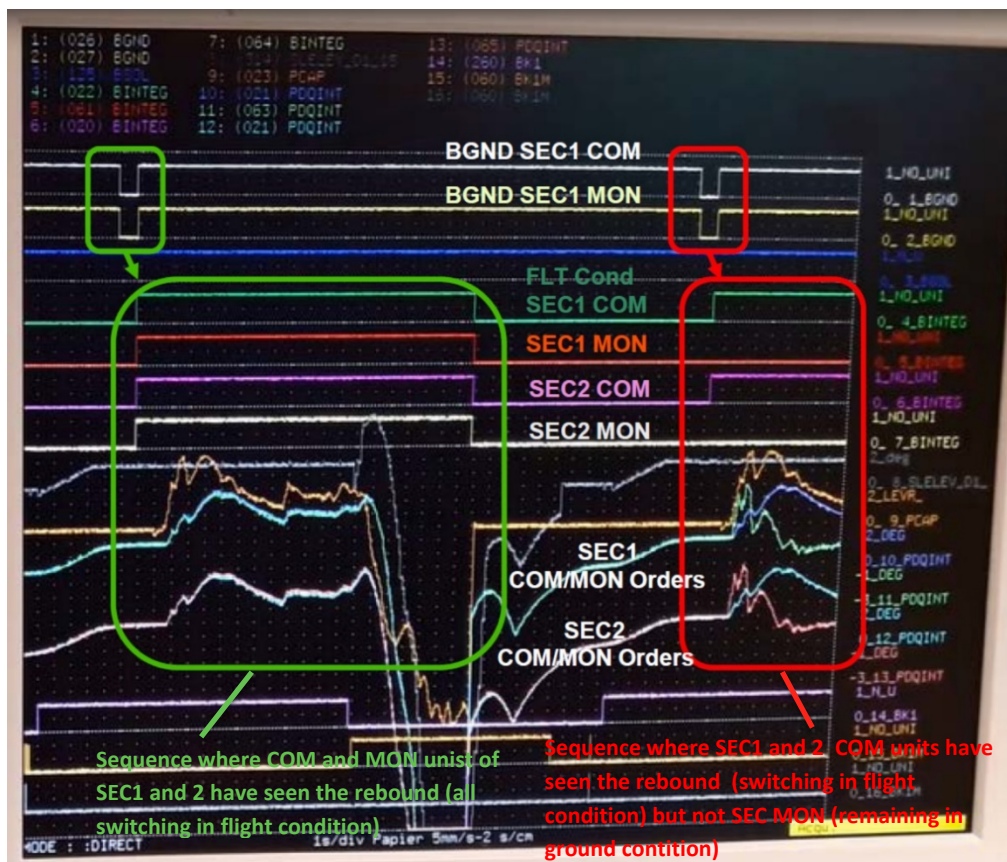
A set of simulation tests were carried out and the sequence where SEC COM initiates a flight condition and MON remains in ground condition was reproduced at several occasions (Figure 63).

Figure 63 Rebound test with two LGCIUs and SECs. SEC COM and MON seeing ground/flight condition

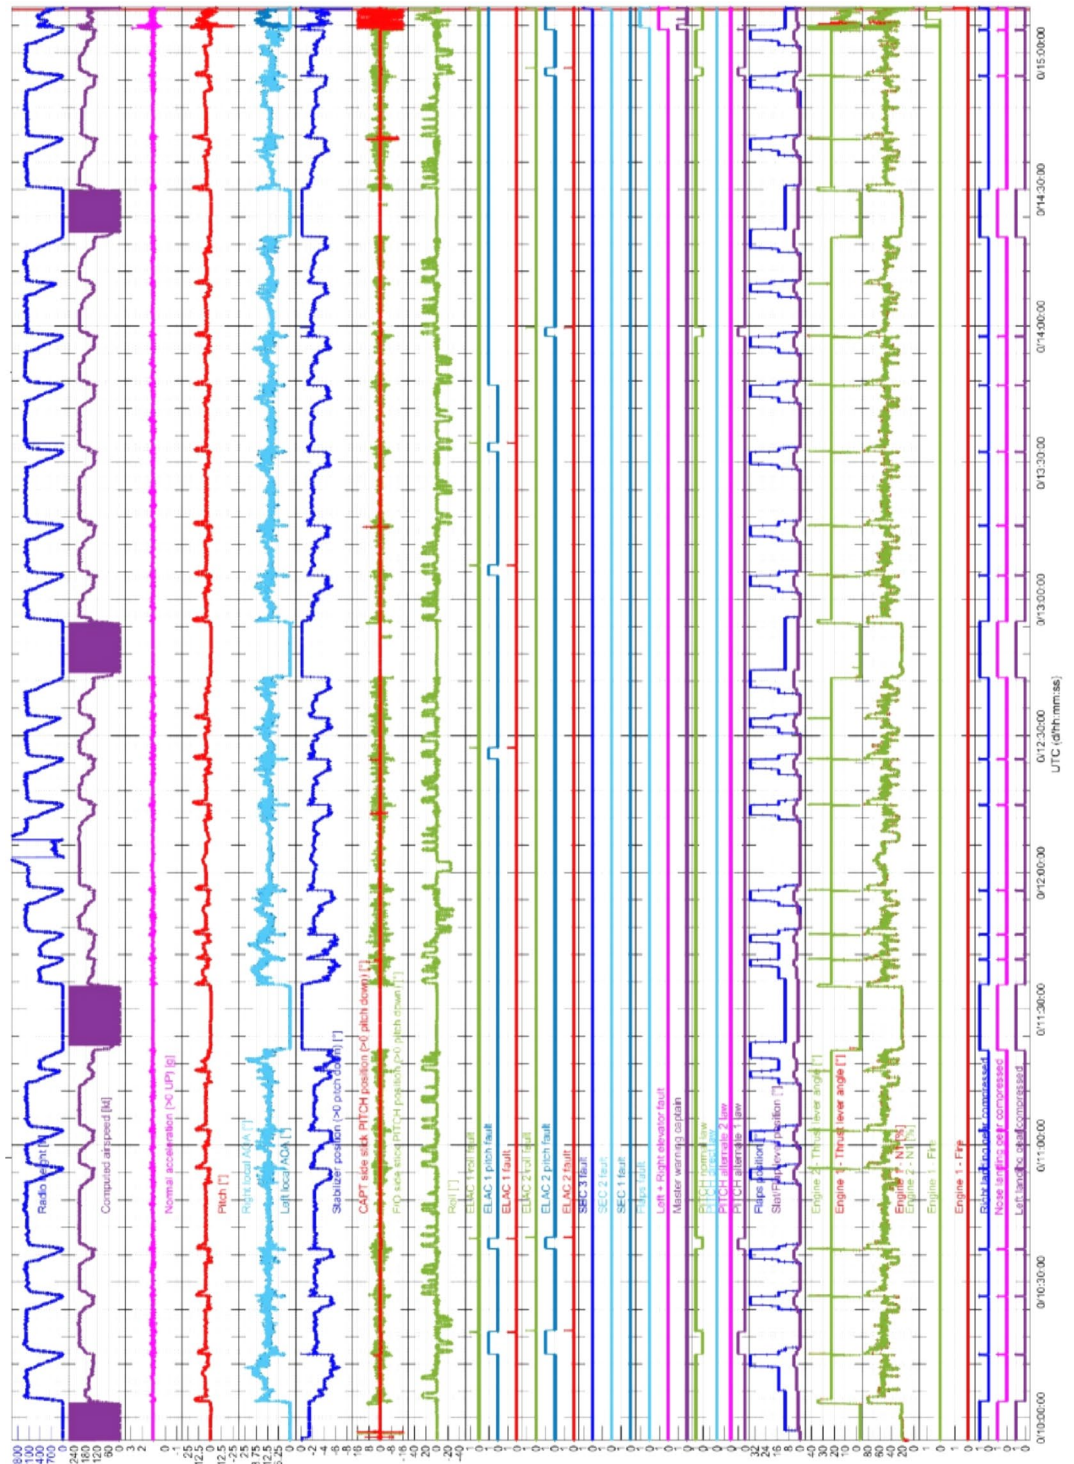
FDR data, all day

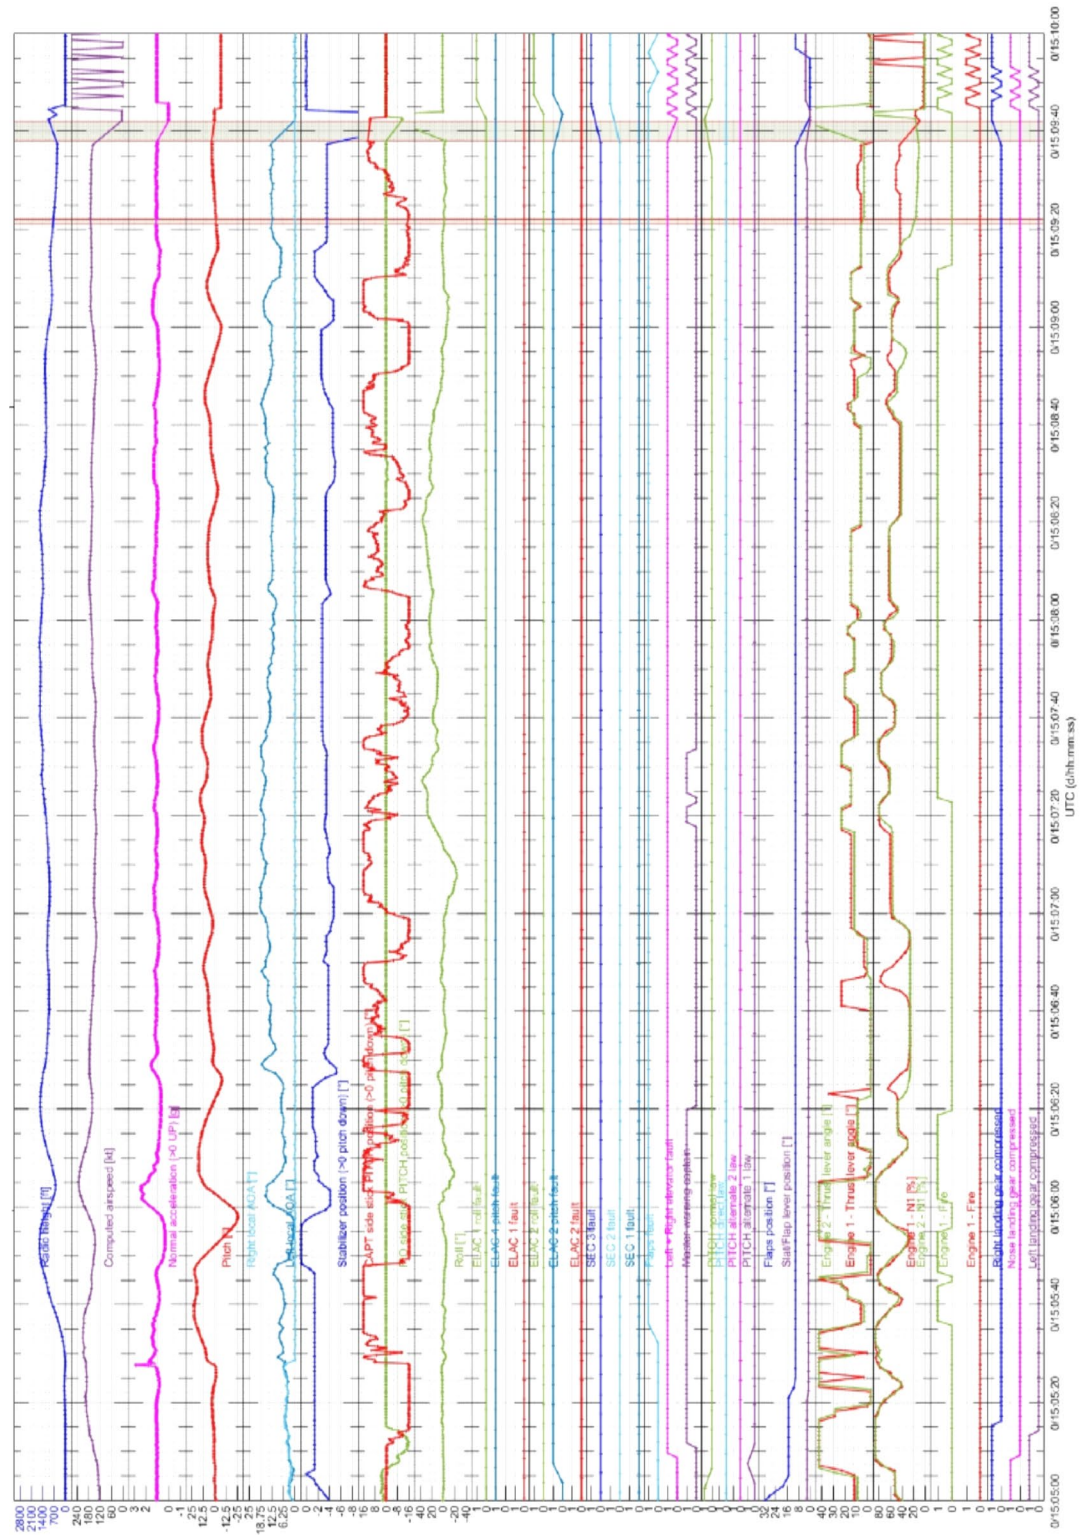
FDR data, event flight

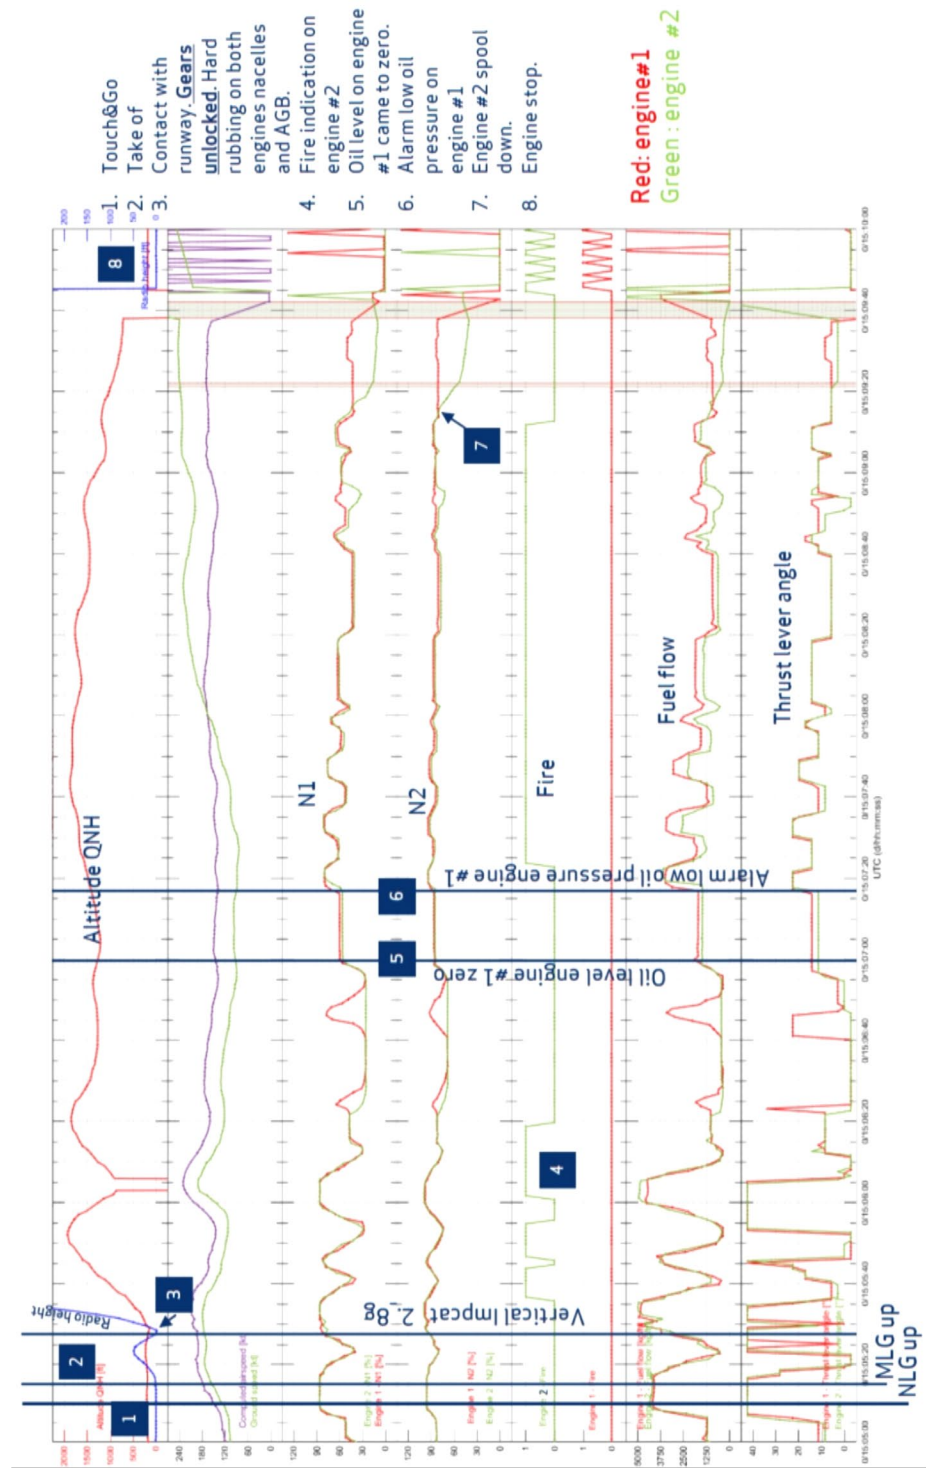
FDR data, engine parameters
