Air Accident Investigation Sector

- Final Report -

AAIS Case N°: AIFN/0010/2017

Descent below Cleared Altitude during Approach and FMS not reconfigured following a reset during the Second Approach

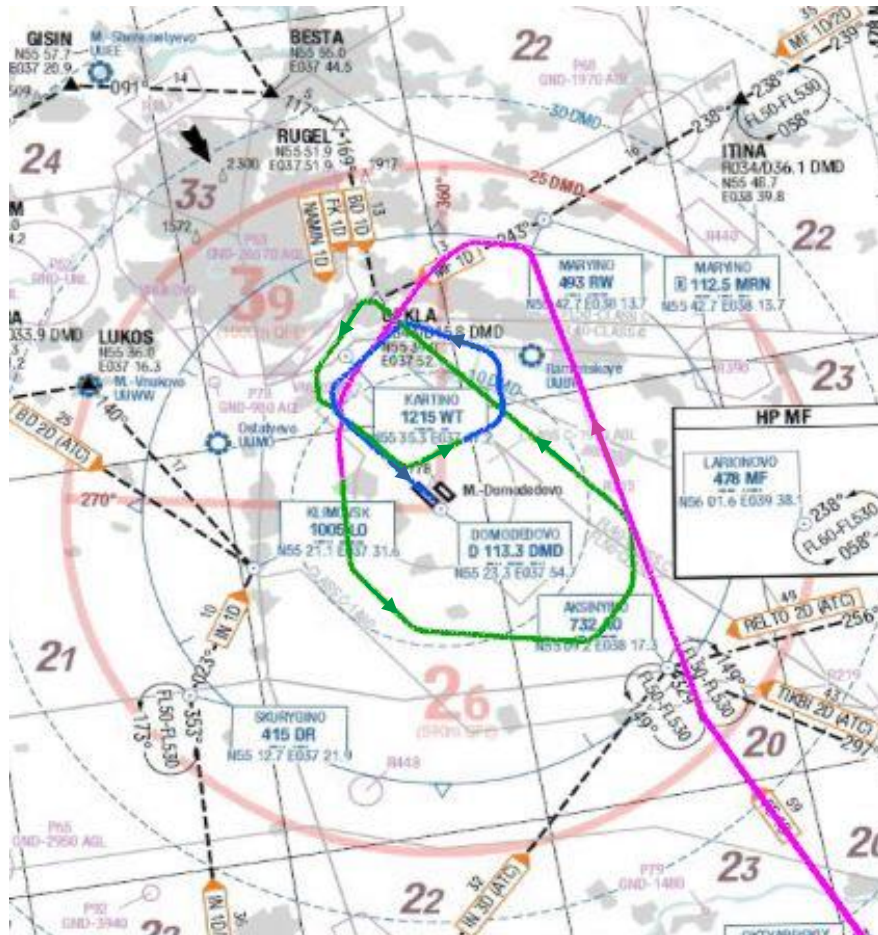
Figure 2 – Approaches and Landing attempts - UDD Runway 14R STAR Transitions Chart

The flight crew flew one go-around and one discontinued approach and landed on runway 14R from the third approach. The go-around, discontinued and landing are shown in figure 2. The trajectory in magenta depicts the first approach and go-around, the green line illustrates the second approach and discontinued approach, and the third approach and landing is shown by the blue line.

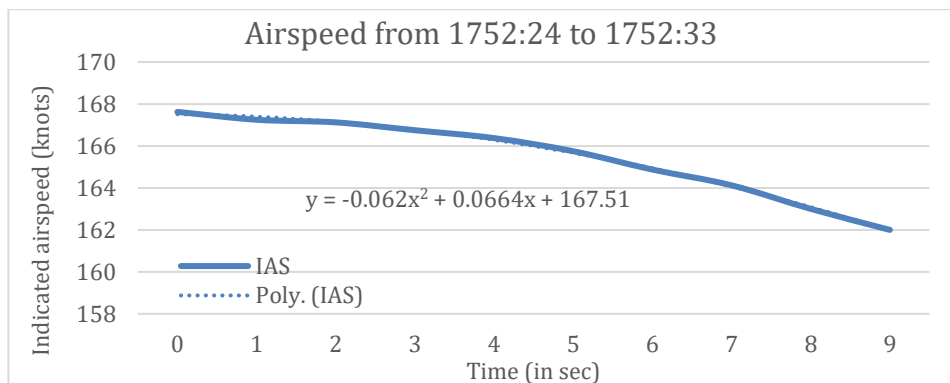
Figure 30. Second order polynomial of IAS

Figure 30 shows the equation for the indicated airspeed for the stated period as:

$$y = -0.062x^2 + 0.0664x + 167.51 \dots\dots\dots \text{(Equation 1)}$$

The target speed of the 'speed managed' mode was 143 knots, and by using Equation 1, it takes about 21 seconds for the IAS to reach 143 knots as target speed.

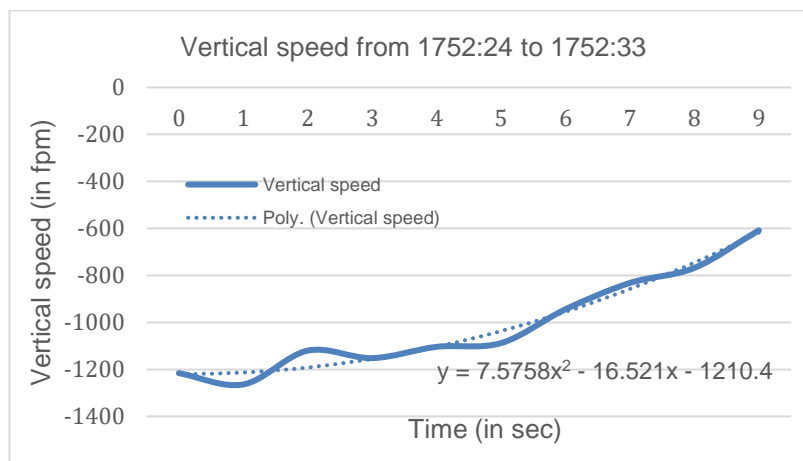
Figure 31. Second order polynomial of V/S

Figure 31 shows the equation for the vertical speed for the stated period as:

$$y = 7.5758x^2 - 16.521x - 1210.4 \dots\dots\dots \text{(Equation 2)}$$

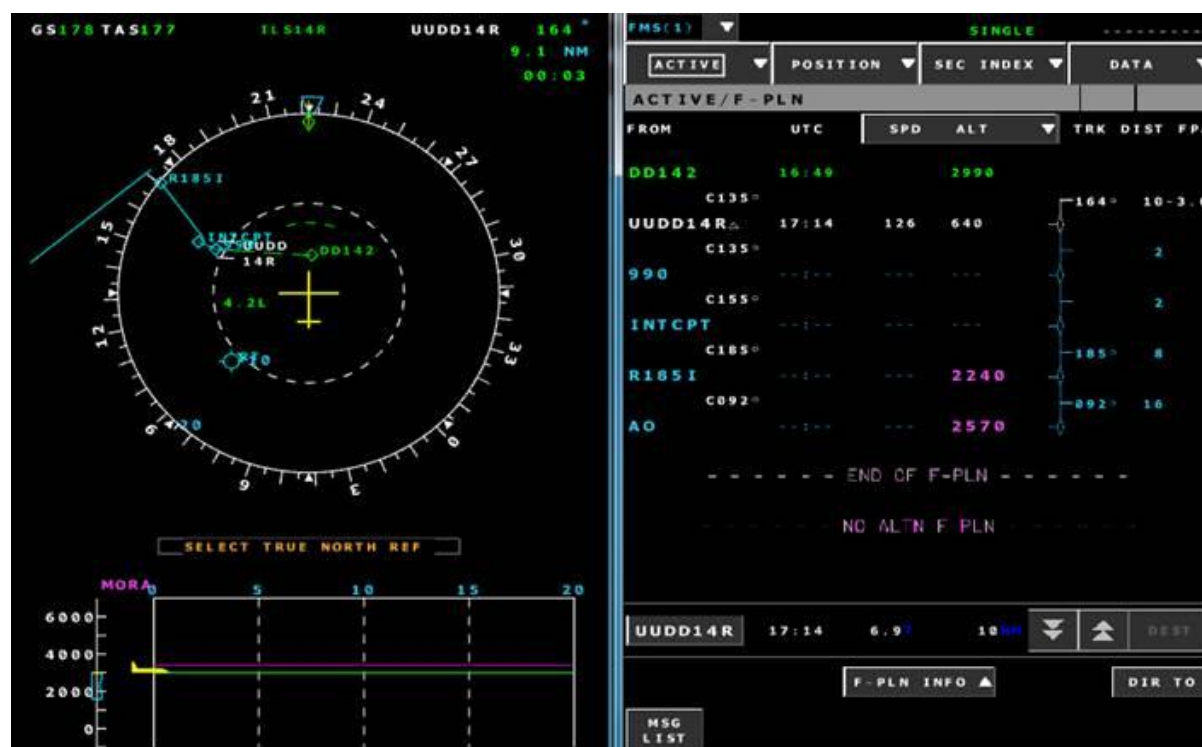
At 1752:15, the indicated active waypoints were UDD14R as displayed on the FMS (figure A1.3).

Figure A1.3 – Illustration of FMS flight plan displays on MFD and ND after DD142 waypoint was sequenced

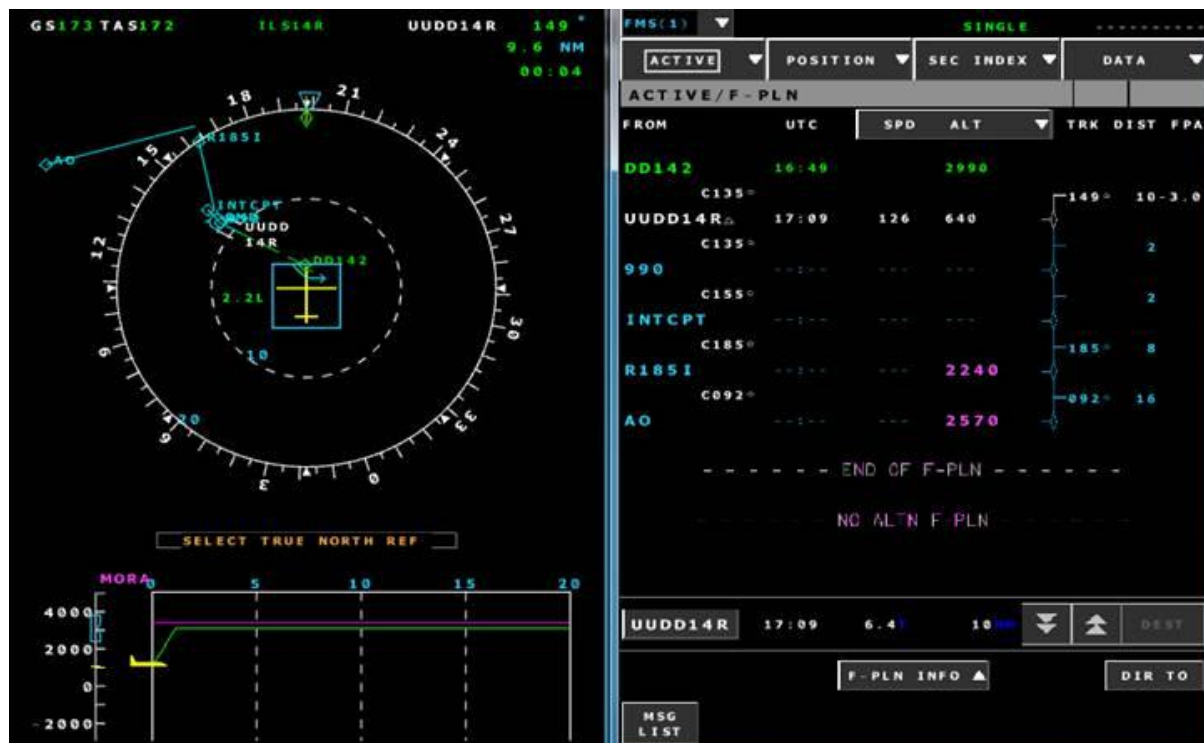
The figure A1.4 below illustrates the Aircraft position versus approach path at the time of go-around activation.

Figure A1.4 – Illustration of FMS flight plan displays on MFD and ND at the time of go-around activation

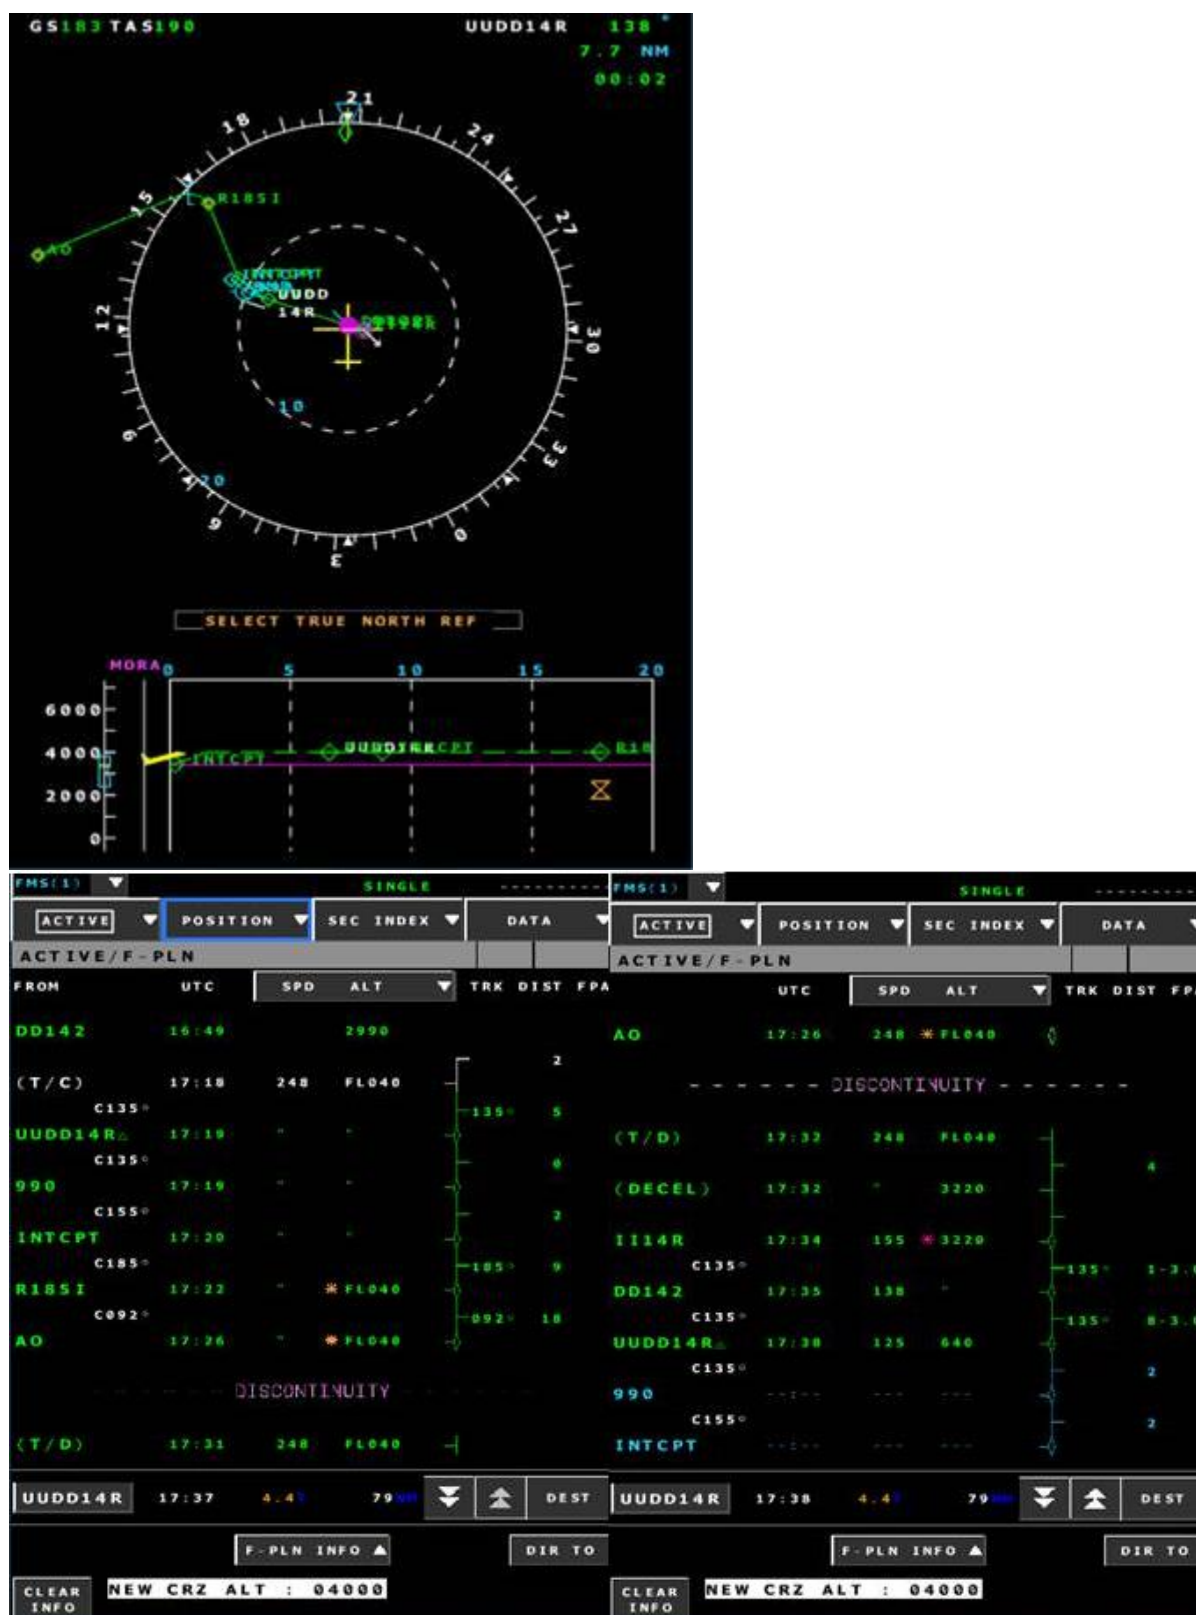
The previous ILS 14R approach was automatically re-strung into the FMS flight plan on the go-around flight phase as shown in figure A1.5 below).

Figure A1.5 – Illustration of FMS flight plan displays on MFD and ND when previous ILS 14R approach was automatically re-strung into the FMS flight plan on go-around flight phase
