## **Aircraft Accident Investigation Bureau of Myanmar**

**FINAL REPORT OF ACCIDENT OF A COLLISION WITH TERRAIN  
INVOLVING BIMAN BANGLADESH AIRLINES AIRCRAFT  
BOMBARDIER DHC-8-402, REGISTERED S2-AGQ AT YANGON  
INTERNATIONAL AIRPORT, MYANMAR ON 8 MAY, 2019**

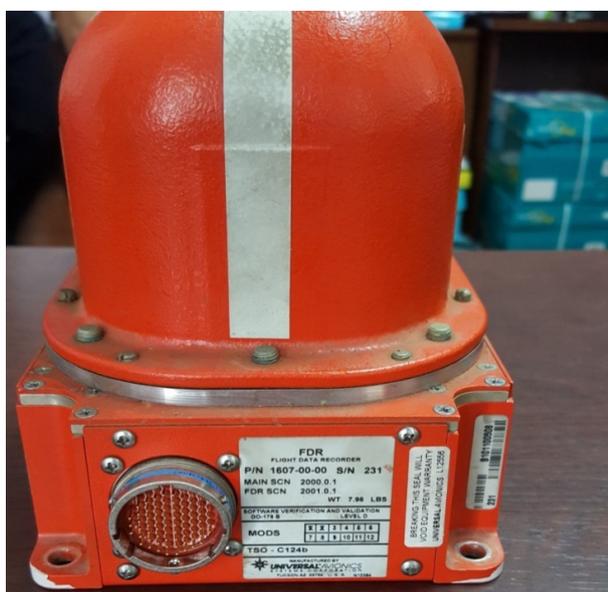
Figure (17) Flight Data Recorder

Approximately 533 hours of data was recorded on the solid state flight data recorder (FDR). The FDR was a Universal Avionics FDR-25, Part Number 1607-00-00 and Serial Number 231.
