Report

Incident on **25 May 2001**
at **Cayenne-Rochambeau Airport (French Guyana)**
to the **Airbus A340-311**
registered **F-GLZC**
operated by **Air France**

BEA

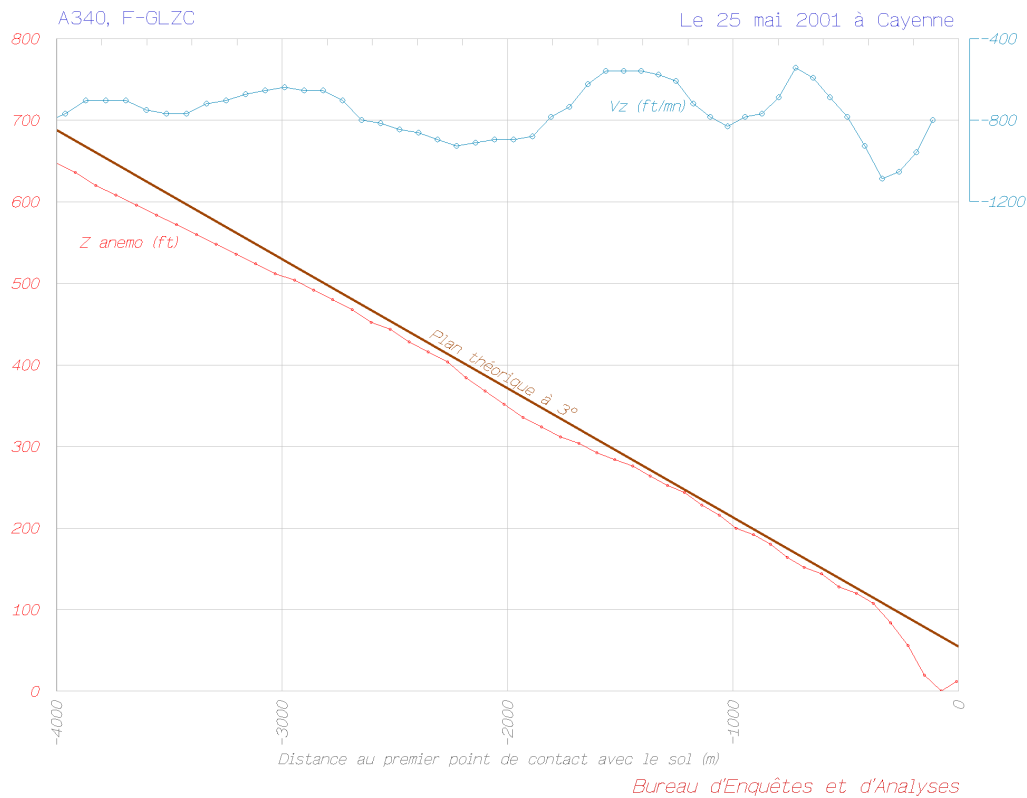
Note: the vertical speed is not recorded directly by the FDR. It can be deduced by deriving the barometric altitude or the radio height near the ground. However, the barometric altitude is error-strewn from the moment the airplane passes into ground effect, in other words at a height corresponding to its wingspan (165 ft), and the radio height only corresponds to the height in relation to the aerodrome if it is corrected to the profile

of the terrain overflown. The available topographical data is not, however, sufficiently exact to perform this calculation. To determine the vertical speed near the ground, the investigators this integrated the accelerations recorded before the first main landing gear touchdown.
