**FINAL REPORT ON THE ACCIDENT OCCURRED
ON 25 MAY 2008
AT BRUSSELS AIRPORT ON A BOEING
B747-209F REGISTERED N704CK**

Ref. AAIU-2008-13
Issue date: 10 July 2009
Status: Final

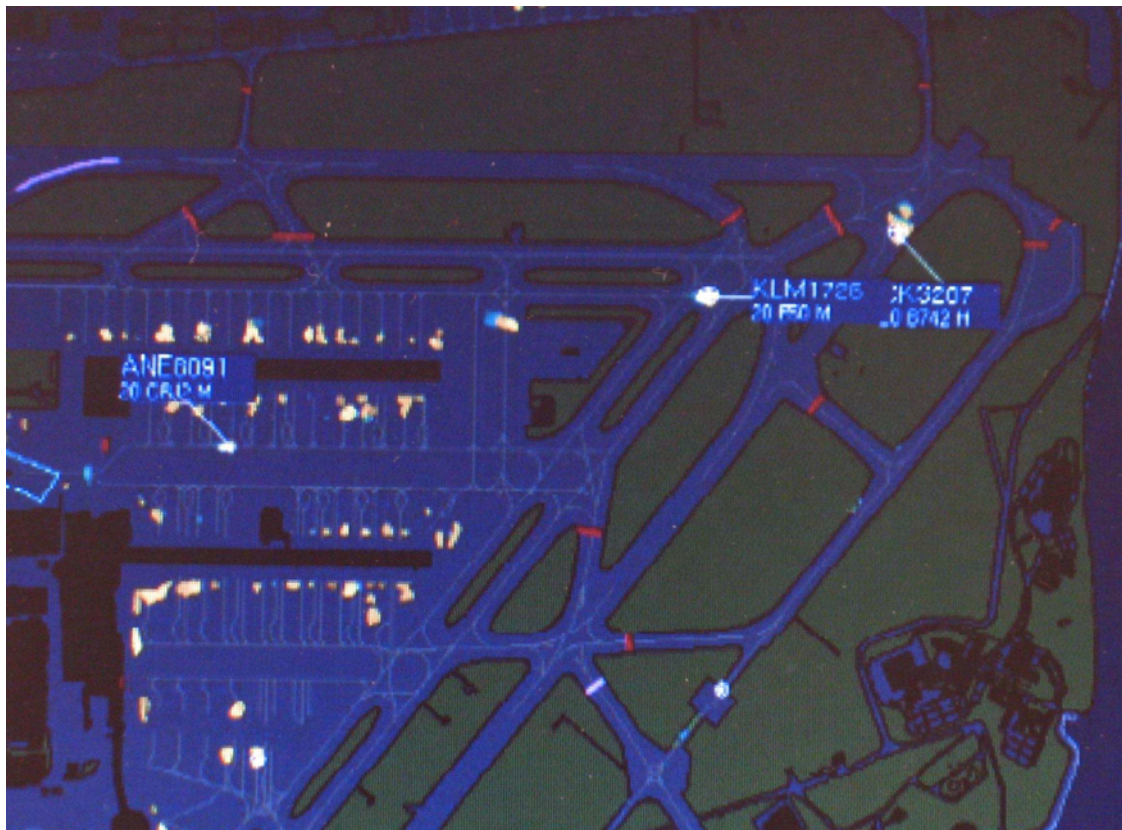
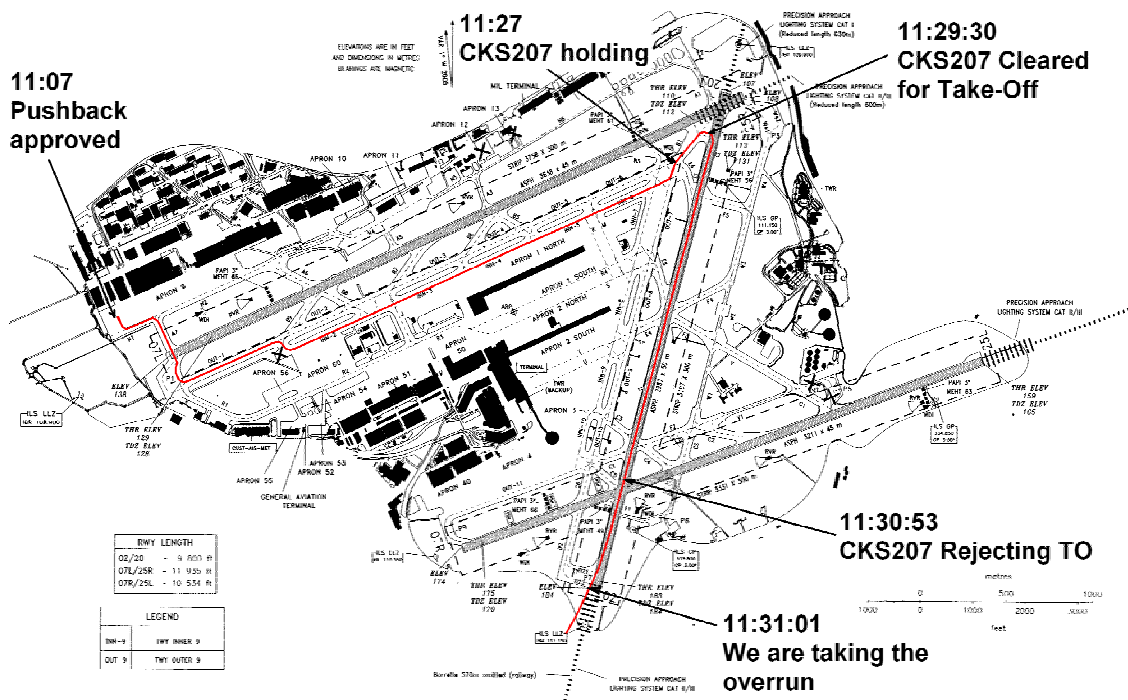
Ground radar image of CKS207 lining up on R20.

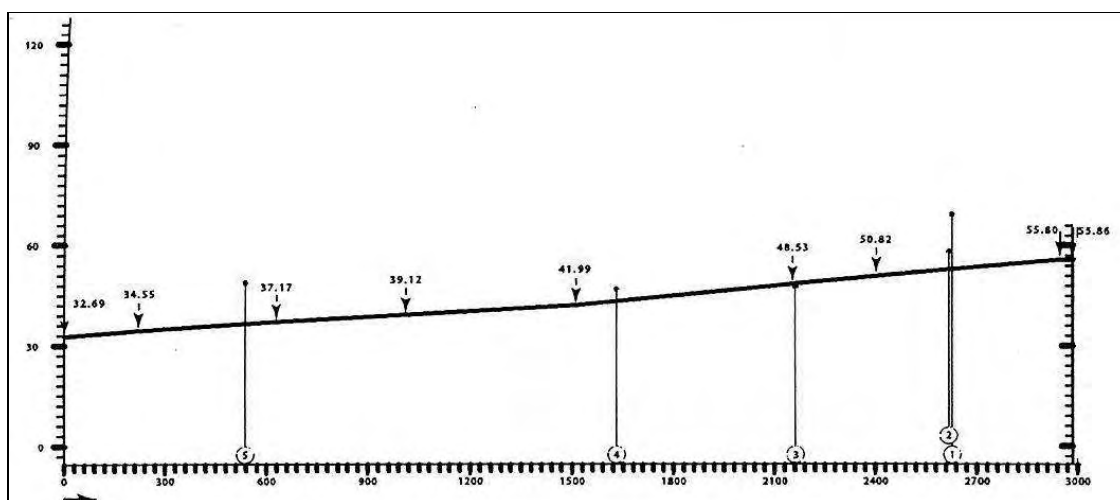
**Runway 20 - slope**

The slope on runway 20 is on average +0.78%; but from 0 to 1500m, the runway has a slope of 0.62, then for the remaining 1487m, it has an increased slope of 0.93%. Both values are complying with the ICAO recommended limits.

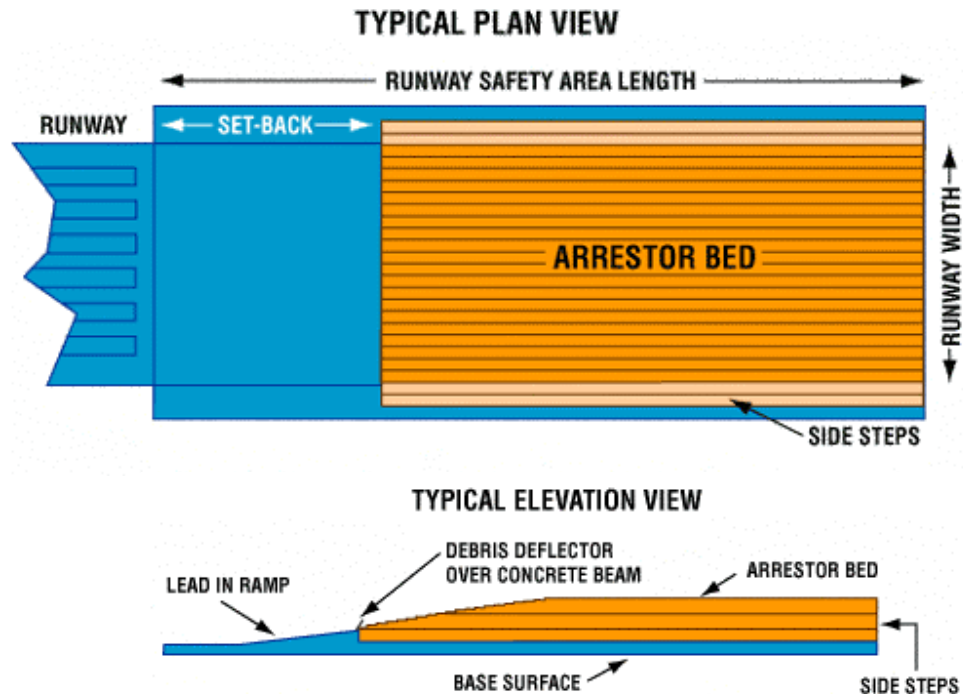
EMAS consists of a bed of cellular cement, designed to crush under the weight of an aircraft.

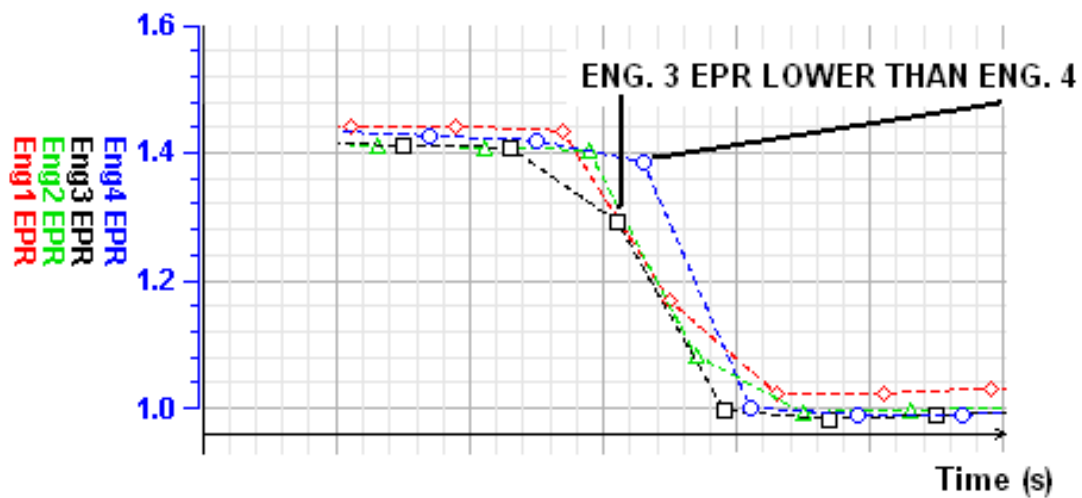
The FDR gives the evolution of Engine Pressure Ratio (EPR) – delivered engine thrust – per unit of time.

As outlined hereabove, the EPR parameter is taken once every 4 seconds for a given engine, and sequentially each second for each different engine. In the graph hereabove, the sequence is engine Nr2 (green triangle) then Nr3 (black block), then Nr4 (blue circle), and finally Nr1 (red losange).

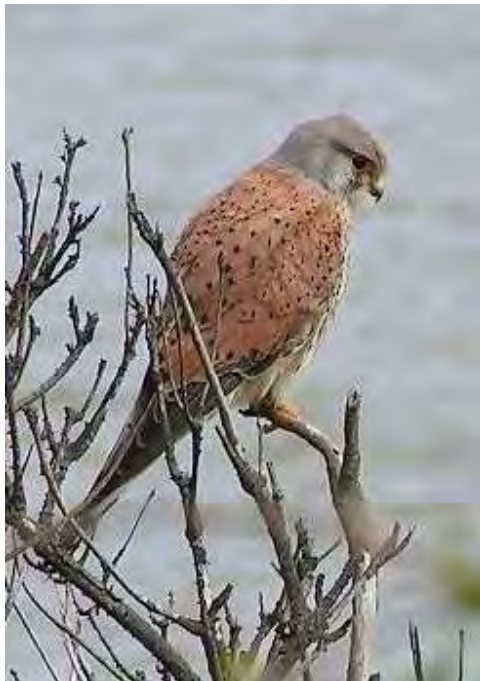
The results were consistent with the characteristics of the European Kestrel (*Falco Tinnunculus*).

The **European Kestrel** (*Falco tinnunculus*) is a bird of prey species belonging to the falcon family.
