Accident  
on 22 June 2003  
at Guipavas (21)  
to the Bombardier Canadair  
CL-600 2B 19  
registered F-GRJS  
operated by Brit Air

REPORT TRANSLATION  
**f-js030622a**

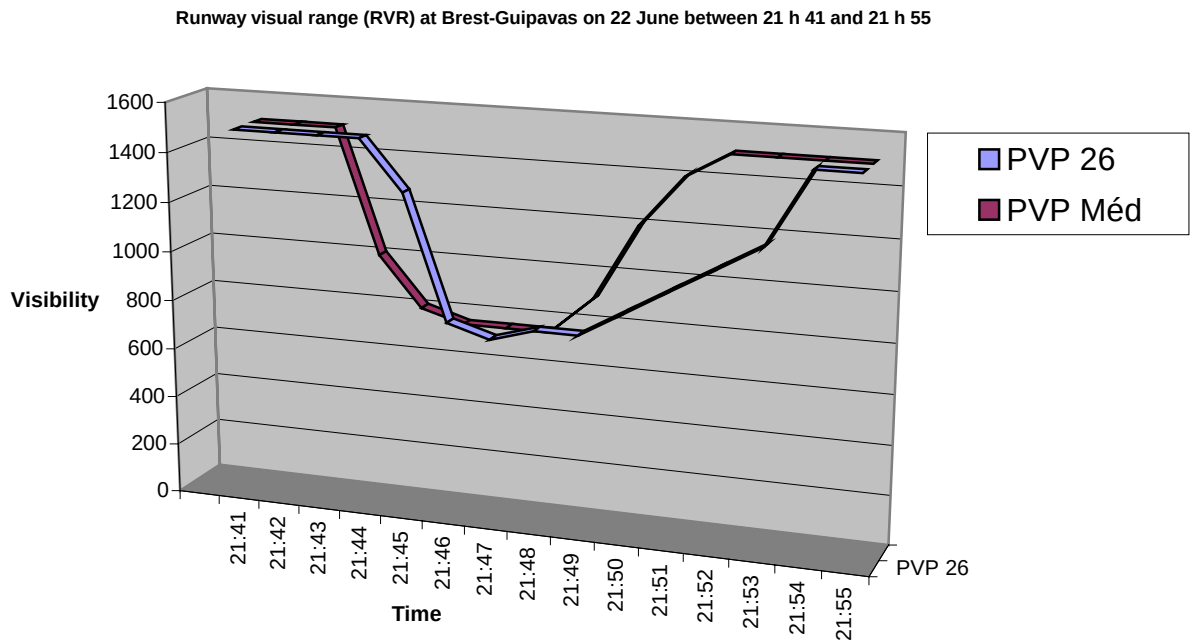
Threshold 26 = transmissometer through the threshold of Runway 26 Left.  
Median = second transmissometer through the runway centre point.

The rapid variation in the RVR's indicate the passage of fog banks. These indications nonetheless should be interpreted cautiously, since the location of the accident was over two kilometres from the runway threshold.

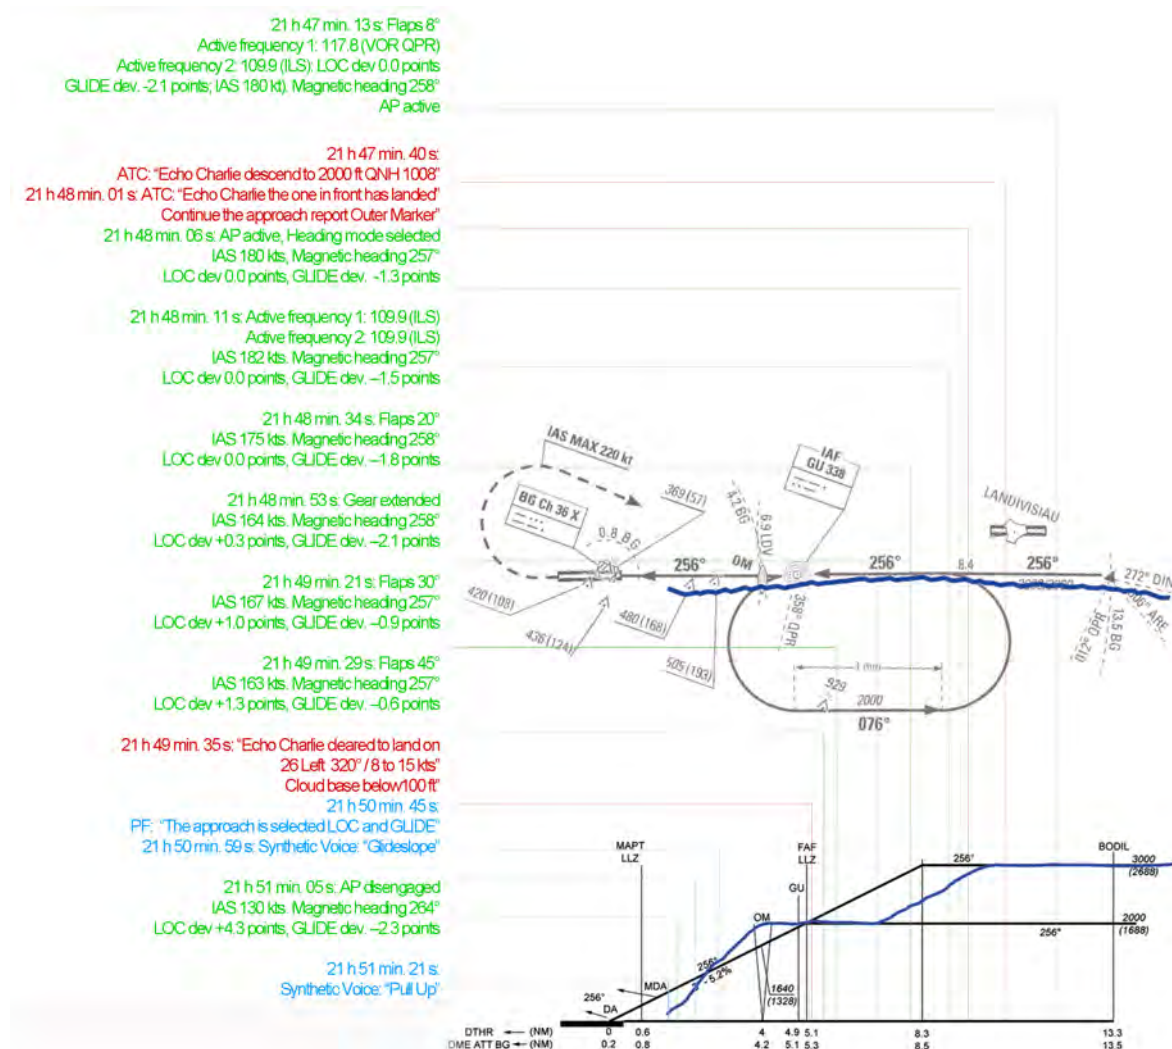
The following track was obtained, among other sources, from the recorded latitude, longitude and altitude parameters.

Note: The wind information presented in the preliminary report was obtained from the FDR and has been removed from the present diagram due to its lack of precision (see para. 1.16.1).

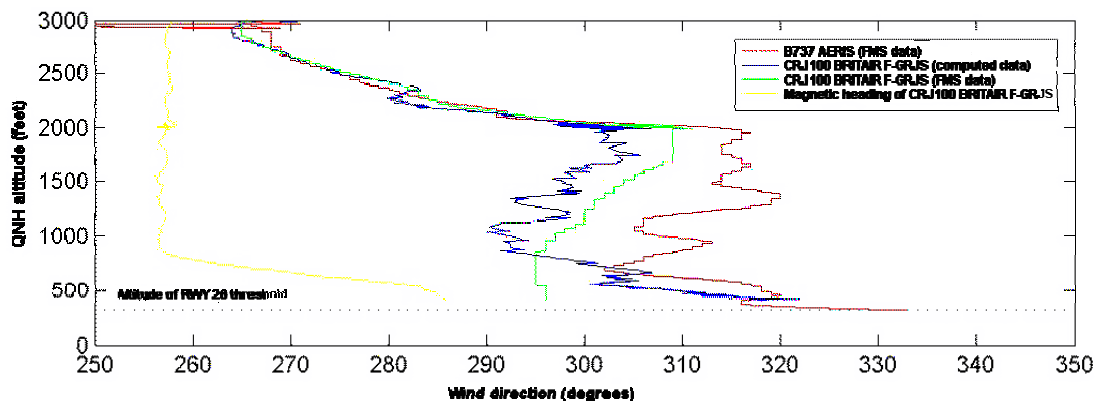
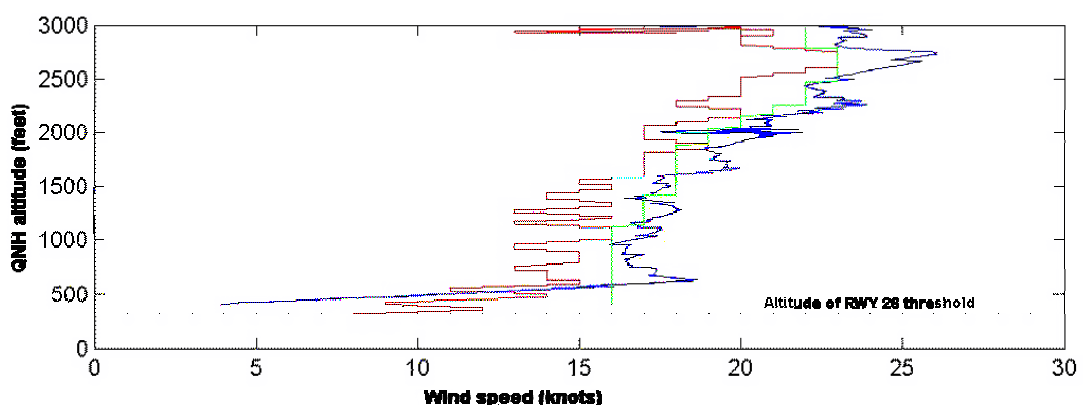
The results of these calculations were compared with the other available recordings (FDR of the previous aeroplane and meteorological sounding balloon released above the aerodrome at 00 h 00, or around two hours after the accident). They are represented on the following diagrams:

The various sources, despite some disparities, show that a wind rate was present between one thousand feet and the ground: the wind force went from a value of between 15 and 20 knots, to a value between 5 and 10 knots, and the wind direction was veering from west to north.

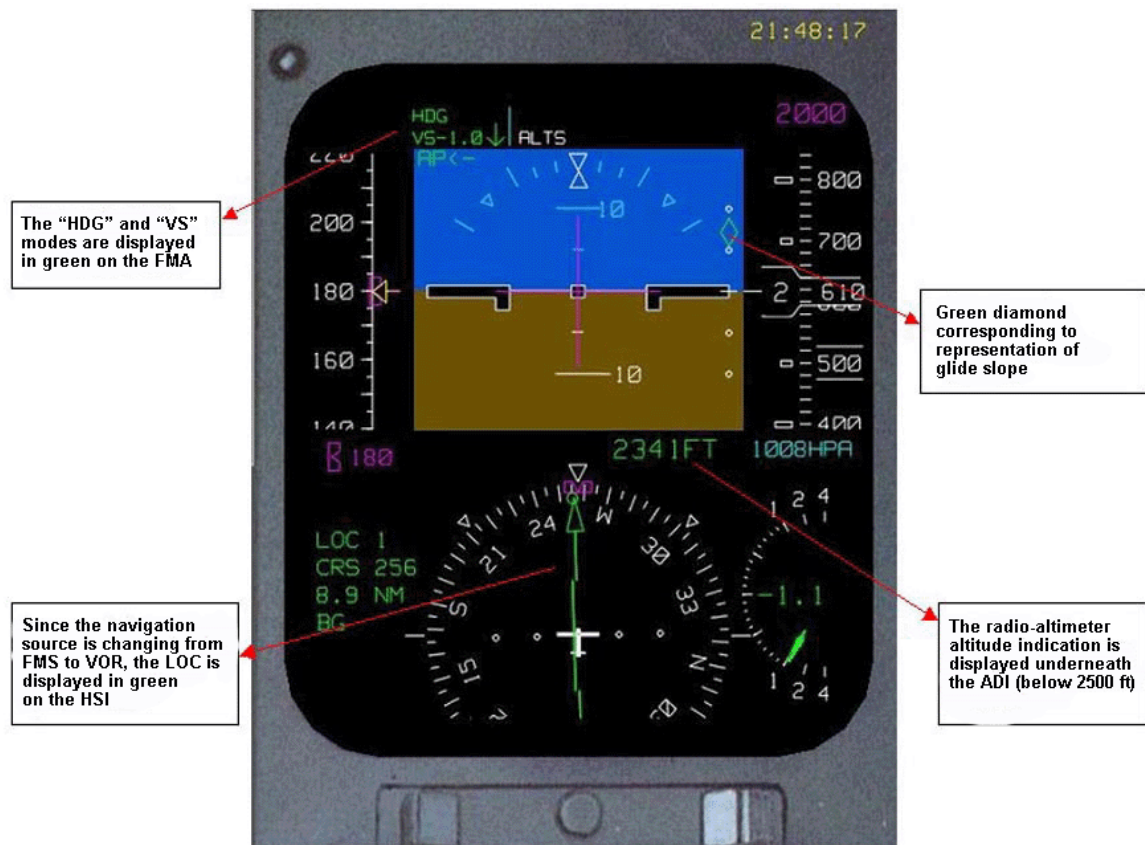
At that moment, the PFD was displaying the following information:

Note: The PFD images in this part of the report were created at the BEA, using data from the flight recorders.

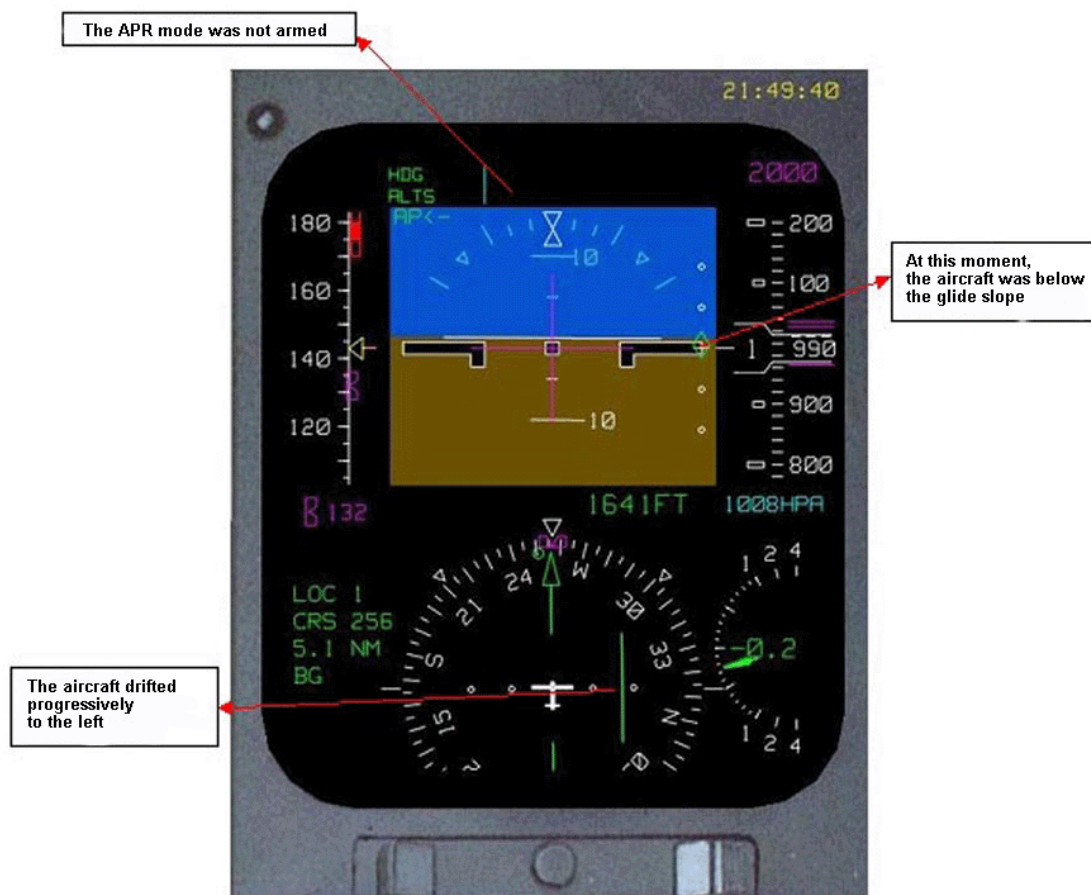
During these exchanges, the aeroplane passed down through the glide slope then passed back above. During this period, when the workload was very high, the crew did not detect the aeroplane's drift. For her part, the Controller indicated after the accident that she had looked repeatedly at the screen without seeing the aeroplane, probably because the latter was in an area where loss of radar contact was a known phenomenon.

Immediately after the end of these exchanges, sixteen seconds after the aeroplane passed through the glide slope, the Co-pilot said, "(...) we haven't got (\*) approach (\*)". These words are extremely difficult to hear and it has not been possible to reconstitute the whole sentence. The Co-pilot told the investigators that he had been out of the control loop while reading the checklist, configuring the aeroplane, and talking to Control. These words may mean that he was trying to analyze the situation, and the allusion to "approach" means that he was aware that the "APPR" mode was not armed. At that moment, the LOC display on the HSI attains right-hand stop. It will remain in this position until the ground impact.

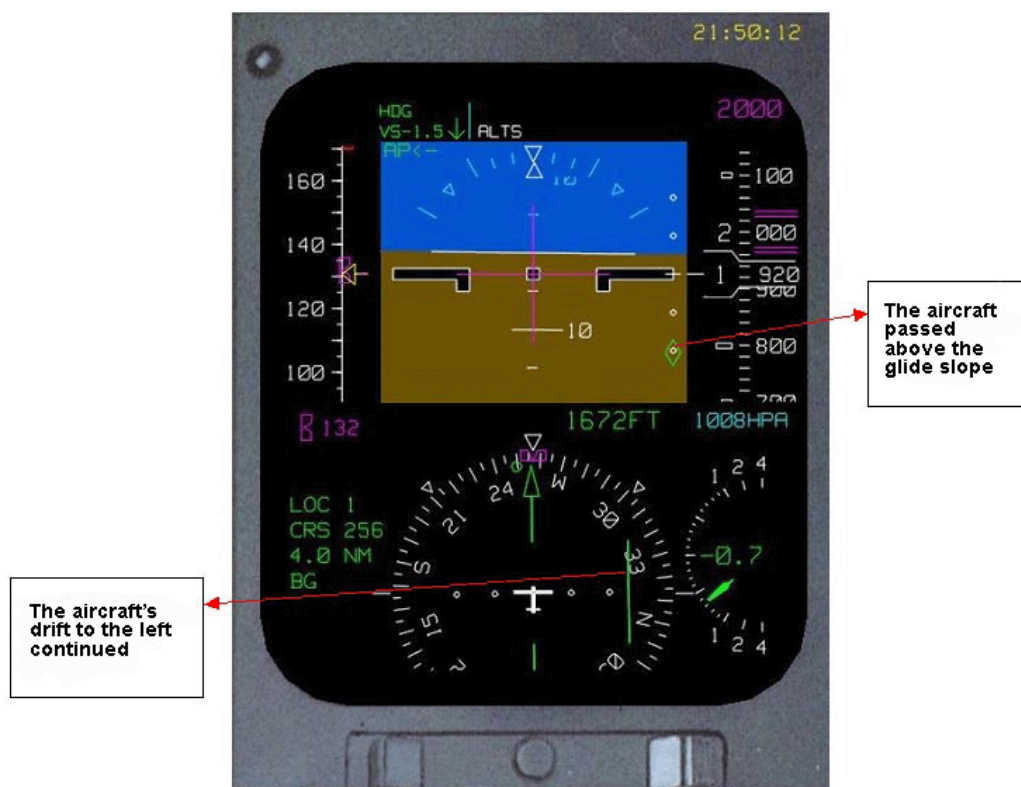
Between 21 h 50 min 00 s and 21 h 50 min 12 s, the Captain, seeing that the aeroplane had passed above the glide slope, tried to have it descend in “VS” mode. The following modes were recorded successively: “ALT CAP”, “VS”, “ALT CAP” again, and finally “VS” at 21 h 50 min 12 s. This succession of commands can be explained by the fact that since the aeroplane was in level flight at 2,000 ft and the altitude selector was most probably set at 2,000 ft (the last authorised altitude), the first command was not accepted by the autopilot. It was necessary to change the target altitude in order to make the aeroplane descend: this is no doubt what the Captain did at the second attempt. The Co-pilot's exclamation at 21 h 50 min 09 sec., and the Captain's remark “Oh didn't it catch it?” probably correspond to this difficulty, and, during the twelve second sequence, the crew's attention is monopolised by the descent. The deviation with regard to the glide slope attained a maximum value of 2.1 points.

When the aeroplane passed the Outer Marker, according to the recorded parameters, it is likely that the “OM” symbol was not displayed on the PFD. The crew made no announcement relative to passing the Outer Marker and did not report to ATC. (The frequency was, moreover, occupied by exchanges between ATC and the aeroplane on the ground).

At 21 h 50 min 14 s, the Captain said “fifteen hundred, seventeen hundred, it's OK”, then five seconds later “(Sixteen) hundred feet, it's OK”. These figures probably represent the selected vertical-speed values of the “VS” mode. At that moment, the two pilots were focused on managing the aeroplane's flight path in the vertical plane. The words “heading, VS” pronounced by the Captain show that he was aware they were in “HDG” mode. The deviation from the localizer had not yet been detected.

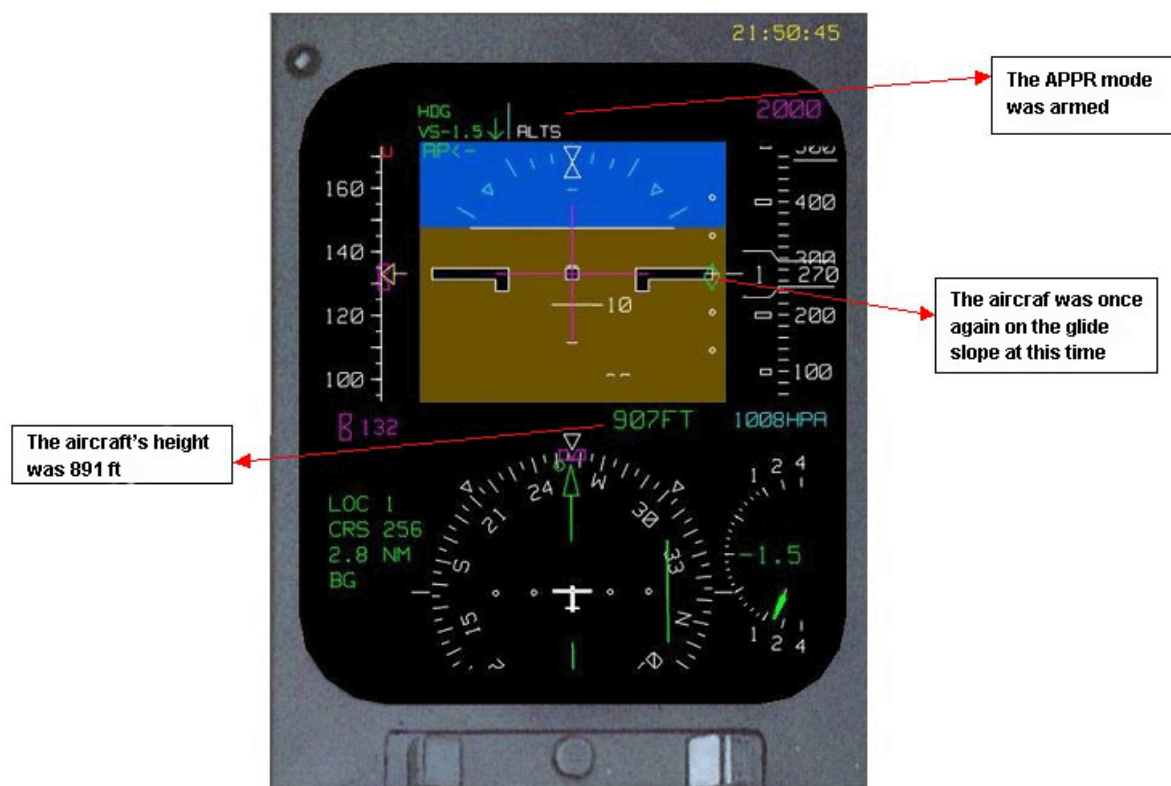
At 21 h 50 min 45 s, the aeroplane captured the glide slope and the Captain announced, "The approach is selected LOC and GLIDE". He had therefore just armed the "APPR" mode but, since the aeroplane was outside the localizer-beam capture envelope, no capture occurred. At that moment, while radar contact had been re-established, the Controller indicated that she had stopped looking at the screen because she was busy looking after the taxiing aeroplane and had already cleared the Brit Air to land. The aeroplane passed through and would remain under the glide slope until the impact with the ground.

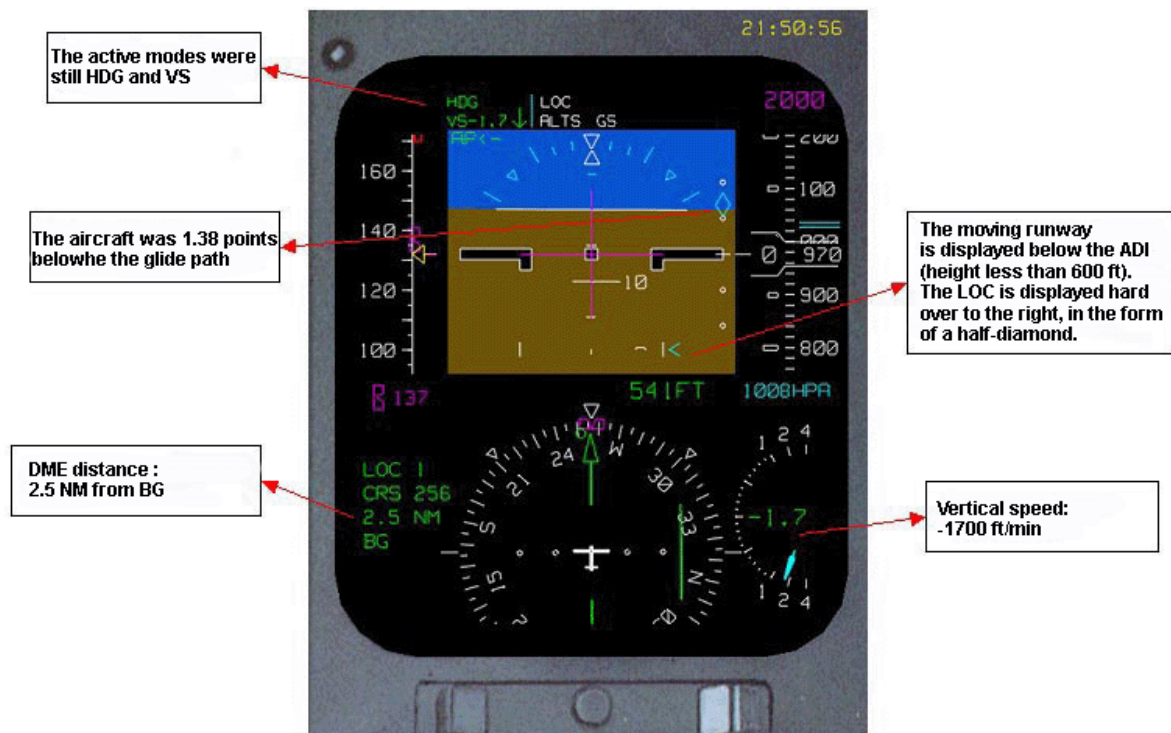
Between 21 h 50 min 52 s and 56 s, the Co-pilot said “(\*) come right” on two occasions, which clearly corresponds to a request to correct the flight path towards the right, therefore to an awareness as to the aeroplane's position in the horizontal plane. The Captain's answer seems to indicate acquiescence. In his testimony, the Co-pilot indicated that what made him realize that the aeroplane was not on the localizer centreline was seeing the white LOC display on the FMA. Seeing the LOC displayed hard over to the right on the HSI told him that the aeroplane was to the left of the planned flight path, without his realizing what the actual deviation was. The widened representation of the deviation in relation to the localizer centreline, which occurred at six hundred feet radio-altimeter height, at around 21 h 50 min 55 s, could also have contributed to his becoming aware of the aeroplane's position.

After the GPWS “Five hundred” announcement, numerous “Glide slope” and “Sink rate” announcements are heard. At the same time, the aeroplane began to turn to the right, which shows that the Captain was also aware of the aeroplane's position in the horizontal plane.

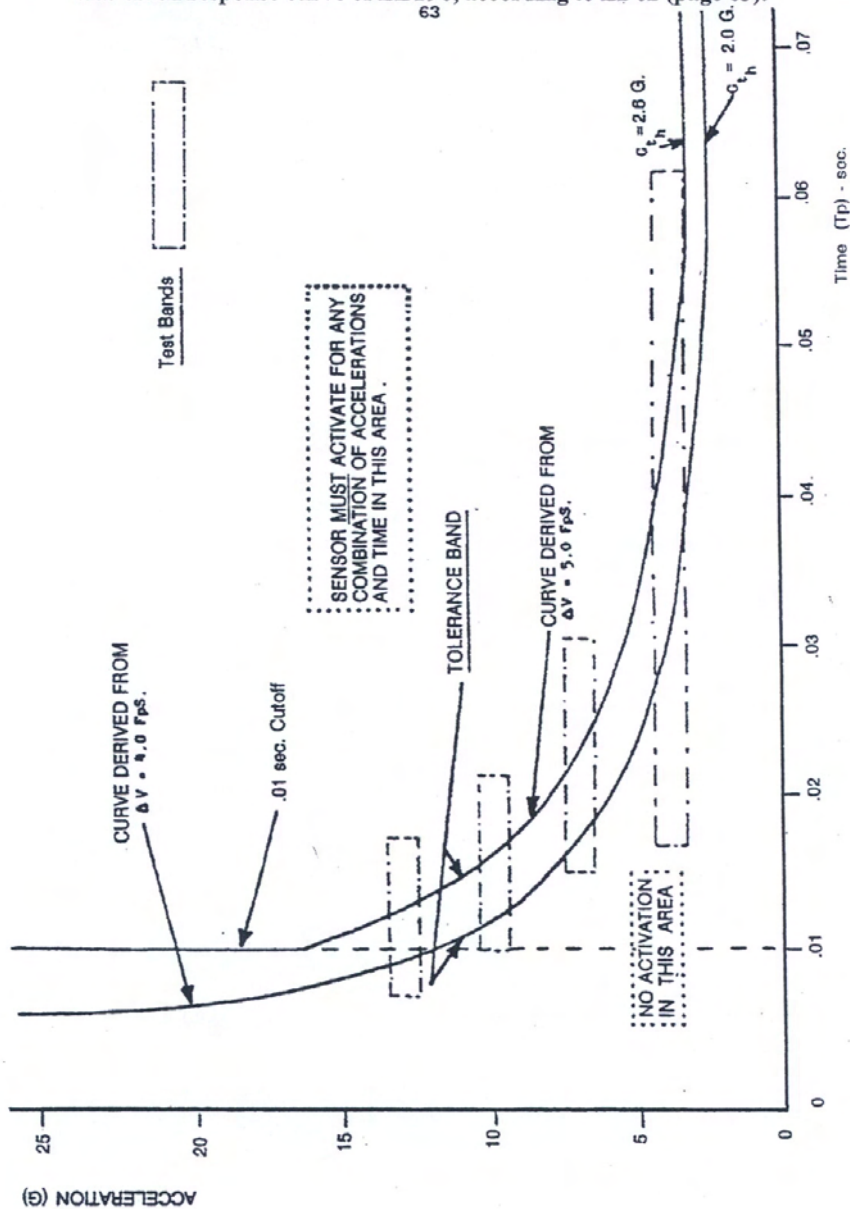
Figure 5-7 : Crash Sensor Response Curve

The crash response curve of ELT96, according to ED62 (page 63).
