**AERONAUTICAL ACCIDENT INVESTIGATION  
AND PREVENTION CENTER**

**FINAL REPORT  
A-00X/CENIPA/2008**

**ACFT REGISTRATION:      PR-GTD and N600XL**

**MODELS:      B-737 8EH and EMB-135 BJ LEGACY**

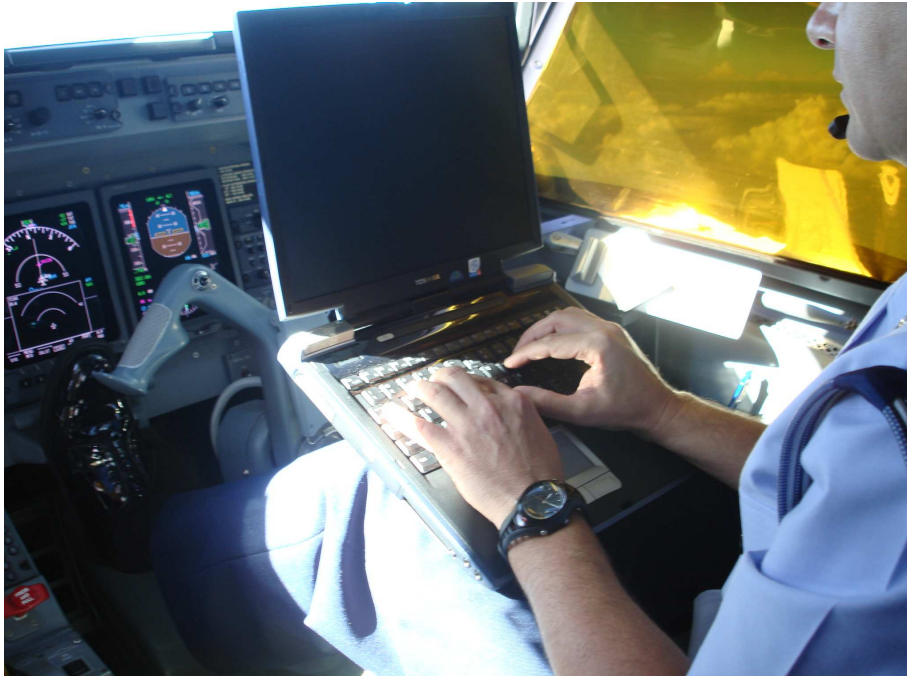
**Figure 33**

a) Use of the *laptop* by the SIC during cruise flight, leveled at FL370 and FL380. (Figure 33 shows the TCAS Box open, as should be expected):

- Likewise, it was observed that the control column is an obstacle for the contact of the *laptop* with the aircraft panel, preventing any type of inadvertent activation of the various systems;
- The *laptop* screen prevents the PIC from sighting the panel ahead and, thus, He cannot see the indications of the Transponder on the RMU and MFD;

- When the *laptop* is handled by the PIC, it is possible for the SIC to maintain normal visual contact with the panel ahead of him, sighting all the visual indications of the Transponder, as well as the indications of the panel ahead of the PIC, even considering the parallax.

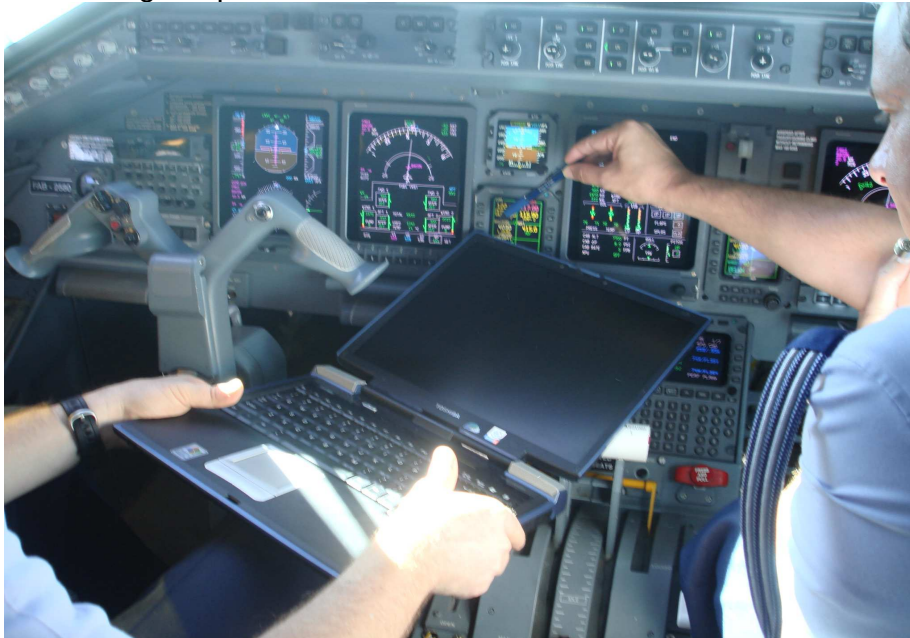
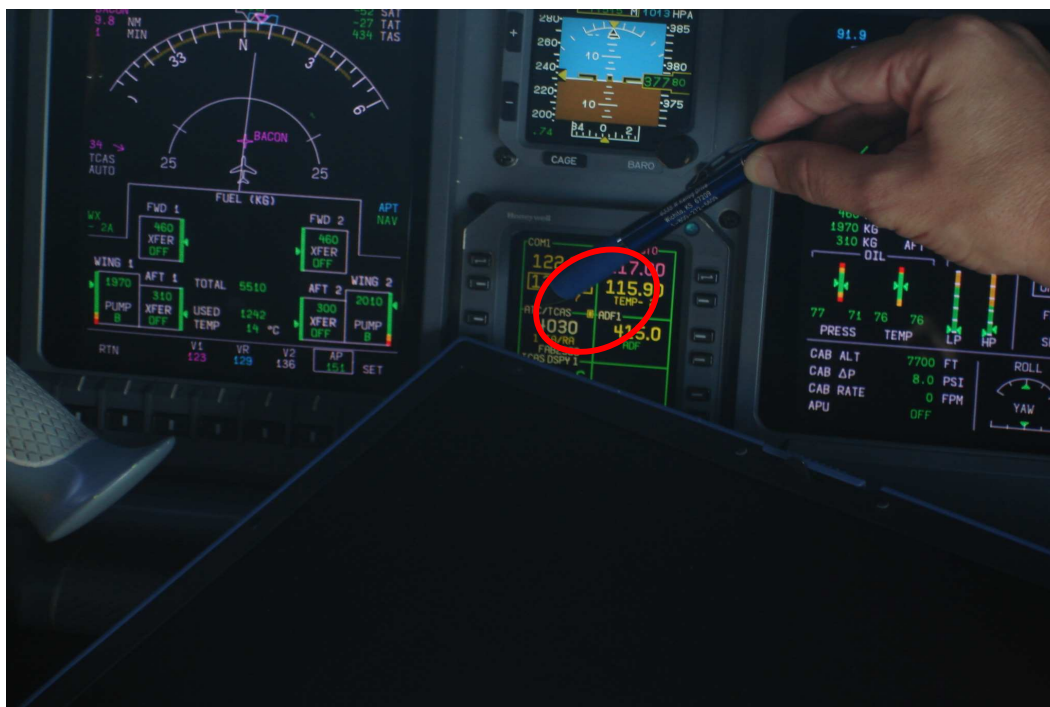
c) Handling of the *laptop* by both pilots, in a attempt to hit the RMU button related to the Transponder (cruising level FL370 and FL380):

- By handling the *laptop* with the screen open at a pronounced angle (close to horizontal), it is possible to hit the command Button of the Transponder. However, this unintentional action can be easily noticed, as the signals can be monitored visually. On the other hand, one has to consider that it is not logical to operate the laptop in such a position;
- All the time, it was possible to observe the indications of the transponder on the various displays, both for the SIC and the PIC. The use of the laptop is not capable of interfering in the sighting of the aircraft panel by both pilots at the same time.

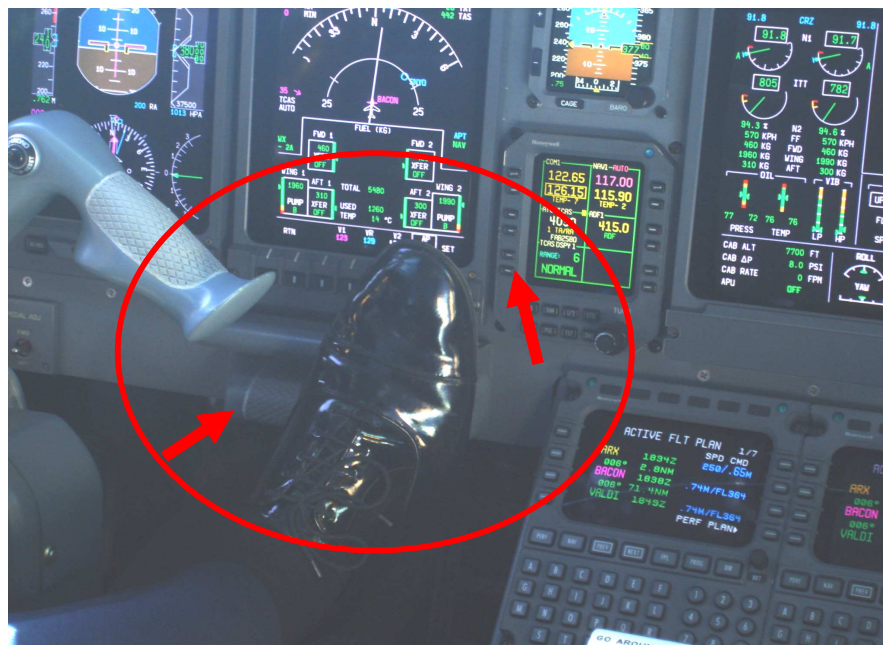
Figure 36

d) During the reconstitution flight, while in cruise and level FL370, the PIC's foot was placed on the *footrest* and then subsequently it was attempted to strike the RMU1, as shown by figure 23:

- The flight reconstitution indicated, therefore, that, for the buttons on the left side of the RMU to be reached with the right foot, it is necessary an intentional movement of the tip of the shoe forwardly, which was considered very uncomfortable due to the angle the foot must flex. With this in mind, the involuntary handling was considered an action with a high level of difficulty.

- No evidence was found in the ergonomic aspect, relative to the positioning of the RMU and the *footrest*, which could be considered as a contributing factor to the accident.

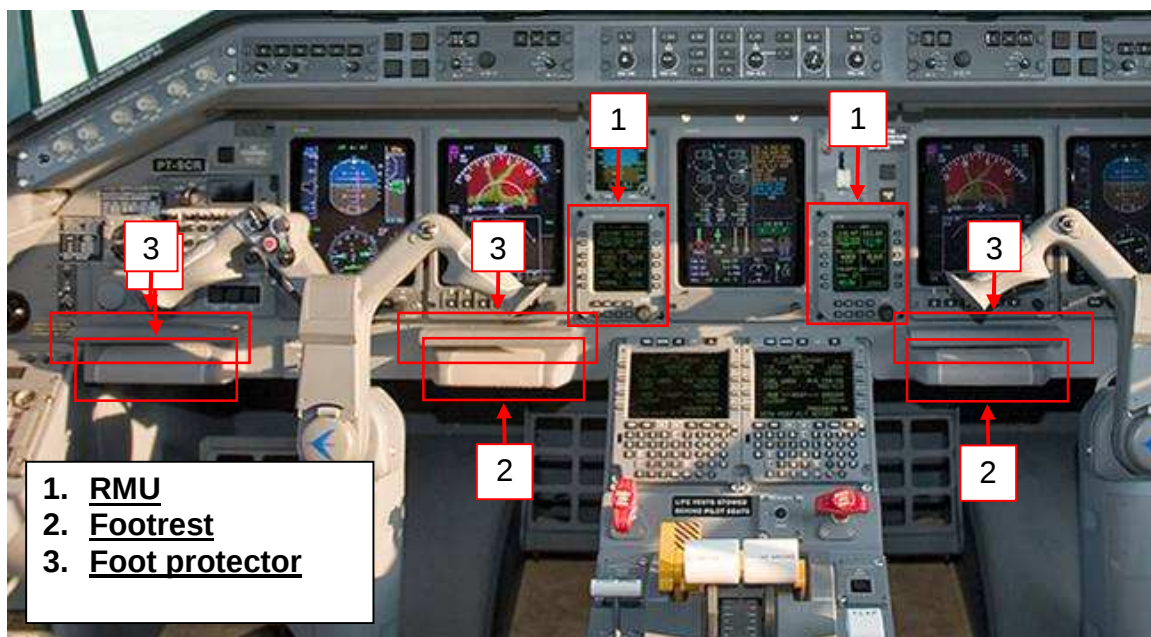
Figure 37

e) Ergonomic Aspects – Considering the positioning of the RMU1 and RMU2 in the instrument panel of the EMB-135BJ as in the picture above:

- With relation to “position”, the location of the RMU in the frontal panel of the aircraft is considered excellent when one verifies the angle of sight from both the PIC and SIC’s perspective.
- With relation to “luminosity”, the perception and understanding of the information of the RMU in the frontal panel of the aircraft were considered of easy interpretation, due to the size of the letters and distribution of colors, even with the intense luminosity present during the flight.

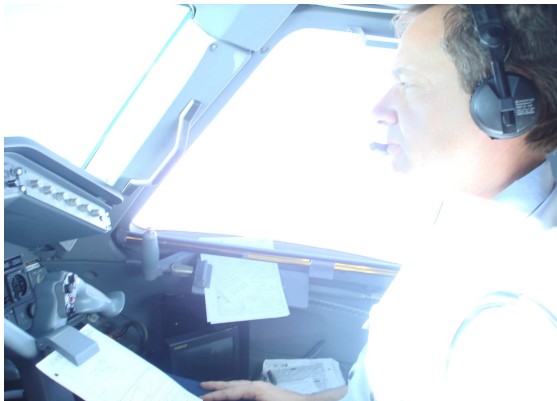
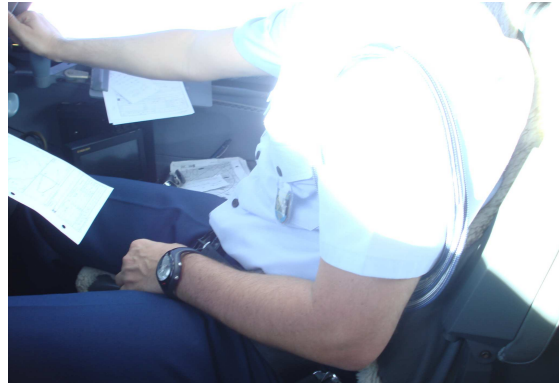
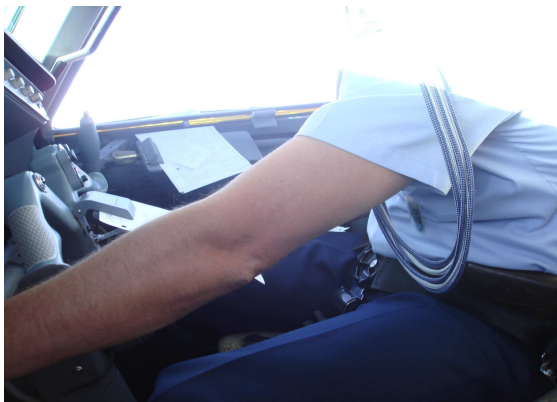
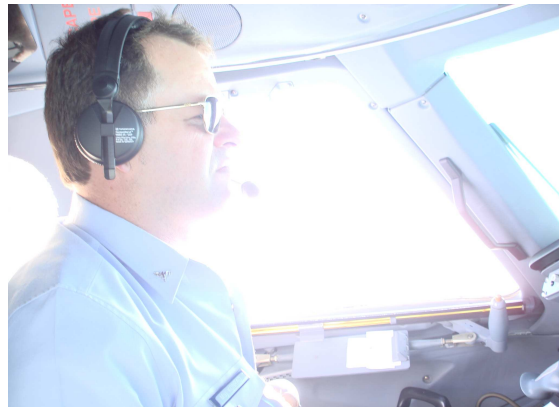
h) Aspects related to the influence of the sun for the visualization of the aircraft panels and their respective instruments (without the use of the sunshades, with lateral views of the SIC and PIC, same magnetic headings and same flight time of the accident flight):

- It is possible to observe that the sunshine touches the SIC on the chest, in a area that is tangent to the chin is above the abdomen (Figures 41 and 42);
- The SIC reported a sensation of discomfort due to the intense heat on his chest;
- As the sunshine touches the SIC below his chin, his eyes end up being protected by the overhead panel, allowing a perfect visualization of the instruments, as they are not directly hit by the sunlight (Figures 38 and 39);
- Since the frontal panel of the PIC is also protected from the sunshine, it is possible for the SIC to visualize it normally (despite the parallax), in the same way he visualizes his own panel;
- For the PIC the conditions were similar, and, even with the sunlight coming from the left, the visualization of the instrument panel was not hindered (Figure 44). There is evidence of the use of the sunshade by the crew.

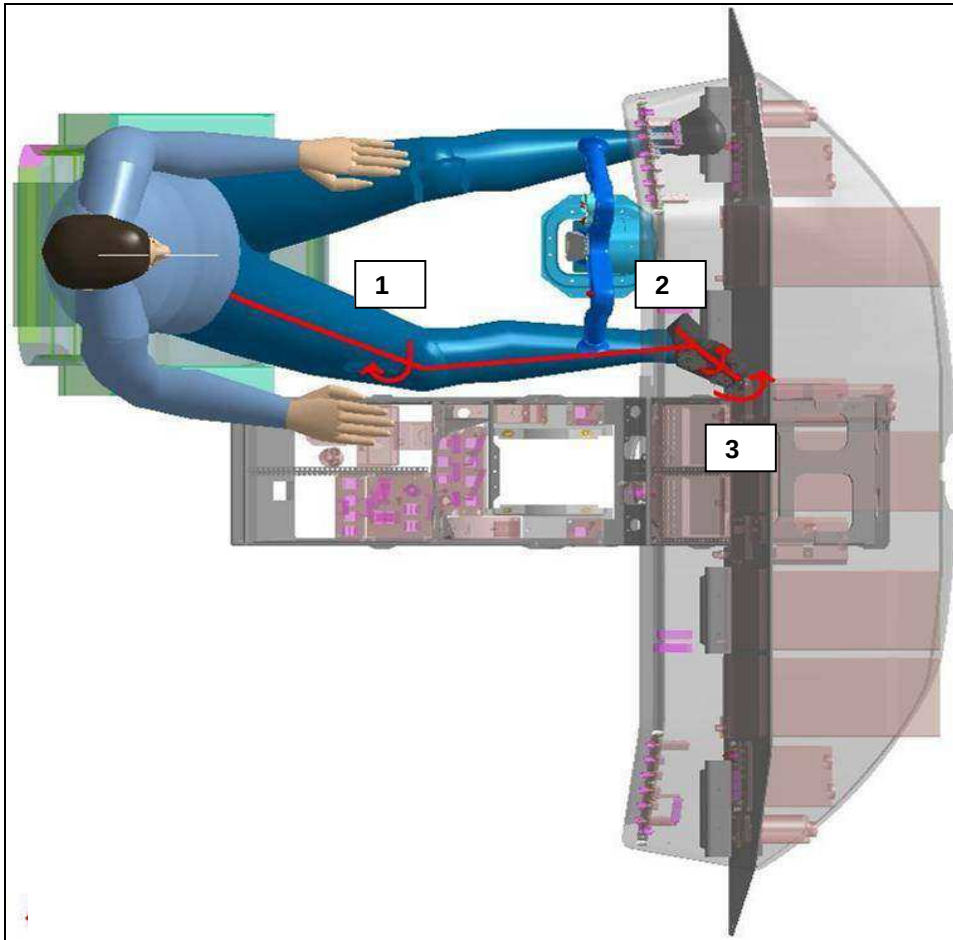
Figure 48

Additionally, the following picture shows the movements the PIC should perform so as to get his foot reaching the RMU1:

- (1) – Thigh lateral rotation
- (2) – Foot Inversion
- (3) – Plantar flexion.

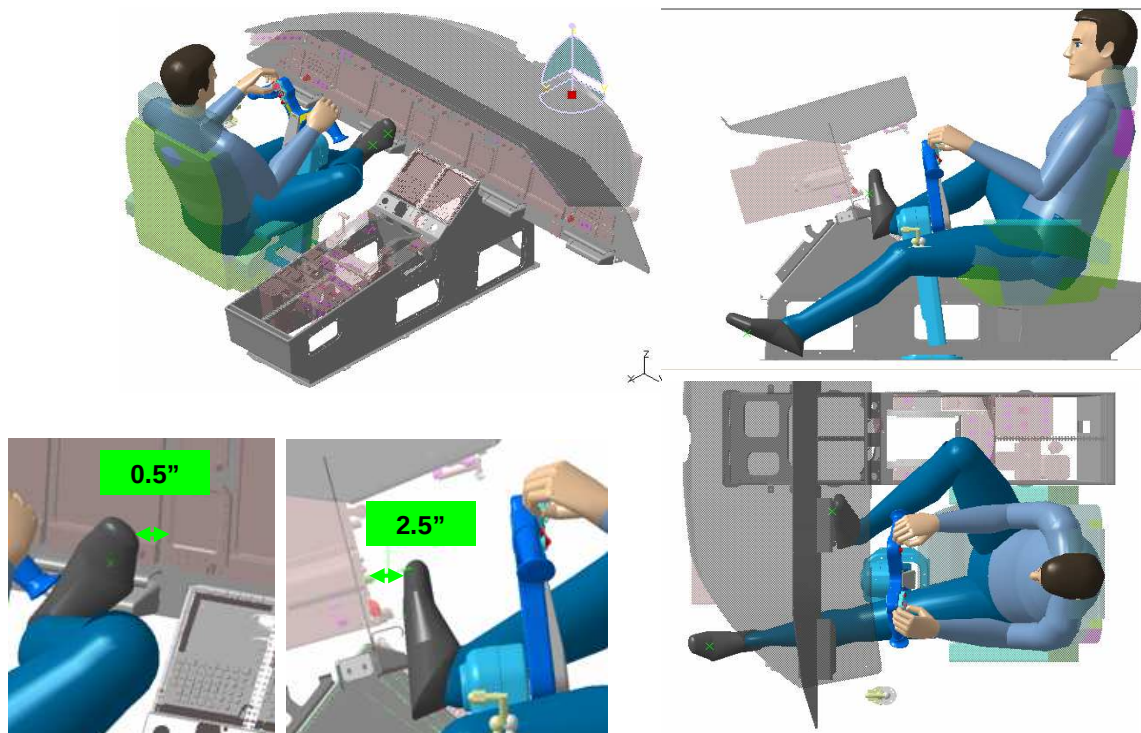
**Situation (a):** Figure 49 represents the position of the virtual human model, equivalent to the PIC, in the normal flight condition (DEP), using the *footrest* with the seat reclined 10°.

From this Table, it can be observed that all the angles measured in the simulation exceed the comfort limits. The posture of the pilot in this position is unnatural and uncomfortable, this being the same for any attempt to reach the RMU with his foot. These

measurements eliminate the possibility of an inadvertent command from the foot on the RMU.

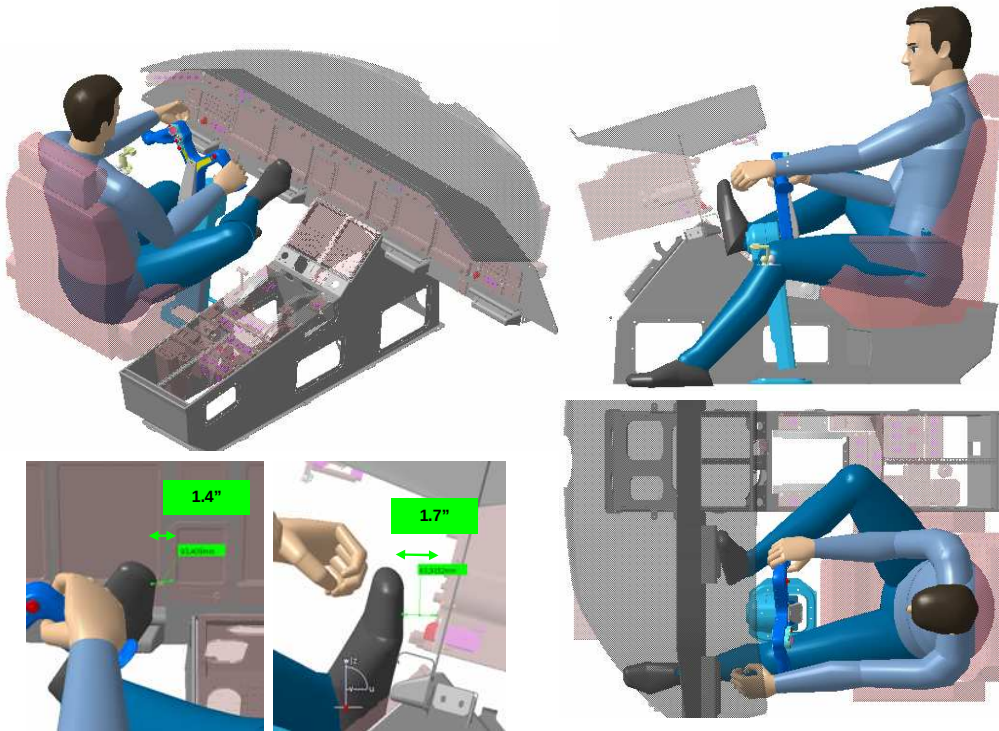
**Situation (b):** Figure 50 represents the position of the virtual human model, similar to the PIC, trying to utilize the *footrest* with the seat moved 2" back from DEP without reclining the seat and still having access to the primary flight controls (control wheel and pedals):

From this table, the posture of the pilot in this position eliminates the possibility of an inadvertent command from the foot on the RMU, because it is unnatural and uncomfortable.

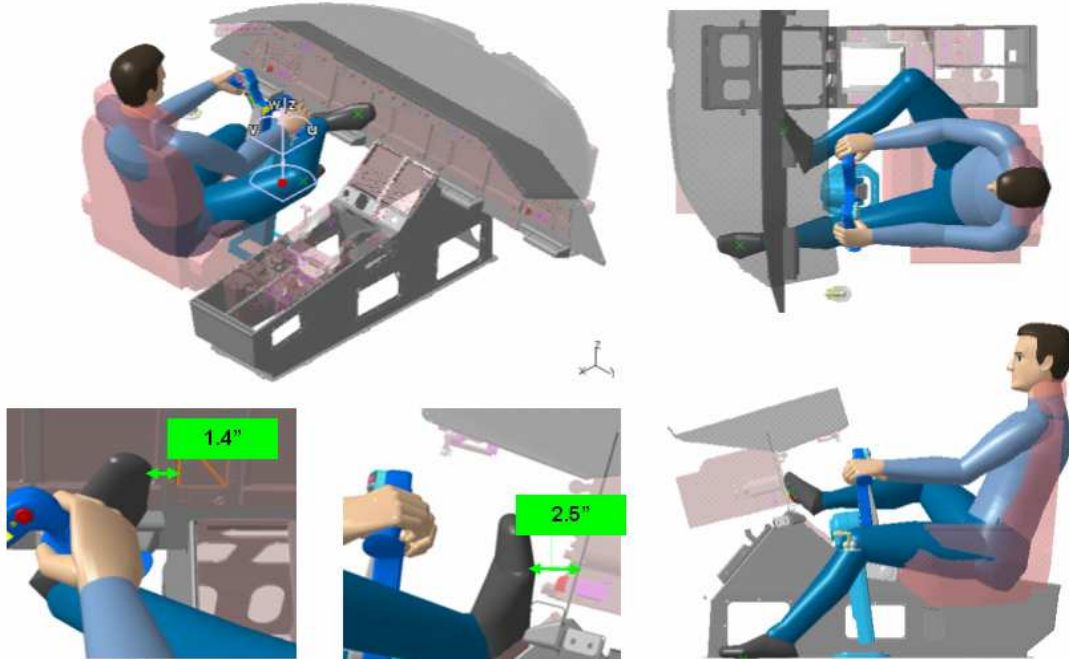
**Situation (c):** Figure 51 represents the position of the virtual human model, similar to the PIC, trying to utilize the *footrest* with the seat moved 2" back from DEP (i.e., without reclining the seat) and keeping access to the primary flight controls (control wheel and pedals), and now with the seat reclined 10°.

From this table, the posture of the pilot in this position remains unnatural and uncomfortable, which also eliminates the possibility of an inadvertent command from the foot on the RMU.

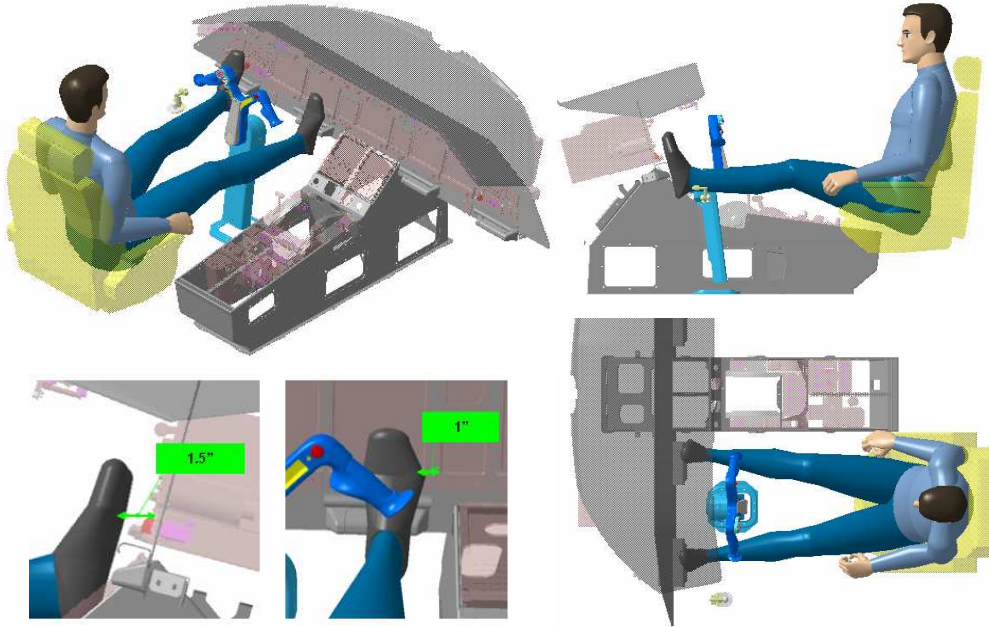
**Situation (d):** Figure 52 represents the position of the virtual human model, equivalent to the PIC, trying to utilize the footrest with the seat all the way to the back and without reclining the seat:

Comparing the values of the body angles required to utilize the footrest in the three conditions evaluated, it can be drawn that the comfort in the utilization of the footrest is inversely proportional to the proximity of the seat with the DEP, as follows:

The utilization of the footrest with the seat in the flying position for the evaluated conditions, from the ergonomic point of view is extremely uncomfortable and therefore not usual or practical if we consider that the PIC would be looking for comfort while resting his right foot on the *footrest*.

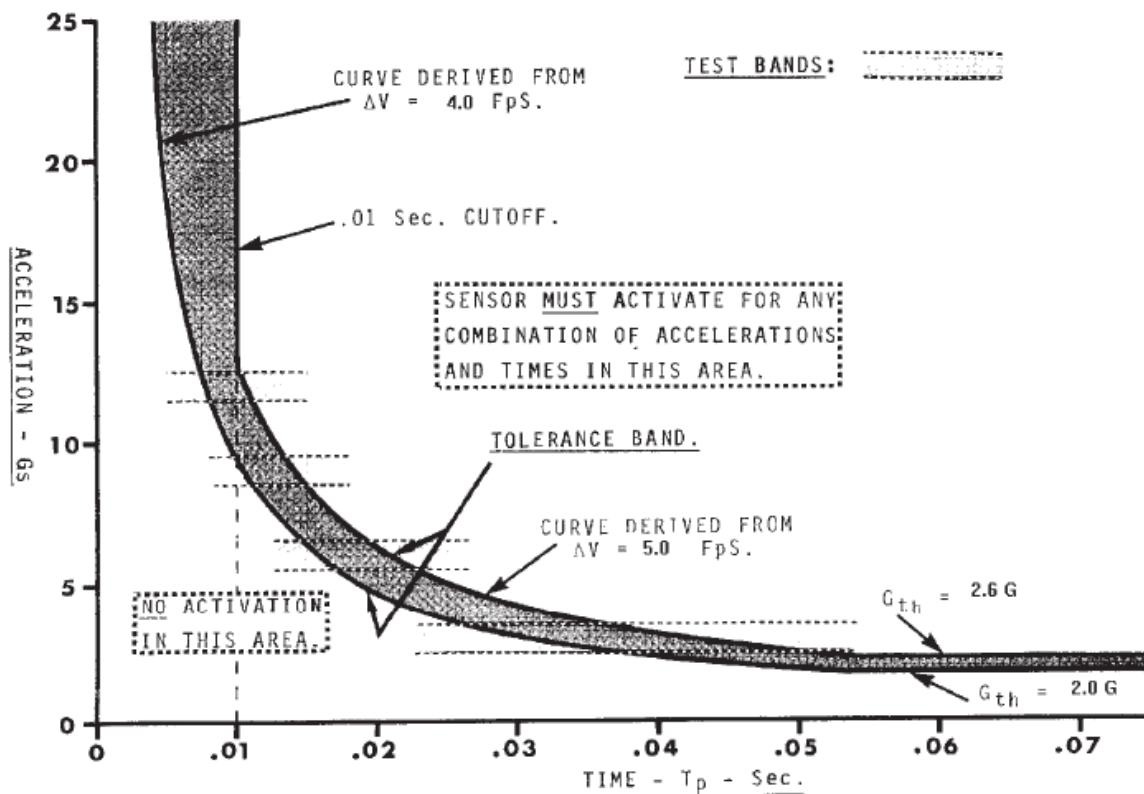
Figure 53

The crash force activation sensor or G-Switch is designed to activate according to the plot time versus longitudinal G force as shown by the Figure 1. For short impact the G force to activate the ELT is much higher than a relatively long impact.

After the N600XL and PR-GTD collision, no signal from the PR-GTD ELT was received by COSPAS/SARSAT system to help the search and rescue effort. While the PR-GTD was already in a spiral dive and before it suffered the in-flight breakup, the recorded FDR information revealed that the longitudinal acceleration did not exceed 0.5 G. This value was not sufficient to activate the ELT, according to figure 1.

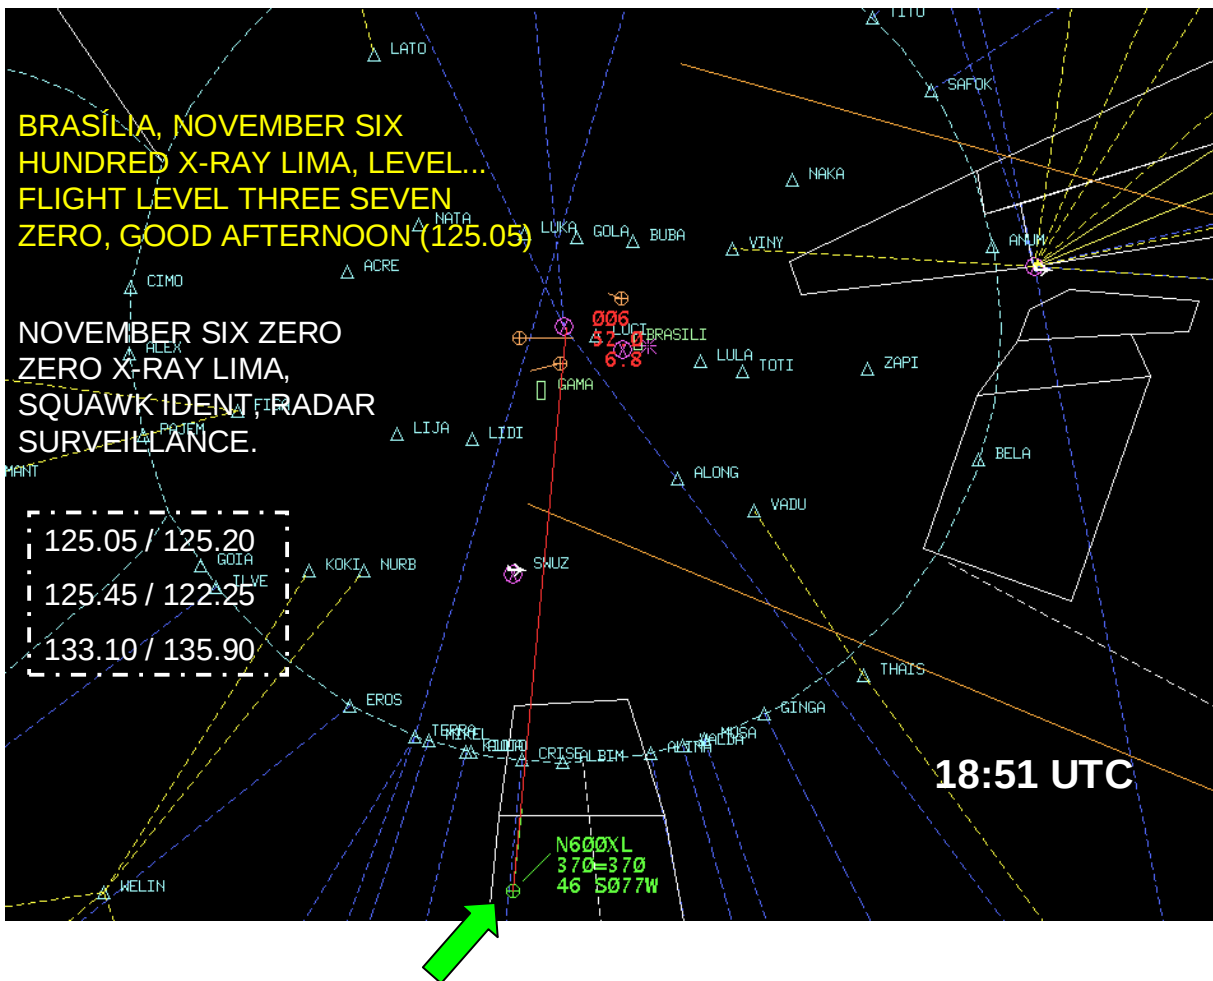
Figure 55 above depicts a view of the data block at the moment of the last two-way radio contact with Brasilia Center, sector 5, on the frequency 125.05 MHz.

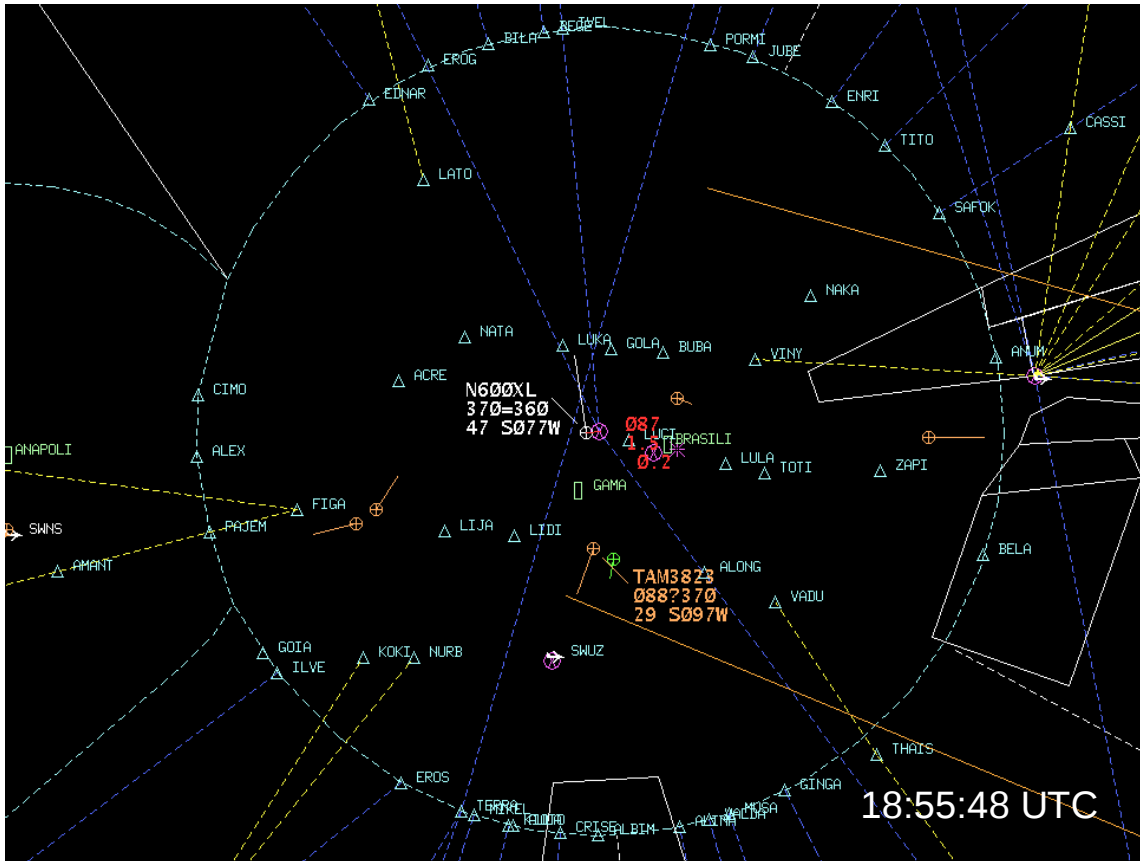
**Figure 56**

The information of the data block was that the aircraft, from that point on, **was flying at a flight level that was different from the flight level requested in the active flight plan**, as shown in Figure 56 below.

The controller's failure to act may have been caused by a lack of perception or a mistaken perception of the information conveyed by the data block.

The failing to act, on the part of the controller, leads us, then, to the possibility of an inadequate situational awareness to react correctly to the pieces of information presented by the equipment, something that contributed to the N600XL maintaining of the FL370 after passing BRS VOR.

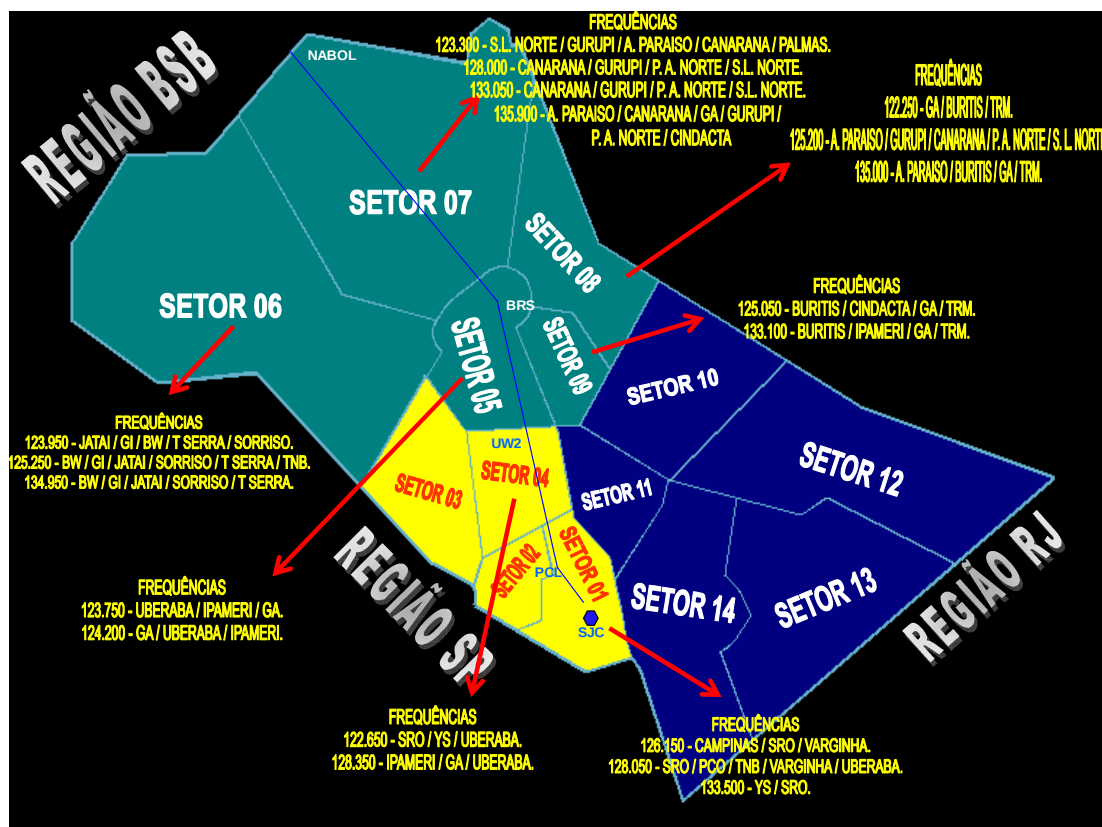
### Figure 57

When the controller verified the aircraft entering sector 7, to the north of Brasilia, he had to have instructed the aircraft to change frequency to 135.9 MHz, in accordance with the sector frequency table (Figure 57), besides analyzing and deciding about the adequate instruction regarding the change to FL360 authorized by the active flight plan.

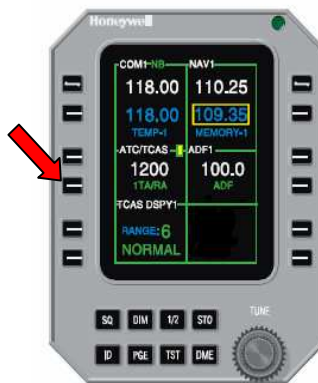
Figure 58

According to the information available, the loss of the Transponder signal on the screen of the air traffic controller occurred around 19:02 UTC, indicating that the STANDBY feature of the transponder had probably been selected.

For the Standby mode to be selected, it is necessary to press the fourth top to bottom left button, in one of the RMUs (it has to be pressed twice in a 20-second interval).

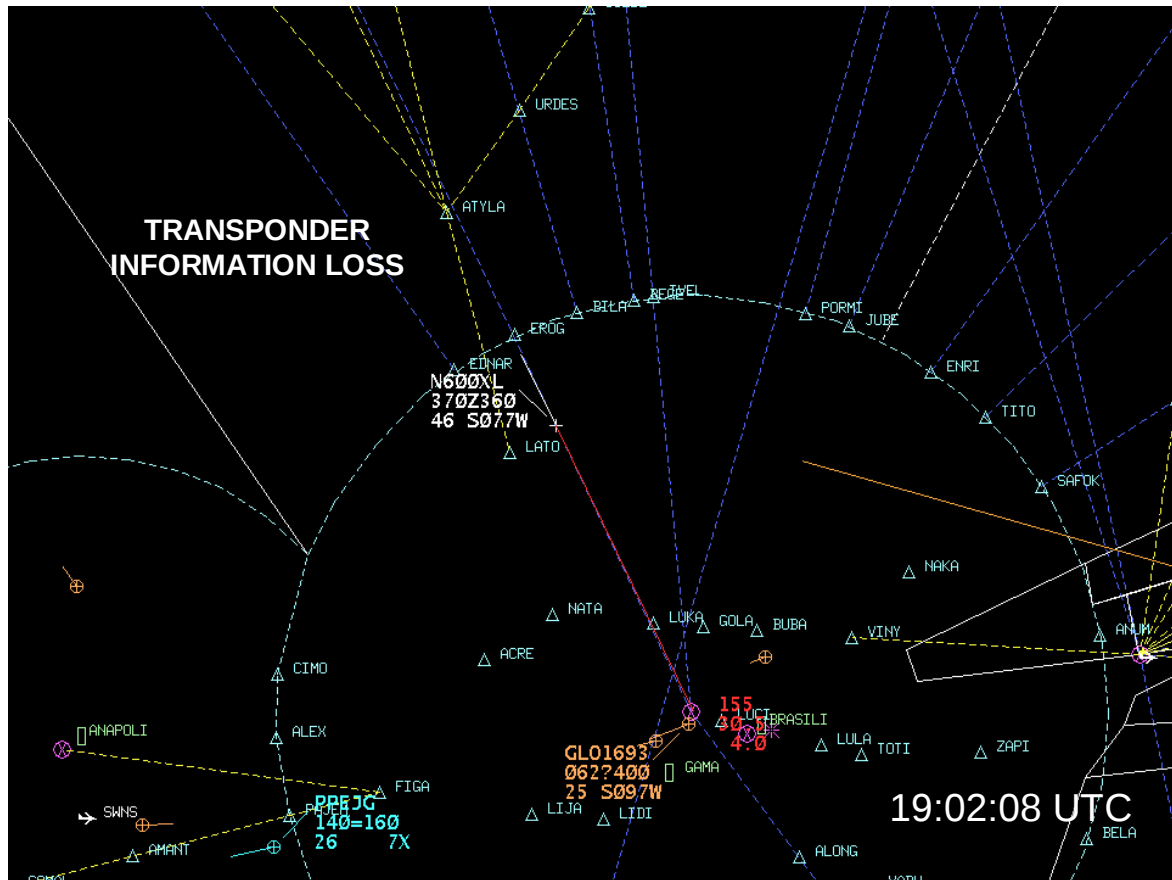
Figure 59

As seen in figure 59, the white data block pertaining to N600XL displays a letter Z between the two levels earlier identified as NIV and CFL, according to the ATECH Controller's Manual already mentioned, meaning **aircraft with a valid 3D altitude**. This meant that, from that moment on, the altitude information relative to that aircraft **was being obtained by 3D primary radar equipment and not from the transponder mode C** any longer.

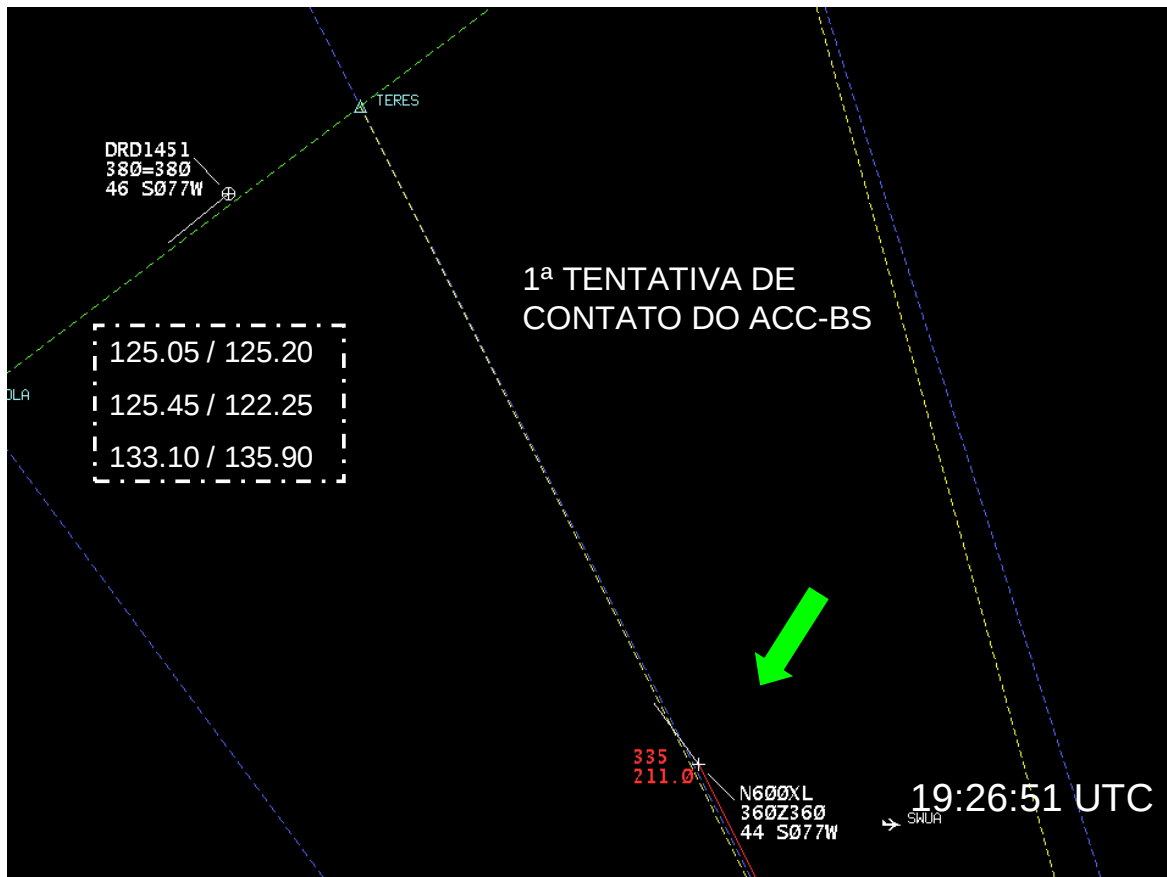
Figure 60

Despite being transmitting on 125.05 MHz, the first call was only made when the aircraft was already at **211 NM away from BRS VOR.**

The aircraft icon still showed a correlation between the primary radar and the 3D radar returns.

The effective range of the frequency 125.05 MHz at FL 300 is 300 NM. Although the aircraft was within the frequency theoretical maximum range, the positioning of the aerals is for sector 09.

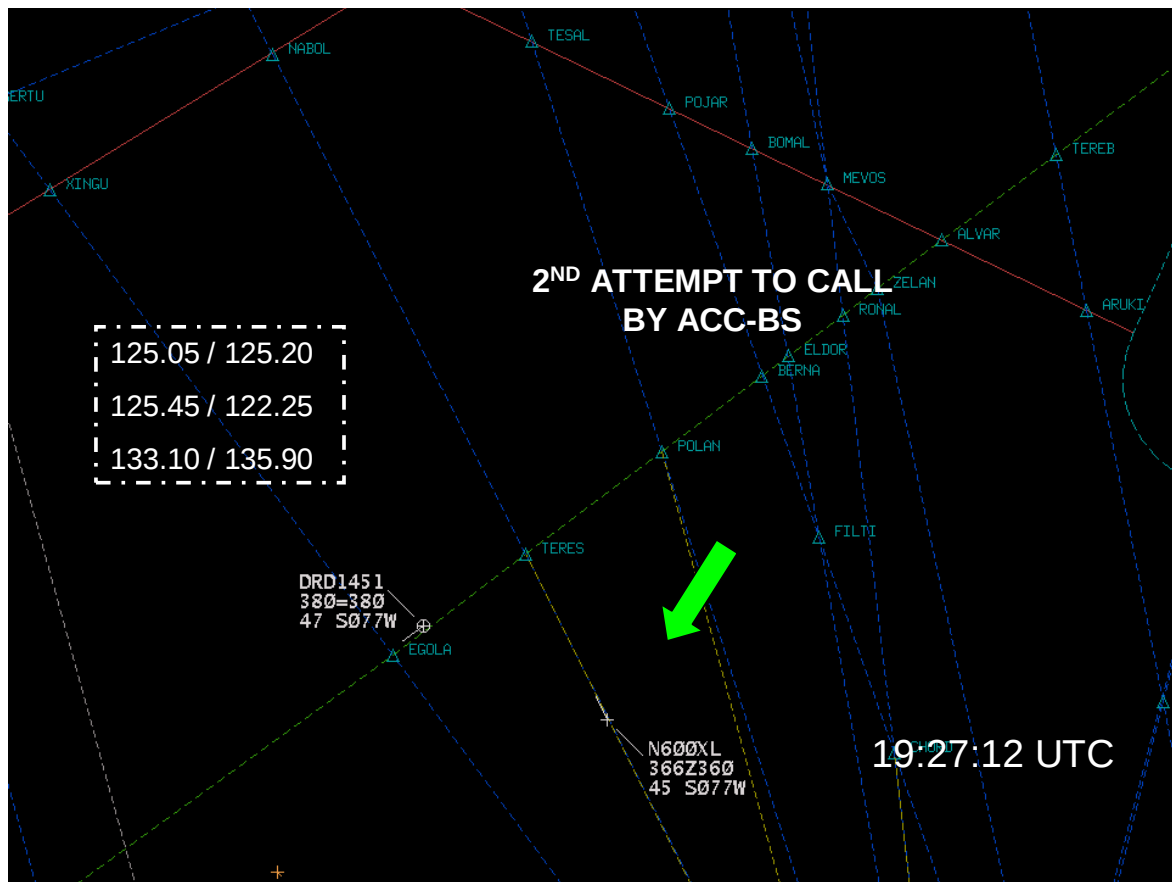
Figure 61

At the **second attempt, at 19:27:12 UTC**, for the **first time** a frequency change to **135.9 MHz** was commanded. Such a command should have been given, at least, 30 minutes earlier.

The aircraft was already at **218.5 NM from BRS VOR**, still with primary radar contact and correlation.

There was not any reply from N600XL to either call. The controllers did not take any alternative actions, such as resorting to an alternative, in an attempt to establish contact.

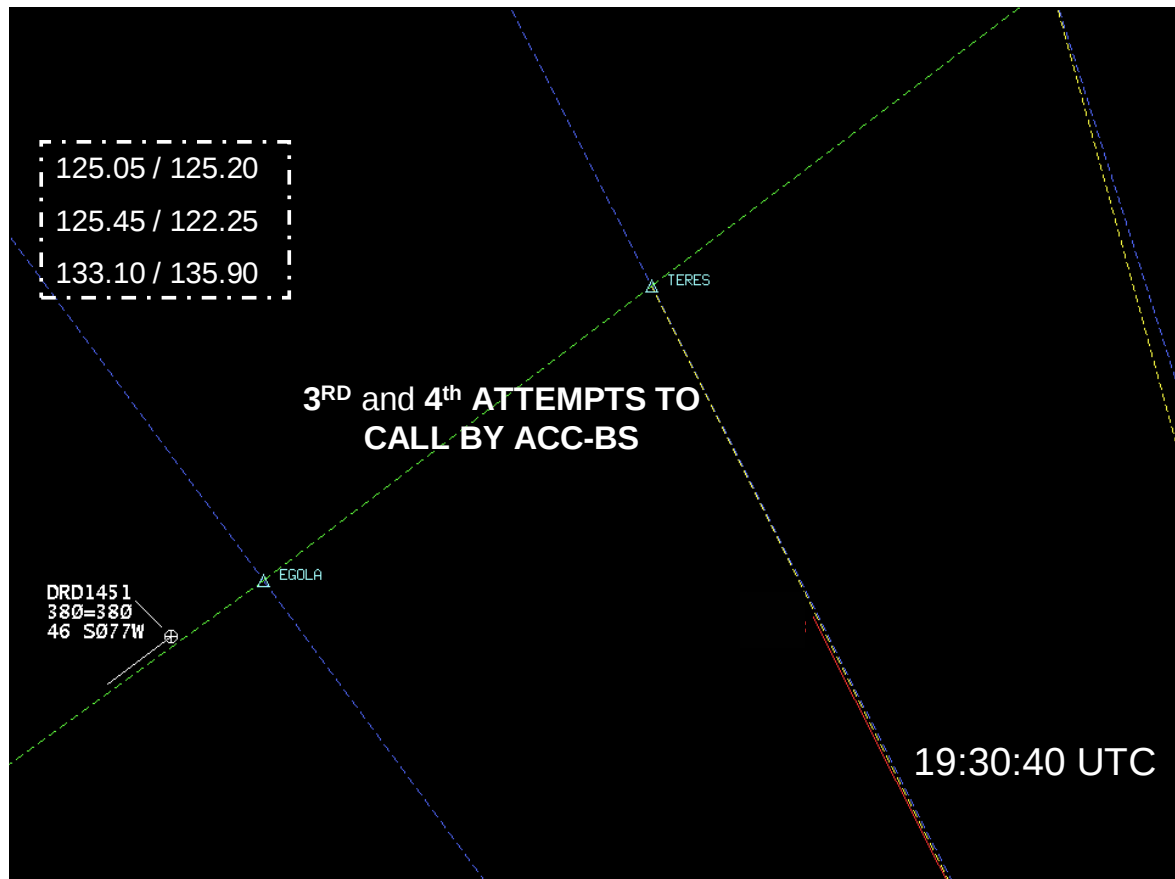
Figure 62

The ACC lost primary radar contact with the aircraft for two minutes. A **third attempt of radio contact** was made, at **19:30:40 UTC**, when the aircraft was already at **248 NM** from BRS VOR.

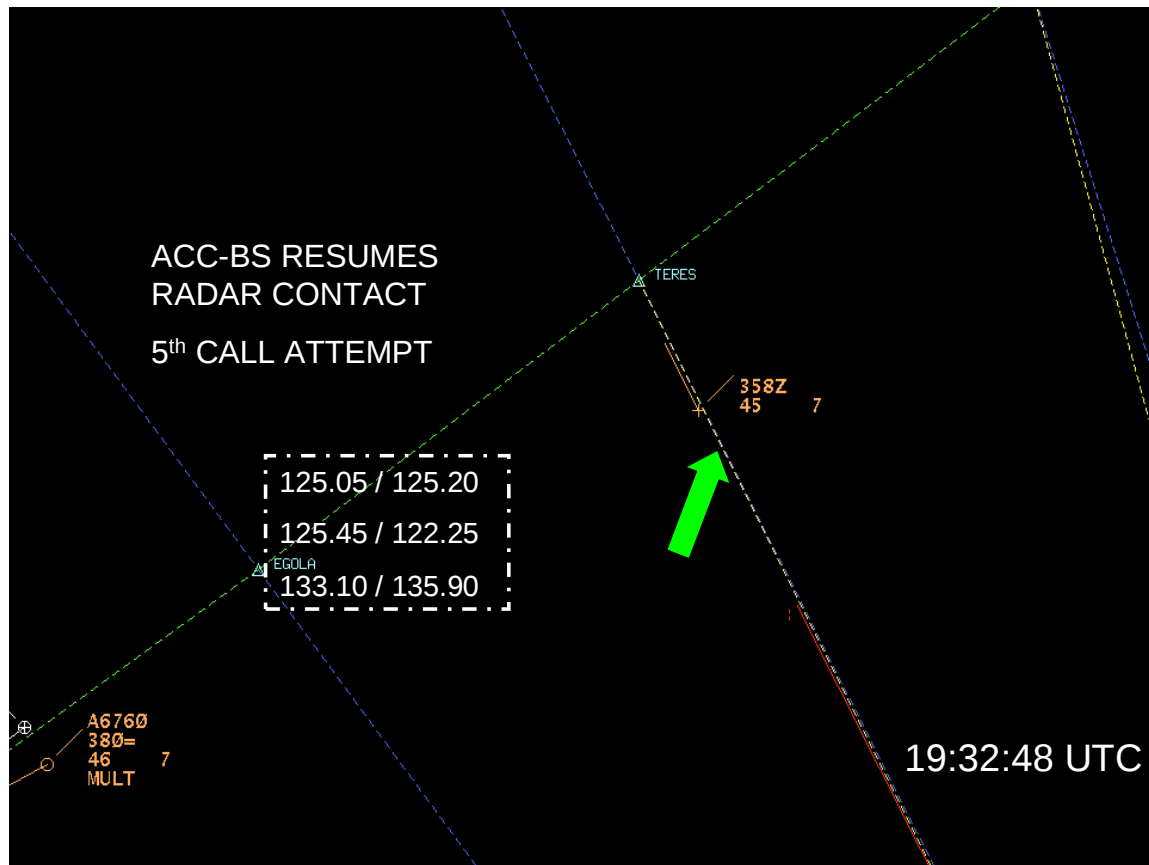
Figure 63

At **19:32:48 UTC**, the aircraft reappeared as a primary radar contact, at **265 NM**, but now without its correlation symbol. Instead of the earlier data block, it had only speed and 3D radar altitude information. This type of altitude information can not be used for vertical spacing under RVSM. The controller then made the **fifth** unsuccessful **attempt** to contact.

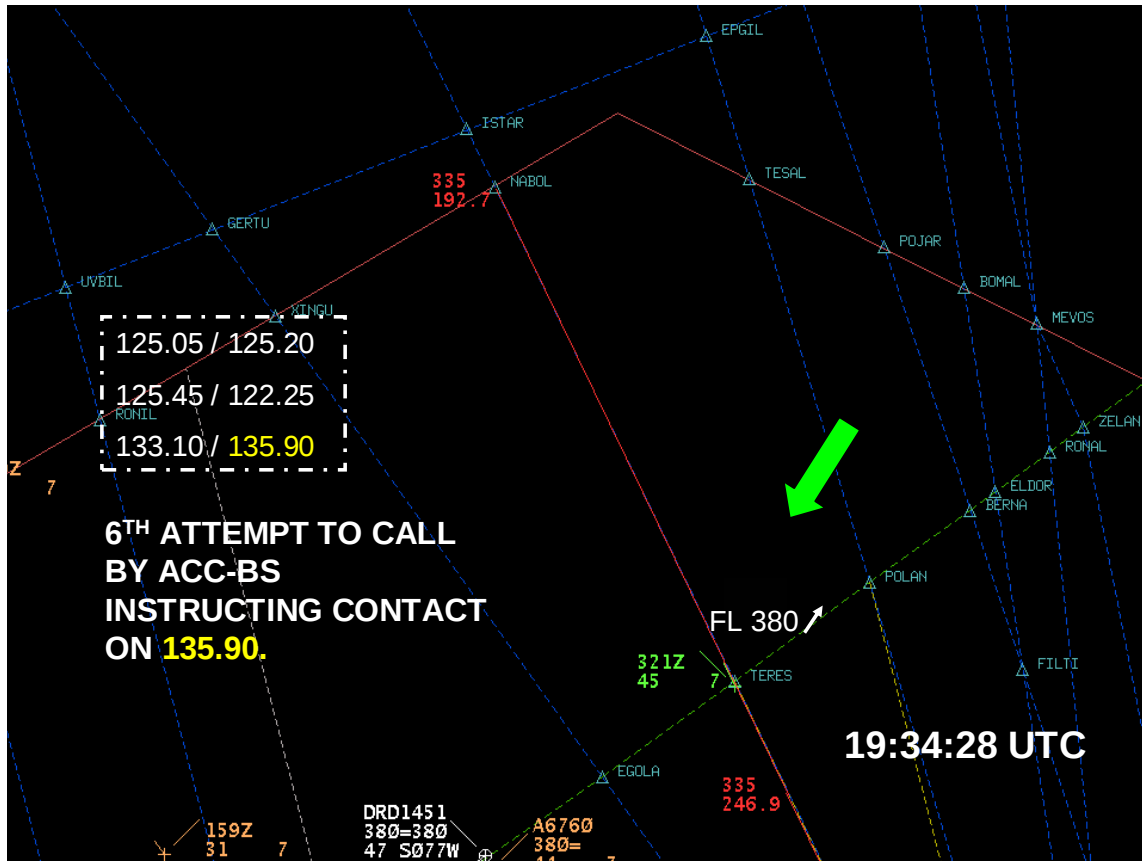
**Figure 64**

At **19:34:08 UTC**, the controller made the **sixth attempt**, and for the **second time** he added an instruction of frequency change to **135.9 MHz**, when the aircraft was already at **280 NM**.

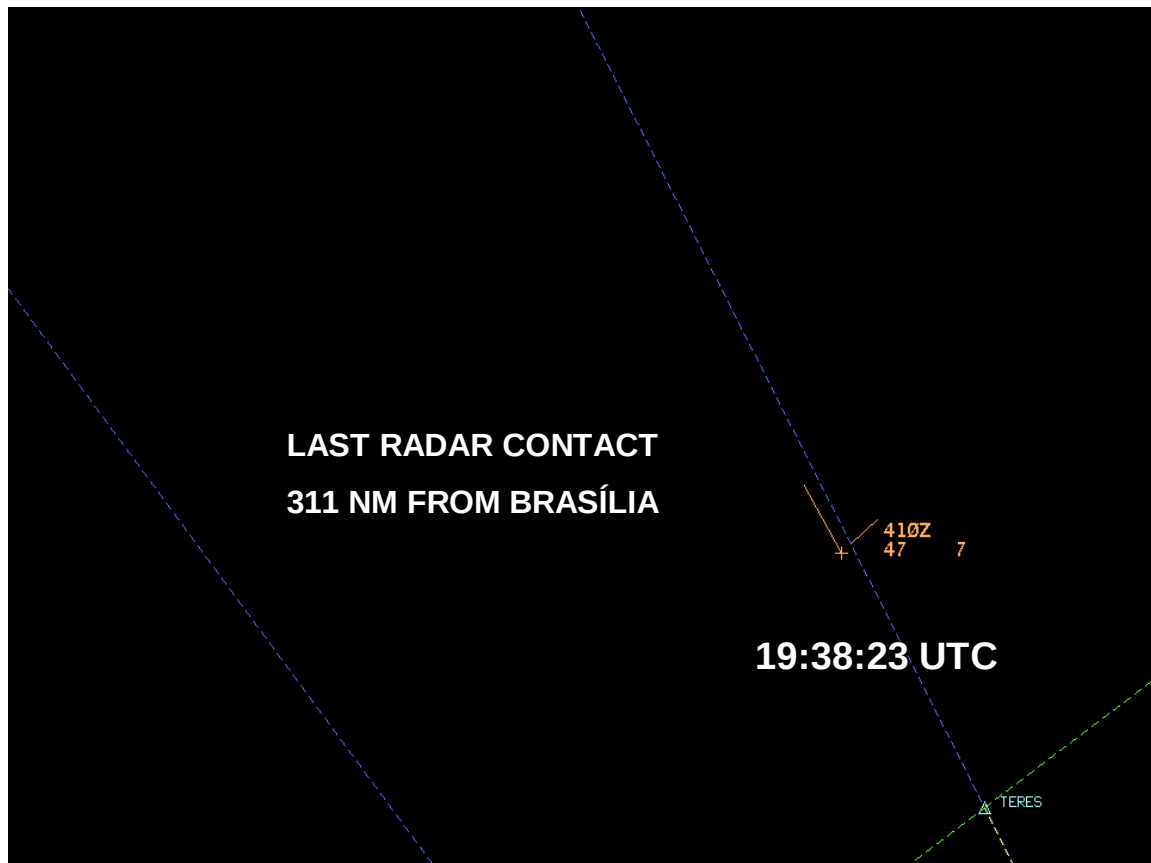
Figure 65

At 1938:23 UTC, the primary radar contact was lost, when the aircraft was at 311 NM. If the transponder had been transmitting, the secondary radar coverage would have been available to the controllers.

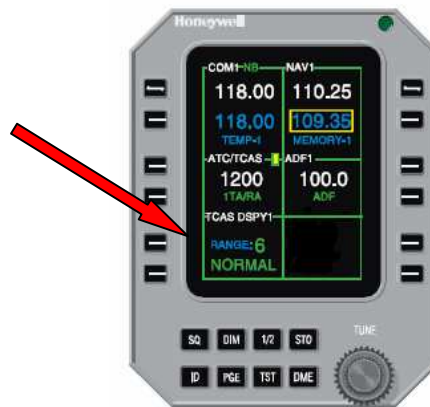
Figure 66

in the RMU, mainly due to the fact that the field that indicates the operation mode of the transponder in the RMU is located just below the field “COM”.
