**AERONAUTICAL ACCIDENT INVESTIGATION  
AND PREVENTION CENTER**

**FINAL REPORT  
A-00X/CENIPA/2008**

**ACFT REGISTRATION:      PR-GTD and N600XL**

**MODELS:      B-737 8EH and EMB-135 BJ LEGACY**

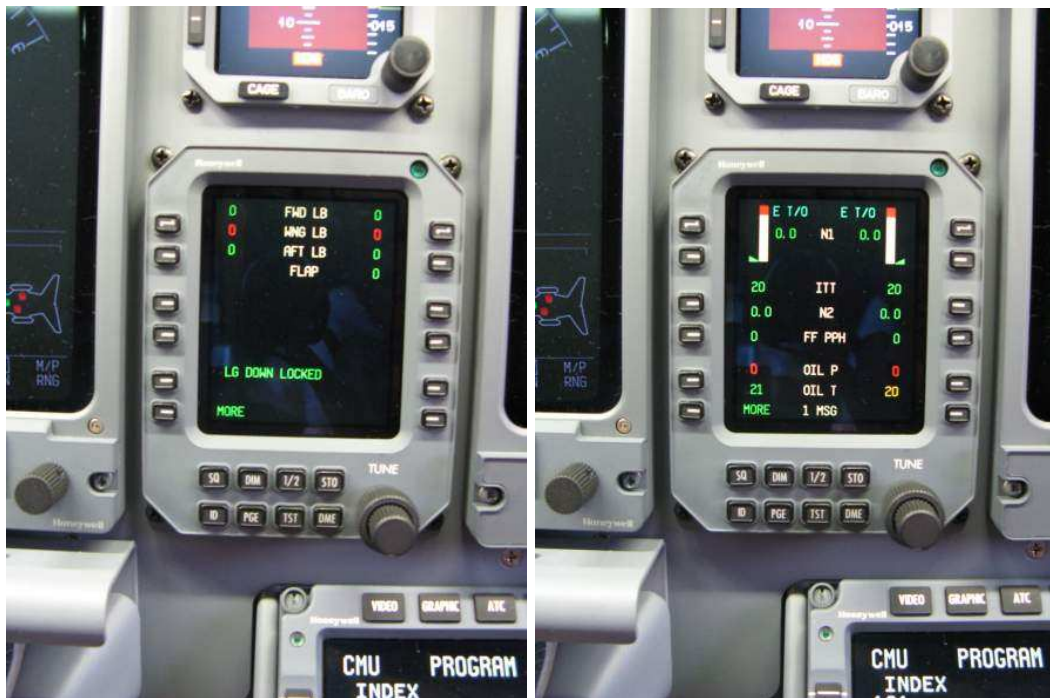
The RMU is used primarily for adjusting the navigation and communication frequencies. It also functions as a backup for the EICAS; therefore, pages of the RMU can be accessed to check the fuel status, engine parameters, flap position, TCAS, etc., as shown in the Figures below.

Fig. 67 and 68 (Adjustment of communication and navigation frequencies)

Fig. 69 and 70 (as a back-up, pages with information of the fuel system and engine parameters.

Therefore, it is possible that, while handling the pages of the RMU, the captain unintentionally set the Transponder to STANDBY, by pressing the RMU button twice in less than 20 seconds, without being aware of his action.

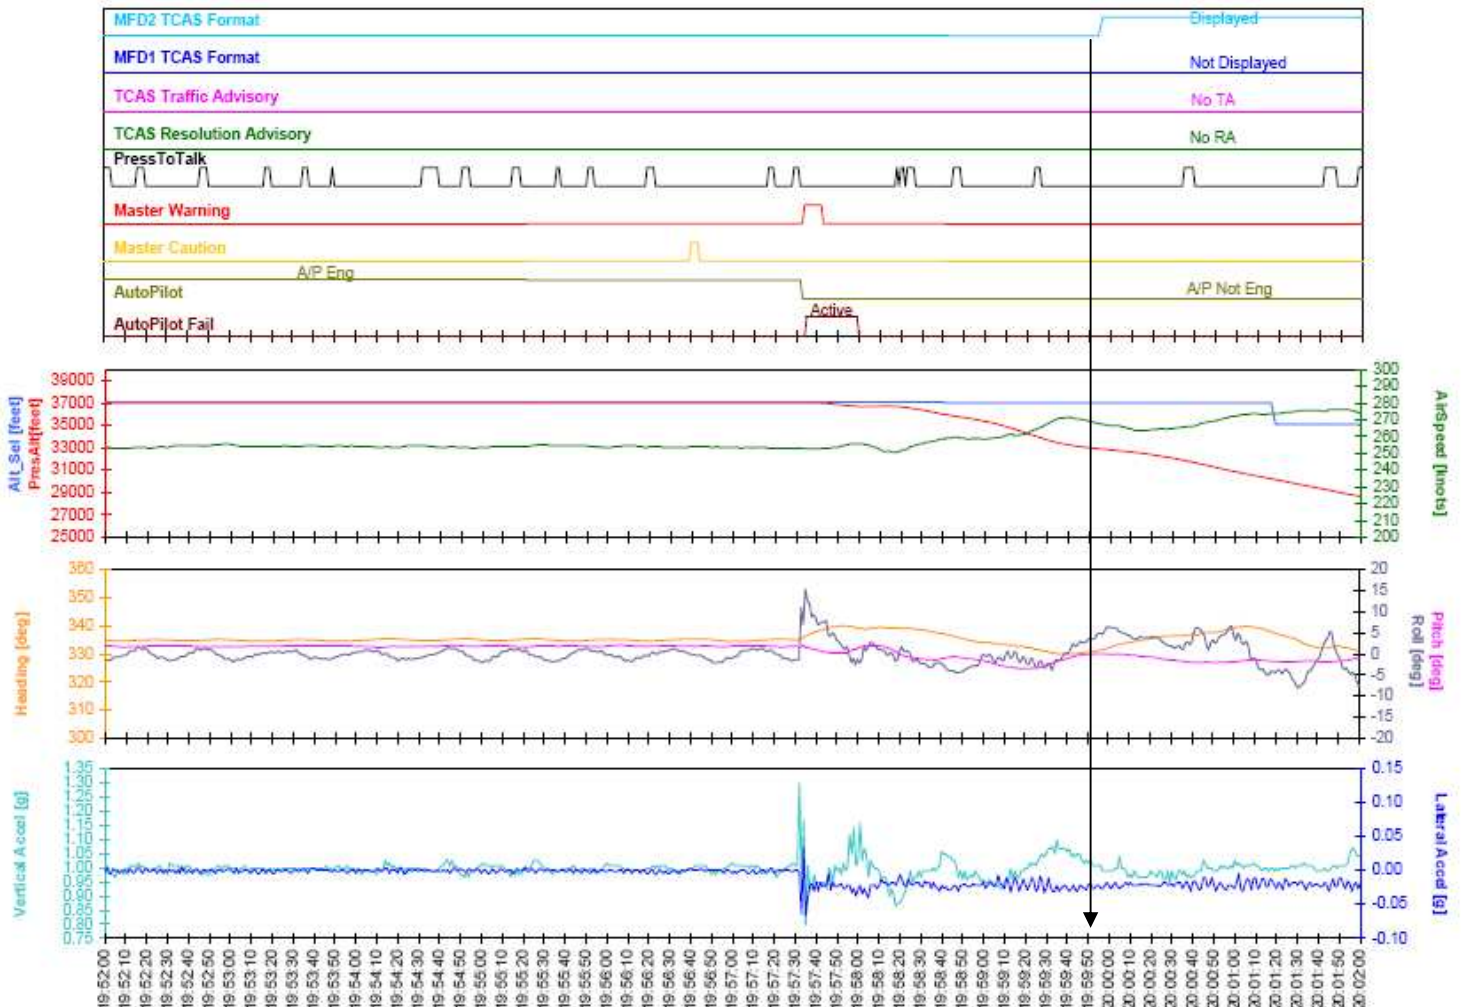
Fig. 71

The Figure 71 (above) shows the data from the DFDR of N600XL, with the opening of the TCAS screen on the MFD2 display (co-pilot side), precisely at 19:59:50 UTC.

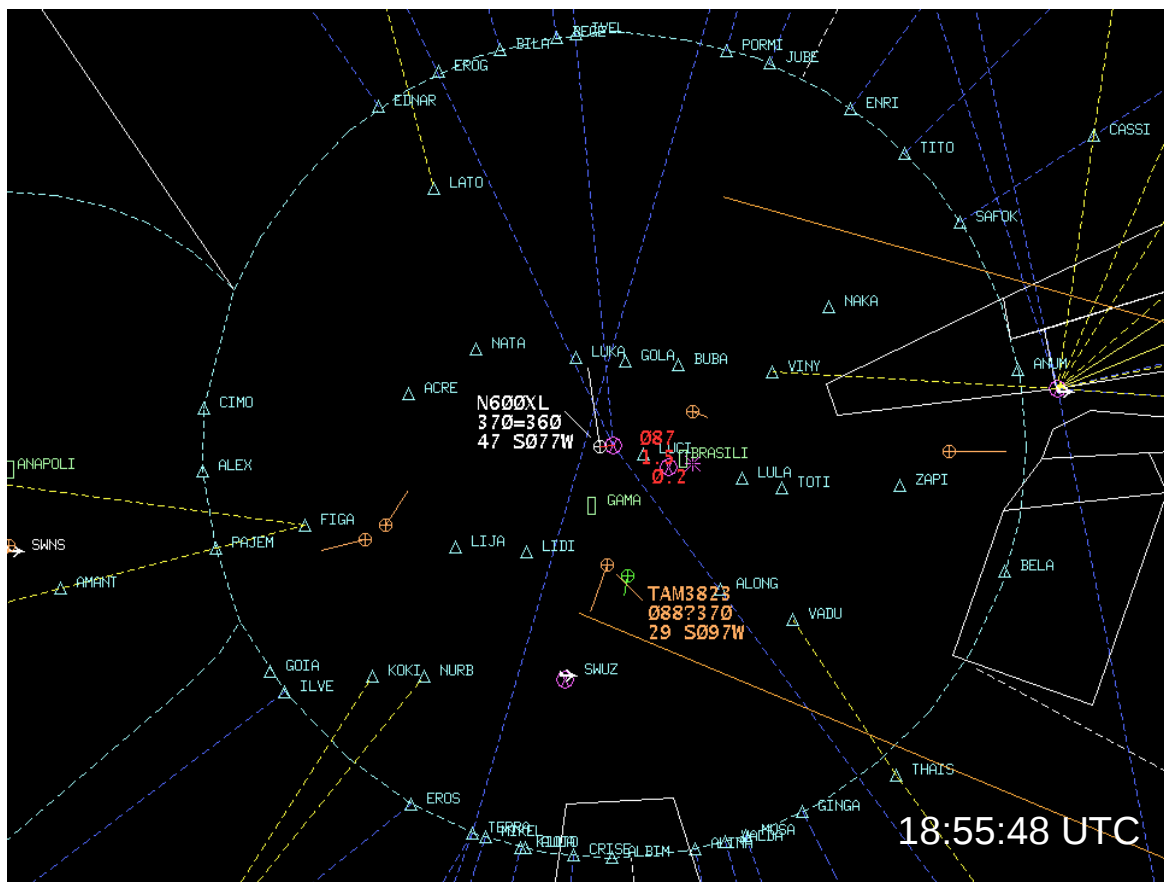
After the vertical of BRS VOR, the data block pertaining to N600XL started to show, as specified, the information 370=360, warning the controller that the aircraft was at flight level 370, while the level authorized for that segment was FL 360 (See Figure 70).
