## **SAFETY INVESTIGATION REPORT**

**Malaysia Airlines Boeing B777-200ER (9M-MRO)  
08 March 2014**

**The Malaysian ICAO Annex 13 Safety Investigation Team for MH370**

Issued on 02 July 2018  
MH370/01/2018

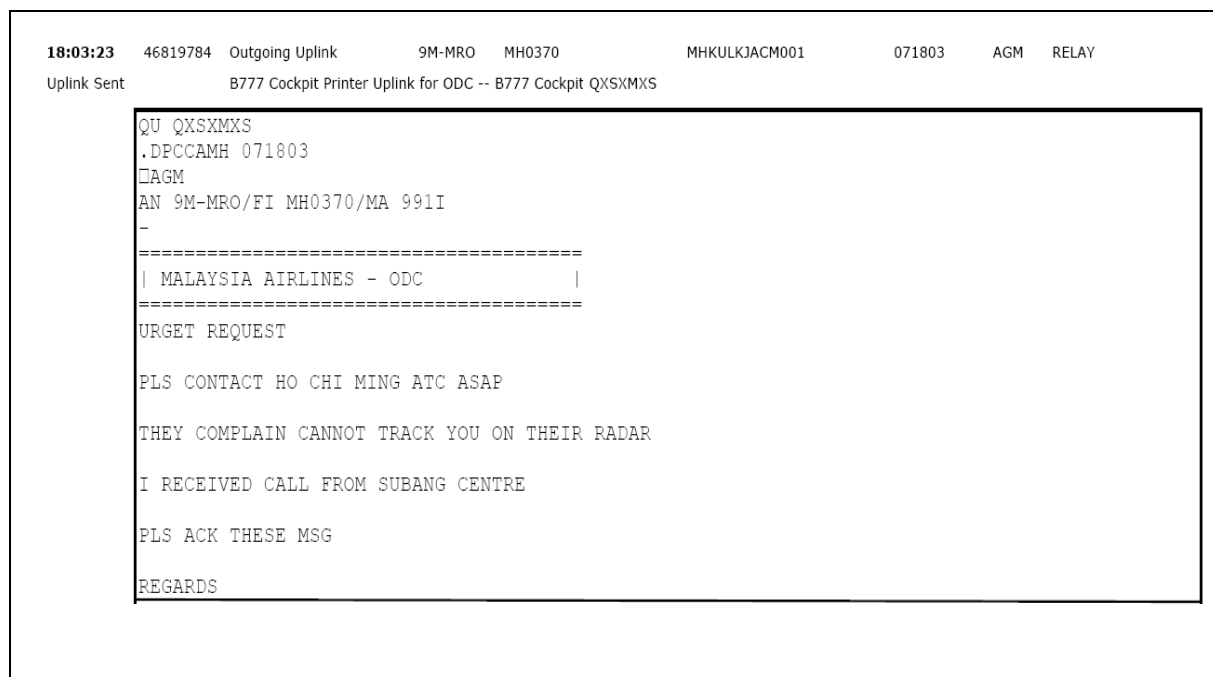
Figure 1.9I - Message from MH ODC

The first message sent to the aircraft cockpit printer from the MAS ODC was at 1803:23 UTC. The ACARS message requested the crew to contact the HCM ACC immediately. The incoming downlink message at 1803:24 UTC showed the message failed to reach the aircraft. Messages are auto transmitted every 2 minutes and the message was retransmitted until 1843:33 UTC but all messages failed to get a response. Automated downlink message by ACARS showed 'failed'. Message sent to the aircraft cockpit printer and the Automated Downlink messages are shown in *Figures 1.9I* and *1.9J* (below), respectively.

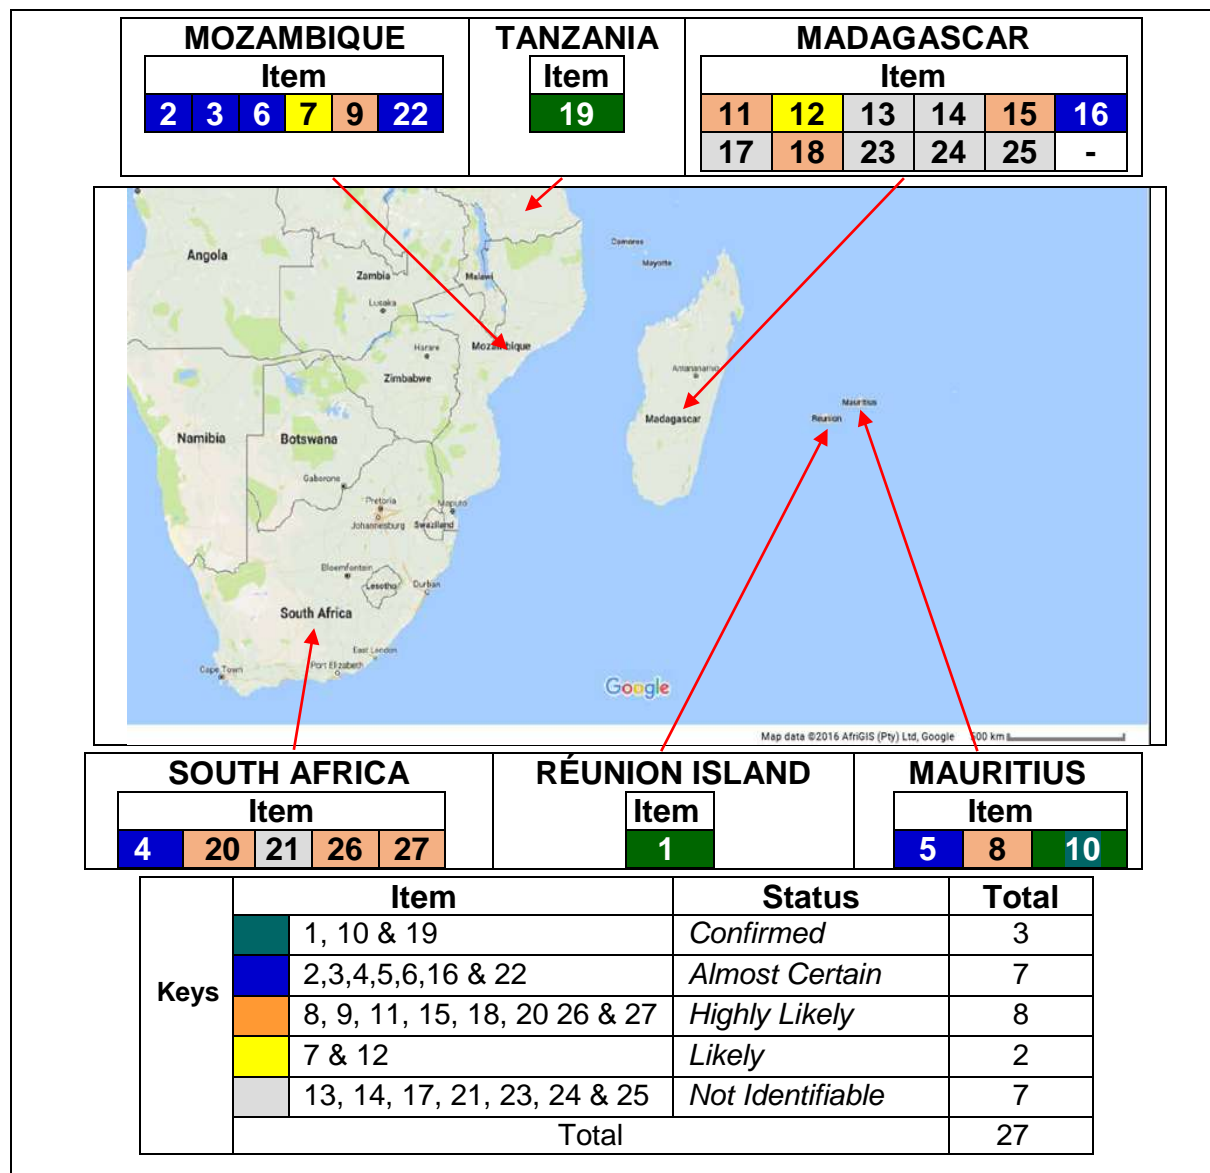
*Figure 1.12B - Locations and Status of Identification of the Debris*

confirmed/possibly from MH370 have been found as far as the south eastern coast of Africa. Refer to *Figure 1.12B* (below).

South Africa, Madagascar and Mauritius. *Figure 1.12B* (above) shows the distribution of the debris found in the above respective areas. *Table 1.12A* (below) provides a summary of the items of debris examined.

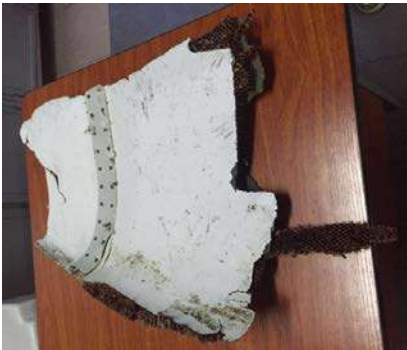
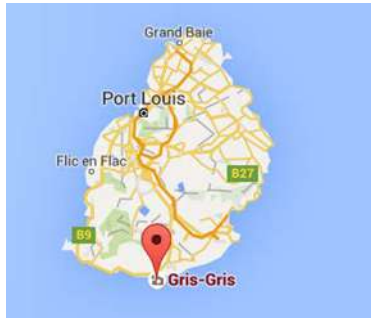
<p>No. 1 Flap Support Fairing Tail Cone</p>

<p>Gris Gris Beach, Mauritius</p>	<ul style="list-style-type: none"> <li>• Examination showed that part is <i>highly likely</i> from MH370</li> <li>• Refer to <i>Appendix 1.12F</i></li> </ul>

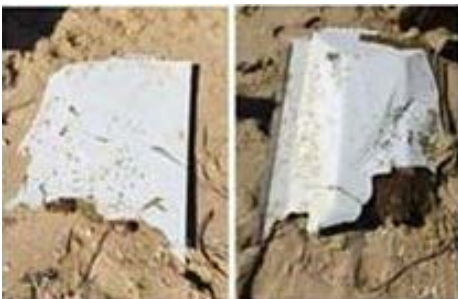
<p>Left Wing Trailing Edge Panel</p>

<p>Macenta Peninsular, Mozambique</p>	<ul style="list-style-type: none"> <li>• Examination showed that part is <i>highly likely</i> from MH370</li> <li>• Refer to <i>Appendix 1.12G</i></li> </ul>
Item 10	10 May 2016

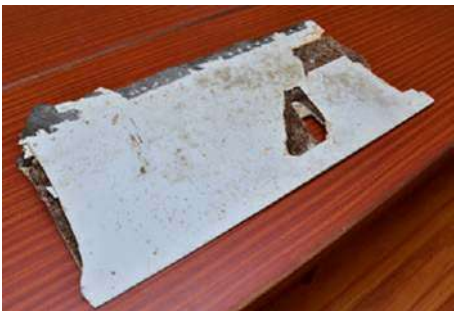
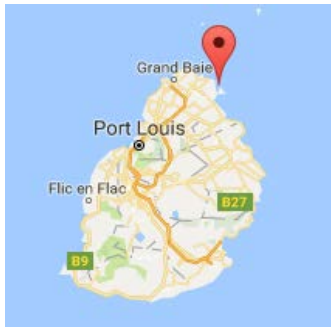
<p>Left Outboard Flap</p>

<p>Ilot Bernache, Mauritius</p>	<ul style="list-style-type: none"> <li>• This part is <i>confirmed</i> from MH370</li> <li>• Refer to <i>Appendix 1.12H</i></li> </ul>

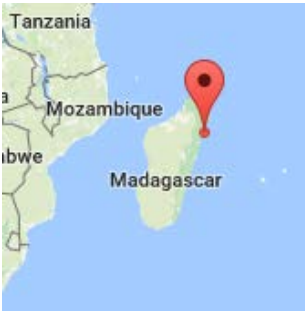
<p>Bottom panel on the Wing or Horizontal Stabilizer</p>

<p>Riake beach, Nosy Boraha Island, Madagascar</p>	<ul style="list-style-type: none"> <li>• Examination showed that part is <i>likely</i> from MH370</li> <li>• Refer to <i>Appendix 1.12J</i></li> </ul>

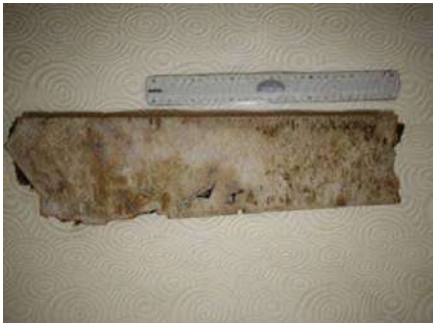
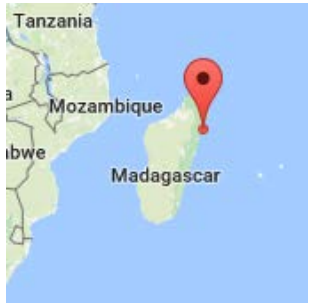
<p>Unidentified part</p>

<p>Riake beach, Nosy Boraha Island, Madagascar</p>	<ul style="list-style-type: none"> <li>• Not identifiable</li> <li>• Refer to <i>Appendix 1.12L</i></li> </ul>

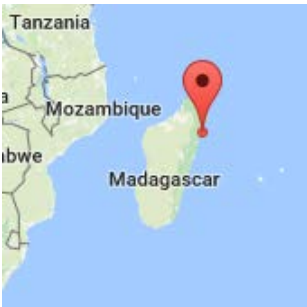
<p>Unidentified part</p>

<p>Antsiraka beach, Madagascar</p>	<ul style="list-style-type: none"> <li>• Not identifiable</li> <li>• Refer to <i>Appendix 1.12M</i></li> </ul>
Item 18	12 June 2016

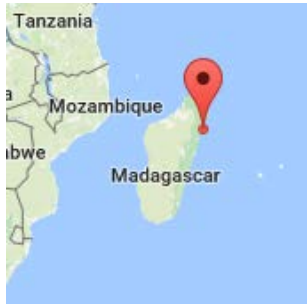
<p>Right Forward Nose Landing Gear Door</p>

<p>Antsiraka beach, Madagascar</p>	<ul style="list-style-type: none"> <li>• Examination showed that part is <i>highly likely</i> from MH370</li> <li>• Refer to <i>Appendix 1.12N</i></li> </ul>

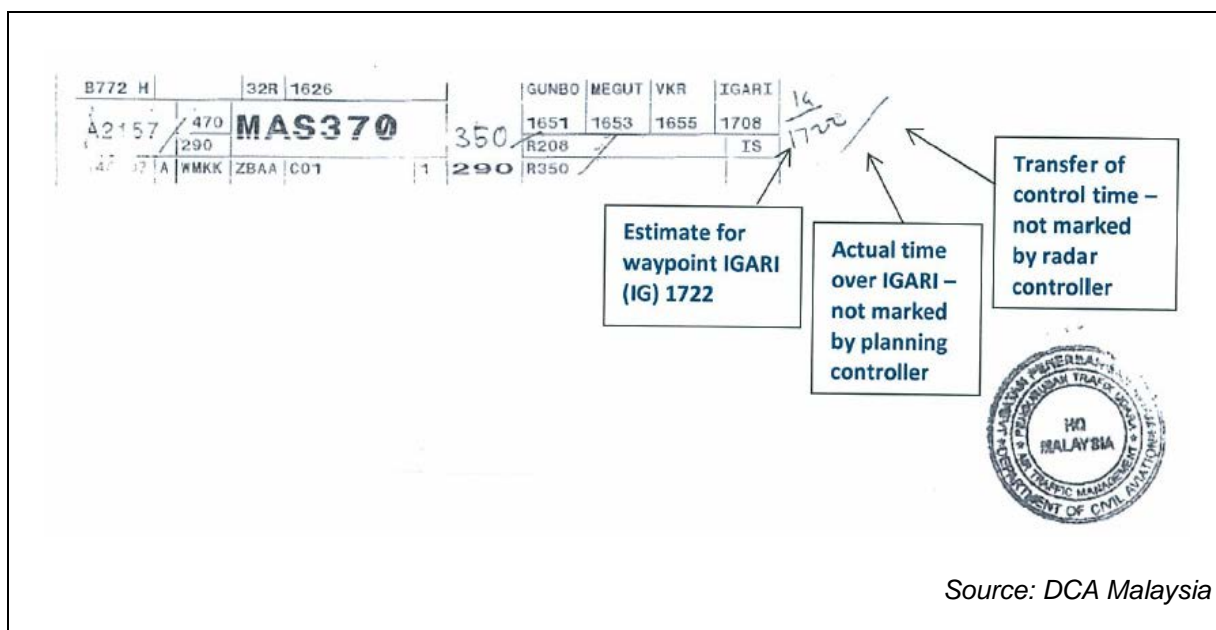
i) Two markings have been left out on the flight progress strip (FPS), *Figure 2.2G*, (below) of MH370:

- (1) The actual time (1721) when MH370 passed over IGARI - FPS' Estimate IG (abbreviation for IGARI) 1722, and
- (2) The transfer of control time (1719) on the FPS.

*Figure 2.2G - Flight Progress Strip on MH370 from KL ACC*

Since the two recordings on the Flight Progress Strip for MH370 were not marked by the Air Traffic Controllers (Planner and Radar) KL ACC did not have the record of the time of the last radio contact and the actual time of MH370 passing over waypoint IGARI.

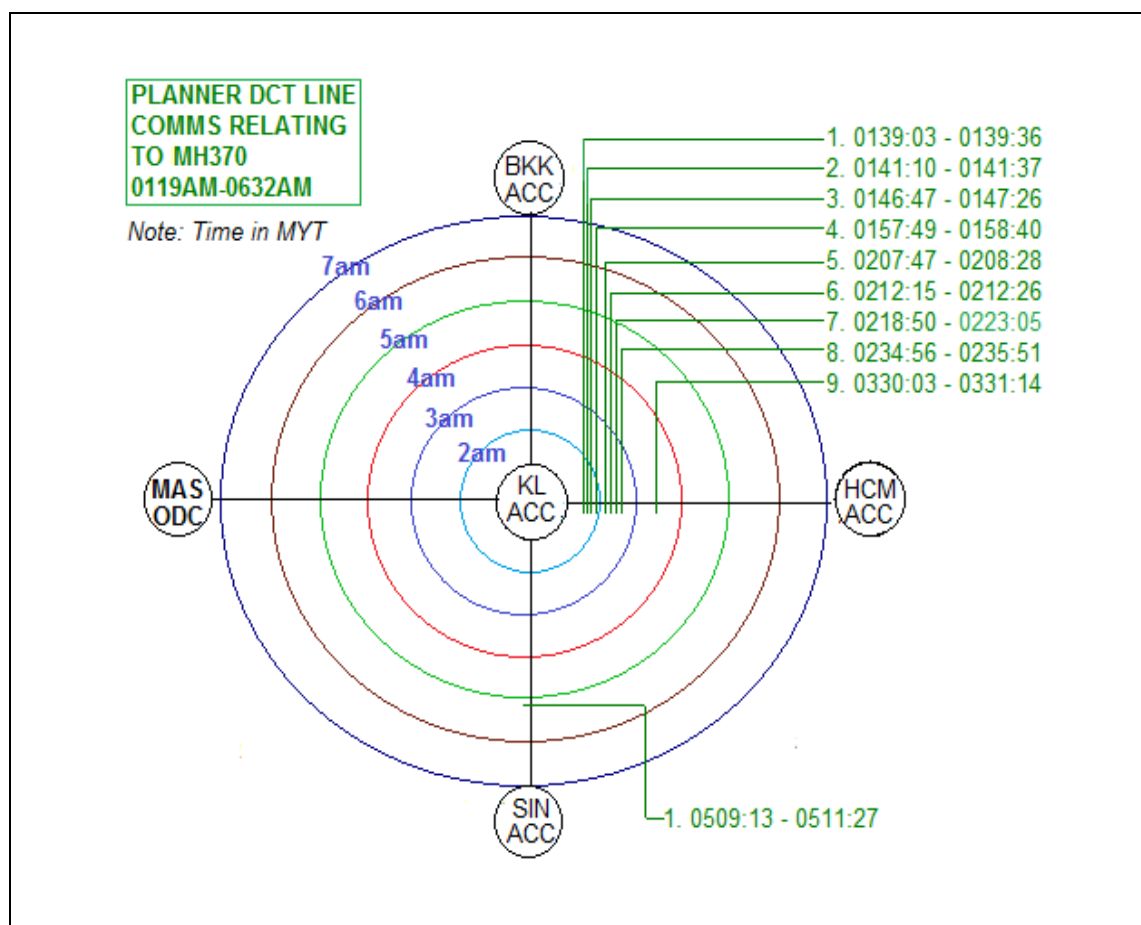
Figure 2.2J - Planning Controller Direct Telephone Line Communication Exchanges between KL ACC and HCM ACC, KL ACC and Singapore ACC from 0119 to 0632 [MYT]

- (2) The time and the Planning Controller's direct line communications exchanges with HCM ACC, and Singapore ACC, from 1719 to 2232 UTC [0119 to 0632 MYT], is illustrated in concentric circles (*Figure 2.2J above*) when MH370 went missing. The illustrations at 0100 (MYT) begins with the innermost concentric circle followed by 0200 [MYT] on the next concentric circle with 0700 [MYT] on the outermost concentric circle (it depicts the timeline for 08 March 2014 on the KL ACC Planning Controller's direct line

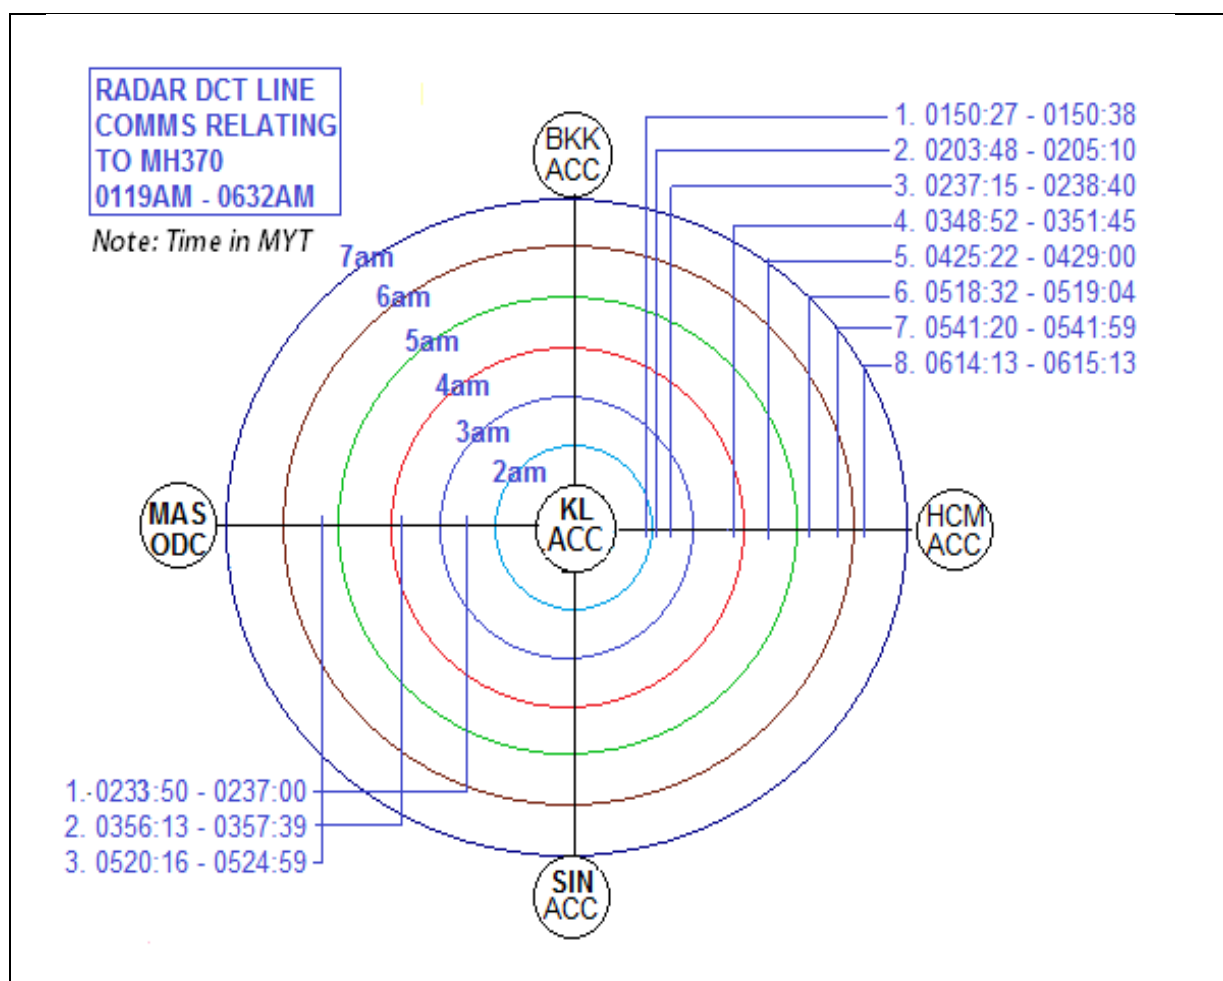
*Figure 2.2K - Radar Controller's Direct Line Communication Exchanges*

It begins with 0100 [MYT] at the innermost concentric circle followed by 0200 [MYT] on the next concentric circle with 0700 [MYT] on the outermost concentric circle (it depicts the timeline for 08 March 2014 on the KL ACC Radar Controller direct line communication exchanges with HCM ACC and ODC 0119 to 0632 [MYT] when MH370 went missing).

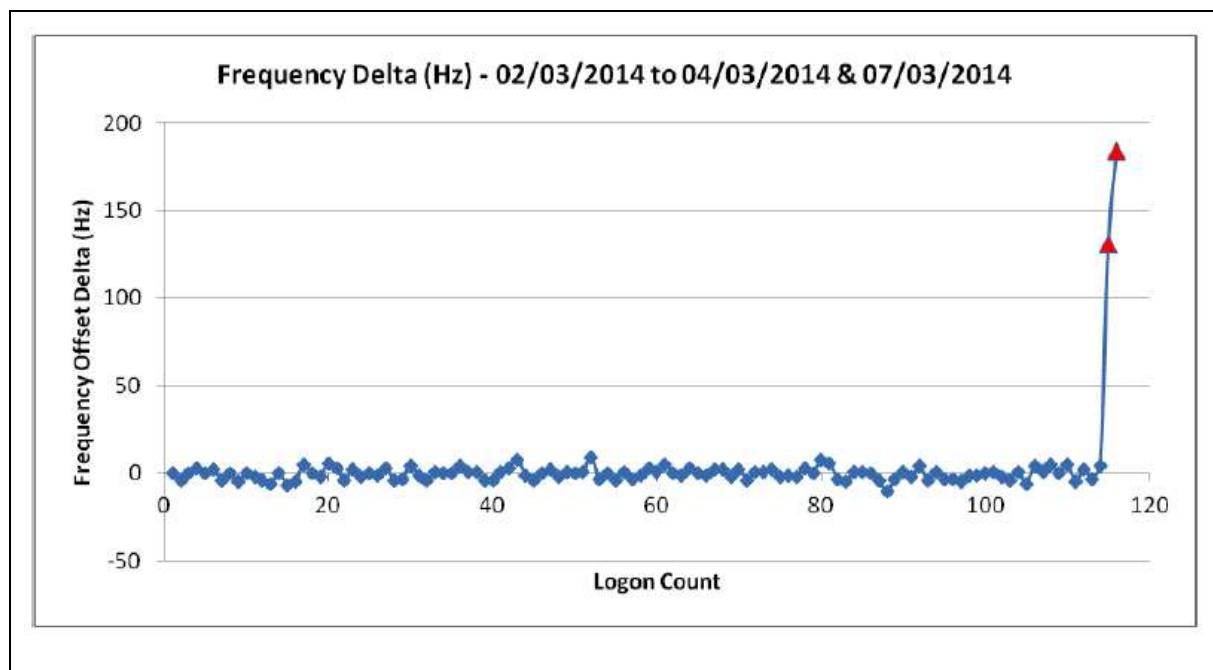
- 1) During each of the two in-flight Log-Ons that occurred during flight MH370, the GES recorded abnormal frequency offsets for the SATCOM transmissions. This is in contrast with the 'normal' Log-On behaviour.

- 2) *Table 1.9D* in *Section 1.9.5* shows the frequencies of these Log-On bursts, as measured at the GES, plus differences from assumed reference frequencies. The table also shows the very high delta frequencies between the respective Log-On Request and Log-On Acknowledge bursts.
- 3) The following graph (*Figure 2.5A*) shows the delta frequencies between pairs of Log-On Request and Log-On Acknowledge bursts for over one hundred Log-Ons of the SATCOM on-board 9M-MRO, up to and including the two during flight MH370. In every case prior to MH370 the delta frequencies were fairly small. Only the last two pairs of transmissions (the 1825 and 0019 Log-Ons) show significant deltas. Note that for ease of display, only the magnitude is shown for the two MH370 Log-On frequency deltas.

*Figure 2.5A – Delta Frequencies between Pairs of Log-On Request and Log-On Acknowledge*

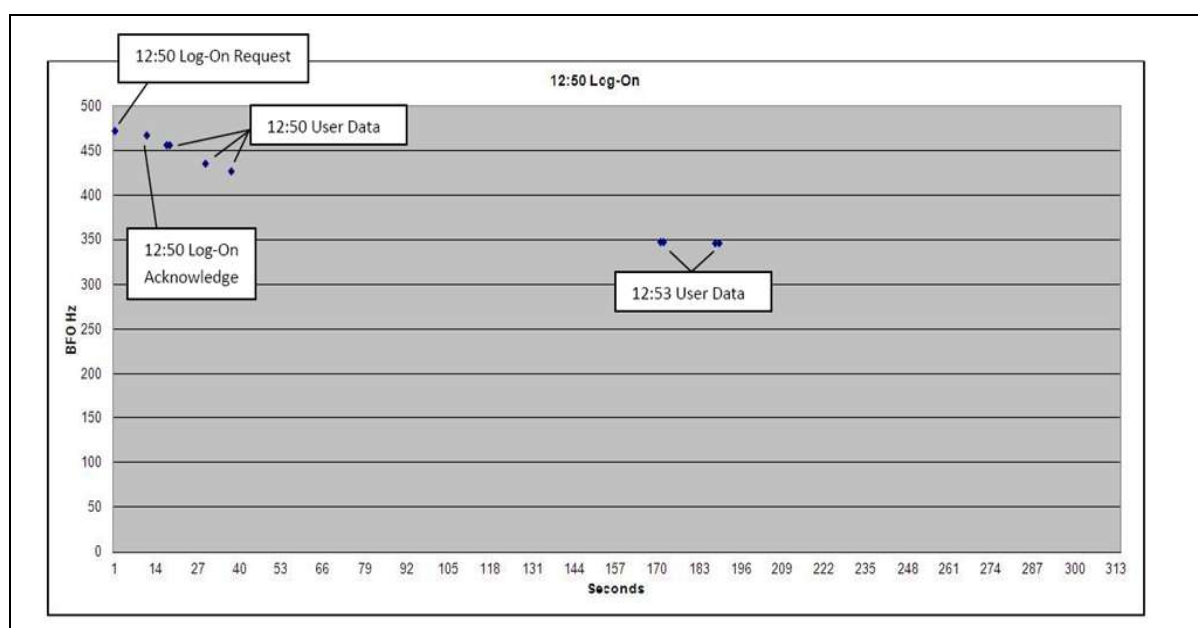
- 6) These frequency offsets can be seen in the plot (*Figure 2.5B*) below, for a 9M-MRO SATCOM Log-On (believed to have taken place after a lengthy power down), at 1250 on 07 March, whilst the aircraft was on the ground at Kuala Lumpur, prior to the departure of MH370. The frequency has stabilised to a value of around 350Hz, within three minutes of the Log-On Request.

*Figure 2.5B - SATCOM Log-On Frequency Offsets at 1250, 07 March 2014*

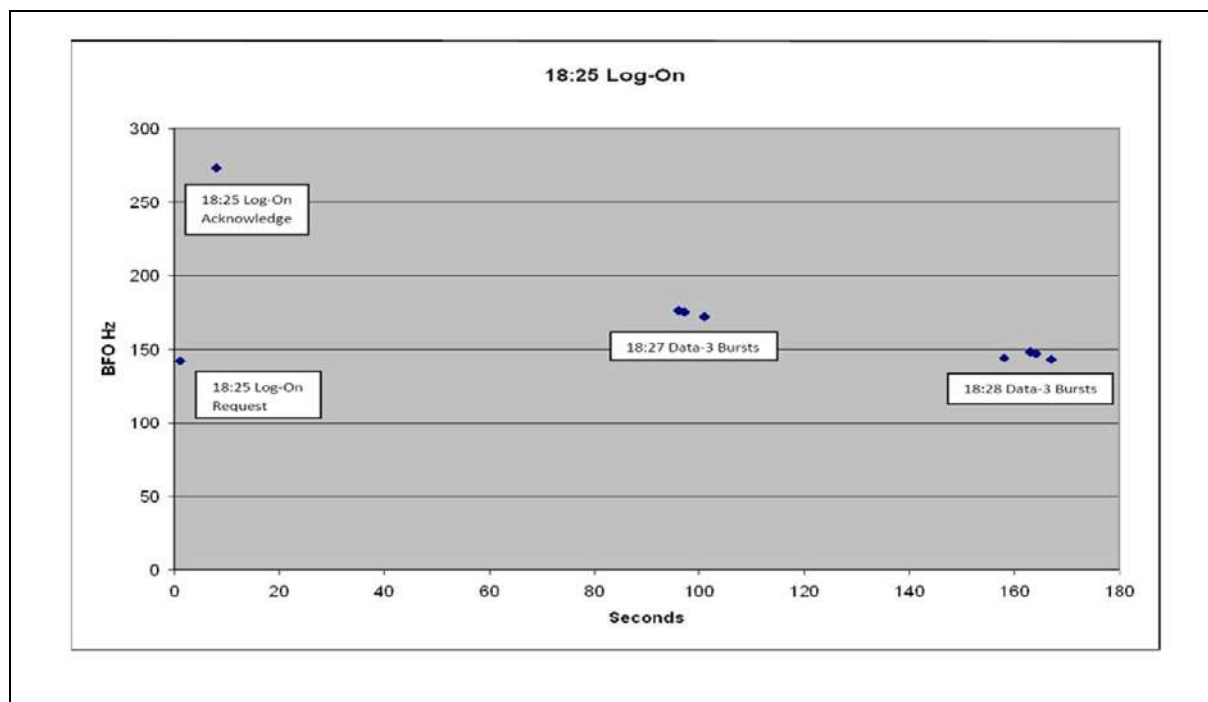
Figure 2.5C - SATCOM Log-On Frequency Offsets at 1825, 07 March 2014

- 7) These frequency offsets can also be seen in the plot (*Figure 2.5C*) below for the MH370 1825 Log-On. As with the 1250 Log-On, the frequency has stabilised within three minutes of the Log-On Request, this time at around 150Hz.

- 8) The 1825 Log-On Acknowledge and the subsequent Data-3 transmissions exhibit a frequency offset, which decays to the steady state value. This frequency decay endorses the belief that the SATCOM had been powered down prior to the 1825 Log-On.

- 9) The 1825 Log-On Request does not exhibit the frequency offset decay though. However, it is possible that the OCXO frequency was rising at this time, prior to decaying to its steady state value. It is noted that the 1825 Log-On Request was received at the GES with a low Received Carrier/Noise Density Ratio (C/No) and a channel Bit-Error-Rate (BER) of 5 and could therefore have been logged at the Ground station with a BFO measurement error suggesting that the BFO figure may not be reliable. Non-zero channel BER transmissions are not uncommon for a satellite link. The C/No (and hence channel BER) can be impacted by the gain of the SATCOM antenna and also atmospheric effects, as well as interference due to collisions with a (lower power) burst from another aircraft.

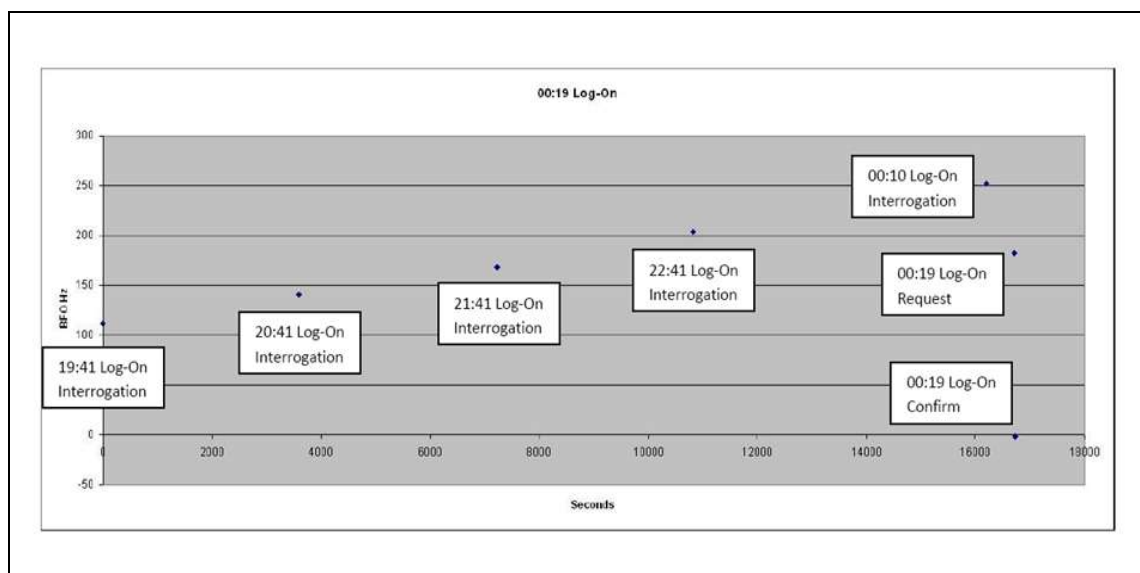
*Figure 2.5D - Log-On Interrogation Transmissions*

- 12) For the 0019 BFOs, the following possible error contributions are considered:
- a) GES Measurement Errors - There is only evidence to suggest a significant GES measurement error in the case of a burst that is received at the GES with a non-zero channel BER, as in the case of the 1825 Log-On Request. This was not the case with the 0019 BFOs, so it can be discounted.
  - b) SDU OCXO Reference Error – OCXO stability has been measured over both temperature (circa -0.65Hz/deg. C) and time (as described above). The OCXO double

- f) Uncompensated Vertical Velocity - The SATCOM SDU does not consider vertical velocity in its Doppler calculation. It has been calculated that a vertical velocity of +100ft/min causes about a +2Hz change in the Doppler shift. Therefore, under normal circumstances, only a small frequency error results from the uncompensated vertical velocity. For example, an ascent or descent rate of 2000ft/minute would cause a 40Hz offset. In the case of MH370, a significant vertical velocity could explain at least part of the 0019 Log-On Request and Log-On Acknowledge frequency offsets.

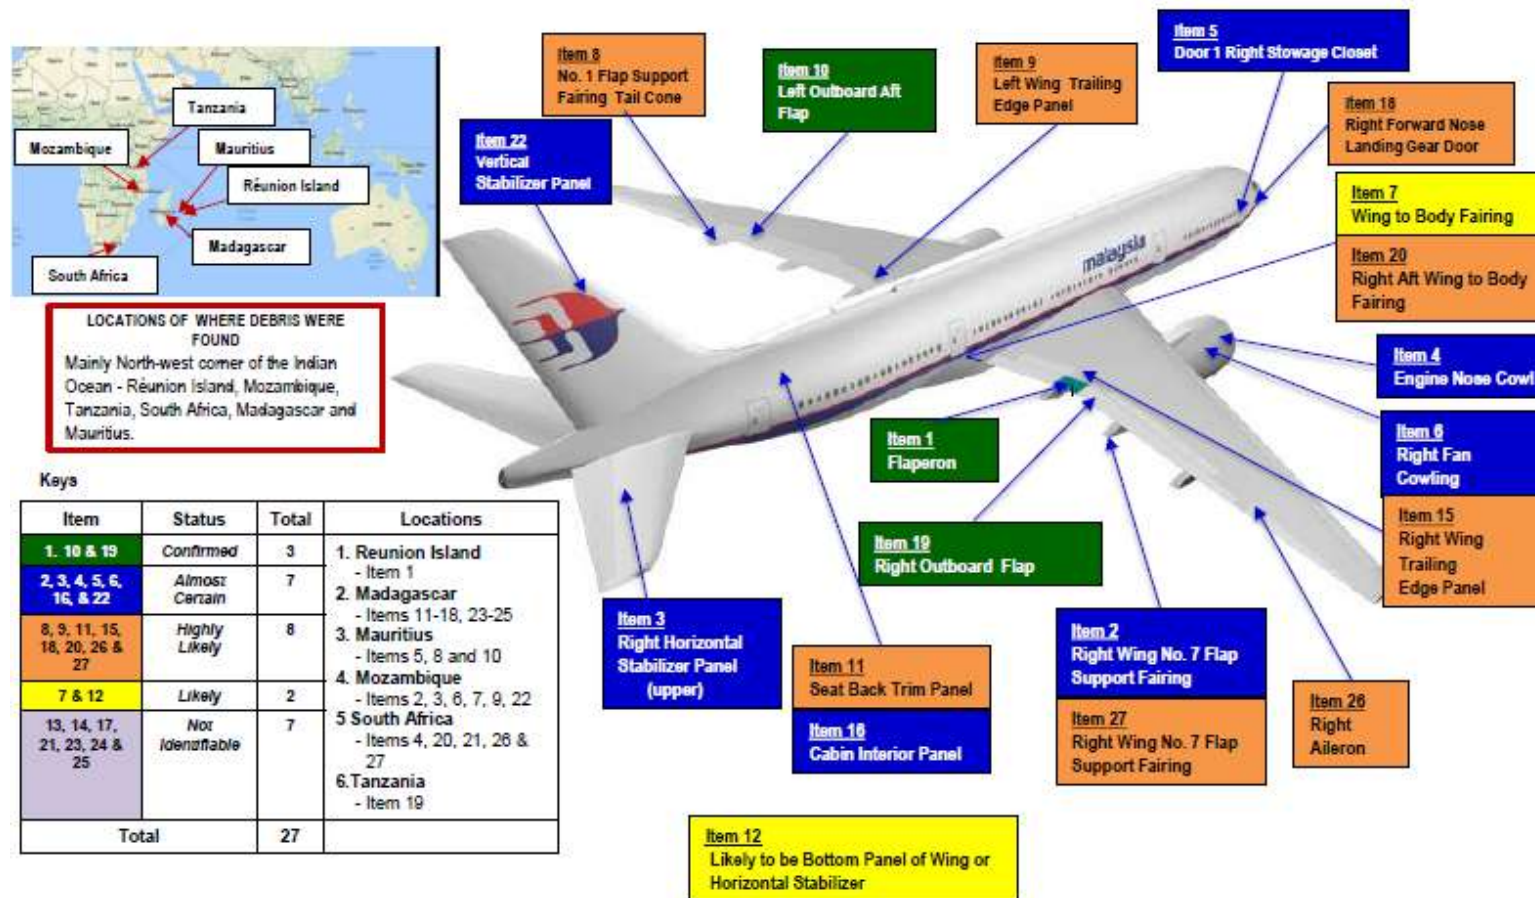
Figure 2.6A - Location of Parts and Debris Found with respect to Aircraft

*Figure 2.6A* (below) shows the locations of the debris with respect to the aircraft.

Item 4 (part of the Engine Nose Cowl) is depicted to be from the right engine. There were no significant differentiators on the cowl segment to assist in determining whether the item of debris was from the left or right side of the aircraft, or the inboard or outboard side the cowl. Similarly, although Item 6 (part of the RH fan cowl) is depicted to be from the right engine in *Figure 2.6A*, there is a possibility that it could also be from the left engine. As for Item 7 - Wing body fairing - this too could be from either side of the aircraft.

Based on the identification of the parts and debris found, it shows that most of those parts and debris were from the right hand side of the aircraft.

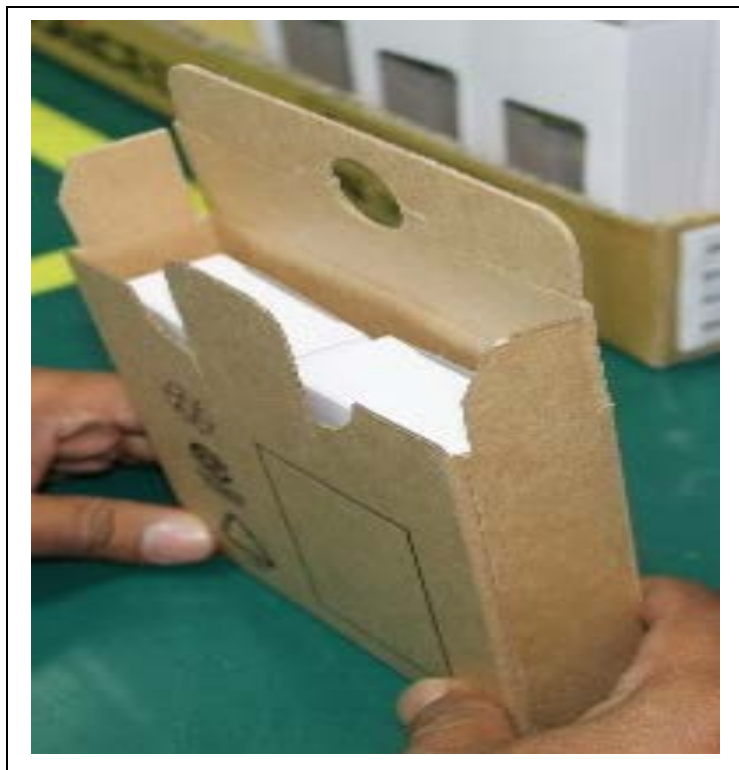
*Figure 2.8A - 2 Batteries in window white box and placed in a brown box*

The tests were carried out with batteries (window white box in brown box (*Figure 2.8A*, [below]) dropped at a height of 120.92 cm (48 inches) on to a wooden platform. It was found that the batteries had no observable physical damage and functioned normally.

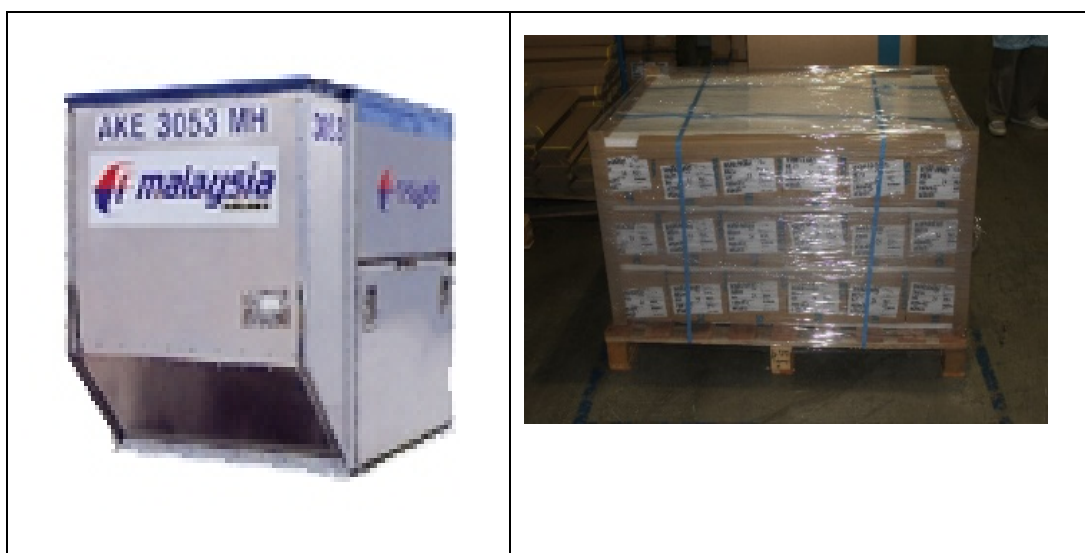
*Figure 2.8B - Sample ULD and Batteries placed next to each other*

In one of the cargo compartments on MH370 the Motorola Solutions batteries and mangosteens were placed next to each other (No. 1 and 'A'). Even though they were placed next to each other in the aircraft (*Figure 2.8B* [below]), the mangosteens were packed in plastic crates and placed in Unit Load Device (ULD) containers. The consignment was also wrapped in a plastic sheet to make it water-proof to a certain extent.

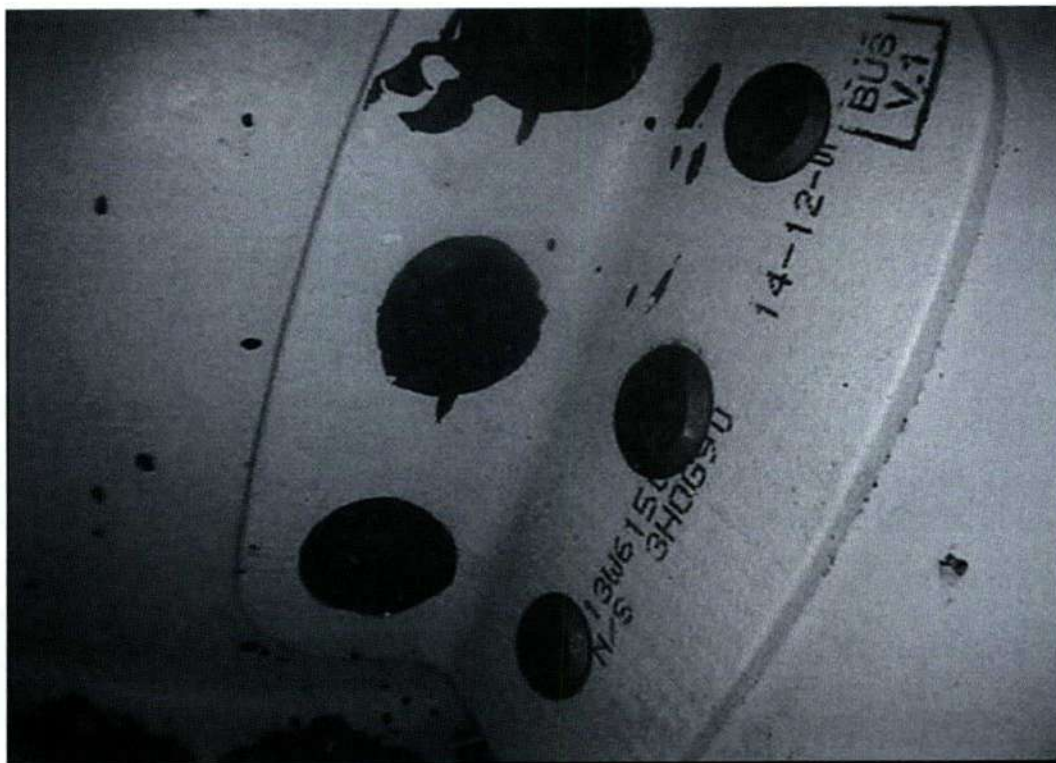
Photograph 1 /Fotografías 1

P/N: 113W6150-1 CLEAT/REFUERZO-

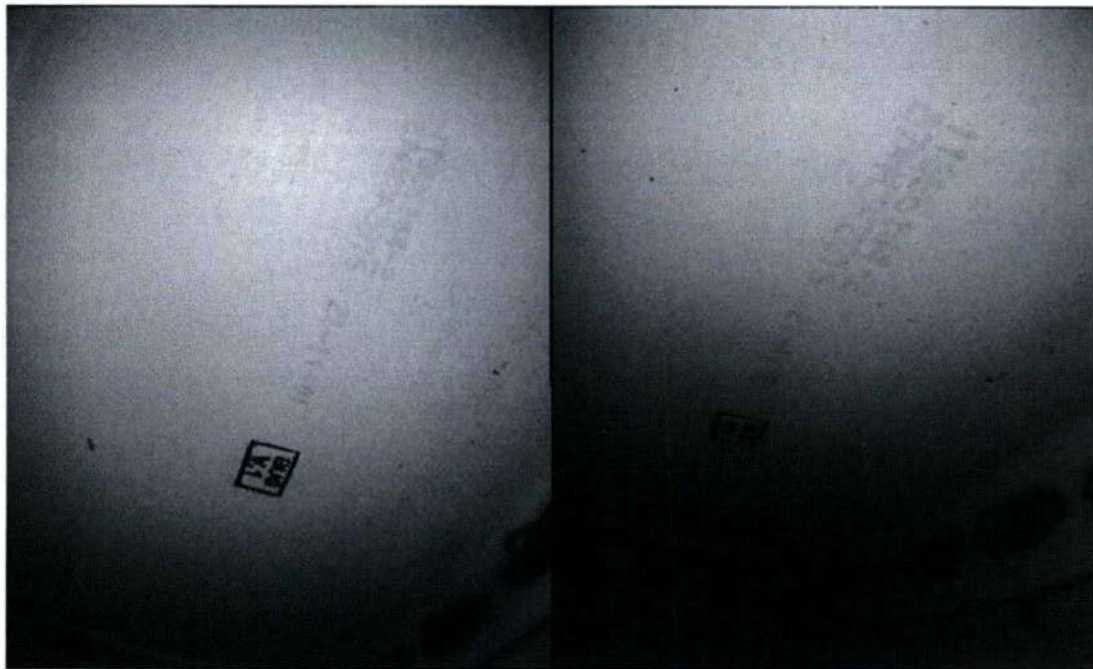
Photograph 2 /Fotografias 2

P/N: 113W6144-2 REAR SPAR/LARGUERO POSTERIOR RECORDABLE PART BUT NOT CLEARLY  
READABLE / PIEZA CON S/N  
REGISTRABLE PERO ILEGILBLE

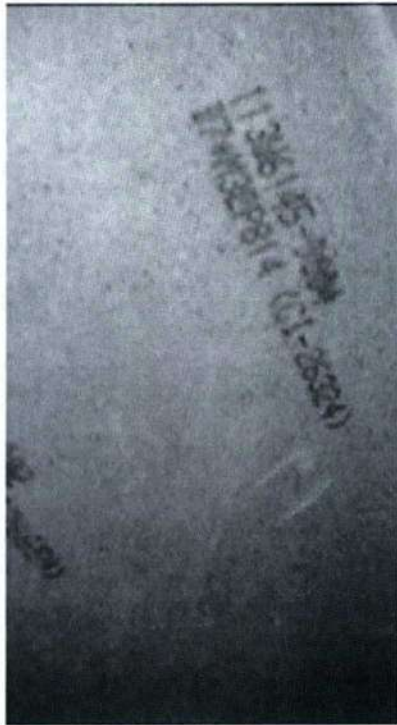
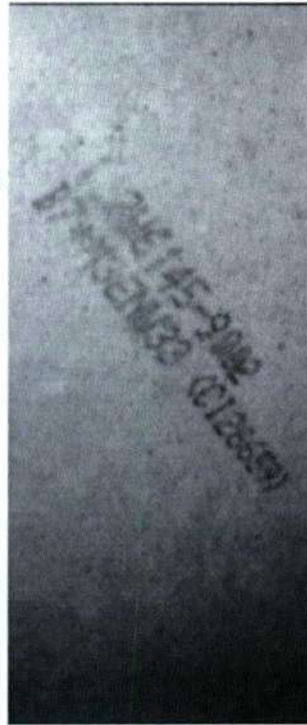
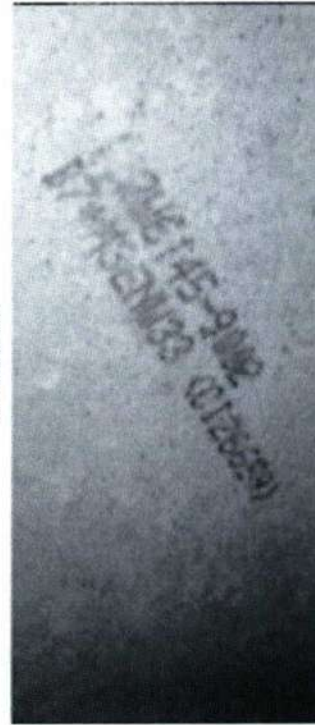
Photograph 3 / Fotografias 3

Deux Numéros sur la nervure (inboard selon Boeing)

P/N: 113W6145-2 & 4 ACTUATOR FITTINGS/NON RECORDABLE PART/  
HERRAJES DE ACTUADOR PIEZA CON S/N NO REGISTRABLE

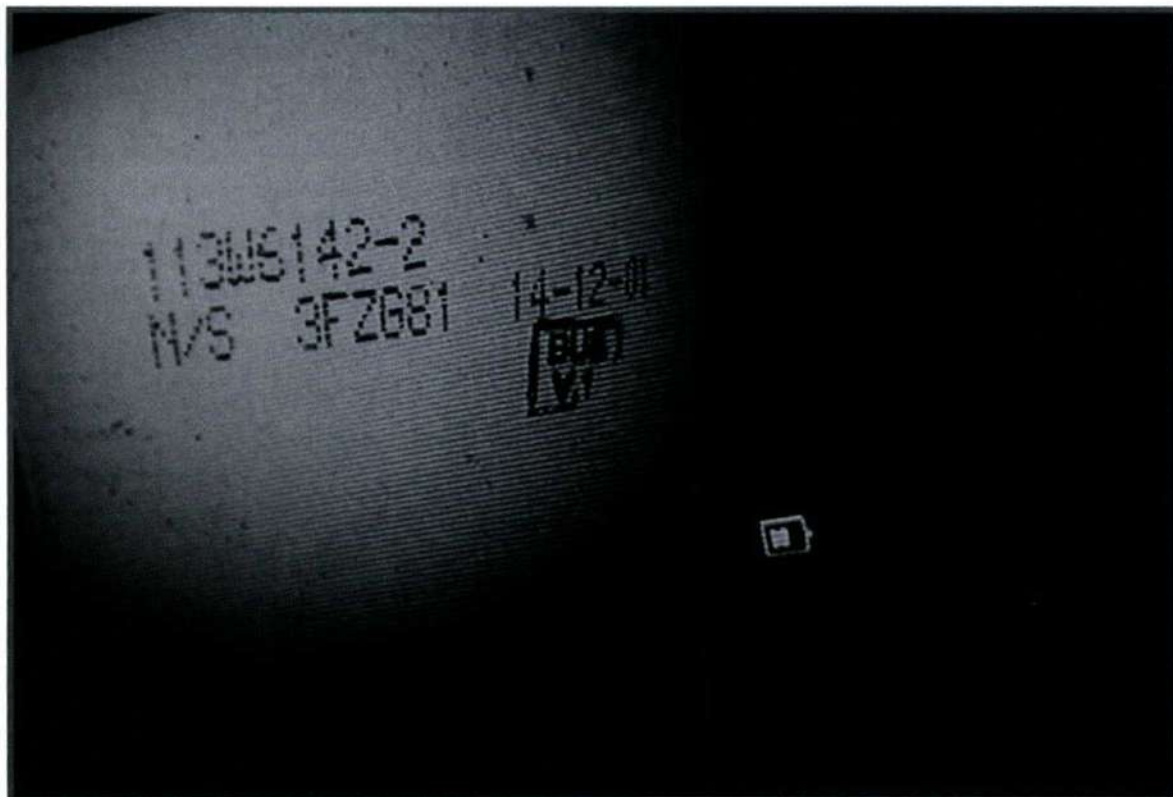
Photograph 4 /Fotografías 4

P/N: 113W6142-2 FRONT SPAR RECORDABLE PART N/S 3FZG81/  
/LARGUERO ANTERIOR PIEZA CON S/N REGISTRABLE N/S 3FZG81

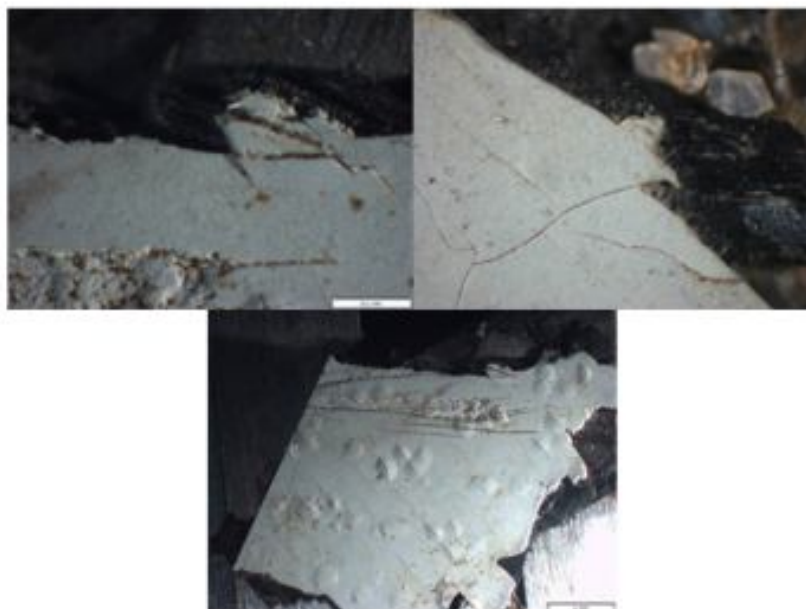
Peinture qui présente une structure intégrée en comparaison avec l'échantillon de peinture intrados, faïençage présent néanmoins avec rayures. Cloquage présent liés à l'osmose.

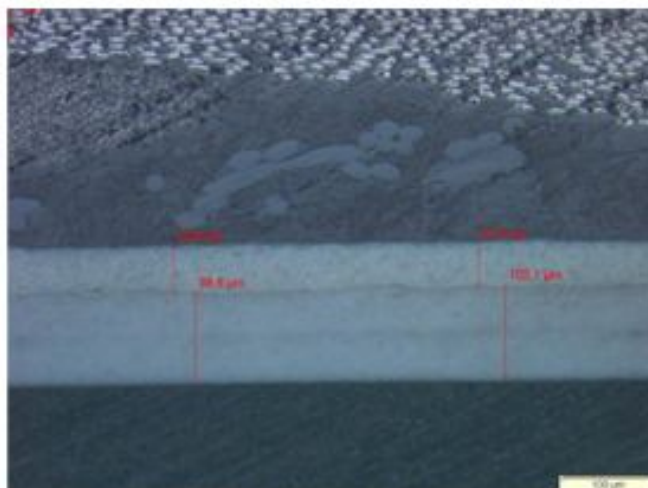
En extrados, le primaire mesure 50µm d'épaisseur et les couches superficielles environ 100µm.

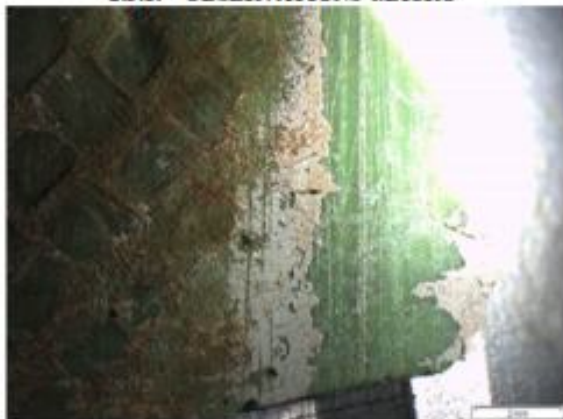
Sur cet échantillon, on observe visuellement : résine du panneau composite (empreinte du tissage carbone), couche de peinture blanche, et une couche épaisse de peinture verte.

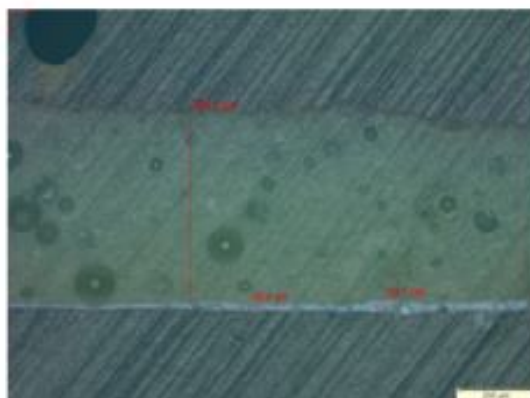
- Primaire 500µm d'une peinture verte
- Finition 20µm

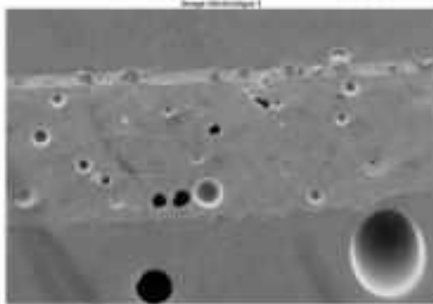
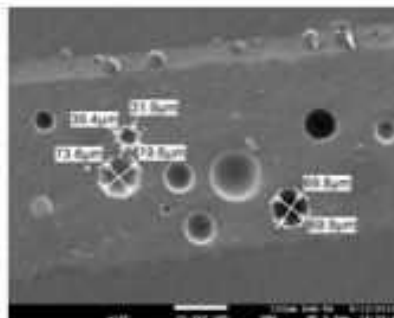
1. Zones hétérogènes dans la peinture de finition, répartition différentielles des charges d'oxyde de Titane, les zones apparaissant plus sombres sont des zones pauvres en charges ou seul est présent le polymère du liant. NaCl présent en surface.

Eléments en présence : Ti, Si, Al.

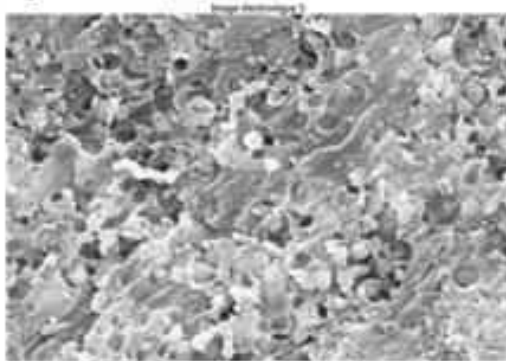
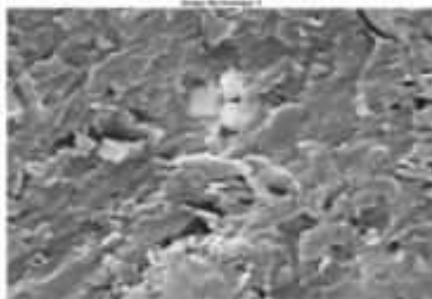
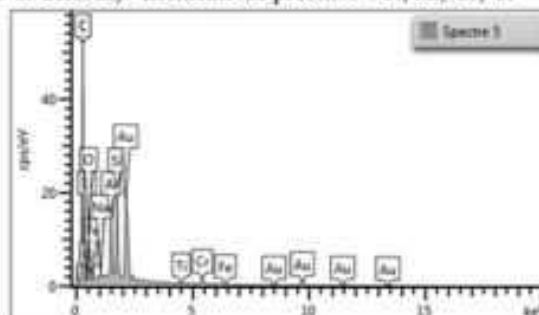
2. Couche « verte » épaisse, poreuse, avec présence importante de Silicates d'aluminium et de pigment chromique (mis en évidence par spectre EDS 5 ci-dessous). Eléments en présence : Si, Al, Cr, Ti

Les porosités sphériques (bulles de gaz qui se créent probablement lors de l'application) sont de quelques dizaines de  $\mu\text{m}$ . (30 à 80 $\mu\text{m}$  de diamètre)

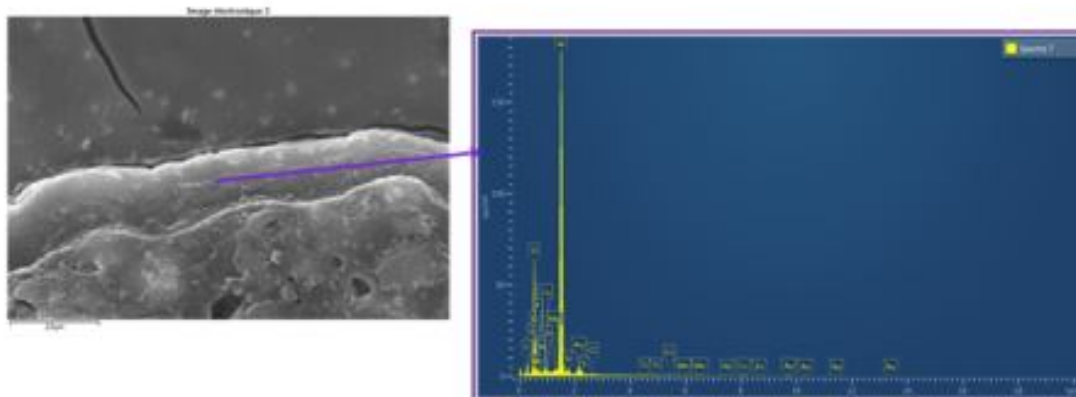
On observe clairement la couche d'anodisation. Celle-ci mesure de 1 à 2µm d'épaisseur. Selon le CMM, il s'agit d'une couche anodisation à l'acide borique. A noter que le bore ne peut être détecté avec cette technique (élément léger).

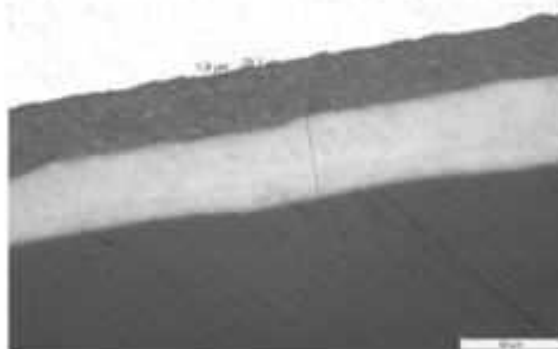
En micrographie optique on distingue nettement, la couche d'anodisation du substrat de 2µm d'épaisseur, la primaire anticorrosion de 30µm d'épaisseur environ, la peinture de finition sur 40µm environ.

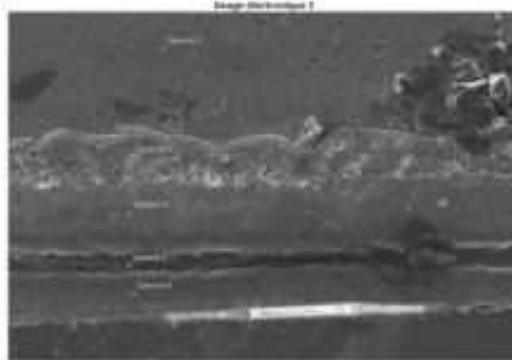
Le système de peinture se compose de trois couches distinctes :

1. Primaire, directement sur la couche d'anodisation. Eléments en présence : Si, O.
2. Deux couches de peinture de finition identique en termes de répartition des charges. Eléments en présence : Ti, Ba, S

Les deux couches présentent une décohésion à l'interface certainement liée au vieillissement du système résultant de son exposition à l'eau de mer (phénomène de cloquage)

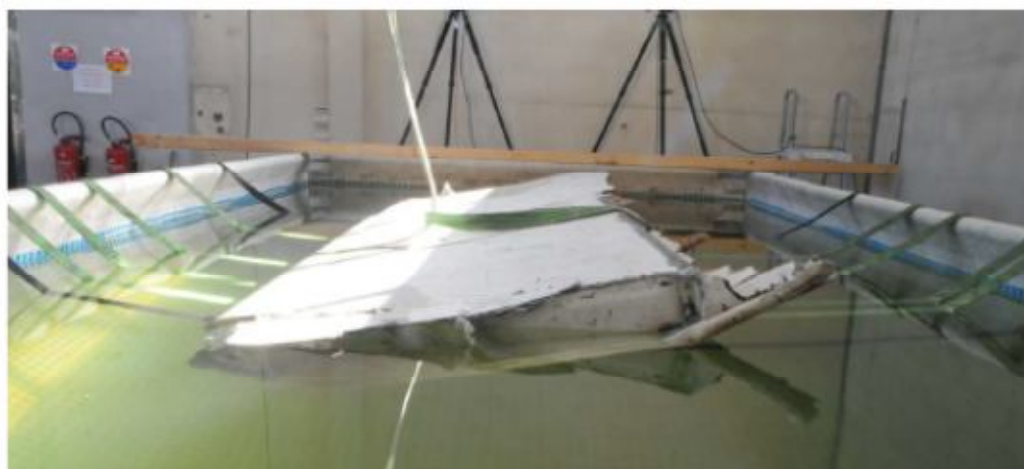
Figure 4 : Equilibre en surface, intrados vers le haut

Intrados vers le haut le flaperon flotte avec le bord de fuite dégagé de la surface et le bord d'attaque sous la surface (Figure 4). Dans sa grande direction, la ligne de flottaison est sensiblement parallèle à l'envergure.

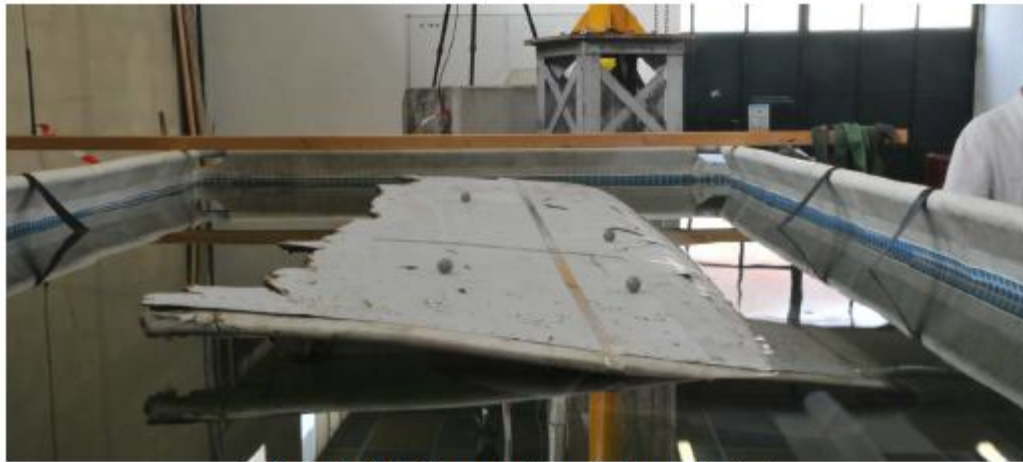
Figure 5 : Equilibre en surface, extrados vers le haut

Posé avec l'extrados vers le haut, le flaperon se stabilise dans une position relativement comparable (Figure 5).
