## **SAFETY INVESTIGATION REPORT**

**Malaysia Airlines Boeing B777-200ER (9M-MRO)  
08 March 2014**

**The Malaysian ICAO Annex 13 Safety Investigation Team for MH370**

Issued on 02 July 2018  
MH370/01/2018

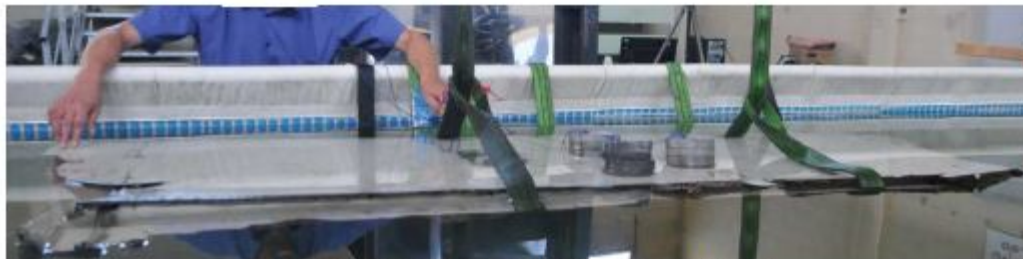
Figure 6 : Immersion complète, intrados vers le haut

La réserve de flottabilité est importante puisque pas moins de 41 kg de lest supplémentaires ont été nécessaires pour l'immerger totalement. En pratique la réserve de flottabilité est légèrement inférieure à  $41/1023.5 = 0.040 \text{ m}^3$  puisqu'une partie des lests utilisés se trouvait immergée (Figure 6).

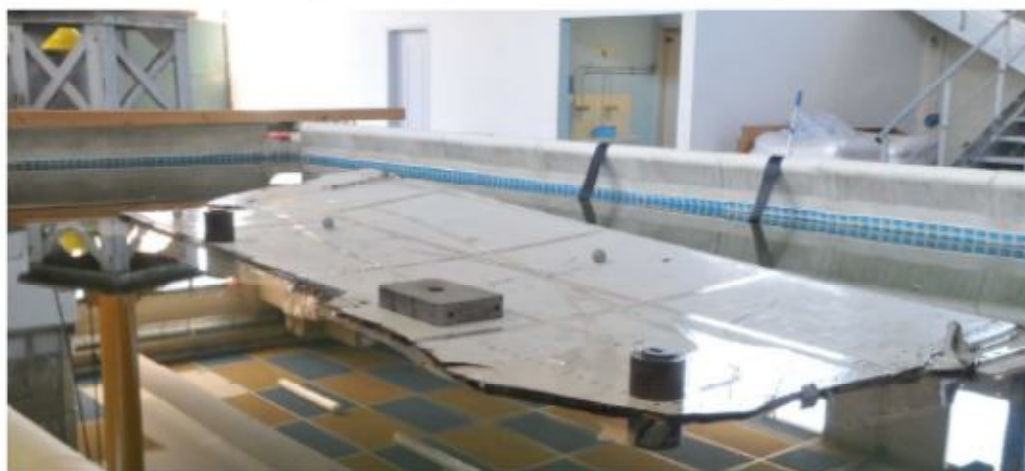
Figure 8 : Intrados émergé

Afin d'évaluer les conditions dans lesquelles cette flottaison était réalisée, le flaperon a été lesté pour faire coïncider la flottaison effective avec celle délimitée par la présence des crustacés.

Dans le cas intrados vers le haut, il a été nécessaire d'ajouter 13.5 kg sur le long du bord de fuite (Figure 8). Dans le cas où l'extrados est placé vers le haut, seuls 5 kg ont été nécessaires (Figure 9).

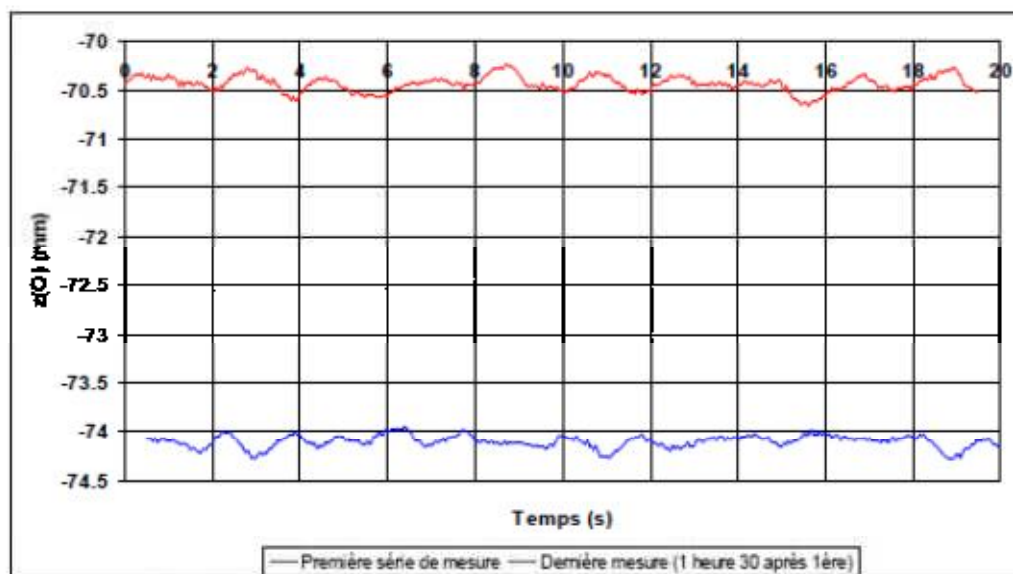
Figure 8 : Extrados émergé – Prise d'immersion après 1 heure 30 dans l'eau

Au bout d'une heure trente dans l'eau, le flaperon a pris  $0.25^\circ$  d'assiette, perdu  $0.3^\circ$  de gîte et s'est enfoncée de 3.5 mm au niveau de la boule origine. Cet enfoncement correspond sensiblement à un alourdissement de 0.2 kg dont la résultante se situerait entre la boule « Origine » et le point B de mise en place des masses.

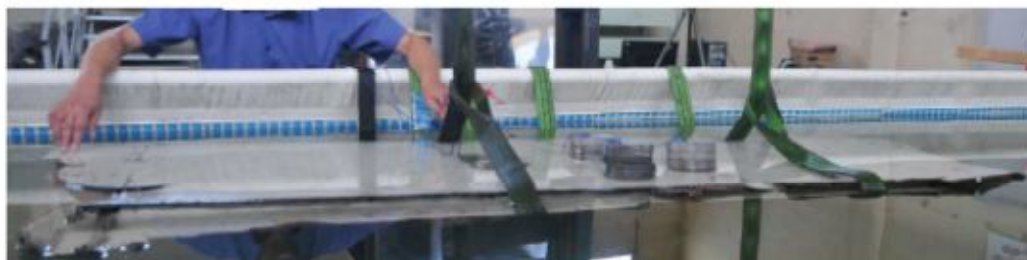
Figure 11 : Immersion complète, intrados vers le haut

La réserve de flottabilité du flaperon est importante puisque 41 kg de lests supplémentaires ont été nécessaires pour l'immerger totalement. En pratique la réserve de flottabilité est légèrement inférieure à  $41/1023.5 = 0.040 \text{ m}^3$  puisqu'une partie des lests utilisés se trouvait immergée (Figure 11) lors de cette expérience. En corrigeant de la poussée hydrostatique sur

les parties immergées des lests, on déduit que la masse effective pour immerger totalement le flaperon est plus proche de 37 kg.

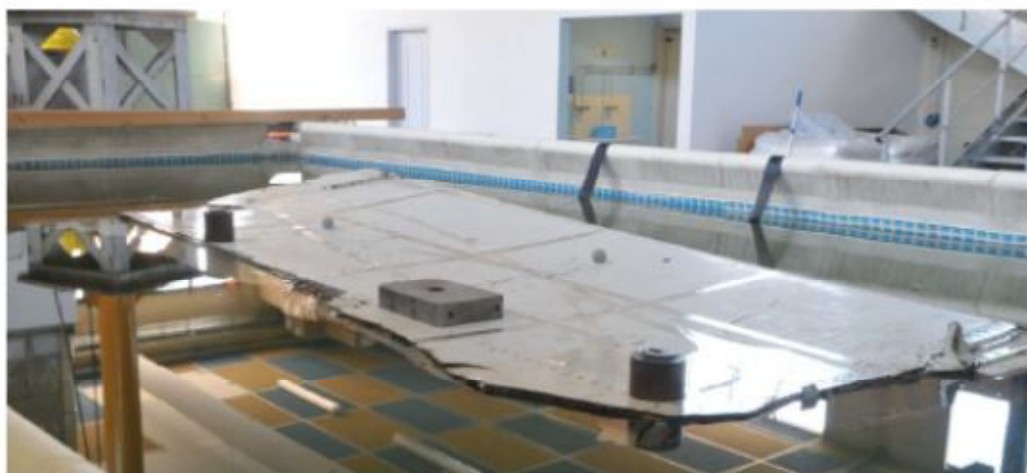
Figure 12 : Bord de fuite affleurant - intrados émergé

Des expériences consistant à lester le flaperon de manière à faire affleurer le bord de fuite à la surface libre, et donc la zone d'implantation des crustacés, ont également été réalisées. Ces expériences menées respectivement pour les configurations intrados émergé et extrados émergé sont illustrées par les Figure 12 et Figure 13.

Configuration flaperon	Masse (kg)	x (mm)	y (mm)
Intrados émergé (Figure 12)	10.0	633	59
	2.0	1544	39
	1.5	77	29
Extrados émergé (Figure 13)	2.5	760	65
	2.5	152	43

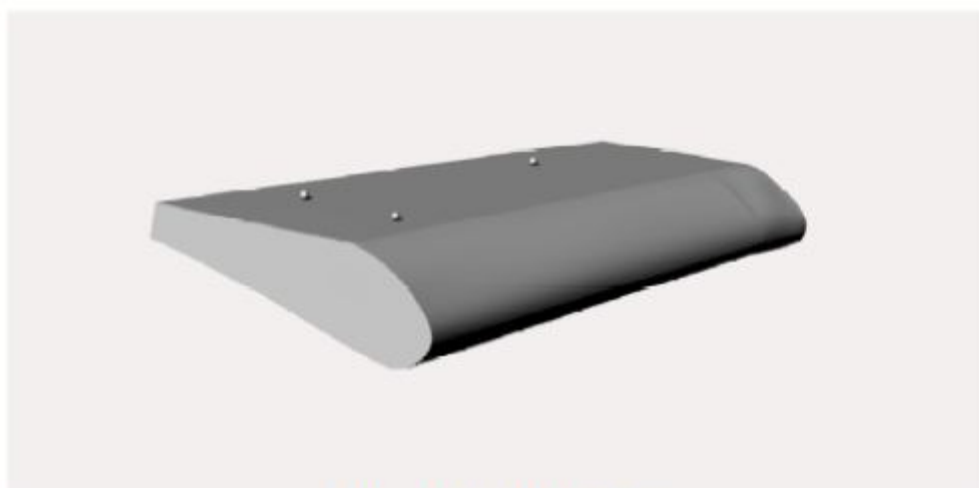
Figure 14 : Vue du volume fermé

L'annexe 1 résume la nomenclature utilisée pour définir les caractéristiques hydrostatiques. A partir du fichier CAO transmis par DGA TA, un nouveau fichier a été défini dans lequel des surfaces ont été construites de manière à délimiter un volume fermé excluant les éléments de peau endommagés que l'on voit au niveau du bord de fuite et sur les côtés. La Figure 14 illustre ce volume. On peut, sur cette base, estimer un déplacement  $V_f$ , appelé « de forme », et qui correspond au volume immergé délimité par l'enveloppe extérieure : ce qui reviendrait à admettre que toute l'eau emprisonnée dans le flaperon est figée et entraînée dans ses mouvements.

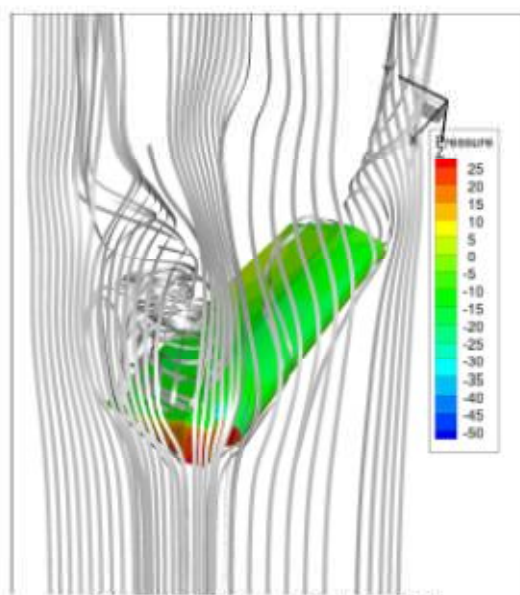
Figure 12 - Cisement hydro de  $150^\circ$

Contrairement aux calculs aérodynamiques, les calculs hydrodynamiques font apparaître des situations pour lesquelles les écoulements sont fortement décollés (Figure 12) conduisant à des fluctuations des efforts. Les calculs ont été réalisés en stationnaires et en instationnaires afin de mieux préciser les valeurs moyennes d'efforts.

Les écarts observés sur les efforts selon les deux approches sont faibles à l'exception du gisement de  $150^\circ$  qui fait apparaître des écarts sensibles sur les coefficients de moment, essentiellement en  $C_M$  (Figure 13 et Figure 14).

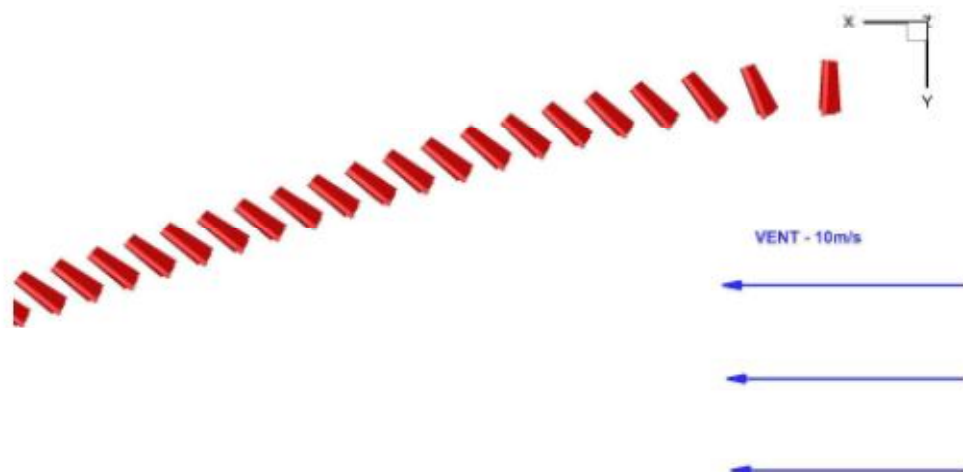
Figure 21 - Trajectoire flaperon - Vent à 10m/s – Situation d'équilibre n°1

Pour un cap initial appartenant à  $[-3^\circ, \sim 172^\circ]$ , les simulations tendent vers la **situation n°1** (Figure 21), bord de fuite face au vent, caractérisée par :

- dérive  $\delta = +126^\circ$
- vitesse  $u = -0.193$  m/s
- vitesse  $v = -0.266$  m/s
- soit une vitesse de  $V = 0.33$  m/s
- cap de  $\psi = +144^\circ$
- un angle de dérive par rapport au vent de  $\beta = 18^\circ$  vers la gauche

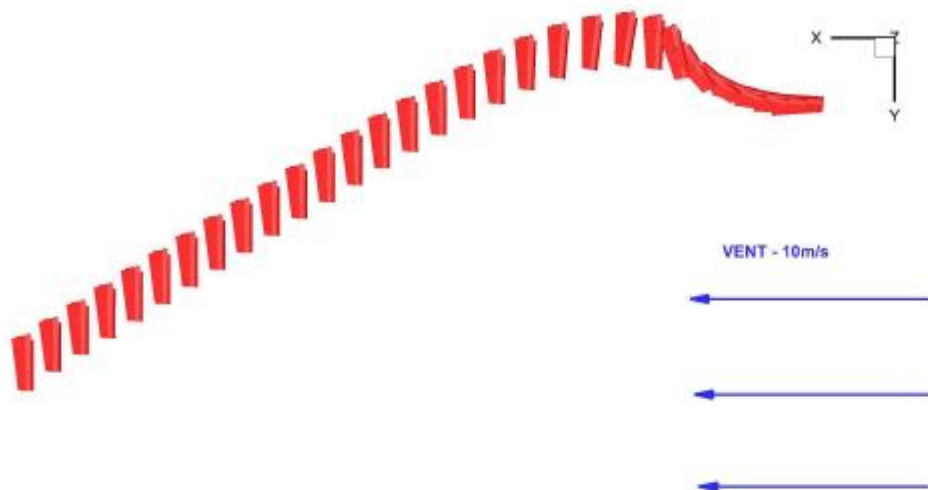
Figure 22 - Trajectoire flaperon - Vent à 10m/s - Situation d'équilibre n°2

Dans les autres cas, les simulations tendent vers la **situation n°2** (Figure 22), bord d'attaque face au vent, caractérisée par:

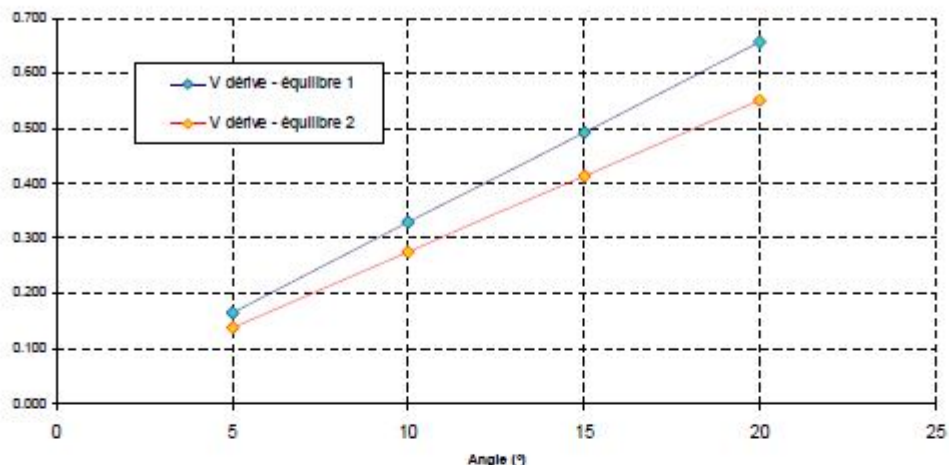
Figure 24- Influence de la vitesse du vent sur la vitesse de dérive

Compte tenu de la modélisation, la vitesse de dérive est, en régime permanent, une fonction linéaire de la vitesse du vent illustrée sur la Figure 24.

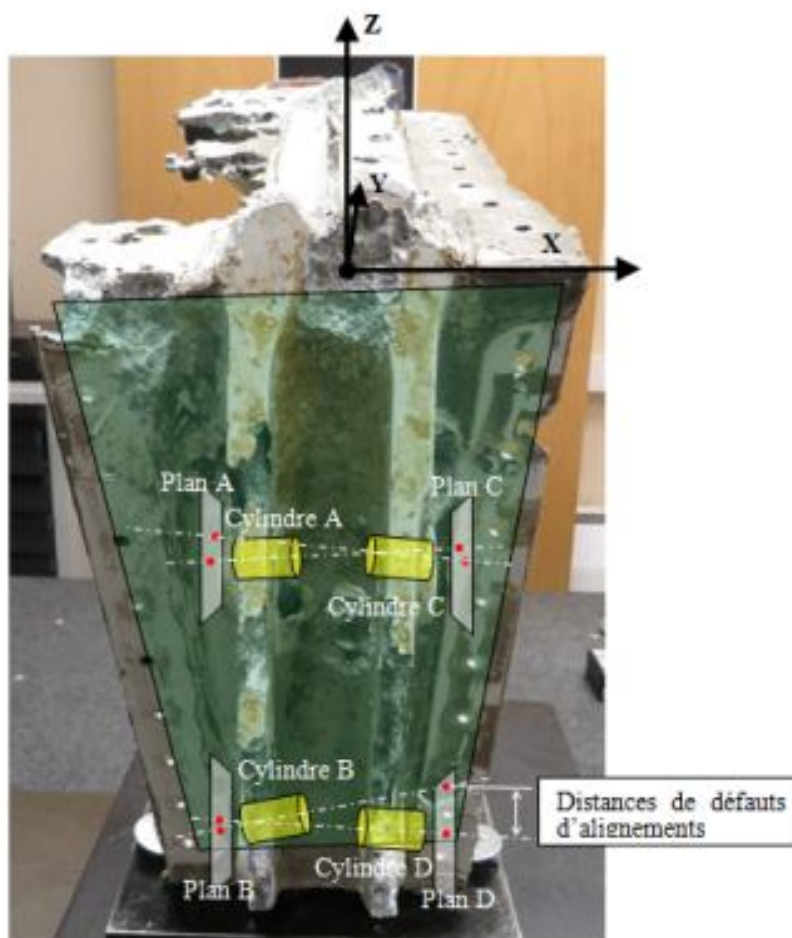
Si l'on accepte que le référentiel soit réaliste (problèmes d'orientations dues aux déformations et à la corrosion du Flaperon), l'ensemble des angles des plans et cylindres, sont pratiquement confondus avec l'axe X.

L'axe du cylindre B a plus d'angle que les autres et donc une plus grande distance entre intersections (plan D). Une répétabilité de mesures a été effectuée sur cet alésage et elle s'avère être bien plus mauvaise que pour les autres surement due à un défaut géométrique du cylindre (corrosion, déformation). Il en découle une incertitude de mesure plus élargie.

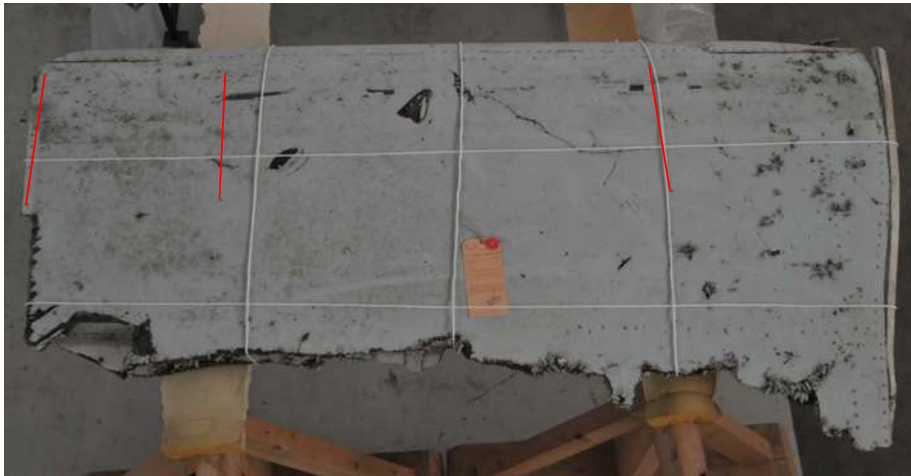
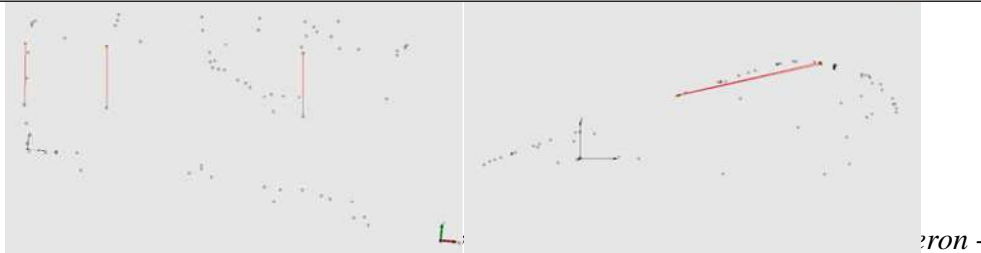
The first measurement on 06 August 2015, presented in appendix 6, only related to the upper surface and the ribs to prevent any manipulation of the part that could be damaging for the biological examination. It showed the absence of any significant distortion of the flaperon as can be seen in the illustration below.

The 3D measurement shows that the three lines measured remained aligned on the upper surface and appear to be together seen from the side, indicating the absence significant distortion on the part

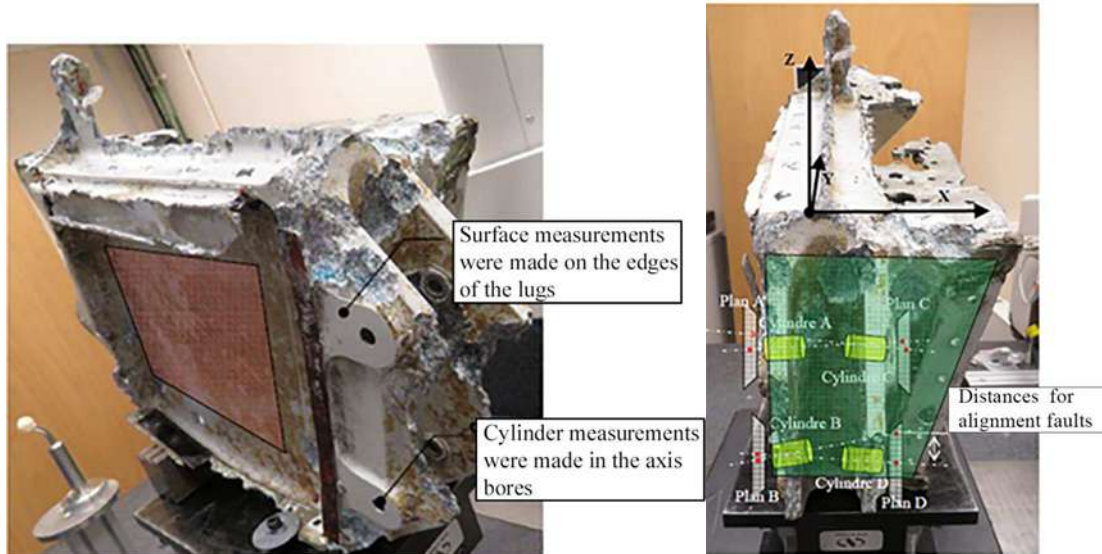
- Creation of references for the measurements and measurements on the inboard hinge fitting -

In the absence of any plans of the hinge fittings and for the purpose of measuring possible overall distortion of the latter, references were made by the metrology department based on non-distorted parts, as illustrated below, on the inboard hinge fitting. The distortions were thus measured against these references and not against the plans of the part. The complete metrology report is in appendix n°10.

Plate n°40 shows a slight distortion of the outboard hinge fitting towards the outside of the aeroplane.

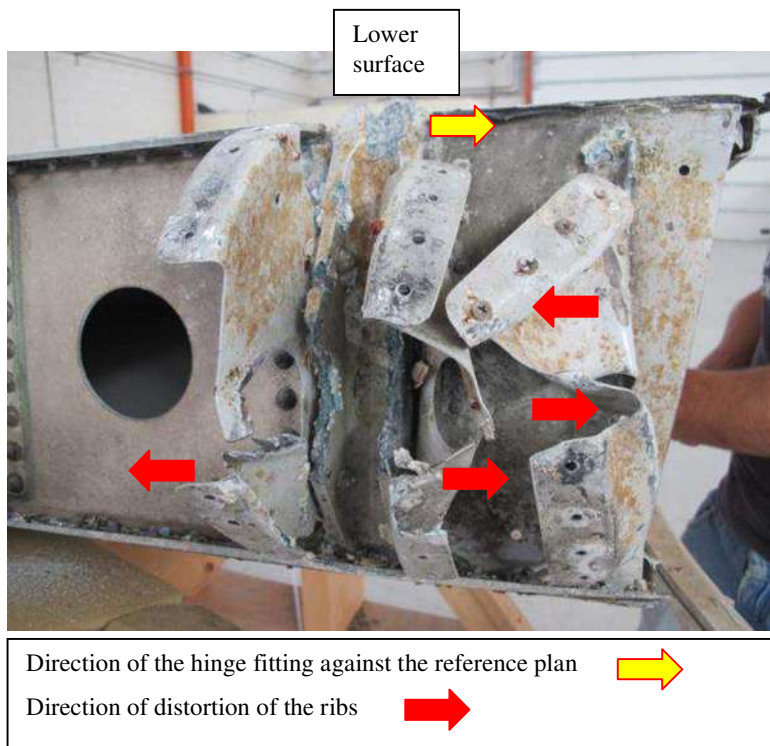
- Distortions of the outboard hinge fitting and of the leading-edge ribs

Plate n°42 summarizes the direction of the distortions of the hinge fittings with those noted on the ribs close to the hinge fittings. All of these distortions were correlated and were going in the inboard – outboard direction. The image below shows an example of these observations for the outboard side.

The leading edge ribs were bent and in places seemed to have been torn by another part. After the visit made to an aircraft, it appeared that the hinge point that allowed the return of the activator at the level of the hinge fitting could be the cause of the tears of the while the ribs could have pressed on the shaft or the body of the activator, which would explain the form of the folds (see plate 43).

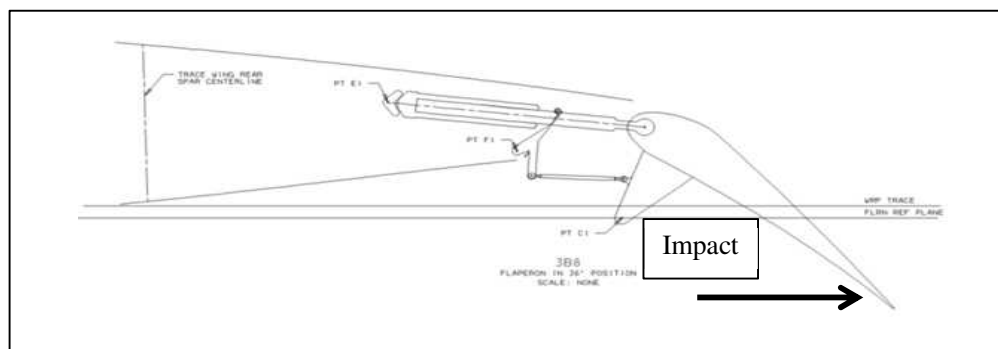
- Presumed position of the flaperon on impact -

1. Considering an impact with water as likely, and considering the damage observed, it seems that the flaperon must have been deflected at the time of the impact,

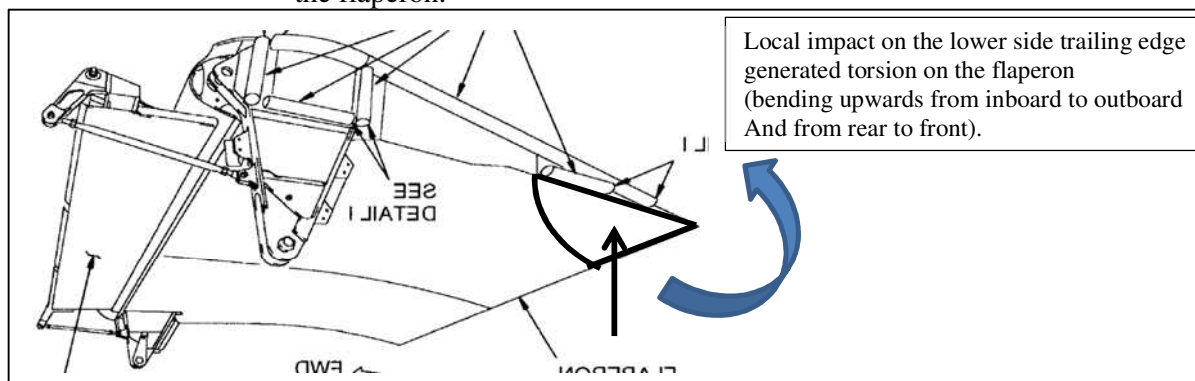
- Impact point and torsion loading on the flaperon -

2. The damage being greater on the trailing edge on the inboard side, notably on the lower surface side, it appears that the contact occurred first in this zone. The loads generated, pushing from the lower surface towards the upper surface locally (unlike uniform aerodynamic loading), resulted in a bending load from the rear towards the front as well as of inboard towards outboard. This caused torsion on the flaperon.

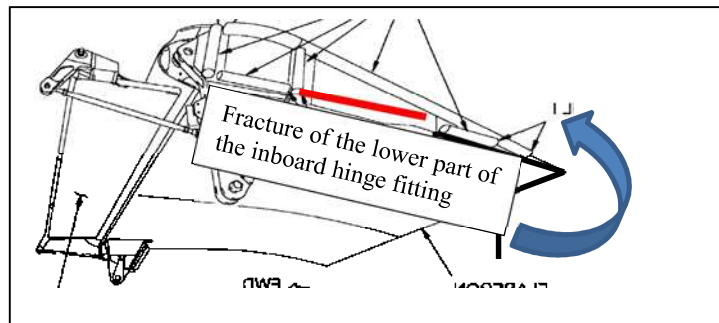
- Fracture of the lower part of the inboard hinge fitting -

4. Almost simultaneously, this torsion from inboard towards outboard and from the rear to the front broke off the lower part of the inboard hinge fitting, not designed for this type of load.

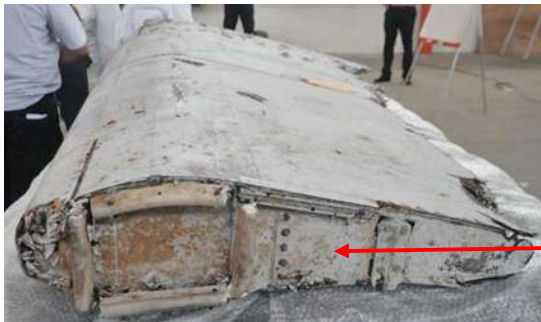
When the crate was opened, it was noted that the identification plate was missing (see plate n°1). It was then decided to :

Missing identification plate

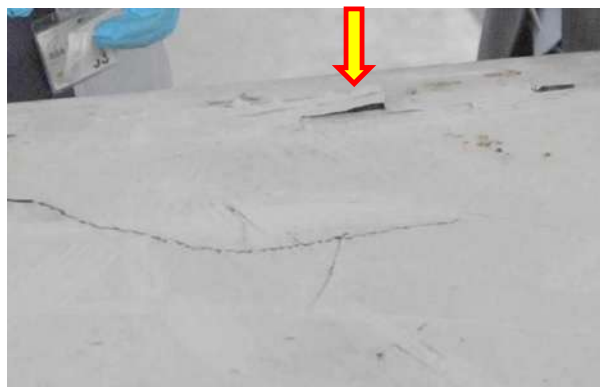
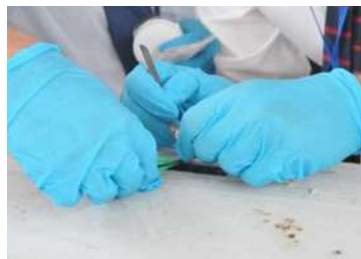
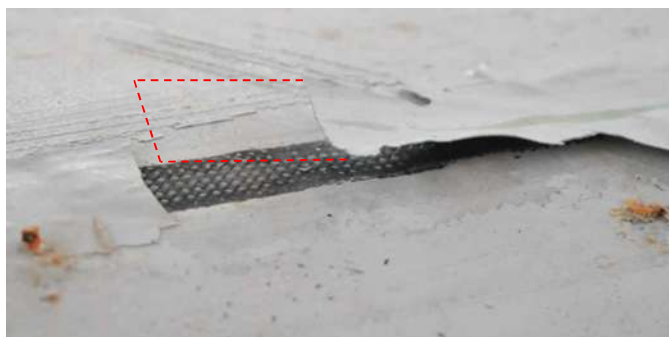
Paint sample

- sample a piece of the paint that seemed to be a touch-up for analysis (see plate 2),
- check the presence of a temporary repair which had not been replaced, according to Malaysia Airlines (see plate n°3 and appendix 3 for the plan),
- undertake an boroscope search for the numbers identifying the various parts that make up the flaperon.

Piece of paint sampled

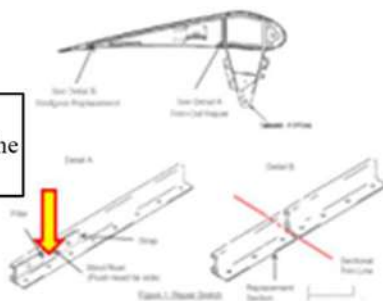
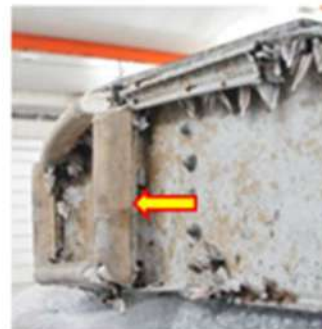
Repair on the joint moulding

Addition of a  
riveted piece on the  
back of the joint

This repair is a minor and temporary repair and that should be replaced by a modification (according to ref. 6 in appendix 11). It thus seems probable that application of the modification was not recorded.

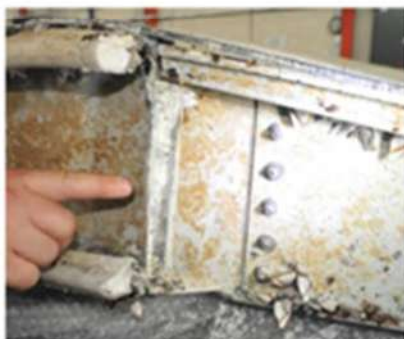
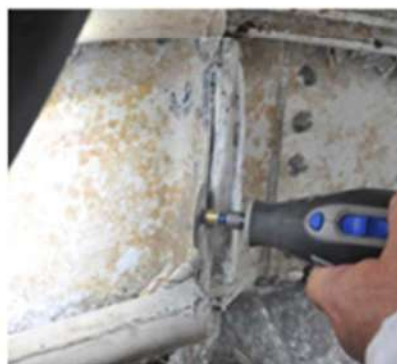
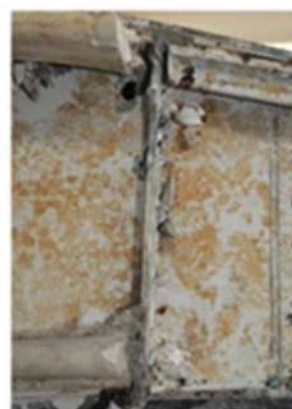
Cutting off joint moulding to  
check repair

No repair on  
joint moulding

View of area  
after cutoff

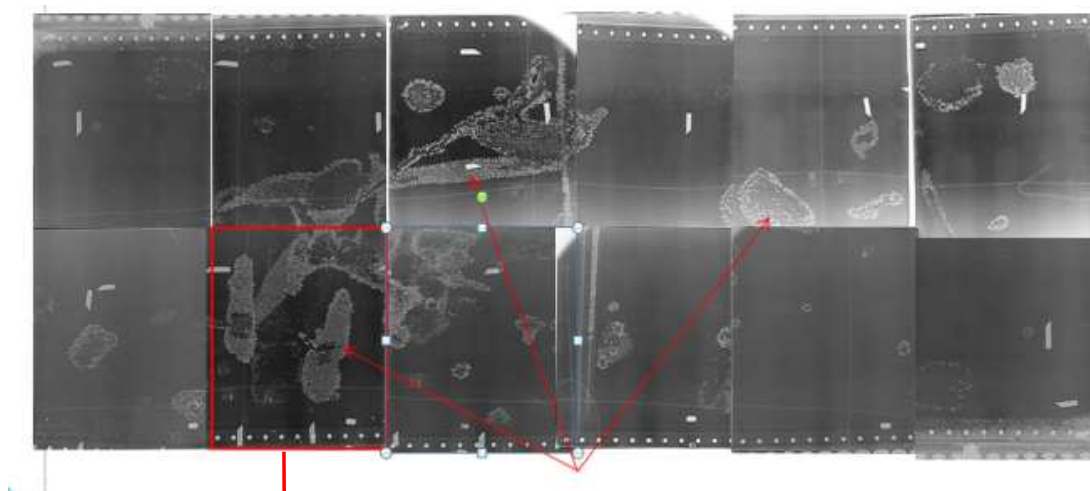
Planche 15 : X-rays of the flaperon

The lightest zones correspond to salt deposits following sea water penetration in the cracked composite

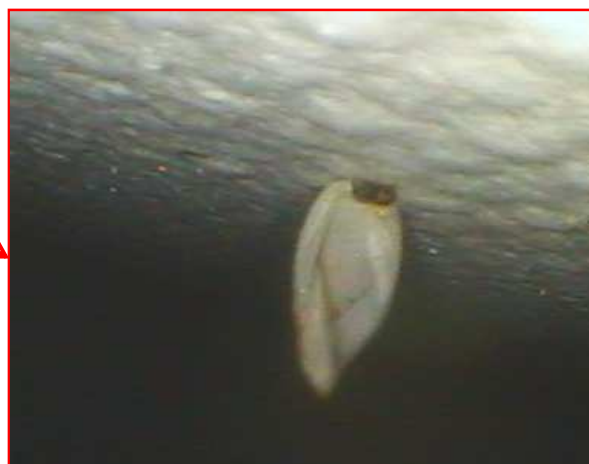
Boroscope of the zone: presence of a crustacean inside the flaperon

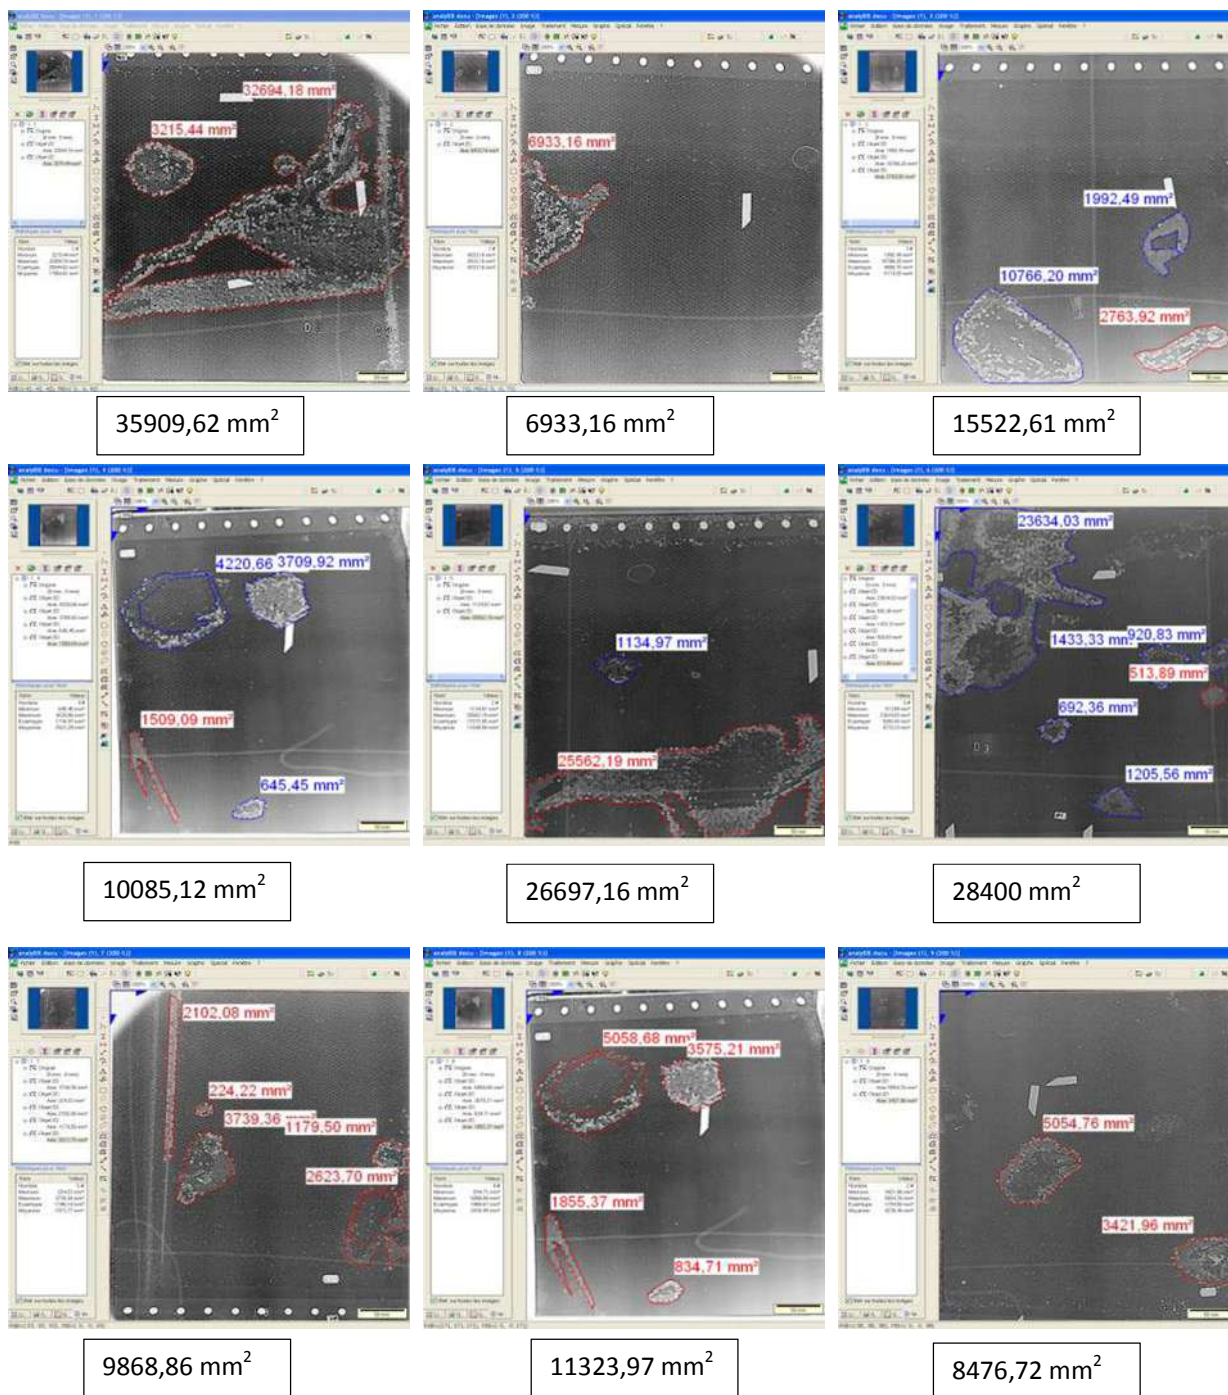
Planche 16 : Area of the zones covered in salt

Total area = 153217 mm<sup>2</sup> ( 0.153 m<sup>2</sup>)

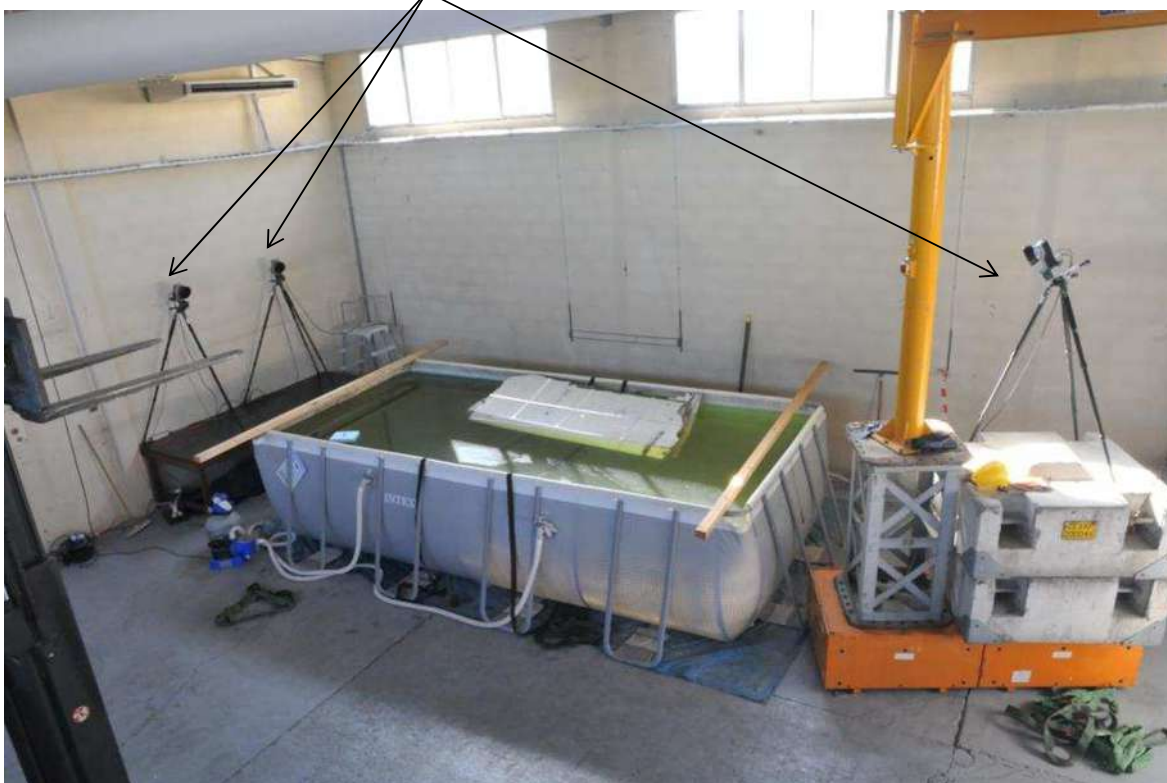
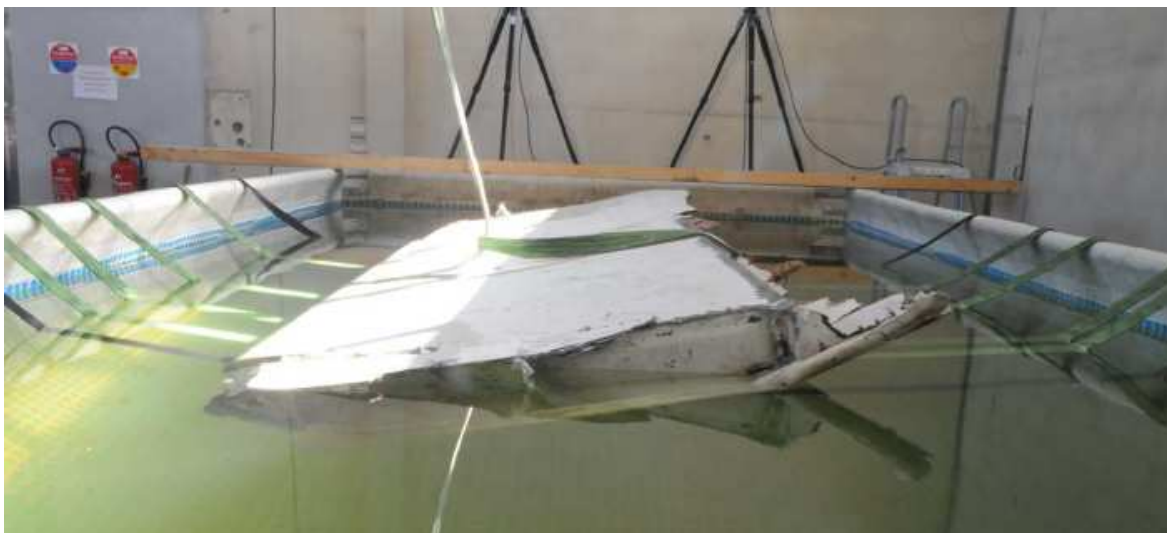
Planche 21 : **Buoyancy test**

DGA TH cameras around the pool

Flaperon in the pool

Positioning the flaperon in the pool

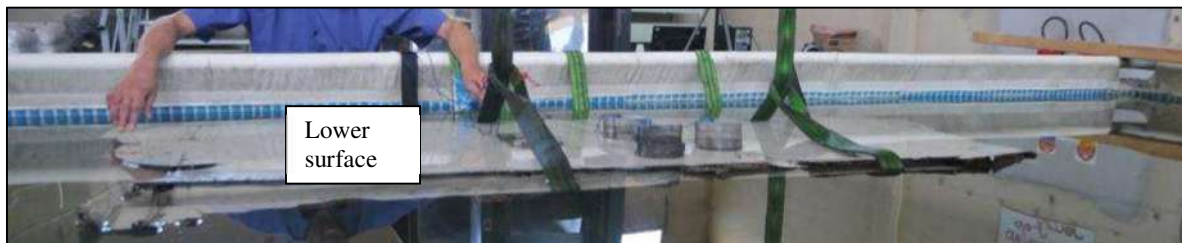
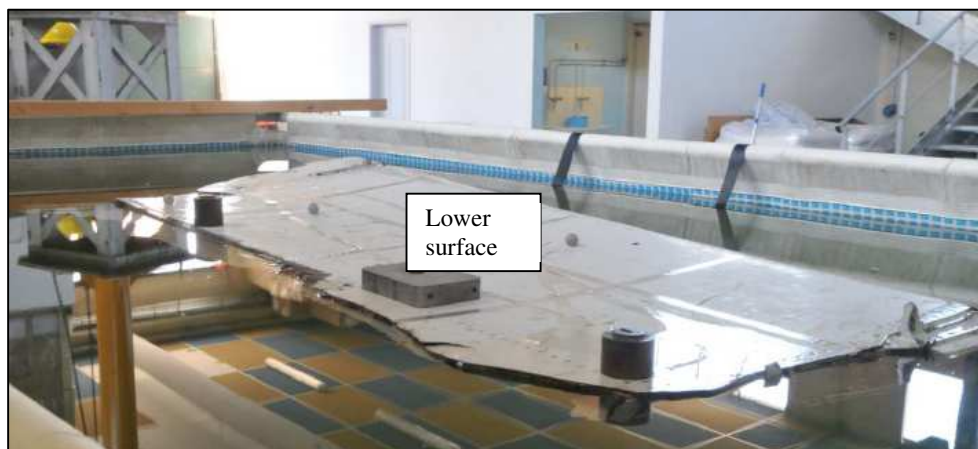
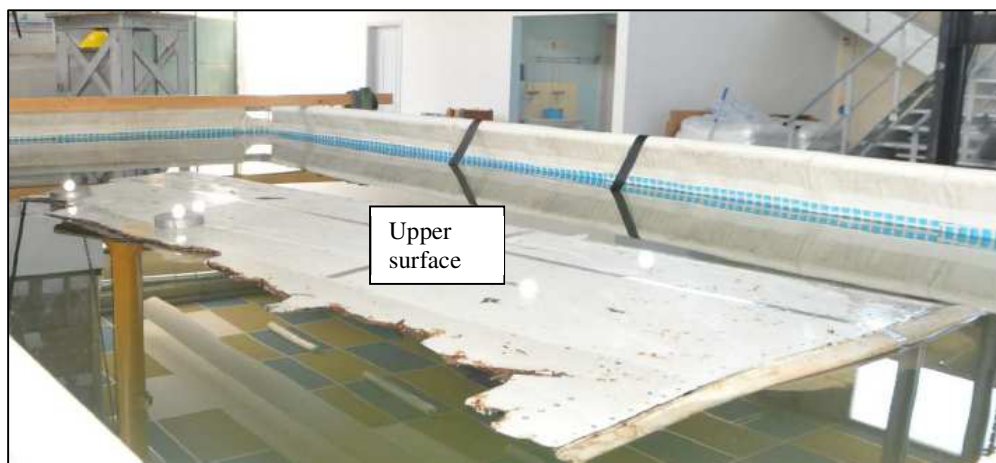
Planche 22 : Buoyancy test

The effective weight to immerse the flaperon completely was 37 kg (41kg –Archimedes buoyancy on weights).

The added weight, which did not touch the water and was thus effective, to immerse the lower surface trailing edge upwards was 13.5 kg.

The added weight, which did not touch the water and was thus effective, to immerse the upper surface trailing edge upwards was 5 kg

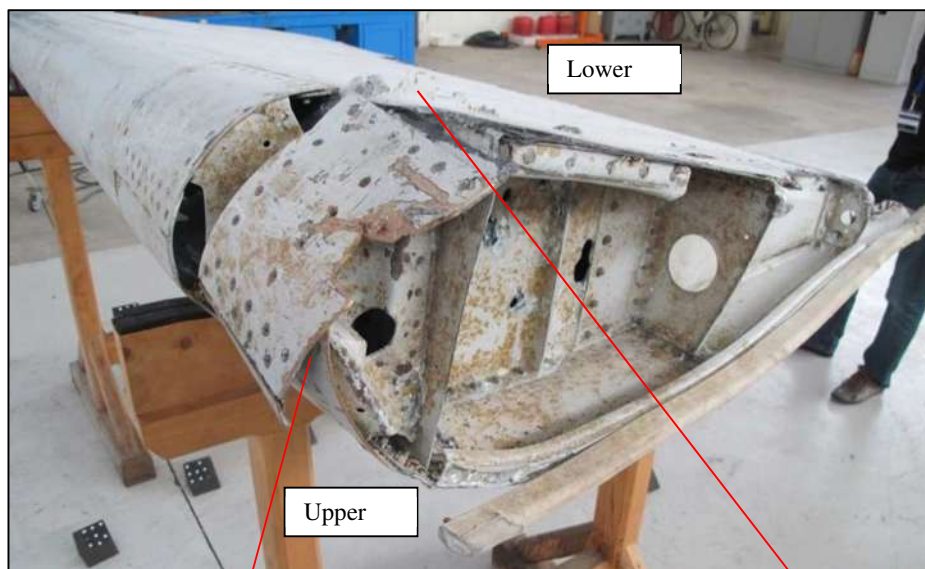
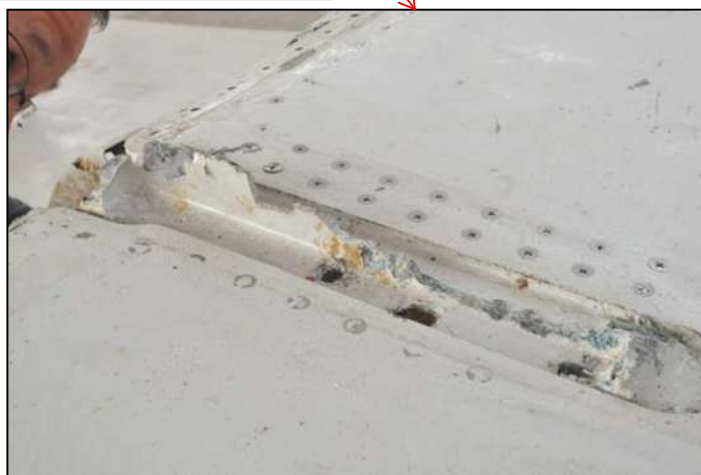
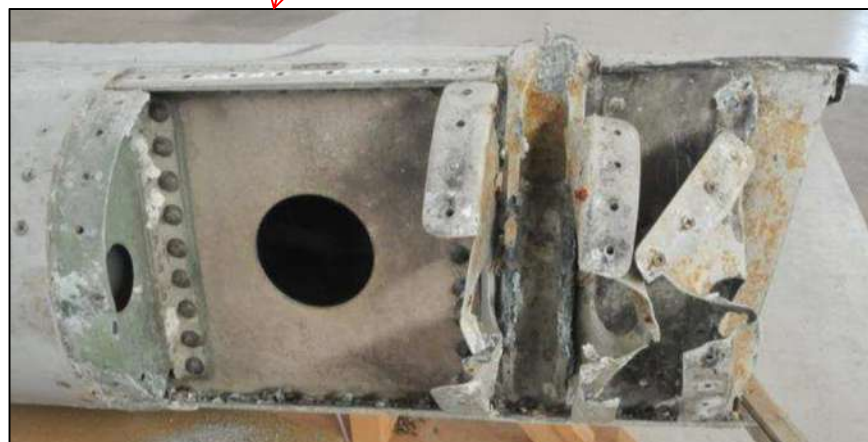
Planche 23 : Hinge fitting on the outboard side

Disassembly of leading edge panel

Lower surface fracture

Leading edge fracture

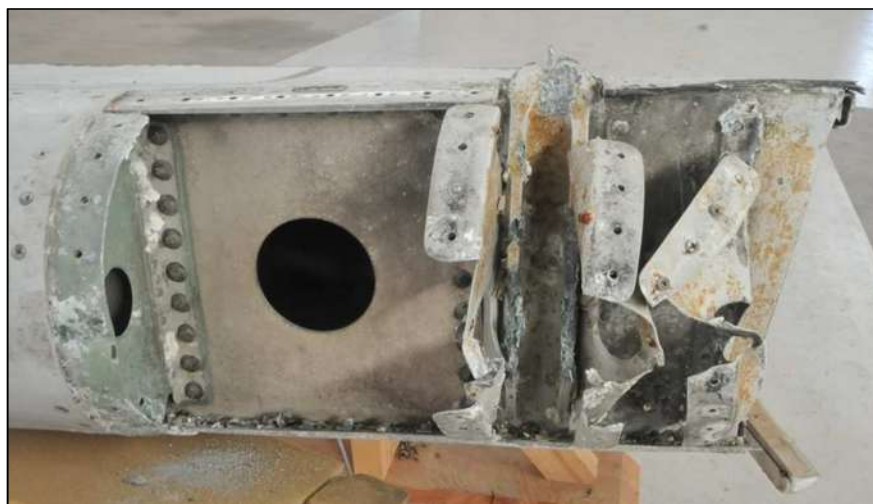
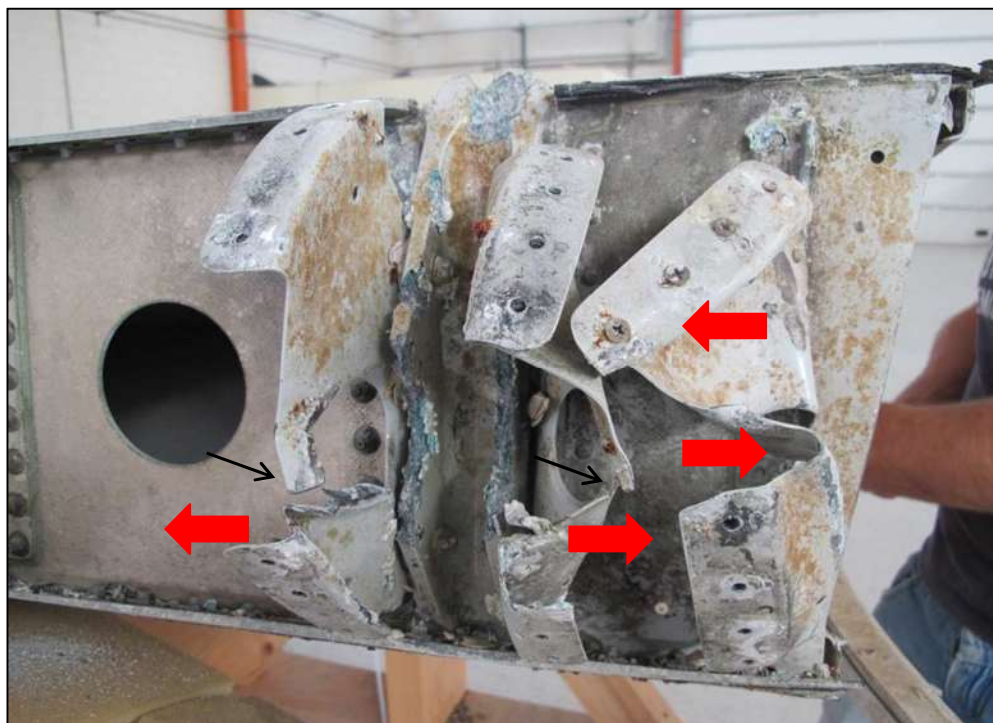
Planche 24 : Hinge fitting on the outboard side

Direction of distortions on rib  
tears

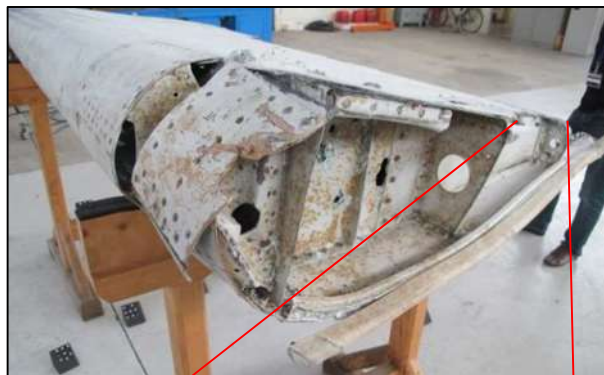
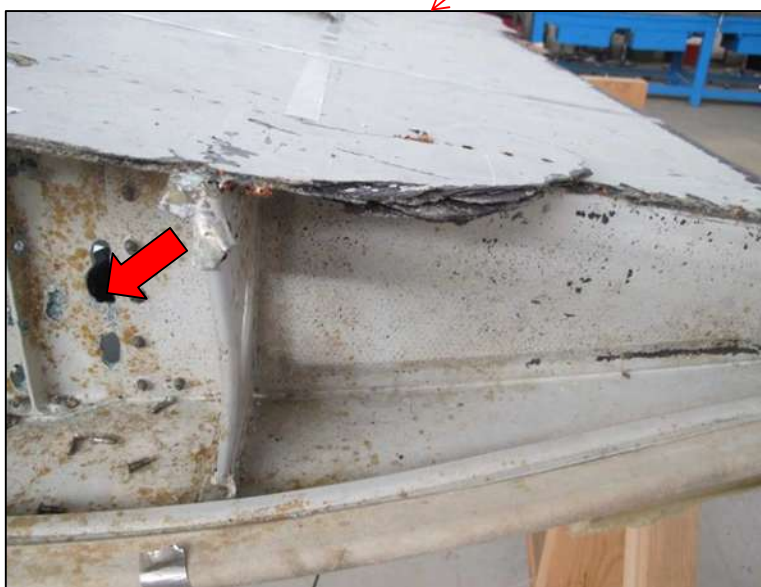
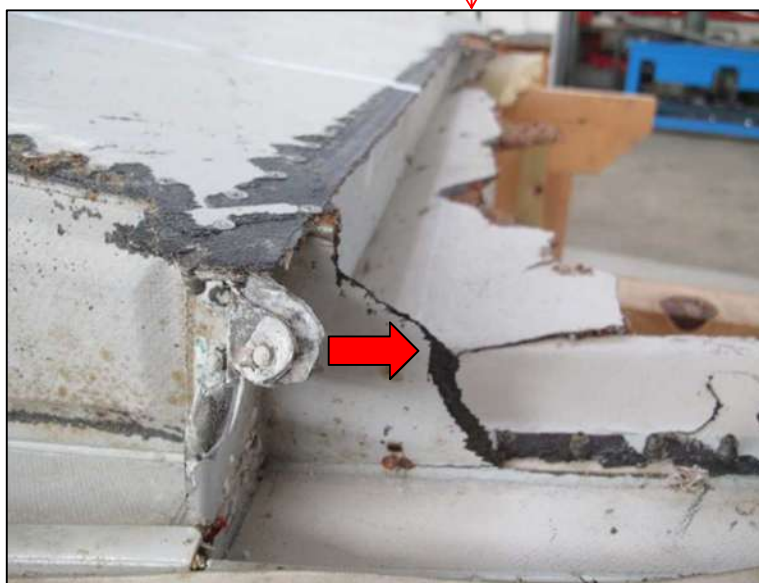
Planche 25 : Elements located aft of the outboard hinge fitting

Direction of distortions

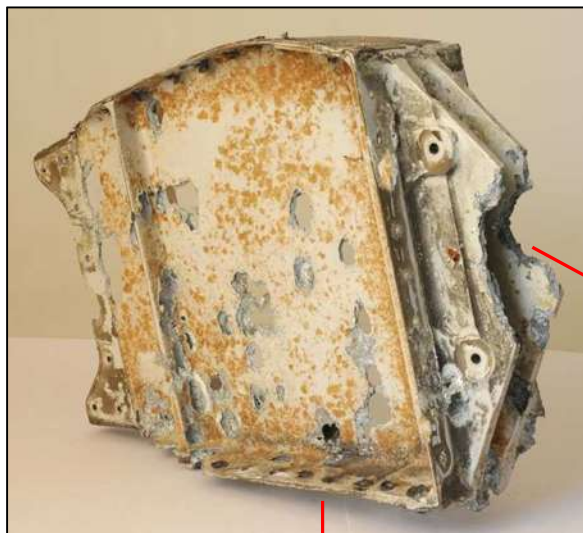
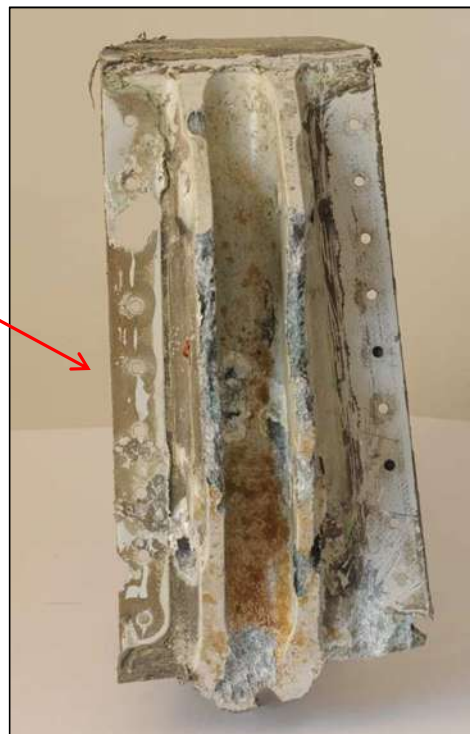
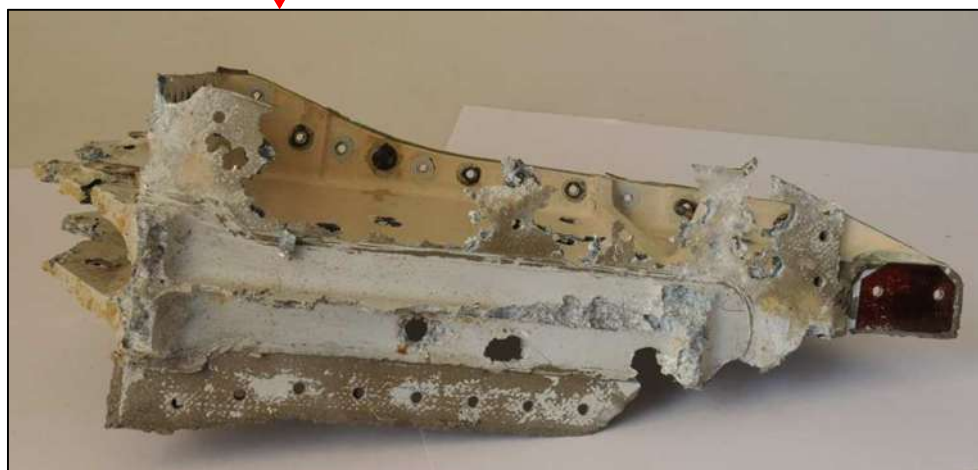
Planche 27 : **Outboard hinge fitting disassembled**

Outboard hinge fitting  
disassembled

Leading edge fracture

Lower surface  
fracture
