## **SAFETY INVESTIGATION REPORT**

**Malaysia Airlines Boeing B777-200ER (9M-MRO)  
08 March 2014**

**The Malaysian ICAO Annex 13 Safety Investigation Team for MH370**

Issued on 02 July 2018  
MH370/01/2018

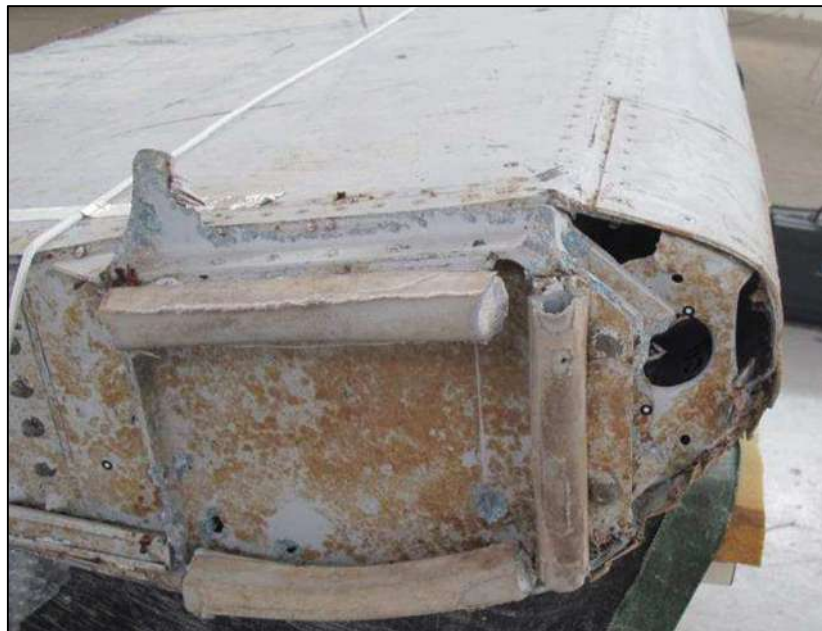
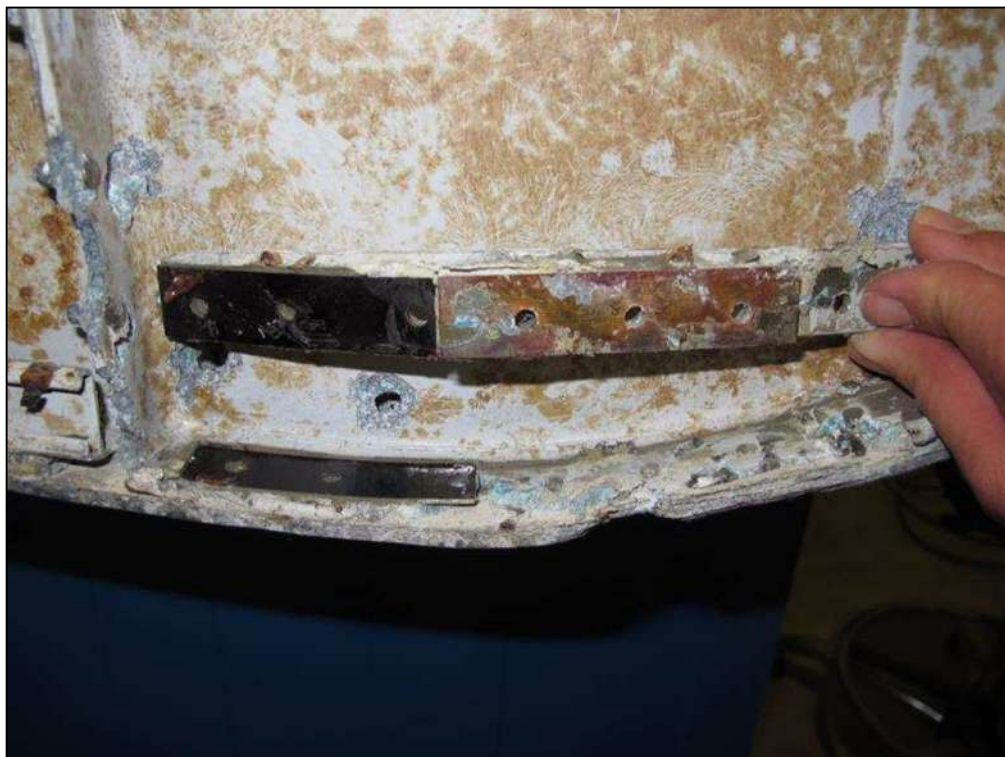
Planche 31 : Inboard hinge fitting

Disassembly of leading edge panel

Repair: disassembly of seal retainer

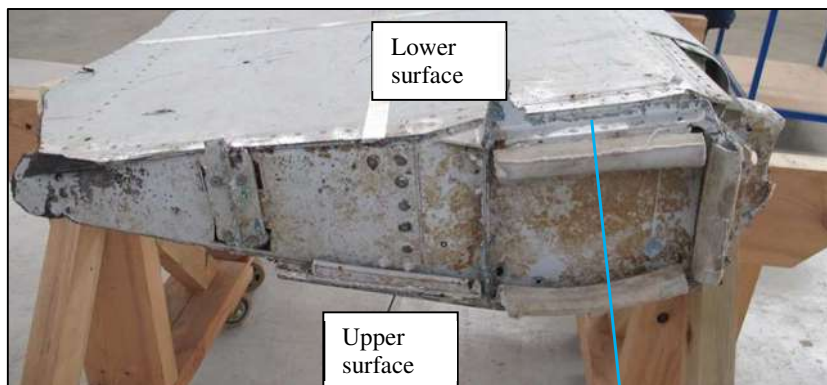
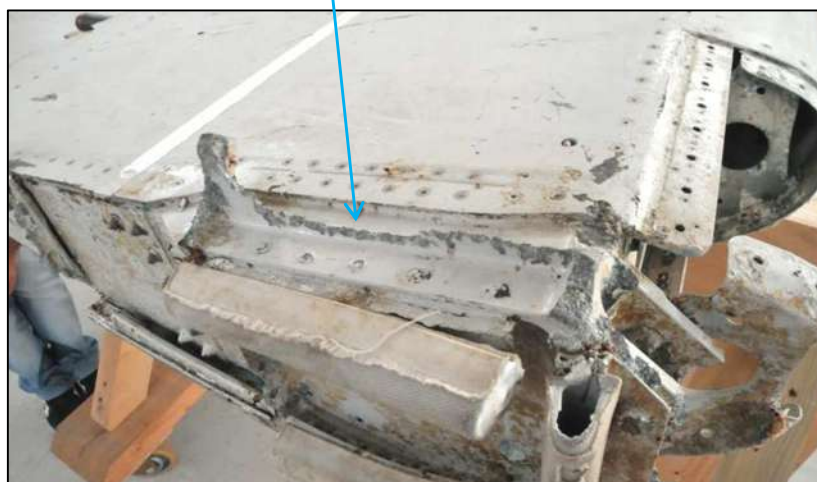
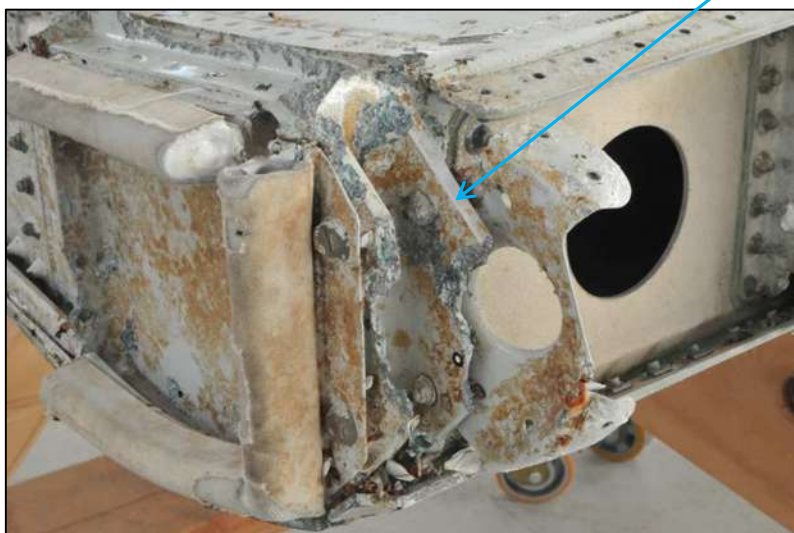
Planche 32 : Inboard hinge fitting

Lower surface side hinge fitting fracture

Leading edge side hinge fitting fracture

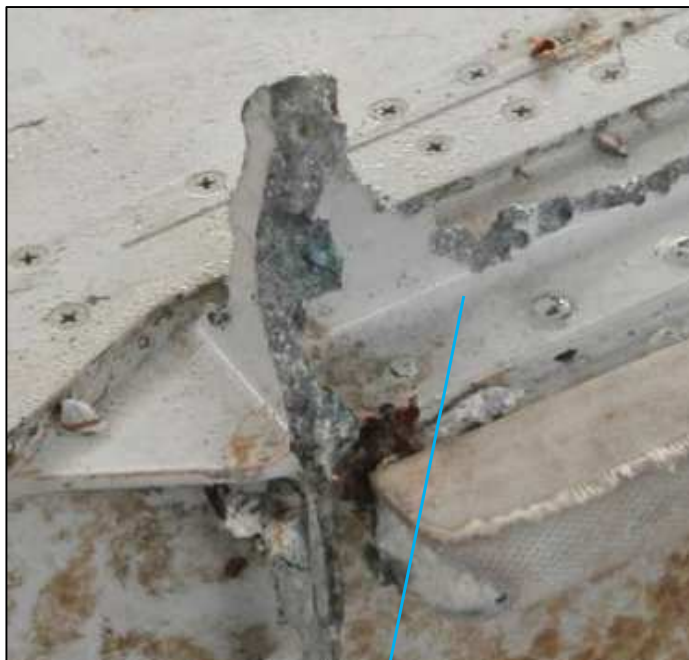
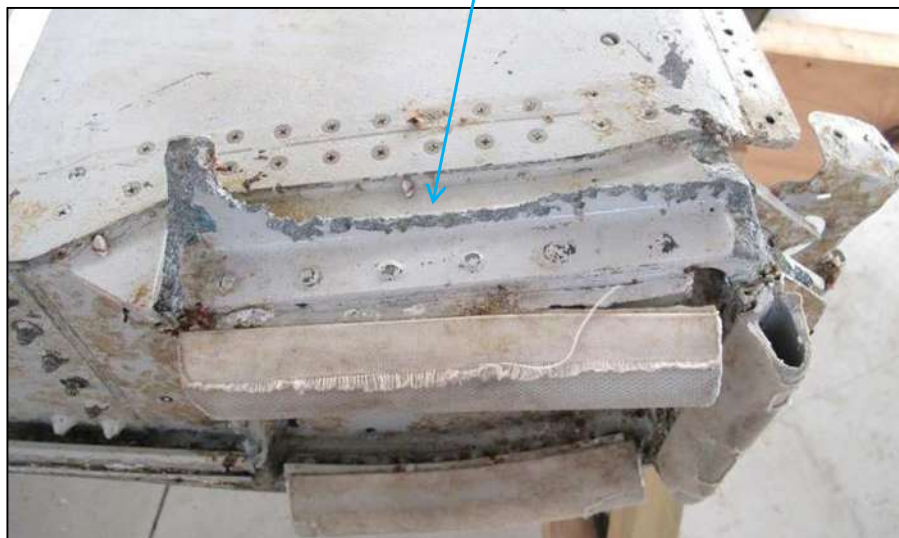
Planche 34 : **Inboard hinge fitting**

Lower surface side hinge  
fitting fracture

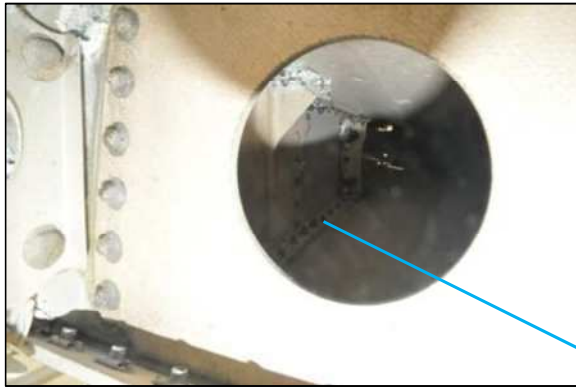
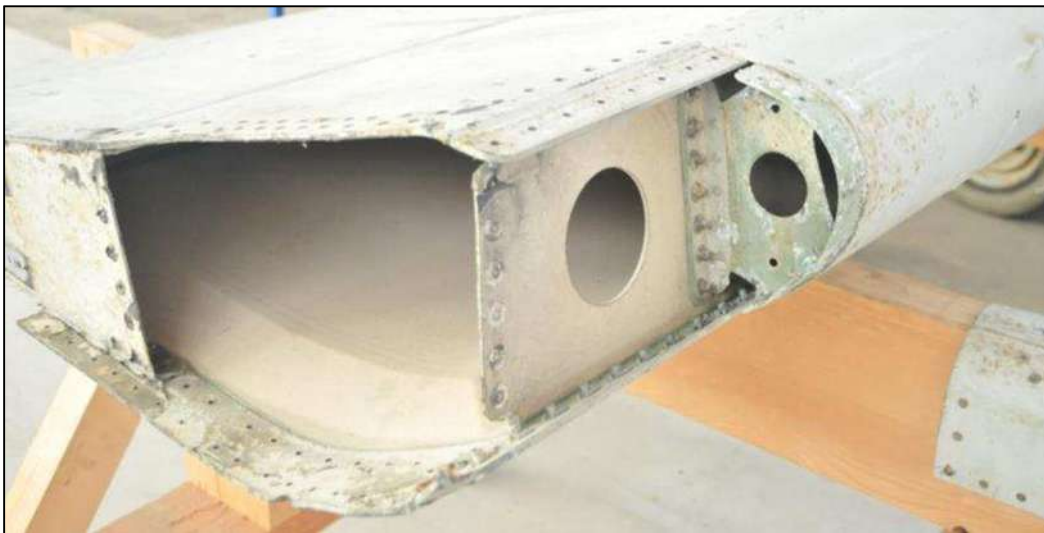
Planche 36 : Flaperon after disassembly of the hinge fitting on the inboard side

Lower surface side hinge  
fitting fracture

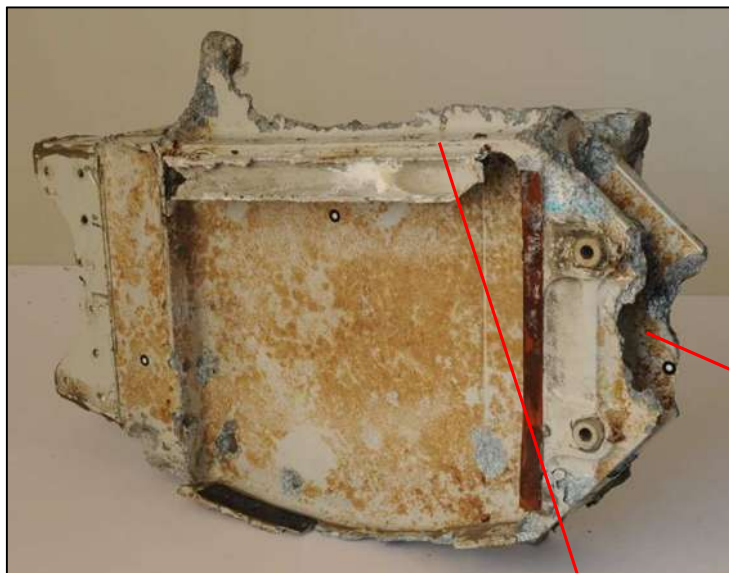
Planche 37 : Inboard hinge fitting disassembled

Inboard hinge fitting  
disassembled

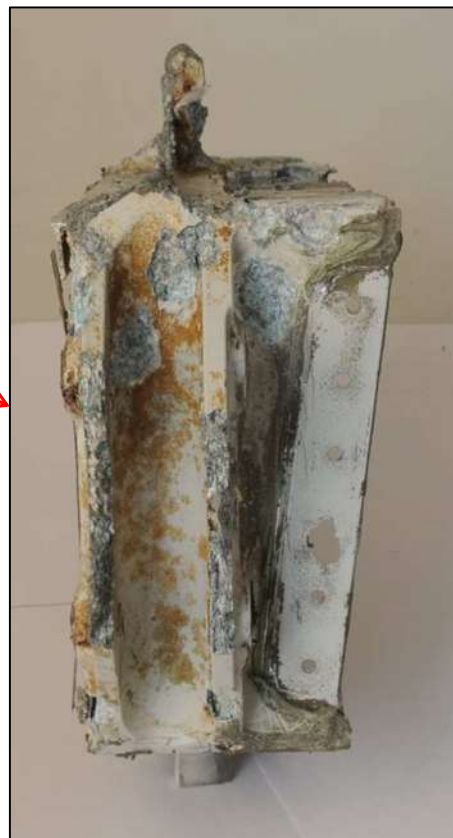
Leading edge fracture

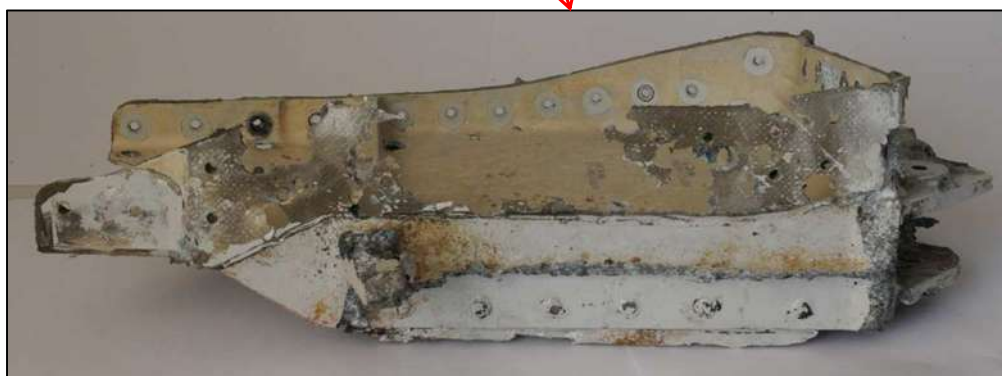
Lower surface  
fracture

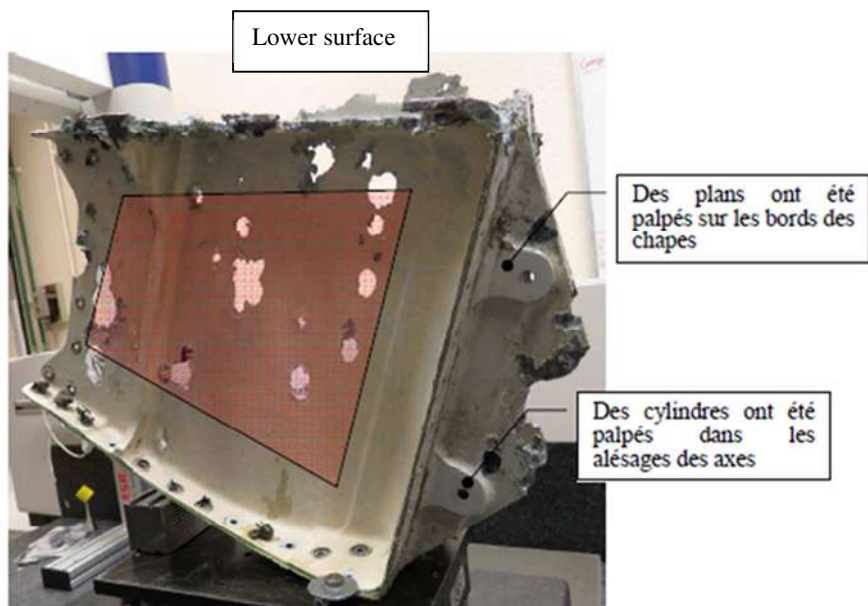
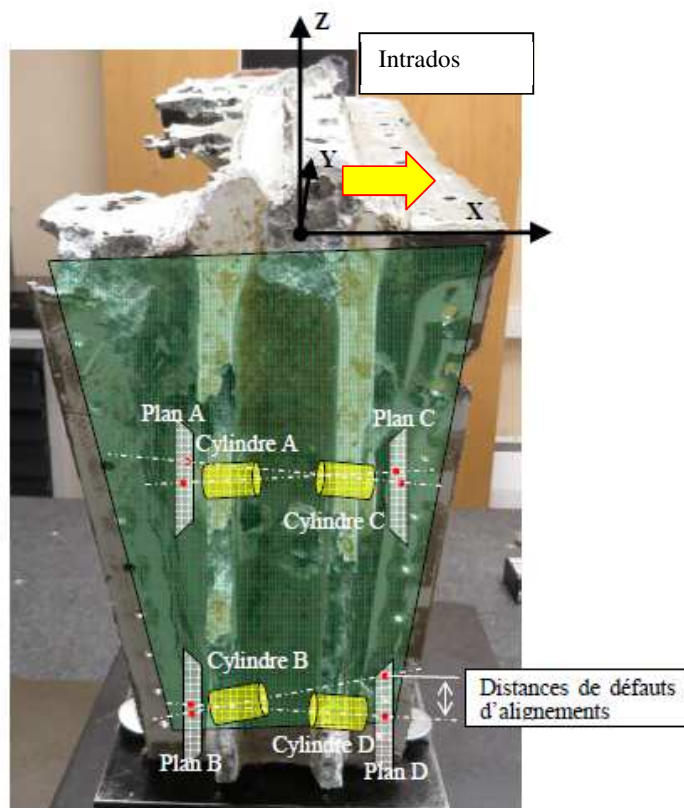
### Planche 41 : Metrology of the outboard hinge fitting

➡ Orientation of hinge fitting in relation to reference plan

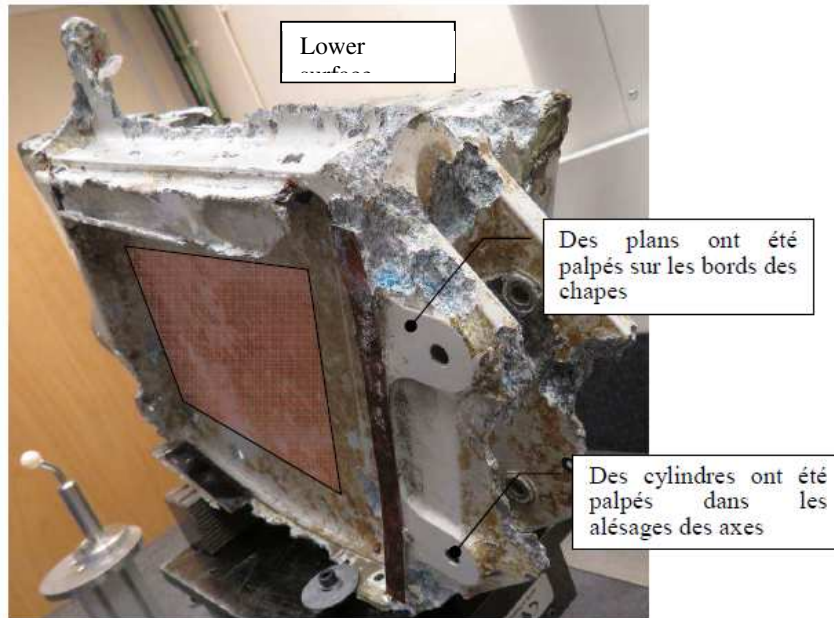
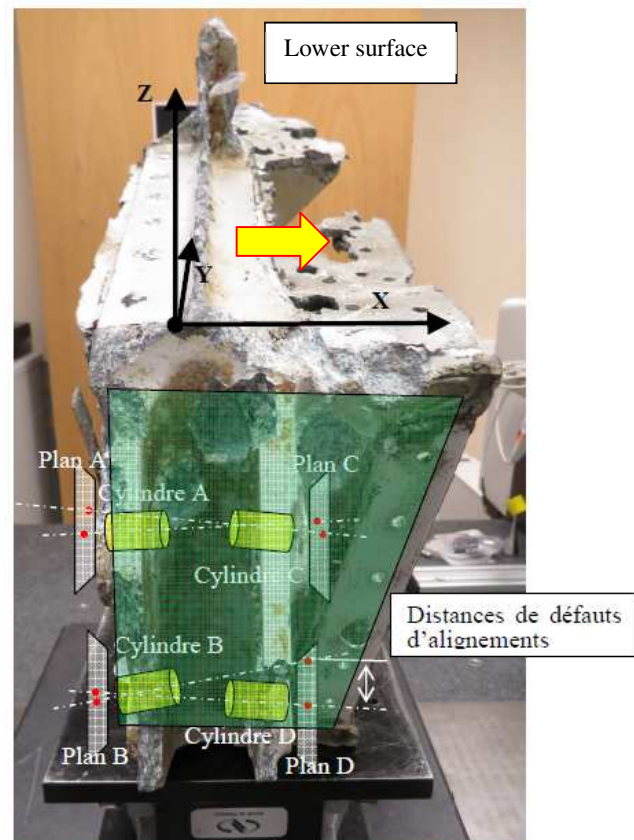
Planche 42 : Metrology of the inboard hinge fitting

➡ Orientation of hinge fitting in relation to reference plan

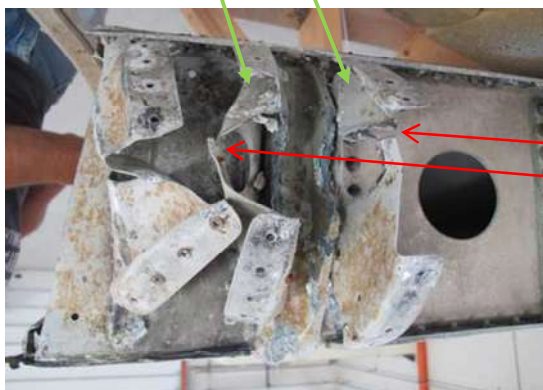
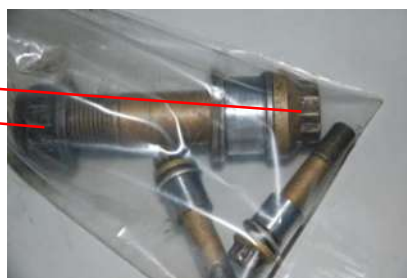
Planche 44 : **Possible explanation of the distortions and fractures of the outboard side leading edge ribs**

Activator hinge point pin and other attachments

The damage to the ribs, especially the tears, seemed to be due to the activator hinge point pin tips.

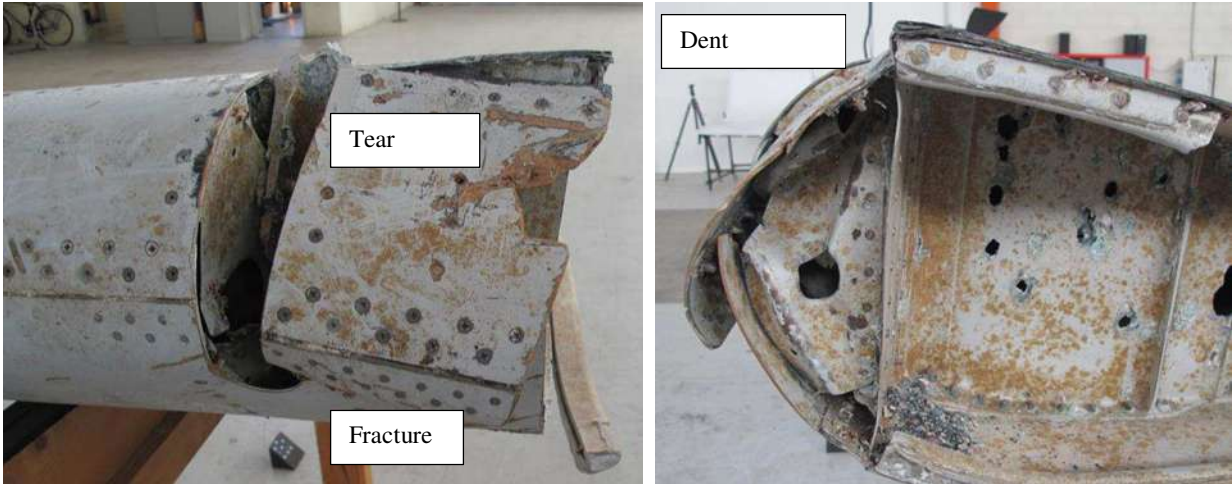
Planche 46 : Damage at the level of the leading edge access doors

Dent and tear on the access door on the outboard side

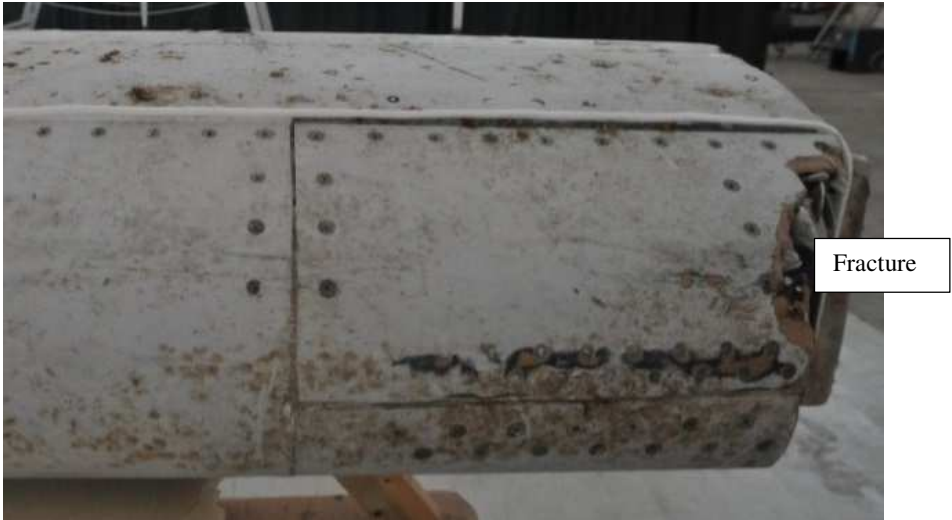
Fracture of the access door on the inboard side

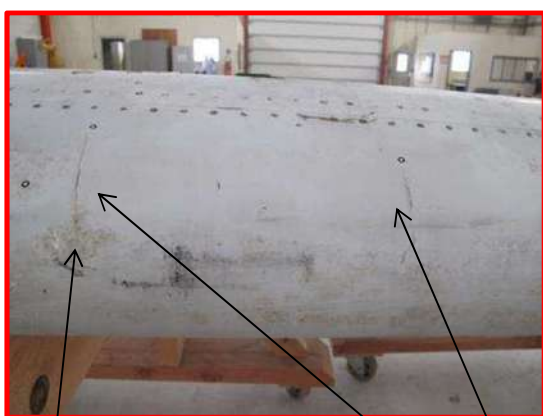
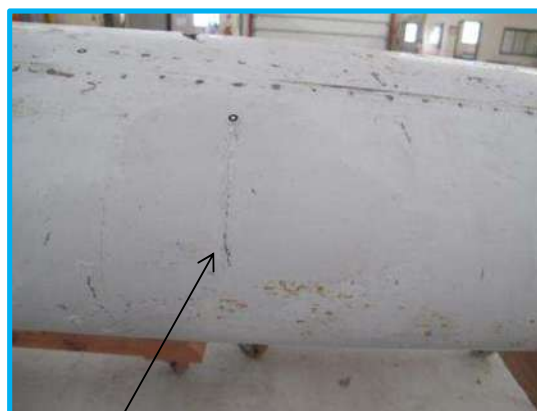
Planche 47 : Impacts on the leading edge

Dent

Vertical cracks

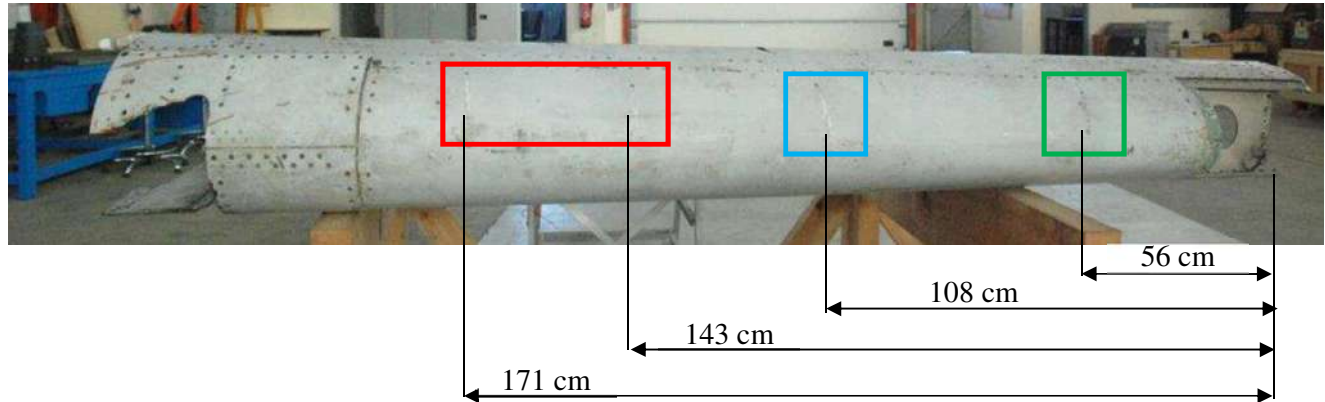
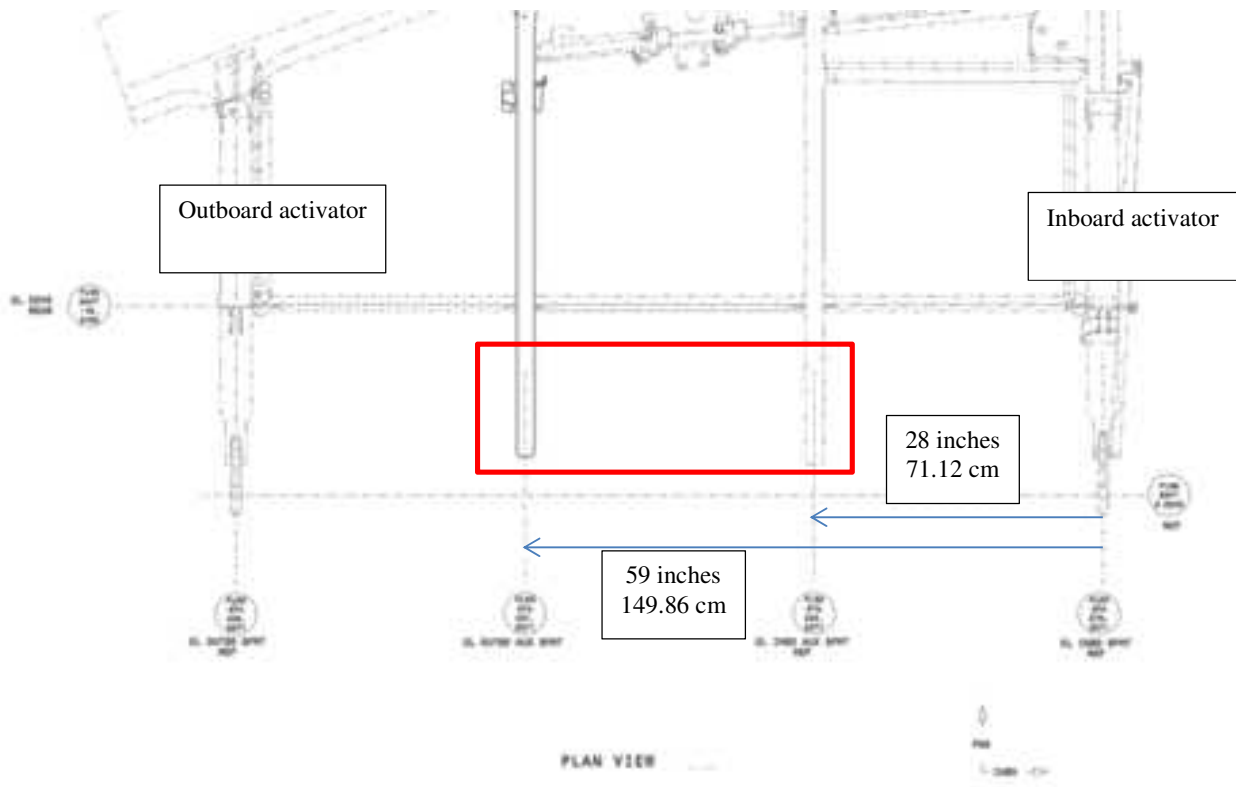
Planche 48 : **Comparison of the impacts with the facing wing panel**

Only two parts facing according to the parts supplied by Boeing

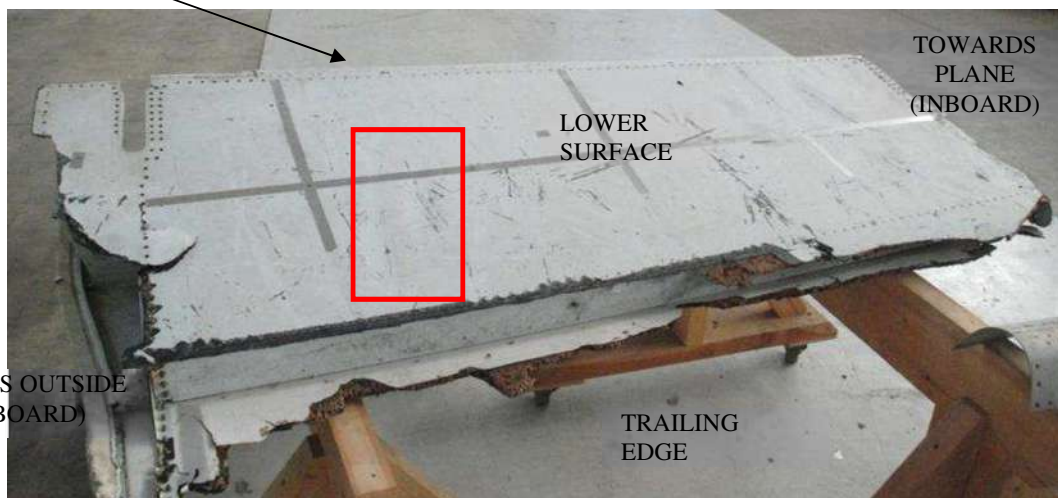
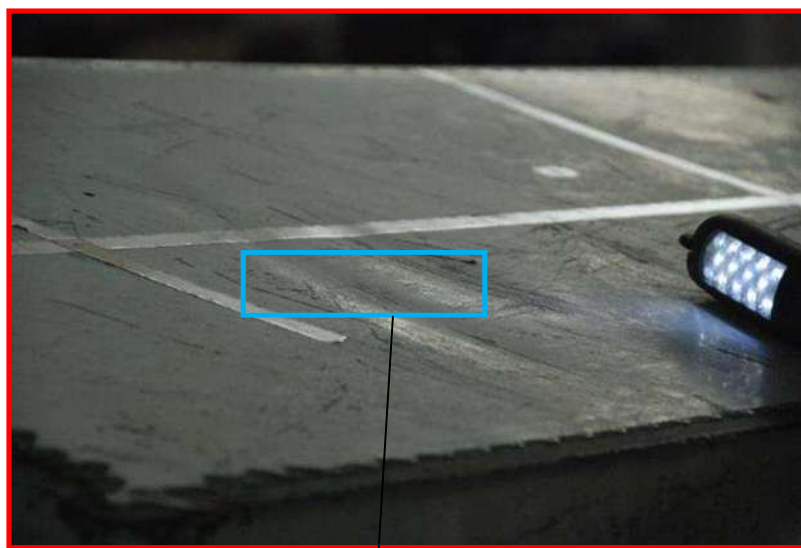
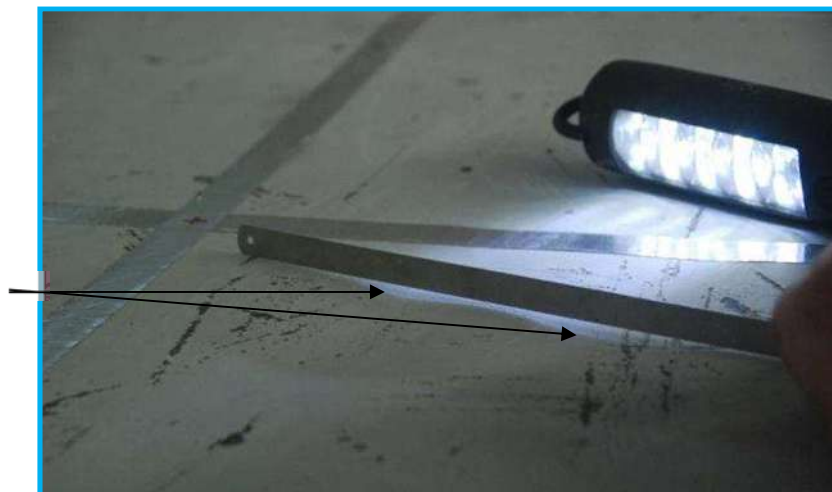
Dents

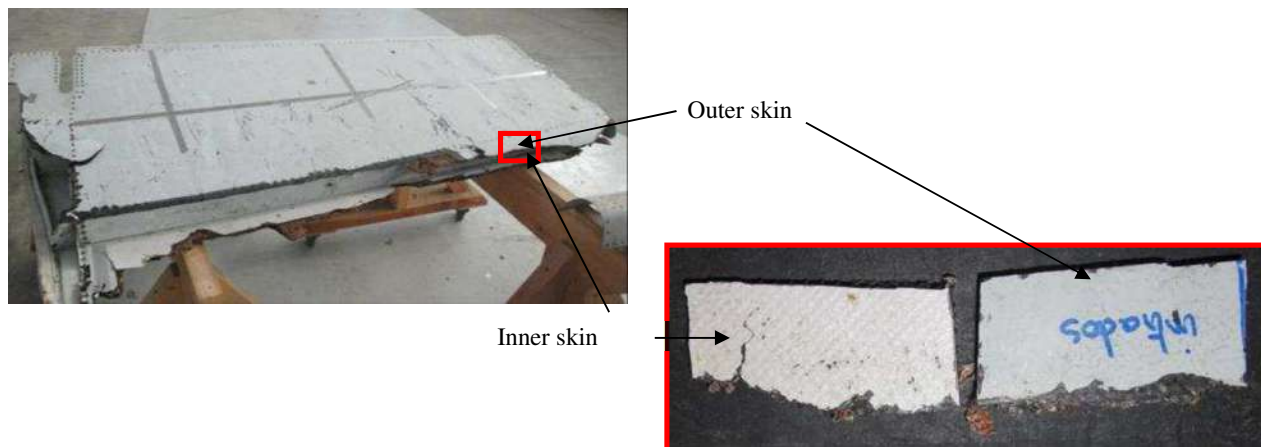
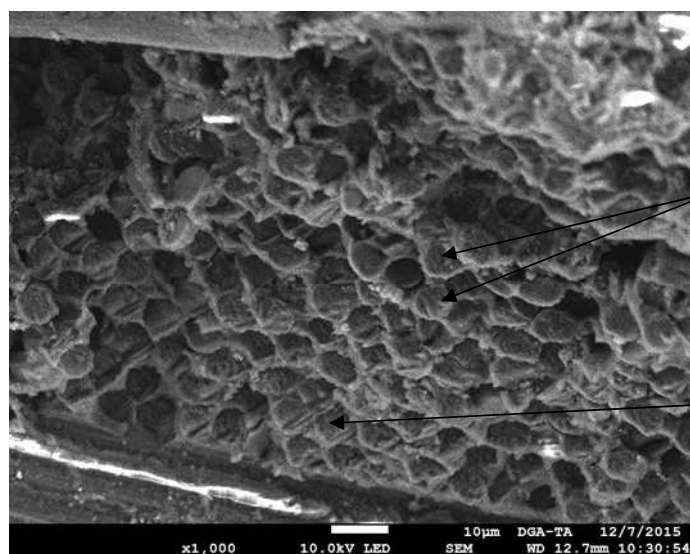
Planche 51 : Lower surface: irregular fracture on trailing edge – SEM Examination

All of the fracture surfaces on the inner skin:  
majority in compression

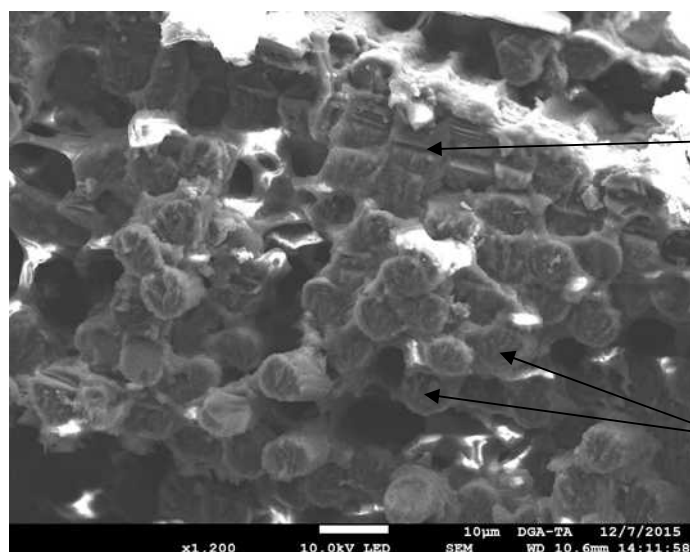
All of the fracture surfaces on the outer skin:  
majority in traction.

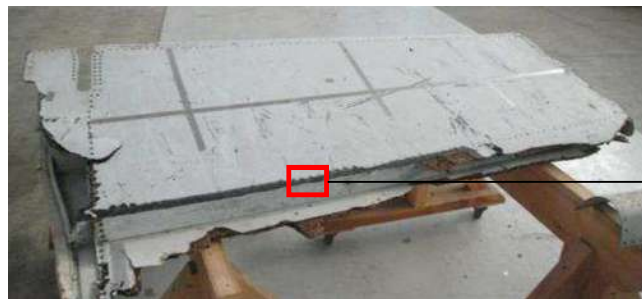
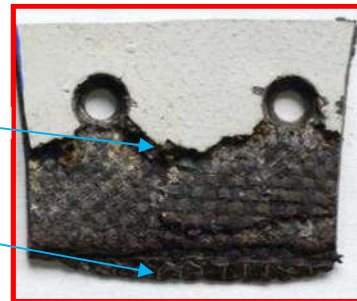
Planche 53 : Lower surface: straight fracture on trailing edge – SEM Examination

Upper layers

Lower layers

All of the fracture surfaces on the upper surfaces: majority in compression.

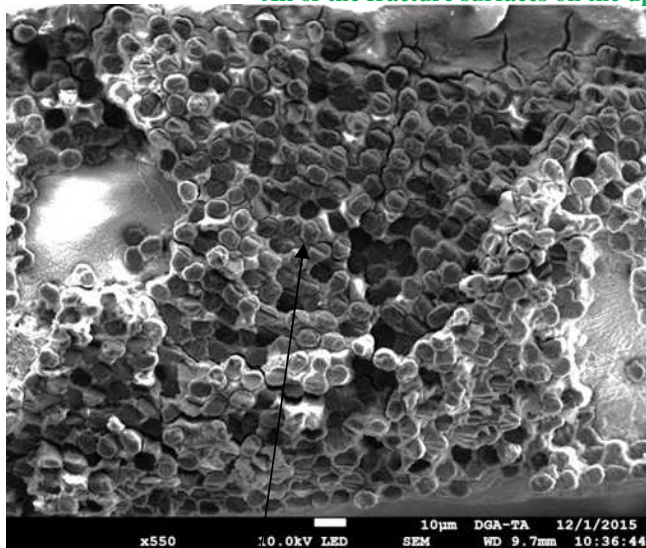
Upper layers : steps characteristic of a compression fracture

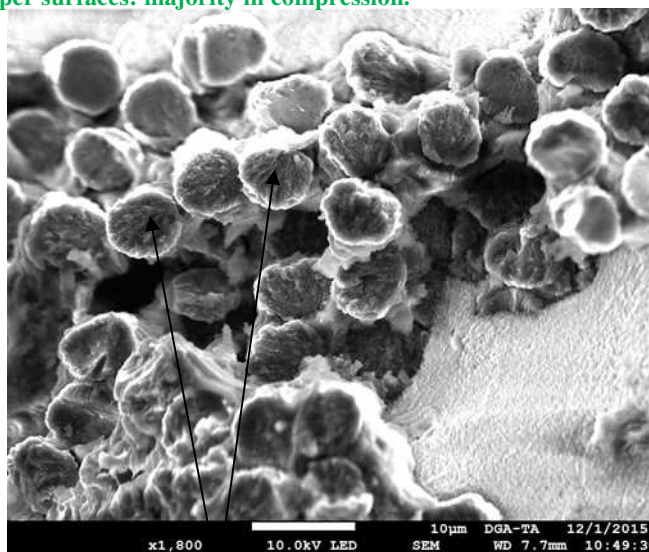
Lower layers: radiating form characteristic of a traction fracture

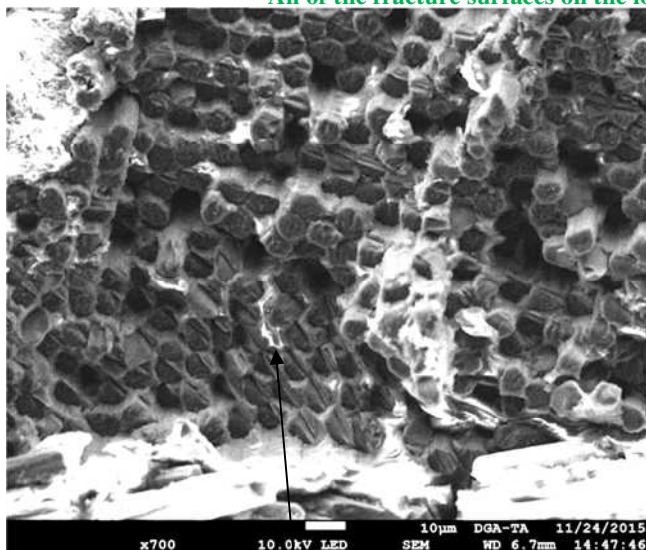
All of the fracture surfaces on the lower surfaces: majority in compression.

Lower layers: steps characteristic of a compression fracture

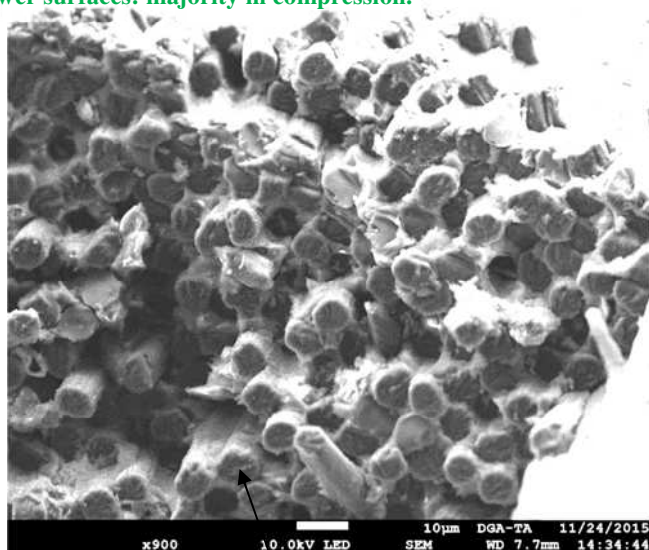
Upper layers: radiating form characteristic of a traction fracture

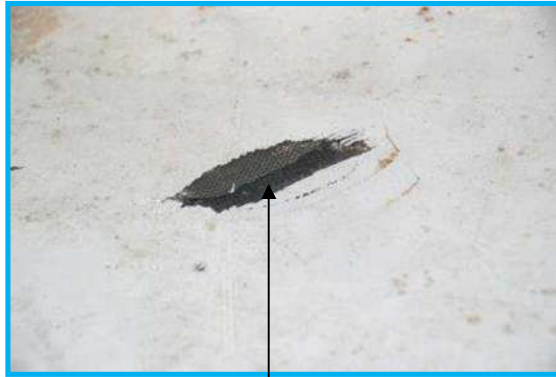
Planche 54 :

Upper surface: dents, impacts, crack

Impact

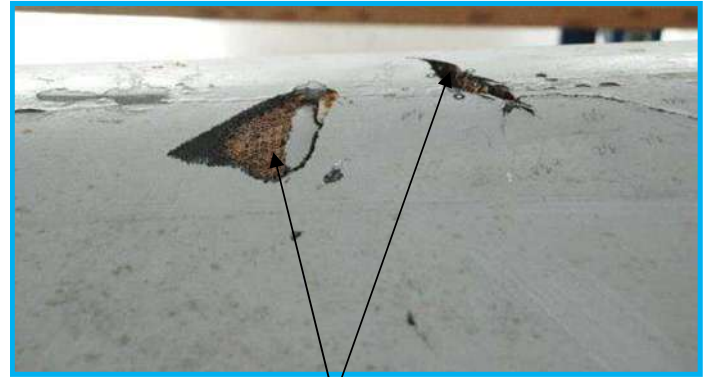
Impacts

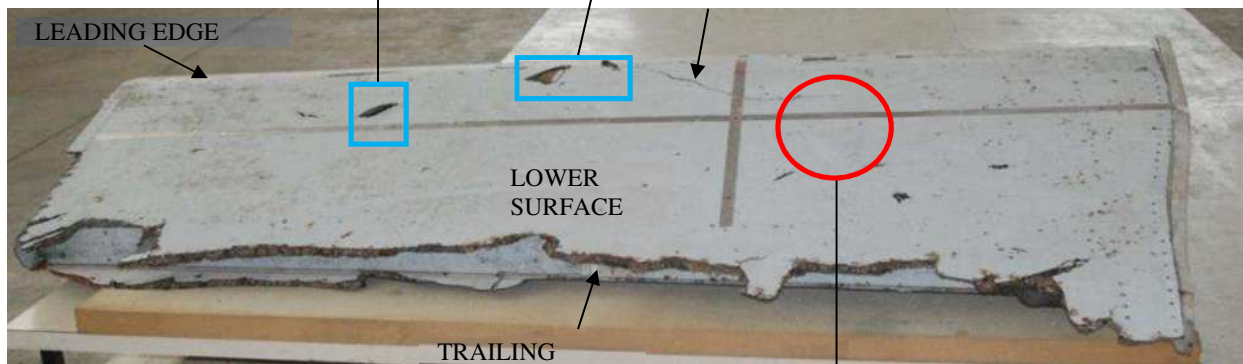
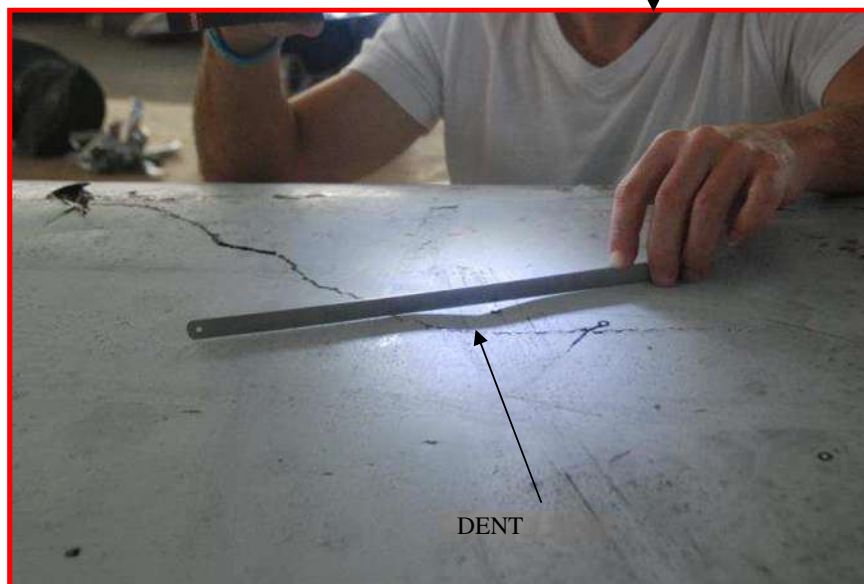
DENT

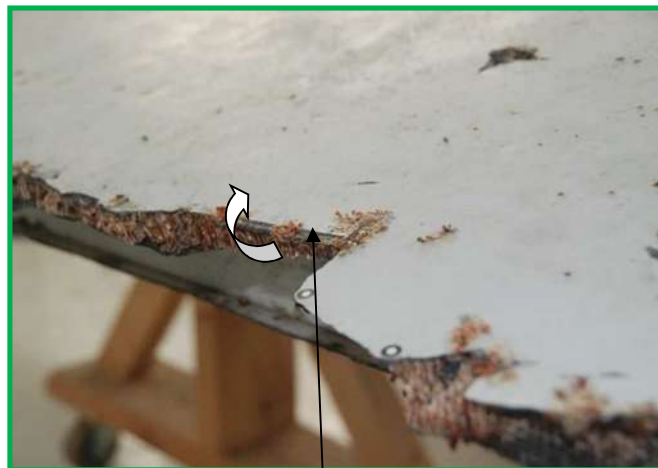
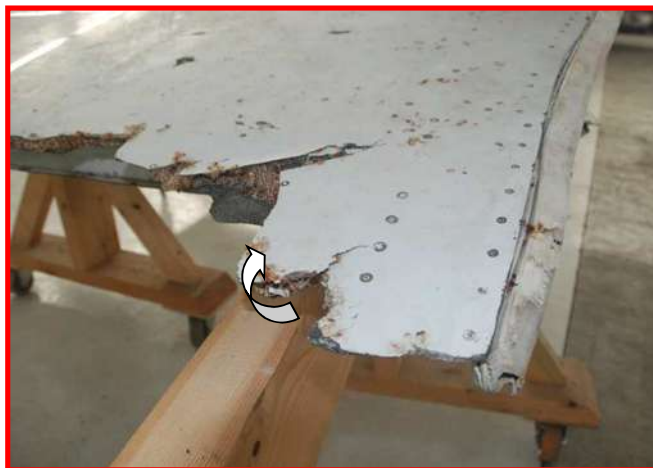
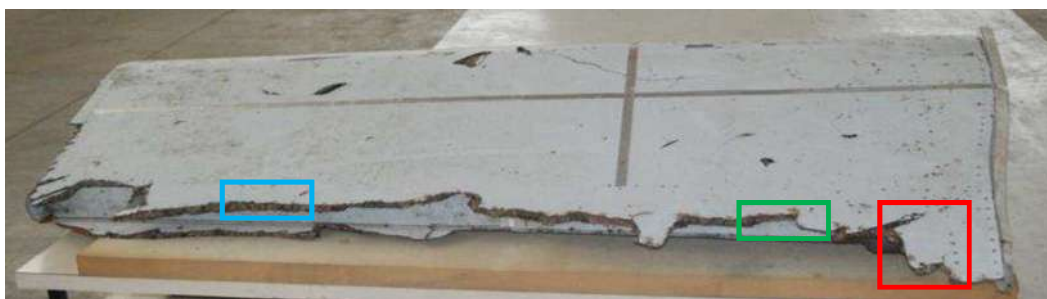
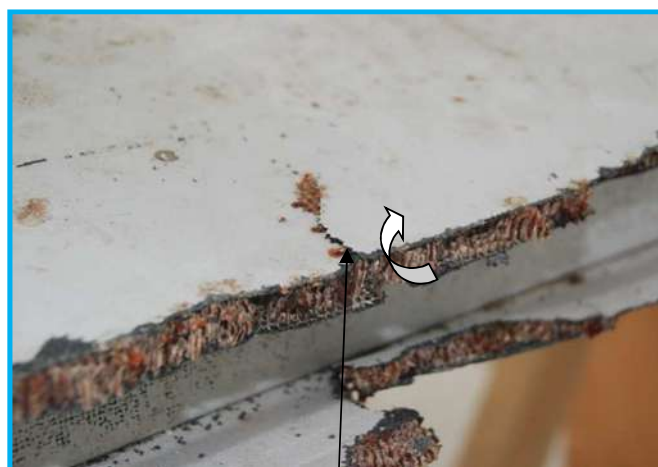
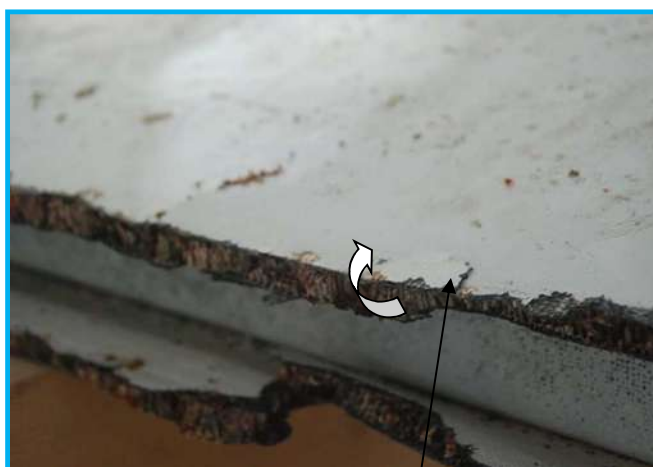
Planche 55 : Upper surface: fracture on trailing edge

Orientation of material upwards

Regular fracture, without protruding fibres

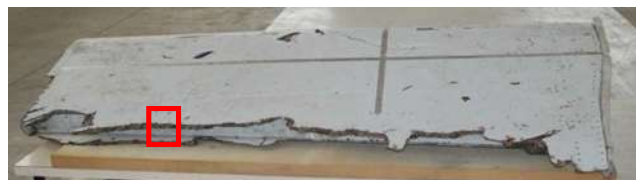
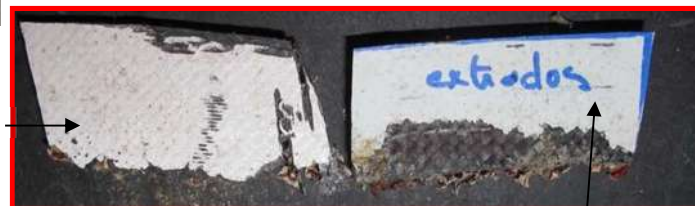
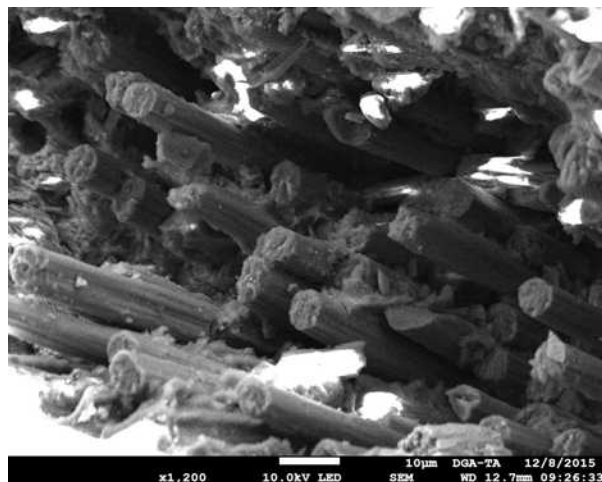
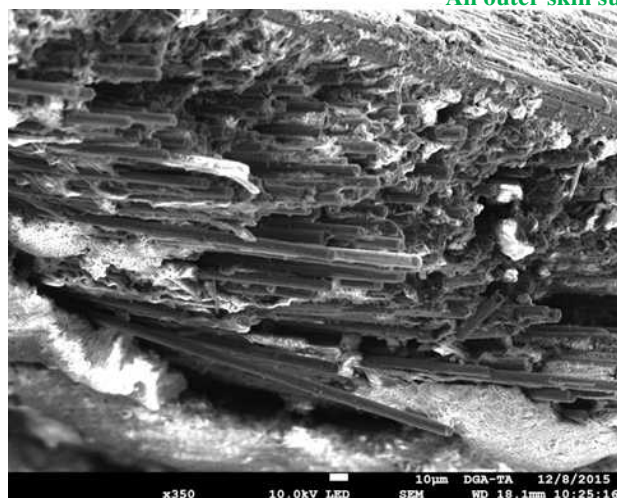
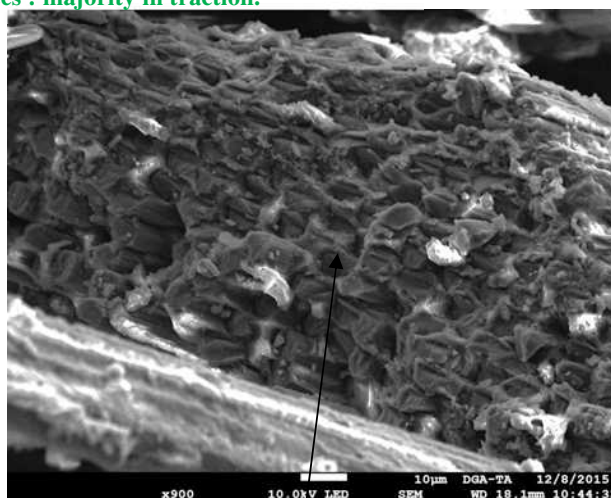
Planche 56 : Upper surface: fracture on trailing edge – SEM examination

Inner skin : surfaces characteristic of a traction fracture

All inner skin surfaces : majority in traction.

All outer skin surfaces : majority in traction.

Outer skin : surfaces characteristic of a traction fracture

Outer skin: steps characteristic of a compression fracture

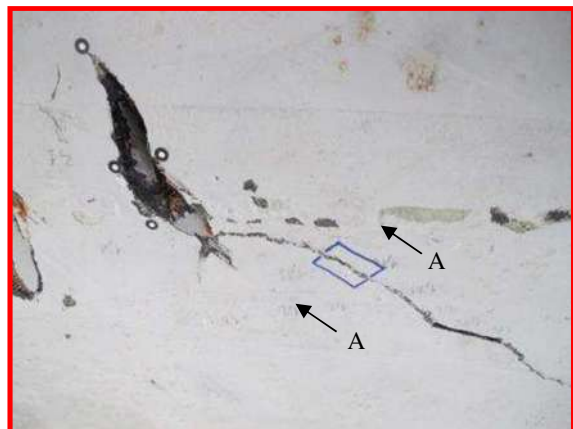
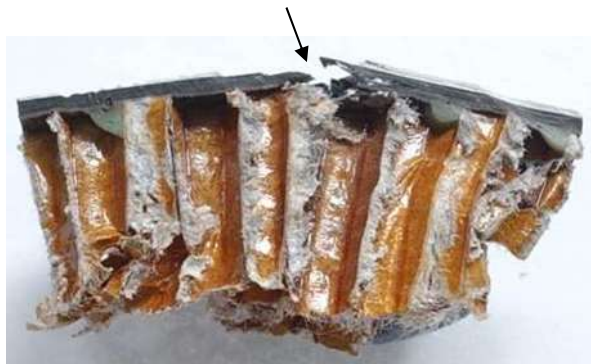
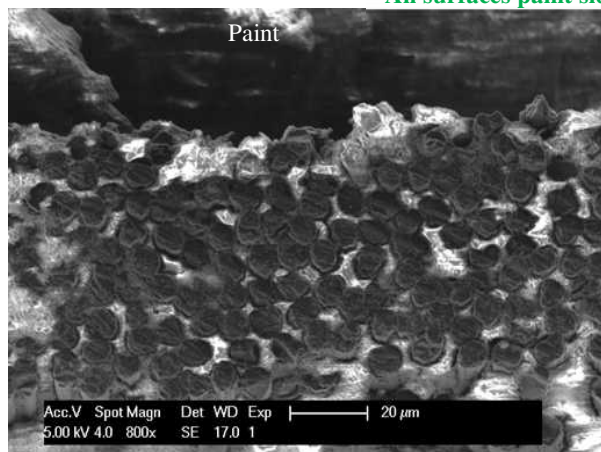
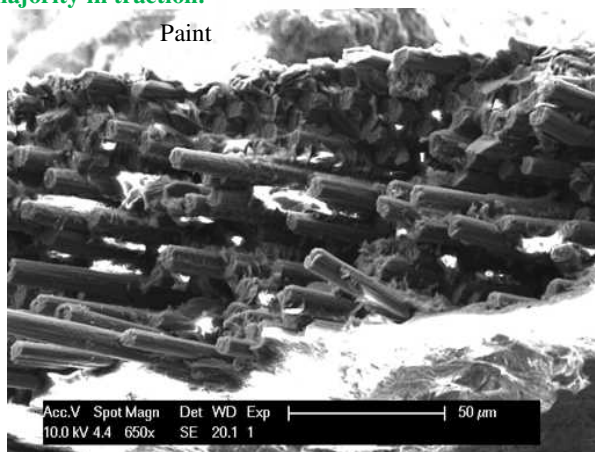
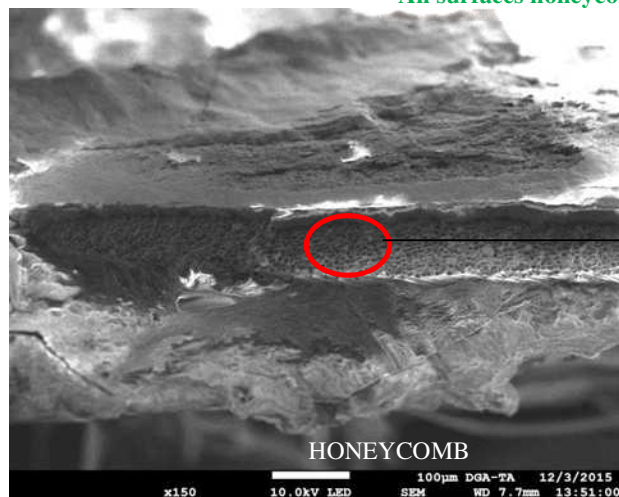
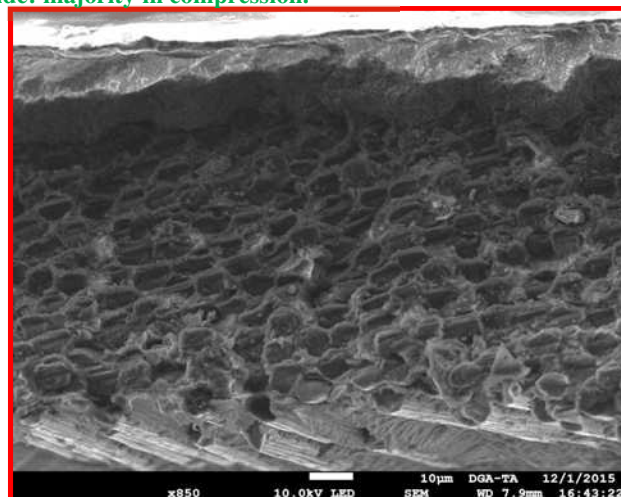
Planche 58 : Upper surface: observation of the crack in a non-protruding part

Macroscopically : bending fracture of outer skin

All surfaces paint side : majority in traction.

Near paint : steps characteristic of compression fracture

Near paint : surfaces characteristic of traction fracture

All surfaces honeycomb side: majority in compression.

Near honeycomb : steps characteristic of compression fracture

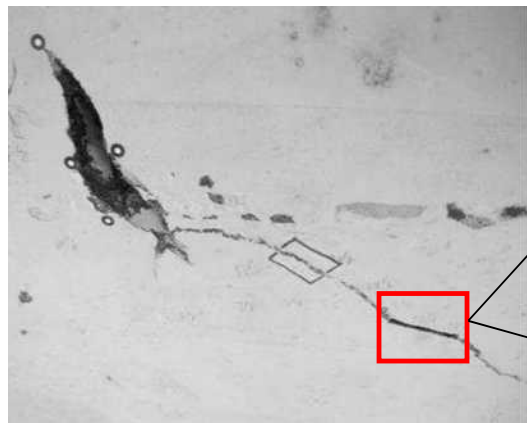
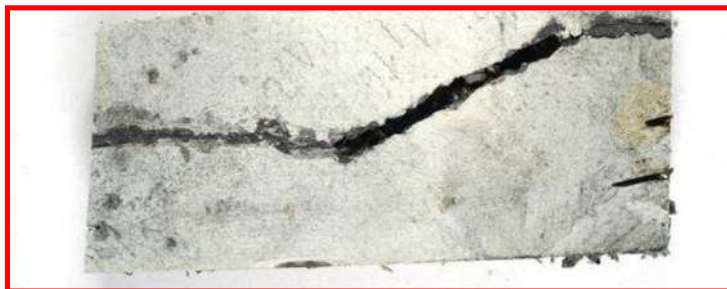
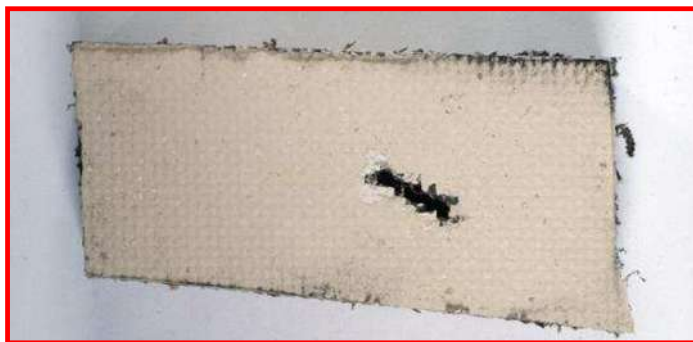
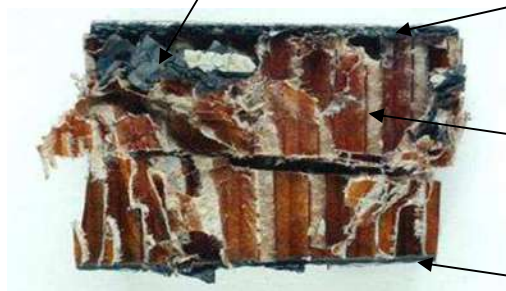
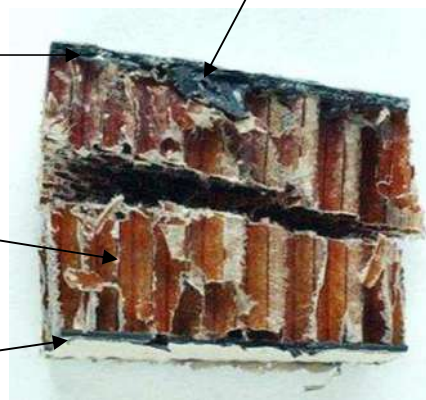
Upper surface: observation of the crack in a protruding part (1/2)

Downwards orientation of material
