## **SAFETY INVESTIGATION REPORT**

**Malaysia Airlines Boeing B777-200ER (9M-MRO)  
08 March 2014**

**The Malaysian ICAO Annex 13 Safety Investigation Team for MH370**

Issued on 02 July 2018  
MH370/01/2018

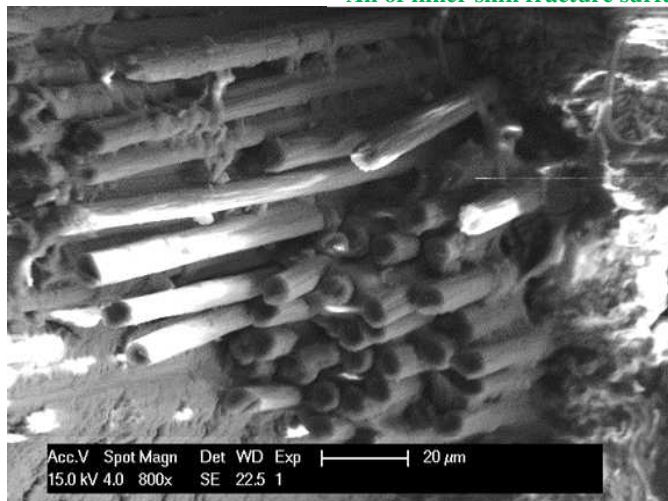
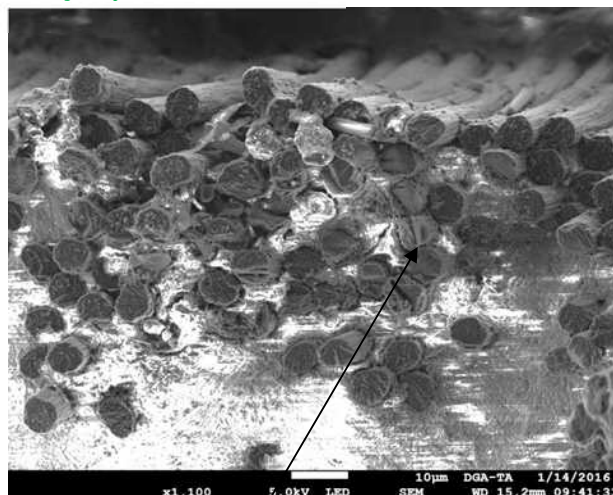
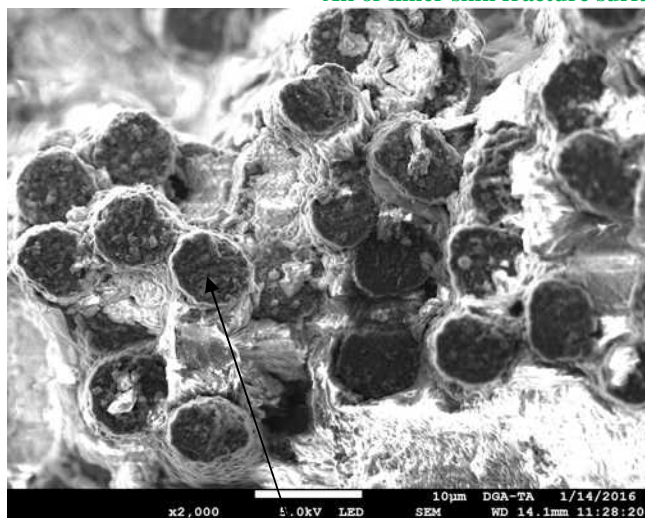
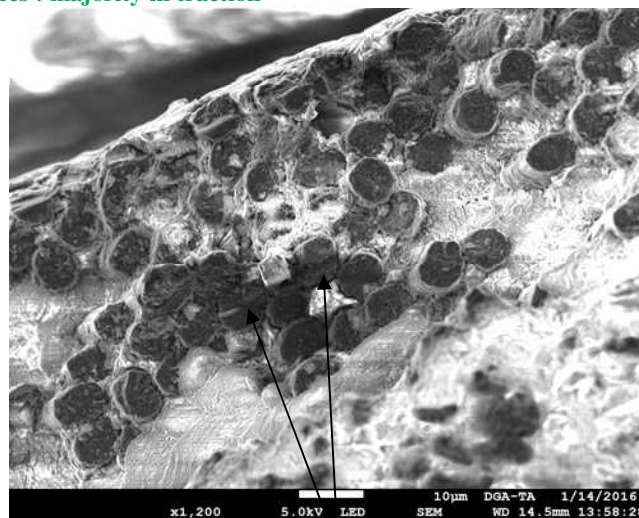
Planche 61 : Upper surface: observation of the crack in a protruding part (2/2)

All of inner skin fracture surfaces : majority in traction .

Outer skin: fracture surfaces characteristic of traction fracture

Outer skin: some fibres in compression

All of inner skin fracture surfaces : majority in traction

Peau skin: radiating form : fracture surfaces characteristic of traction:

Inner skin : some fibres in compression

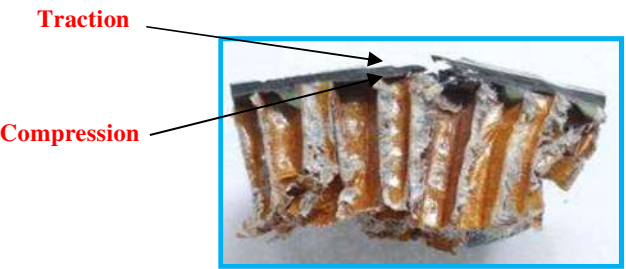
Planche 62 : Summary of the deductions made based on the observations and examinations on the composite structure of the flaperon

Non-protruding crack : **bending**  
fracture : **skin bowing.**

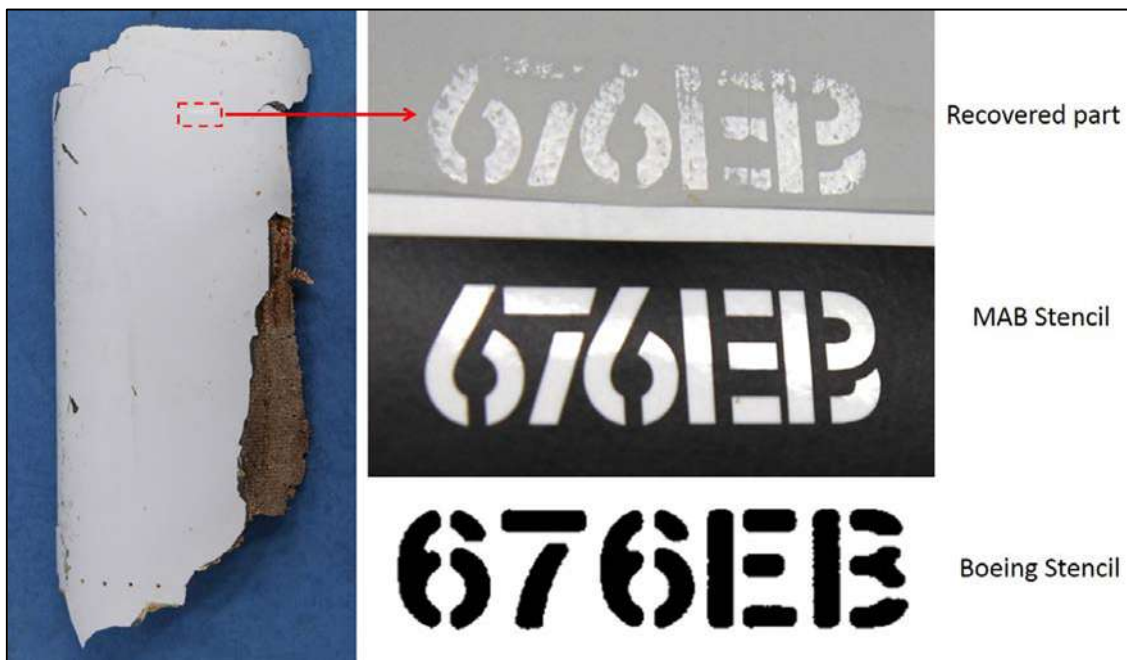
Figure 2: Flap fairing outer surface showing stencil location and comparison

The 676EB stencil font and colour was not original from manufacture, but instead conformed to that developed and used by Malaysia Airlines during painting operations (Figure 2). The part had been repainted, which was consistent with the operator's maintenance records for 9M-MRO.

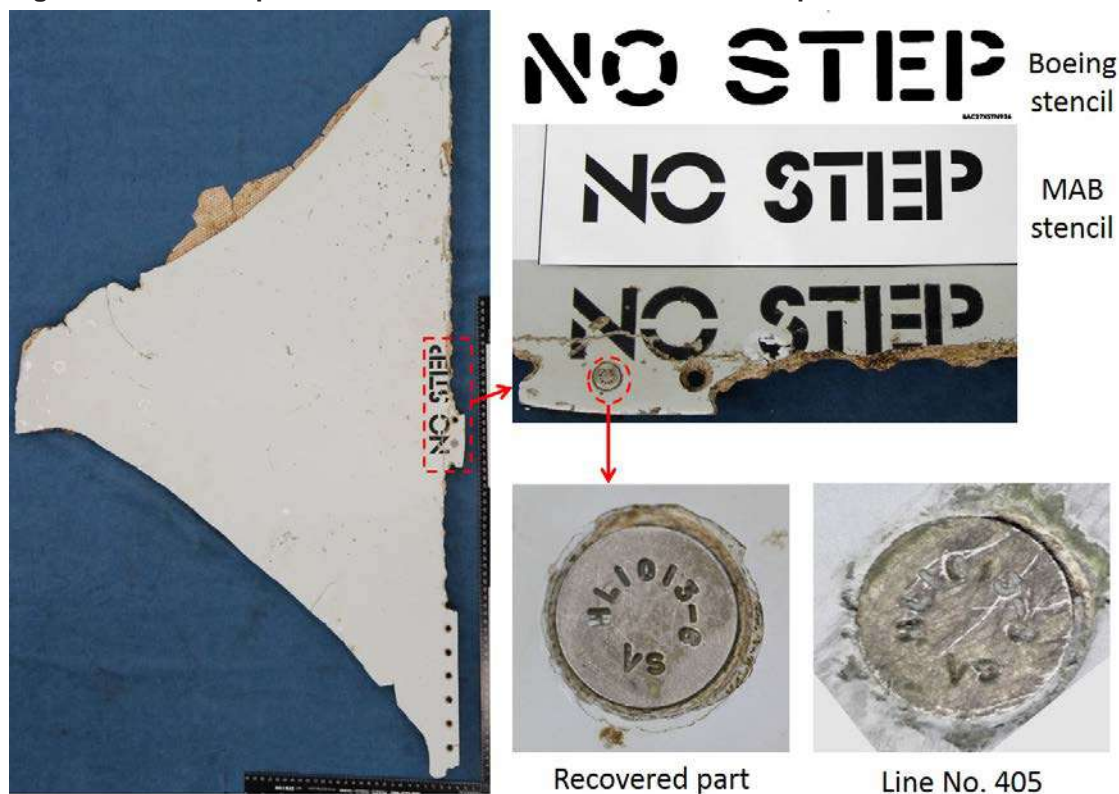
Figure 4: Stabiliser panel “NO STEP” stencil and fastener comparison

A single fastener was retained in the part. The fastener head markings identified it as being correct for use on the stabiliser panel assembly. The markings also identified the fastener manufacturer. That manufacturer's fasteners were not used in current production, but did match the fasteners used in assembly of the aircraft next in the production line (405) to 9M-MRO (404) (Figure 4).

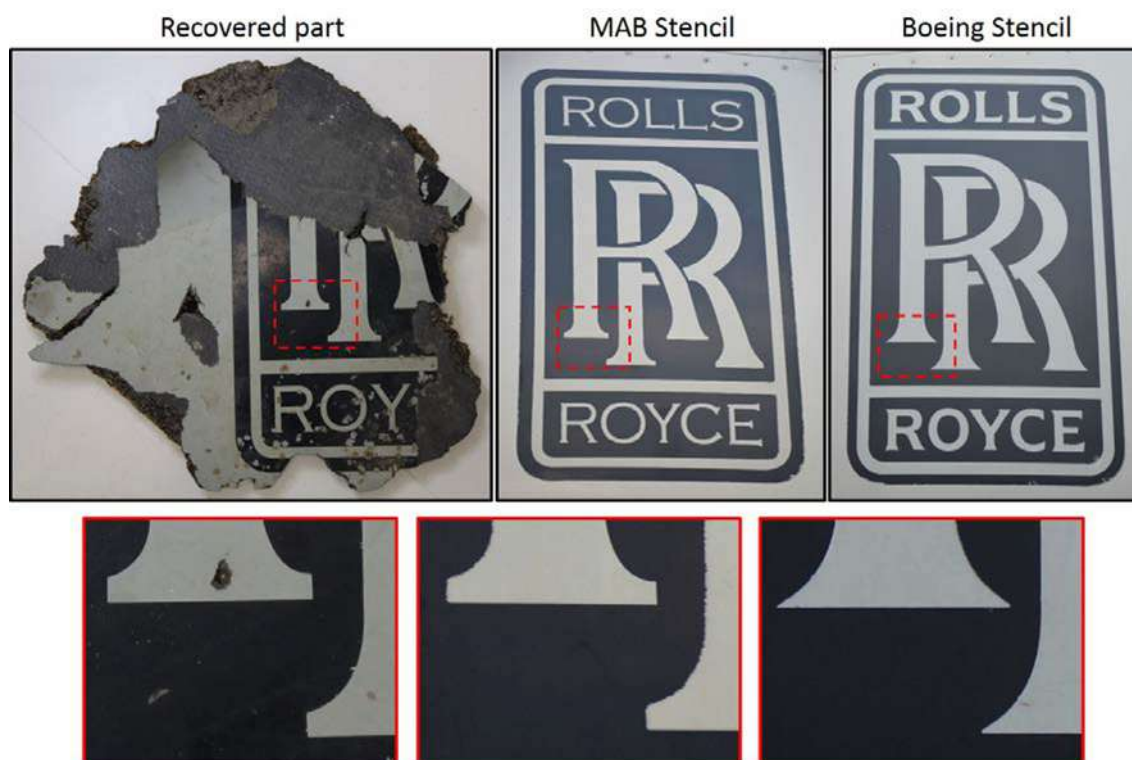
**Figure 1: Comparison of Boeing 777 engine cowling stencils**

There were identical inboard and outboard stencils present on the cowlings of each of the engines and the location of the stencils was found to vary between engines. Taking that into consideration, there were no significant differentiators on the cowl segment to assist in determining whether the item of debris was from the left or right side of the aircraft, or the inboard or outboard side the cowl.

**Note the thickness of the “ROYCE” lettering and the serif geometry on the main ‘R’s (enlarged for ease of comparison).**

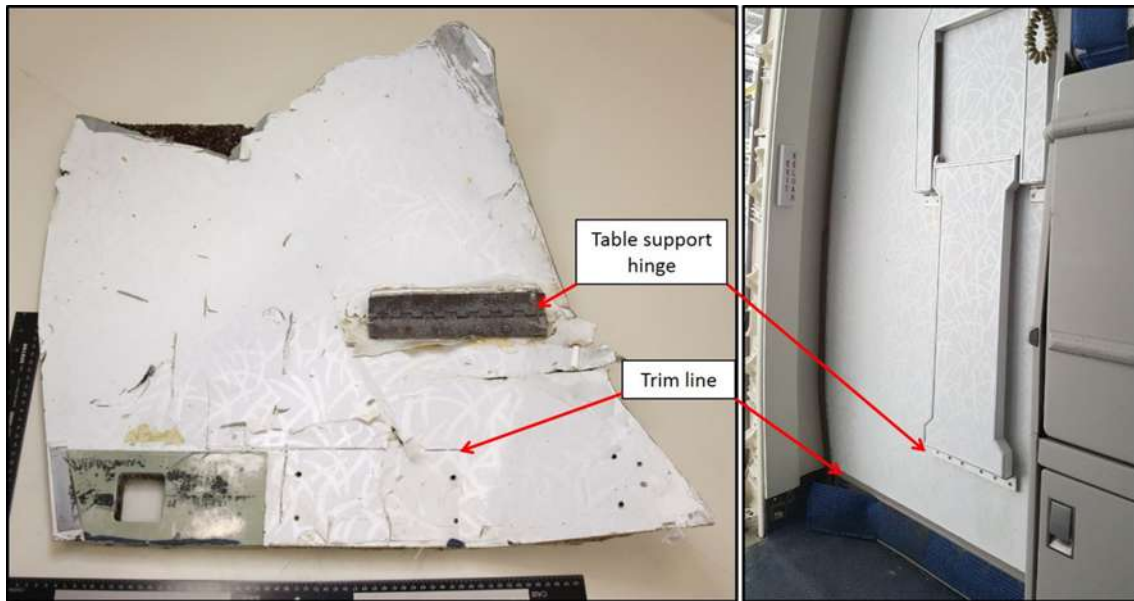
**Figure 2: Comparison of recovered item with Malaysia Airlines Boeing 777 Door R1 panel assembly**

There were no identifiers on the panel segment that were unique to 9M-MRO, however the pattern, colour and texture of the laminate was only specified by Malaysia Airlines for use on Boeing 747 and 777 aircraft. There is no record of the laminate being used by any other Boeing 777 customer.

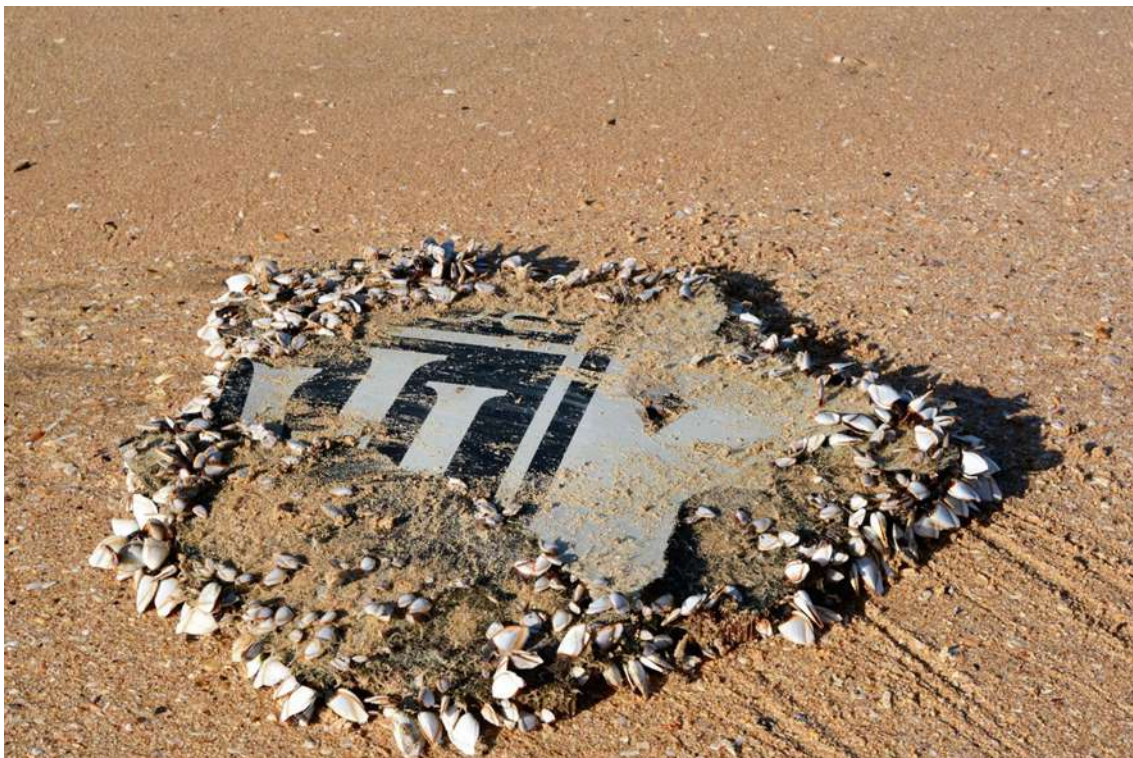
**Figure 3: Photograph taken 23 Dec 2015 showing Part No. 3 significantly colonised by barnacles**

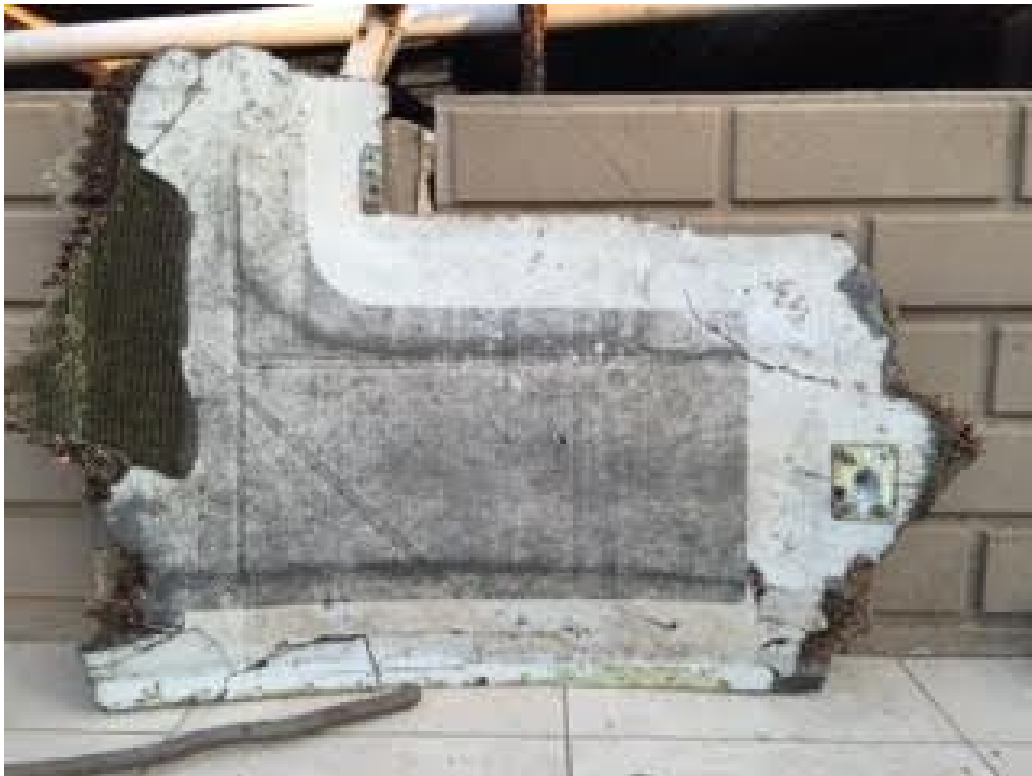
This item was recovered south of Chidenguele in Mozambique on 24 April 2016. It is identified as Item No. 6 from the items recovered; refer to the “*Summary of Possible MH370 Debris Recovered*”.

The structure was of composite honeycomb sandwich with non-metallic core. It had a number of fracture lines and one of the sides which was the 'end of part', was intact. The external skin was dark grey in colour and the inner skin was white.

A part of a metal bracket was still attached on the debris and it was observed that another one had broken off. This was the attachment for the "Hold-Open Stay Rod"

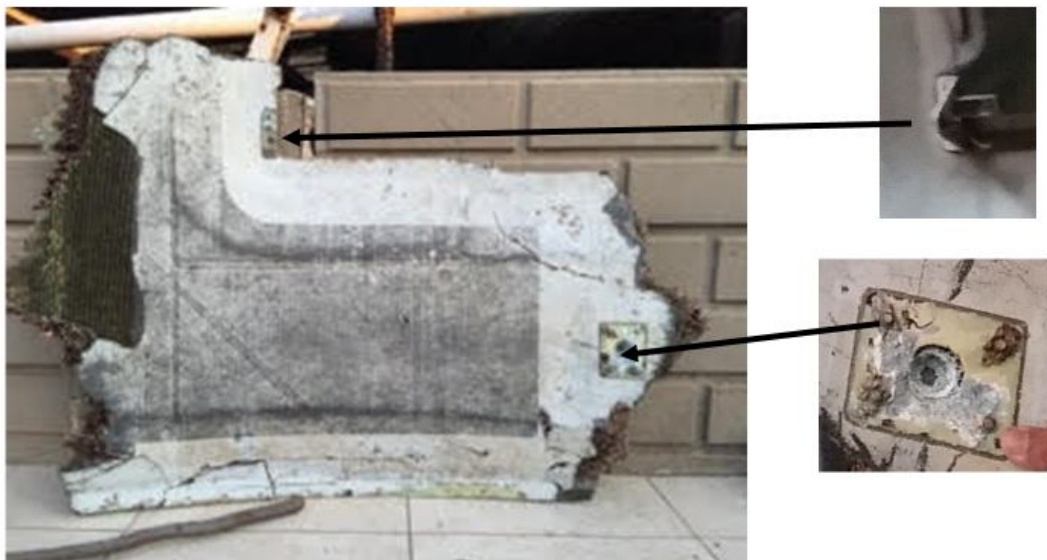
The part was taken to a B777-200ER, formerly operated by Malaysia Airlines (MAS), undergoing a maintenance check at Subang, Malaysia, for identification purposes. The possible location of the part on the aircraft was determined.

The hinge bracket, number of fasteners and fasteners' pitch on the part were consistent with those on the right engine fan cowl on the aircraft. The mount found on the part was also consistent with the mount of the fan cowl "Hold-Open Stay Rod" in regards to its location, shape and size of the mounting bracket.

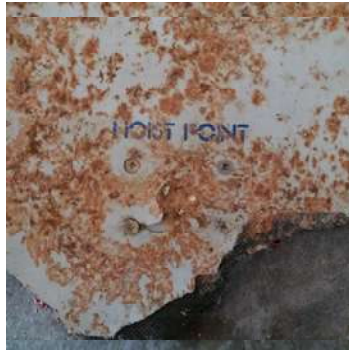
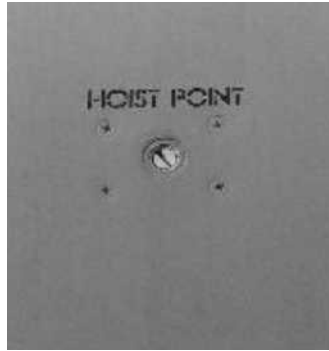
The words "HOIST POINT" were still visible and in the correct location. The fonts used for the words on the part matched those on the fan cowl of the aircraft.

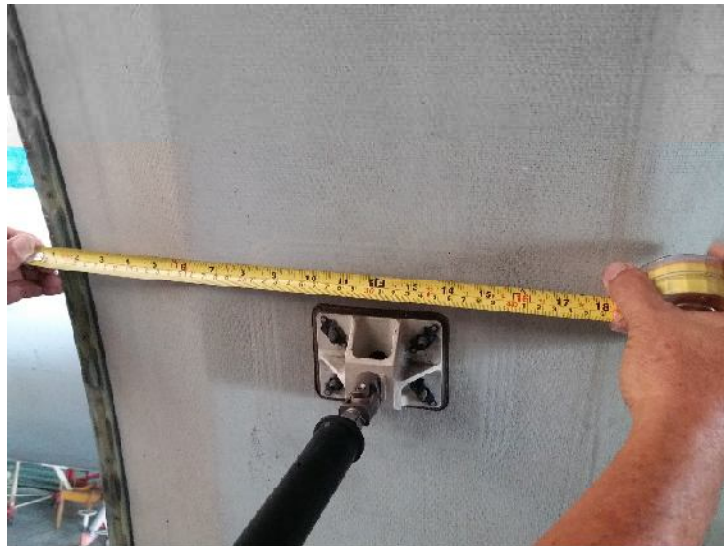
The dimension from the forward edge of the part to the start of the core ramp, which was 18 inches, was also consistent with that of the fan cowl on the aircraft, as shown in the above figure.

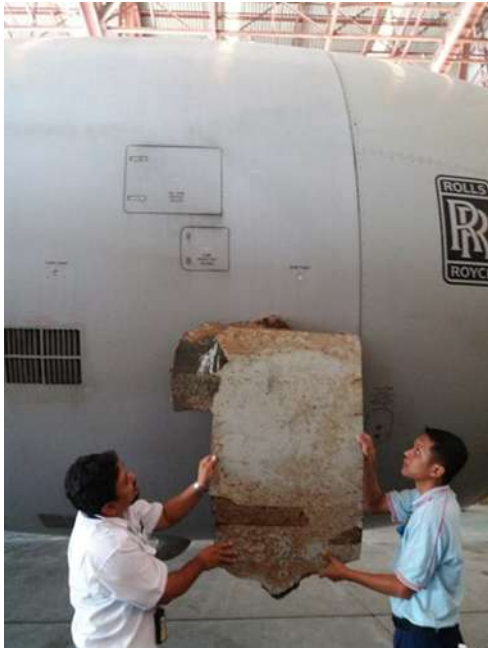
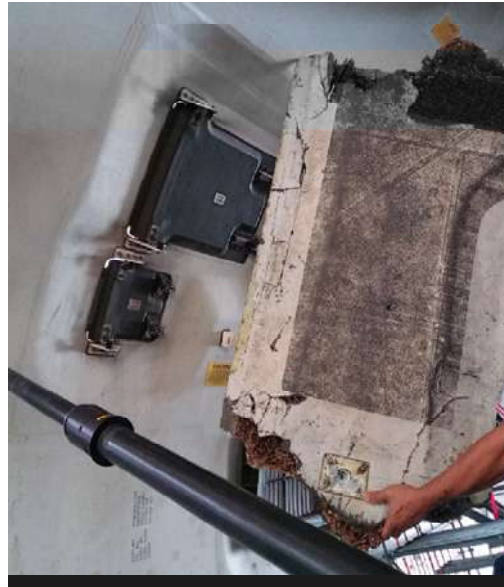
The part was brought near to the right fan cowl and was found to physically resemble it in terms of shape, size, colour and features.

Based on the above, the part is confirmed to be part of the **Right Fan Cowl** of a B777 aircraft.

The fracture on the laminate appears to be more likely a tension failure. The honeycomb core was intact and there was no significant crush on the honeycomb core. All the metal parts were detached and the fastener holes for the hinge door brackets were clearly visible. The attachment for the "Hold-Open Stay Rod" was detached and corrosion was visible on the remaining metal part.

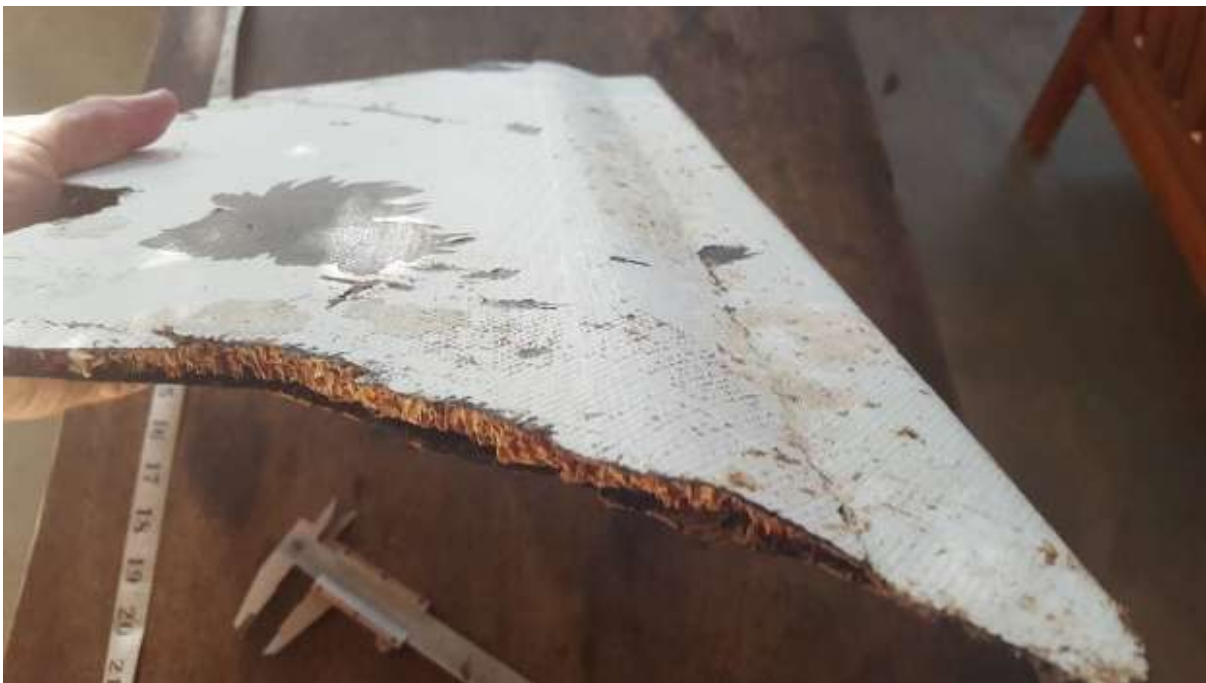
This item was recovered at Anvil Bay, Chemucane, Mozambique on 30 April 2016. It is identified as Item No. 7 of the items recovered; refer to the *“Summary of Possible MH370 Debris Recovered”*.

The part was a typical Carbon Fiber Reinforced Plastic (CFRP) with non-metallic honeycomb core. The part was triangular in shape and approximately 22 inches at its longest edge. It weighed 0.31 Kg. The white paint on both sides of the debris had faded. It had an ‘end of part’ which had a distinctive corner radius but the length of the possible flange could not be determined since it had fractured immediately after the radius. There were no identification numbers on the part. The overall plan form of the part is not flat, it had a curvature.

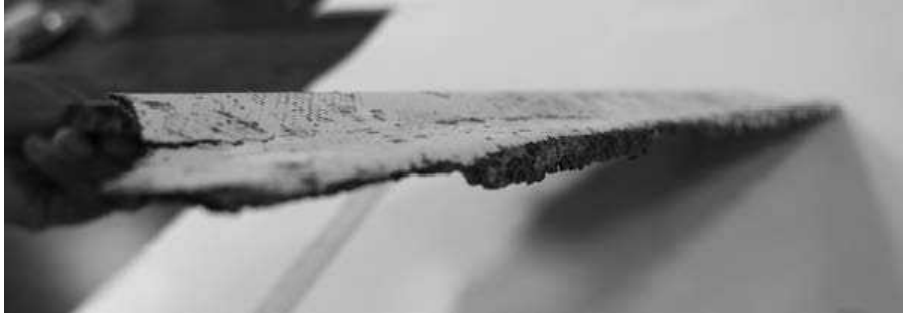
The part had fractured at all sides. One side had fractured immediately after the corner radius. The fibres appeared to have been pulled away and there were no visible kink on the fibres. The core was not crushed; it had fractured along the skin fracture line.

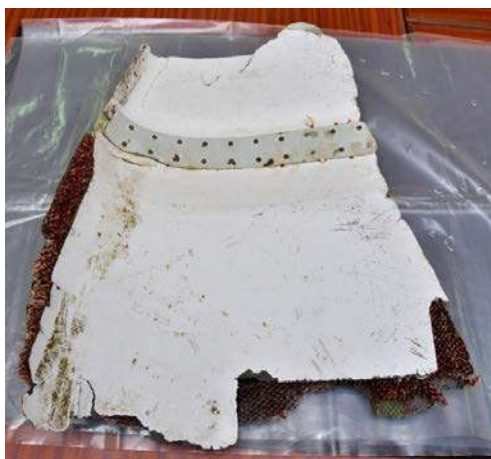
The Debris – external surface

The fracture line on the part showed the fibers to be 'pulled out' showing tension failure. Most of the core was intact and there was no sign of excessive crush.

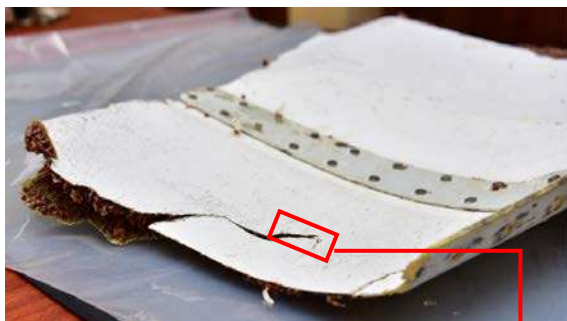
Initial assessment indicated that this could be a flap support fairing tail cone of a B777. The part was identified from the legible numbers that were observed on the inner surface. The following part number 113W9154-401 and serial number 407 were visible on one side. The profile of the part resembled the wing flap support fairing tail cone.

Inner side of the debris

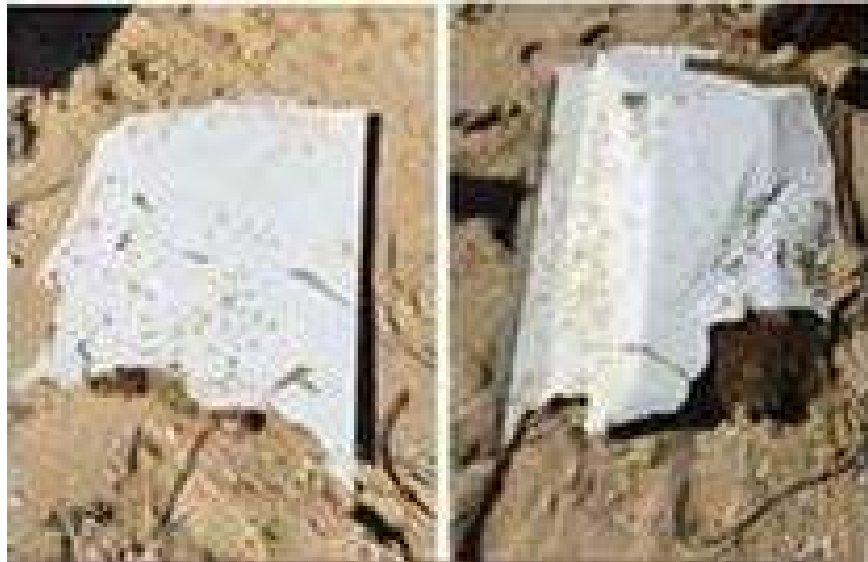
Item 9 was fractured at three places and one edge was still intact. The intact edge was that with the rub strip and indicated that it was the rear section of the panel. The fracture lines showed that the fibres were pulled but there were no signs they were kinked. The core was intact and had not crushed; it had fractured along the skin.

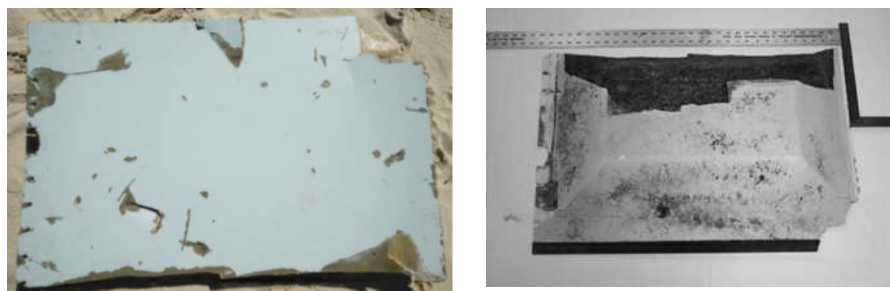
Item 15 had fractured at two places; the rear section was intact with the rub strip. The outboard section had the fasteners torn out with some of the fastener holes still recognizable. The inboard section was observed to have signs of 'net tension' failure as it had fractured along the fastener holes.

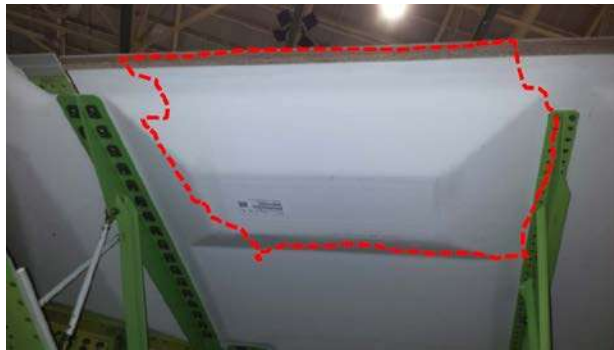
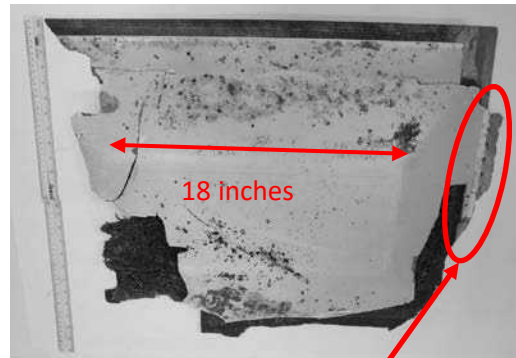
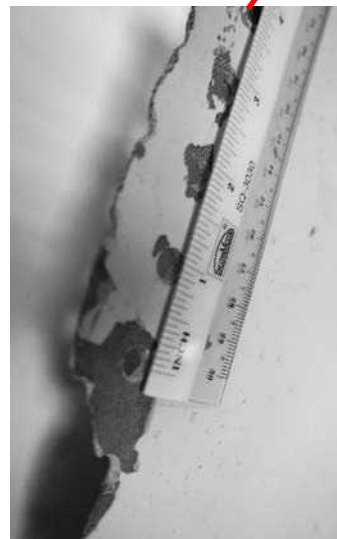
**Item 9**

The above figure shows Item 9 as a section of the “Upper Fixed Panel Forward of the Flaperon” on the left wing. It was observed that the outboard side was fractured and on the inboard side the fastener holes were still visible with a pitch of 1 inch. This fastener pitch matched that on the inboard side of the panel of the aircraft. The fasteners’ pitch on the outboard side was 2 inches. The raised portion of the core of the section of the panel (see figure below) of length 18 inches also matched with that on the aircraft panel.

Fastener Pitch – 1 inch

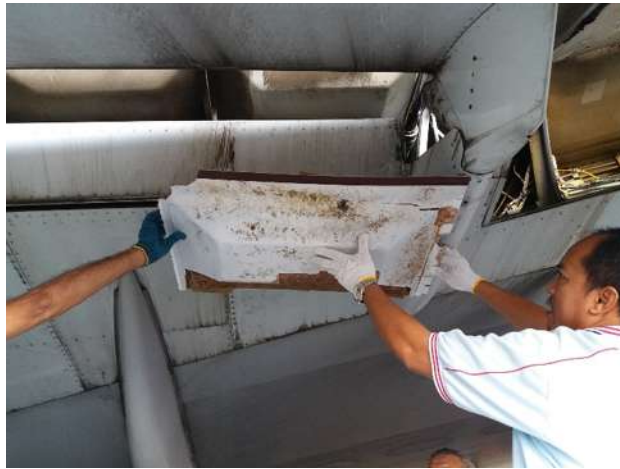
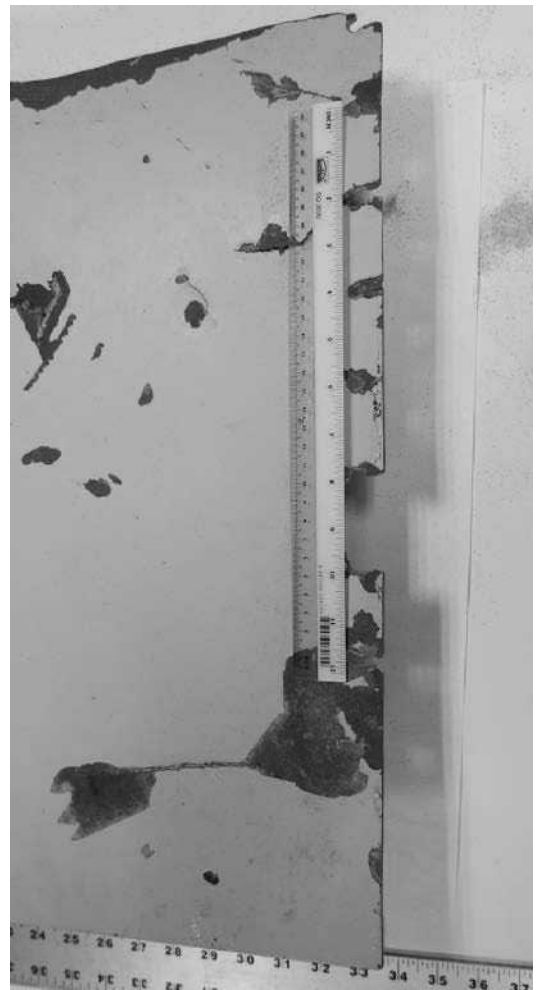
Similar matching process was carried out on Item 15; it was identified to be the outboard section of the “Upper Fixed Panel forward of the flaperon” on the **right** wing (refer to figure below). The pitch of the fasteners’ holes on the right side (outboard) of the panel was measured to be 2 in. and that matched that on the debris.

Item 15 against Upper Fixed Panel  
forward of Right Flaperon

Fastener pitch – 2 inches

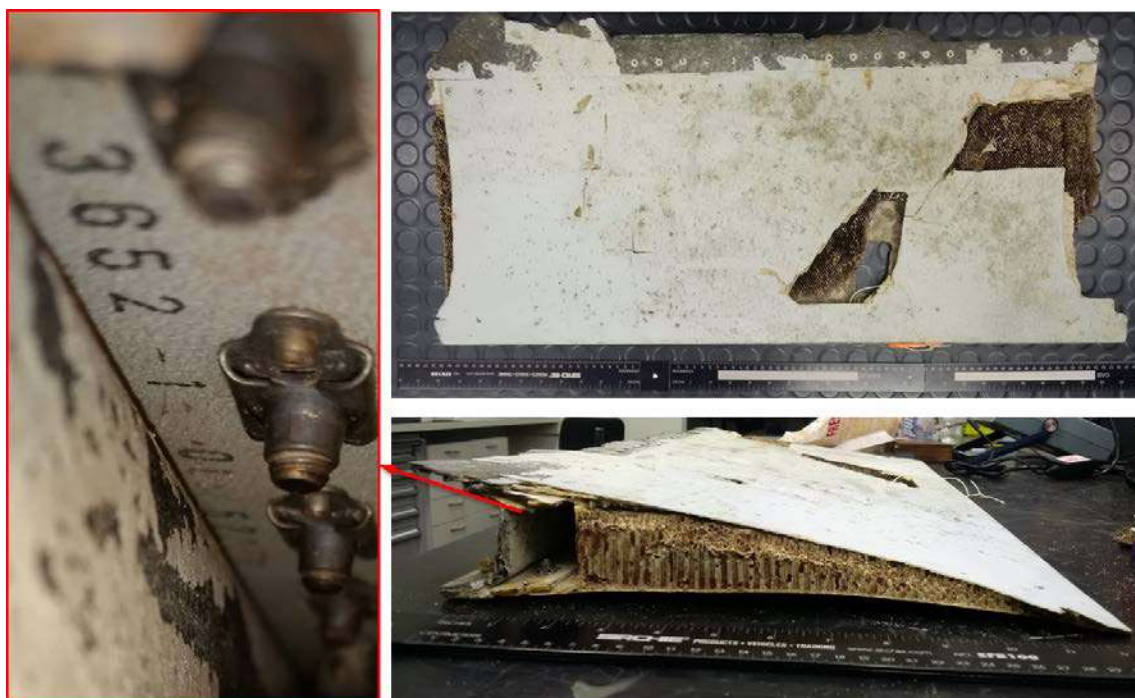
Adjacent to the part number was an “OL” part identifier, similar to those found on the right outboard flap section (Examination update 3). The flap manufacturer supplied records indicating that this identifier was a unique work order number and that the referred part was incorporated into the outboard flap shipset line number 404 which corresponded to the Boeing 777 aircraft line number 404, registered 9M-MRO and operating as MH370.

**Figure 1: Left outboard flap trailing edge section showing part identification numbers**

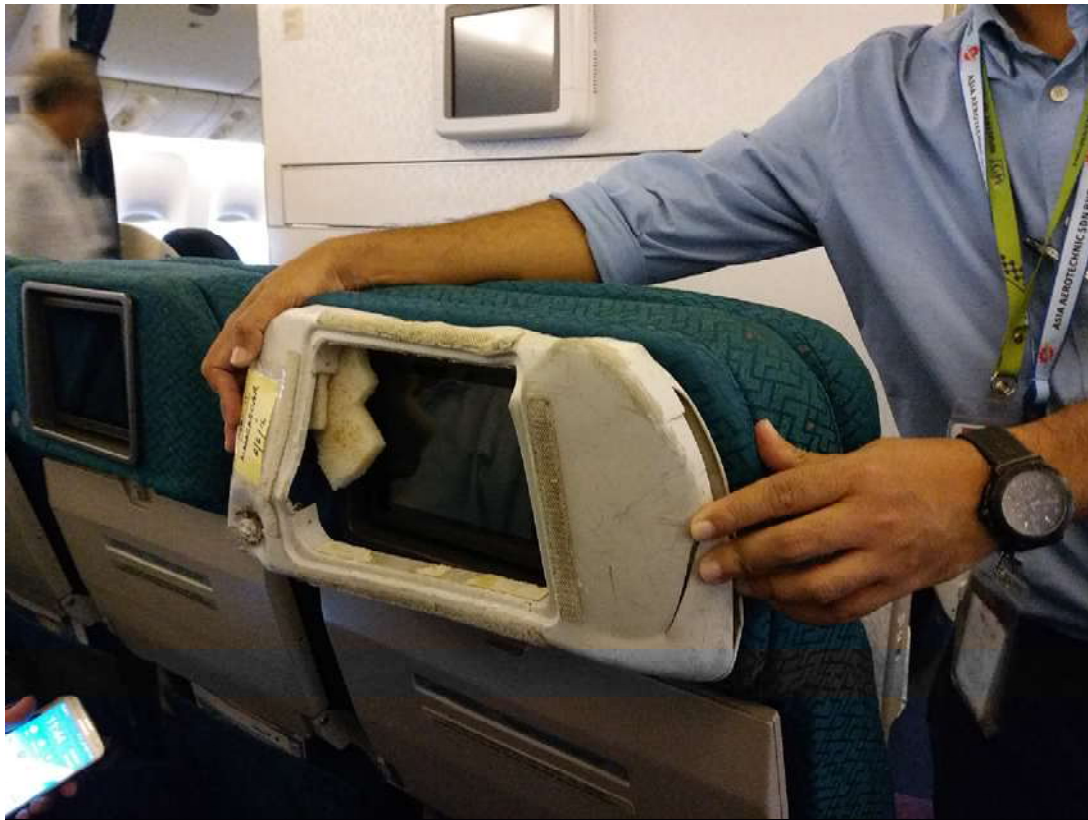
The part was identified as the seat back trim panel which encases the In-Flight Entertainment (IFE) monitor, as shown in the photograph below. There was a small fragment of fabric around the coat hanger on the debris, which was greenish in colour. This colour matched the seat

fabric used on the Malaysia Airlines (MAS) B777 on the center seats. The location of the coat hanger on the left conforms to the Right Hand, Triple Seat Assembly column in the Economy (EY) class.

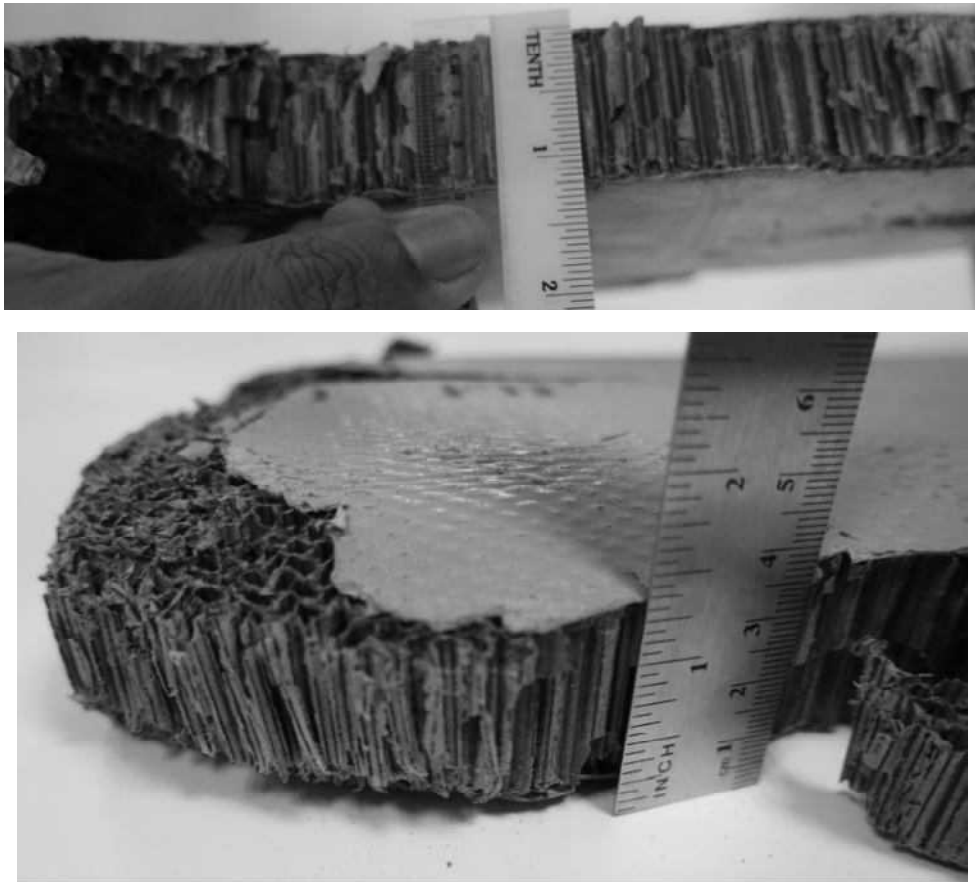
The carbon fibre laminate had fractured and appeared to have pulled out but there was no crush on the core.

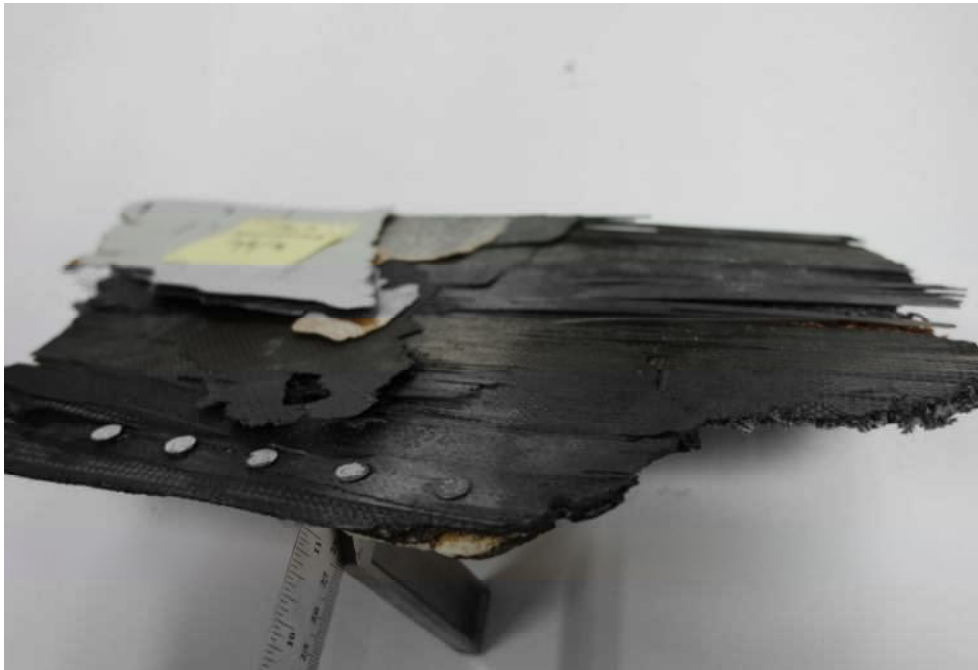
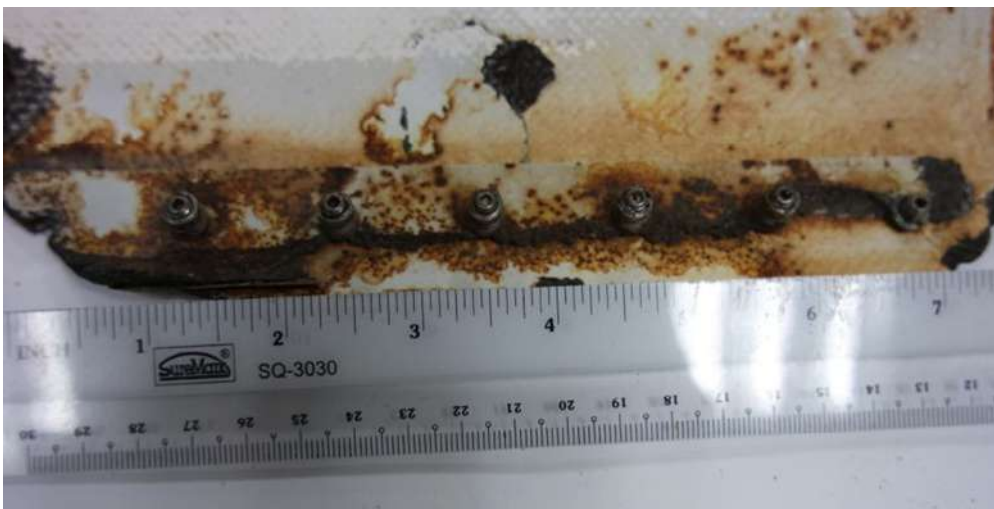
The item was a typical Carbon Fiber Reinforced Plastic (CFRP) construction with honeycomb core. One of the layers in the laminate top surface was clearly visible to be made of Unidirectional Carbon fibers. The fasteners were attached to an angle made of CFRP which was broken at one of the flanges. However, the angle radius was still visible.

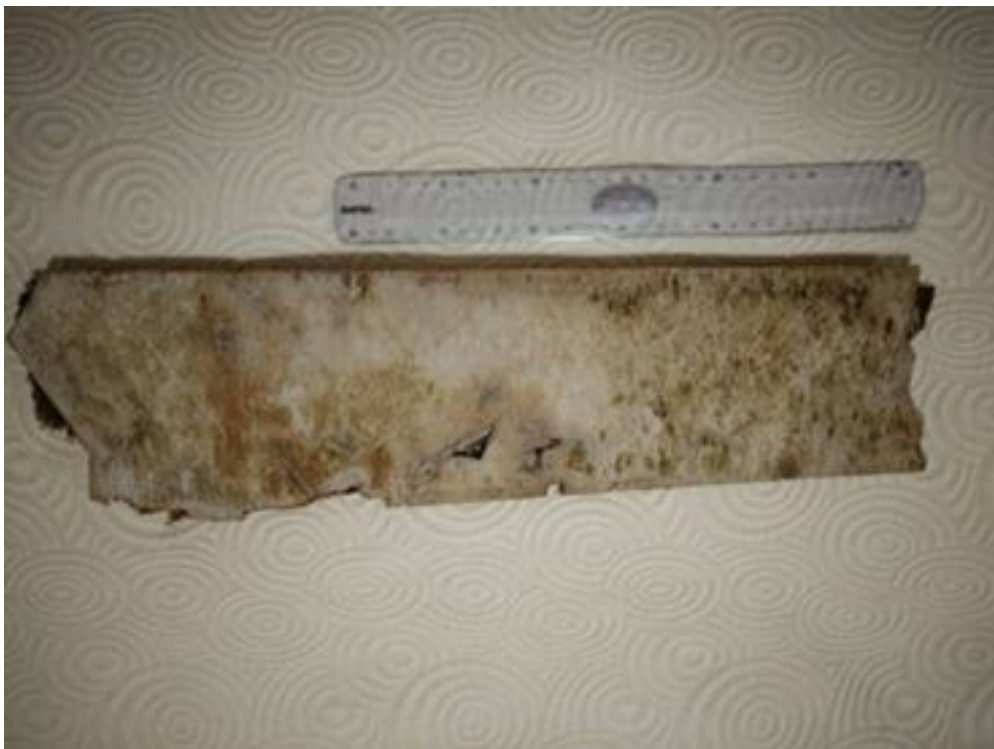
This item was recovered from Riake Beach, Nosy Boraha Island, Madagascar on 12 June 2016. It was identified as Item No. 14 of the items found; refer to the "*Summary of Possible MH370 Debris Recovered*".

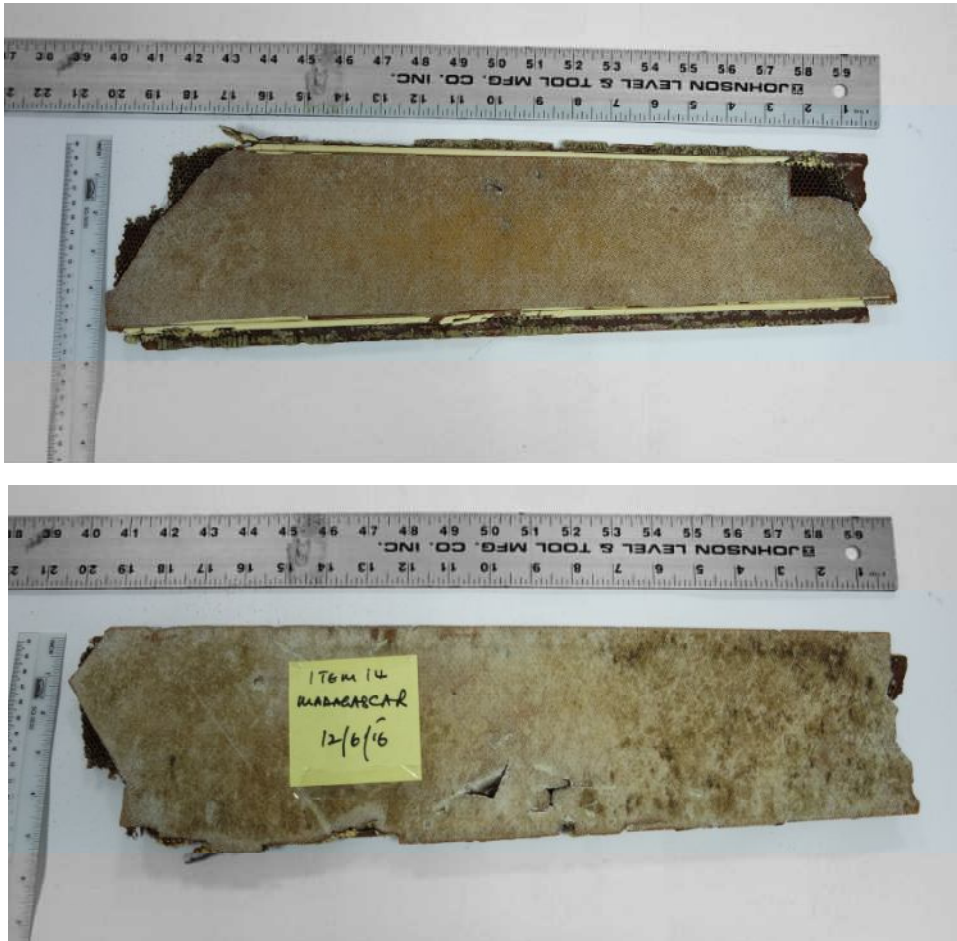
The part was taken to a B777-200ER, formerly operated by Malaysia Airlines (MAS), undergoing a maintenance check at Subang, Malaysia, for identification purposes. The part did not have any distinguishing features to match any on the aircraft. The part resembled a cabin interior piece based on the decorative finish. It did not have any identification numbers.

The part was fractured on all sides. The fibres appeared to be pulled rather than being compressed.

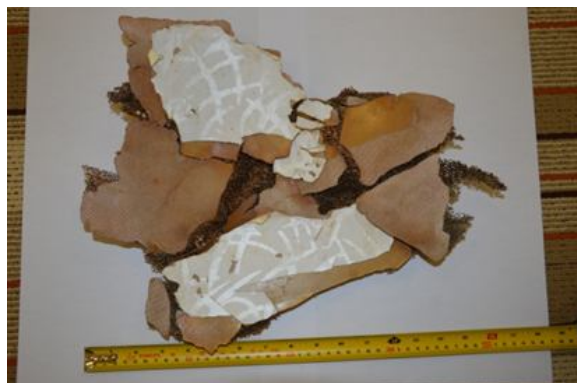
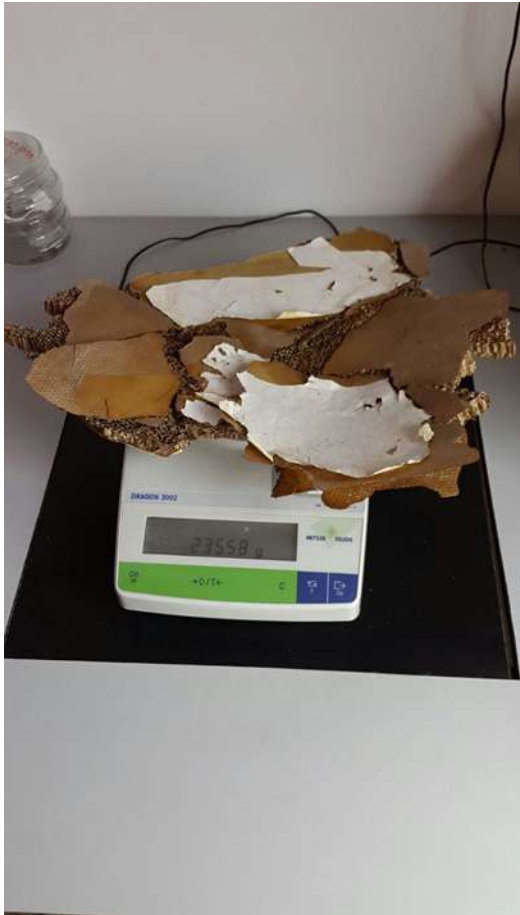
**Item No. 16**

Abnormal marks	Nil	2 localised burn spots. However did not indicate a homogenous fire or heat damage pattern.

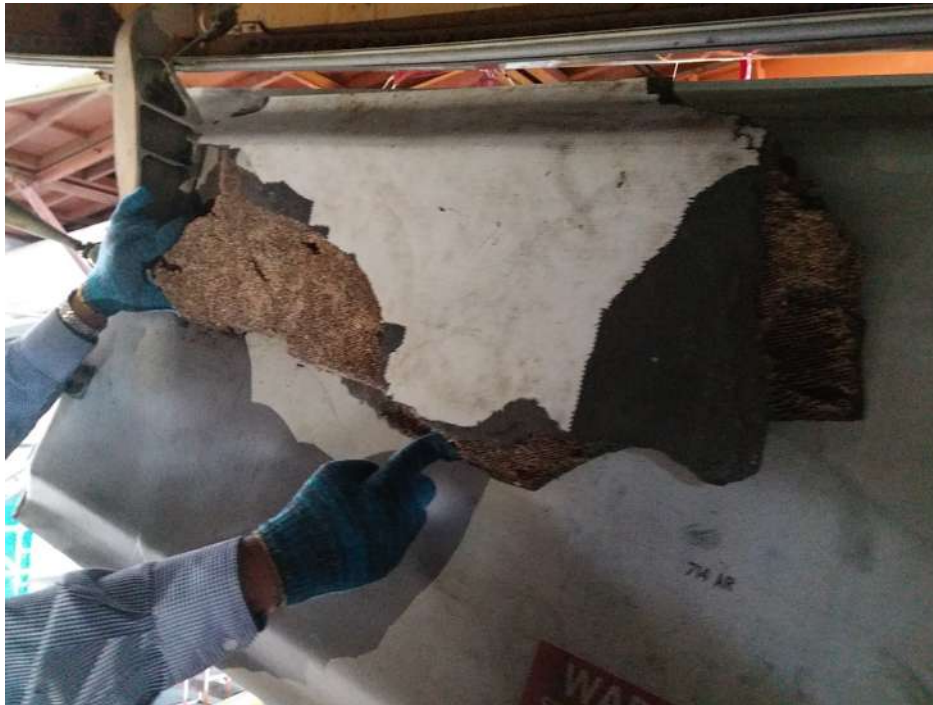
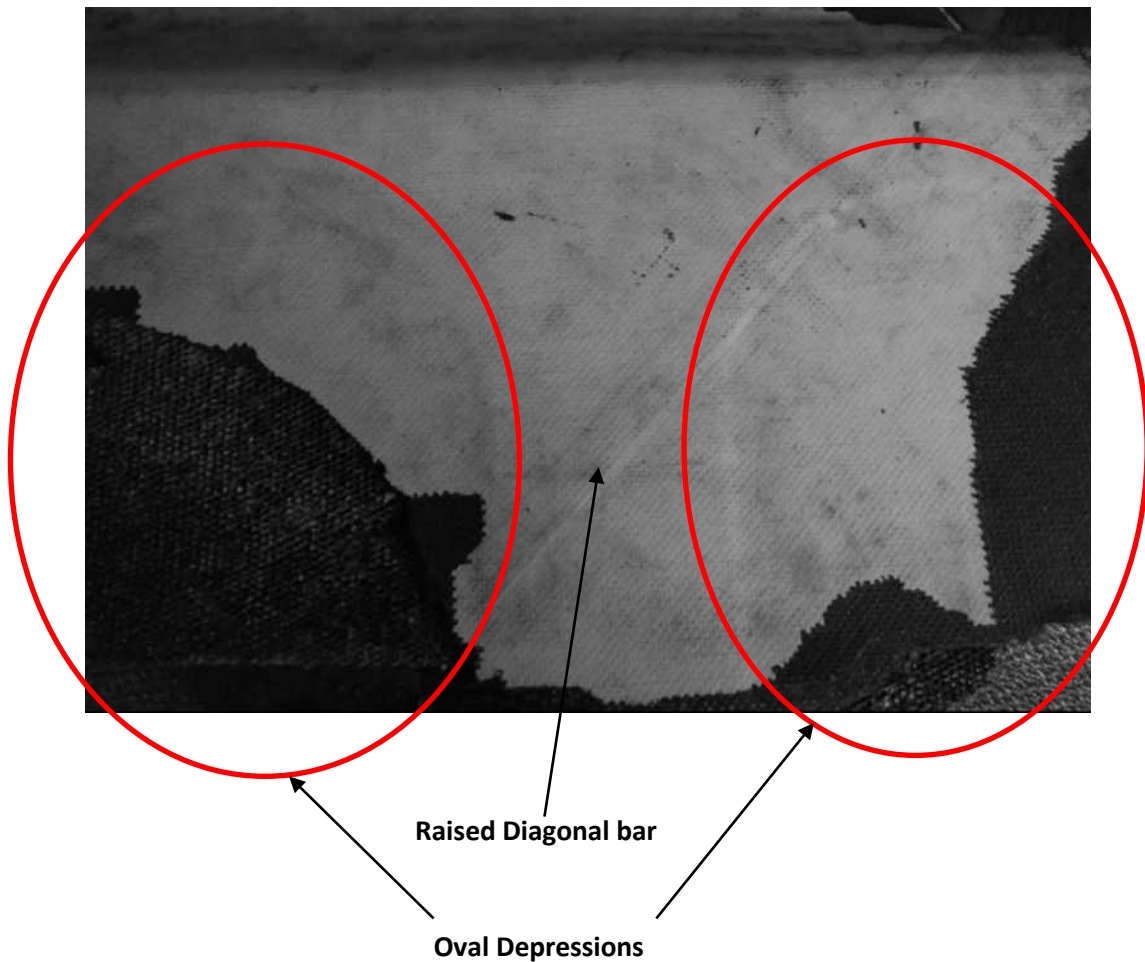
The part was taken to a B777-200ER, formerly operated by Malaysia Airlines (MAS), undergoing a maintenance check at Subang, Malaysia, for identification purposes. The part did not have any identification numbers on it. However the features on the part resembled the Right Nose Gear Forward Door. The oval depressions on the inner skin and the orientation of a diagonal, raised bar matched that on the Right Nose Gear Forward Door on the aircraft.

The above photo shows the item matched the Right-Hand Nose Gear Forward Door. The photo below shows the oval depressions and the raised diagonal bar.

The part was fractured on three edges except at one end, the edge where the hinges were installed. Close visual examination of the fracture lines showed the fibers were pulled and there was no sign of kink.

The part is positively identified as the Right Hand Nose Gear Forward Door of a B777 aircraft. From the location where it was found, and being consistent with the drift path modeling for debris from an aircraft ending its flight in the South Indian Ocean, it is highly likely that it is from MH370 (aircraft registered as 9M-MRO).
