## **SAFETY INVESTIGATION REPORT**

**Malaysia Airlines Boeing B777-200ER (9M-MRO)  
08 March 2014**

**The Malaysian ICAO Annex 13 Safety Investigation Team for MH370**

Issued on 02 July 2018  
MH370/01/2018

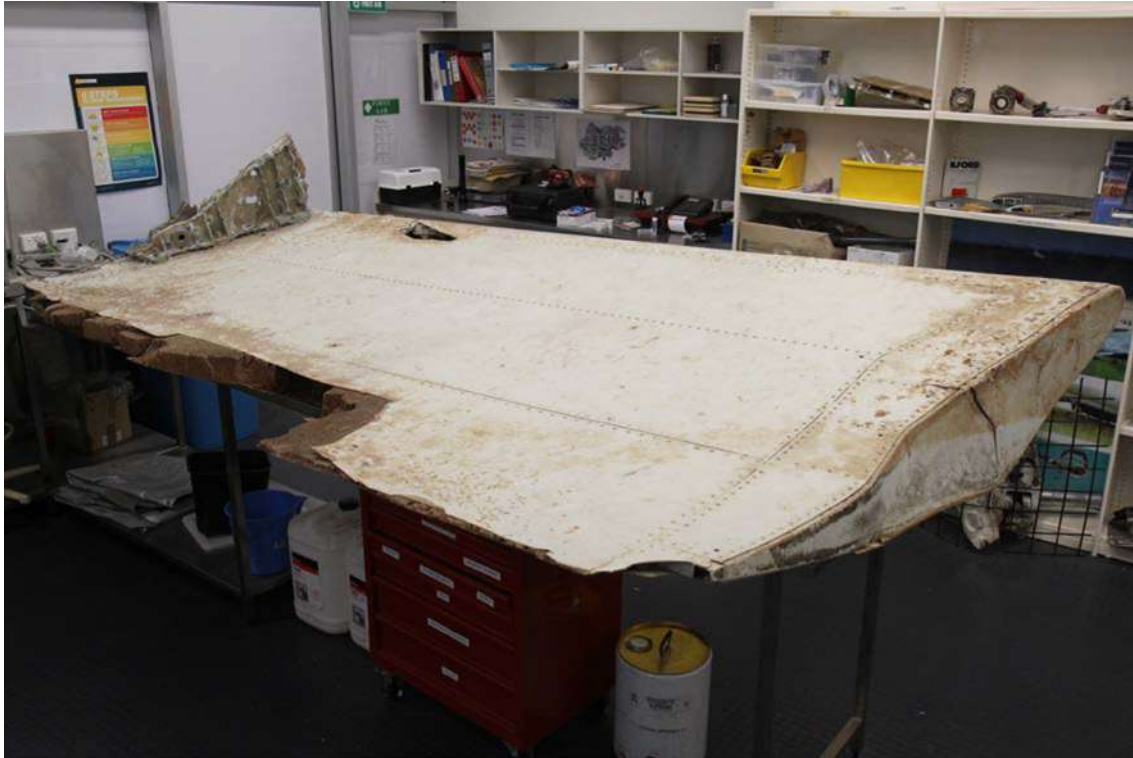
**Figure 1: Inboard section of outboard flap (inverted)**

On 20 June 2016, a large item of debris was found on the island of Pemba, off the coast of Tanzania. Preliminary identification from photographs indicated that the item was likely a section of Boeing 777 outboard flap (Figure 1).

Based on the above information, the part was confirmed as originating from the aircraft registered 9M-MRO and operating as MH370.

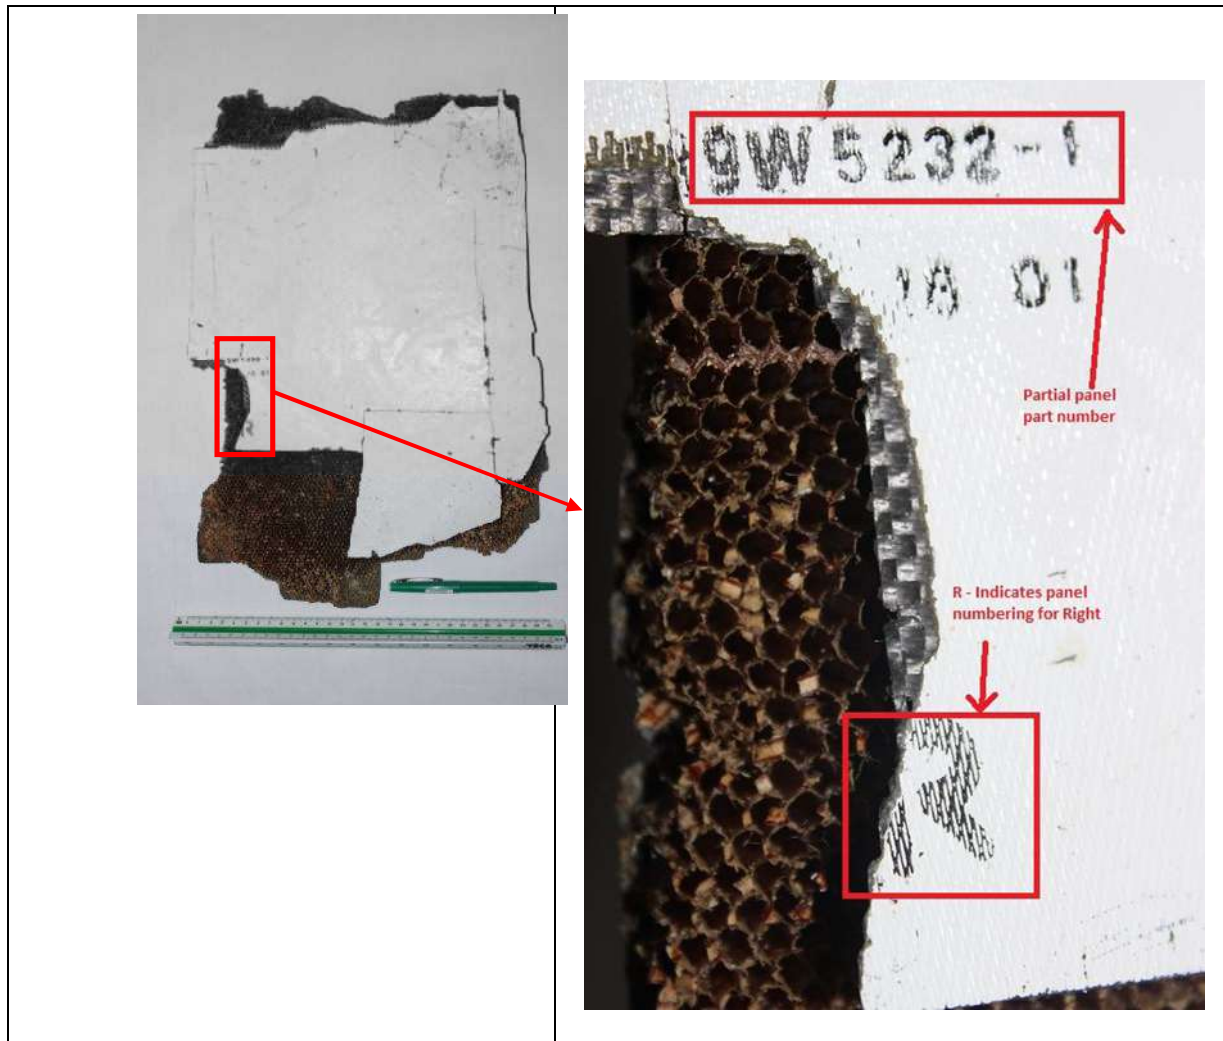
Part of the identification number was visible on the debris indicating that it is part of the right aft wing to body fairing panel, 196 MR. Part of the part number, 149W5232-1, was visible with the letter 'R' below it, indicating it is a panel on the right side of the aircraft.

This part was fractured on all sides. Visual examination of the fracture lines indicated that the fibers appeared to have pulled away with no sign of kink on the fibers.

This item is confirmed to be part of the right aft wing to body fairing panel from a B777 aircraft. From the location where it was found, and being consistent with the drift path modeling for debris from an aircraft ending its flight in the South Indian Ocean, it is highly likely that it is from MH370 (aircraft registered as 9M-MRO).

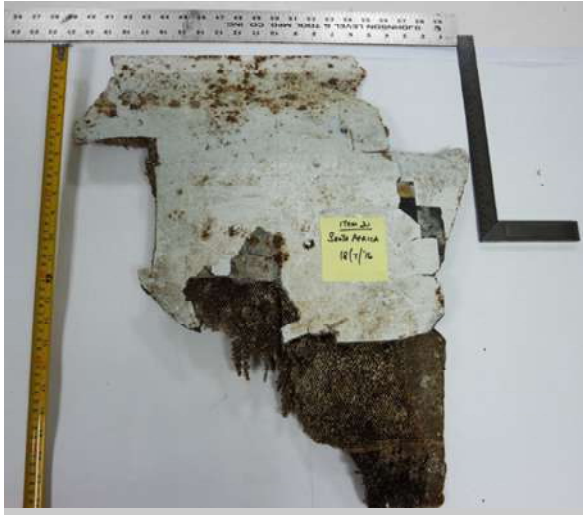
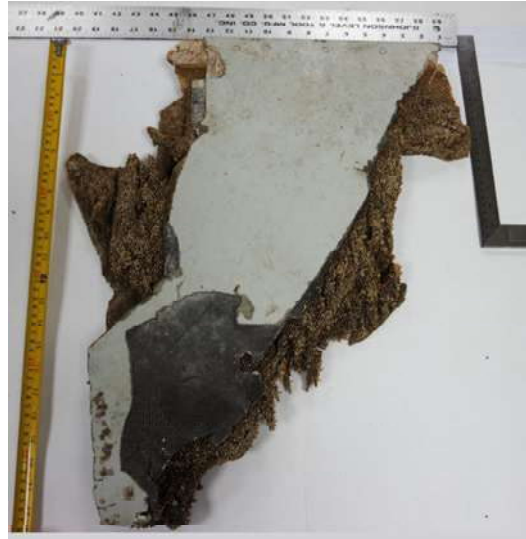
The debris was observed to be of Carbon Fiber Reinforced Plastic (CFRP) honeycomb sandwich construction. The honeycomb core was non-metallic. The grey paint top coat was still intact. It was triangular in shape with an approximate length of 21 inches and weighed 0.87 Kg.

The part was fractured on all sides except on one edge. Some fasteners were still intact in position. The fibers appeared to be pulled and not kinked.

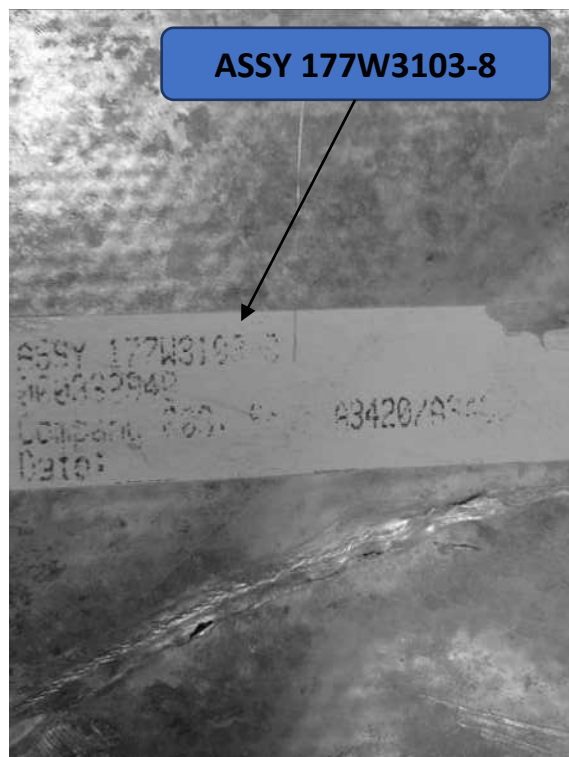
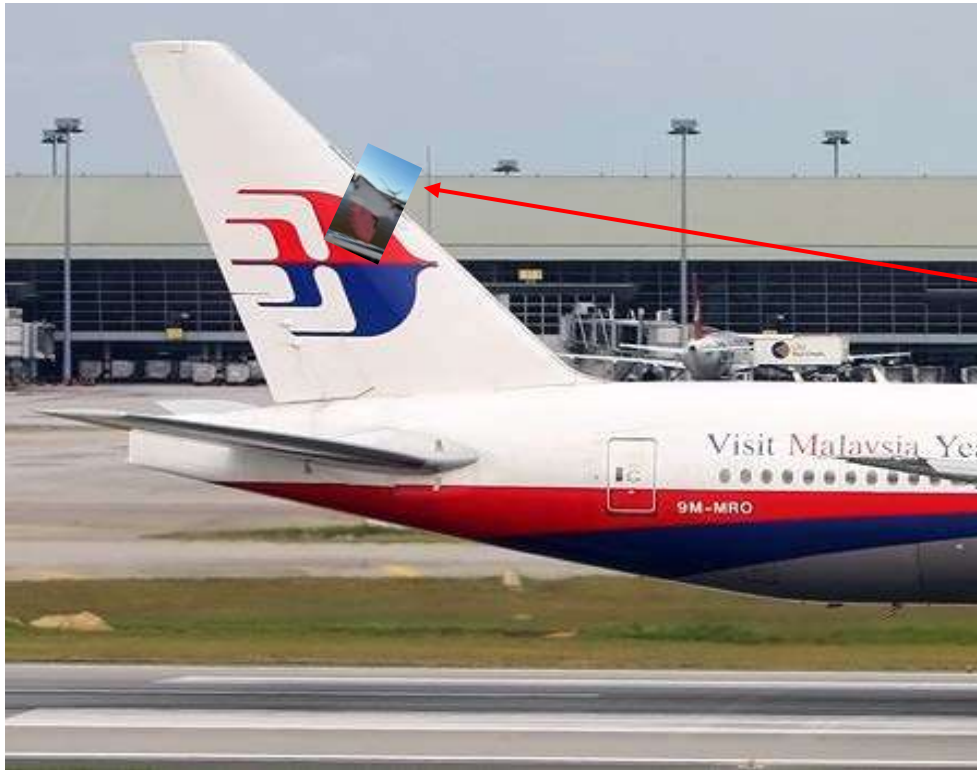
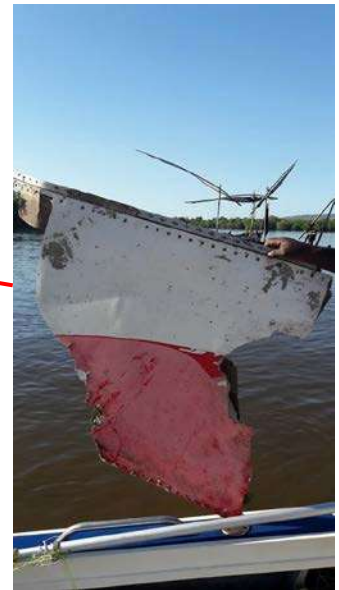
On the interior side of the part, there was still a decal with part identification numbers. Refer to the picture below. The Assembly (Assy) Number 177W3103-8 was visible. When referred to the Boeing 777 Illustrated Parts Catalog (IPC) this part was confirmed to be the right vertical stabilizer panel between the auxiliary and front spar. The red/white paint on the panel and the paint configuration appeared to match that of the Malaysia Airlines 'kite' logo on the right side of the vertical stabilizer. Refer to the photos below.

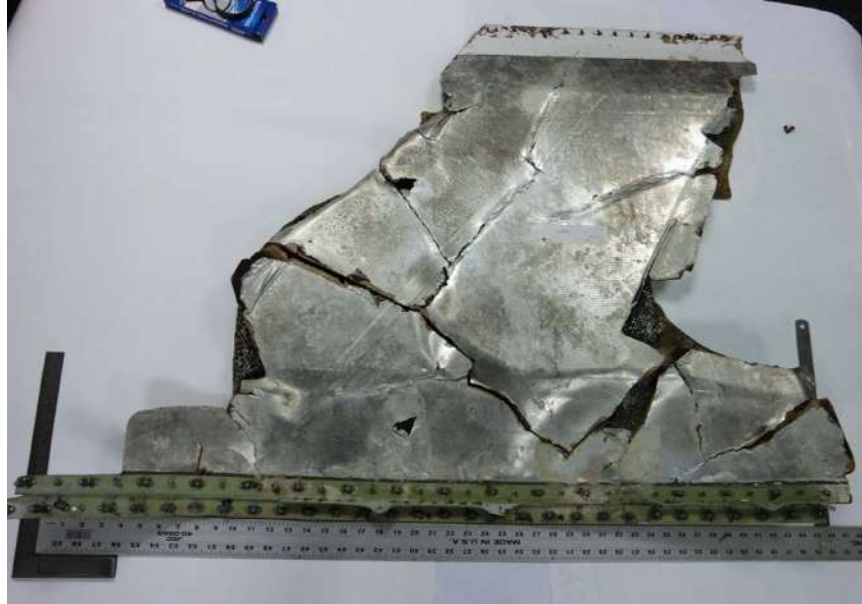
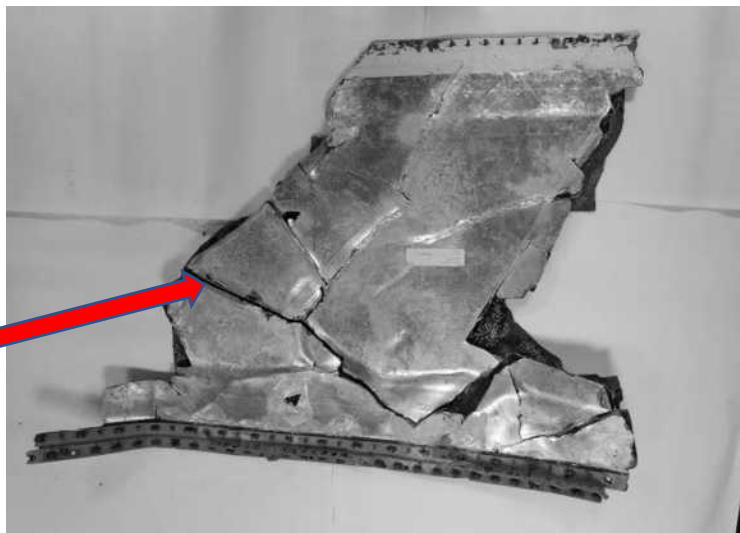
The outer skin had slightly buckled and dented but the inner skin was fractured in several places.

The internal  
laminate  
seems to be  
squashed

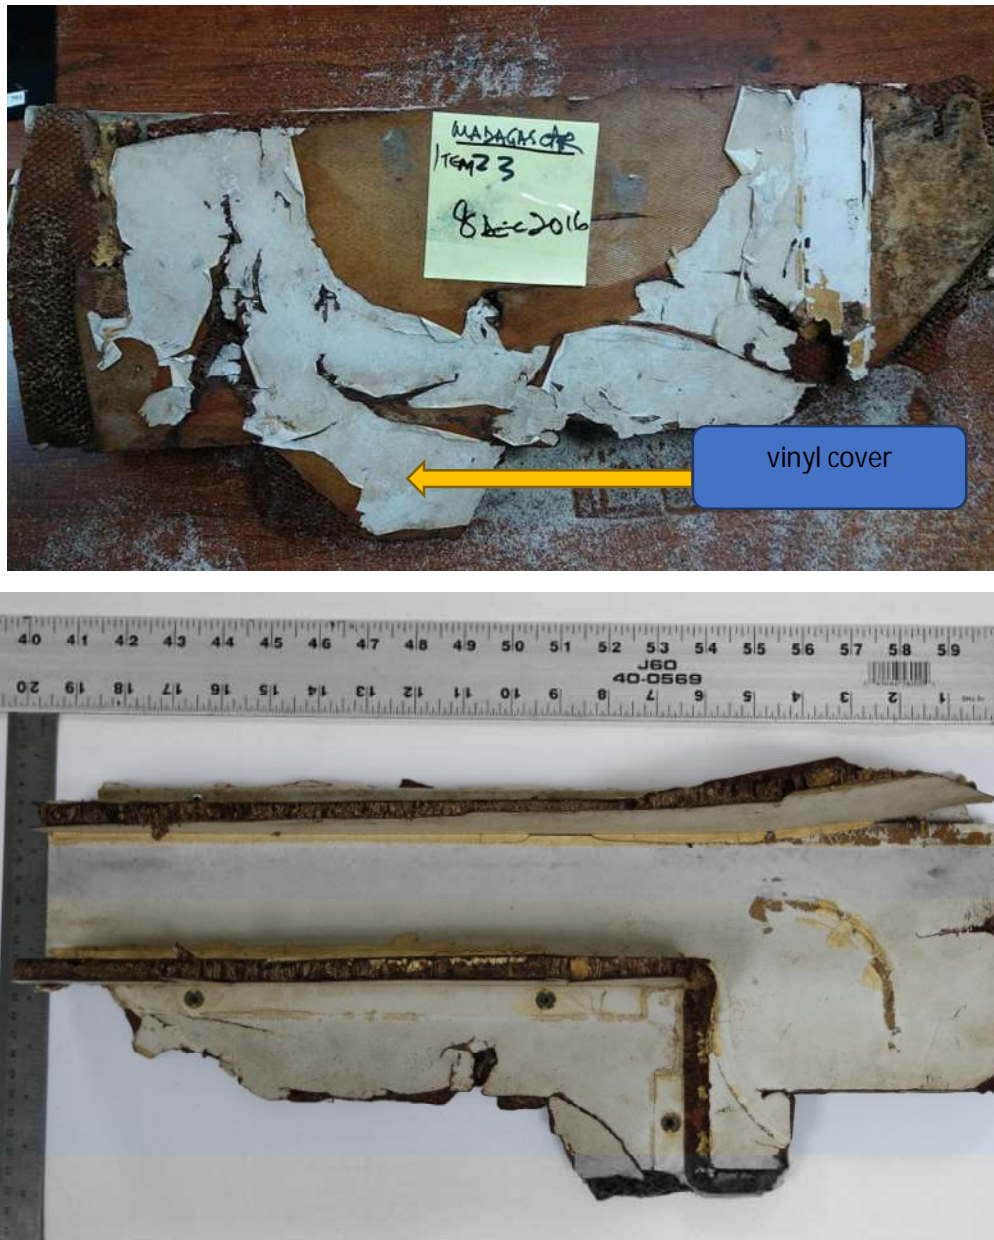
It was a basic composite part with non-metallic honeycomb core. The laminate was obviously not made of carbon fiber since it was brown in colour. The part was measured to be approximately 20 inches in length and weighed 0.545 Kg.

The part was taken to a B777-200ER, formerly operated by Malaysia Airlines (MAS), undergoing a maintenance check at Subang, Malaysia, for identification purposes. The part structure construction characteristics showed that it was not part of the aircraft structure. It appeared more likely to be from the aircraft interior based on the vinyl and edge sealant which was on the part. The vinyl and sealant colour on the part matched that of the parts generally used in aircraft galleys.

The fractured fibres on the item indicated the fibres were pulled out which could indicate tension failure on its structure.

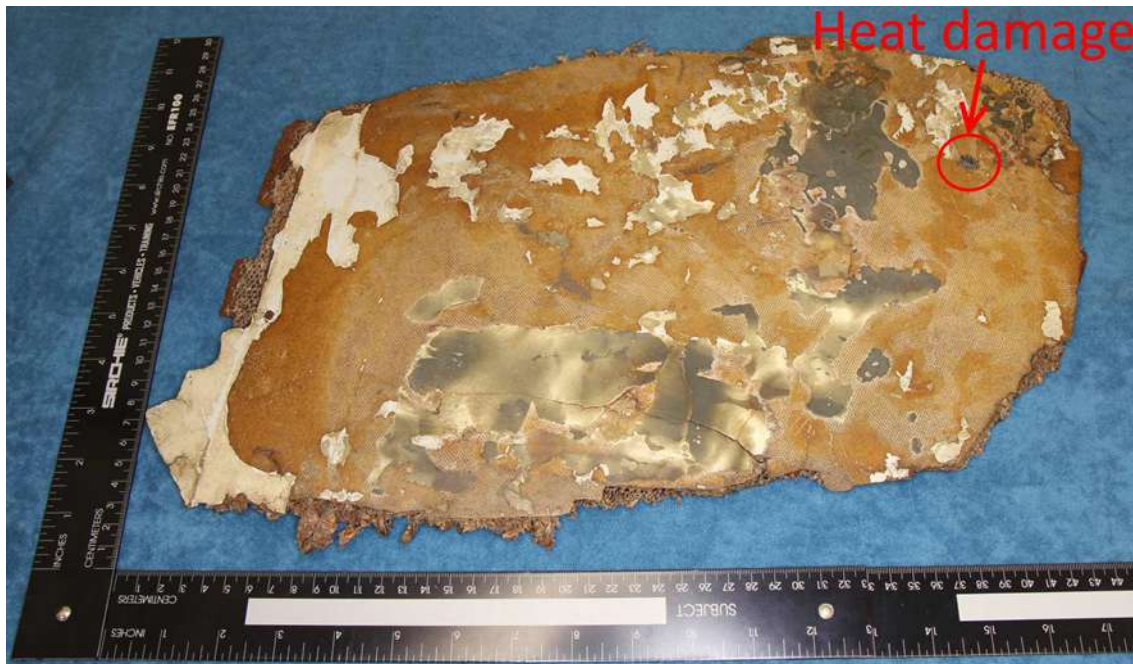
Figure 2: Larger composite panel showing discrete area of heat damage

Despite no evidence of overall gross heat damage, two small (<10mm) marks on one side of the larger item and one on the reverse side were identified as damage resulting from localised heating (Figures 2 and 3). A burnt odour emanating from the large item was isolated to these discrete areas. The origin and age of these marks was not apparent. However, it was considered that burning odours would generally dissipate after an extended period of environmental exposure, including salt water immersion, as expected for items originating from 9M-MRO.

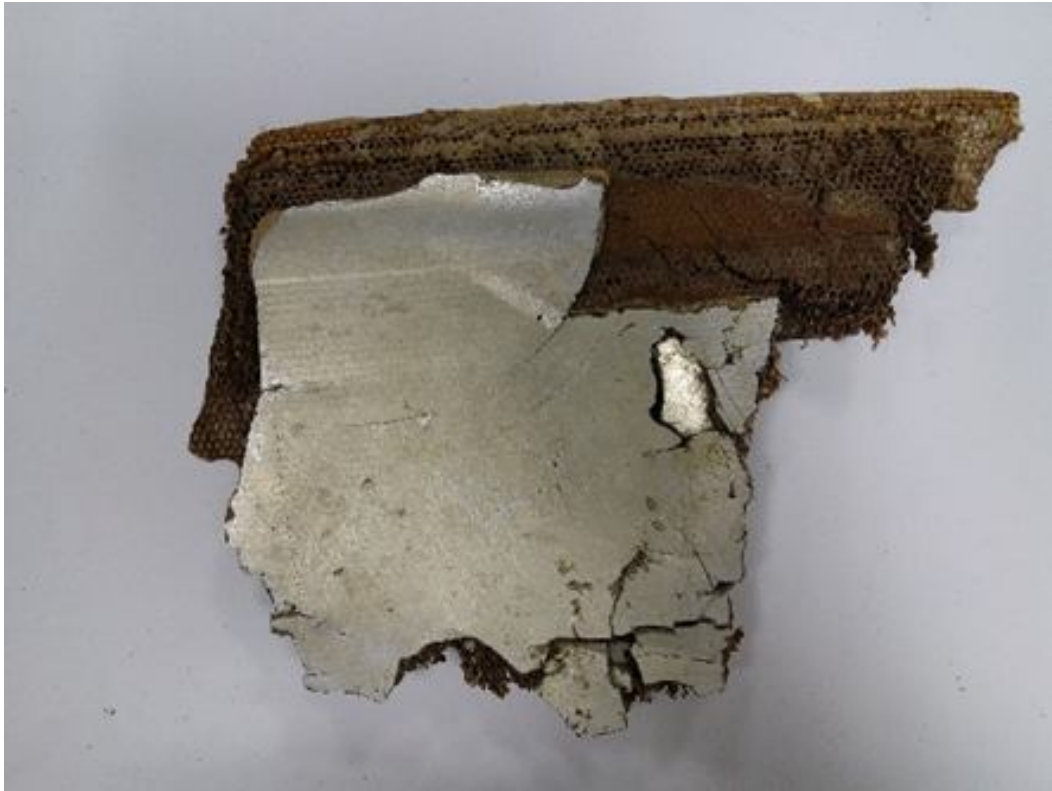
It was of Carbon Fibre Reinforced Plastic (CFRP) honeycomb sandwich construction. The outer and inner skins were carbon fibres and the core was non-metallic. The outer skin was grey in colour.

The part was fractured on all sides and some portion of the inner skin had peeled off from the core. Some section of the skin and core were crushed. Visual examination of fibers showed that they were rough and there was no visual evidence of the fibers being kinked.

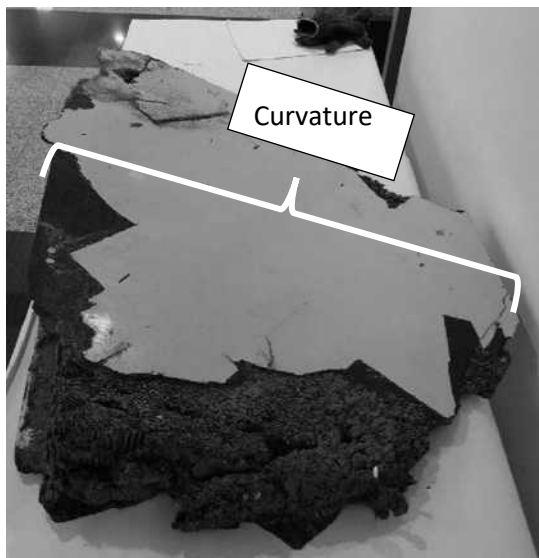
The non-metallic honeycomb was soaked with water resulting in the core material to swell. The following photos show the part's characteristics including the dimension.

The part showed slight curvature in only one direction; the non-metallic honeycomb core was wet

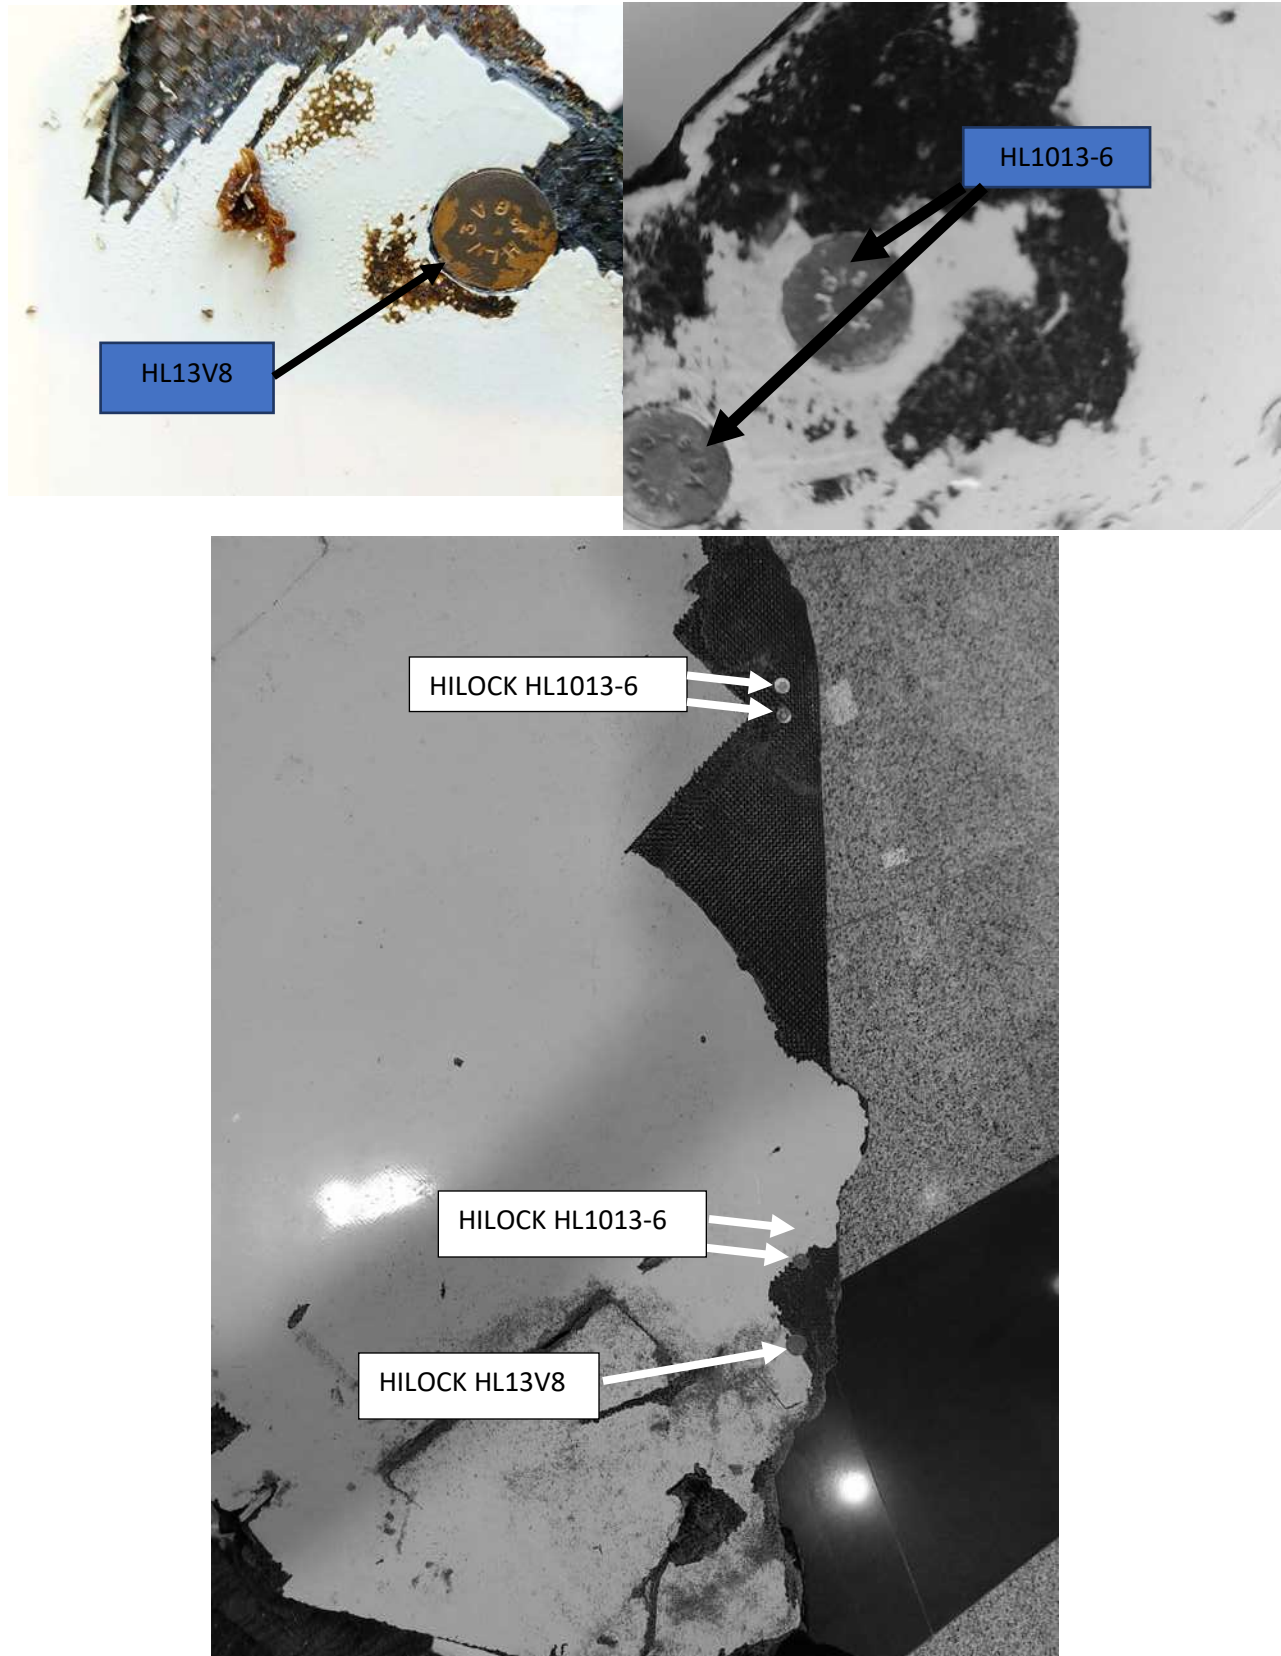
Several Hi-lock fasteners with numbers HL1013-6 and HL13V8 were visible as shown below.

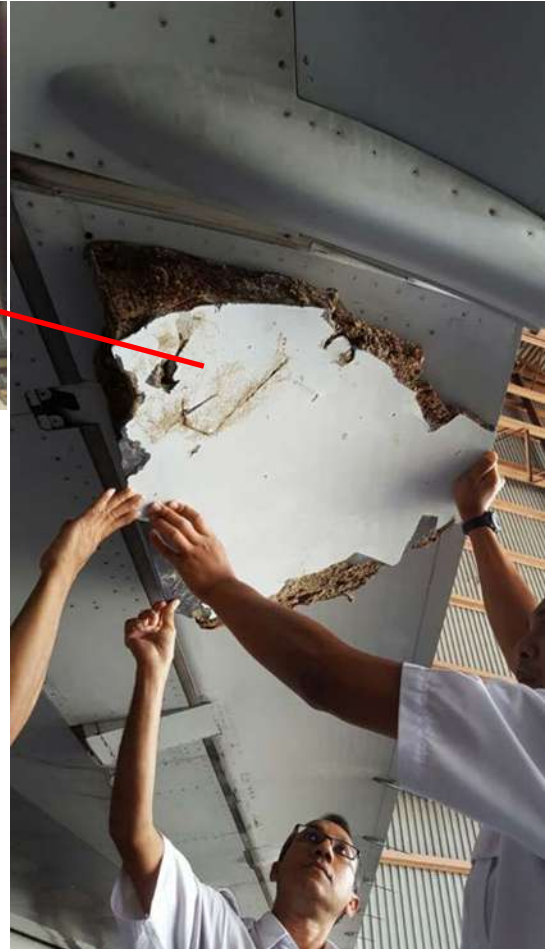
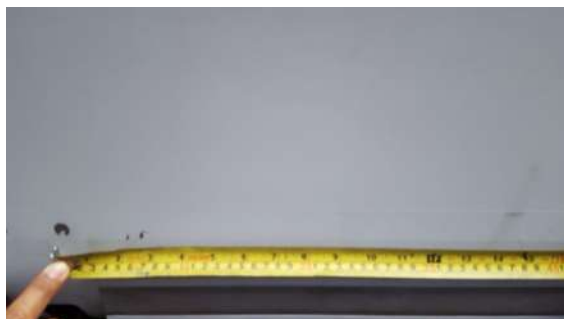
Spacing of fasteners on the aileron on aircraft

The debris closely matched the inboard section of the Right Aileron.

The numbers on the head of the fasteners on the debris were compared with those on the inboard section of the right aileron on the aircraft. These numbers matched. Additionally the spacing of the fasteners on the aileron also matched those on the debris. Refer to the photos above. The core and its dimensions also matched those on the inboard section of the right aileron. These confirmed that the debris is part of the inboard section of the right aileron of a B777 aircraft.

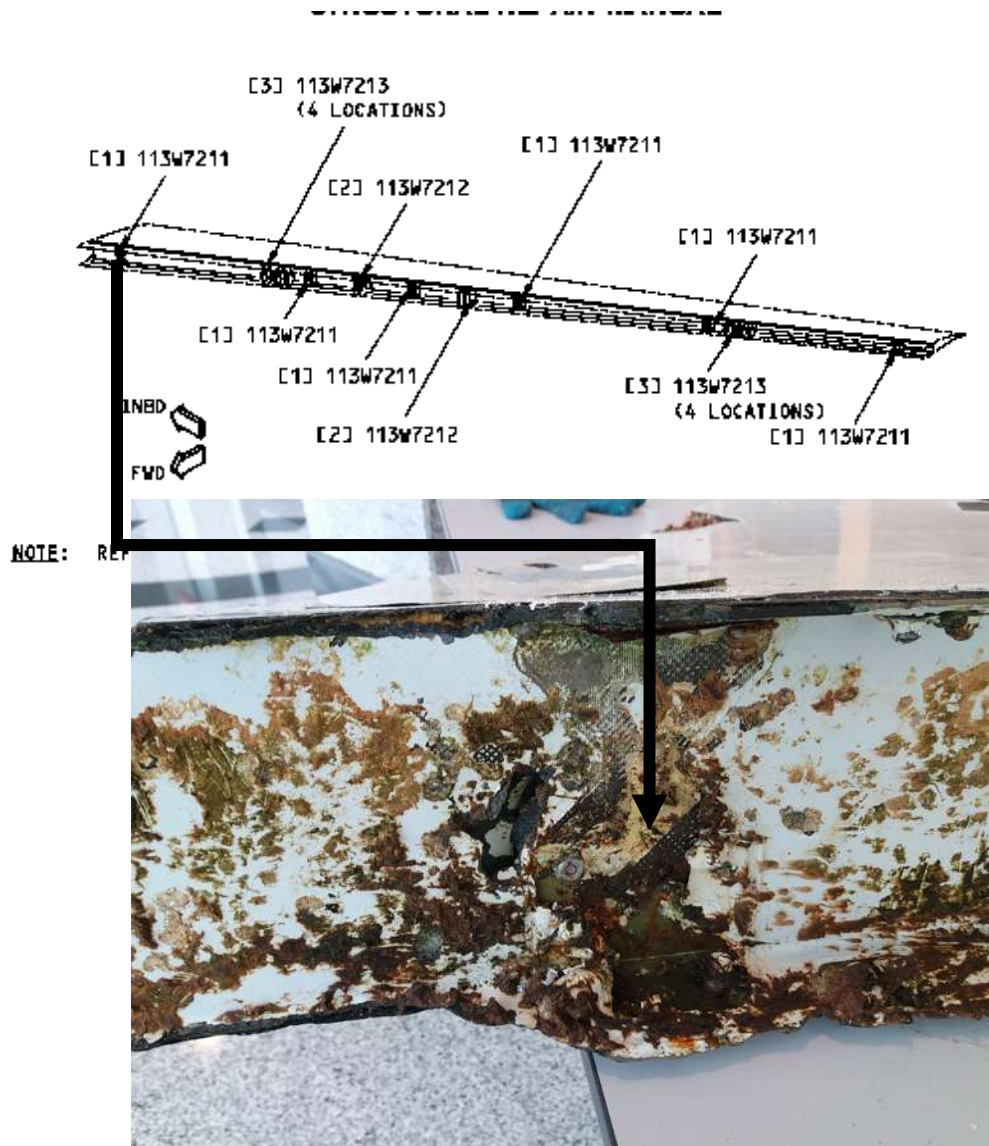
There were fractures on all sides; however, part of the spar was still intact. Several fasteners were also still intact without failures. Except for the fasteners there were no other identification numbers.

The B777 Structure Repair Manual (SRM) diagram below shows the left aileron (the right is opposite). The hinge fitting area is shown. The fitting on the debris appeared to have suffered a tension overload fracture.

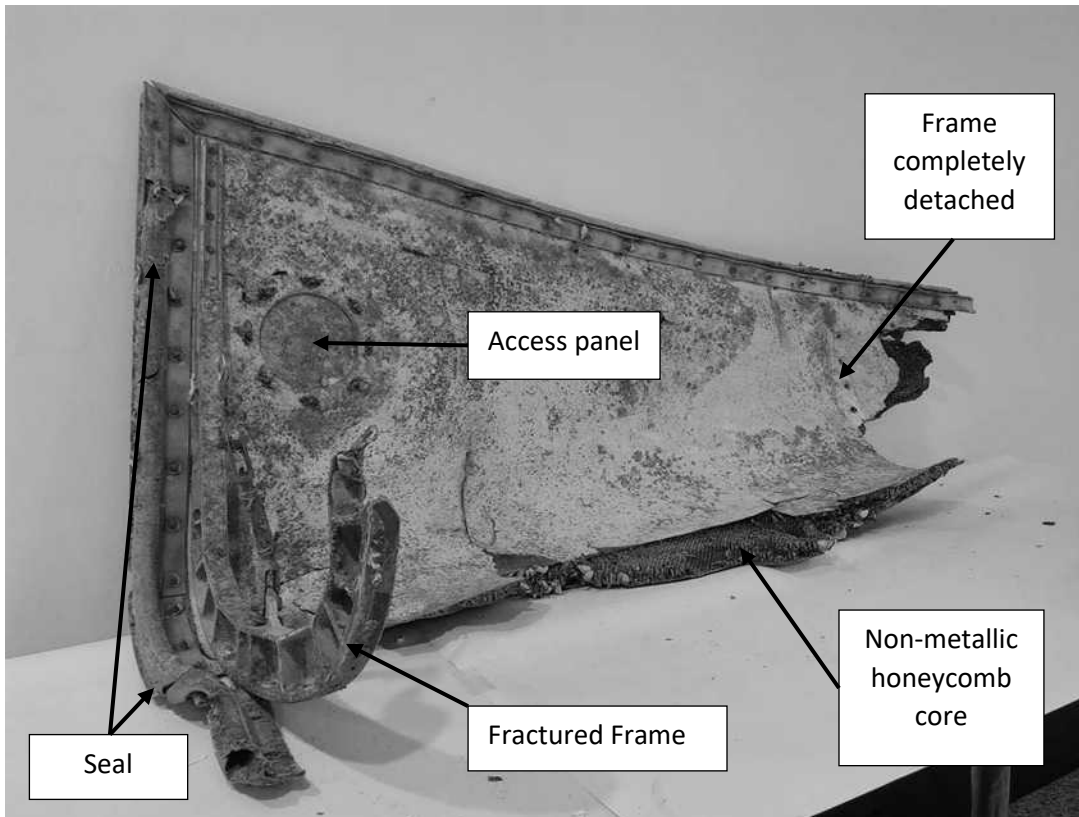
This part was made of composite Carbon Fibre Reinforced Plastic (CFRP) with non-metallic honeycomb core. A fractured metallic frame was still attached to the assembly. Seals were still intact around the part. An access panel was also still intact and completely attached in its position. There was evidence of another metallic frame installed on the part shown by its visible fastener holes; however this was completely detached from the part assembly. Refer to the picture below.

The part was fractured almost through its symmetry axis. One of the frames was completely detached from the skin. It may be due to fasteners pull through as the fasteners' holes appeared to be torn off with diameters larger than the fasteners. The bracket had broken off with some sign of twist which is evidently shown by the bent push rod.

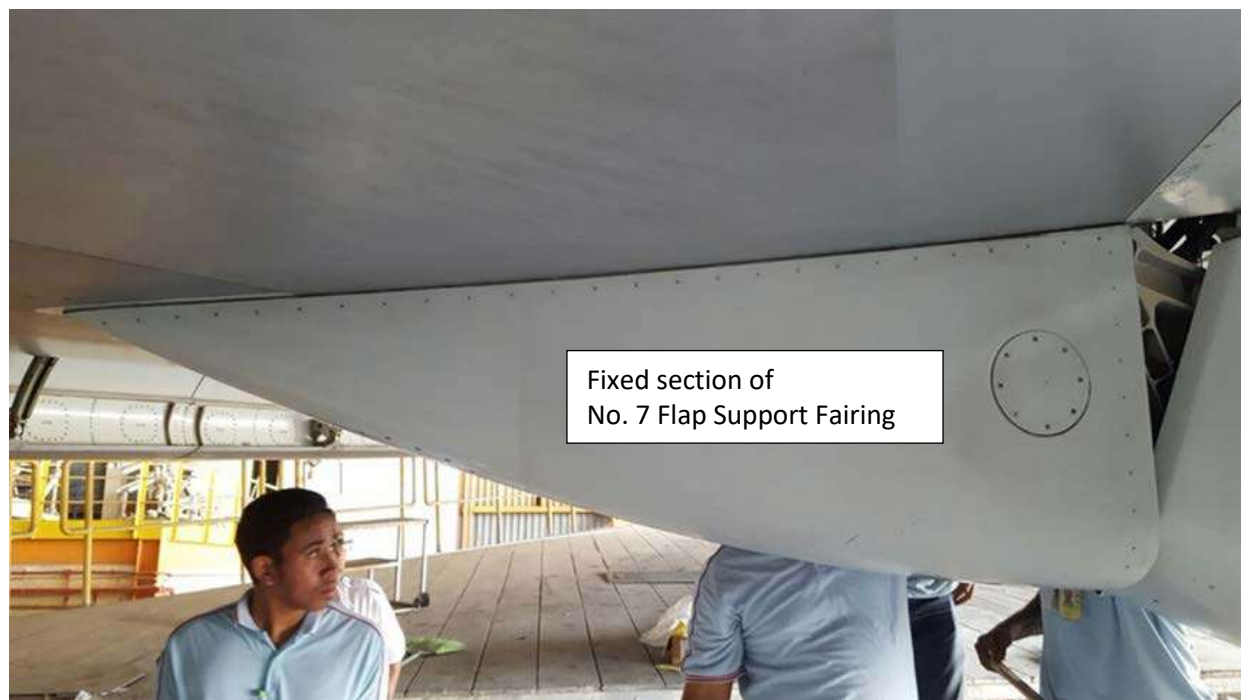
It was easily matched to the fixed, forward section of the No. 7 flap support fairing, as shown in the pictures below. Item No. 2, found on 27 December 2015 at Daghatane Beach, Mozambique, is also part of the same fairing; however it is part of the rear, moveable section.

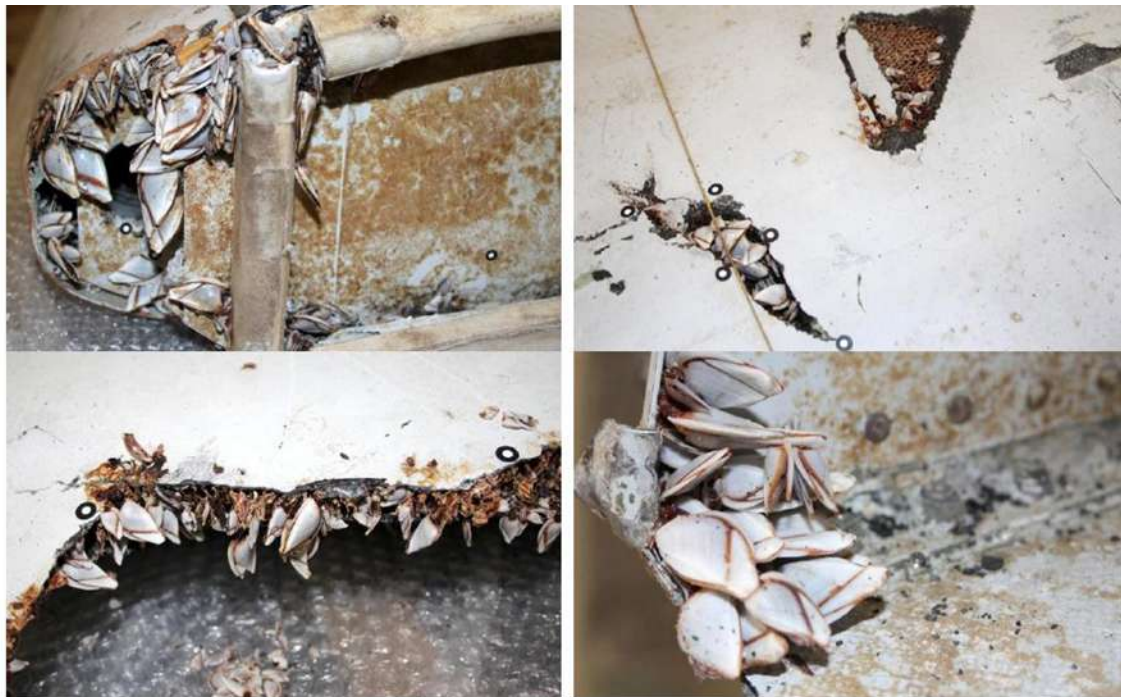
Figure 1 - Fastening of barnacles more on the rough portions of the flaperon, from left to right and top to bottom: front left edge with the largest barnacles, small colonies on scratched areas of the dorsal side, colonies attached to the bare composite on the back edge, colony on a metal corner.

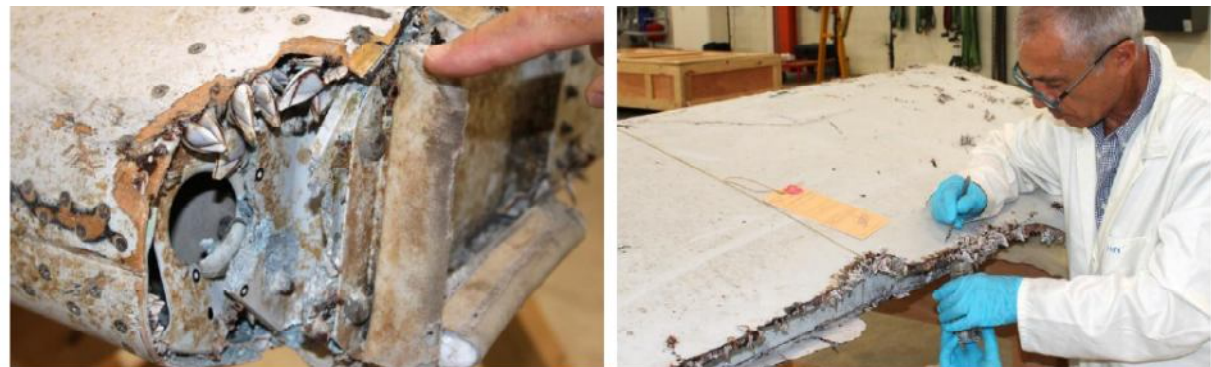
Figure 4: Location of 2 samples taken on 9 August 2015

- One from the left front angle (Fig. 4 left)
- The other from a rear edge (Fig. 4 right)

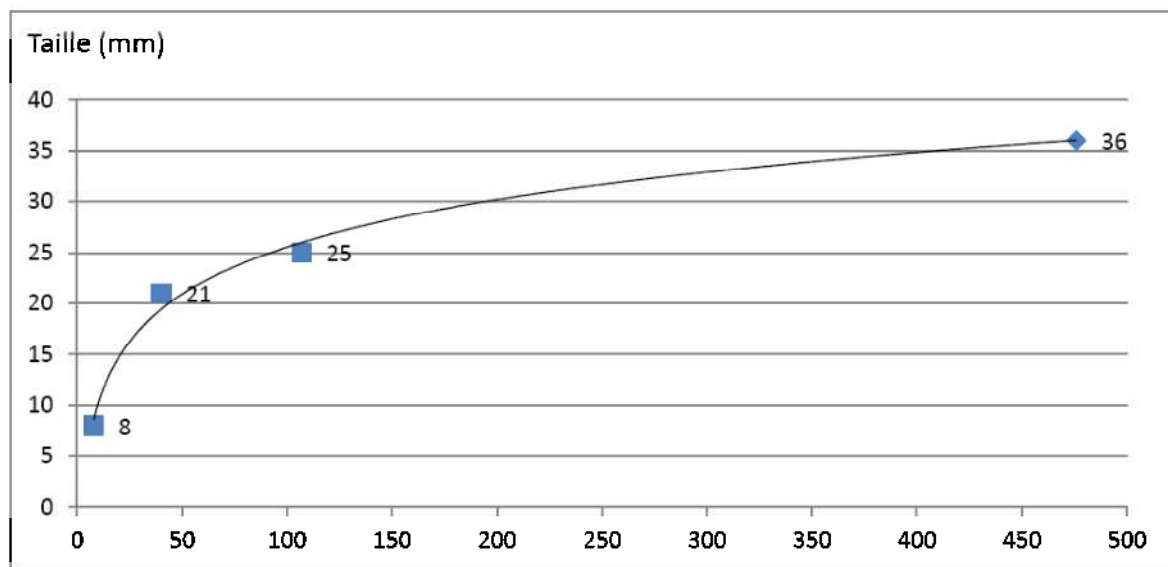
Figure 6 - Increase in size of the capitulum of a *Lepas anserifera* barnacle depending on the number of days (days 0-500). The first three points (squares) correspond to the literature data (see Evans, 1958). The last point (diamond) is extrapolated from the first three items of data by estimating logarithmic growth. The size of 36 mm corresponds to a growth period of 476 days, or 15-16 months.

The growth of the specimens stopped on the day of the discovery of the flaperon on Réunion Island, on 29/7/2015. The initial colonization therefore dates back to 10/04/2014, or 33-34 days after the disappearance of the Boeing 777-200 on flight MH370.

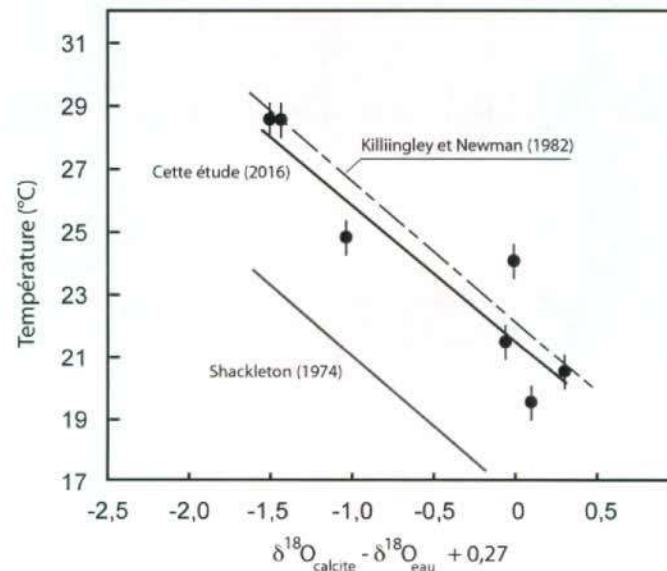
Figure 8 : Calibration des valeurs de composition isotopiques des valves de cirripèdes en fonction de la température de formation. Les points noirs représentent les valeurs que nous avons déterminées expérimentalement.

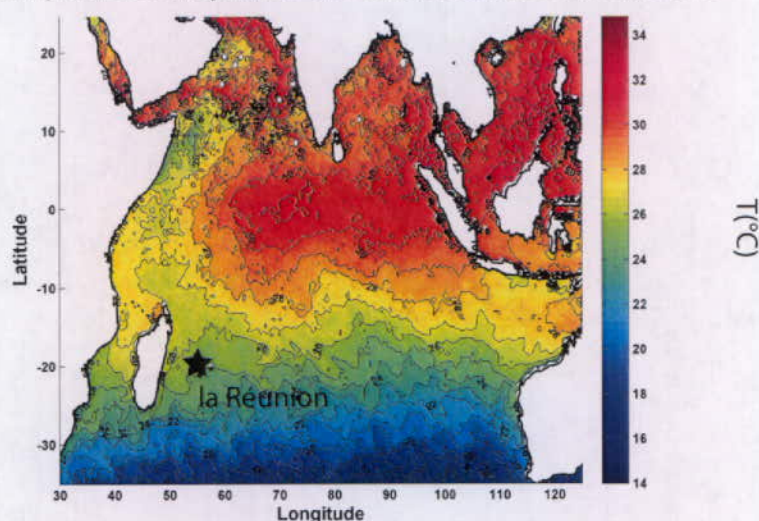
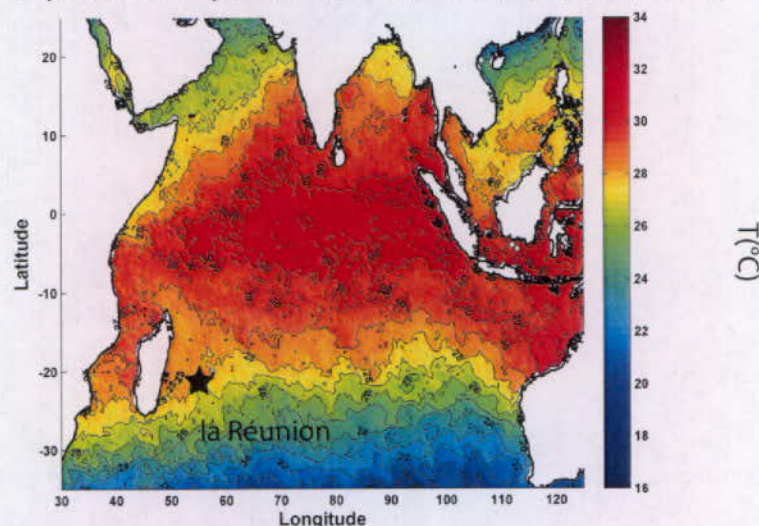
Figure 9 : Distribution des températures moyennes des eaux de surface de l'Océan Indien durant le mois de juin et de mars 2015. L'étoile noire représente l'île de la Réunion.

- 3 - au début de leur croissance, les cirripèdes les plus grands étaient baignés par des eaux dont la température était voisine de  $28,5 \pm 1^\circ\text{C}$  (Figure 13). La distribution des courants et les variations de températures dans les mois qui précèdent la découverte du flaperon (Figure 9) suggèrent que celui-ci a dérivé dans des masses d'eau situées à E-NE de l'île de la Réunion.

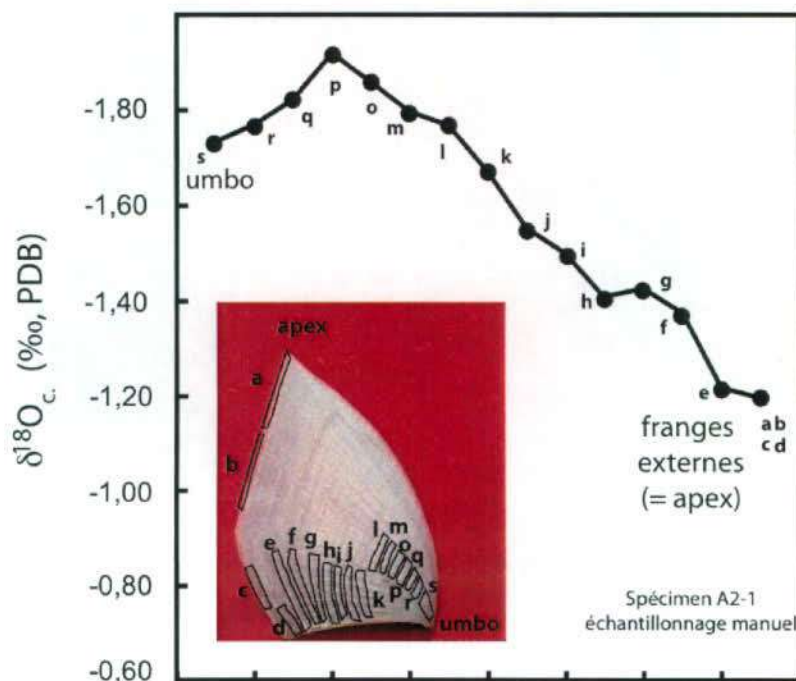
Figure 10 : Profil isotopique ( $\delta^{18}\text{O}$ , ‰ vs PDB) basse résolution du spécimen A1-2. A noter que la partie correspondant à l'umbo présente des valeurs  $\delta^{18}\text{O}$  de plus négatives que celles correspondantes aux bords externes. Par convention l'échelle des ordonnées a été inversée dans toutes les figures avec  $\delta^{18}\text{O}$  en ordonnées, ce qui permet de représenter un axe de température croissant vers le haut.

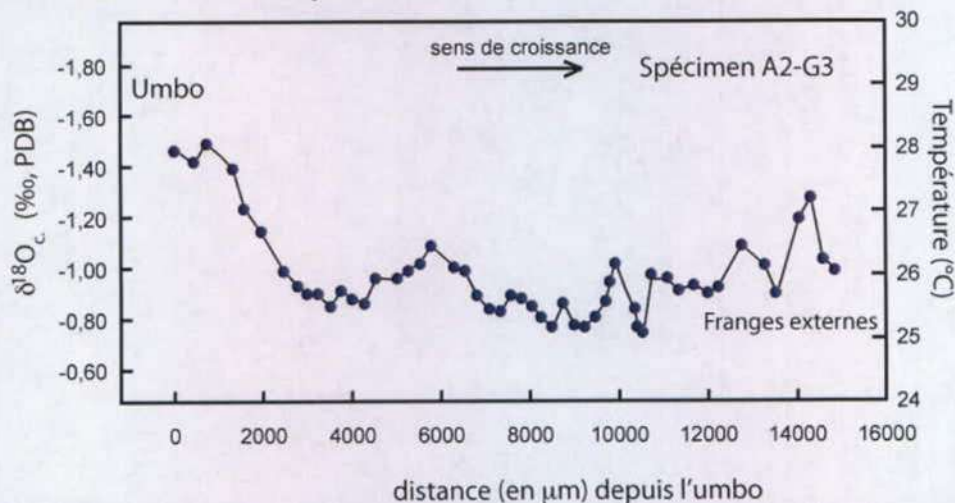
Figure 11 : Profil isotopique ( $\delta^{18}\text{O}$ , ‰ vs PDB) haute résolution et température de formation de la valve du spécimen A2-G3. On note que la partie correspondant à l'umbo s'est développée dans de eaux plus chaudes que les franges externes.

Les valeurs de  $\delta^{18}\text{O}$  de ce spécimen sont comprises entre -1,50 et -0,78‰ (PDB). Les valeurs les plus négatives ont été mesurées dans les zones les plus anciennes contigües à la zone de l'umbo (la plus vieille). Les valeurs les plus élevées sont présentes dans les parties externes (les plus récentes) de la valve. Les valeurs augmentent de 0,7 ‰ entre la zone de l'umbo (~-1,45 ‰) vers la périphérie. Cette augmentation se réalise sur environ 1500  $\mu\text{m}$  de distance à proximité de l'umbo.

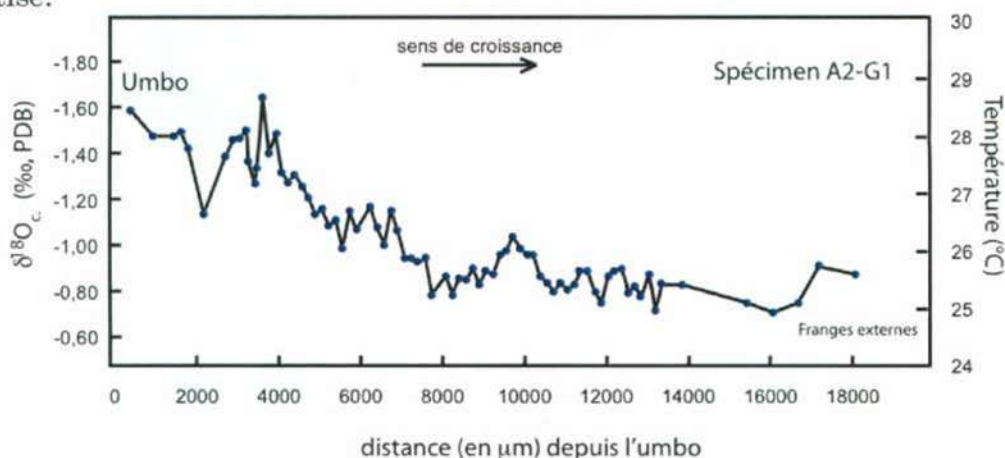
Figure 12 : Profil isotopique ( $\delta^{18}\text{O}$ , ‰ vs PDB) haute résolution et température de formation de la valve du spécimen A2-G1. A noter que la partie correspondant à l'umbo s'est développée dans des eaux significativement plus chaudes que les franges externes.

Les valeurs de  $\delta^{18}\text{O}$  varient de  $-0,72$  et  $-1,60$  ‰ (PDB). Comme pour les échantillons précédents, nous observons que les valeurs les plus négatives correspondent aux zones proches de l'umbo, alors que les valeurs les plus positives correspondent aux zones les plus externes du spécimen. Entre l'umbo et  $7850\text{ }\mu\text{m}$ , le profil obtenu, interprété en terme de température des eaux de surface de l'eau de mer (Figure 12) témoigne d'un refroidissement progressif d'environ  $3^\circ\text{C}$  au cours de la vie de l'animal. Cette diminution de température est significative compte tenu de l'incertitude expérimentale de  $\pm 1^\circ\text{C}$ . Nos résultats montrent qu'au cours de la vie de l'animal, les températures ont diminué de manière plus ou moins régulière, passant d'environ  $28,5 \pm 1^\circ\text{C}$  à  $25,4 \pm 1^\circ\text{C}$ . Dans la seconde partie du profil, entre  $7500$  et  $18180\mu\text{m}$ , les températures restent sensiblement constante ( $25,4 \pm 1^\circ\text{C}$ ), dans la gamme des valeurs précédemment estimées pour les juvéniles qui se sont développés dans des eaux proches de l'île de la Réunion.

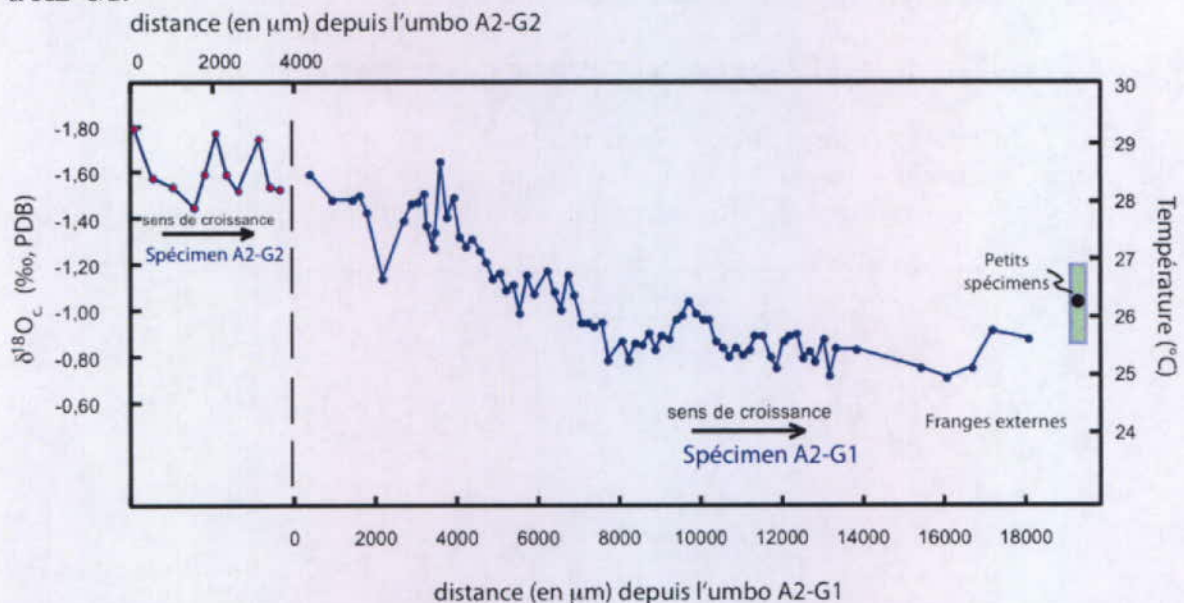
Figure 13: Synthèse des gammes de température déterminées à l'aide des différents profils isotopiques. Le profil isotopique haute résolution du spécimen A2-G1 constitue une référence de la variabilité des températures des eaux de surface à travers lesquelles a transité le flaperon. A titre de comparaison, sont représentés : (i) le profil de la partie proche de l'umbo du spécimen A2-G2 (ii) la gamme de variabilité enregistrée par les cirripédés juvéniles (boîte colorée). On notera que les deux plus grands spécimens (A1-G1 et A2-G2) ont commencé leur croissance dans des eaux dont les températures étaient proches de  $28,5 \pm 1^\circ\text{C}$ .

Le profil isotopique couvre une distance d'environ 3500  $\mu\text{m}$  à partir de l'umbo. Les valeurs de compositions isotopiques de l'oxygène (Tableau 9) et de températures sont comparables à celles obtenues au voisinage de l'umbo de l'échantillon A2-G1 (Figure 13).

Ces résultats indiquent que dans les quelques mois qui ont précédé l'échouage, le flaperon a dérivé progressivement depuis des eaux chaudes ( $29 \pm 1^\circ\text{C}$ ) vers des eaux sensiblement plus froides ( $25,4 \pm 1^\circ\text{C}$ ) présentes près de l'île de la Réunion.
