## **SAFETY INVESTIGATION REPORT**

**Malaysia Airlines Boeing B777-200ER (9M-MRO)  
08 March 2014**

**The Malaysian ICAO Annex 13 Safety Investigation Team for MH370**

Issued on 02 July 2018  
MH370/01/2018

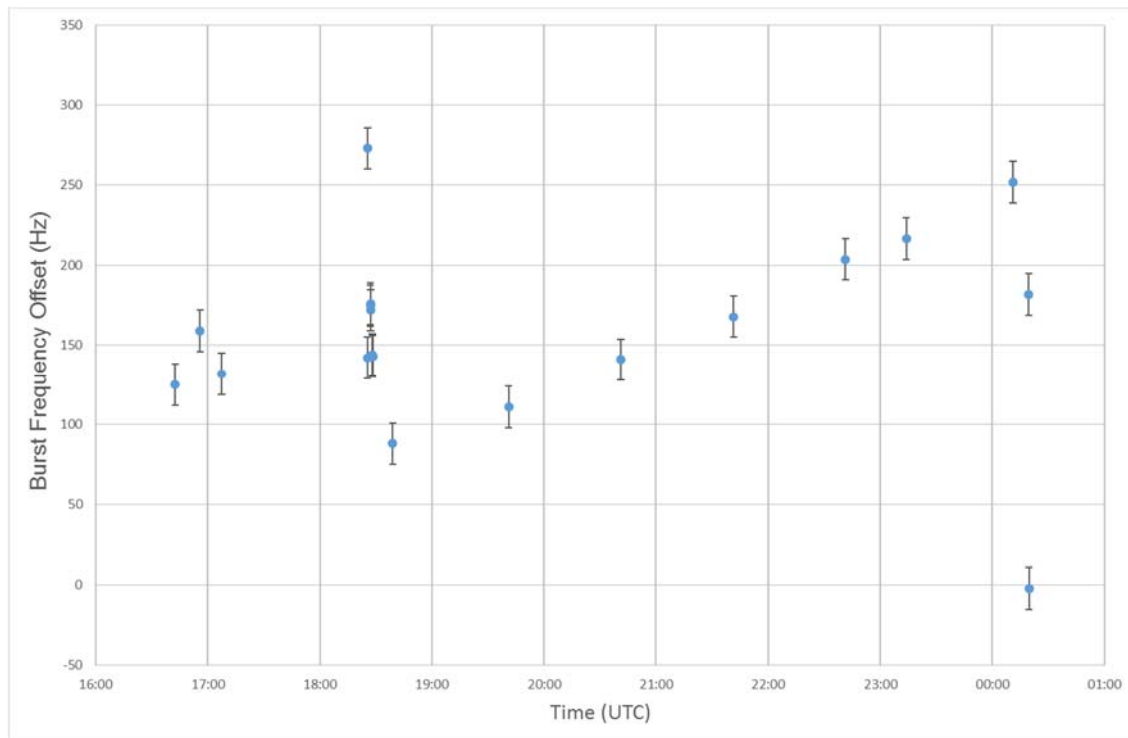
**Figure 1: Recorded BFO values throughout the flight**

***This graph illustrates the measured BFO recordings throughout the flight with the appropriate error bars on the measurements. After 18:39 the BFO values follow an approximately linear trend until the final two values at 00:19.***

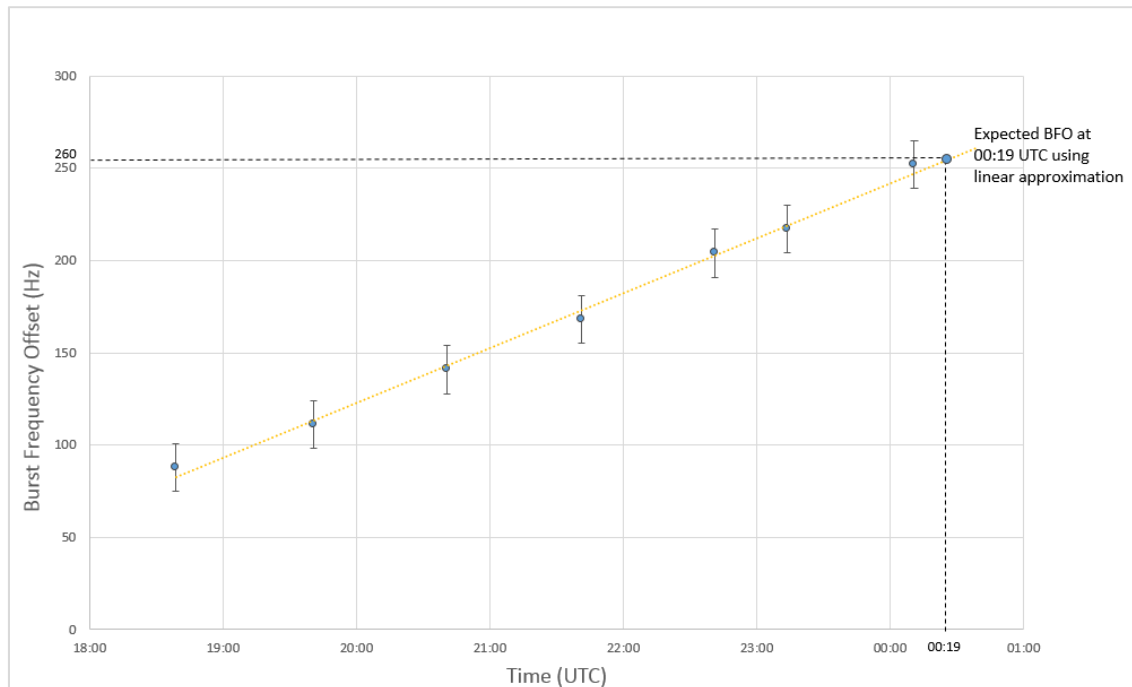
**Figure 2: Linear approximation of the BFO values between 18:39 and 00:11**

The trend of the BFO values from 18:39 until the 6<sup>th</sup> arc (00:11) is due to the change in location of the aircraft and can be linearly approximated (Figure 2). If this linear approximation is extrapolated to 00:19, and if neither the Satcom system nor the aircraft flight path were altered after 00:11, a BFO value of approximately 260 Hz would have been expected.

***This graph illustrates 5 BFO values recorded between 18:39 and 00:11 and the linear approximation of the BFO at 00:19. The first 5 values correspond to the 2<sup>nd</sup>-6<sup>th</sup> arcs. During this time the aircraft is likely to be following a relatively constant southerly track. Continuing this linear trend to 00:19, a value of 260 Hz would be expected.***

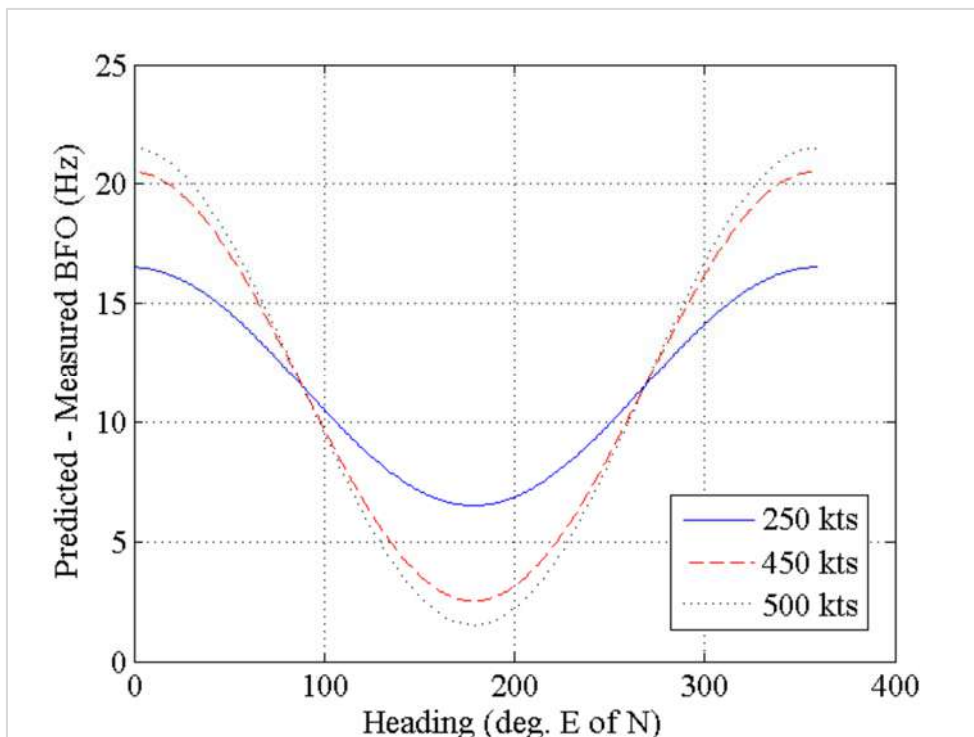
**Figure 3: Variation in estimated BFO differences at 00:19 for given track angles and groundspeed**

***This graph indicates that the lowest BFO differences, and therefore the closest to our measured values, would be attained for any given speed by continuing in a southerly direction.***

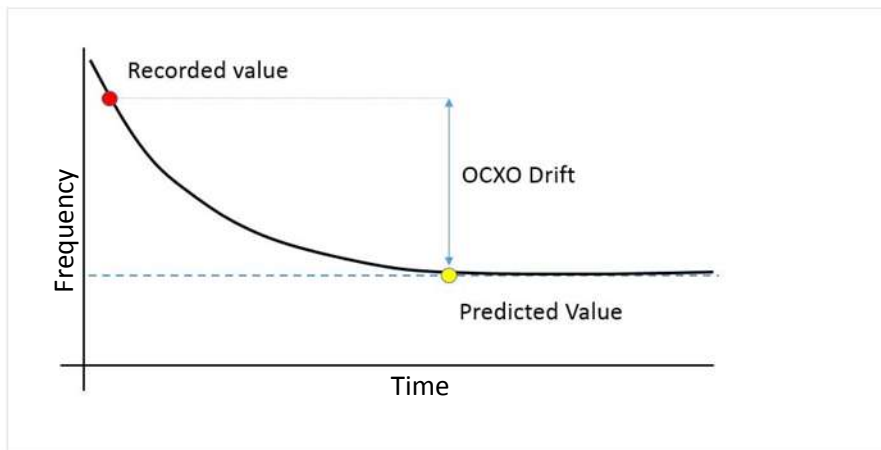
**Figure 4: Representation of 9M-MRO SDU decaying warm-up characteristic (not to scale)**

All available information indicated that, after power-up, the SDU in 9M-MRO exhibited a decay characteristic, represented in Figure 4. The values recorded shortly after power up would therefore be greater than the steady state value.

***This graph illustrates the warm-up characteristic of the 9M-MRO SDU. After power is restored to the SDU, the OCXO drift results in BFO value being above the steady state value until the OCXO has stabilised.***

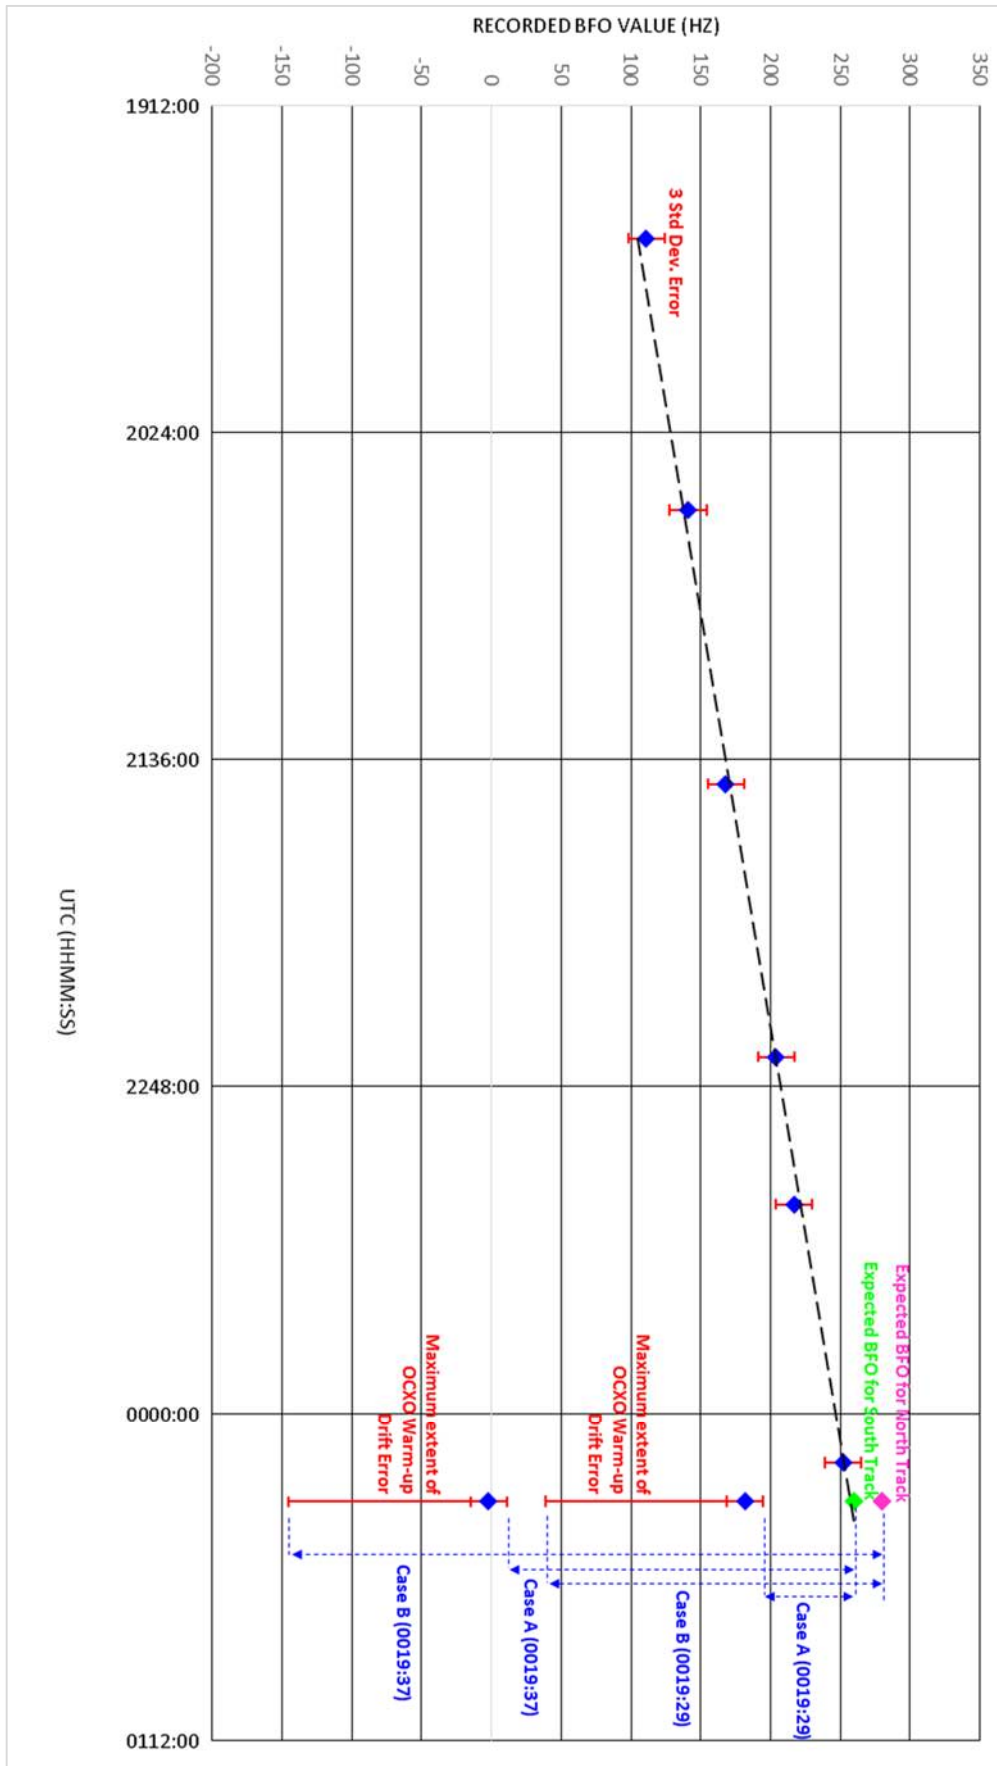
Figure 5: Association of BFO differences to descent at 00:19

00:19:37 log-on ACK	Case A (minimum)	Case B (maximum)
Predicted BFO level flight	260 Hz	280 Hz
Measured BFO	-2 Hz	-2 Hz
Possible error (3 std dev.)	13 Hz	-13 Hz
OCXO Drift	0 Hz	130 Hz
Derived descent rate	260 - (-2 + 13) = 249 Hz (249 / 1.7) * 100 ≈ 14,600 ft/min	280 - (-2 - 13 - 130) = 425 Hz (425 / 1.7) * 100 ≈ 25,000 ft/min

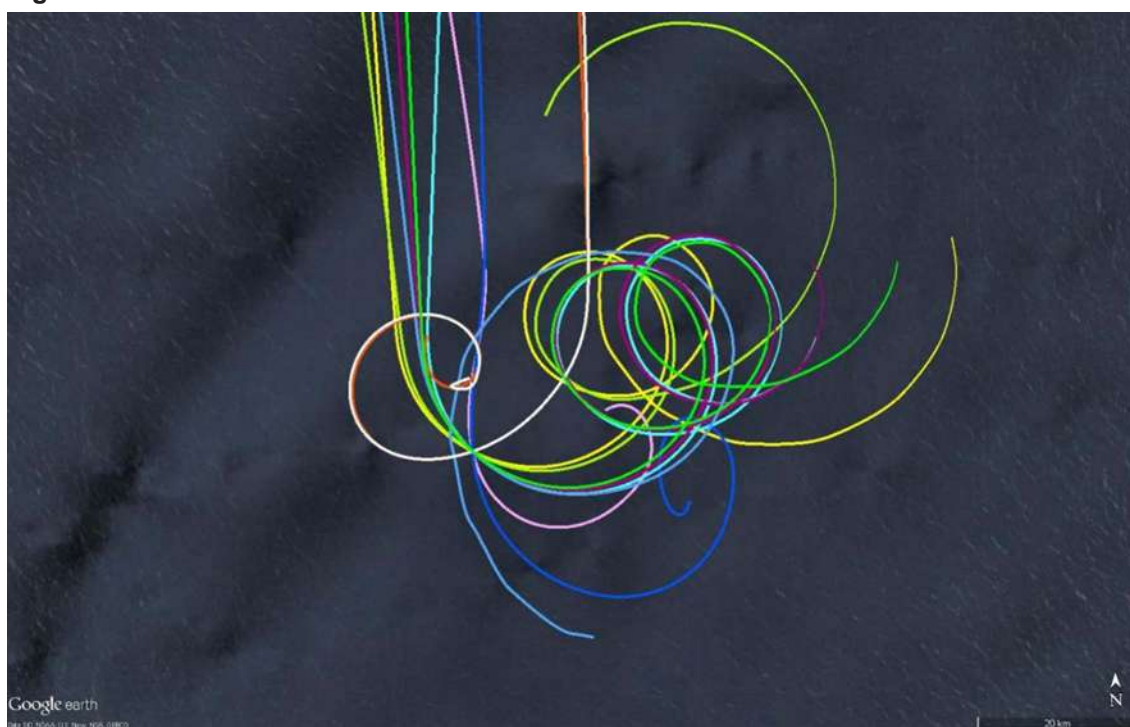
**Figure 6: Results from simulated scenarios**

***This figure illustrates the resulting flight paths from the simulations performed by the manufacturer and aligned at a point consistent with when the final BTO transmission may have occurred.***

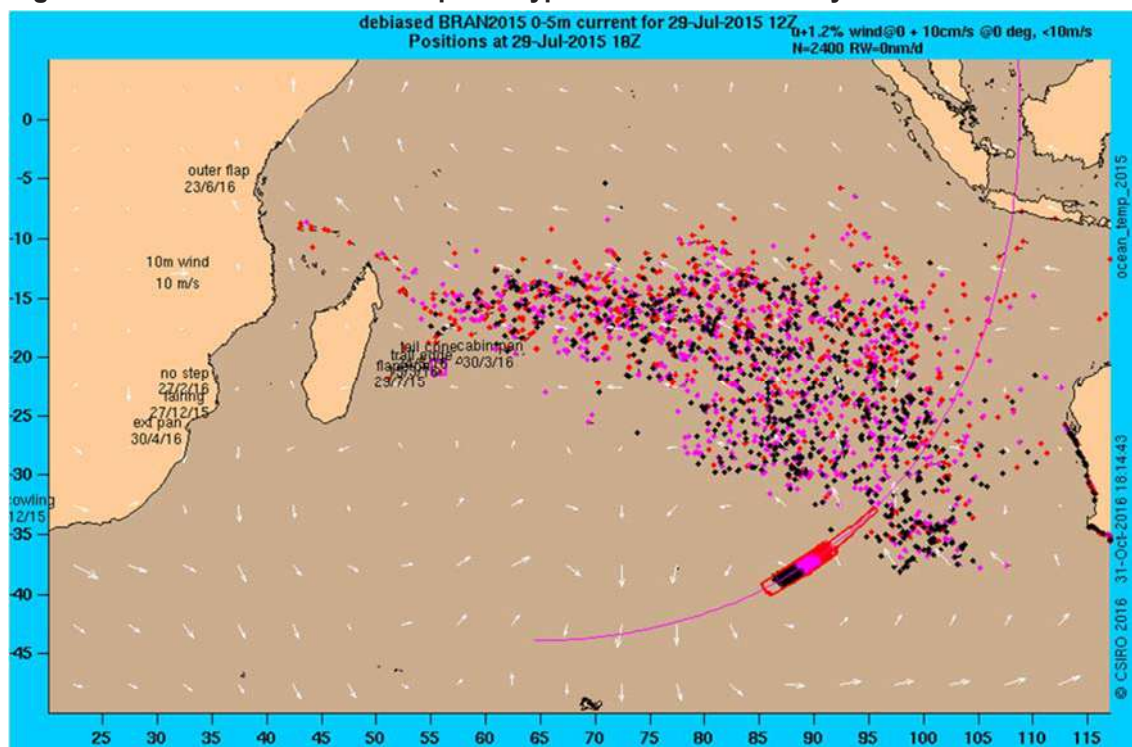
**Figure 8: Simulated location of flaperon-type drifters after 500 days**

Using the collected field data, a new forward-tracking numerical simulation was performed. Within the simulation, flaperons were deployed on and around the current search area and allowed to drift freely. Results after 500 days of simulated drift are presented in Figure 8. For comparison, Figure 9 shows the results of a simulation where the original undrogued drifter model was used. By comparing the two figures, it can be seen that the flaperons generally moved further west within 500 days due to the extra speed at low winds.

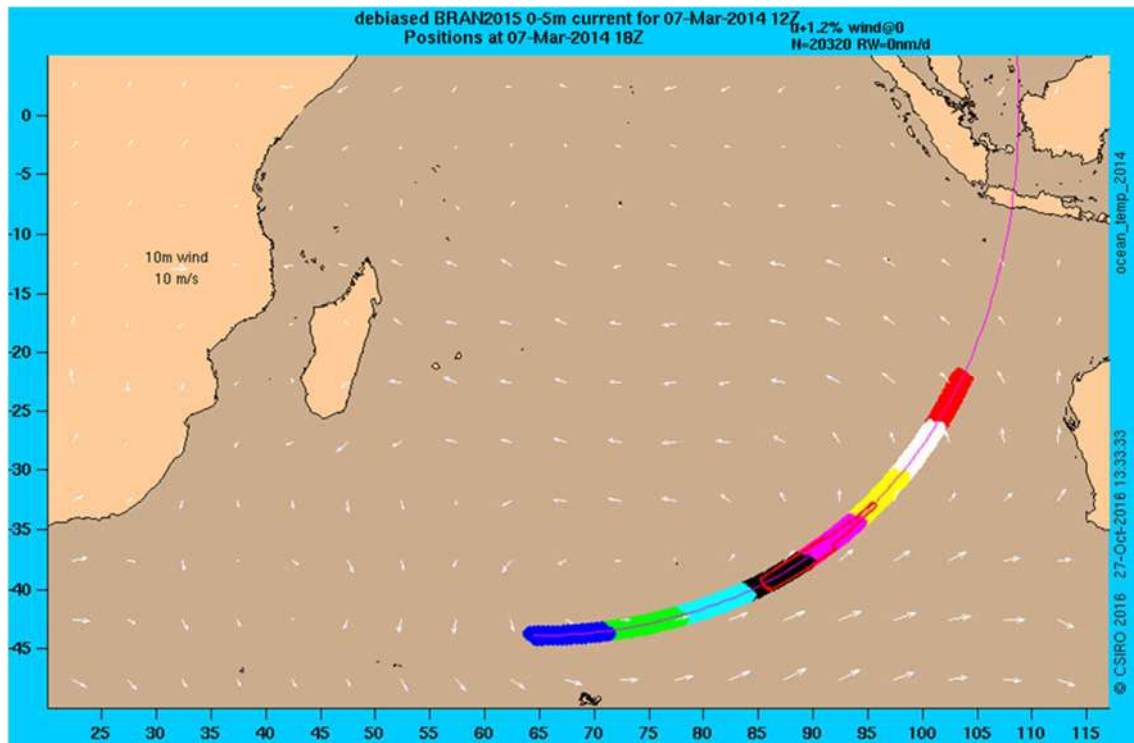
Figure 10: Simulated starting location of undrogued drifters

Figure 10 illustrates the starting location of the simulated drifters along the 7<sup>th</sup> arc. After eight months of simulated drift (Figure 11), some initial conclusions can be drawn about the drifter's path with respect to debris discovered to date. A significant number of drifters arrived on the coast of Western Australia. Similarly, a number of drifters had arrived on the coast of Africa. The colour of each drifter identifies its starting location as marked along the arc.

- Drifters starting in the southern half of the current search area or below (dark blue, green, light blue) can be observed on and around the coast of Western Australia, with many drifting towards Tasmania. No debris has been discovered on the Australian coast. This indicates that a starting location within the current search area, or further north, is more likely.
- A significant number of red drifters have already reached the coast of Madagascar and mainland Africa. This is not consistent with the time at which debris was discovered. The first item of debris was not discovered on Reunion Island until 16 months after the accident. This suggests a reduced likelihood of debris originating from the northernmost areas shown in Figure 10 (red and white coloured regions).

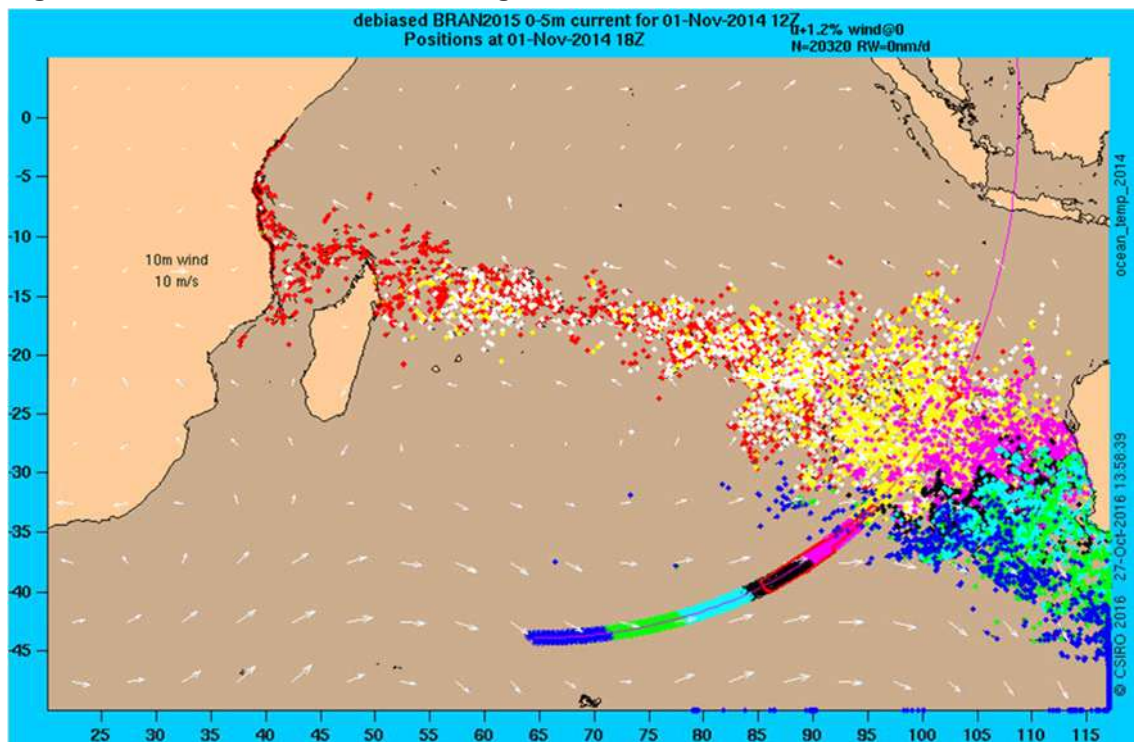
Figure 11: Simulated location of undrogued drifters after 8 months

*A significant number of drifters from the light blue and green areas have made landfall on the West Australian coast. Similarly, drifters from the red and white areas have begun to make landfall on the African coastline. Neither are consistent with times and/or locations at which MH370 debris was discovered, therefore reducing the likelihood of debris originating from these locations.*

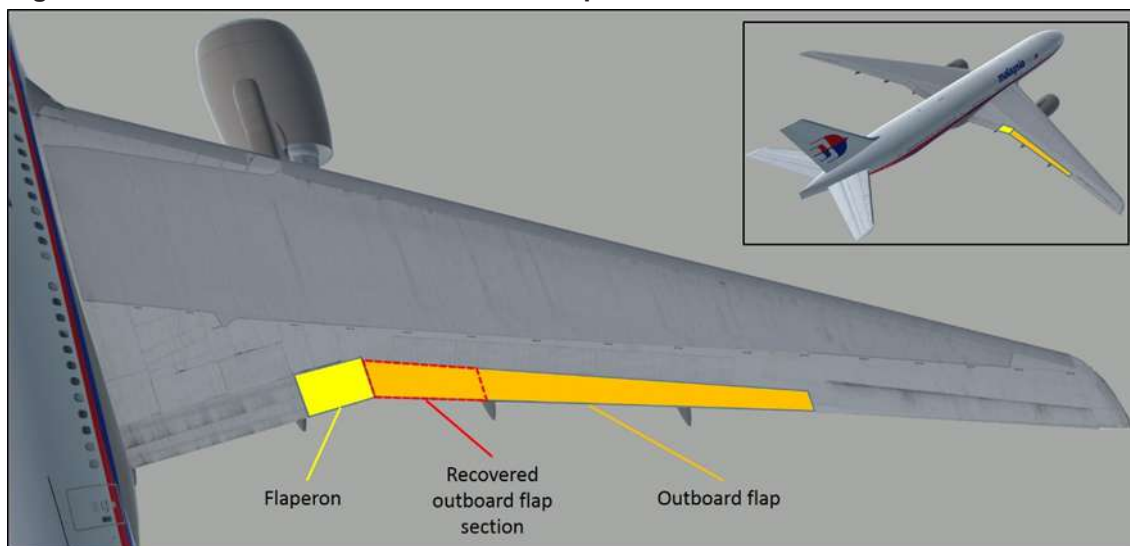
**Figure 12: Location of recovered outboard flap section**

The recovered right, outboard wing flap section (Figures 12, 13 and 14) was examined for any evidence of interaction with mechanisms, supports and surrounding components that may indicate the state of flap operation at the time of fracture and separation from the wing. The purpose of the examination was to inform the end-of-flight scenarios being considered by the search team. The most significant items of evidence in relation to this are documented below.

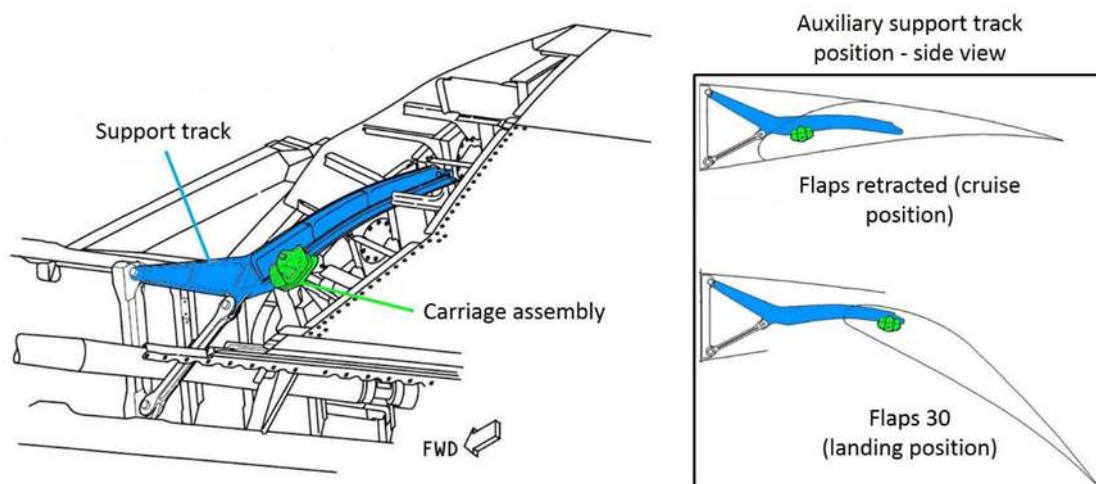
**Figure 15: Outboard flap, inboard auxiliary support**

A fibreglass and aluminium seal pan is located at the inboard end of the outboard flap. It houses the inboard auxiliary support, comprising a deflection control track (support track) and carriage assembly. The support track is affixed to the rear of the wing. Using rollers in the carriage assembly, the inboard end of the flap is guided along the support track as the flap moves through its deflection range. The track is fully inserted into the flap in the 'up' position and progressively withdrawn from the flap as the flaps are deployed (Figure 15). The inboard auxiliary support track and carriage assembly were not present with the recovered debris.

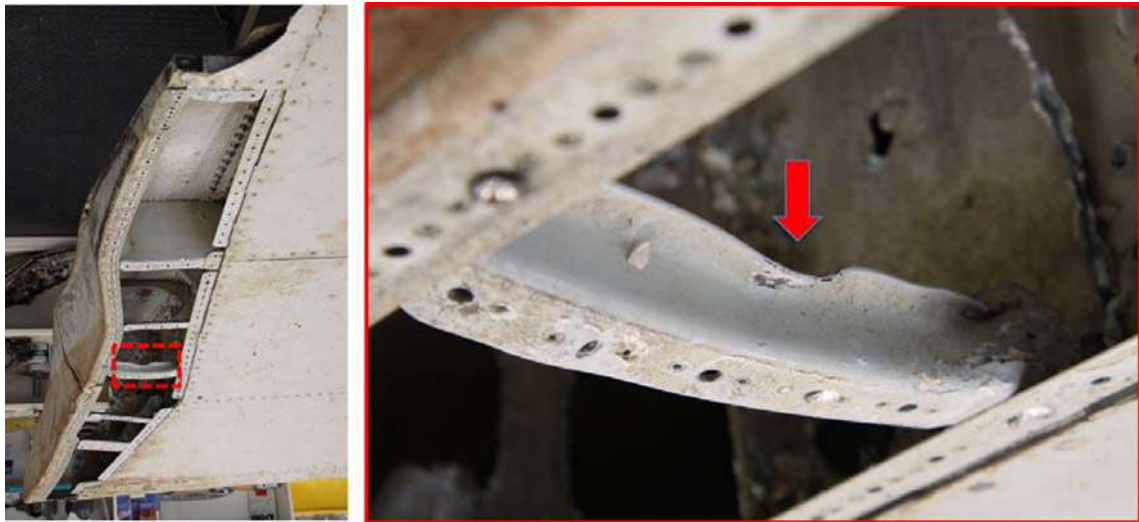
**Figure 17: Outboard flap, damaged stiffeners within the seal pan cavity**

An outwards-fracture of the fibreglass seal pan initiated at a location adjacent to the damaged aluminium stiffeners (Figure 19). The damage was most likely also caused by impact from the support track. That damage provided further evidence of the support track position within the flap seal pan cavity, indicating that the flaps were retracted at the point of fracture and separation from the wing.

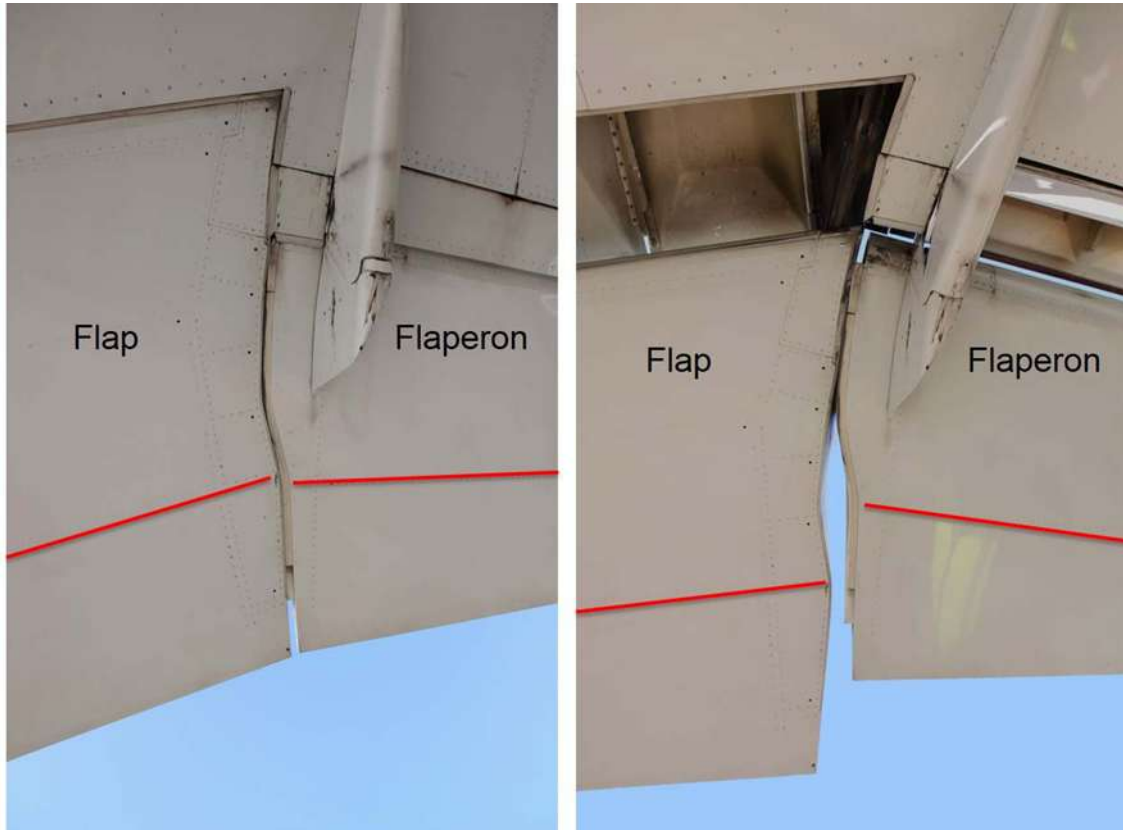
**Figure 22: Flaperon and outboard flap from below, showing relative alignment of rear spar rivet line (highlighted) in the flaps retracted (left) and extended position (right)**

The flap seal pan was also fractured adjacent to the rear spar. The fracture resulted from external impact, puncturing the fibreglass and plastically deforming the supporting aluminium structure within the seal pan cavity (Figure 20). Comparable damage was noted at the outboard, rear spar and surrounding structure of the adjacent flaperon (Figure 21). It was noted that the two areas in question are aligned when the flaps are in the retracted position, with a significant offset existing at other stages of flap extension (Figure 22).

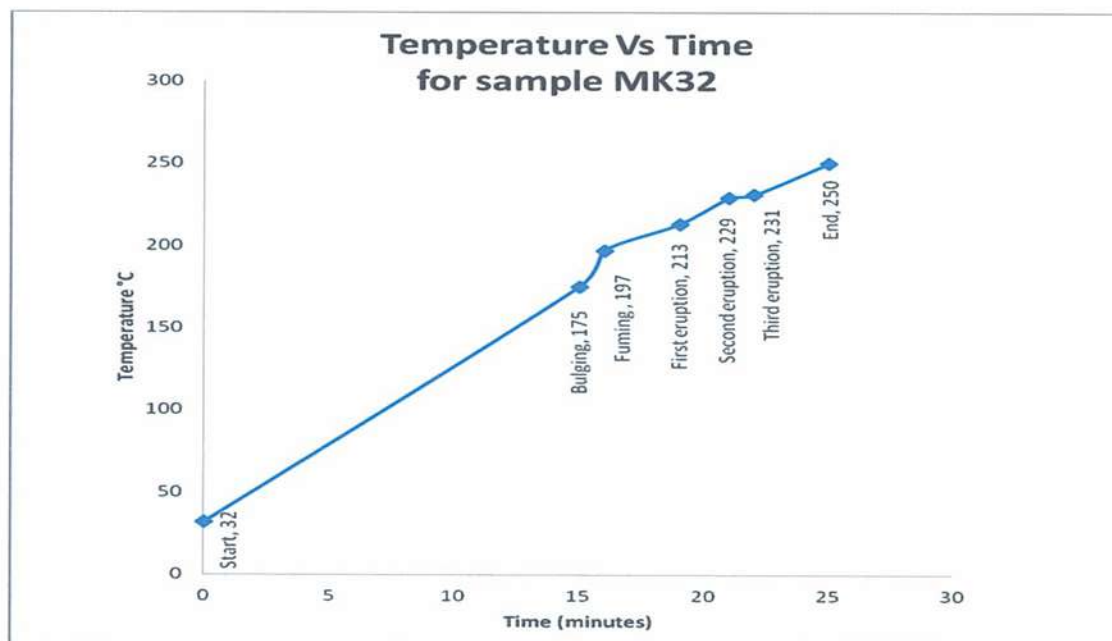
**Test No. 1: Test Results On Barang Kes Bertanda: MK32**

Test Date		6 May 2014 (start at 1435 hrs)	
Event Sequence	Duration (Minutes)	Temperature Applied	Observation
1	0	32°C	Starting
2	15	175°C	Sample surface starts bulging (observable)
3	16	197°C	Fuming starts to developed
4	19	213°C	The first eruption sound with thick fumes
5	21	229°C	The second eruption sound with thick fumes
6	22	231°C	The third eruption sound with thick fumes
7	25	250°C	Fumes continue but subside. Test end.

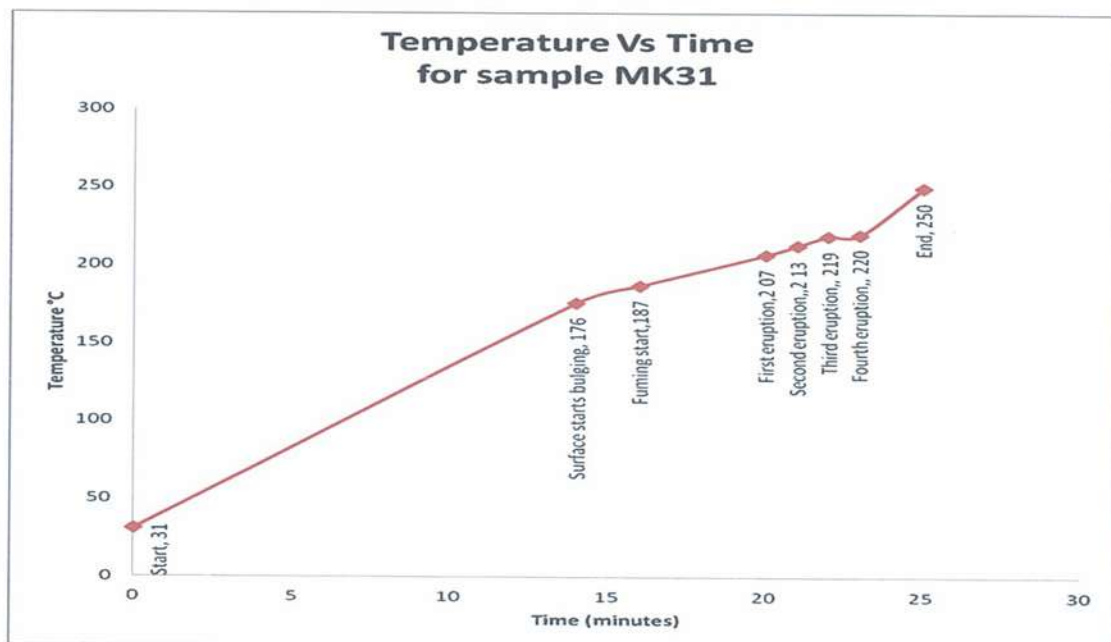
**Test No. 2: Test Results On Barang Kes Bertanda: MK31**

Test Date		7 May 2014 (start at 1505 hrs)	
Event Sequence	Duration (Minutes)	Temperature Applied	Observation
1	0	31°C	Starting
2	14	176°C	Sample surface starts bulging (observable)
3	16	187°C	Fuming starts to developed
4	20	207°C	The first eruption sound with thick fumes
5	21	213°C	The second eruption sound with thick fumes
6	22	219°C	The third eruption sound with thick fumes
7	23	220°C	The fourth eruption sound with thick fumes
8	25	250°C	Fumes continue but subside, end test.

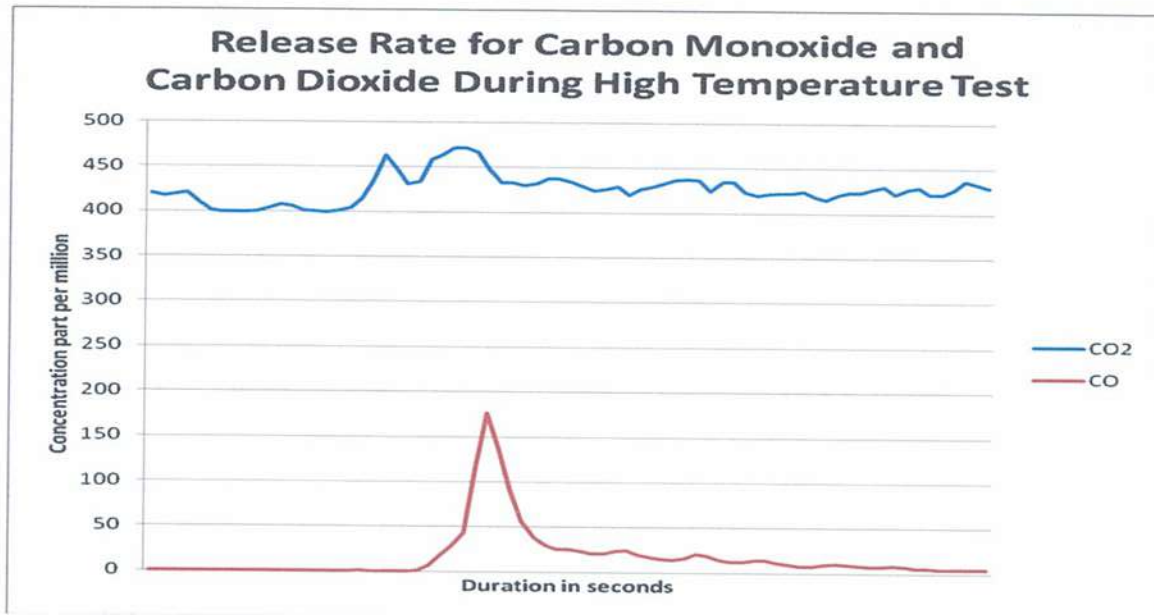
RESULTS

Maximum Fume Release Rate of Carbon Monoxide (CO) is 176.5 ppm  
Maximum Fume Release Rate of Carbon Dioxide (CO<sub>2</sub>) is 471 ppm

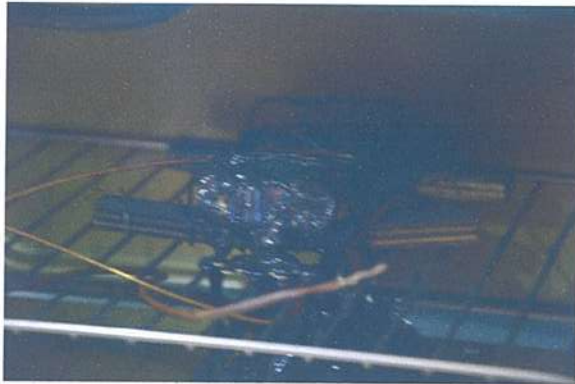
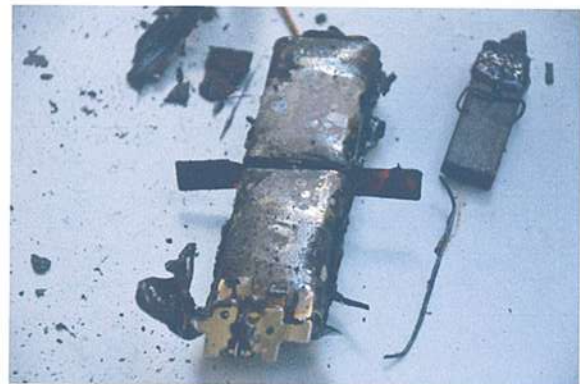
**Left overs after High Temperature Test were applied to Barang Kes bertanda: MK32 of Lithium Ion Battery Model: PMNN 4081BRC**

- a. It is found that both Barang Kes Bertanda: MK31 and Barang Kes Bertanda: MK32 experience 'Bulging' and then produced toxic fumes (such as Carbon Monoxide and Carbon Dioxide) if they are exposed to high temperature between 175 °C to 197 °C.**
- b. It is found that both Barang Kes Bertanda: MK31 and Barang Kes Bertanda: MK32 experience ruptured and then eruption (small explosion with released of fumes), if they are exposed to high temperature between 207 °C to 231 °C.**

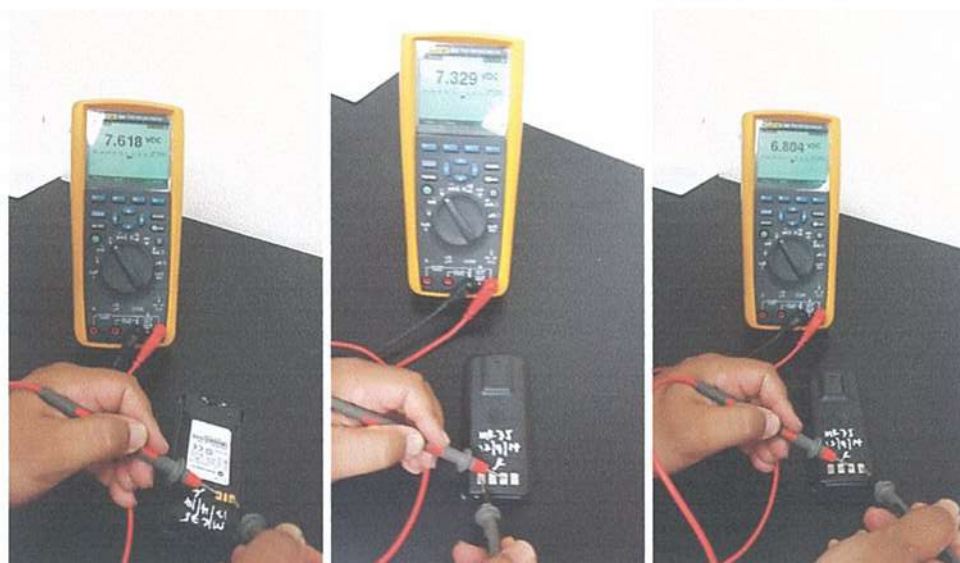
**Fig. 1 : Functional Test of Sample Battery Capacity**

Identification	Storage Voltage	Percentage (%)
Barang Kes: MK 27 Barang Kes: MK 28 Barang Kes: MK 29 Barang Kes: MK 30 Barang Kes: MK 31 Barang Kes: MK 32 Barang Kes: MK 33 Barang Kes: MK 34 Barang Kes: MK 35 Barang Kes: MK 36	<p><b>All sample give same quantity of Storage Voltage as follows:</b></p> <p><b>From Outside of battery ( 4 Charging Terminal)</b></p> <p><b>Between terminal T1 &amp; T3 Voltage measured is 7.3 V (up to 1 decimal)</b></p> <p><b>Between terminal T3 &amp; T4 Voltage measured is 6.8 V (up to 1 decimal)</b></p> <p><b>From Inside of battery ( 3x Walkie talkie Terminal)</b></p> <p><b>Between terminal T1 &amp; T3 Voltage measured is 7.6 V (up to 1 decimal)</b></p>	<p><b>For all sample the Average Storage capacity is about 60% from the original maximum Storage Voltage of 11 V.</b></p>

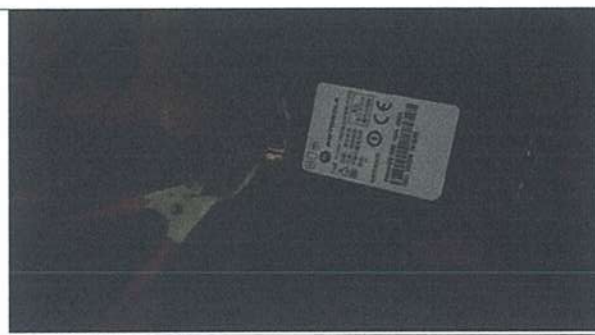
**Figure 2:**

When touching the 2 opposite terminals of the sample test battery, it is clearly observed the light due to sparking and the sparking sound is also heard. (without explosion).
