### Accident Investigation Final Report

All Engines-out Landing Due to Fuel Exhaustion

Air Transat  
Airbus A330-243 marks C-GITS  
Lajes, Azores, Portugal  
24 August 2001

22 / ACCID / GPIAA / 2001

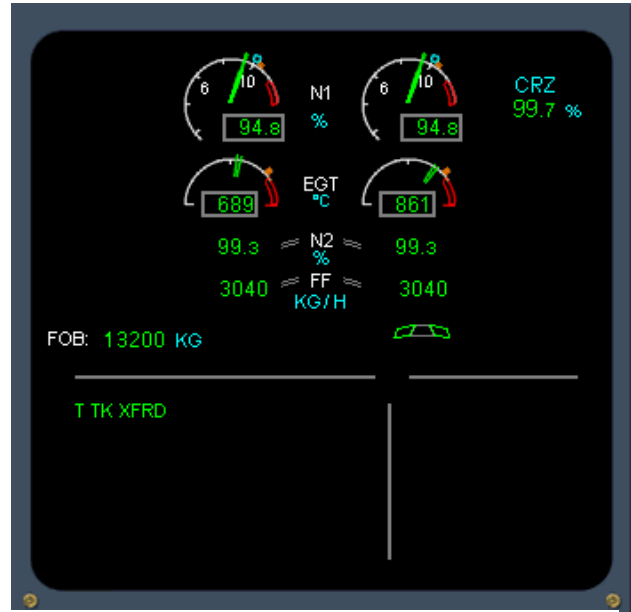
Figure 5 - E/WD & Trim Tank Transferred Memo

A trim tank is located in the THS. The trim tank transfer system is a fully automatic mode system that controls the center of gravity of the aircraft. When the aircraft is in cruise, the primary Fuel Control and Management Computer (FCMC) calculates the C of G and compares the result to a target value that depends on the aircraft actual weight. From this calculation, the FCMC optimizes the C of G by deciding to transfer fuel to or from the trim tank. There is normally only one aft transfer at the beginning of the flight. During the flight, there is a series of small forward transfers. If the actual C of G is different from the target C of G by more than 0.5% and the aircraft is above Flight Level 255, an appropriate transfer occurs. If an inner tank quantity drops below 4 000 kg, forward transfer also occurs to maintain the fuel in the inner tanks between 4 000 kg and 5 000 kg until the trim tank is empty. If during a forward transfer the inner tanks are out of balance by more than 500 kg, the transfer is automatically stopped on the heaviest side until the fuel balance is achieved. A final forward transfer occurs when the time to destination is less than 35 minutes, when either set of wing tanks is below 4.0 tons, or when the aircraft descends through FL245. When fuel is being transferred, a "TRIM TANK XFR" message appears on the ECAM Memo screen; when the trim tank is empty, a "TRIM TANK XFRD" message appears on the ECAM Memo portion of the E/WD screen.
