**Aircraft Accident Investigation Bureau**

**Interim Investigation Report on**

**Accident to the B737-8 (MAX) Registered ET-AVJ operated by  
Ethiopian Airlines**

**On 10 March 2019**

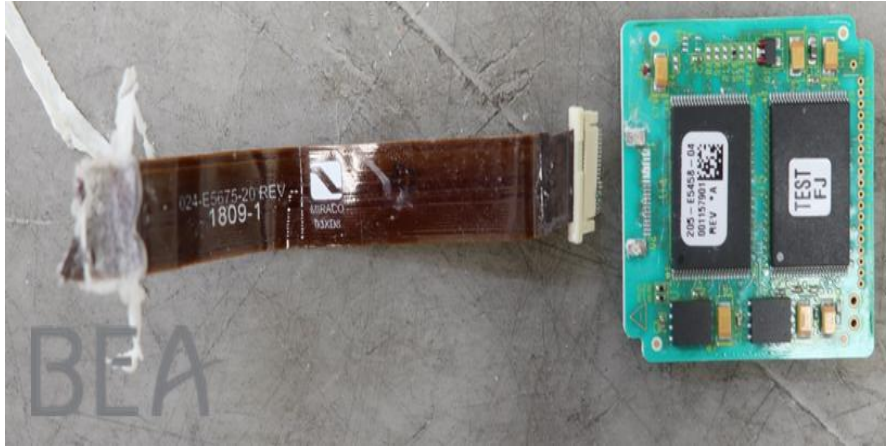
FIGURE26 : FDR MEMORY BOARD, FLEX AND CONNECTOR

The memory board was visually inspected with a Keyence microscope. Apart from the connector pads, the memory board was in good condition. There was no trace of impact. The two memory chips as well as the micro-processor were found in good condition.

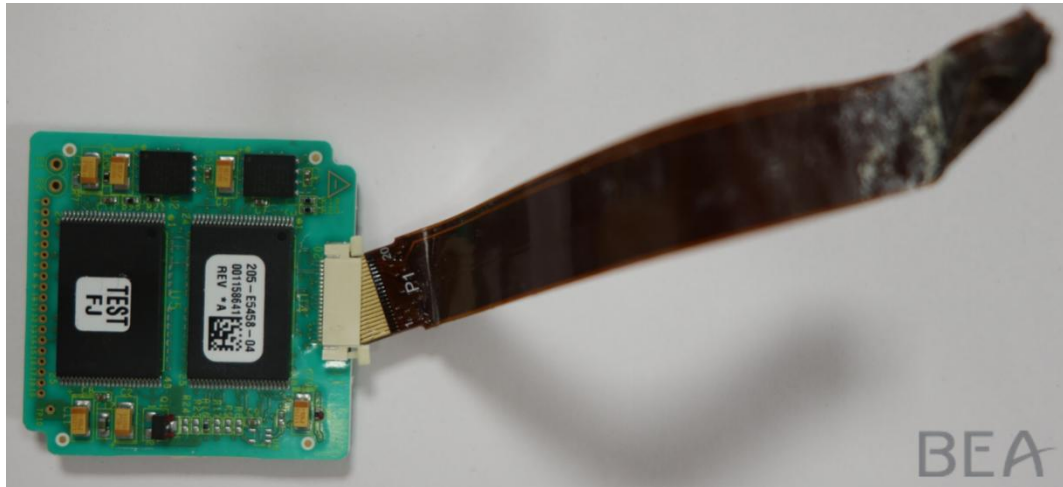
FIGURE 31: CVR MEMORY BOARD AND FLEX

The CVR memory board and flex were visually inspected with the Keyence microscope. There was no damage on the board and the connector was in good condition. A second observation with the X-ray was made, which confirmed that the connector soldering were in good condition.

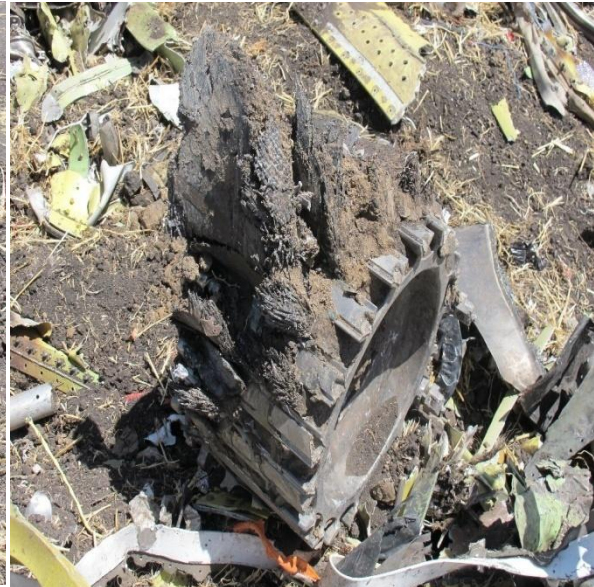
FIGURE 37: - R/H ENGINE - S/N 602695 - FAN DISK

The right engine core was recovered from the site and examined by the group. The recovered core of the right engine was more damaged than the left-hand engine. The engine was reportedly recovered at a depth of approximately 10 to 15 meters depth on the right side of the excavation site.

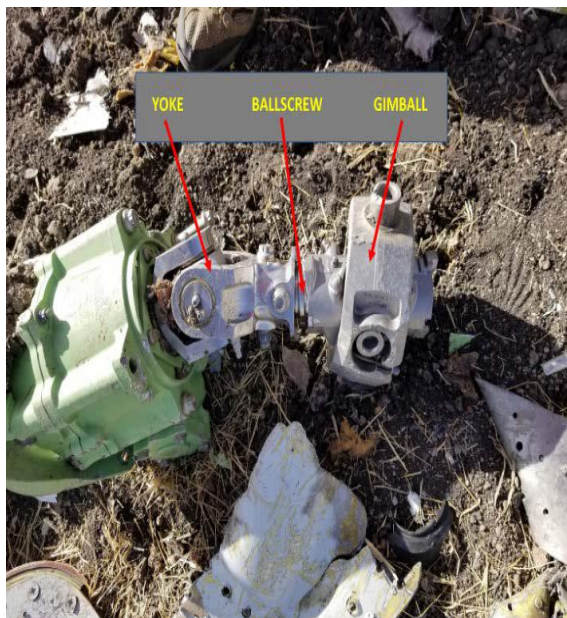
**FIGURE45: FLAP TRANSMISSION & BALLSCREW**

Two parts of the actuation system were located and examined at the impact site. One consists of the ballscrew, yoke, gimbal and flap transmission; the other consists of just the ball screw, yoke, and gimbal (see **Figures** respectively).

The installed location of each unit has not been identified. The position of each gimbal is consistent with the flaps in the fully retracted position.

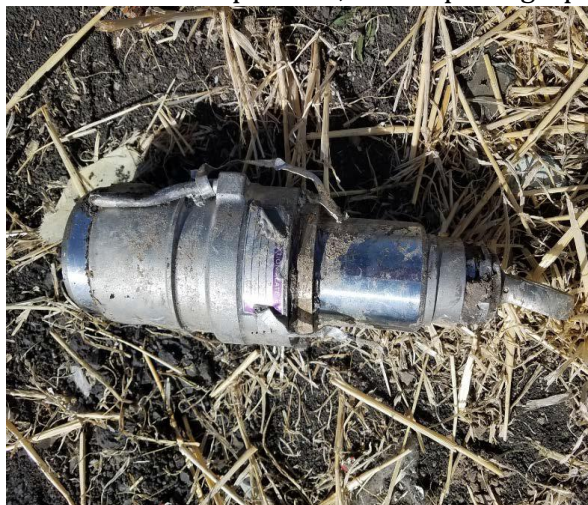
FIGURE 48: SLAT ACTUATOR (POSITION UNKNOWN)

Two of the 8 leading edge slat actuators were photographed (see Figures below) at the impact site. The installed location for each actuator has not been identified. The actuator position, as photographed, is in the fully retracted position.

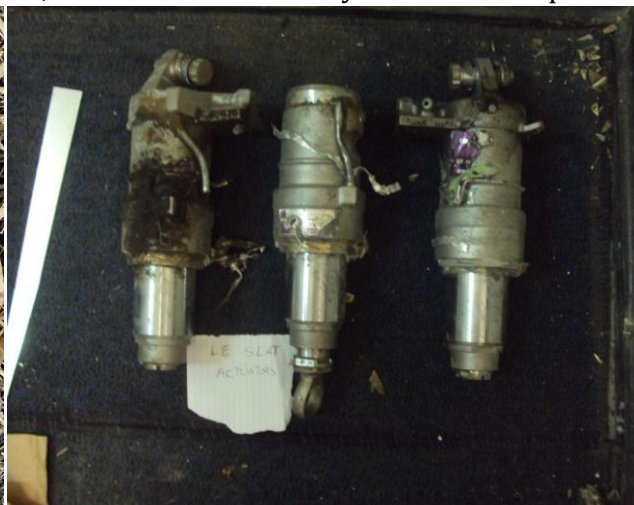
FIGURE 49: LEADING EDGE SLAT ACTUATORS

During the examination of the wreckage pile located at the Addis Ababa airport AIB store the Airworthiness group identified a total of three leading edge slat actuators at the impact site. The actuator position, as photographed, are in the fully retracted position,

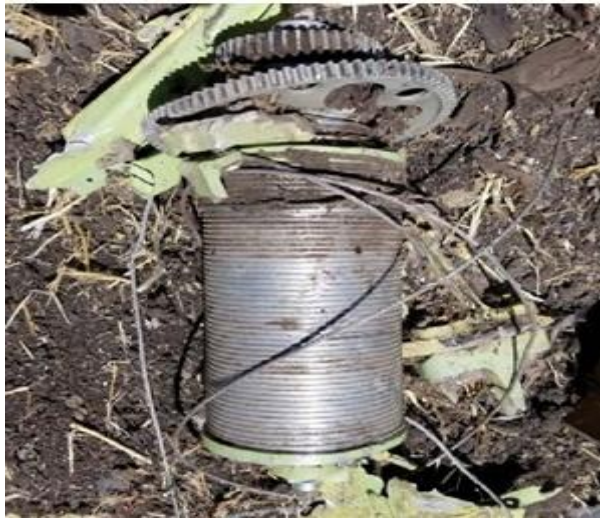
FIGURE 50:AFT CABLE DRUM

Two parts of the control system were located and examined at the impact site. One consists of aft cable drum; the other consists of the stab trim actuator (see Figures below respectively). These components do not provide any evidence of what position the horizontal stabilizer may have been at the time of impact.

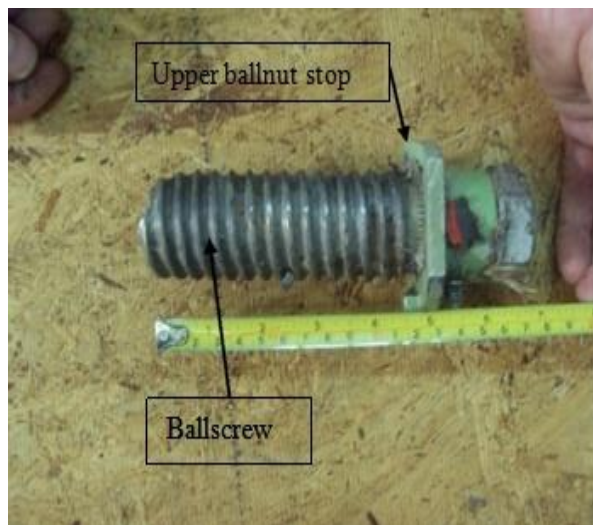
FIGURE53:UPPER BALLSCREW SEGMENT

Examining the fracture surfaces, the upper screw segment fits with the fracture face just inside the ballnut giving a measurement between the stops on the ballnut and the upper ballnut stop of ~5". Referencing Boeing document D251A122 (737NG Control Position Data), this measurement equates to a stabilizer trim setting of 1.5 degrees Airplane Nose Down (AND) or an indicated position of 2.5 units of trim. Although the data is for the 737NG, the position of the MAX stab trim holds the same relationship. According to Boeing:

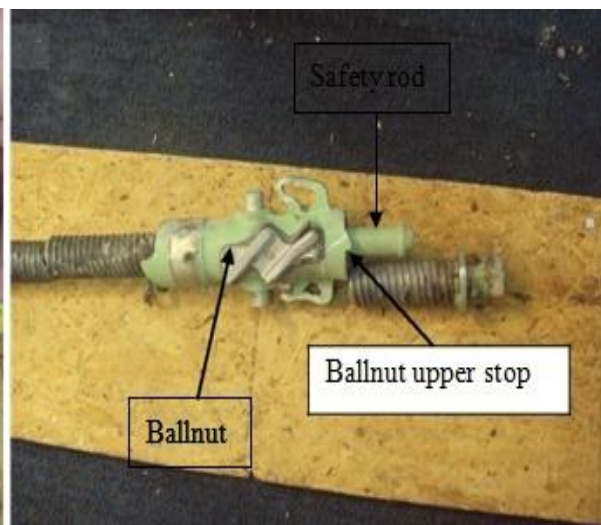
FIGURE 54: BALLNUT AND UPPER BALLSCREW SEGMENT

The figure below shows the relationship of the ballnut position along the ball screw. There is a safety rod which acts as a secondary load path should the ball screw fracture in service for any reason. It is attached to a separate set of secondary gimbals below the primary support gimbals on the primary brake housing and to the top of the ball screw. Figure 54 shows the safety rod and that it protrudes out from the ball nut. However, the fracture faces on the 5" long upper screw portion (note the measurement in Figure 53) match those found near the ballnut upper stop. This is consistent with the safety rod being pulled out several inches prior to final fracture.

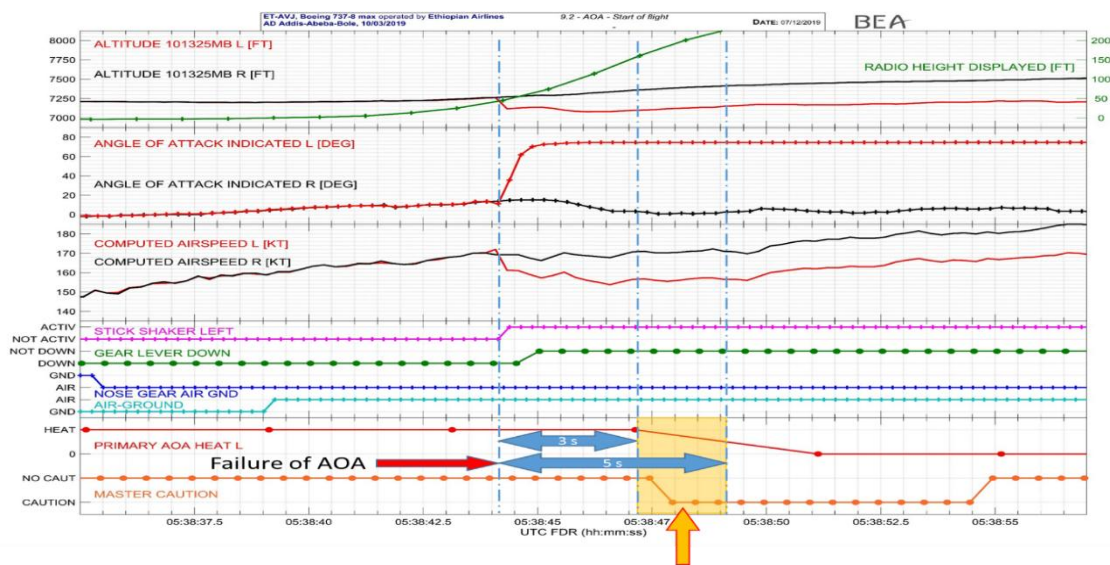
FIGUR  
E 56:

At 5 h 38 min 48 s, a master caution triggered. From that time, the primary AOA heat LH recorded values underlined a failure of the vane heating (first recorded OFF value at 5 h 38 min 51s, sampling rate of the parameter: 0.25 Hz). The reason of the master caution was the anti-ice left alpha vane indication.

The recorded computed airspeed values and the recorded corrected pressure altitude values were computed with the signal coming from the AOA sensor resolver No2. Their values were consistent with the shape of the LH AOA recorded values (for both parameters, an increase followed by a decrease). The triggering of the stick shaker underlined that the signal coming from the resolverNo1 matched also the LH AOA recorded values. Due to the way the AOA values were recorded, both resolvers of LH AOA sensor provided similar values. The failure impacted the signals provided by both resolvers of the LH AOA sensor.

According to the description provided in §1.6.3.3 it took between 3 to 5 s between the AOA heat failure and the triggering of the associated master caution. The LH AOA heat failure triggered at a time consistent with a single event leading to both heat failure and erroneous values from both resolvers at the same time.

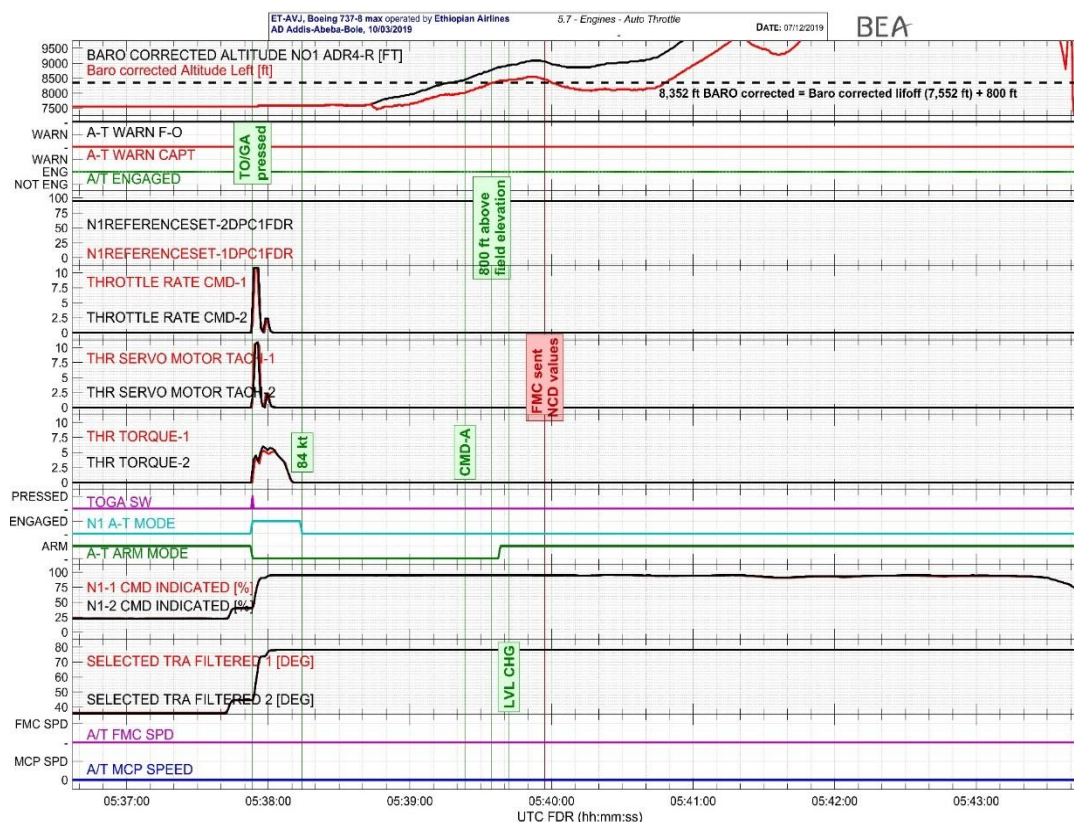
FIGURE 62: AUTO THROTTLE BEHAVIOR DURING THE FLIGHT OF THE EVENT

- At 05 h 37 min 53 s, the TO/GA switch was pushed. A/T switched to the N1 mode. The automatic takeoff and climb was engaged. A/T moved automatically the throttles forward (*THROTTLE RATE CMD*-[1/2] values, *THR TORQUE*-[1/2] values were positive). TRA did not move anymore until the end of the flight because the FMC used the LH baro corrected

altitude values, which were lower than the true ones. Thus, FMC did not detect the thrust reduction altitude when it was sending valid engine commands. And LH and RH TAS diverged by more than 25 kts the FMC did not send any valid N1 target values

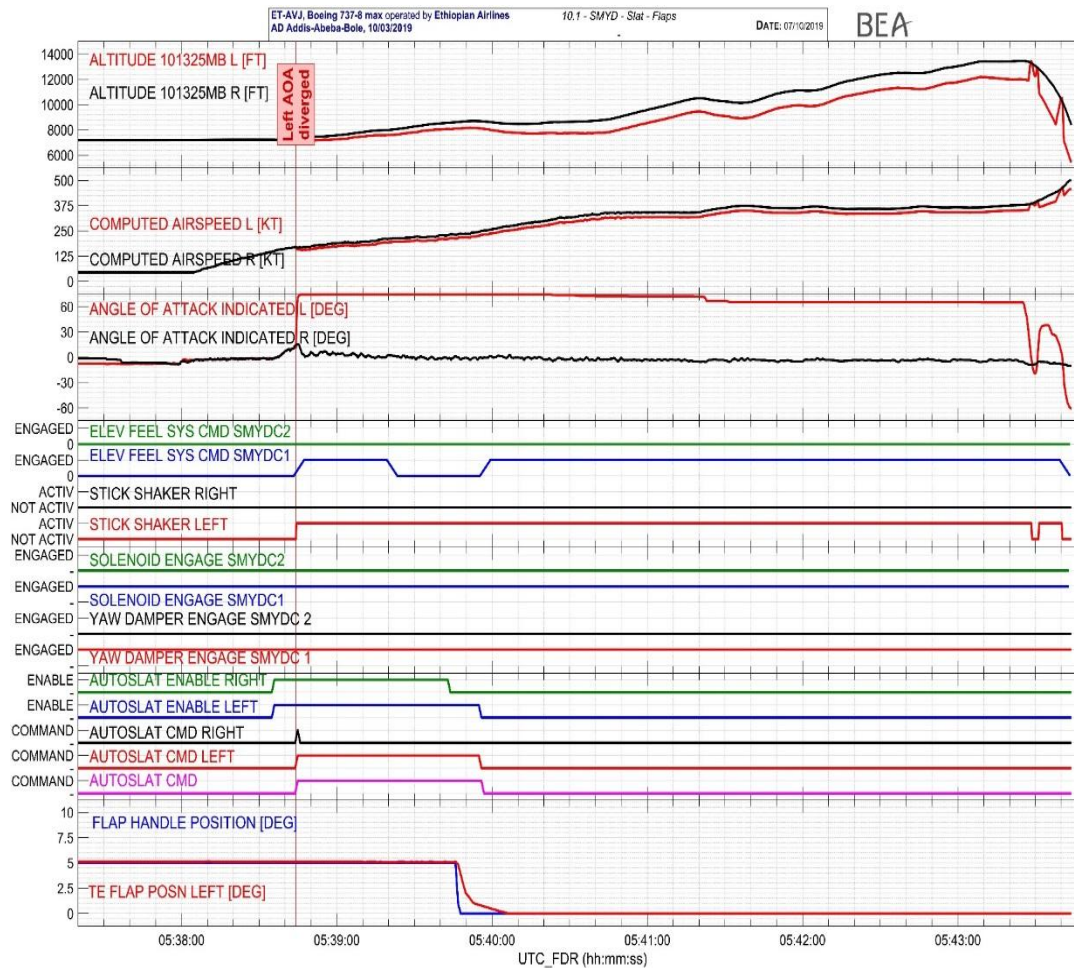
FIGURE63: AUTOSLAT, LEFT STICK SHAKER AND ELEVATOR FEEL SYSTEM

- the autoslat system triggered (SMYDC 1),
- the LH stick shaker engaged
- the LH elevator feel shift triggered.

At 5 h 39 min 56 s, the autoslat system stopped and the flap handle was at 0 position and flaps were moving up (flaps position lower than 1) with LH computed airspeed values reaching 230kt and RH computed airspeed value 250kt.

At 5h 39 min 44s SMYDC-2 disabled the RH autoslat function due to the RH computed airspeed (230kt reached). SMYDC1 disabled the LH autoslat function 12 s later due to the invalid LH computed airspeed.

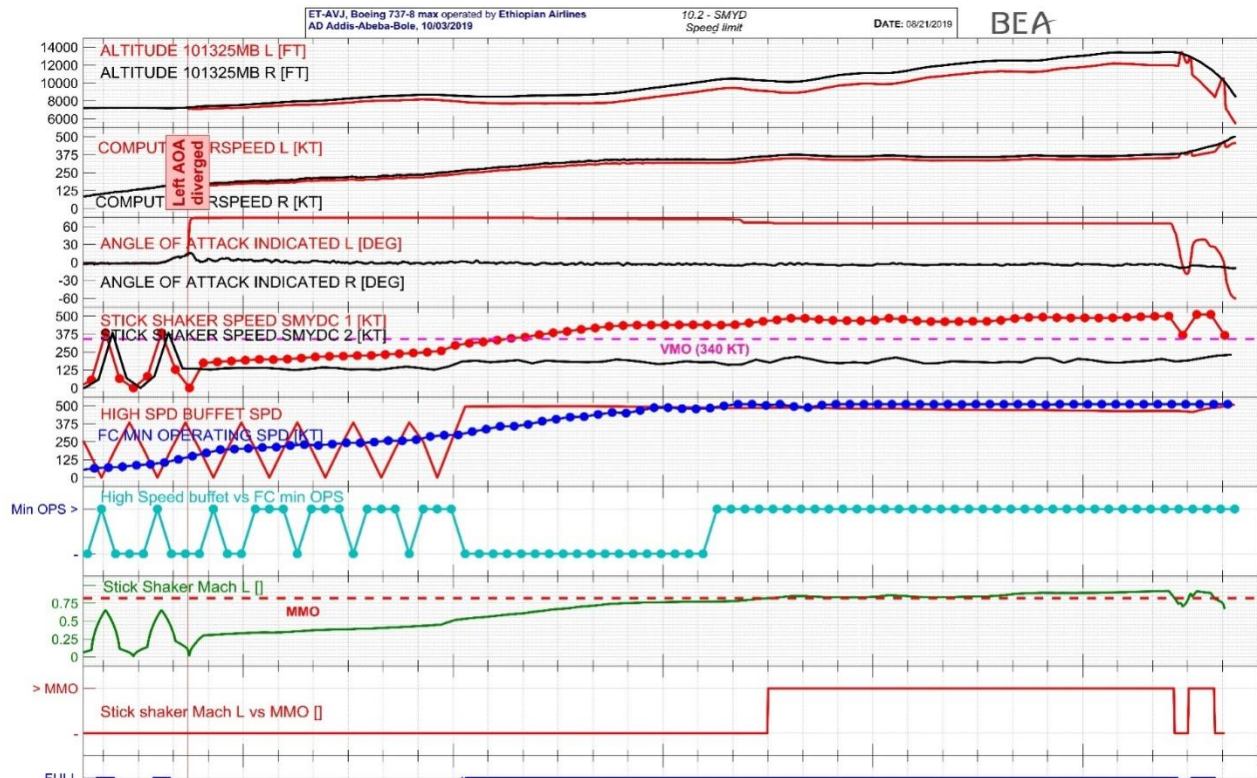
FIGURE 64: SMYD COMPUTED SPEEDS LIMITS

From 5 h 41 min 30 s until the end of the flight by computing the equivalent Mach number, the left Stick Shaker Mach computed numbers were greater than the MMO (0.82) ;

At 5 h 41 min 17 s, SMYDC1 computed FC minimum operational speed values greater than High speed values. Both values were computed by the same computer SMYDC 1.

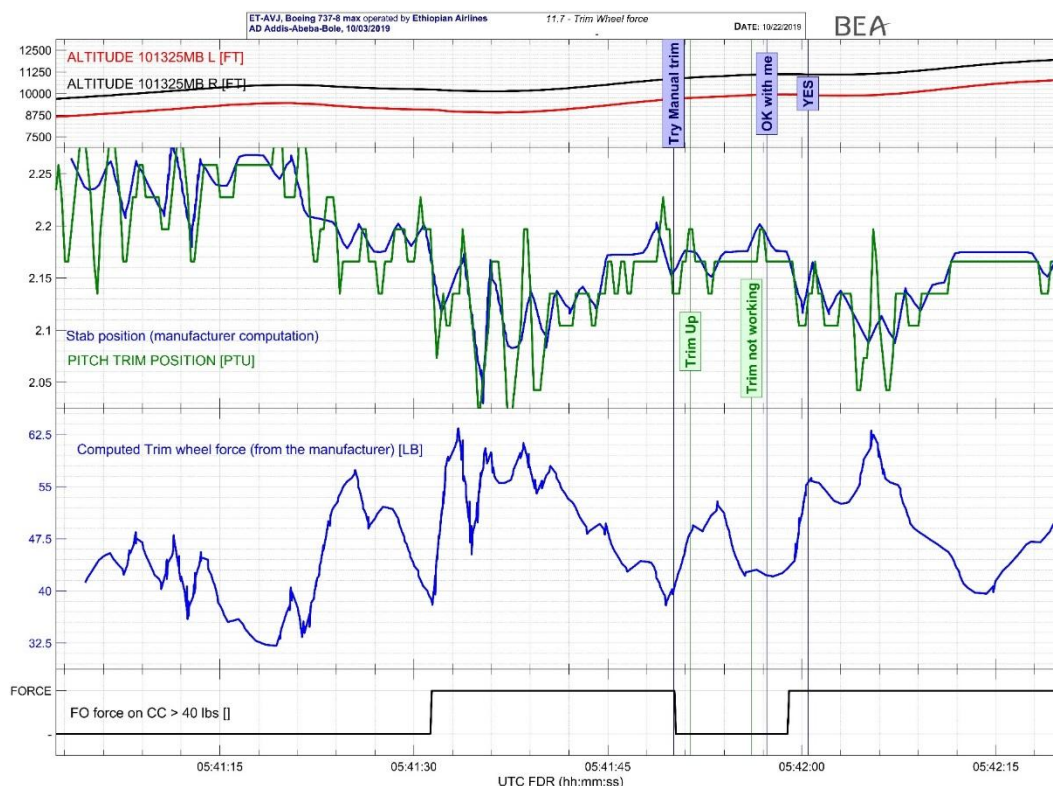
FIGURE 66: FORCE NEEDED TO MOVE THE TRIM WHEEL

By the time the FO tried to move the trim wheel manually a force between 42 lbs and 53 lbs was required according to the aircraft manufacturer computation, (see Figure 6).

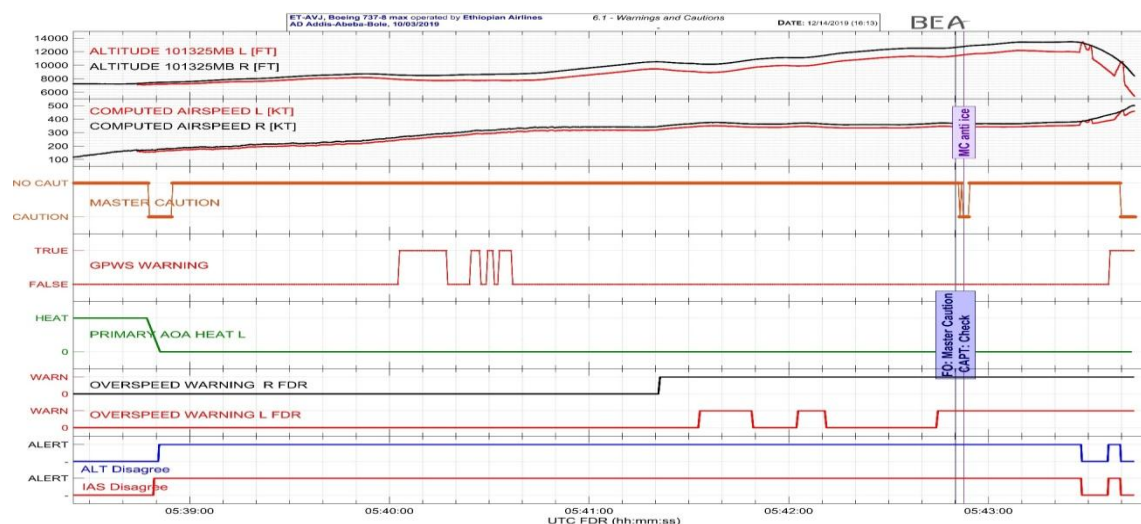
FIGURE 77: ALERTS DURING THE FLIGHT

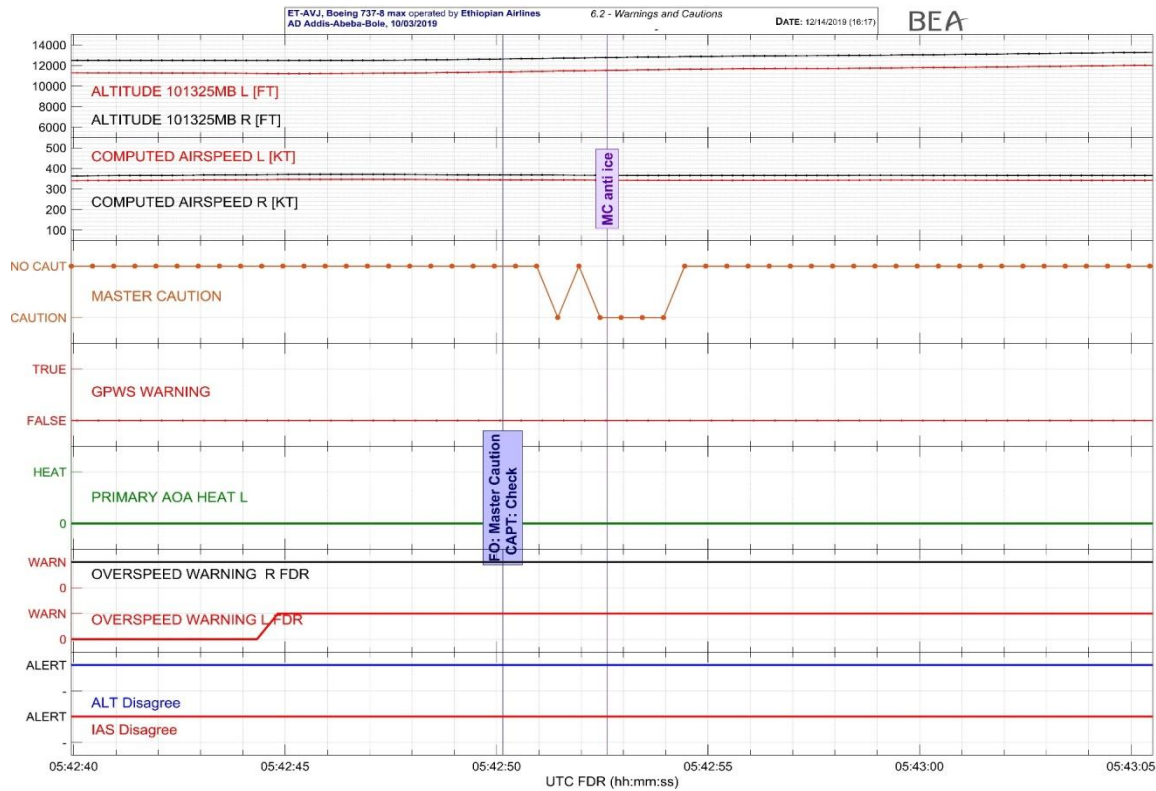
Then master caution triggered a second time at 5 h 42 min 51 s during 2.5 s. The crew detected: "Master Caution/anti Ice/left Alpha Vane".

FIGURE 78: MASTER CAUTION RECALL

The third master caution triggered at 5 h 43 min 40 s. This master caution is still under investigation.

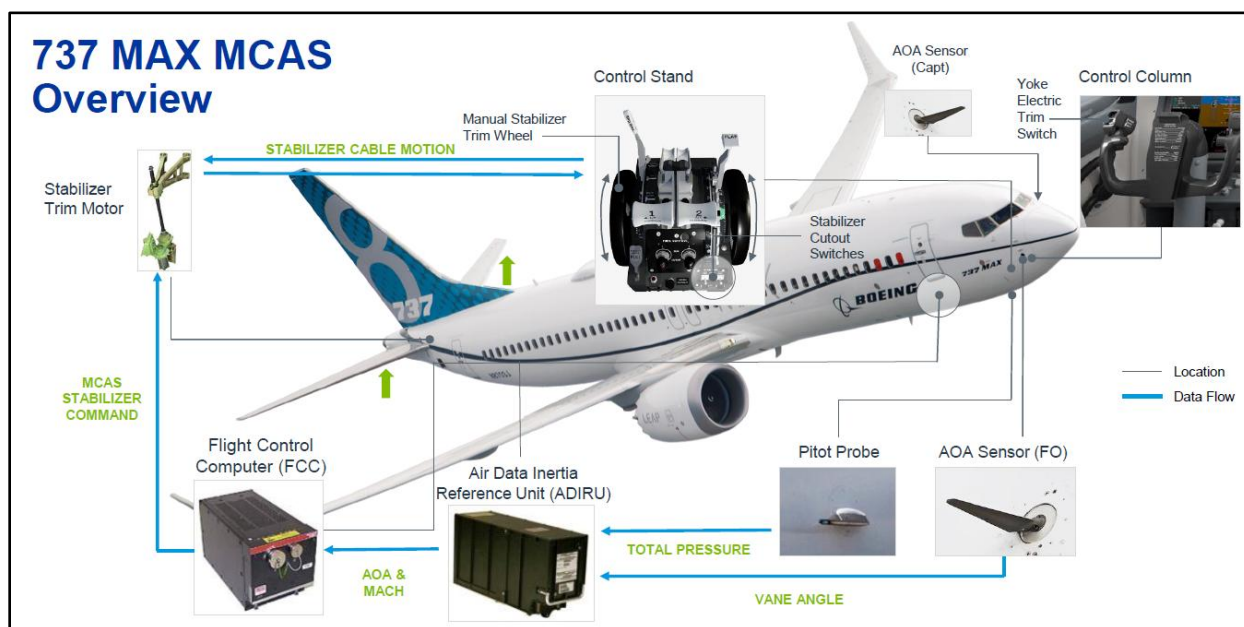
As originally delivered, the MCAS became active during manual, flaps-up flight (autopilot not engaged) when the AOA value received by the master FCC exceeded a threshold based on Mach number. When activated, the MCAS provided a high rate automatic trim command to move the stabilizer AND. The magnitude of the AND command was based on the AOA and the Mach. After the non-normal maneuver that resulted in the high AOA, and once the AOA fell below a reset threshold, MCAS would move the stabilizer ANU to the original position and reset the system. At any time, the stabilizer inputs could be stopped or reversed by the pilots using their yoke-mounted electric stabilizer trim switches, which also reset the system after a 5 second delay.

FIGURE 81: MCAS OVERVIEW

The latter behavior is based on the assumption that flight crews use the trim switches to completely return the airplane to neutral trim. In the FCC software version current at the time of the accident, if the original elevated AOA condition persists for more than five seconds following an MCAS flight control law reset, the MCAS flight control law will command another stabilizer nose down trim input (with the magnitude based on the AOA and Mach sensed at that time).
