**FINAL REPORT**

**the ACCIDENT of the FALCON 900B**

**registered SX-ECH,**

**- 14 September 1999 -**

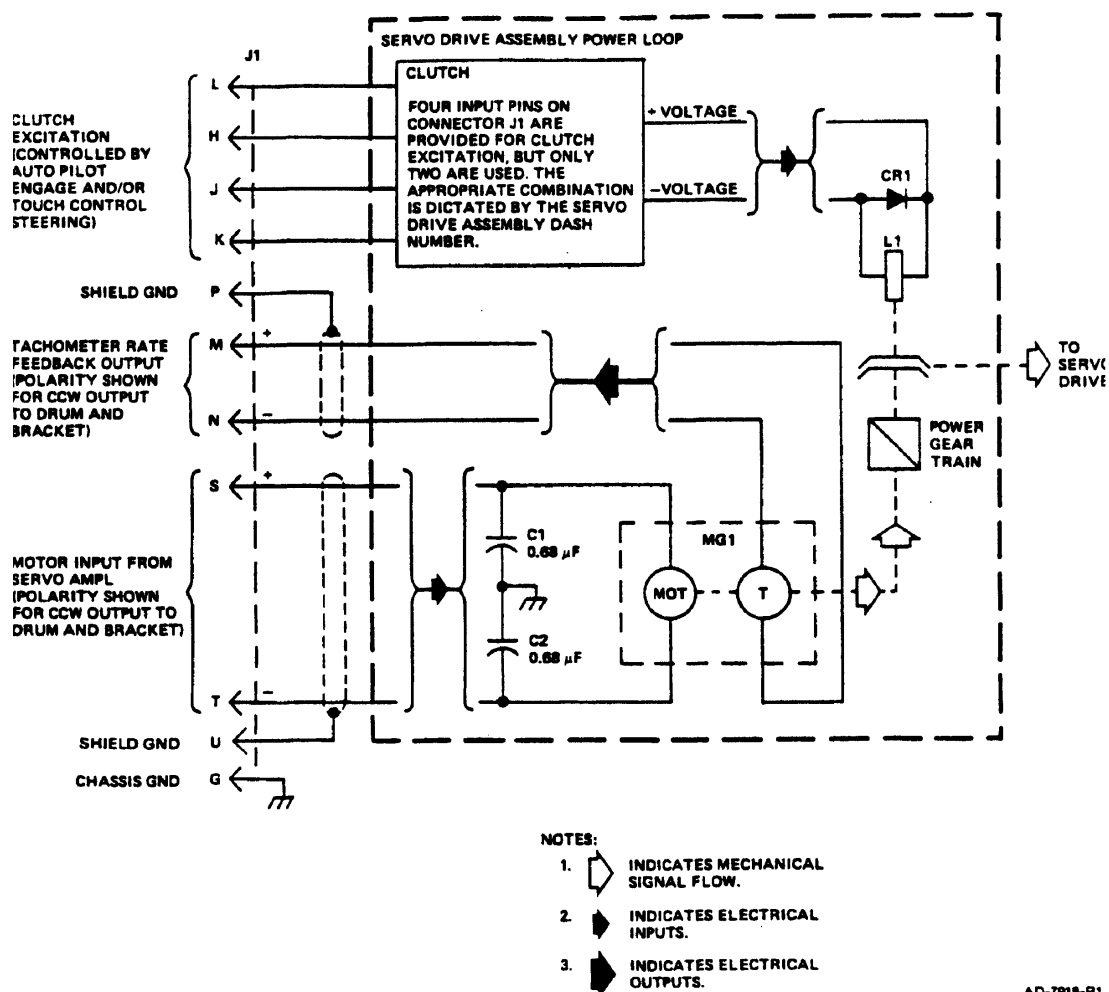
Figure: Elevator servo-motor operation

***Elevator servo-motor operation:*** The output of the servo amplifier is sent to the SM-300 elevator servo drive motor, the "A" processor current monitor to check for servo runaway current, and to the pitch trim threshold sensor.

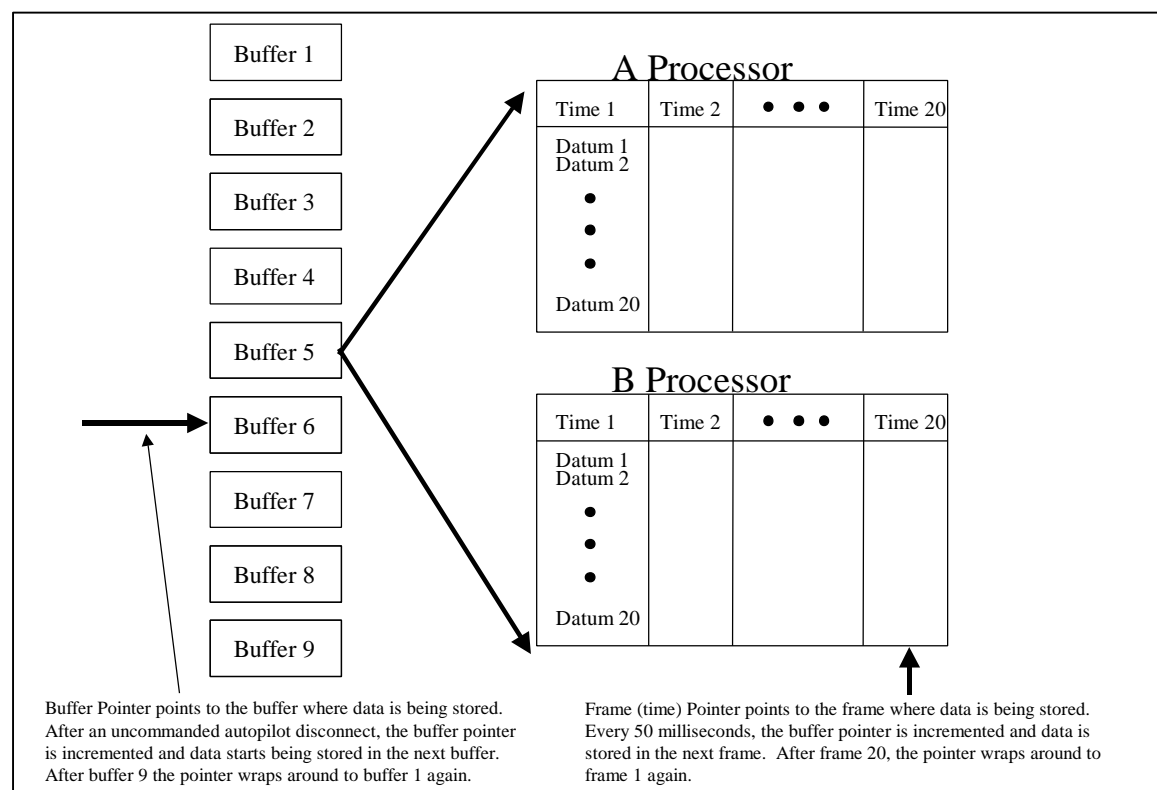
**Figure 1: NVRAM Data Structure**

Consequently, each buffer contains a one second snapshot of data prior to an uncommanded A/P disengagements. The computer continues to cycle through the buffers, retaining only the last eight events. There is no time or date stamp associated with each event.

Correlation of buffers with flight events requires comparison of parameters such as altitude or radio altitude with data recorded on the DFDR or crew reports.

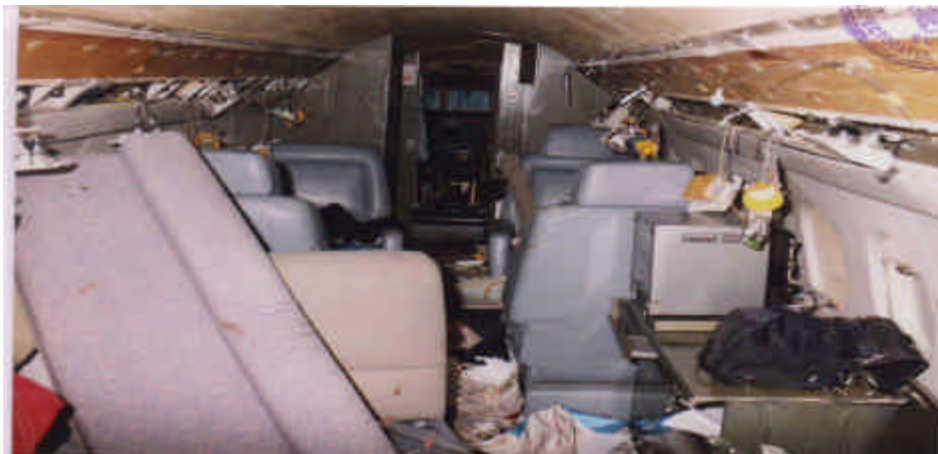
**Photo 3**

An aircraft interior presentation, after the accident, is illustrated in the photo 3 of Annex1.
