*Final Accident Report*

*Accident involving Sudan Airways Airbus 310*

*Registration ST-ATN*

*On 10<sup>th</sup> of June 2008 at 1726 UTC*

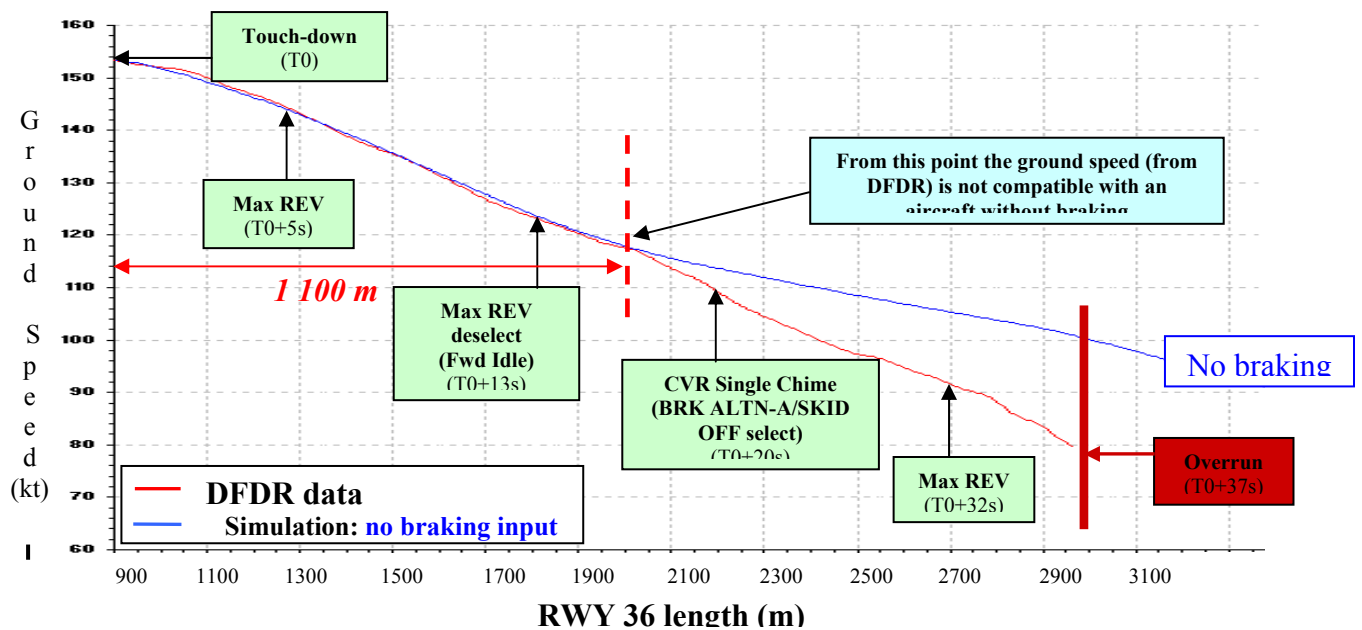
During the first 1 100 meters, the actual rollout matches with aircraft slowing down without braking.

After the first 1 100 meters, the actual rollout diverges from rollout without braking, which indicates that braking was effective

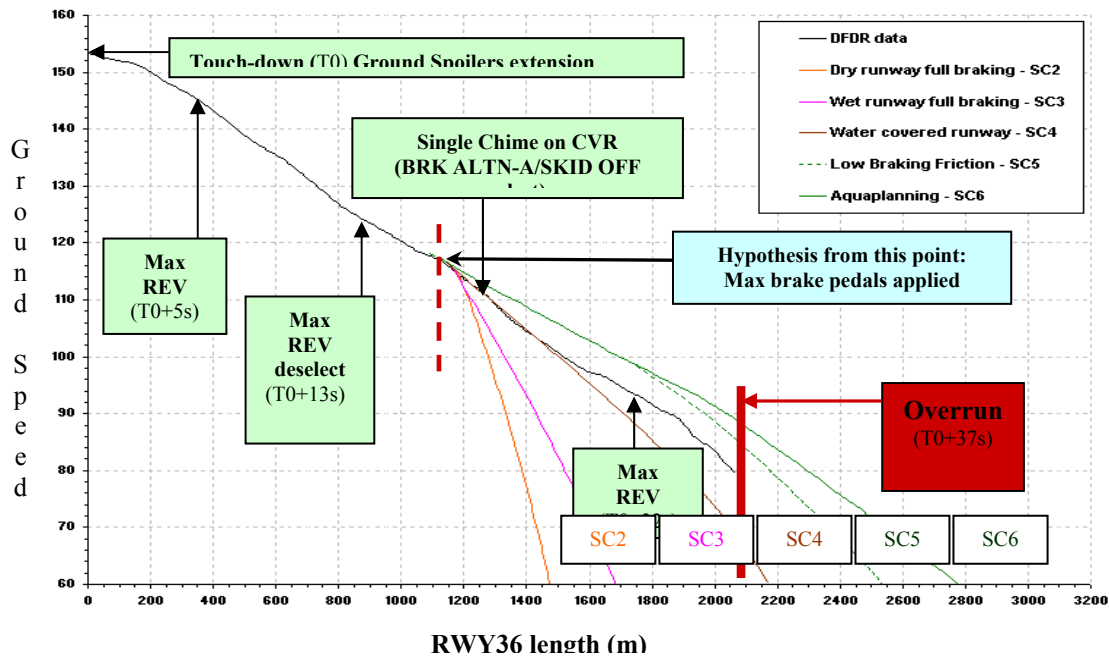
The **actual curve** (in black) is positioned between the **brown curve** (“water covered runway”) and the **dotted green one** (“low braking friction”).

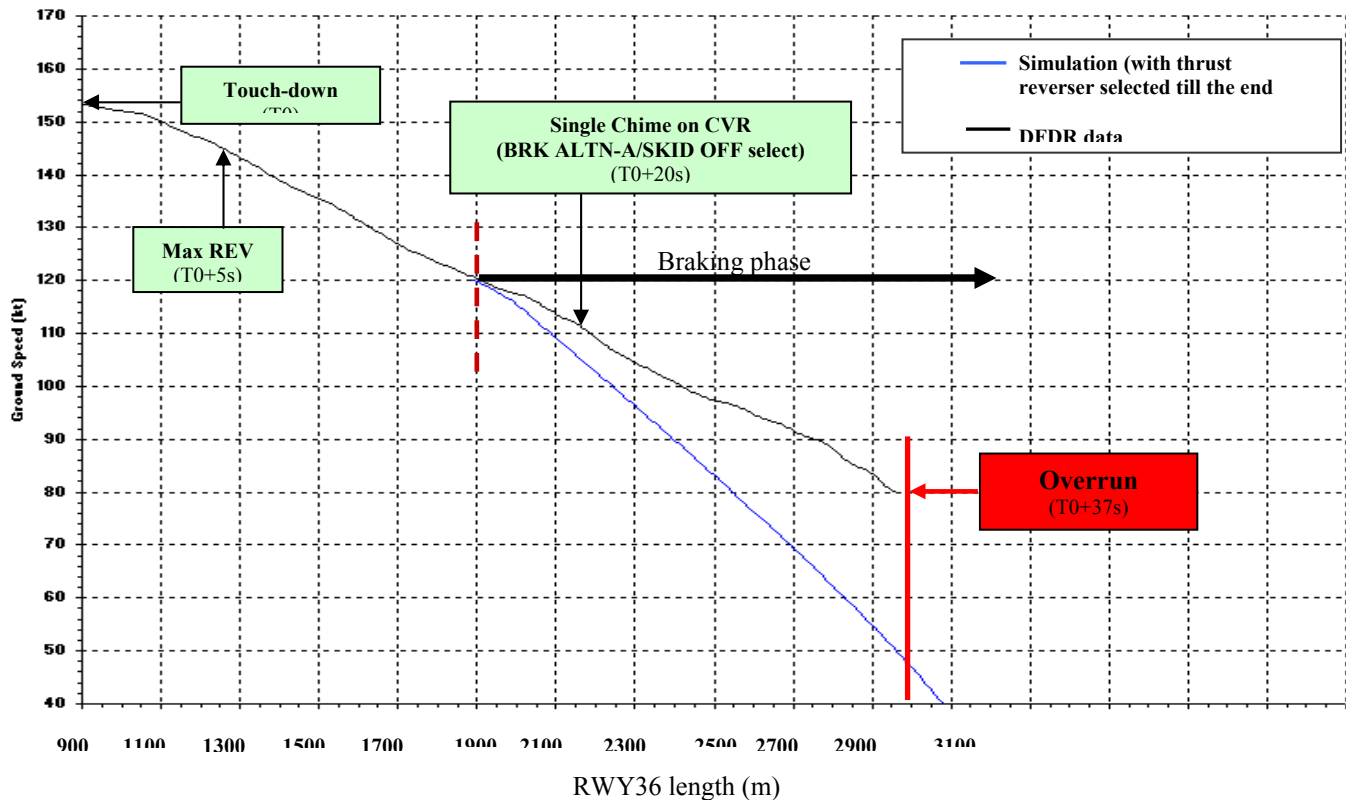
In that case, the aircraft would have overrun the runway at about 48kt instead of 76kt.
