*Accident
on 2 May 2000
at Lyon-Satolas (69)
to the Learjet 35A
registered G-MURI
operated by
Northern Executive Aviation Ltd*

REPORT
g-ri000502a

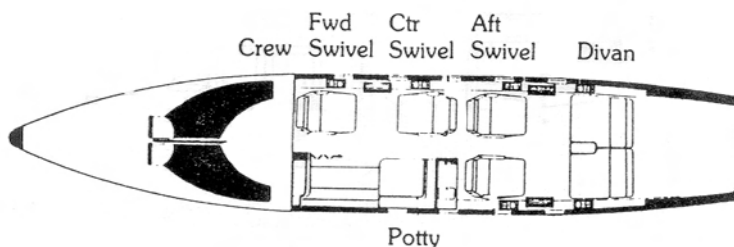
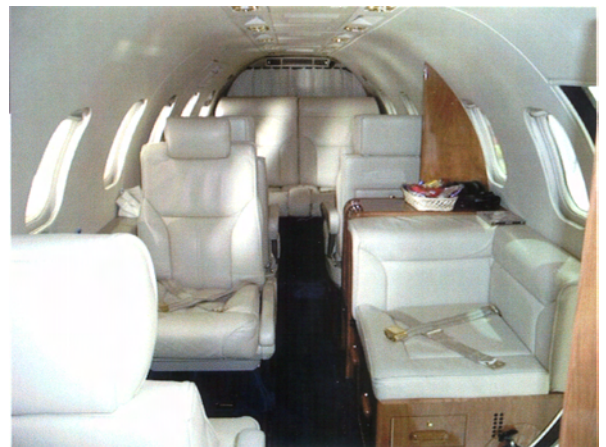
G-MURI was configured in “mid-cabin” version with seven seats. Two passengers were seated in seats at the rear of the cabin, the third in a seat facing them.

Since the fire broke out on the right side, where the emergency exit was situated, the passengers evacuated through the gap that had appeared at the front caused by the destruction of the cockpit.
