FINAL REPORT

**ACCIDENT
INVOLVING ATR 72 AIRCRAFT
REGISTRATION MARKS TS-LBB
ditching off the coast of Capo Gallo (Palermo - Sicily)
August 6th, 2005**

AGENZIA NAZIONALE
PER LA SICUREZZA DEL VOLO

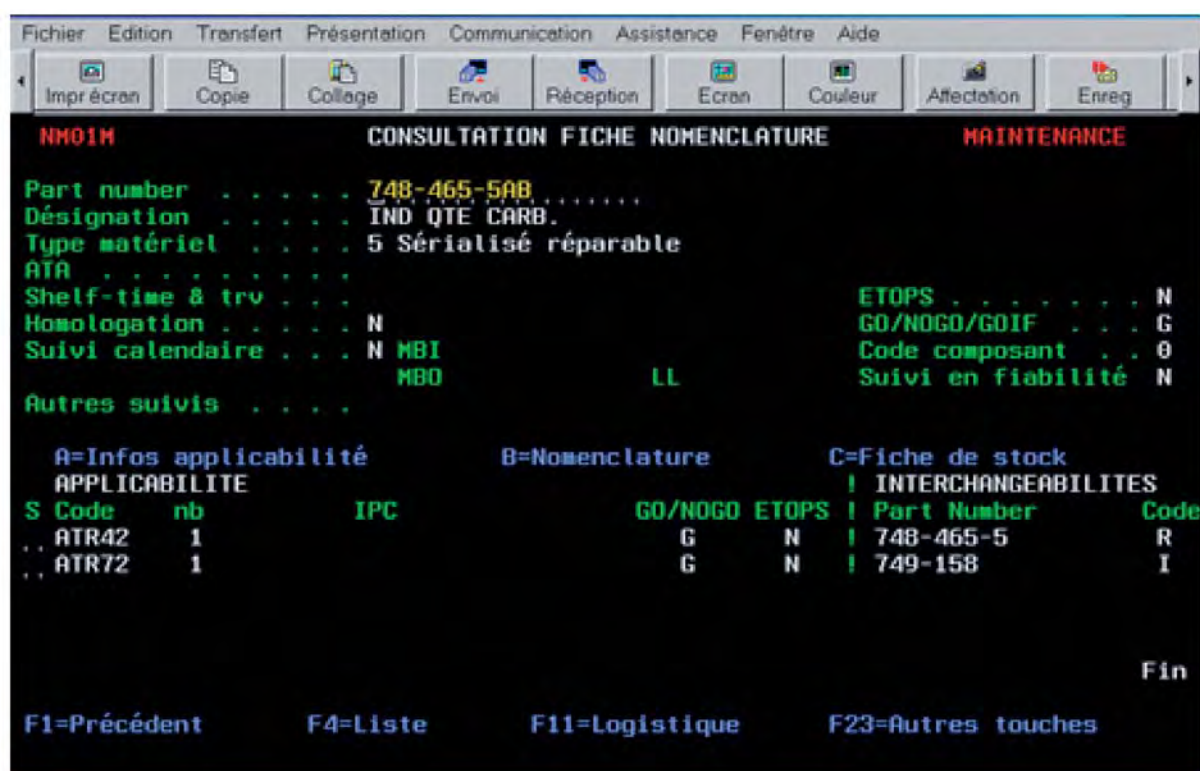
In the section “APPLICABILITÉ” (bottom left of figure 5), the “Code” field indicates in fact the type or the family of aircraft on which the part can be installed, the “nb” field shows the quantity needed on each aircraft and the IPC code in the ®AMASIS video should give the chapter, page, section and figure of the IPC where the part is listed. In the section “INTERCHANGEABILITÉS”, at the bottom right of figure 5 are listed the P/N of other interchangeable parts, while the field “Code” shows any restrictions (“I” means full interchangeability, “R” means interchangeable but with restrictions imposed by the manufacturer).

The information relating to the applicability was wrong as P/N 748-465-5AB identifies an FQI only applicable to ATR 42 aircraft, and not also to model ATR 72.

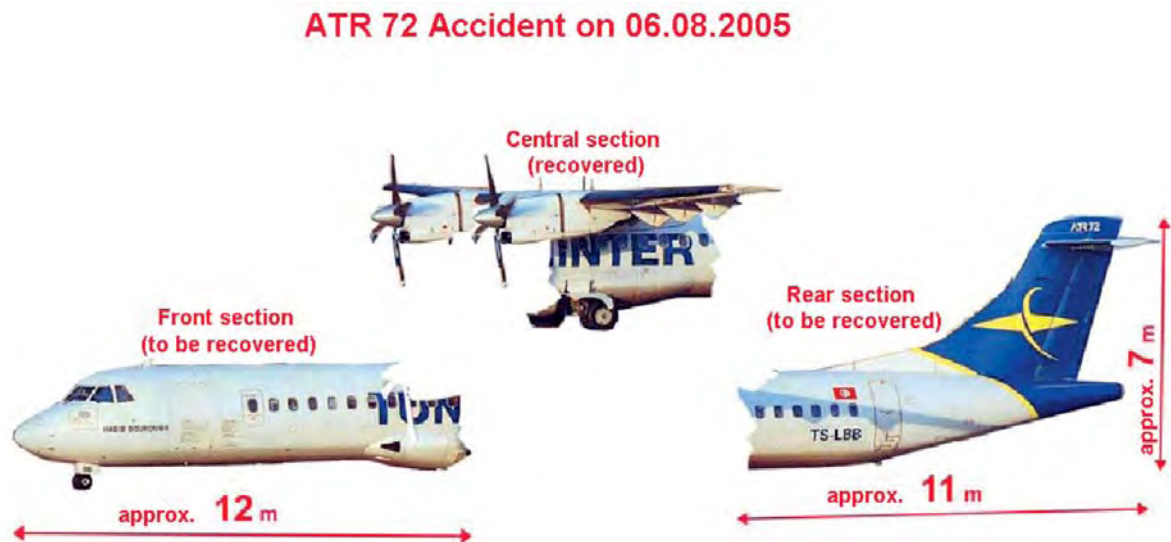
- LH and RH wings with nacelles and engines and part of the central fuselage;
- The rear, including the vertical and horizontal stabilizers and part of the fuselage;
- Front and central section of the fuselage, also including the cockpit.

Figure 6: Illustration showing the three sections the aircraft broke into, following impact with the sea surface (ANSV reconstruction). The indication “to be recovered” refers to the date of August 6th, 2005. These parts were later recovered.

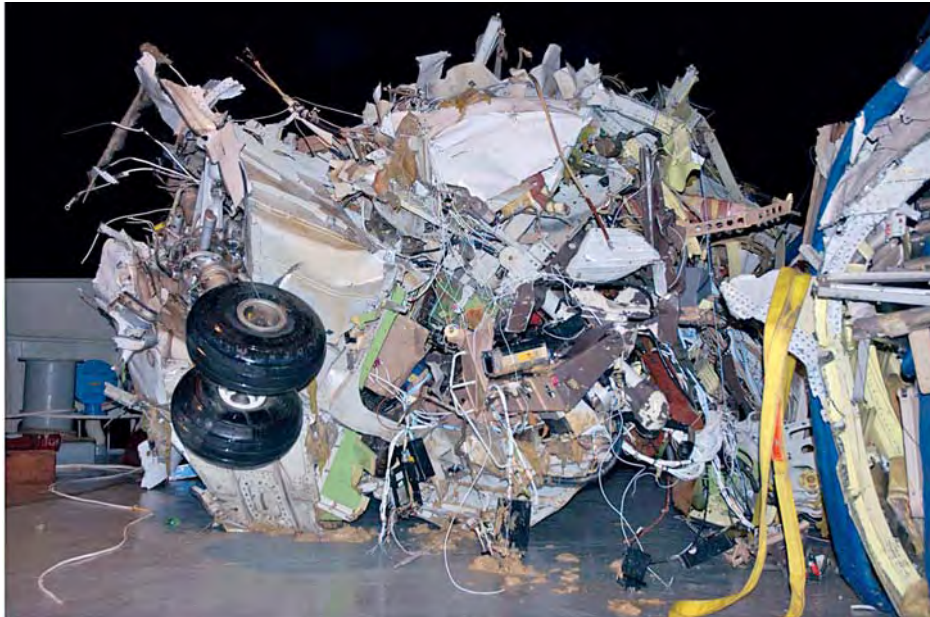
As far as the front section is concerned (cockpit and the front fuselage), this was completely crushed, as can be seen in photo 2, which relates to the recovery of the wreckage, carried out during the last week of August 2005.

Photo 2: Cockpit soon after recovery from the seabed.

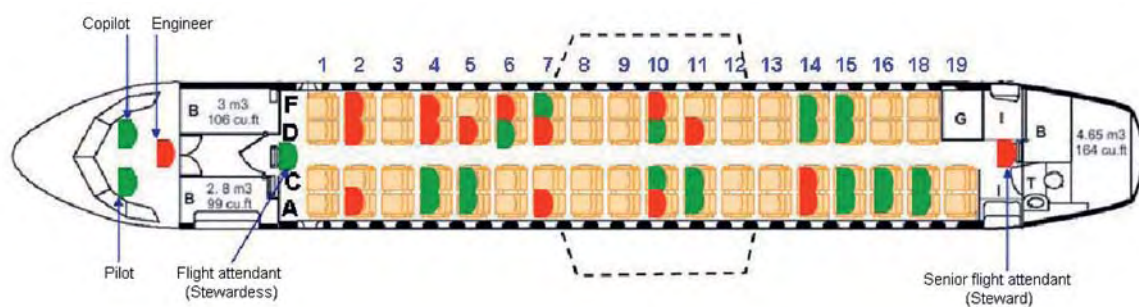
Figure 7: ATR 72, TS-LBB seat occupation on the aircraft before ditching.

With reference to Figure 7, the red boxes indicate the occupants who suffered fatal injuries, while the green boxes indicate the position of the survivors on the aircraft. The following paragraph 1.15.3. provides a description of the type of injuries suffered by the passengers, linking their position on the aircraft to the deformations which occurred to the aircraft following ditching.

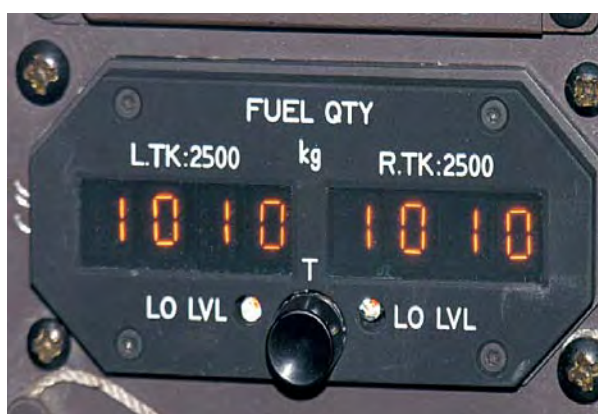
Photo 8: FQI ATR 72.

Difference between FQIs, when not installed on the aircraft, is also determined the P/N on data plate on top of it which is different between ATR 72 and ATR 42 type FQIs .

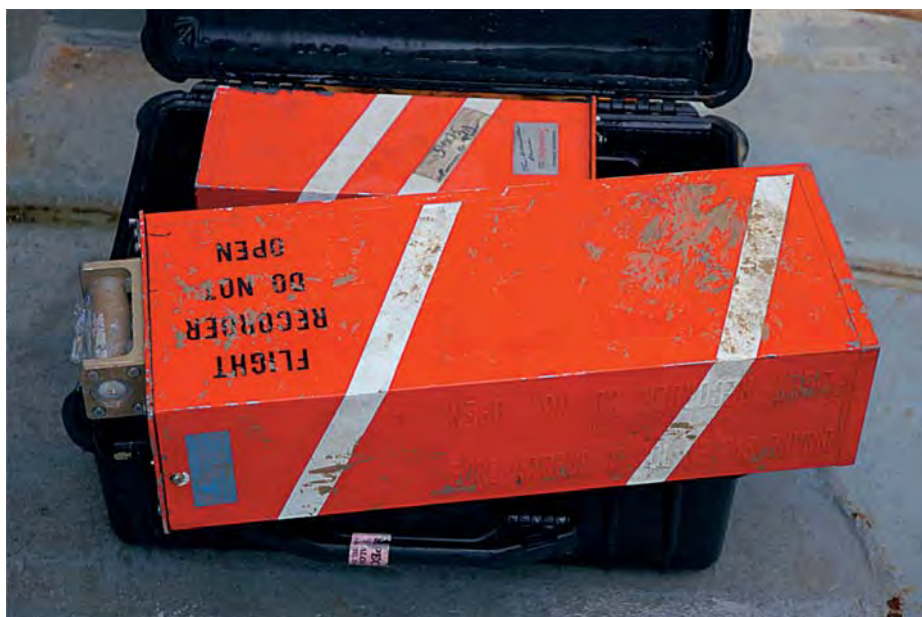
Photo 16: The recovered FDR (foreground) and CVR.

Both units were in reasonable general condition, without evidence of impact or fire damage.

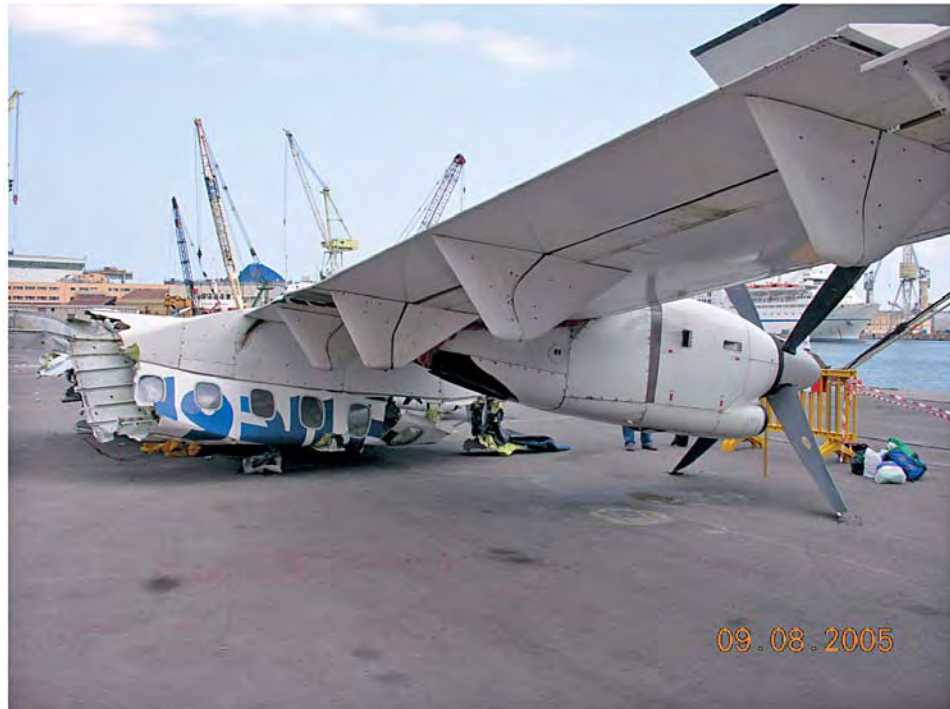
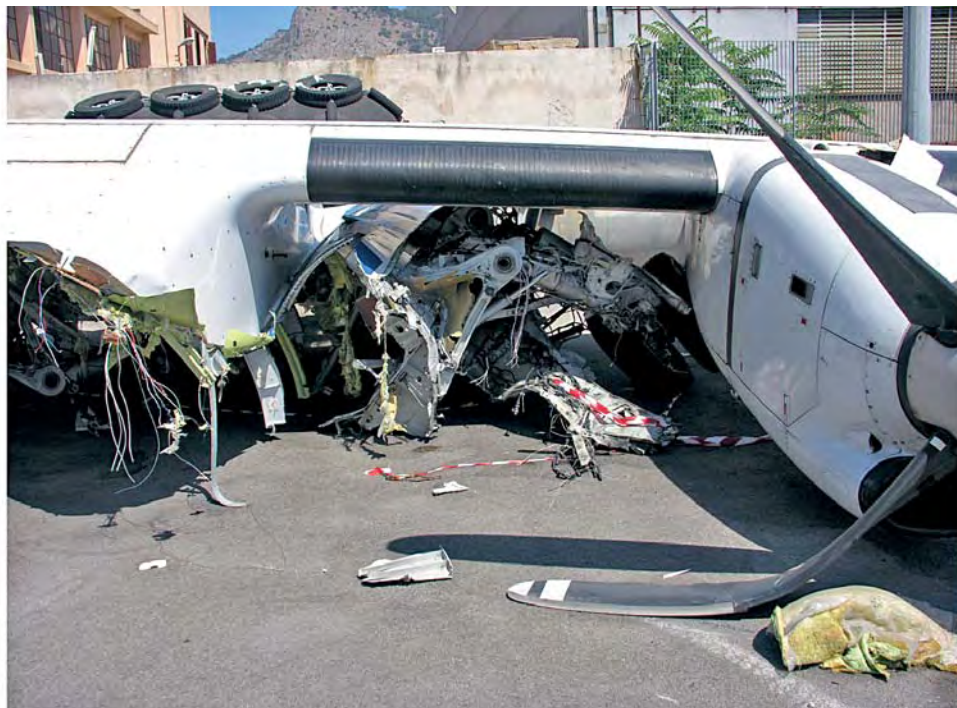
Photo 22: Part of the central fuselage with LH and RH wings at the Port of Palermo.

Photo 23: Part of the central fuselage with LH and RH wings at the Port of Palermo, the central section.

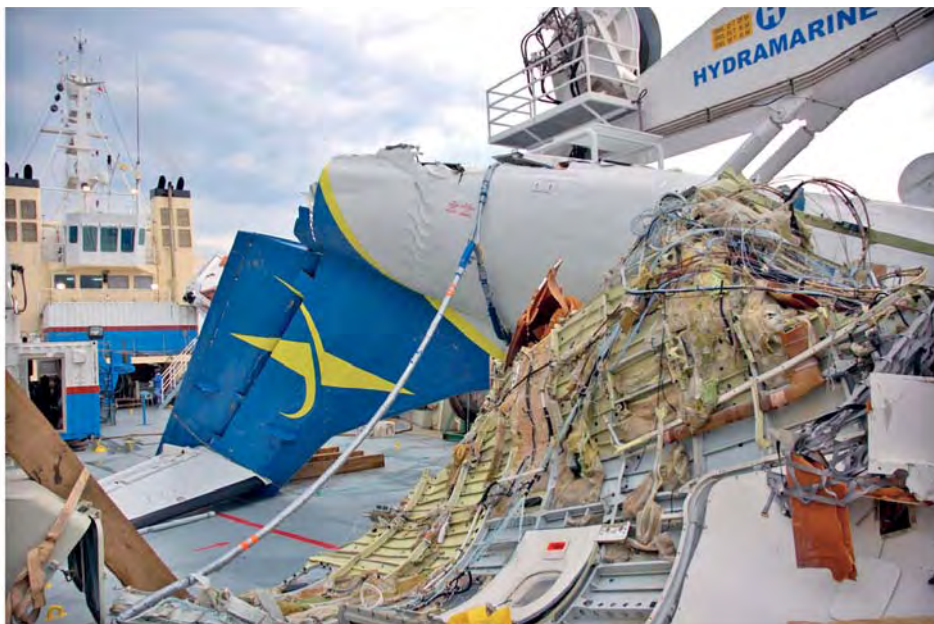
Photo 25: Remains of the wreckage on the ship's deck after recovery.

Considerable structural damage was found on the inside. The pressure bulkhead between the cabin pressurized zone and the tail had a large diagonal gash (see photo 34 and 61). The tail assemblies did not show any significant deformation. The CVR was removed from its housing. It was removed, immediately washed with fresh water and then placed in a container full of distilled water. The supports of the FDR housing appeared damaged and the device itself was missing (photo 61).

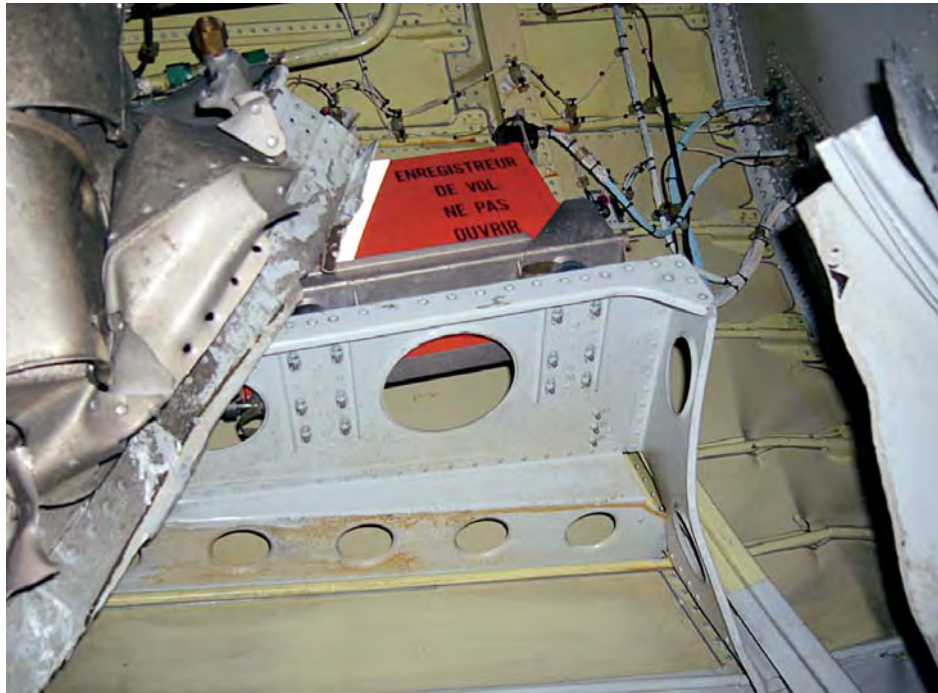
Photo 26: CVR in its housing inside the aircraft.

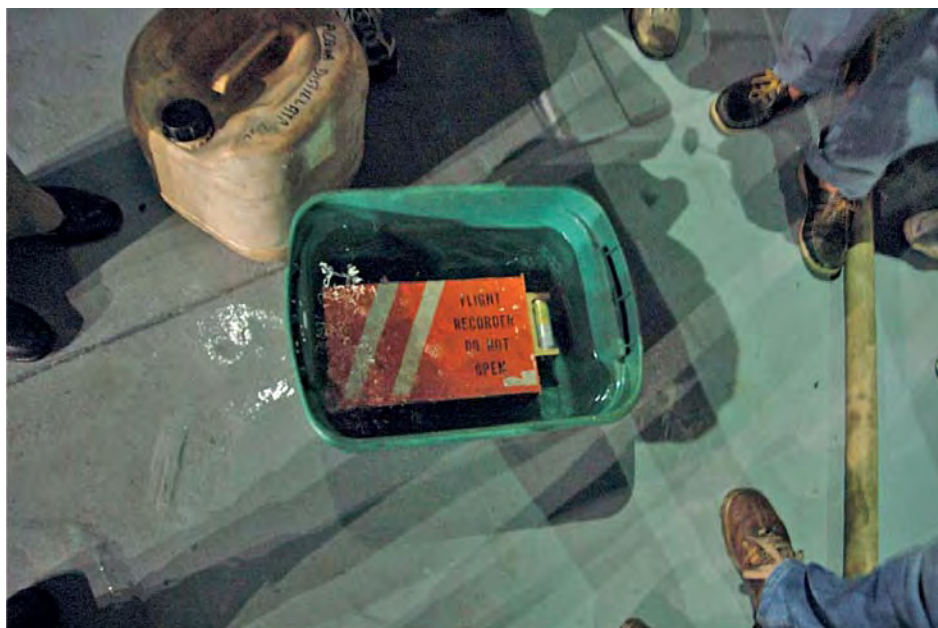
Photo 27: CVR in distilled water, after being recovered from the aircraft.

As described later, the FDR was located and recovered from the bottom of the sea. Also the FDR was washed and placed in distilled water immediately after being recovered, in order to prevent corrosion affecting the quality of the recorded data. Both recorders were then placed under sequestration by the competent judicial authority.

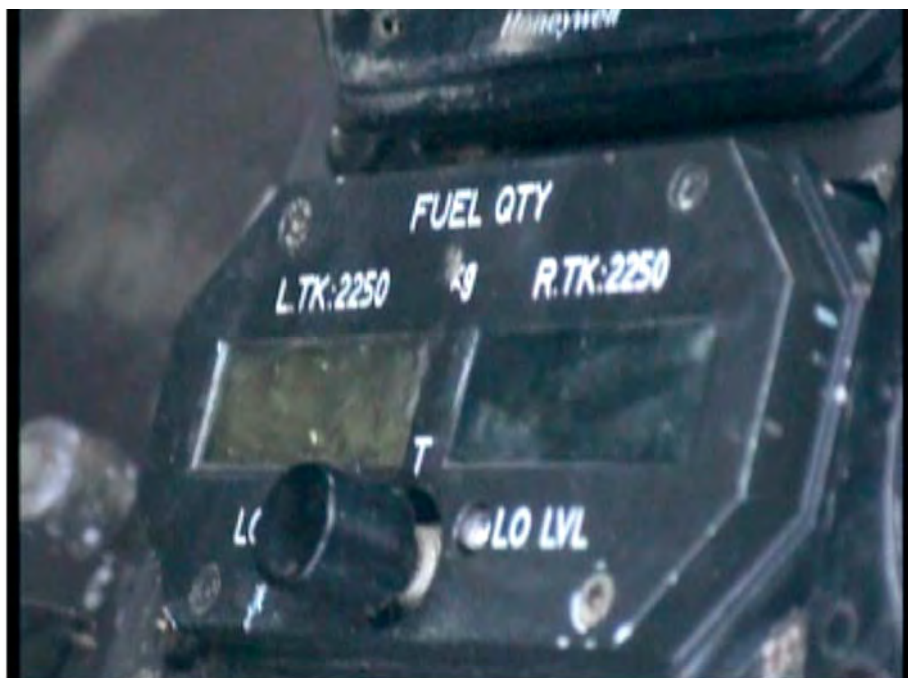
The Fuel Quantity Indicator was still in its housing inside the cockpit. Photo 29 shows the front part of the instrument with the writing 2250 kg, which indicates the maximum fuel capacity of each wing fuel tank. In effect the indication of 2250 kg relates to indicators used by the ATR 42 models. Subsequent checks did in fact confirm that the FQI installed was a model intended for ATR 42 aircraft.

Photo 29: The FQI installed on the TS-LBB - video still taken immediately after recovery.

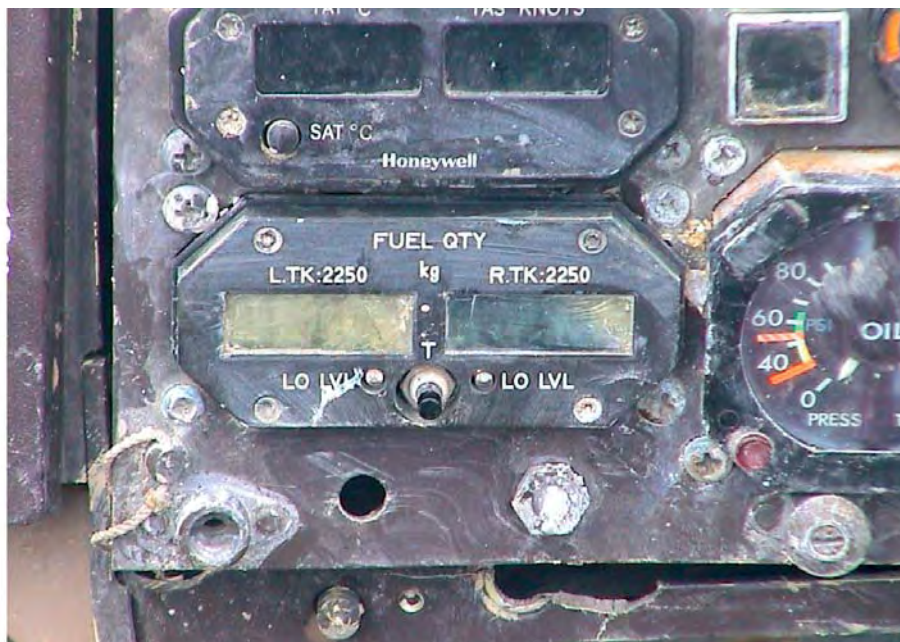
Photo 30: FQI front panel recovered from the wreckage. Note the inscription “2250” corresponding to an ATR 42 type FQI.

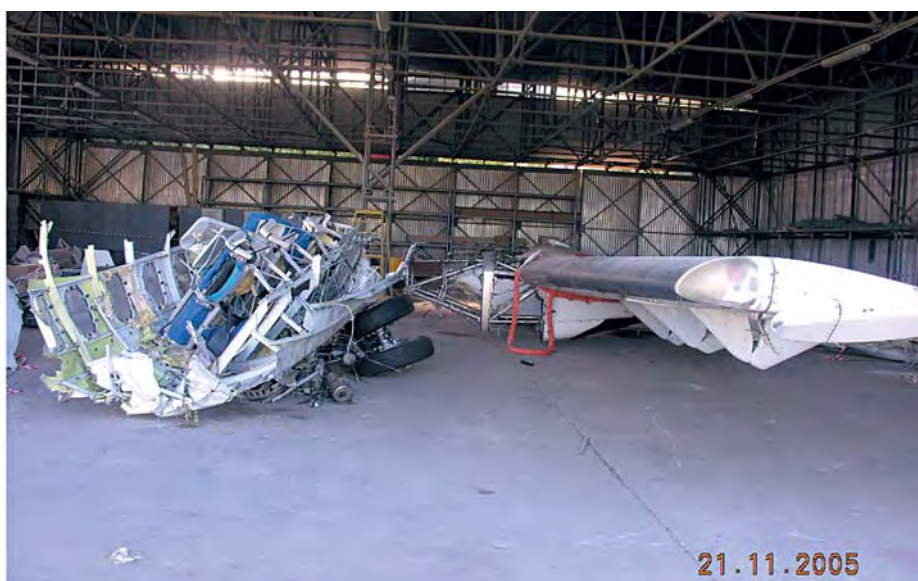
No specific tests have been carried out on the structural parts of the wreckage. Most of the break points showed the typical overload stress characteristics. No evidence of fatigue and corrosion was detected. As already indicated, as far as the rear section is concerned, breaks are localized by the severed section, connected to the remaining part of the aircraft fuselage. No signs of damage were detected in the tail section.

Photo 31: Part of the wreckage inside a hangar at Bocca di Falco.

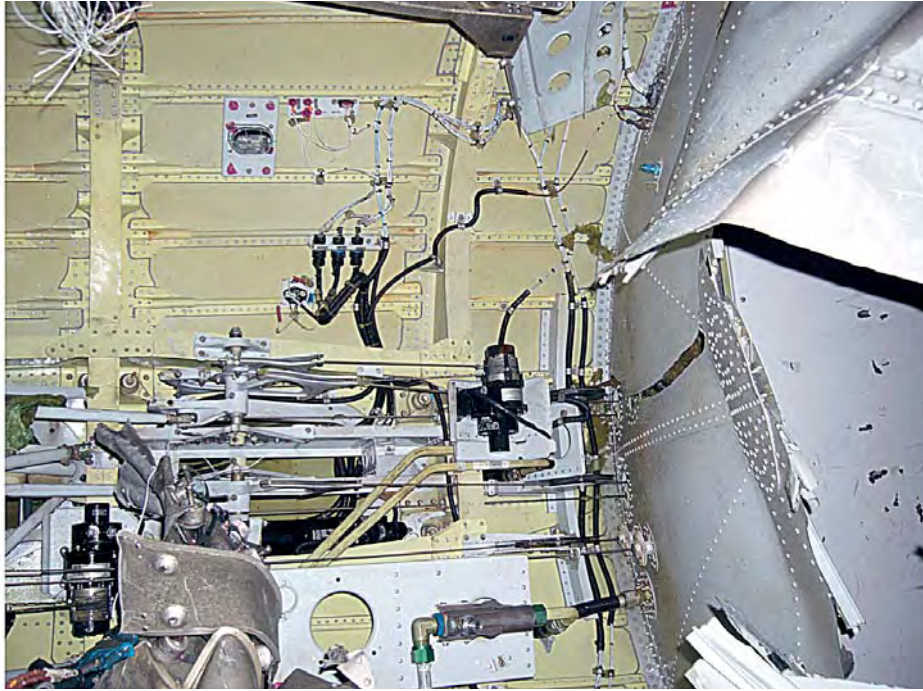
The rear of this section showed a great amount of damage and deformation, resulting in the breaking of the pressure bulkhead between the pressurised and the non pressurised zone. This indicates that the impact of the aircraft against the sea surface was very strong. The rear had in fact completely collapsed, while the seating area was virtually intact.

Photo 34: Rear of the aircraft, inside view. Note the deformation of the pressure bulkhead.

Together with the evidence given by some passengers occupying the back rows, who remember hearing a loud impact and then being immediately surrounded by water, the scene encountered indicates that the rear of the aircraft might have been the first to impact against the water surface, separating from the rest of the structure due to the strong induced bending stress.

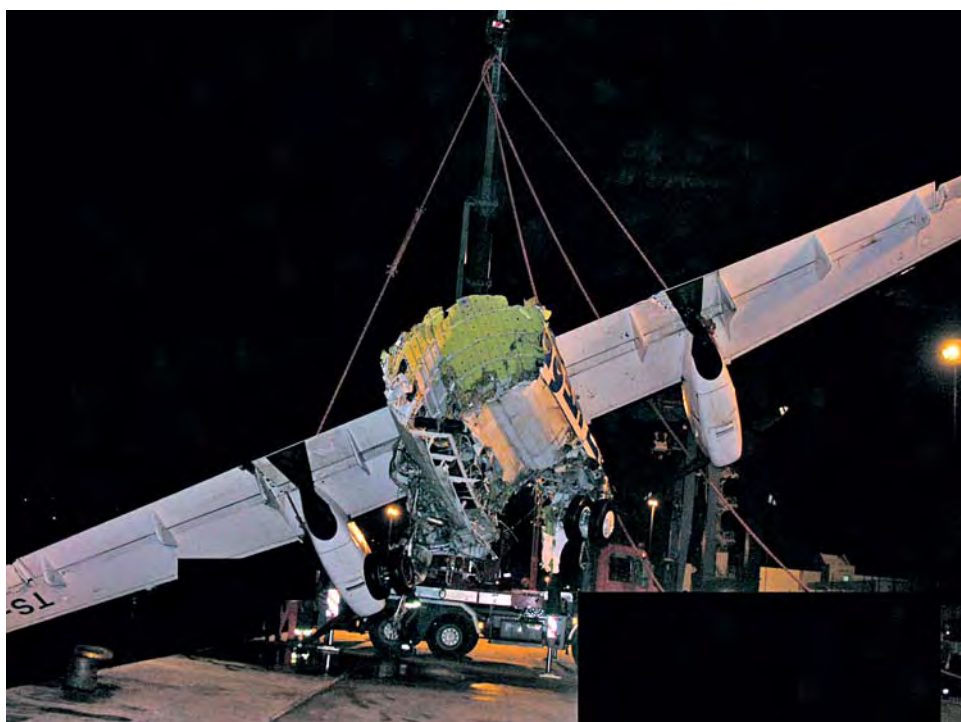
The central section, also including the engines, as previously stated, was recovered on the same day of the event by the Capitaneria di Porto and placed on a wharf of Palermo port for a few days, before being moved to a hangar of Palermo Bocca di Falco airport. No fire damage was detected. In this section were also the corresponding part of the fuselage and the main landing gear. An initial examination of the landing gear showed that this was in the extended and locked position. However, the type of damage found was not compatible with this position. It is very likely that the landing gear moved to the extended position following the strong impact and the detachment of the central part of the fuselage from the rest of the aircraft.

Also this section shows no evidence of breaks due to fatigue and/or any corrosion. All sections show breaks typical of overload.

Photo 36: Central section of the wreckage, with LH and RH wings, during recovery.

The right-hand appeared more deformed than the left-hand, indicating that the right-hand of the aircraft had suffered a stronger impact. The seats on this side were in fact no longer attached. From the evidence, it appears that the central section strongly impacted against the sea surface. The strong bending stresses caused by such impact caused the structure to separate from the rest of the aircraft at the point of the main landing gear and the wing structure.

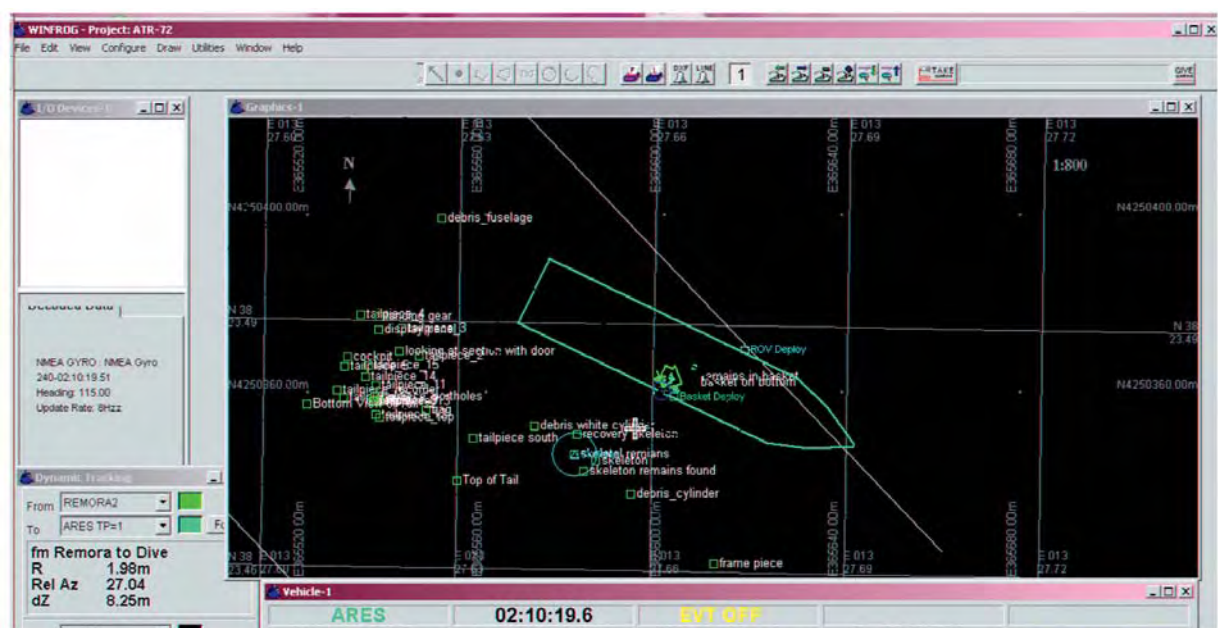
Figure 19: Position of the ship in relation to the parts of the wreckage located.

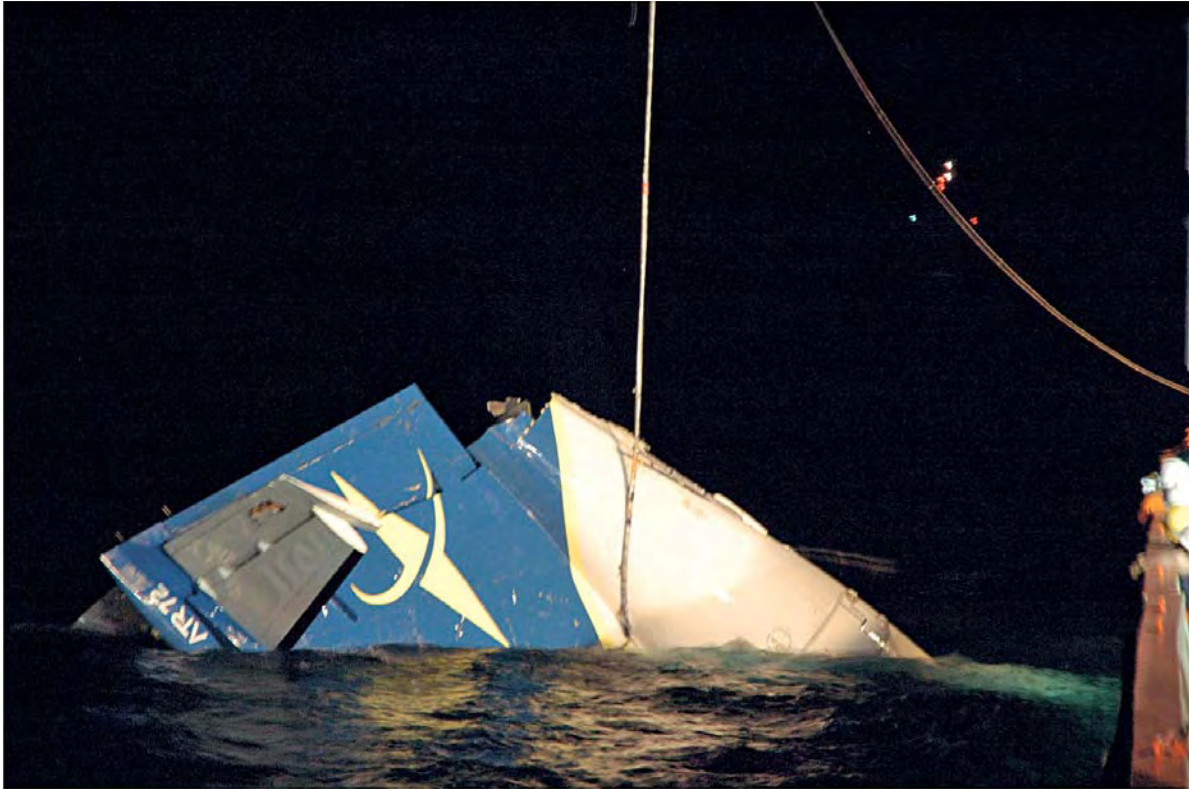
Photo 54: Final stages of wreckage recovery.

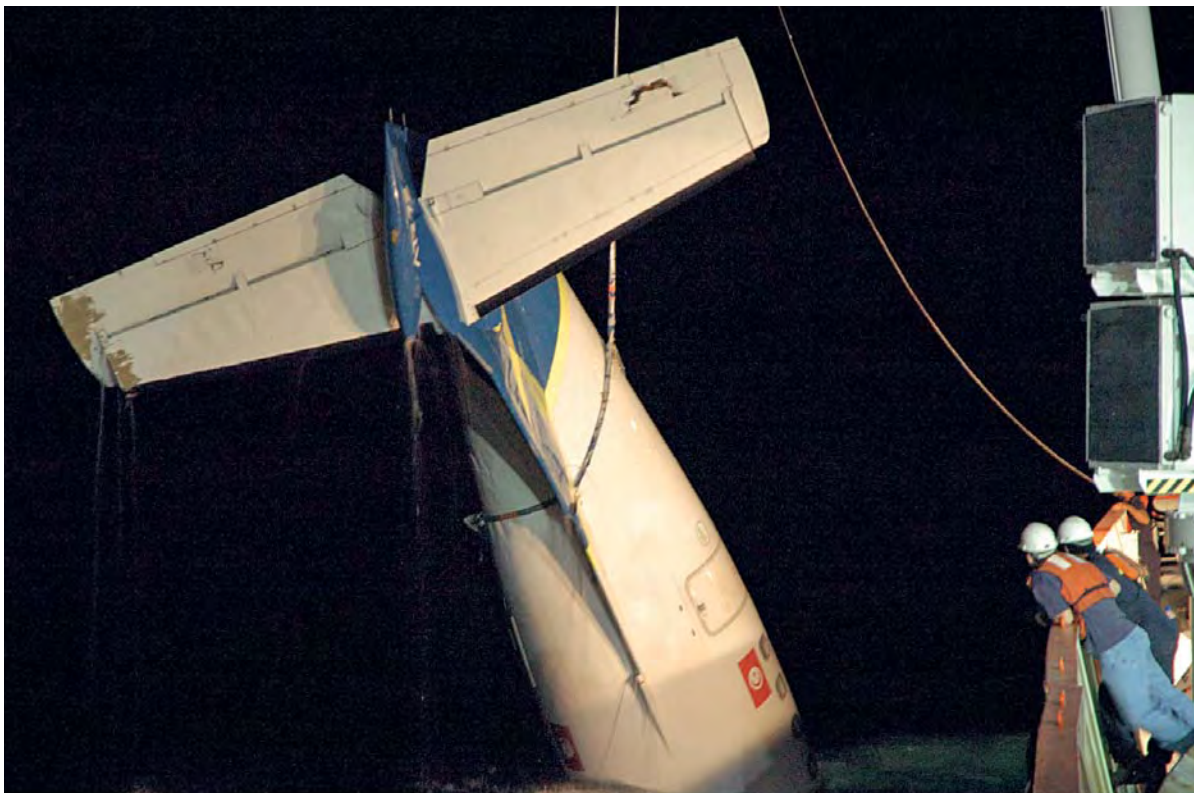
Photo 55: Final stages of wreckage recovery.

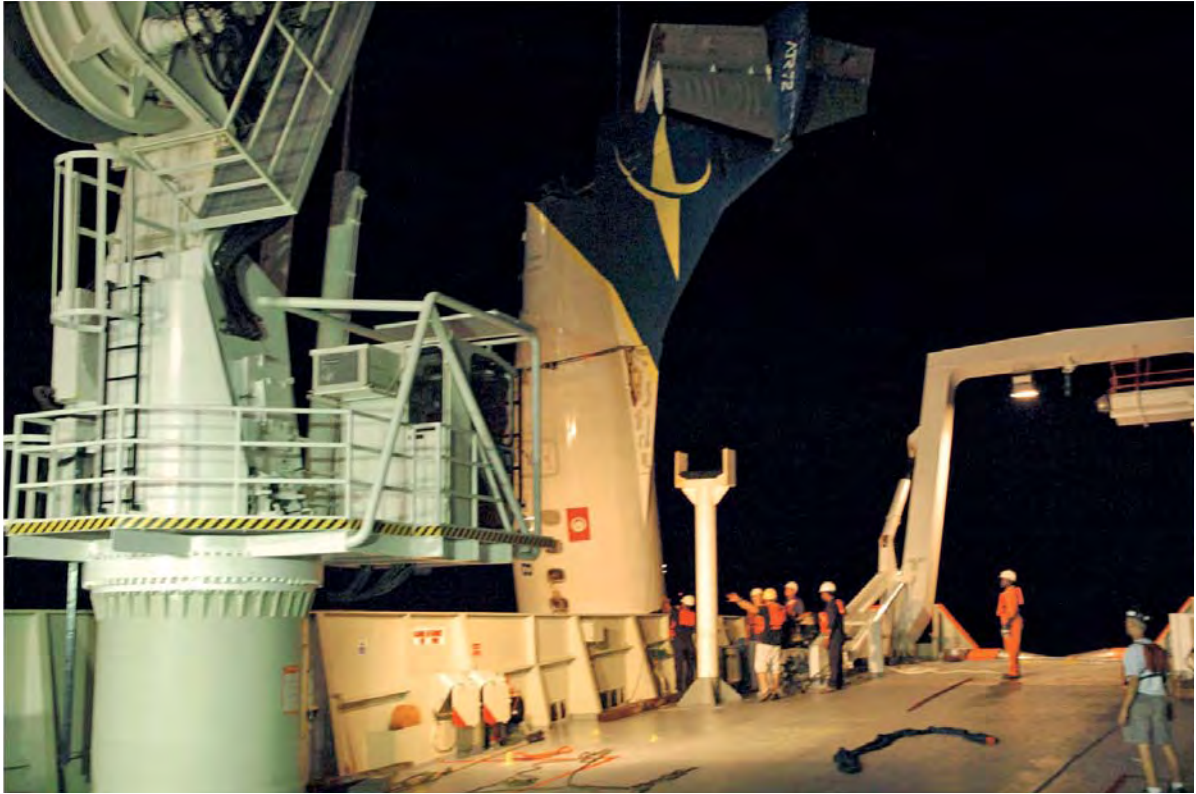
Photo 56: Final stages of wreckage recovery.

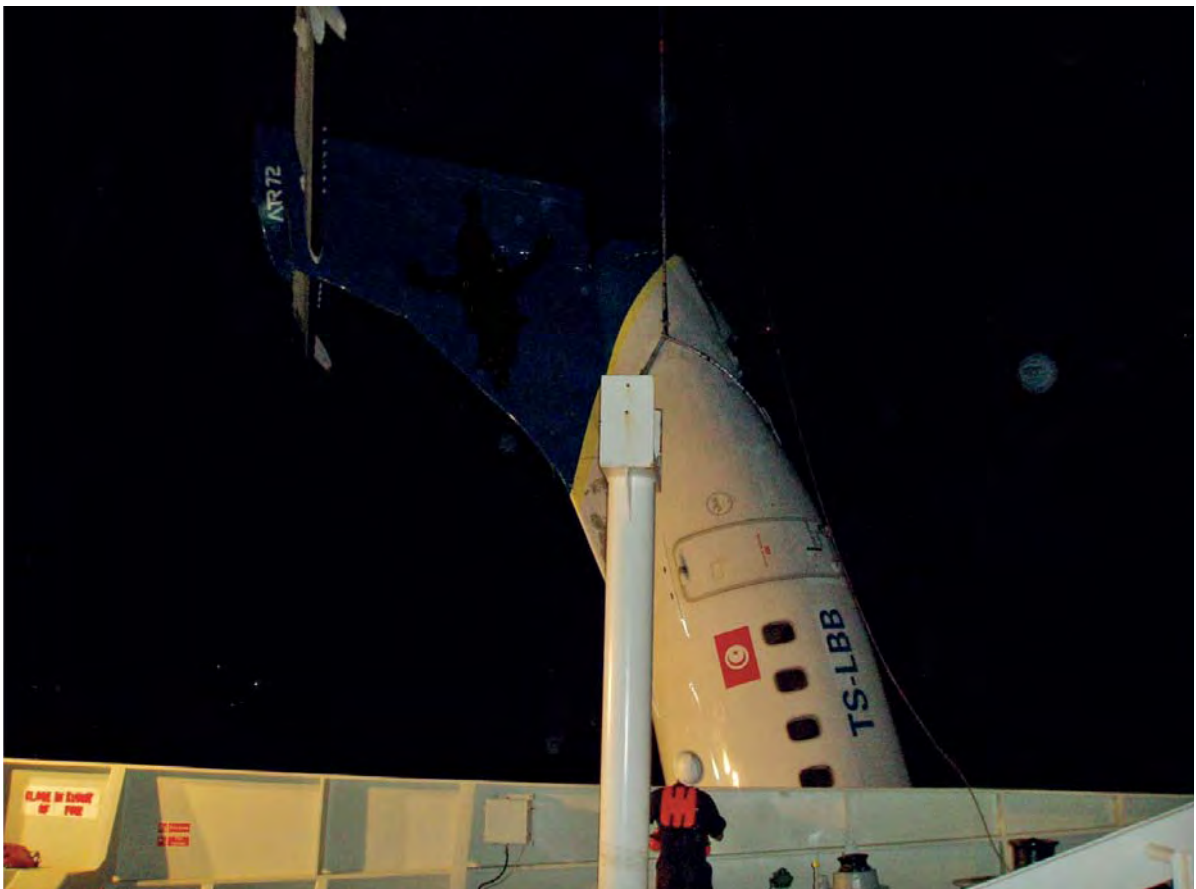
Photo 57: Final stages of wreckage recovery.

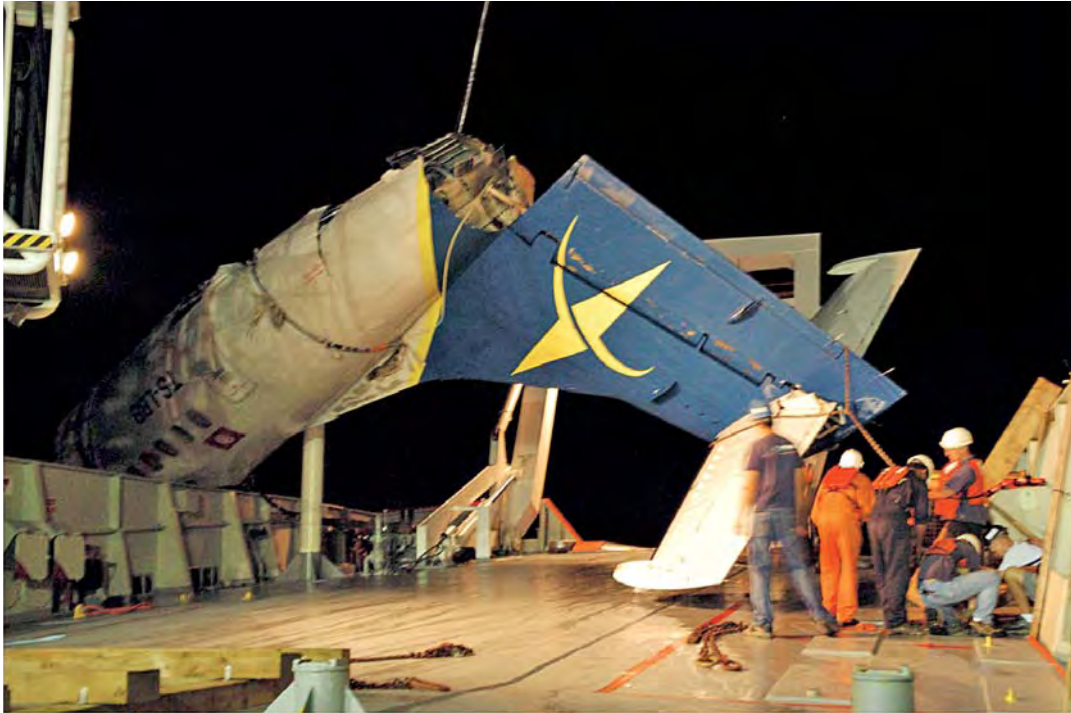
Photo 58: Positioning of the wreckage on the ship's deck

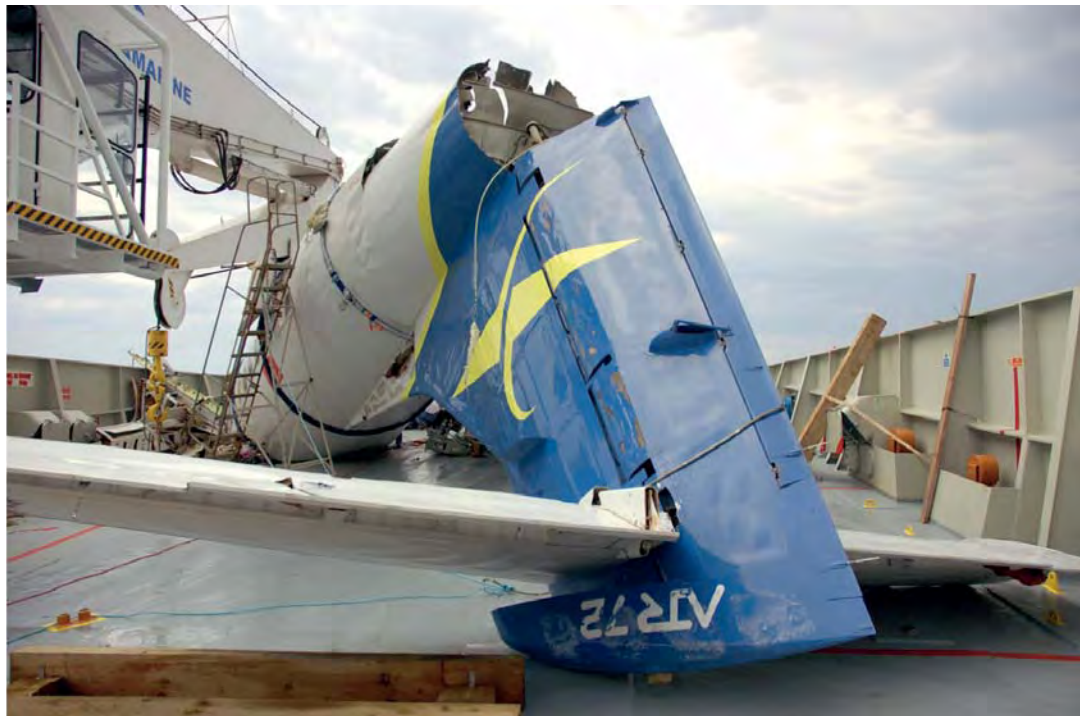
22.00: the recovery of the tail section was completed. This was positioned on the deck of the ship. The rear section was immediately inspected from ANSV personnel, looking for the flight recorders. The CVR was in its position, but the FDR was missing. The FDR housing showed

some deformation, so, there was a strong possibility of the FDR still being at the bottom of the sea. The tail section was also searched with negative results.

Photo 60: The wreckage on the ship's deck.

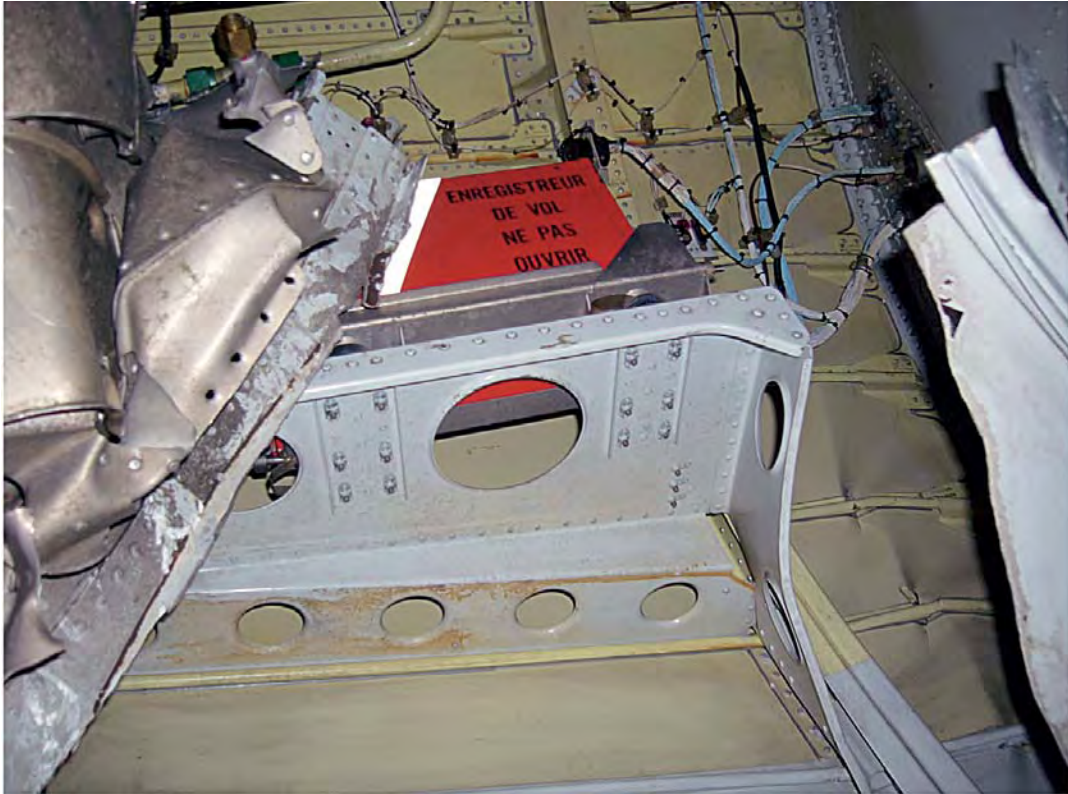
Photo 62: CVR in its housing.

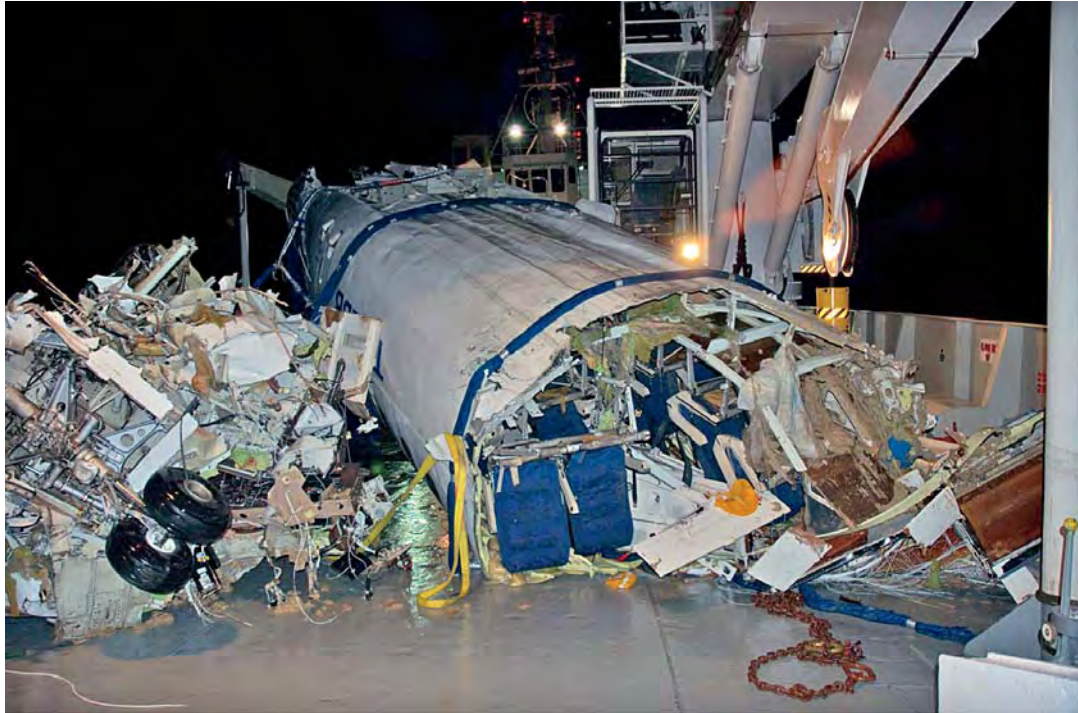
Once the tail section was positioned on the ship's deck, with lifting gear still attached, the recovery personnel realised that a large part of the fuselage remains were still attached to the tail. In fact, the remaining part of the aircraft, including the front of the fuselage and the cockpit, was still attached to it. This meant that approximately 70 to 80% of the wreckage had now been recovered.

Photo 63: Tail section on the ship's deck with front part of the fuselage

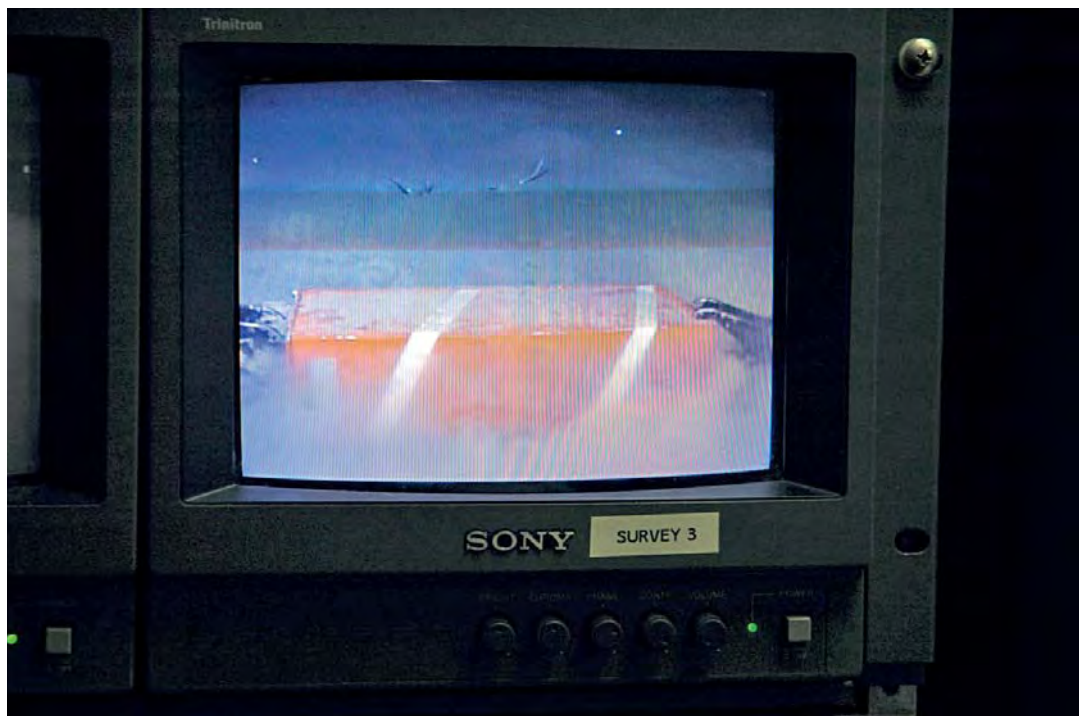
01.40: The research operations on the seabed continue and the FDR is sighted at geographical coordinates 38° 23.42 N - 013° 27.15 E. It appeared in good condition and was brought back to the surface using the ROV mechanical arms.

Photo 64: Recovery of the FDR by the ROV.

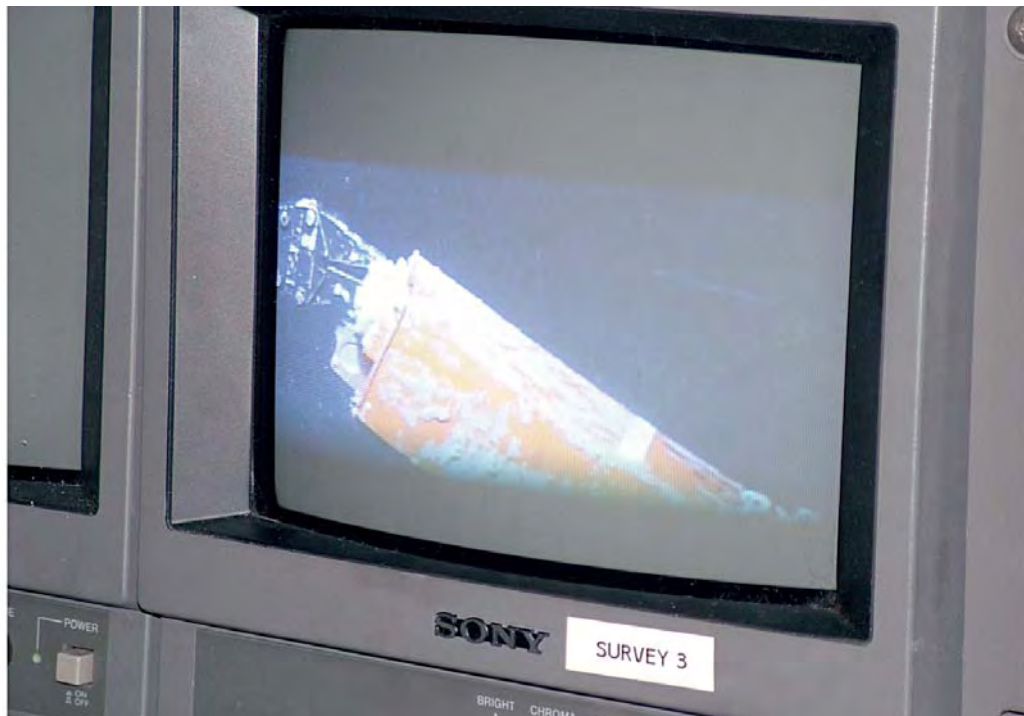
Photo 65: Recovery of the FDR.

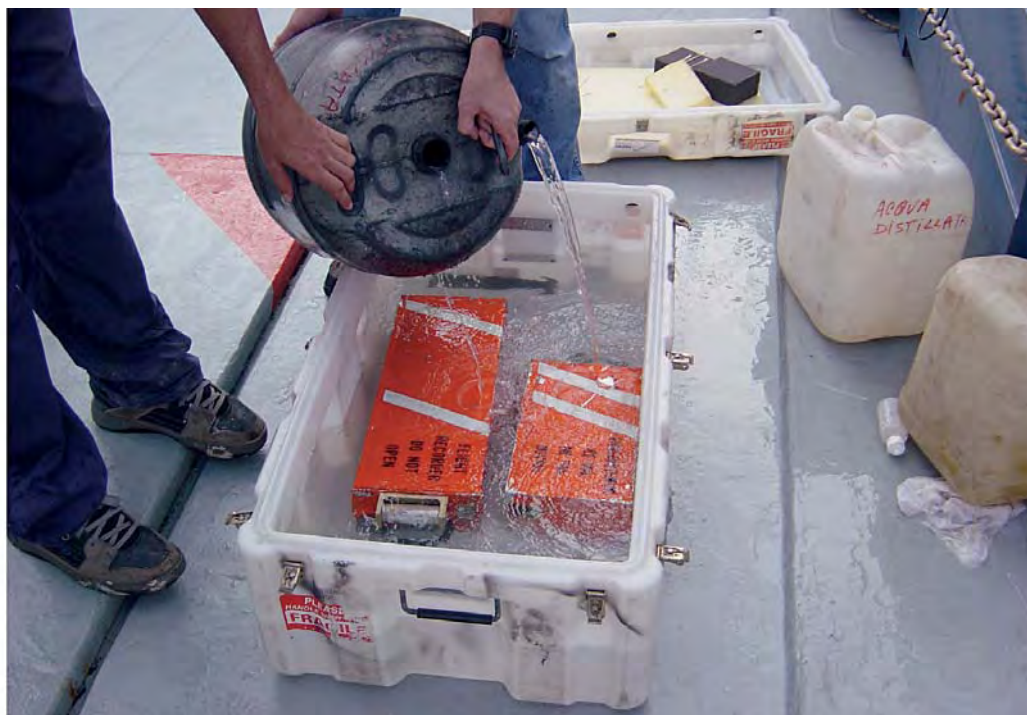
07.40: together with the FDR, other objects were also recovered from the seabed. Also the FDR was immediately immersed in distilled water and then placed in the same container as the CVR, in order to prevent as much as possible any corrosion or degradation of the data magnetic tapes.

Photo 66: FDR (on the left) and CVR (on the right) immersed in distilled water for preservation and transport purposes.

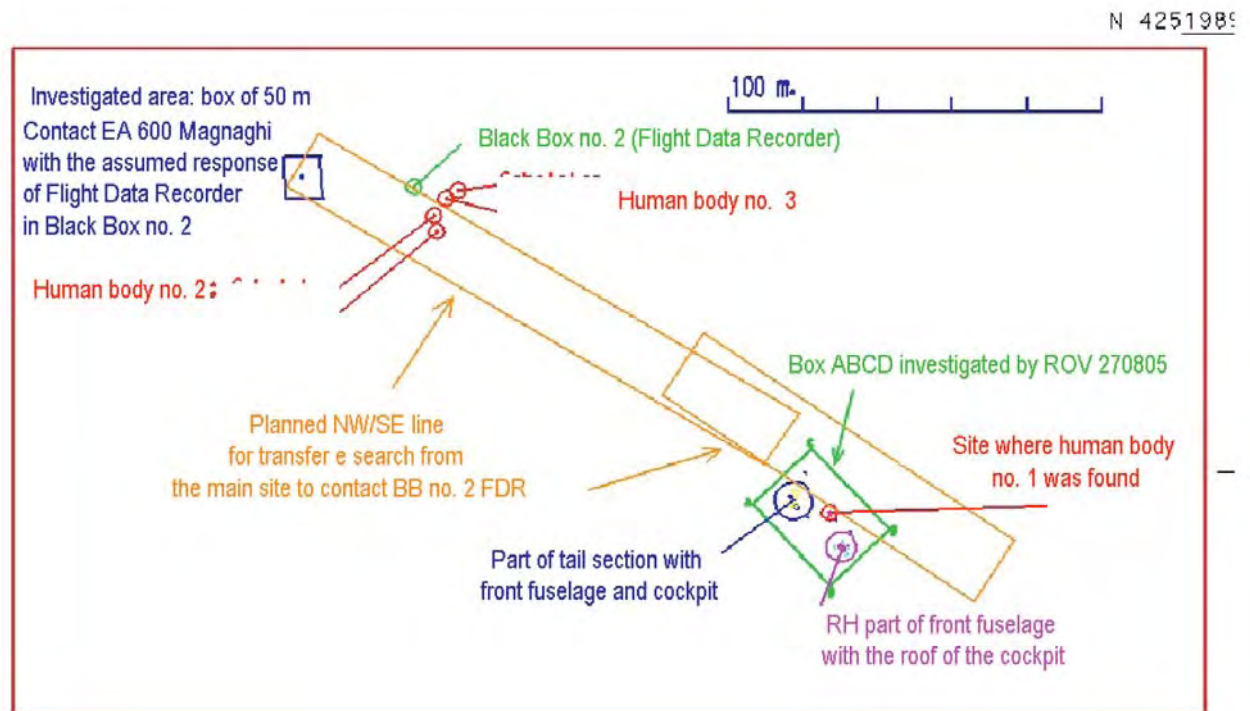
Figure 20: Position of the wreckage and parts recovered.
