FINAL REPORT

**ACCIDENT
INVOLVING ATR 72 AIRCRAFT
REGISTRATION MARKS TS-LBB
ditching off the coast of Capo Gallo (Palermo - Sicily)
August 6th, 2005**

AGENZIA NAZIONALE
PER LA SICUREZZA DEL VOLO

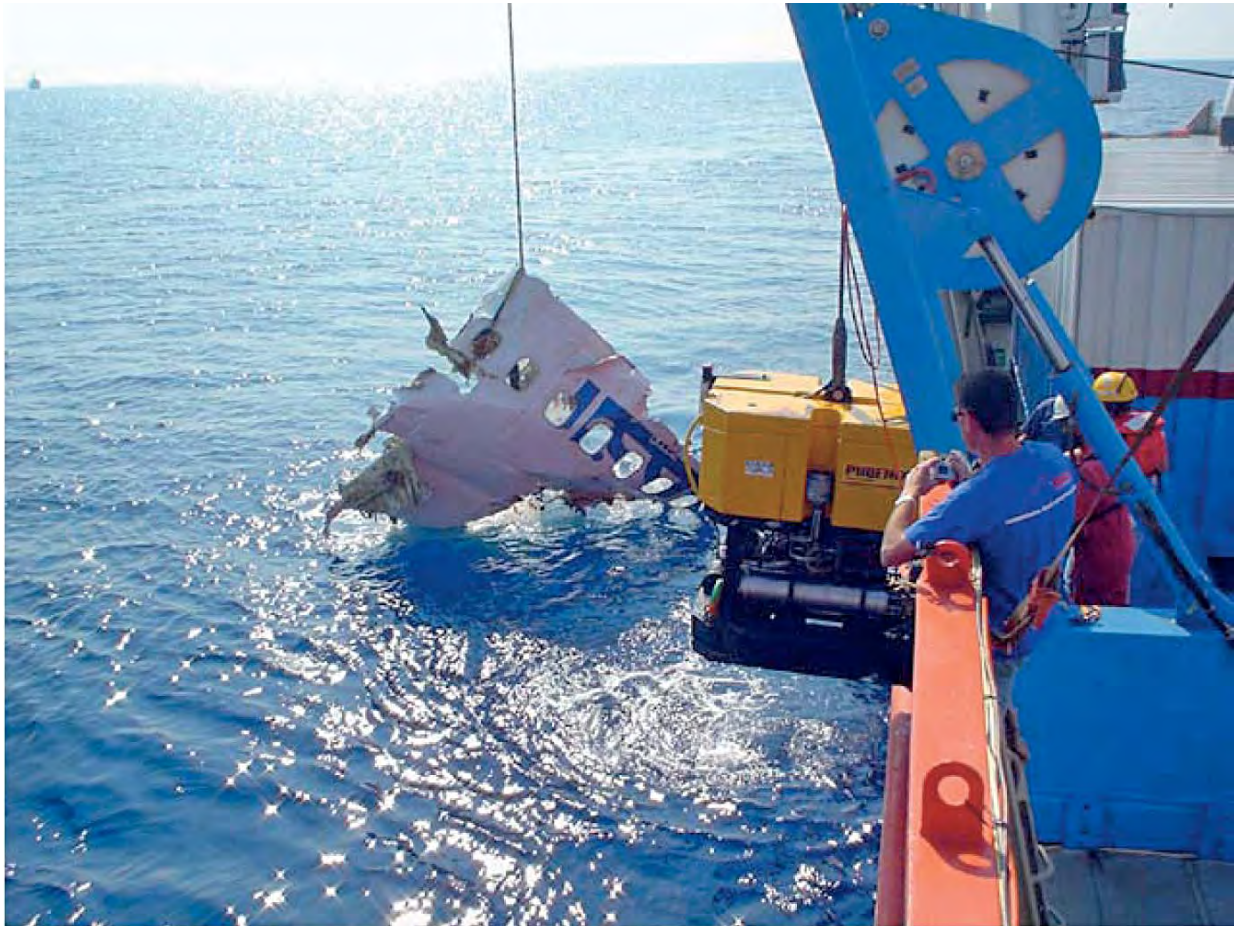
Photo 67: Recovery of aircraft right-hand fuselage panel.

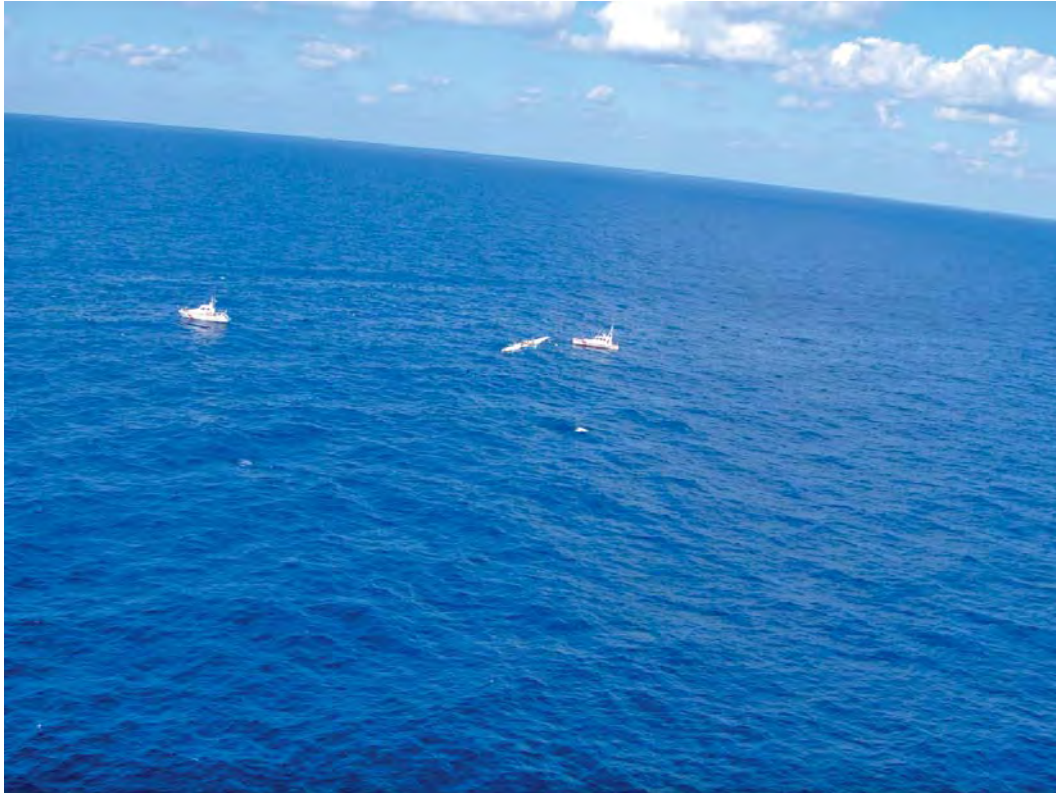
Photo 68: Recovery of the LH and RH wings.

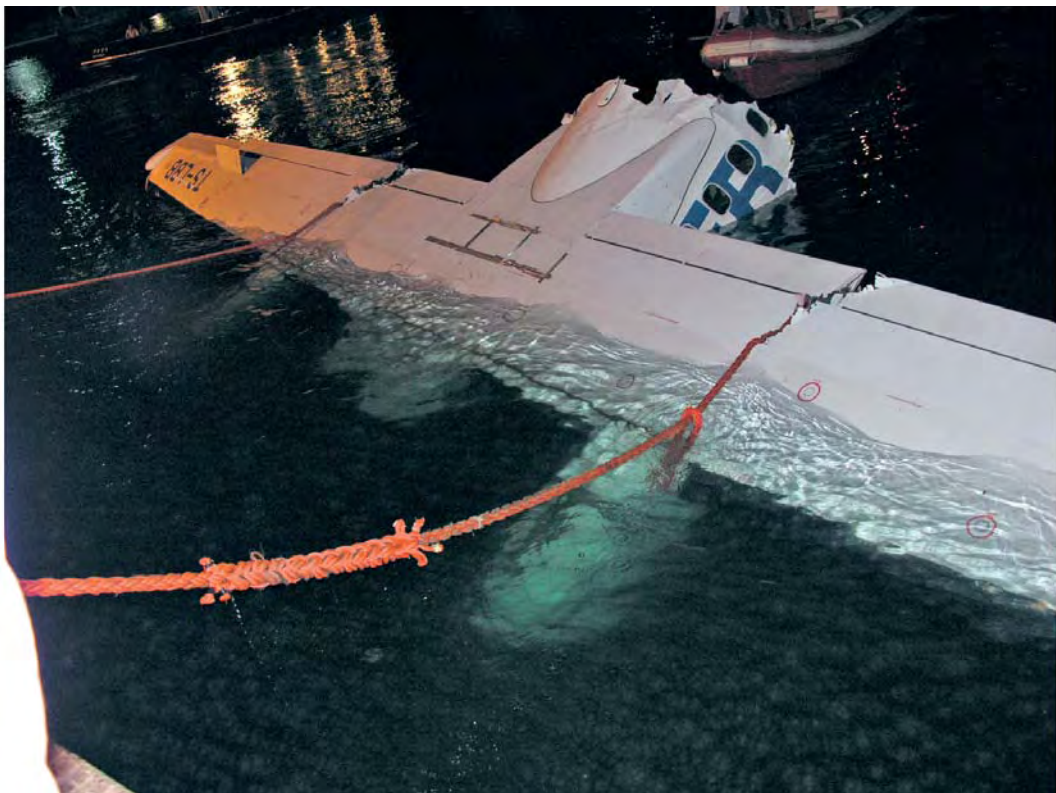
Photo 69: Recovery of the LH and RH wings, arrival at the port of Palermo.

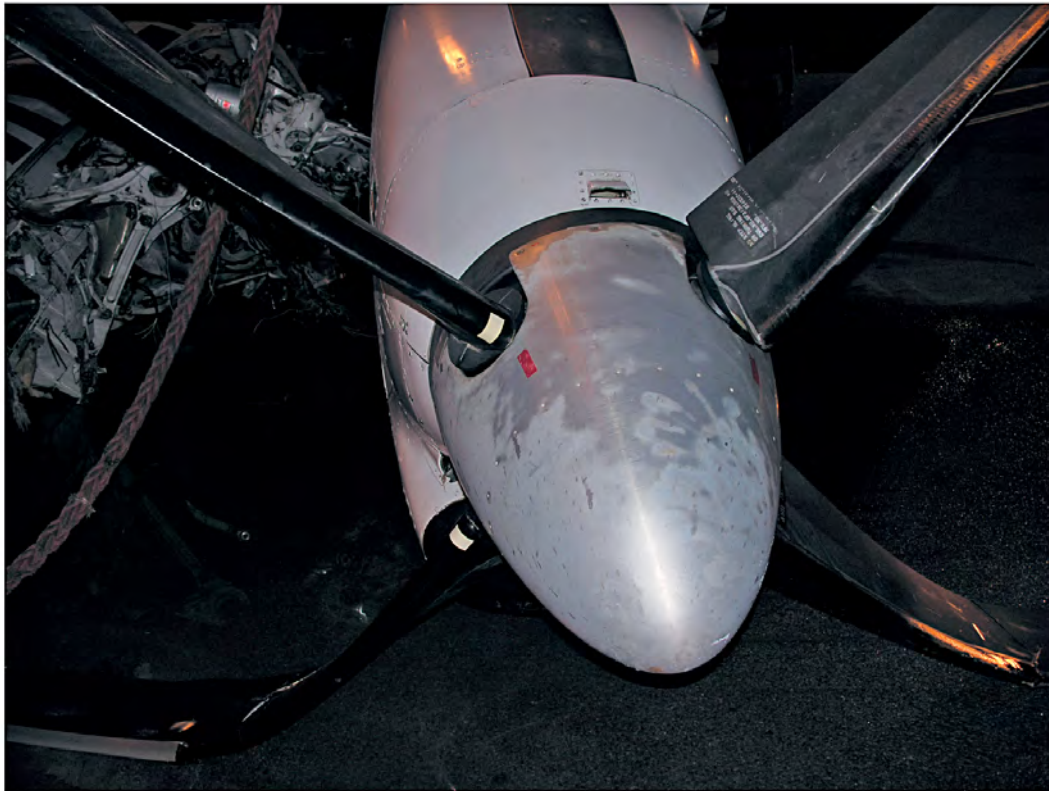
Photo 70: Note the feather position of the right engine propeller.

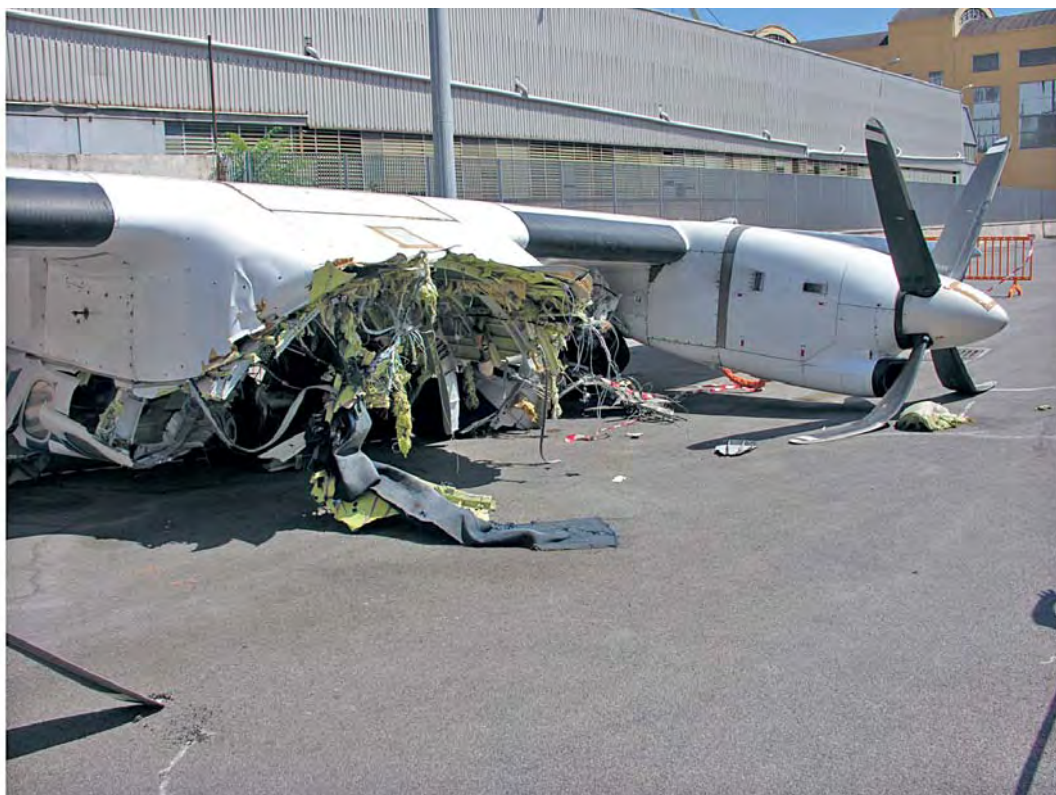
Photo 71: LH and RH wings with part of the central fuselage and engines after recovery.

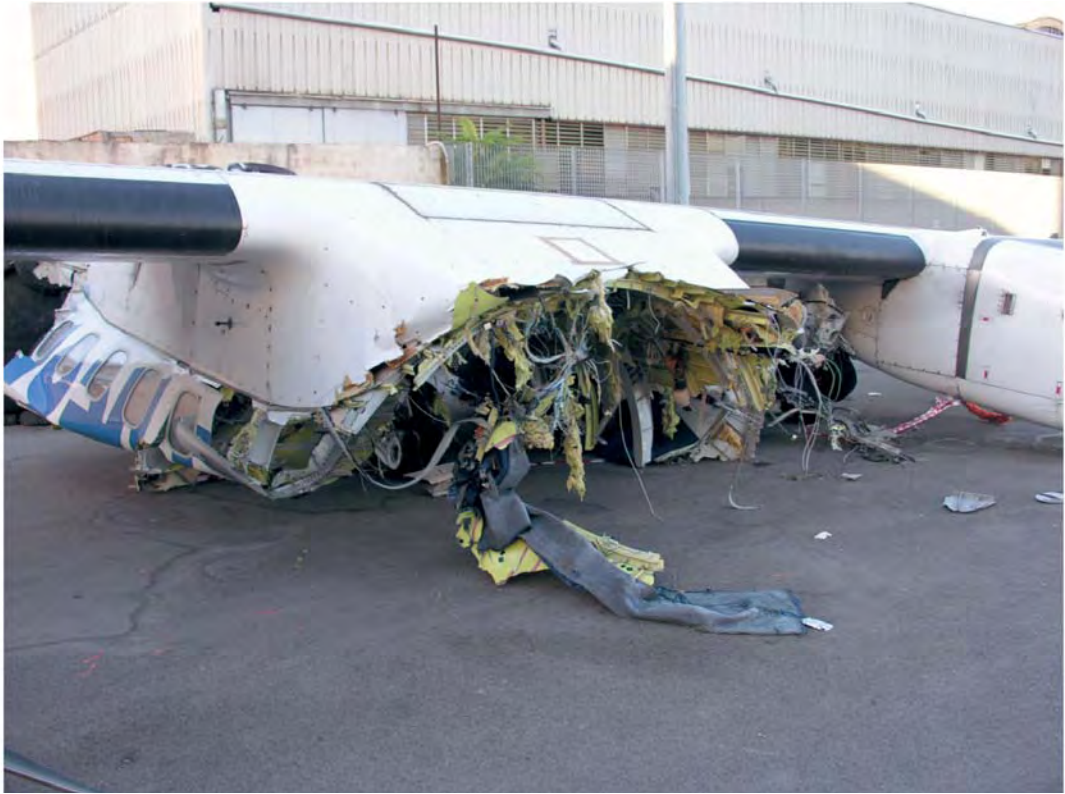
Photo 72: LH and RH wings and engines after recovery, the central fuselage section, front view.

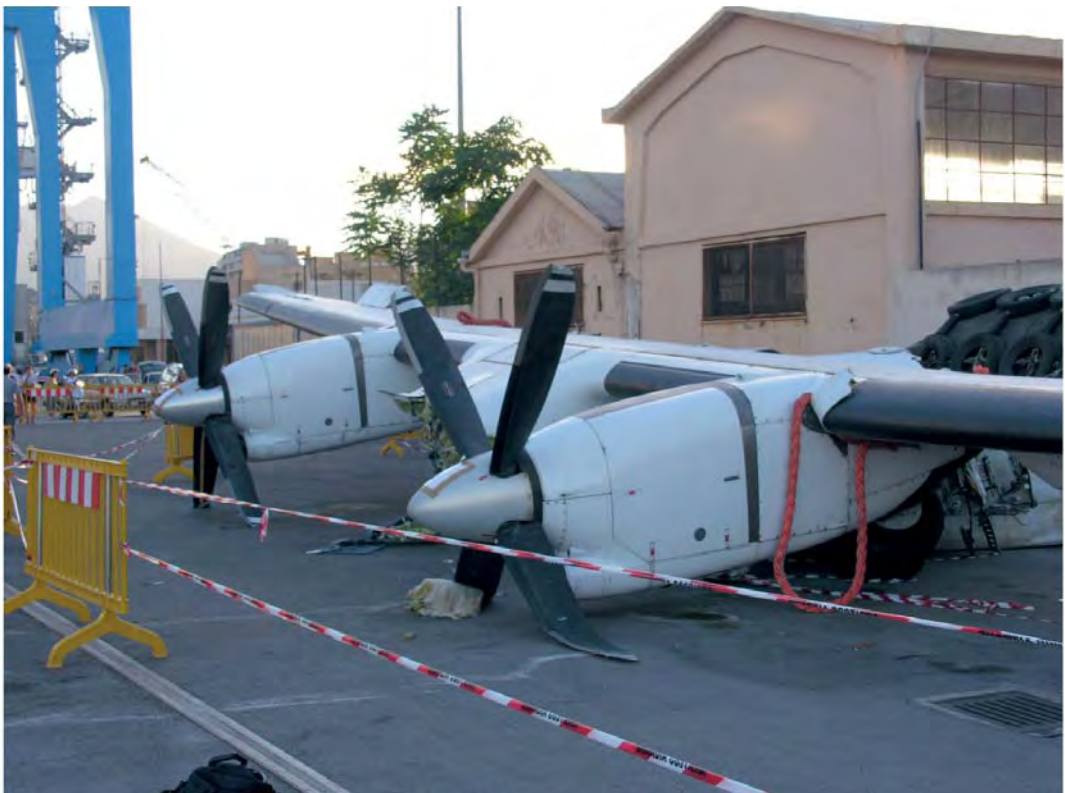
Photo 73: LH and RH wings and engines after recovery, whole view.

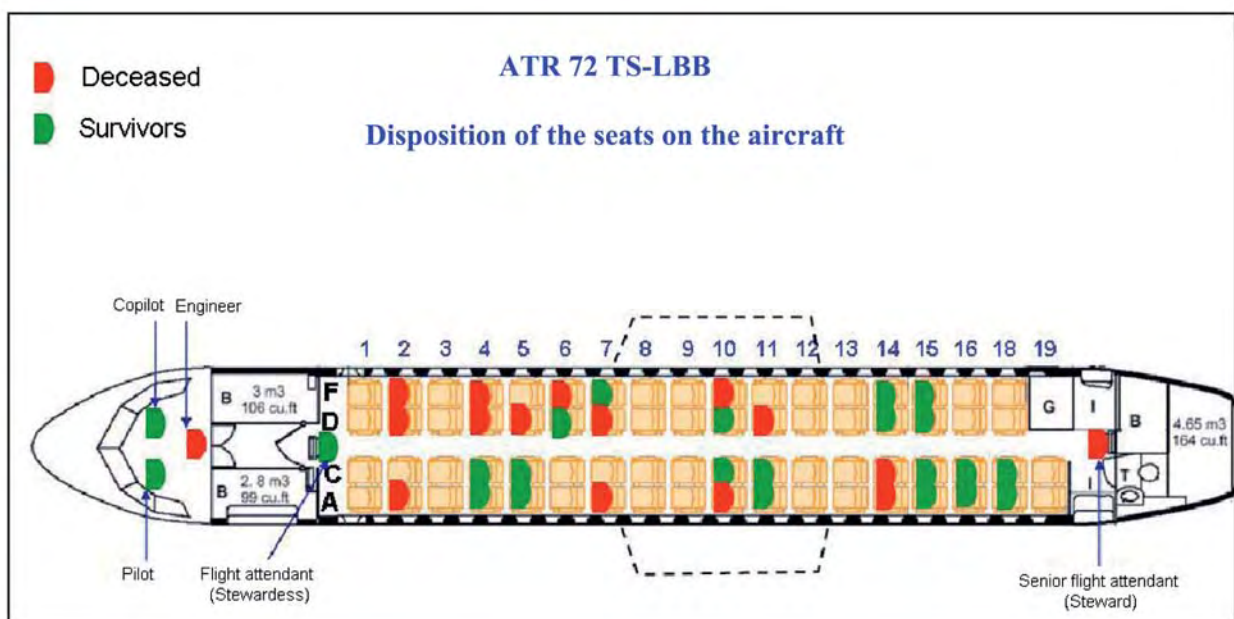
It is underlined that the aircraft tail section came away from the rest of the aircraft at row 13 and the break line also reached part of row 14. The passengers occupying seats 14A and 14C did in fact suffer fatal injuries, with serious head and chest injuries. The senior flight attendant, also in the rear section of the aircraft, suffered fatal injuries with lacerations and contusions on most of the body. He was recovered from the sea, still on his seat, which had completely detached from the cabin floor.

Figure 21: Disposition of the seats on the aircraft.

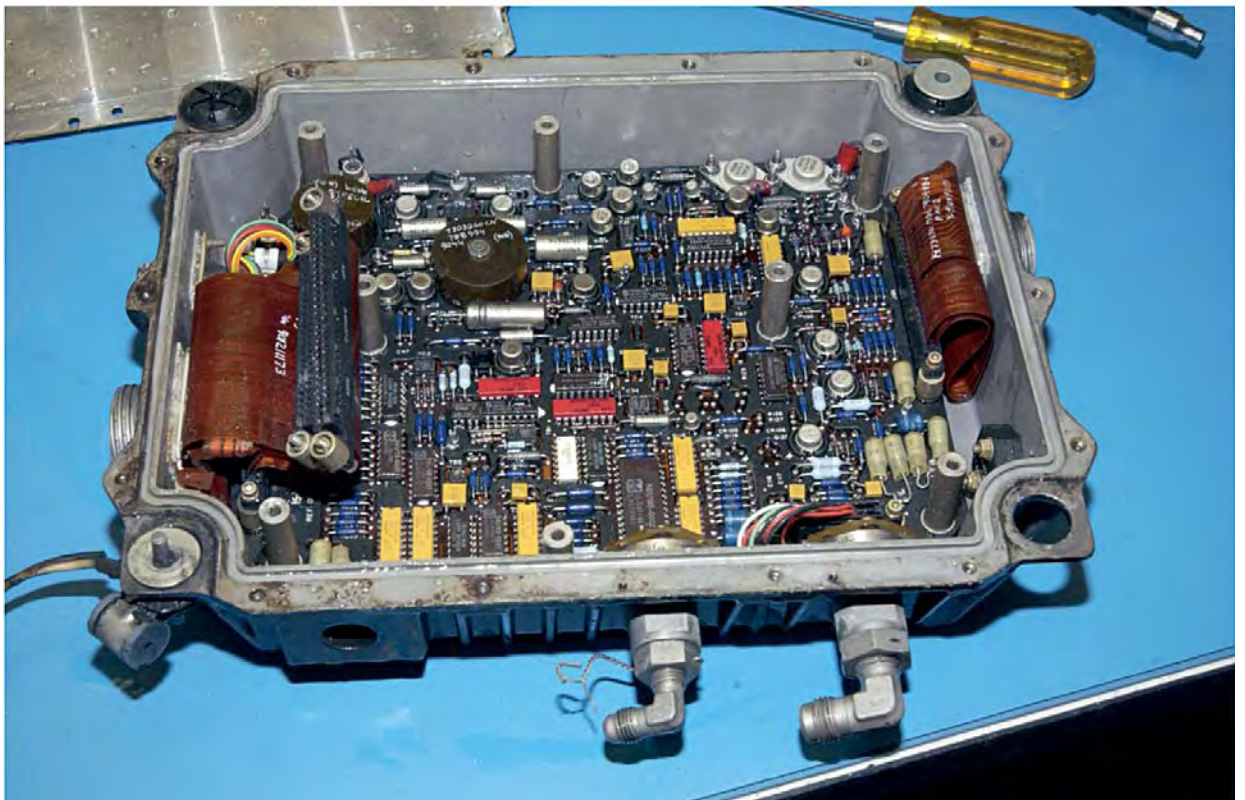
The information recovery operation gave positive results. This was also due to the good condition of the devices. The data recovered are in the form of a list of failure codes that have occurred from the date of the last reset, but they are not associated to a time parameter that could indicate when exactly they happened.

From the analysis of these data, it is possible to safely confirm that the engines did not suffer any notable failures, such as high turbine temperatures, compressor stall and/or malfunctioning of the internal components, which may have caused a spontaneous engine shutdown.

Photo 75: EEC internal circuits.

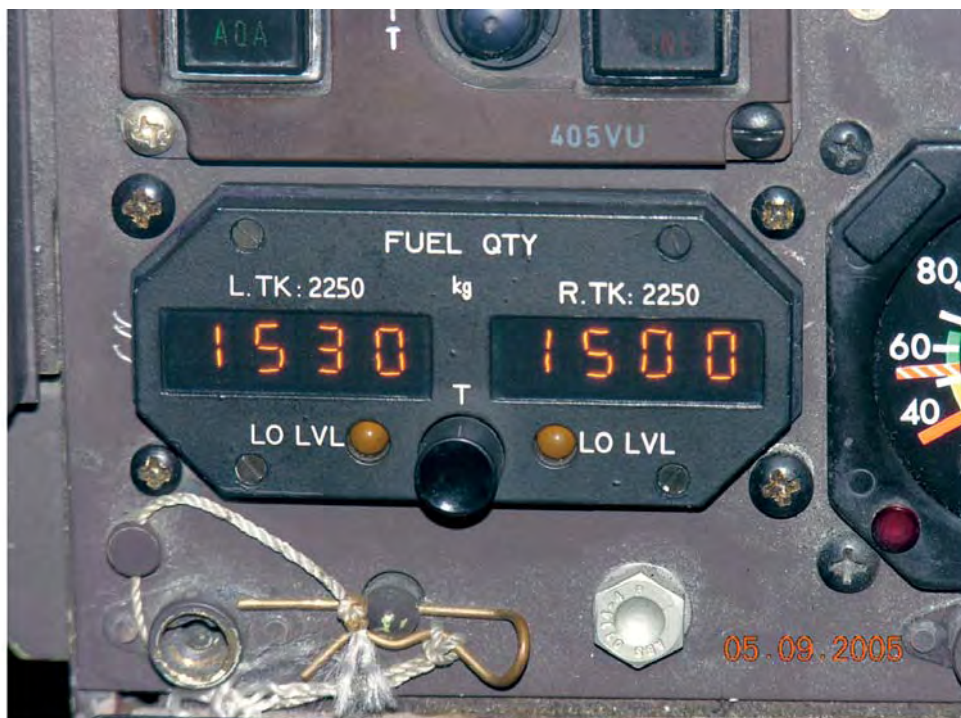
Photo 77: Indication given by an ATR 42 FQI fitted on an ATR 72 with 400+400 kg of fuel in each tank.

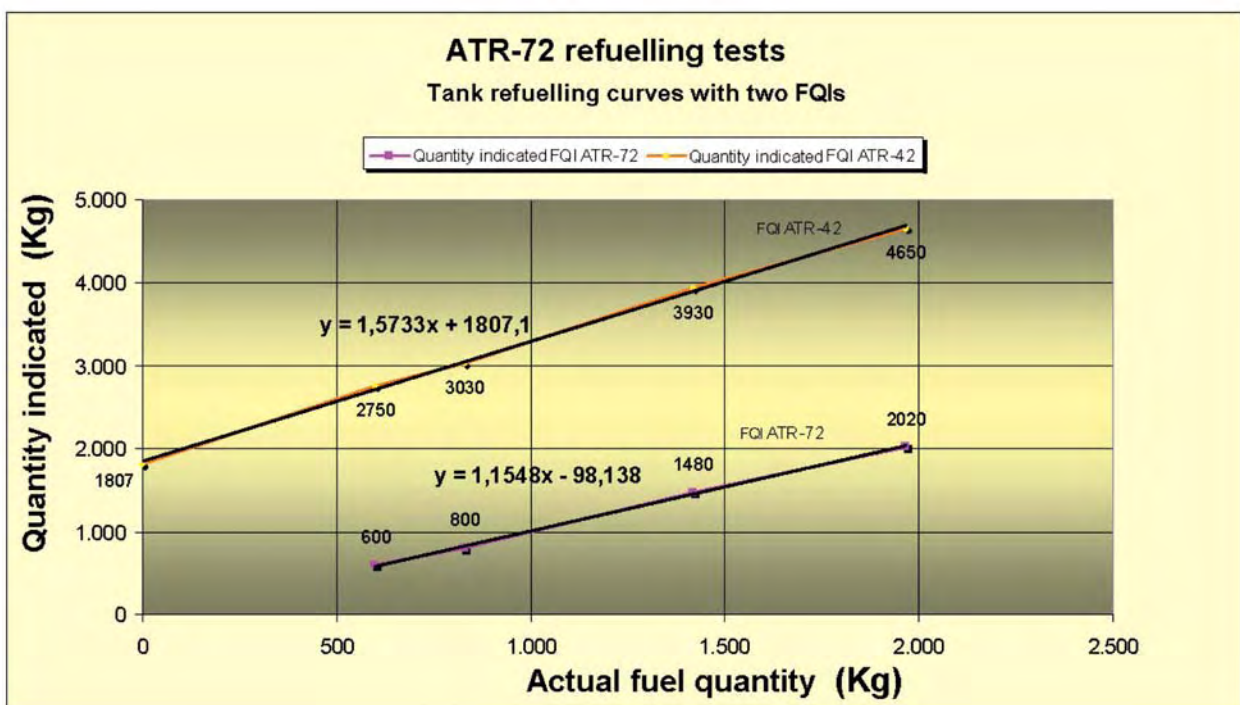
Figure 22: Tank refuelling experimental curves using two FQIs.

From the analysis of the results, it is therefore possible to state that the quantity indicated by an ATR 42 type FQI installed on an ATR 72 aircraft is higher than the quantity actually present in the fuel tanks and that it follows a linear variation curve, which is shown in the graph itself. In particular, by extrapolating the data based on the value of 0 kg, the indication of an ATR42 type FQI is equal to approximately 1800 kg. This is the quantity given by the TS-LBB crew to the air

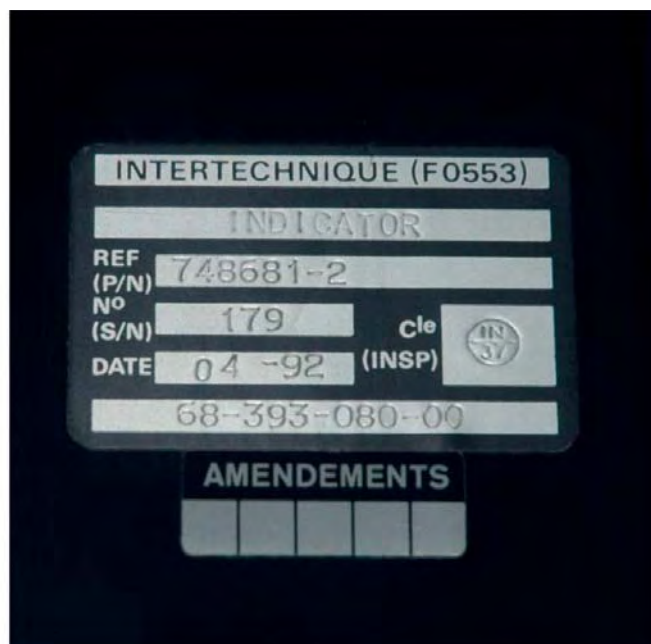
The same search was then performed by inserting P/N 748681-2, therefore omitting the dash between the first and second group of numbers. This is the P/N as printed (see photo 80) on FQI S/N 179, removed from the aircraft TS-LBB for replacement. In this case, the video monitor responded with the information relating to P/N 748681-2, called INDICATOR.

Photo 80: FQI S/N 179 nameplate (Data Plate).

- The ®AMASIS system also recognises dashes between alphanumeric groups as significant characters.
- The P/N number stamped by the manufacturer Intertechnique on the S/N 179 FQI, is different from the one listed in the IPC for the ATR 72 aircraft, with the dash after the digits 748 being missing. P/N 748681-2 is also listed on the document called "Authorised release certificate – Airworthiness approval tag" (subsequently replaced by JAA FORM ONE, now EASA FORM ONE); the P/N of ATR's IPC reflects the Intertechnique certification P/N as determined by Intertechnique itself.

On the contrary, the plate attached to instrument P/N 748681-2 S/N 179 (see Photo 80), which was removed from TS-LBB, has no hyphen after the first three figures.

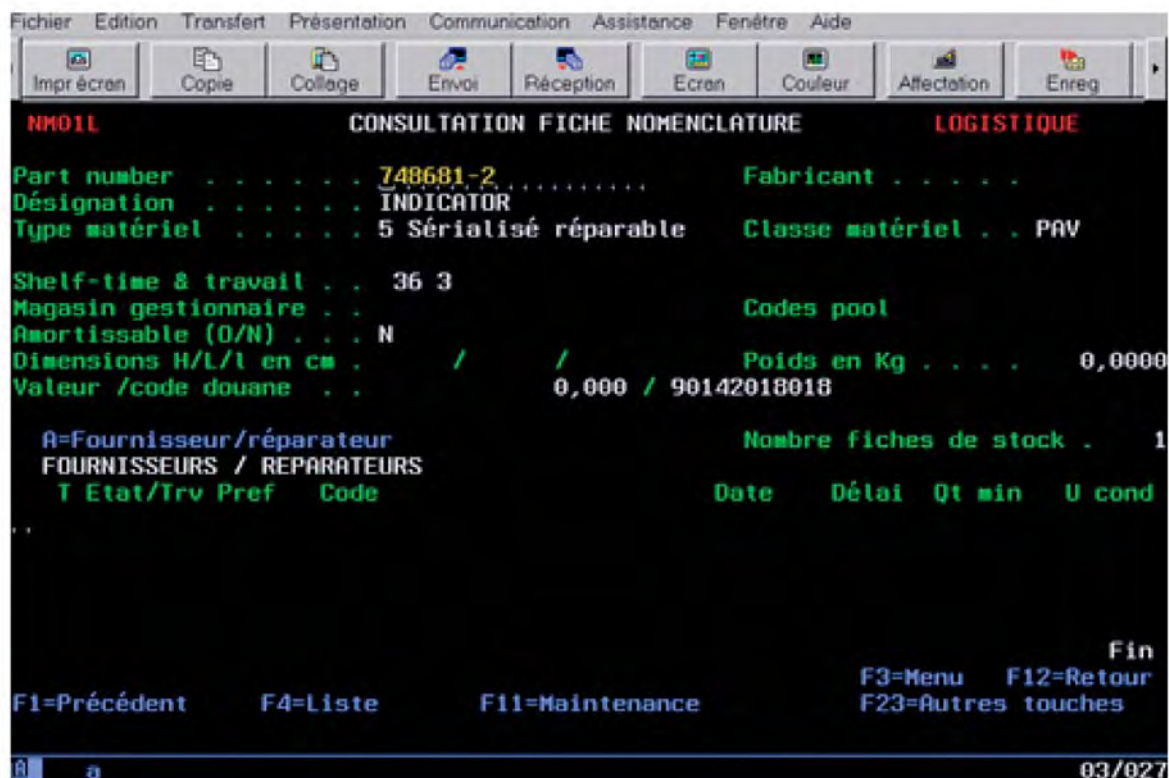
Photo 81: Information supplied for P/N 748681-2.

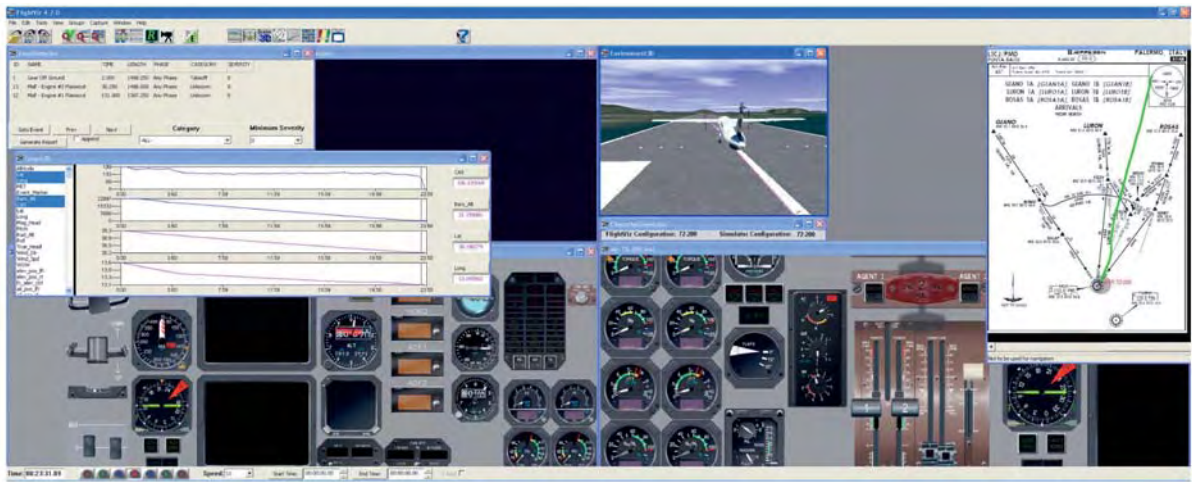
Figure 23: Reproduction of flight made, Simulation 1, final part.

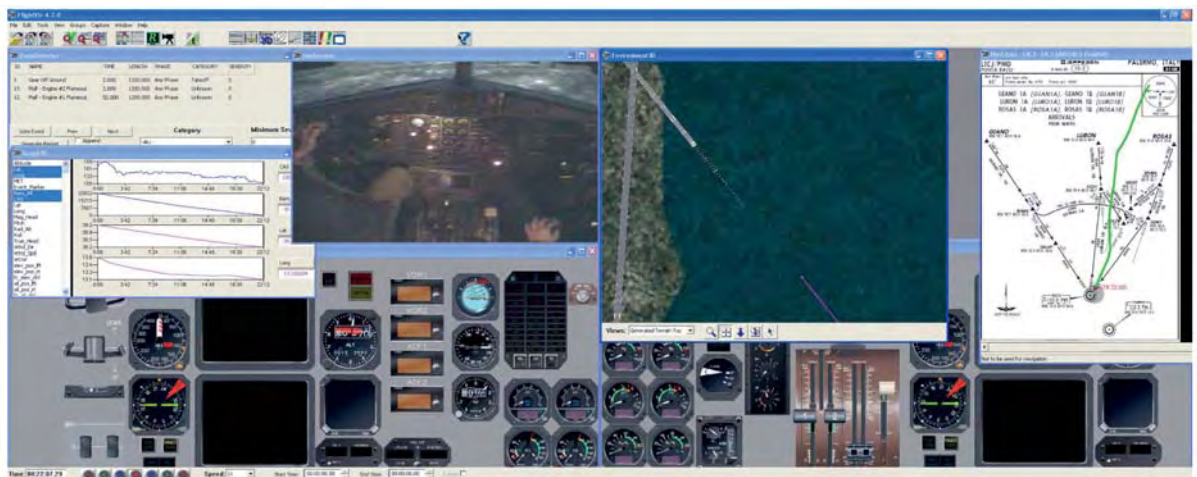
Figure 24: Reproduction of flight made, Simulation 2, final part.

From the figures regarding the speed profile shown in Tables 10 and 11 above, it will be noted that said profile is more linear in Simulation 1 than in Simulation 2, despite the fact that in neither case the speed was always constant or equal to the VmHB (optimum speed – optimum gliding speed) selected for the “fictitious” mass of 19.000 kg.

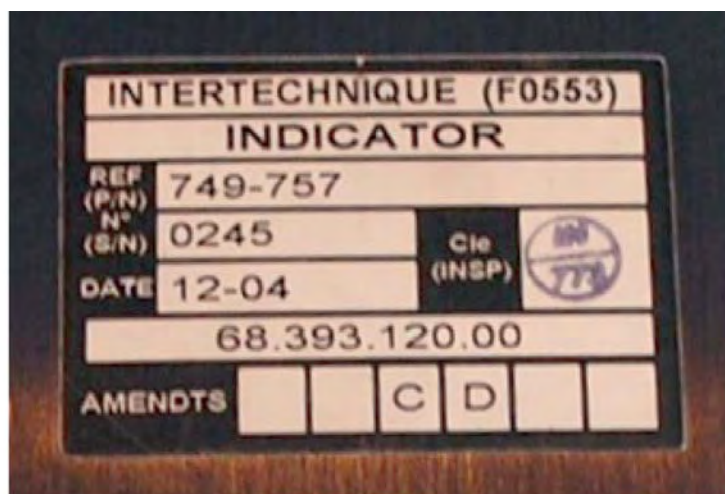
It is pointed out that only in the latest CMM, 28-42-83, is the hyphen dropped after the first three figures of the Part Number (P/N); however, during a visit to FQI's manufacturer premises and from the observation of some FQI's produced in December 2004 (photo 83) and April 2005 (photo 84), it has been noted that the identification plates attached to the instruments continue to feature it.

Photo 83: FQI Identification Plate.

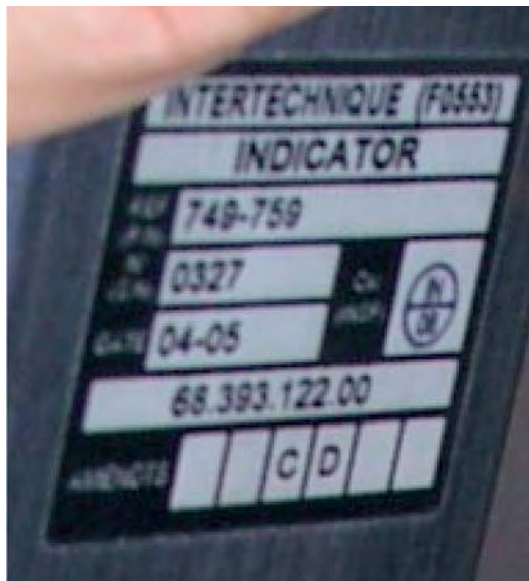
Photo 84: FQI Identification Plate.

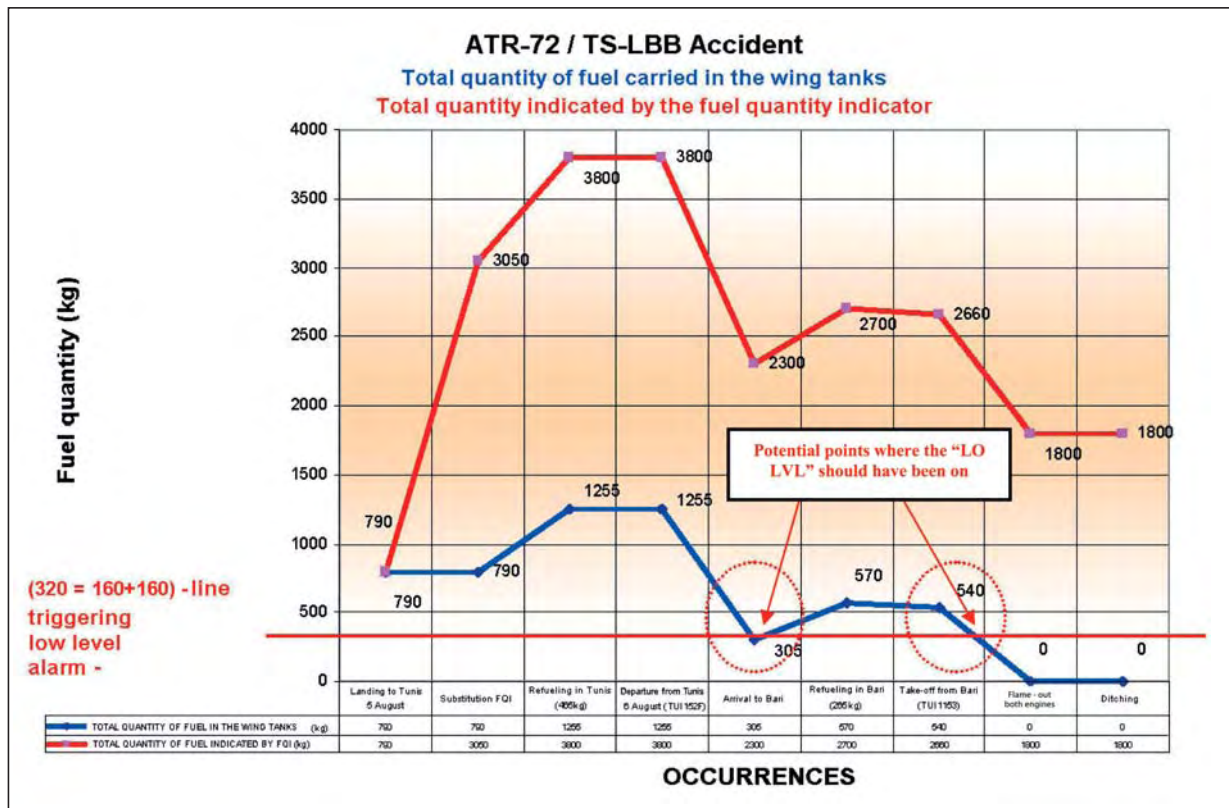
²³ With an ATR 42 type Fuel Quantity Indicator installed on board an ATR 72, the fuel quantity indicated obeys the following law of variation, determined experimentally: $Y = 1,572 X + 1807,8$ (in which X is the quantity of fuel actually carried on board). For example, with 600 kg fuel actually on board, the quantity indicated by the ATR 42 type FQI will be about 2750 kg.

The graph shown in Figure 27 gives the quantity of fuel actually on board (blue line) and the quantity indicated by the FQI (red line) for each stretch flown by TS-LBB.

Figure 27: Quantity of fuel indicated (red line) and actually on board (blue line). Note: a margin of error of approximately $\pm 2-3\%$ should be considered for the figures stated.

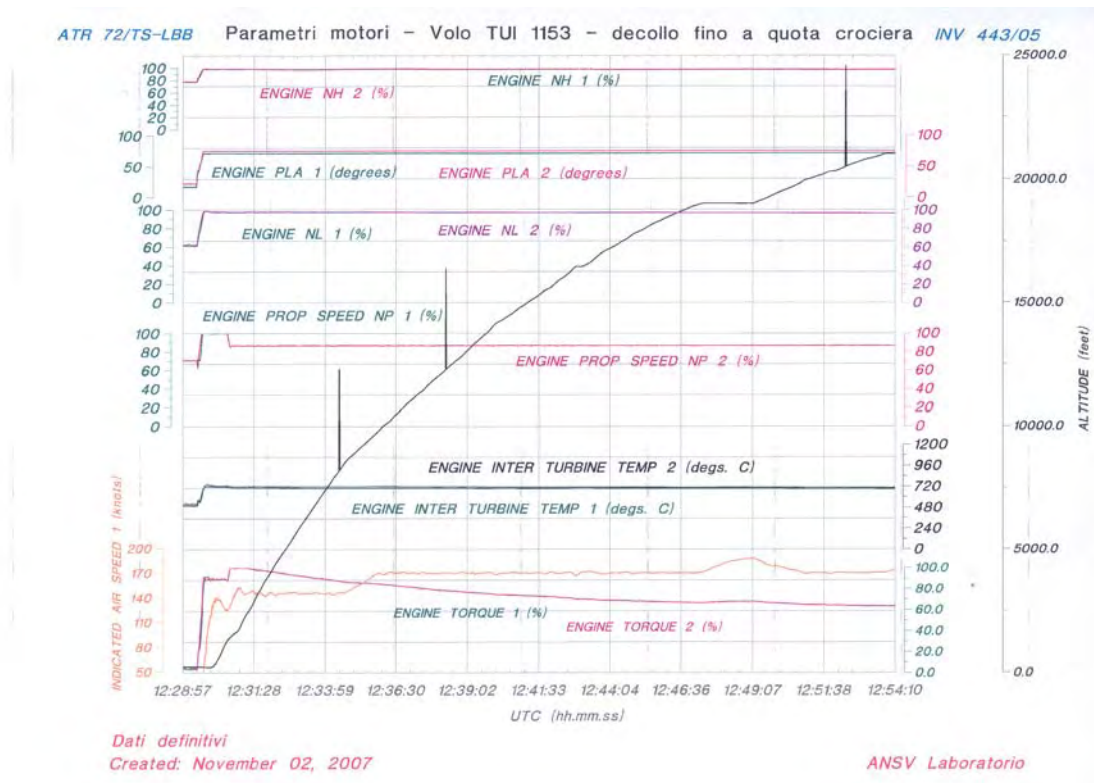
It will be noted from the graphs shown in Figure 28 that the engine parameters were normal and within the prescribed limits in the takeoff and climb to initial cruising altitude phase. The flight thus went off normally, without any aspect of particular note, from takeoff from Bari airport until the first engine flame out (right engine). The data extracted from the FDR regarding the working of the two engines suggest nothing out of the ordinary throughout the whole of the phase preceding the RH engine shut down.

The temperature, engine speed and fuel flow readings were, in fact, within normal values, as

Figure 28: Pertinent engine parameters from takeoff to initial cruising altitude.

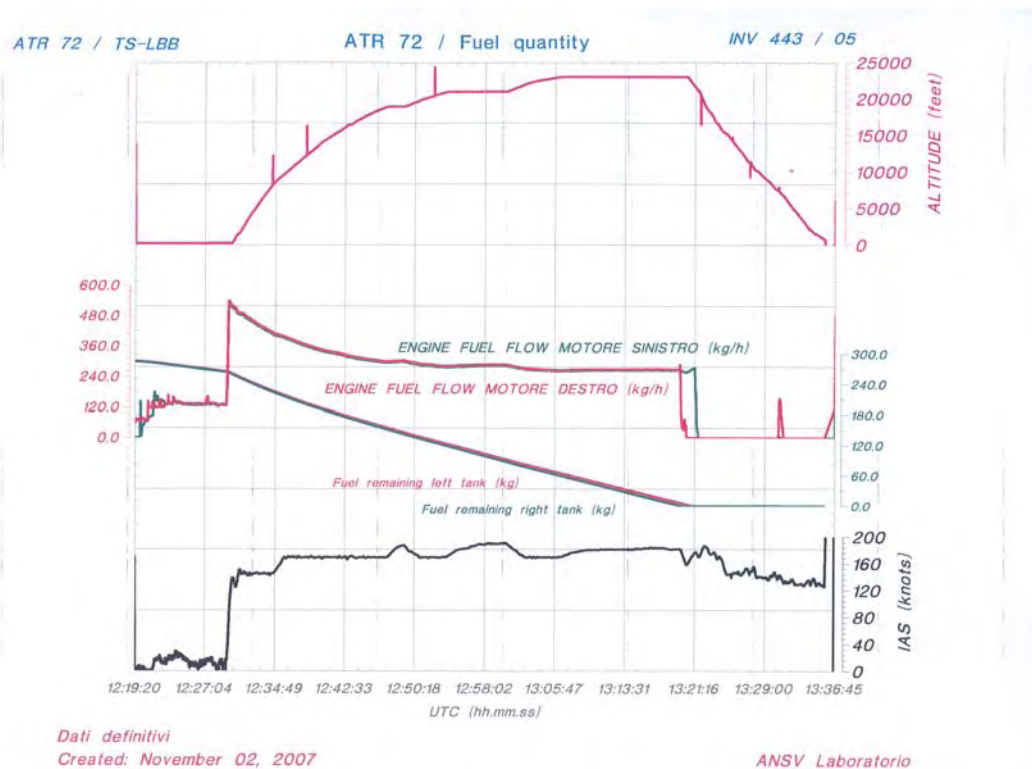
illustrated in the graphs in Figure 28. Fuel consumption was normal and settled at a rate of about 10 kg/min in the cruising phase (graphs in Figure 29).

Figure 29: Fuel quantity and consumption status. "Fuel remaining" parameter is determined from the fuel flow data and it is not directly recorded by the FDR

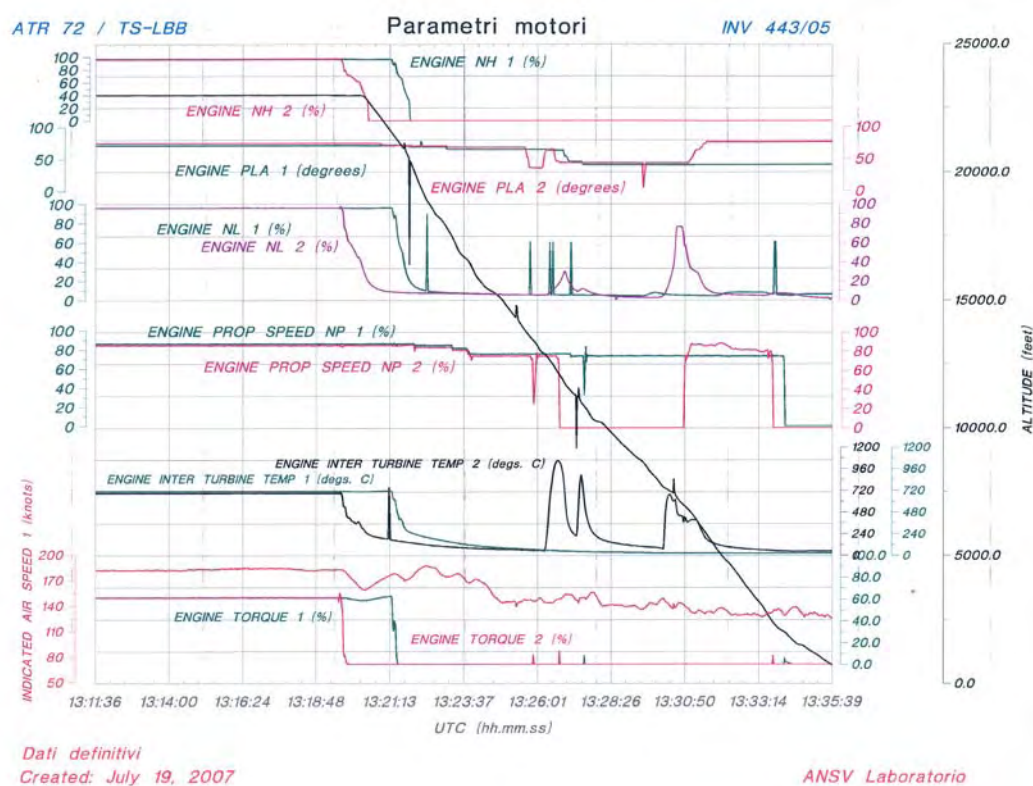
An analysis of the cockpit conversations that emerge from the CVR, plus the FDR data regarding aircraft altitude and speed parameters and the information supplied by the flight crew, have made it possible to reconstruct the action taken by the crew at the time when the first failures occurred. Figure 30 illustrates the main engine operation parameters; it may be seen that both engines shut down in linear fashion, without increases in internal temperature or an abrupt increase/decrease in speed in either engine.

Figure 30: Pertinent engine parameters.

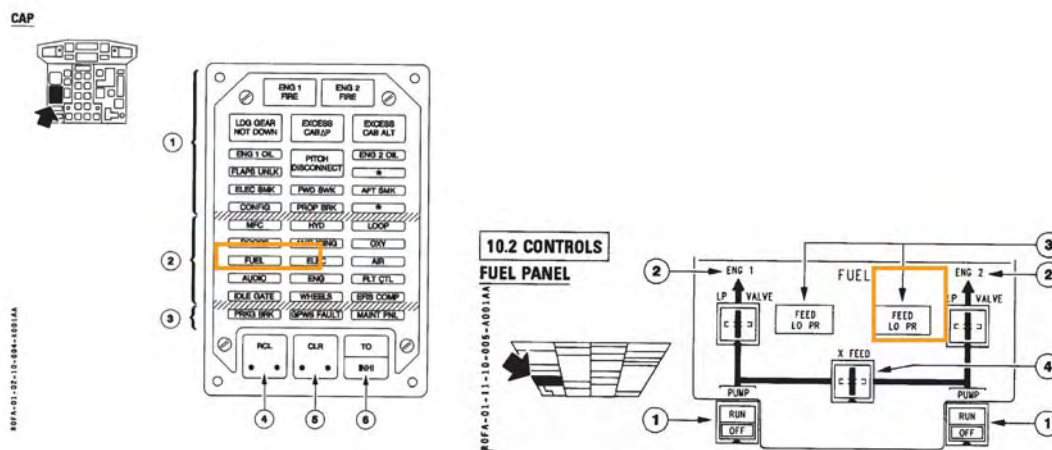
The first indications of malfunctioning to reach the cockpit were the amber “FEED LO PR” and “FUEL” lights illuminating on, respectively, the fuel panel and the Crew Alerting Panel (CAP), accompanied by the associated single chime.

Figure 31: CAP and Fuel Panel.

The “FUEL” warning light on the CAP lighting up alerts the crew to an abnormal situation requiring corrective action, and the “FEED LO PR” warning light illuminates whenever the pressure of the fuel flow into the engine concerned falls below 350 mbar (5 psi). This is a sign of a possible fuel pump failure, a suspected leak in the fuel ducts, or shortage of fuel. In the case in point, it was a sign of shortage of fuel.

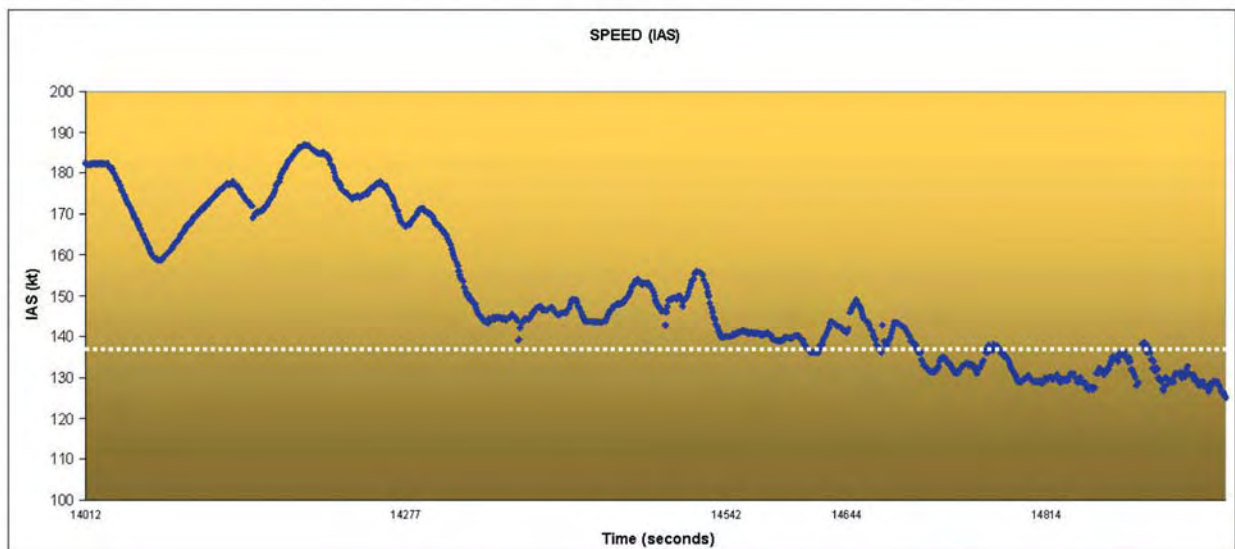
Prior to attempting re-ignition, the aforementioned procedure (“BOTH ENGINES FLAME OUT”) prescribes achieving and maintaining what is known as drift-down speed (V_{mHB} , optimum descent speed). This speed is given in the OPS DATA section in the QRH; with an aircraft mass of 17.000 kg, as in the case in point, said speed is about 129 knots with flaps 0°, and 137 knots for an aircraft mass of 19.000 kg (dotted line in figure 32). At the time of the second failure, the aircraft was flying at a speed of about 180 kts, and the flight crew in any case maintained speeds considerably higher than those prescribed by the procedure down to an altitude of about 6000 ft. As will be seen, moreover, from the speed graph shown in Figure 32, which covers the final phase of the flight after both engines had shut down, the speed varied considerably over time. However, as was also confirmed by the tests performed on the flight simulator, it is no easy matter for a flight crew to succeed in maintaining a constant speed profile throughout an emergency similar to the one that involved TS-LBB. This is primarily so because of the difficulty of using the emergency instruments provided with a reduced electrical supply (airspeed indicator, stand-by horizon, altitude and vertical speed indicator) and the practical problems encountered in handling and operationally manage the flight.

Figure 32: Indicated Air Speed (IAS) final phase recorded by FDR.

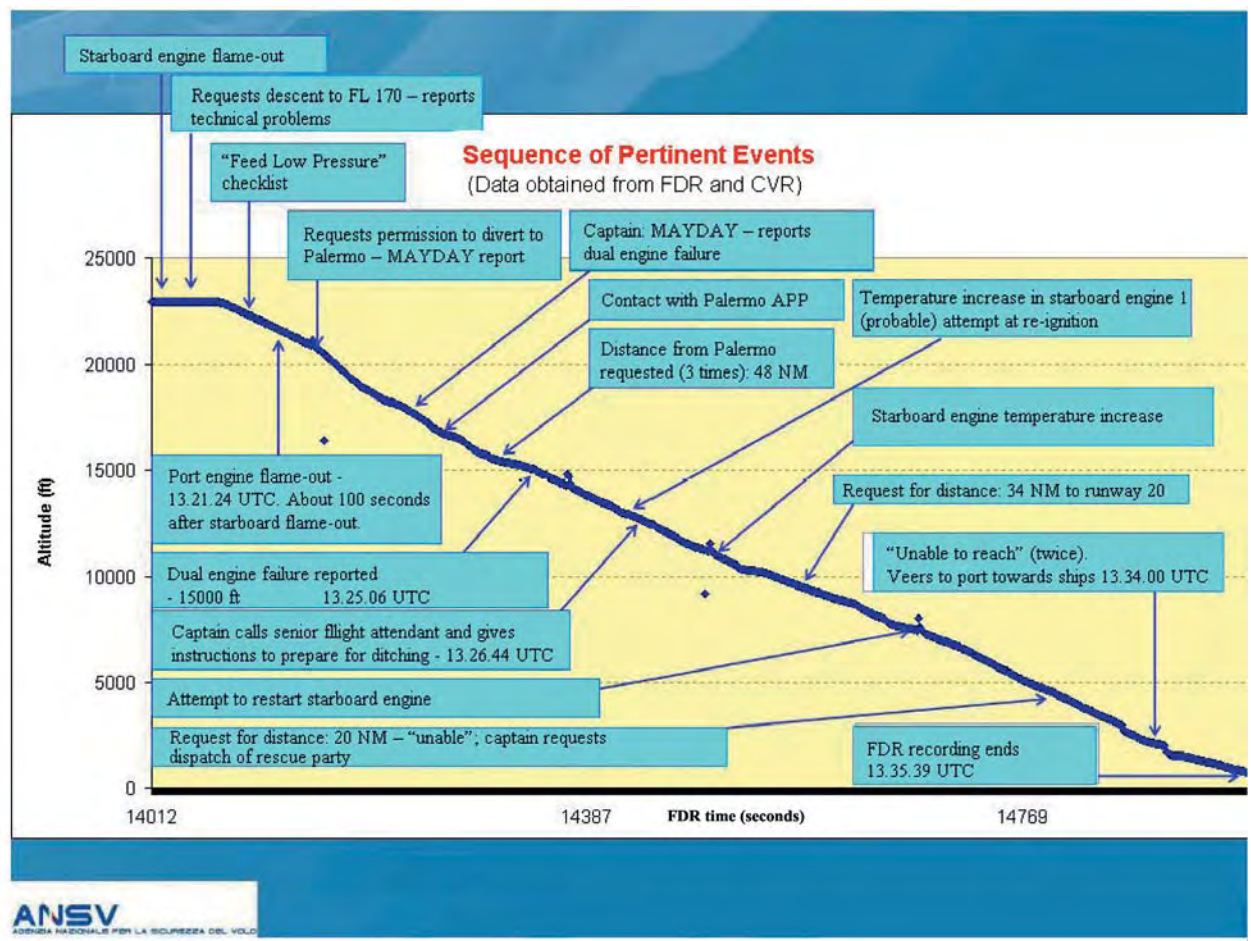
The table in Attachment “H” details the sequence of pertinent actions performed in the cockpit over the 17-minute interval between flame out in the first engine and ditching. Whereas Figure 33 shows the same sequence in diagram form, taking aircraft altitude as the base parameter.

Figure 33: Sequence of pertinent events.

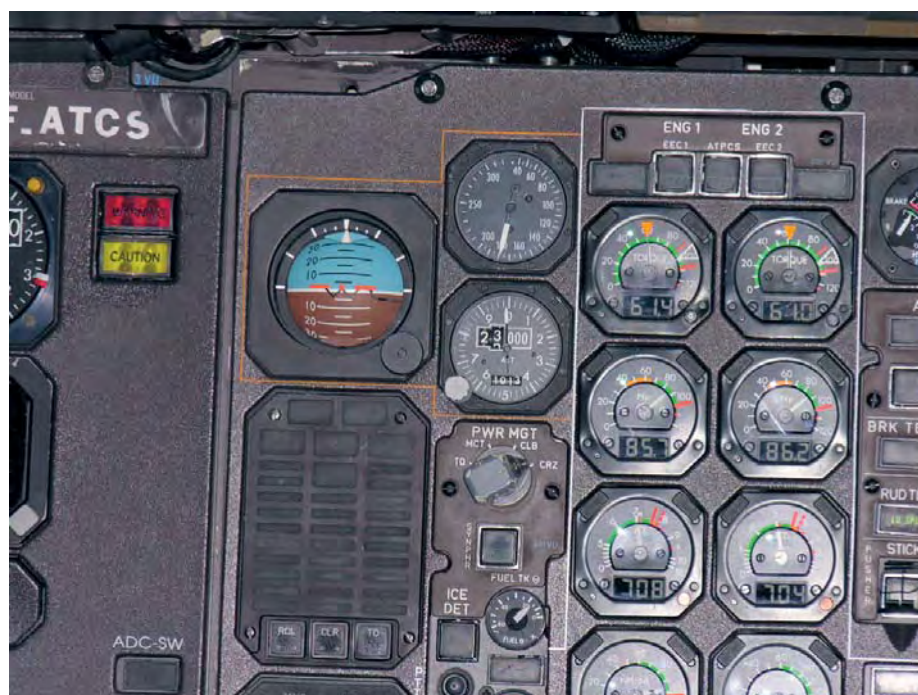
After identifying the first failure and starting to apply the relevant check list, the crew detected a loss of thrust in the RH engine followed, shortly after, by the other (LH) engine failure. This emergency situation was not handled correctly, as the checks prescribed in the applicable “BOTH ENGINES FLAME OUT” check list were not performed. However, the particular operating conditions in which the crew found itself must be borne in mind: without information in the cockpit on the distance from Palermo (with the second engine out of action, the DME values are not available), with reduced flight instruments, with a misleading fuel quantity reading, dual engine failure and the prospect of ditching. With dual engine failure, and hence with the electrical generators inoperative, flight instrument availability is limited and the crew has only the stand-by instruments to rely on for the purposes of handling the aircraft.

Photo 85: Detail of stand-by instruments.

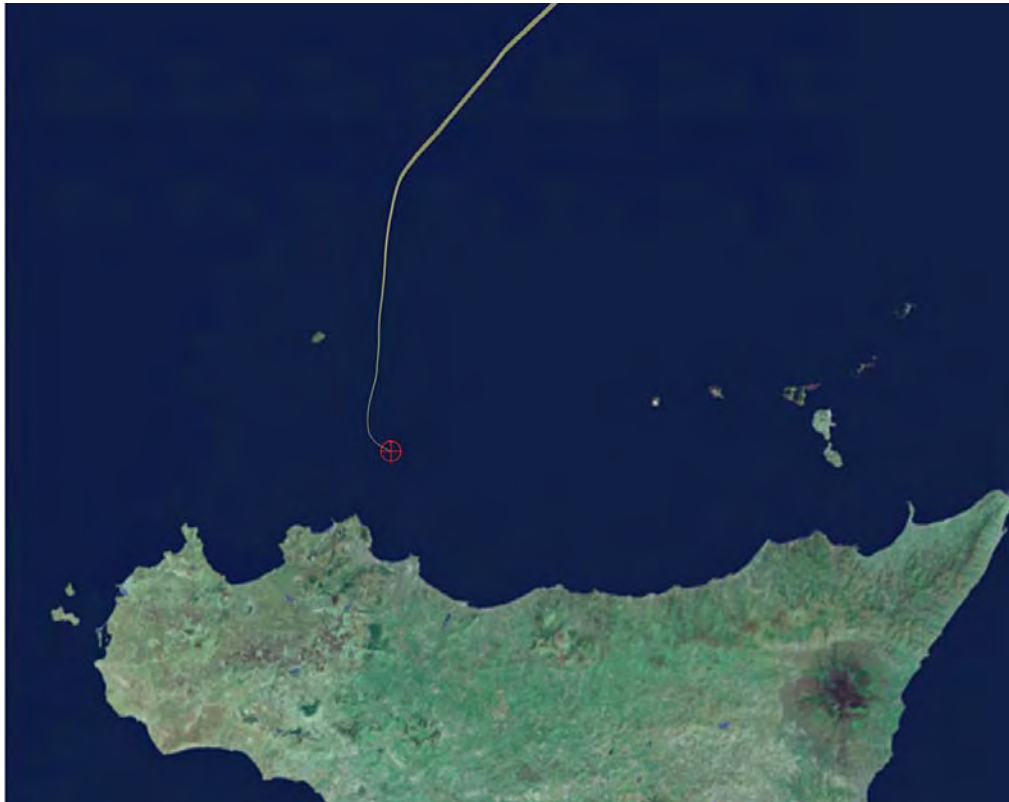
In flight conditions of this kind, the captain in any case had the presence of mind, once he had actually realised that it was impossible to land at Palermo (Palermo APP reported at the altitude of about 4000 ft that the distance was 20 NM), to steer the aircraft in the direction of two vessels, veering away from the previous heading to left and requesting that the vessels in question be alerted so as to facilitate the pinpointing of the aircraft for subsequent rescue purposes.

Figure 34: Final phase of the TS-LBB flight path (FDR data).
