FINAL REPORT

**ACCIDENT
INVOLVING ATR 72 AIRCRAFT
REGISTRATION MARKS TS-LBB
ditching off the coast of Capo Gallo (Palermo - Sicily)
August 6th, 2005**

AGENZIA NAZIONALE
PER LA SICUREZZA DEL VOLO

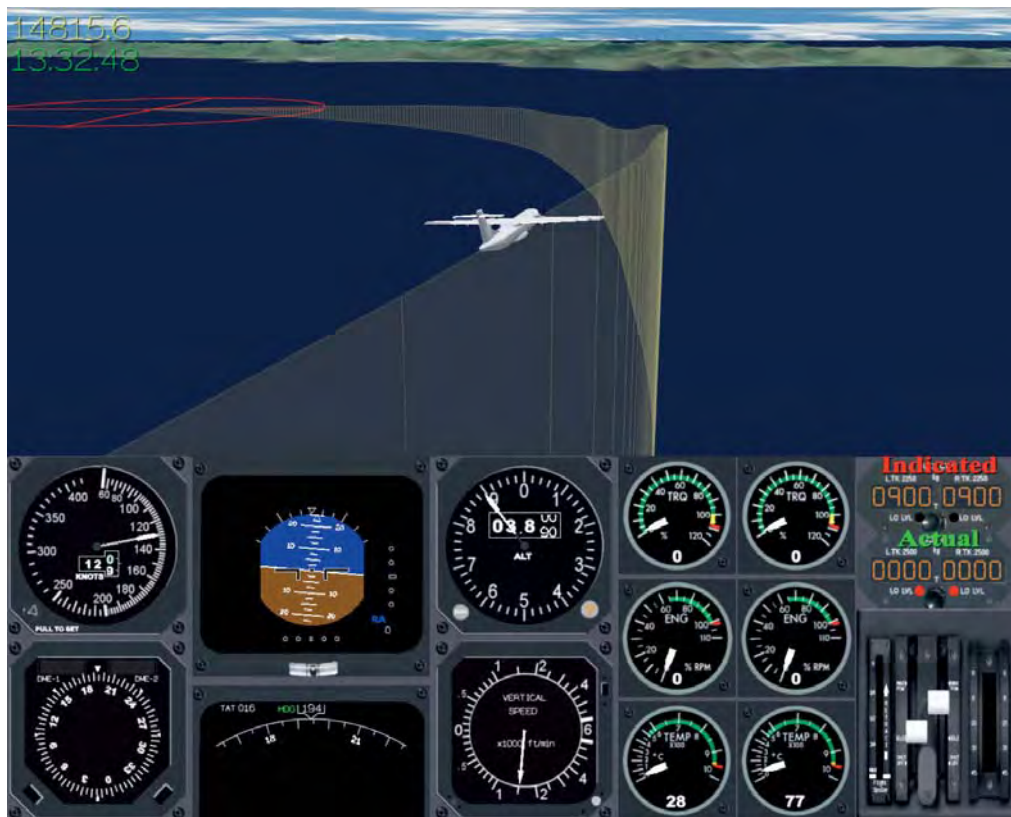
Figure 35: Final phase of the TS-LBB flight path (FDR data).

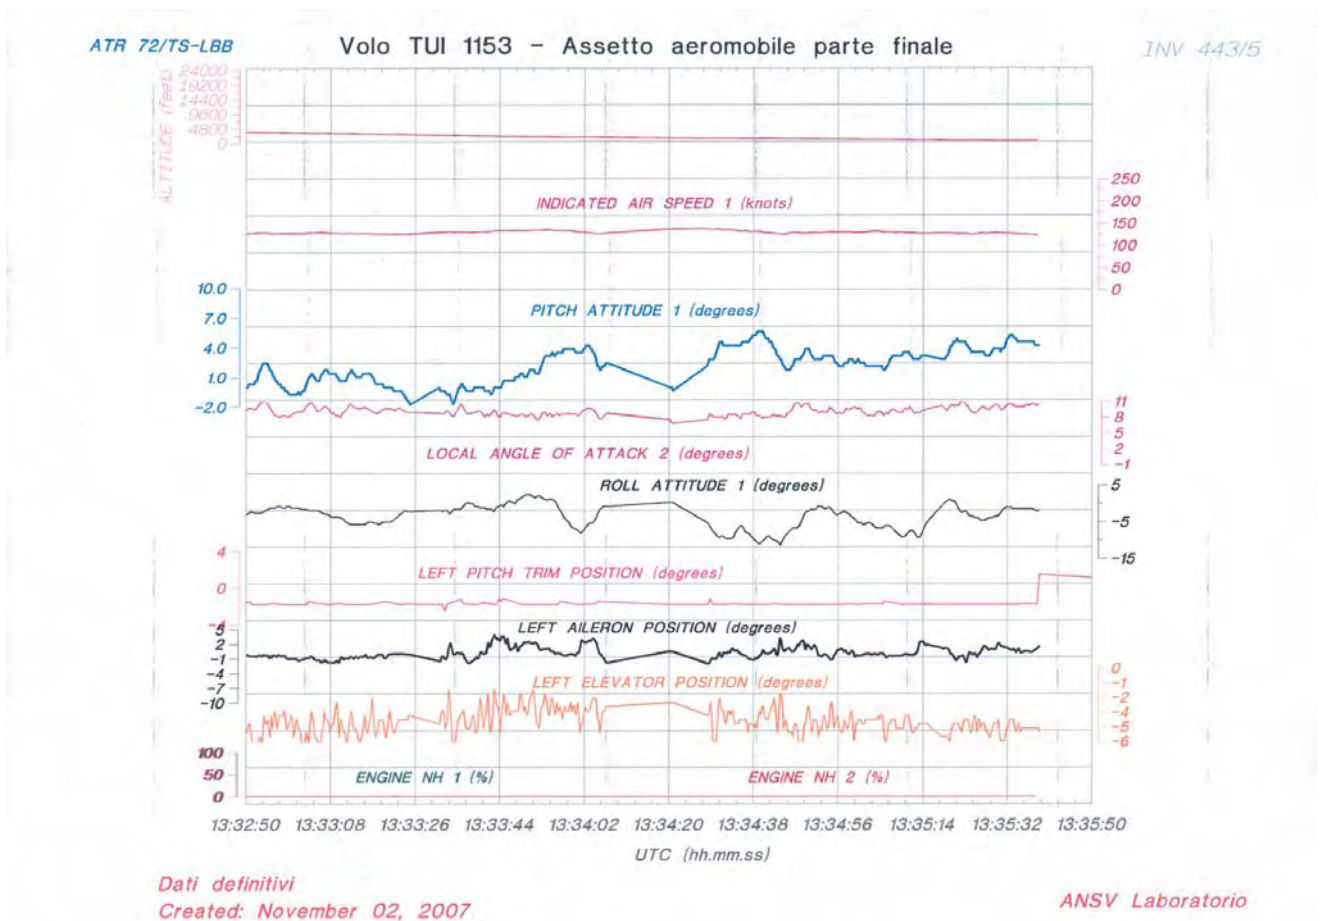
The FDR stopped recording with the aircraft at an altitude of 728 ft and Indicated Air Speed of 125 kts. From analysis of relevant data recorded during the previous minute, it has been determined that the aircraft had a descent rate of approximately 700 to 800 ft/min. Therefore in the hypothesis, highly probable, that the pilot maintained the same descent rate until impact, it can be reasonably assumed that approximately one minute has elapsed between FDR recording interruption and the impact with the sea surface. Such hypothesis is verifiable with the comparative analysis of FDR and CVR end of recording timing, with ATC timing (see paragraph 1.11.4.). Regarding the evaluation of parameters needed for determining the dynamics during the final part and that regarding the ditching, it has been necessary to use the results from wreck analysis, CVR data and available witness statements.

Figure 36: Relevant parameters during final phase.

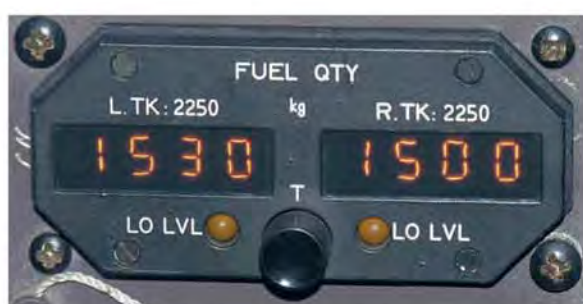
The wing tanks of the ATR-72 and ATR-42 differ in terms of maximum fuel capacity and shape, as well as number of the probes; as a consequence FQIs for the ATR-72 and for the ATR-42 utilize different algorithms to process the input capacitance signals coming from the tank probes and therefore they are not interchangeable (see manufacturer curves in Annex).

Nevertheless the FQIs for the ATR-72 and ATR-42 have the same dimensions and installation interface; this means that an FQI for the ATR-42 could erroneously be installed on a ATR-72 model and viceversa. The only visible difference between the two FQIs is the indication in small white digits of the maximum fuel quantity per tank, which is “2500” for the ATR-72 and “2250” for the ATR-42.

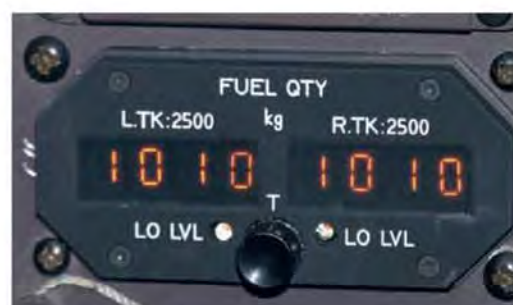
Fuel Quantity Indicator ATR -72

ANSV conducted extensive refuelling tests in order to quantify and assess the effect of an erroneous FQI installation in terms of fuel quantity indication.

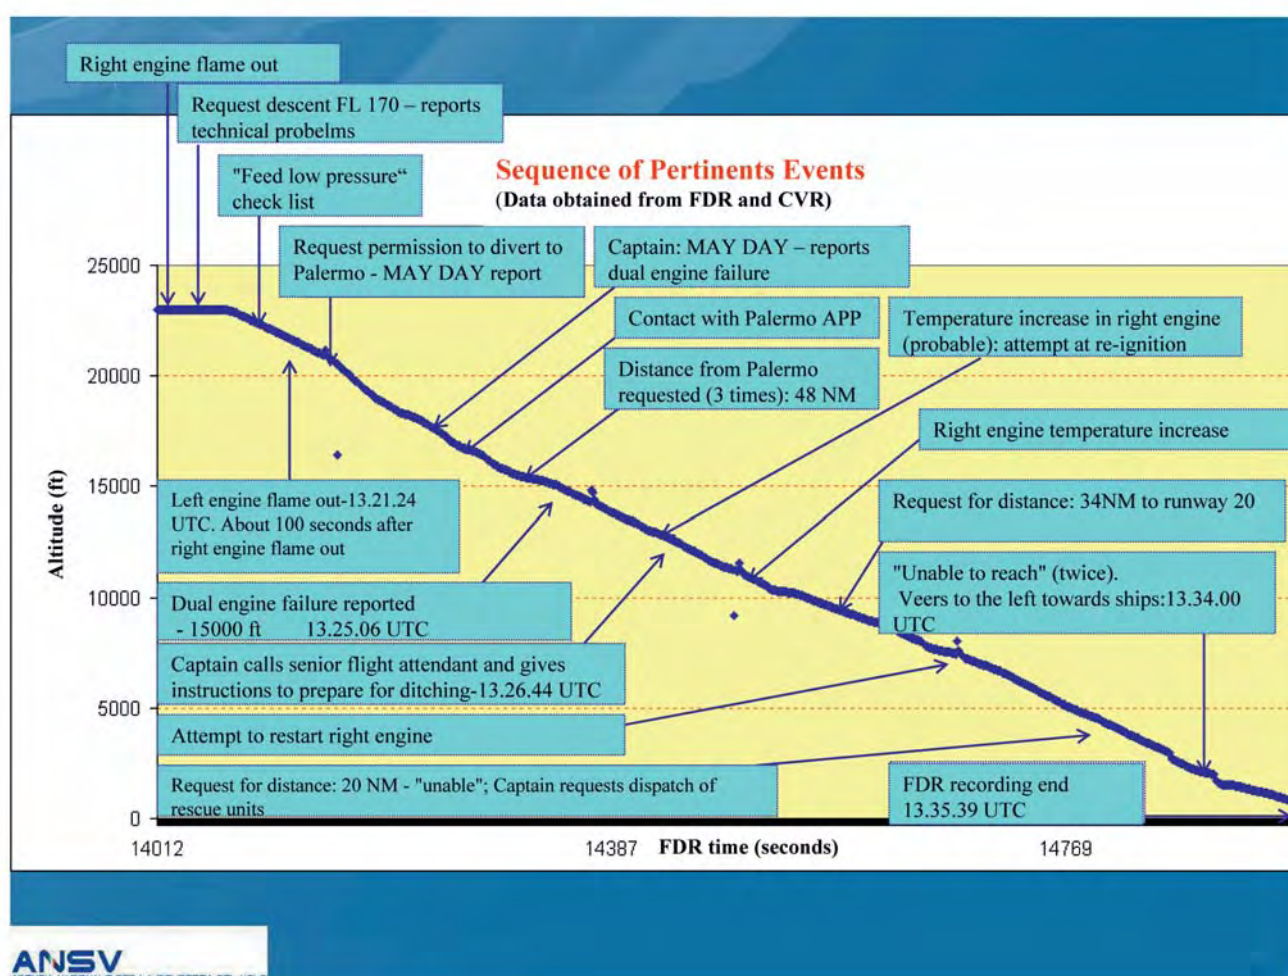
ATR 72 / TS-LBB Ditching - 6 august 2005
Flight TUI 1153 - Sequence Events of interest

| N. | Event | FDR Time (seconds) | UTC time (hh.mm.ss from FDR) | Altitude (ft) | Airspeed (kts) | Note | Distance from Palermo TVOR/DME |
|---|---|---|---|---|---|--|---|
| 9 | TUI 1153 confirms MAYDAY conditions | 14281 | 13.23.54 | 16.290 | 168 | Request latest wind conditions in Palermo | |

| N. | Event | FDR Time (seconds) | UTC time (hh.mm.ss from FDR) | Altitude (ft) | Airspeed (kts) | Note | Distance from Palermo TVOR/DME |
|---|---|---|---|---|---|---|---|
| 12 | TUI 1153 requests to Palermo APP if there is another airport closest than Palermo | 14345 | 13.24.58 | 14.880 | 144 | TUI 1153 informs Palermo APP that they have both engines failed and that they are at 15000 ft - 13.25.02 UTC | |

| N. | Event | FDR Time (seconds) | UTC time (hh.mm.ss from FDR) | Altitude (ft) | Airspeed (kts) | Note | Distance from Palermo TVOR/DME |
|---|---|---|---|---|---|---|---|
| 34 | Sound ("cricket"). Most probably the stall warning sound | 15035 | | | | | |
| 35 | Impact with the sea - CVR ending | 15045 | 13.36.36 | | | Radial 053 from Palermo TVOR/DME | 22 NM |
