**AIRCRAFT ACCIDENT REPORT 5/2009**

**Report on the serious incident to  
BAe 146-200, registration EI-CZO  
at London City Airport  
on 20 February 2007**

**Air Accidents Investigation Branch****Aircraft Accident Report No: 5/2009 (EW/C2007/02/06)**

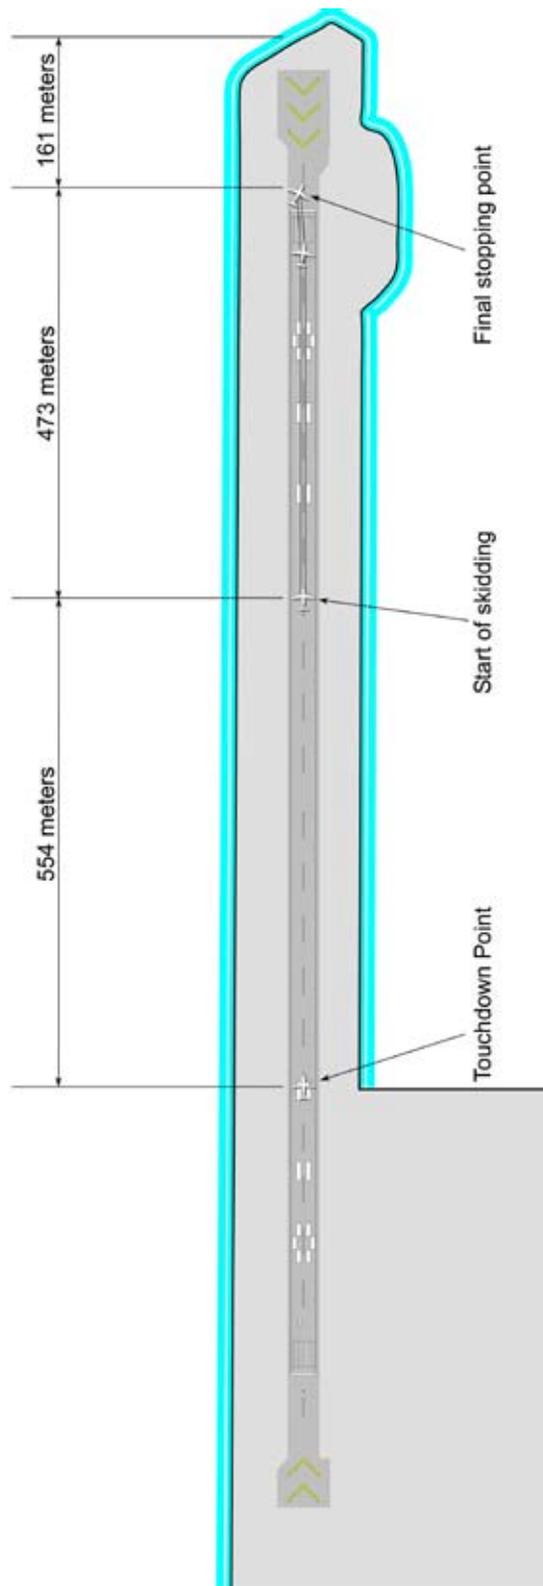
**Figure 9**

The aircraft came to rest in the undershoot area of Runway 28, 161 m short of the dock edge. Based on witness evidence, it touched down at the end of Runway 10 touchdown zone and, on this basis, the aircraft travelled 554 m prior to the start of the skid marks. These were evident for each of the four main wheel tyres over a distance of 473 m. Toward the end of the skid, the aircraft tracked to the left of the runway centreline, but with the aircraft heading to the right, before coming to a halt on a heading of  $130^{\circ}$ . During the skid, the four main wheel tyres had been worn through, causing all to deflate, and all the tyre carcasses to start to roll over the rims of their wheel hubs.

Landing/stopping distances for EI-CZO

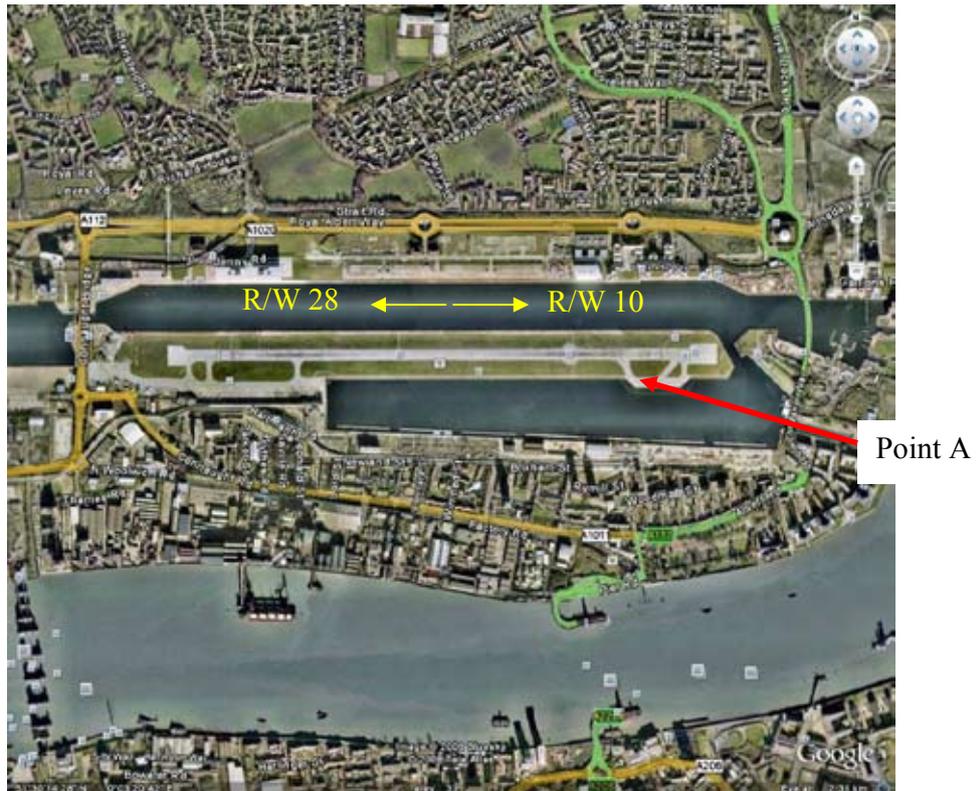
**Figure 10**

The overrun area for Runway 10 at LCY is 192 m, and the Runway End Safety Area (RESA) is 132 m. The RESA therefore forms the majority of the overrun area and exceeds the ICAO recommended length of 120 m for a code two instrument runway. Runway 10 overrun area does not include an arrestor bed; although, the paved surface is grooved. Beyond this area is a small water channel linking the two main water-filled areas of the old dock, located either side of the runway, Figure 10. Overshooting the paved surface or departing the runway to the side would, therefore, carry a significant risk of an aircraft entering the water, possibly in a damaged condition.

The water surface is approximately 1 metres below the level of the runway, and is maintained around this level by lock gates between the docks and the River Thames, which is tidal at this point. When the docks were originally constructed, the water depth was approximately 20 metres, but they have silted up since their commercial use ended. In places, the water depth is only around 1 to 2 metres.

Photograph illustrating the nature of the undershoot and overrun areas, and the proximity of the water-filled docks to Runway 10/28

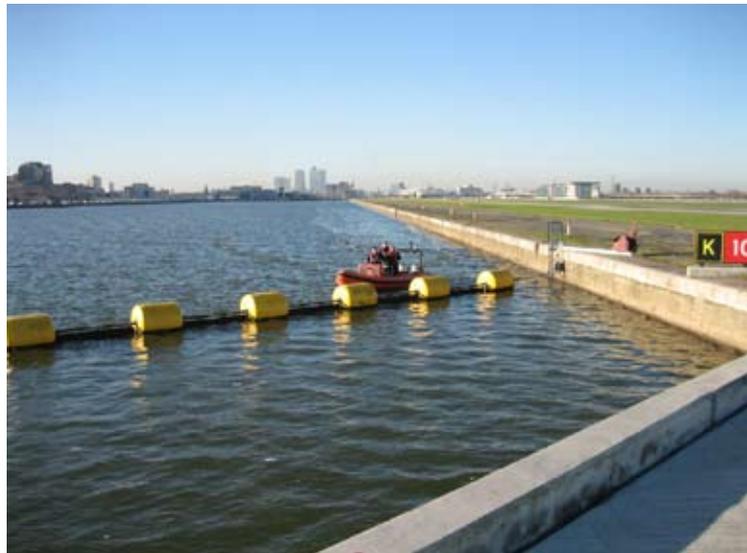
**Figure 11**

The London City Airport Fire and Rescue Service (AFRS) operates three rapid intervention rigid inflatable boats (RIBS), Figure 11, two of which are on standby at any one time, and which are capable of deploying buoyancy aids. Two towable slide rafts can be used in conjunction with the RIBS, which are capable of seating up to 60 persons. Both RIBS are positioned on the south side of the runway at a location which ensures the minimum of delay in their deployment by the AFRS.

Photograph taken from point A in Figure 10, looking west, showing one of the rapid intervention boats, and illustrating the proximity of the southern 'old' dock to the taxiway and runway

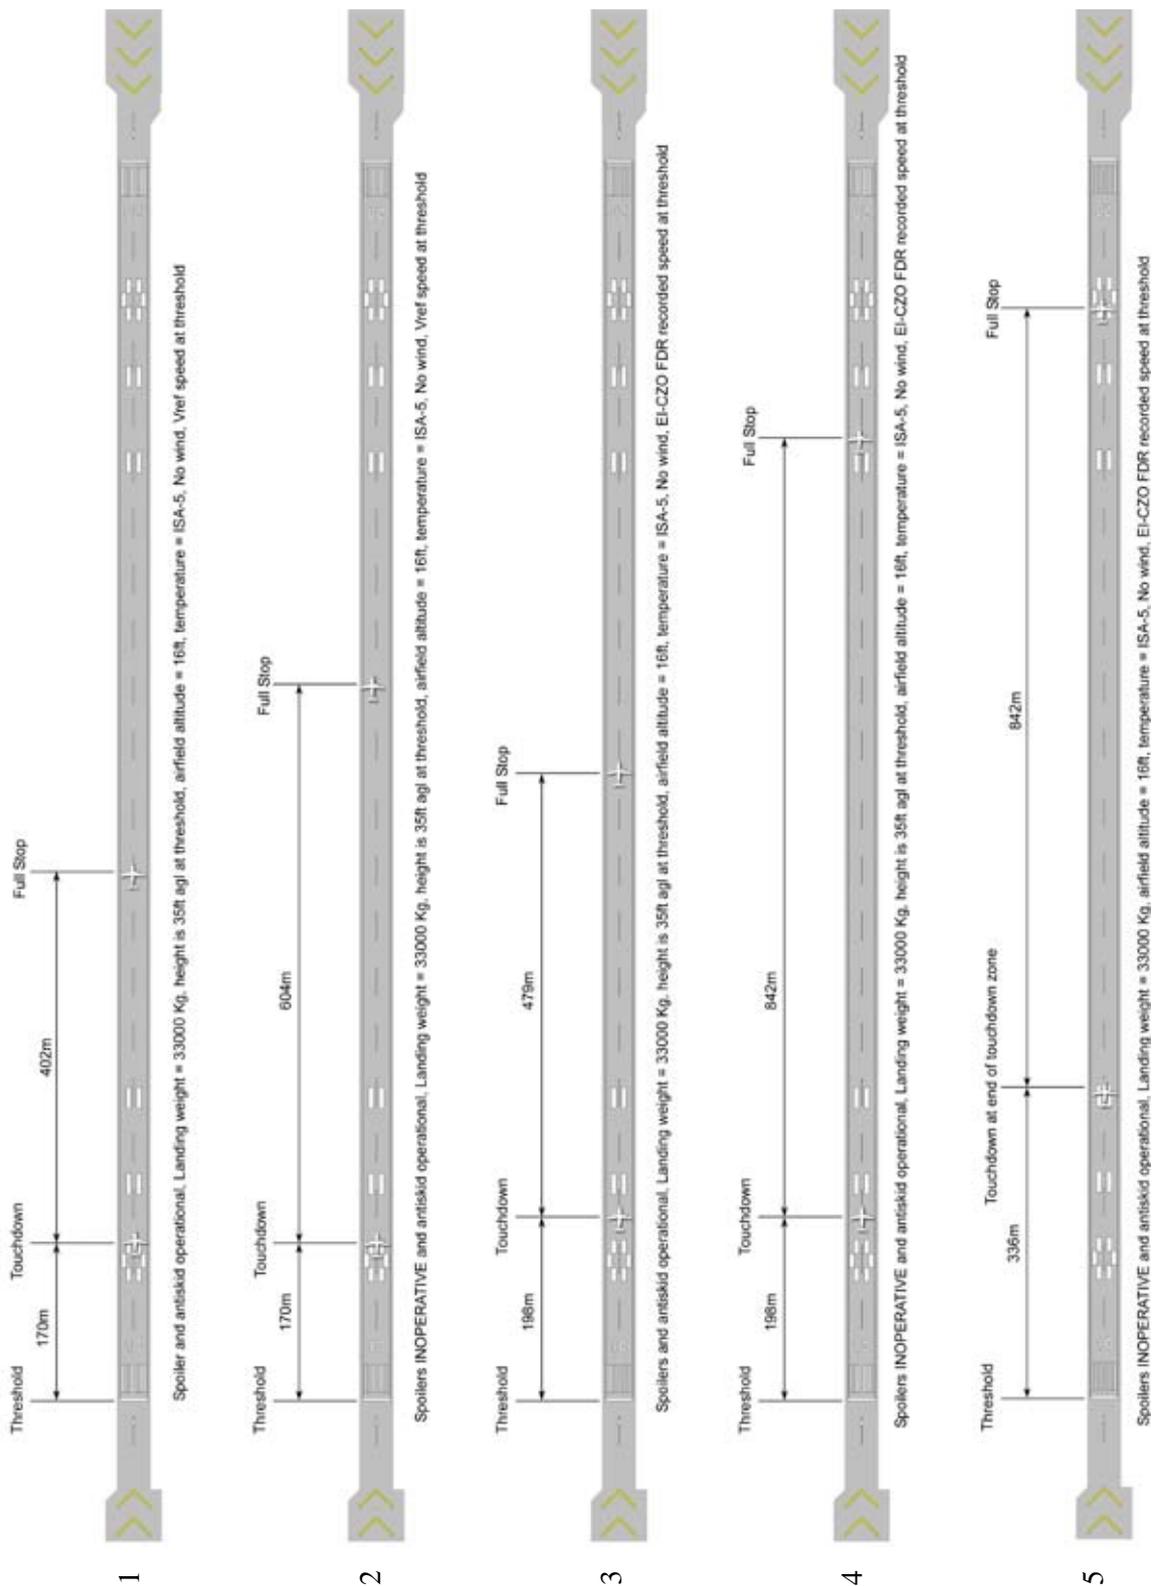
Figure 12

The aircraft manufacturer calculated the stopping distances for the BAe 146-200 based on parameters taken from the incident to EI-CZO but with a landing weight of 33.0<sup>8</sup> tonnes. The calculated distances for a dry<sup>9</sup> runway surface under the various conditions, are shown in Figure 12, (1)-(5). They also assume that the correct braking technique is employed in all cases.

When EI-CZO's recorded speed over the threshold of 124 kt is used, and with the lift spoiler and anti-skid systems operational, the threshold to touchdown distance extends to 198 m, and the touchdown to full stop distance increases to 479 m (3). Under the same conditions, but with the spoilers inoperative, the distance from touchdown to full stop increases to 842 m (4).

BAe 146-200 landing/stopping distances calculated by the manufacturer
