Bureau Enquêtes-Accidents

R E P O R T

*on the accident on 12 November 1999
North of Pristina (Kosovo)
to the ATR 42-300 registered F-OHFV
operated by SI FLY*

F-FV99112A

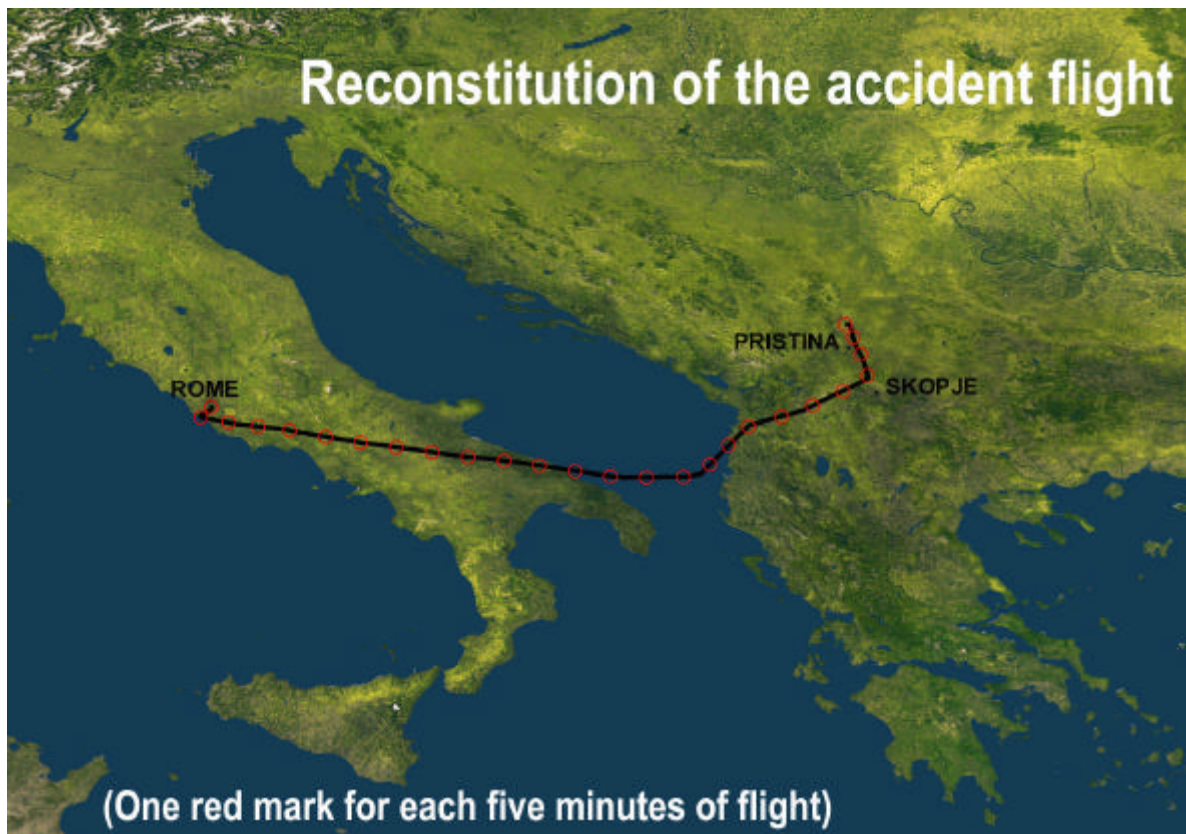
Figure 1 : Track of the accident flight

At 9 h 57 min 34 s, the flight was transferred by Skopje control to the Pristina military air traffic control organisation. The latter identified it on radar and the crew replied "Flight condition is now VFR" to a request from the controller.

At 10 h 14 min 33 s, the CRC alarm was heard, the crew noted 240 feet on the radio altimeter. Two seconds later the aircraft struck high ground.

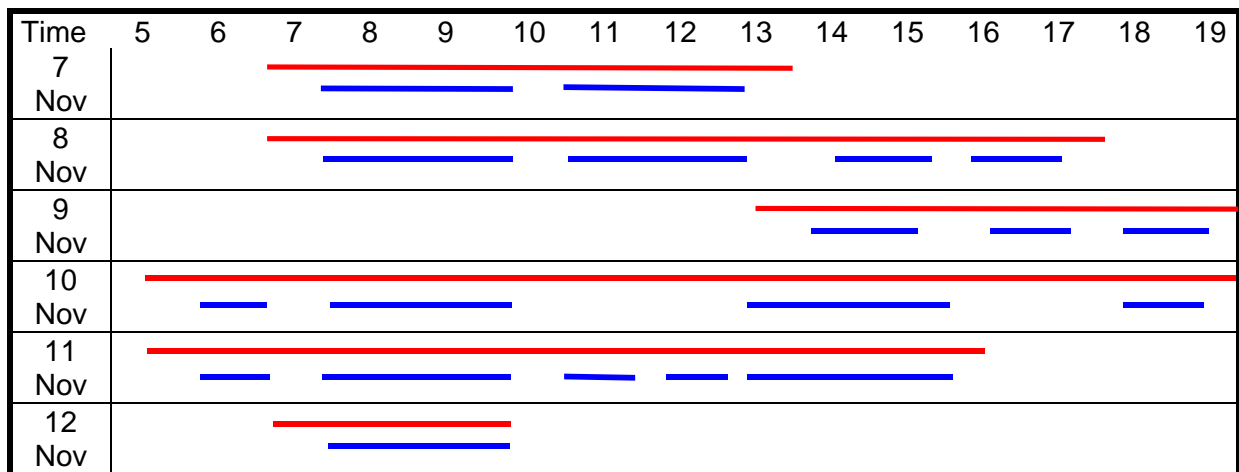
Figure 2 : Captain's activity in the week preceding the accident

Since the 1st of November, the Captain had flown fifty-two hours. He had had two non-flying days, on the 4th when he was available for the Director of flight operations, and the 6th when he had a rest day. Between the 7th and the day of the accident, he had flown thirty-two hours. The day before the accident, he had ferried from Ancona to Rome beginning his duty period at 5 h 45. His day continued with the Rome-Pristina-Tirana-Pristina-Rome line.

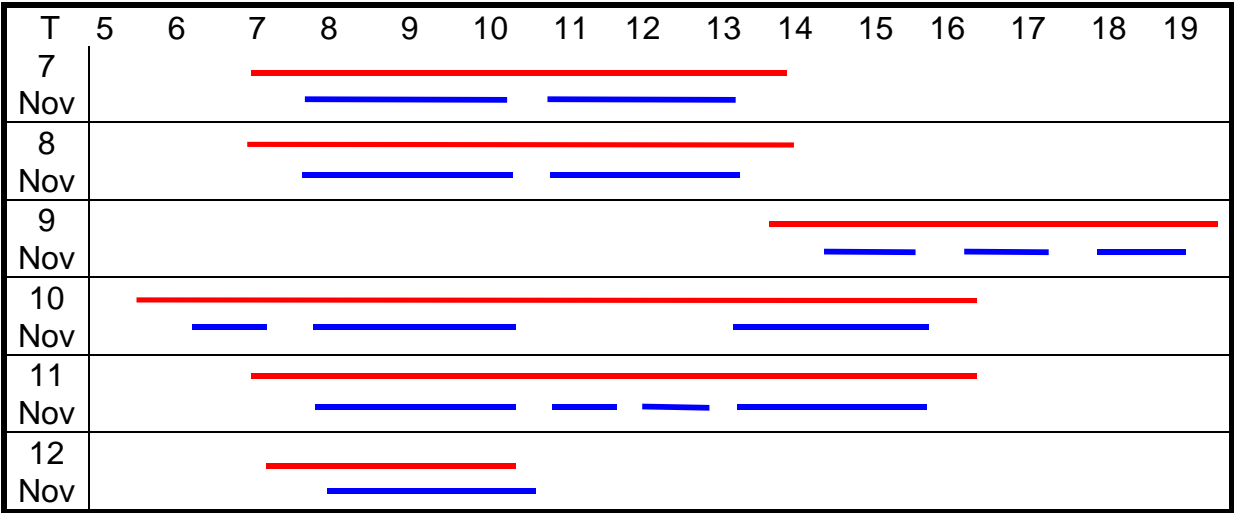
Figure 3 : Copilot's activity in the week preceding the accident

Since the beginning of November, he had flown forty-three hours. He had had two non-flying days, on the 4th when he was available for the Director of flight operations, and the 6th when he had a rest day. Between the 7th and the 12th, he had flown 27 h 30 min. The day before the accident, he had done the Rome-Pristina-Tirana-Pristina-Rome route with the same Captain.

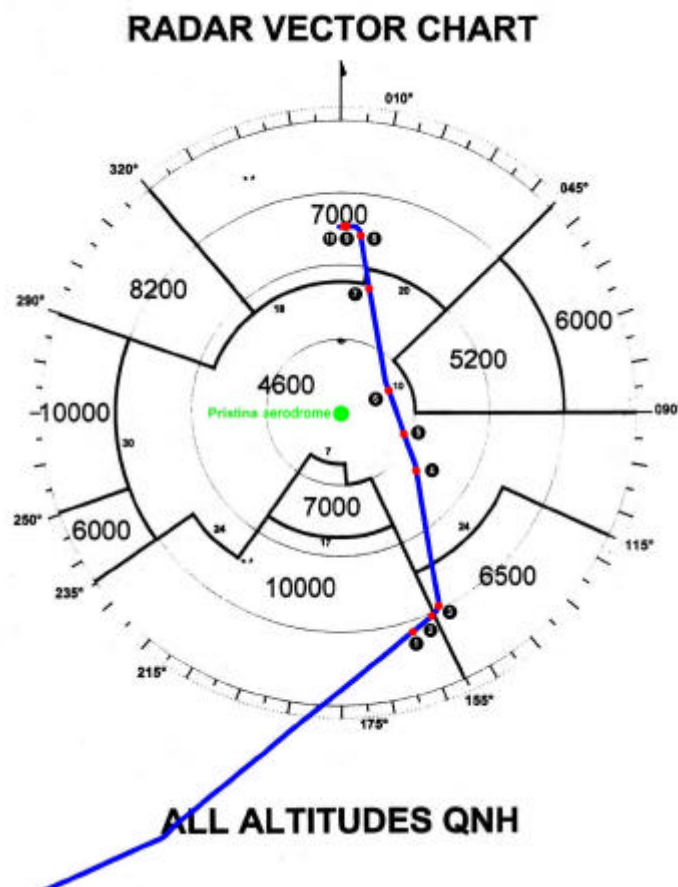
Figure 9 : Radar Data

At the time of the accident, a French Air Force AWACS was on a mission in the region. Information relevant to the tracks of KSV 3275 and HCN 993 was provided to the investigators. It showed an approximate speed of 250 kt for KSV 3275 and of 400 kt for HCN 993. It allowed them to validate the track calculated from the parameters recorded on the aircraft's Flight Data Recorder (see 1.11.3) and to determine the relative position of the two aircraft at the moment when HCV 993 became number one for landing (see § 2.2).

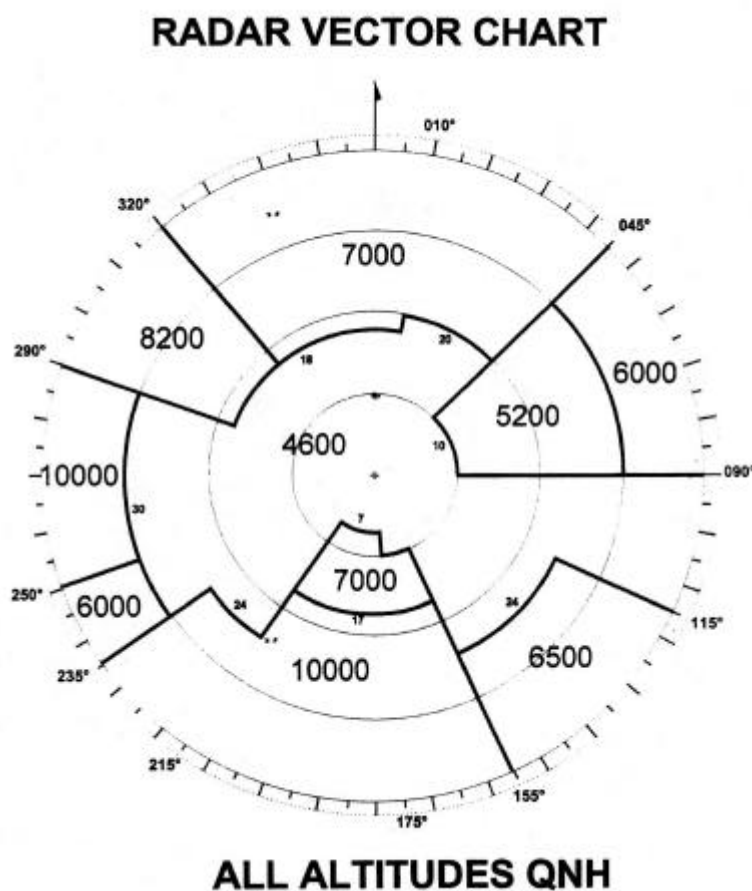
Figure 15 : Radar Vector Chart

Common practice at Pristina is to ask pilots their flight conditions and to offer radar vectoring to intercept the runway 17 ILS at 4,600 feet regardless of the flight conditions. Aircraft are vectored towards the north to go past the eastern edge of the CTR then to fix on the ILS by a left turn. The altitude instructions are given by the controller in accordance with the safety altitudes defined in the Radar Vector Chart (see fig.15).

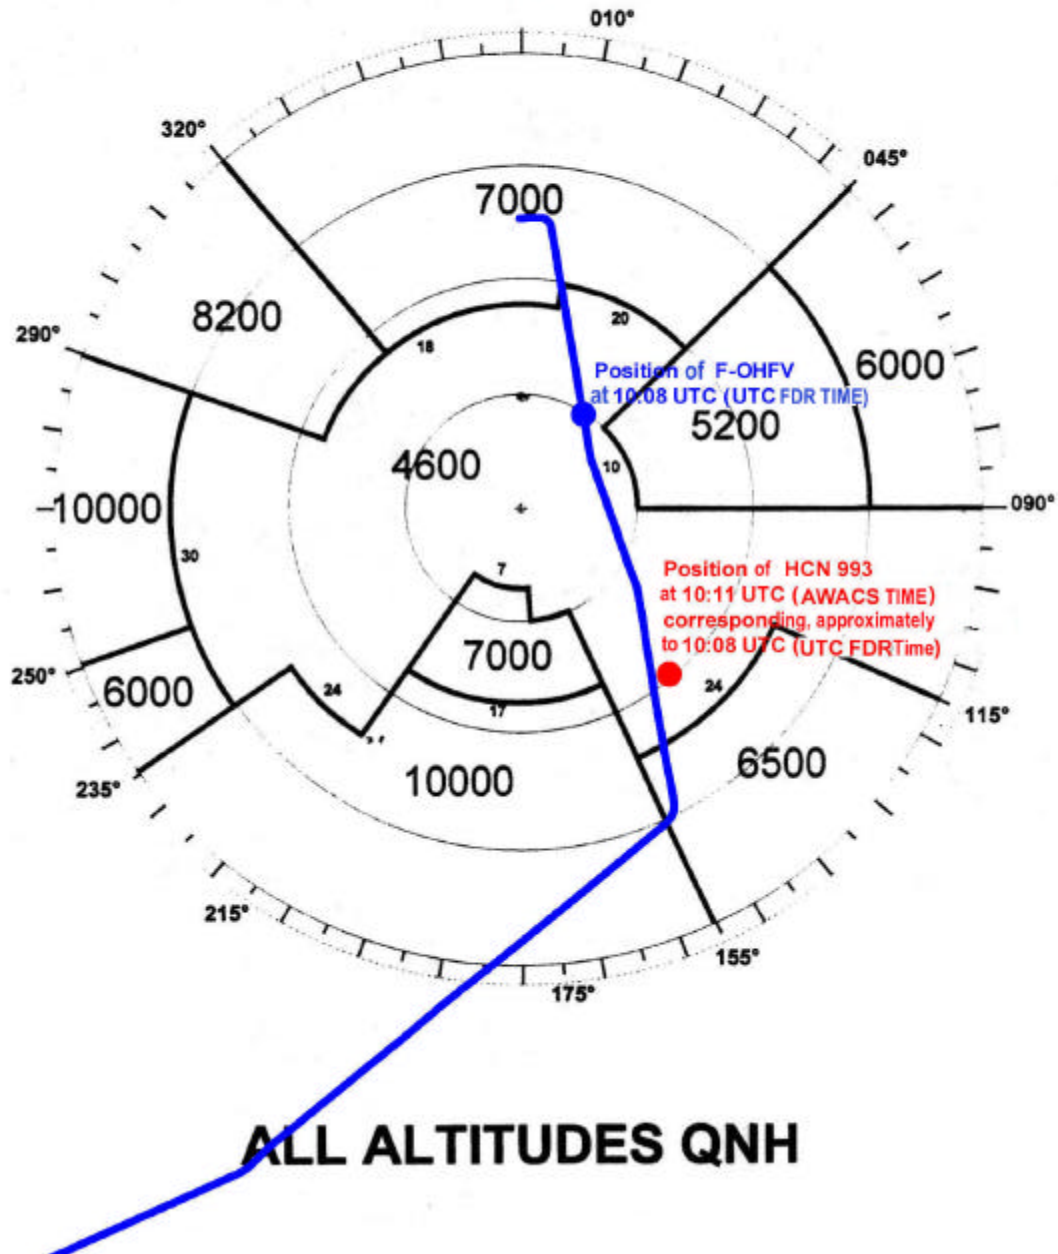
Figure 18 : Relative position of aircraft F-OHFV and HCN 993 when HCN 993 took number one position for landing

Position of **F-OHFV** and **HCN 993** at 10:08 UTC

These relative positions must be viewed with caution due to the low sample rate of data related to HCN 993, and to the difference of around 3 minutes between the UTC time on F-OHFV's FDR and that of the AWACS which recorded the track of HCN 993

After announcing the type of service provided, RIS in this case, the controller gave headings and altitudes to flight KSV 3725 which were in accordance with the minimum radar safety altitudes in the sector to vector it towards the ILS interception point. However, having changed its position to number two for approach, he had to extend its track away to the north a little more than he had planned, which took the aircraft into an area where the radar minimum safety altitude went up from 4,600 to 7,000 feet. This manoeuvre probably led to the loss or clutter of the ATR's radar signal, because of poor detection in this mountainous region. This
