AIFN/0008/2014

Smoke Emission from Passenger Entertainment System Video Display Unit

Operator: Flydubai
Type: Boeing 737-800
Registration: A6-FEK
Location: Enroute Dubai to Kiev
Date of Occurrence: 19 April 2014

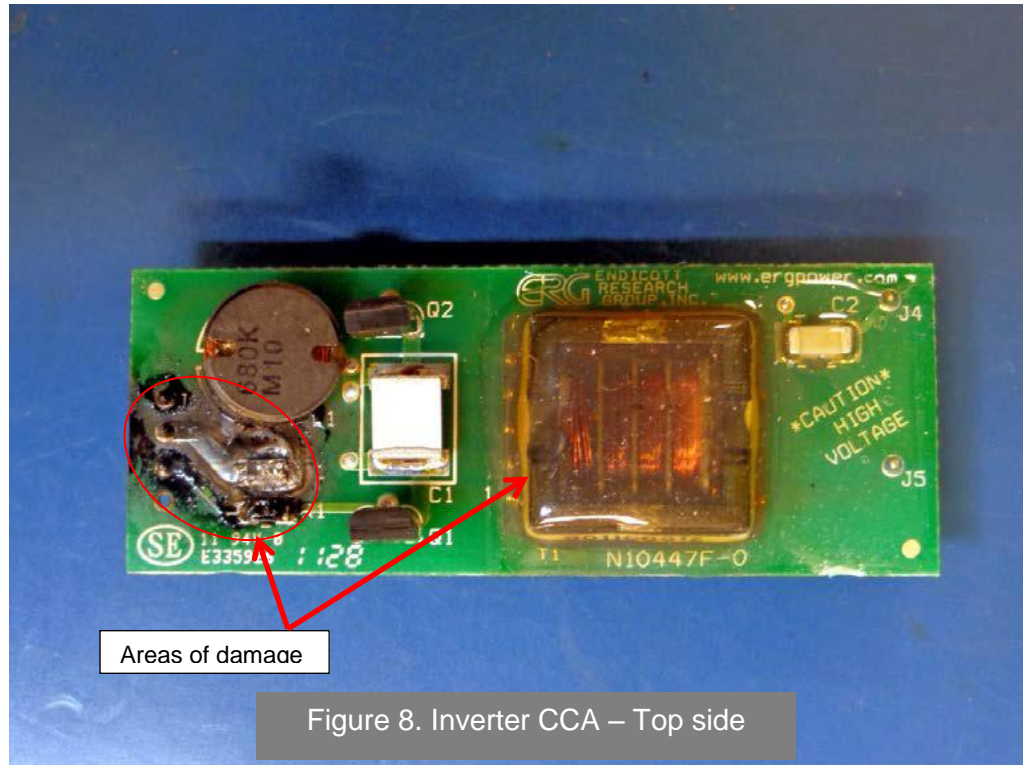
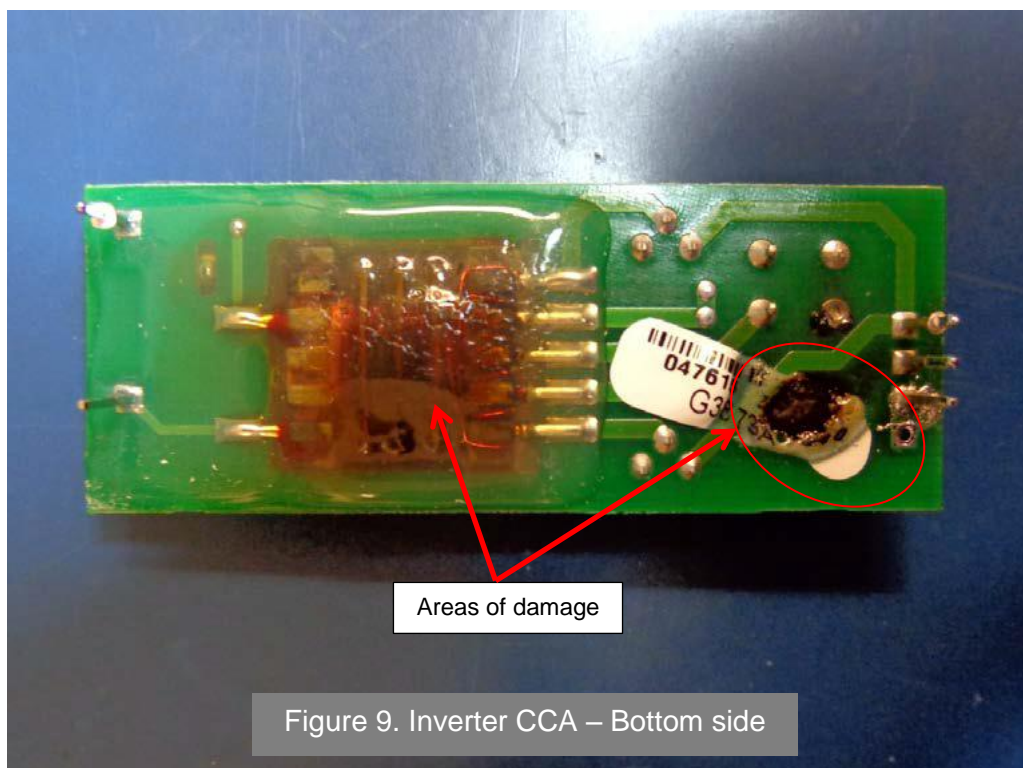
The affected VDU was shipped to the manufacturer for forensic laboratory examination. According to the examination report, there were no external visible signs of smoke, fire, or other noticeable damage to the VDU. Internal damage was limited to the power transformer circuit board components and the area of the fuse that had overheated and emitted smoke and odors momentarily until power to the IFE system was shut off.

The teardown examination found that the component that had failed was the backlight inverter circuit card assembly (CCA) which provides operating power to the cold-cathode fluorescent (CCFL) backlight of the LCD display. The inverter card assembly is mounted on the main circuit card assembly as a daughter card. Its purpose is to output an alternating current (AC) high-voltage signal to power the CCFL backlight tube.
