**04/28/88 Aloha Airlines**

**Official Accident Report Index Page**

<b>Report Number</b>	NTSB/AAR-89/03
<b>Access Number</b>	PB89-91C404
<b>Report Title</b>	Aircraft Accident Report--Aloha Airlines, Flight 243, Boeing 737-200, N73711, near Maui, Hawaii, April 28, 1988
<b>Report Date</b>	June 14, 1989
<b>Organization Name</b>	National Transportation Safety Board Bureau of Accident Investigation Washington, D.C. 20594
<b>WUN</b>	4886A
<b>Sponsor Name</b>	NATIONAL TRANSPORTATION SAFETY BOARD Washington, D.C. 20594
<b>Report Type</b>	Aircraft Accident Report April 28, 1988
<b>Distribution Status</b>	This document is available to the public through the National Technical Information Service, Springfield, Virginia 22161
<b>Report Class</b>	UNCLASSIFIED
<b>Pg Class</b>	UNCLASSIFIED
<b>Pages</b>	262
<b>Keywords</b>	decompression; disbonding; fatigue cracking; corrosion; multiple site damage (MSD); FAA surveillance; maintenance program; nondestructive inspection

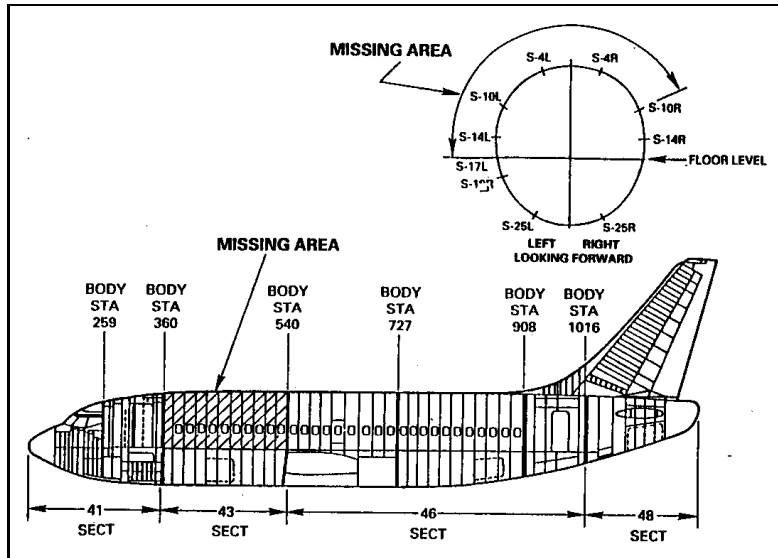
Figure 1.--Boeing 737-200--Body Stations, Stringers, and Section Locations.

A major portion of the upper crown skin and structure of section 43 separated in flight causing an explosive decompression<sup>I</sup> of the cabin. (See **figure 1** and **figure 2**.) The damaged area extended from slightly aft of the main cabin entrance door, rearward about 18 feet to the area just forward of the wings and from the left side of the cabin at the floor level to the right side window level.

The area where the structure was missing extended from body station<sup>4</sup> (BS) 360 aft to about BS 540, and circumferentially from just above the floor on the left side of the airplane (at S-15L), across the crown and down the right side to a position above the window belt (at S-10R). The structure from the top of the window belt to the floor on the right side was distorted severely and bent outward more than 90°. The skin had peeled in this area leaving the frames, stringers, and window forgings in place. On the left side below the floor level, the skin had peeled off the structure in large V-shaped areas.

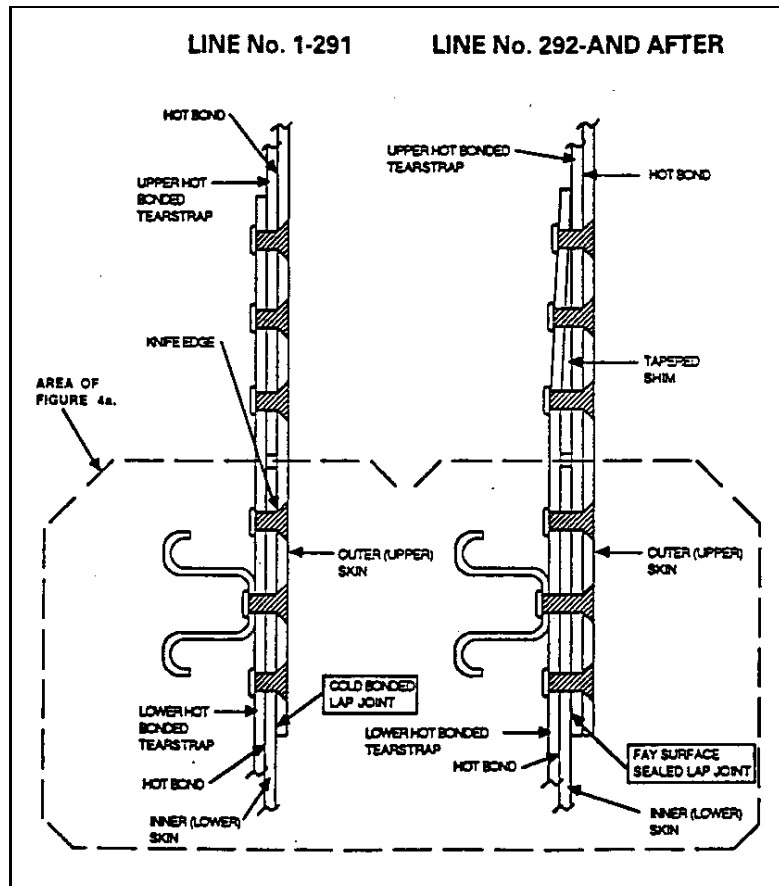
**Figure 4b.--Lap joint section at tearstraps**

load transfer through the joint is borne by the three rows of countersunk rivets that mechanically fasten the skin panels together. Because of the single thickness skin surface that was facilitated by the bonded construction, the countersink for the flush rivet heads extended through the entire thickness of the outer 0.036-inch sheet. A knife edge was created at the bottom of the hole which concentrated stresses. These stresses were cyclic with pressurization loads, and fatigue cracking ultimately occurred at the site.

In a cylindrical fuselage like the B-737, the circumferential pressurization stresses are twice as large as the longitudinal stresses. As fatigue effects take place, cracks propagate longitudinally, perpendicular to the dominant pressurization (hoop) loads. In the B-737, fatigue cracking initially is expected to occur in the outer layer of skin along the lap joint because the outer layer contains a knife edge at each of the countersunk rivet holes. Furthermore, the fatigue cracking primarily is found in the upper row of the outer skin panel lap joint rivet holes because this area carries the greatest stress. For the underlying skin of the lap joint, the area of greatest stress is through the lower row of lap joint rivet holes. However, since the rivet holes in this skin panel are not countersunk, fatigue cracking is not as likely to initiate at this location.

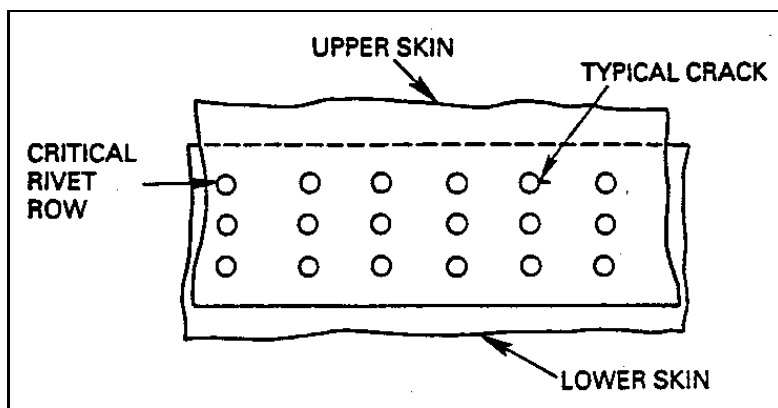
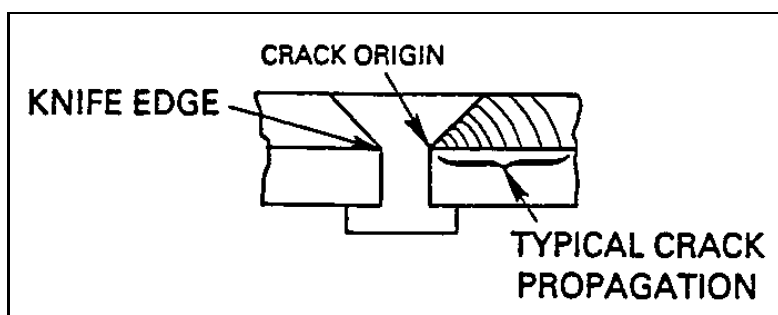
**Figure 6a.--Typical lap joint**

The lap joint piece, S-4L, from BS 519 to BS 536, exhibited fatigue cracking from 16 consecutive rivet holes along the upper row of lap joint rivets. The largest single fatigue crack in one direction measured 0.18 inch from the knife edge of the countersink. (See figure 6.) The longest total combined crack length in both directions across a rivet hole (end to end of the crack including the hole) measured 0.53 inch. Both the cold-bonded lap joint and the hot-bonded tear straps in this area had disbonded. Light to moderate corrosion was present on the previously bonded surfaces.
