Unstabilised approach, hard landing

Aircraft	Embraer ERJ 145 MP registration F-GUBF
Time and date	1.07 p.m. ⁽¹⁾ on Monday 24 May 2010
Operator	Regional CAE
Location	Ljubljana aerodrome (Slovenia), runway 31
Nature of the flight	Scheduled public transport of passengers
(Flight) crew	Pilot-in-command, co-pilot
Consequences	Damage to landing gear and structural components

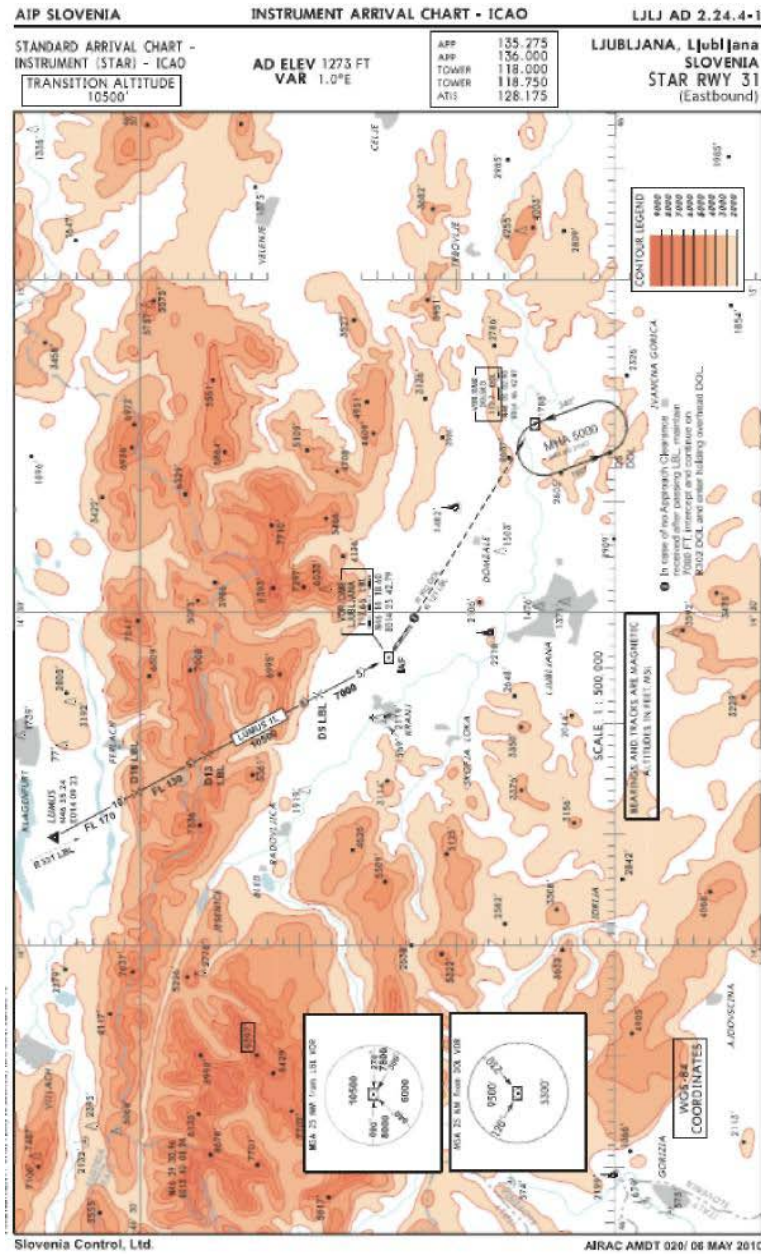
Aerodrome information

Ljubljana aerodrome is located at the foot of the Julian Alps, at the entrance to a valley which runs north-west/south-east. This valley, closed to the north and west by a mountain chain, the highest summits of which reach almost 7,000 ft, is open to the south-east towards the plain and the town of Ljubljana.

Owing to the topographical environment of Ljubljana aerodrome, Regional's Operations Manual states that all members of flight crew must conform that they have familiarised themselves with the instructions set out in Part C of the Manual. In particular, these instructions draw the crews' attention to the prevailing winds at altitude to the west and to the immediate proximity of terrain which could lead to turbulence during the approach phase when the wind has a northerly component.
