**ACCIDENT**

| <b>Aircraft Type and Registration:</b> | ATR 42-320, G-DRFC | |
| <b>Date &amp; Time (UTC):</b> | 16 June 2012 at 0723 hrs | |
| <b>Location:</b> | Jersey Airport, Jersey, Channel Islands | |

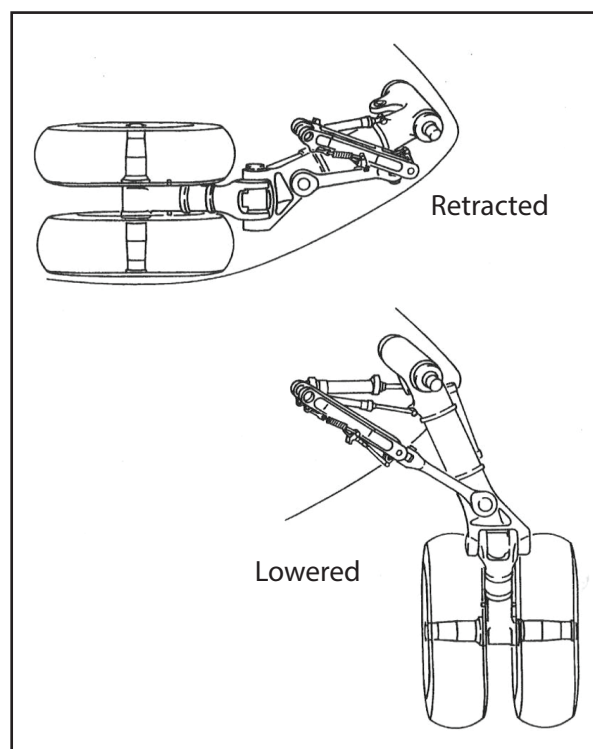
**Figure 3**

Each main landing gear consists of a twin wheel unit mounted on a trailing arm, pivoted on the lower end of a trunnion (Figure 3). The latter is pivoted about an approximately longitudinal axis from a faired structure protruding laterally beyond the profile of the lower fuselage. With the gear retracted, the wheel/axle unit is housed in a recess in the pressure hull below the cabin floor with the axle in a vertical orientation. The trunnion swings through 90° during lowering, to orientate the axle horizontally. Retraction and extension are carried out by means of a double acting hydraulic cylinder connecting the trunnion to the fuselage structure.

Landing Gear general view looking aft
