REPORT

**ON ACCIDENT TO
M/S KINGFISHER AIRLINES ATR-72 AIRCRAFT
VT-KAC AT MUMBAI ON 10.11.2009.**

**AIR SAFETY DIRECTORATE
O/o DIRECTOR GENERAL OF CIVIL AVIATION
OPP. SAFDARJUNG AIRPORT, NEW DELHI**

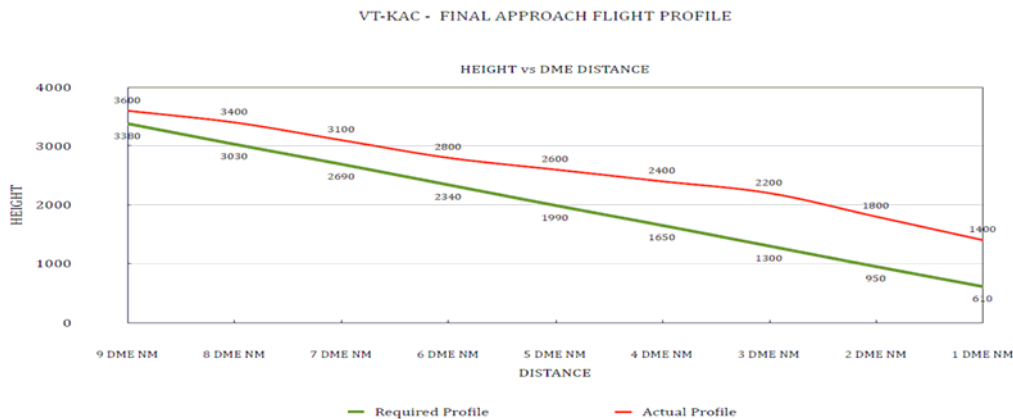
The crew had felt that although the speed was high, they corrected the speed using the condition lever in the full forward position and that correction were adequate enough to make a normal landing and stop the aircraft. Even below 500 ft the rate of descent was high and a maximum value of -2040 ft/min was reached at the radio altitude of 291 ft. The high sink rate warning was continuous till touchdown. The aircraft was high on the approach profile as at one DME from Touch down actual height was 1400 ft against the required height of 610 ft. At 4 DME , ATC had advised the crew to check altitude as they were high. Thus decision of the crew to continue was not in accordance with requirements of the company’s operations manual and regulatory instructions.
