DATA SUMMARY

Date and time	31 October 2008; 07:15 UTC
Site	Lanzarote Airport

Registration	EC-HJQ
Type and model	BOEING 737-800 S/N: 28387
Operator	Air Europa

Operation	Commercial air transport – Passenger – Non-scheduled
Phase of flight	Landing

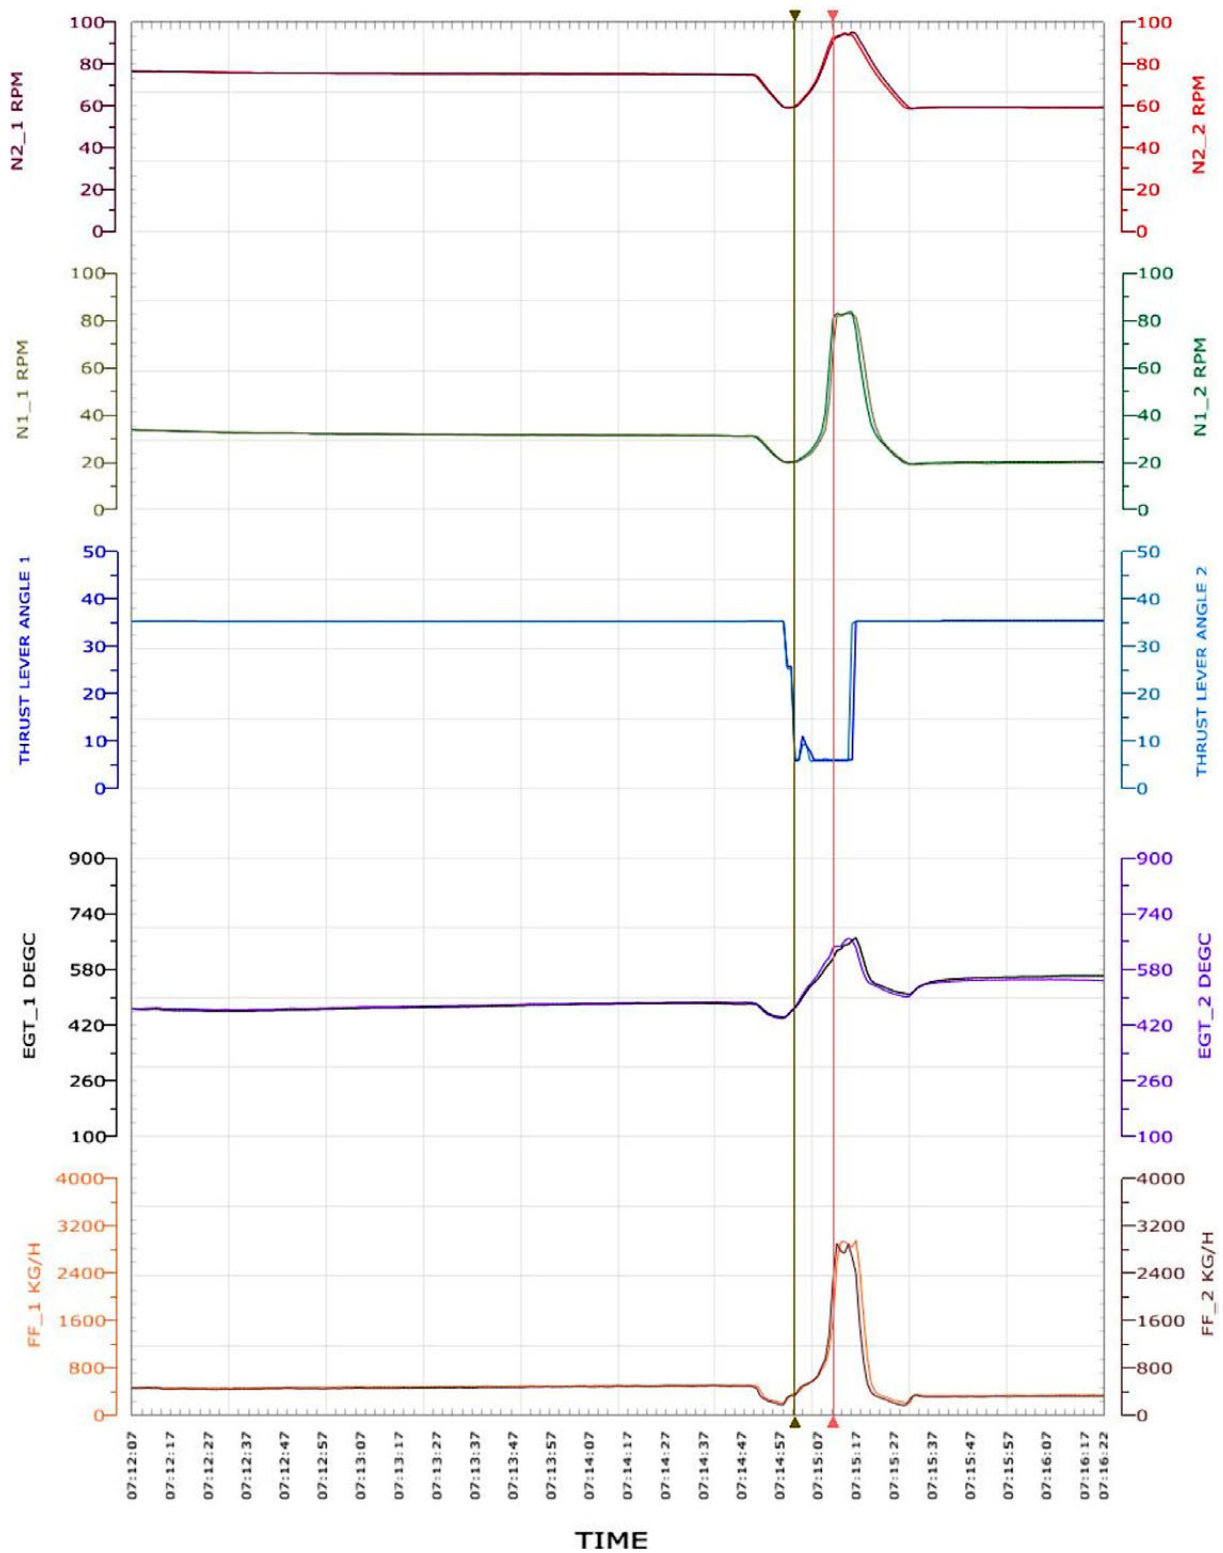
ENGINE PARAMETERS

- REC 52/11.** It is recommended that the aircraft manufacturer include in the appropriate aircraft documentation (FCTM, AFM, etc.) a warning on how delaying an input to the throttles after landing, either to activate the reversers or to execute a go around, can result in a corresponding delay in engine response.
