NATIONAL TRANSPORTATION SAFETY COMMITTEE

AIRCRAFT ACCIDENT REPORT

PT. Garuda Indonesia GA421

B737-300 PK-GWA

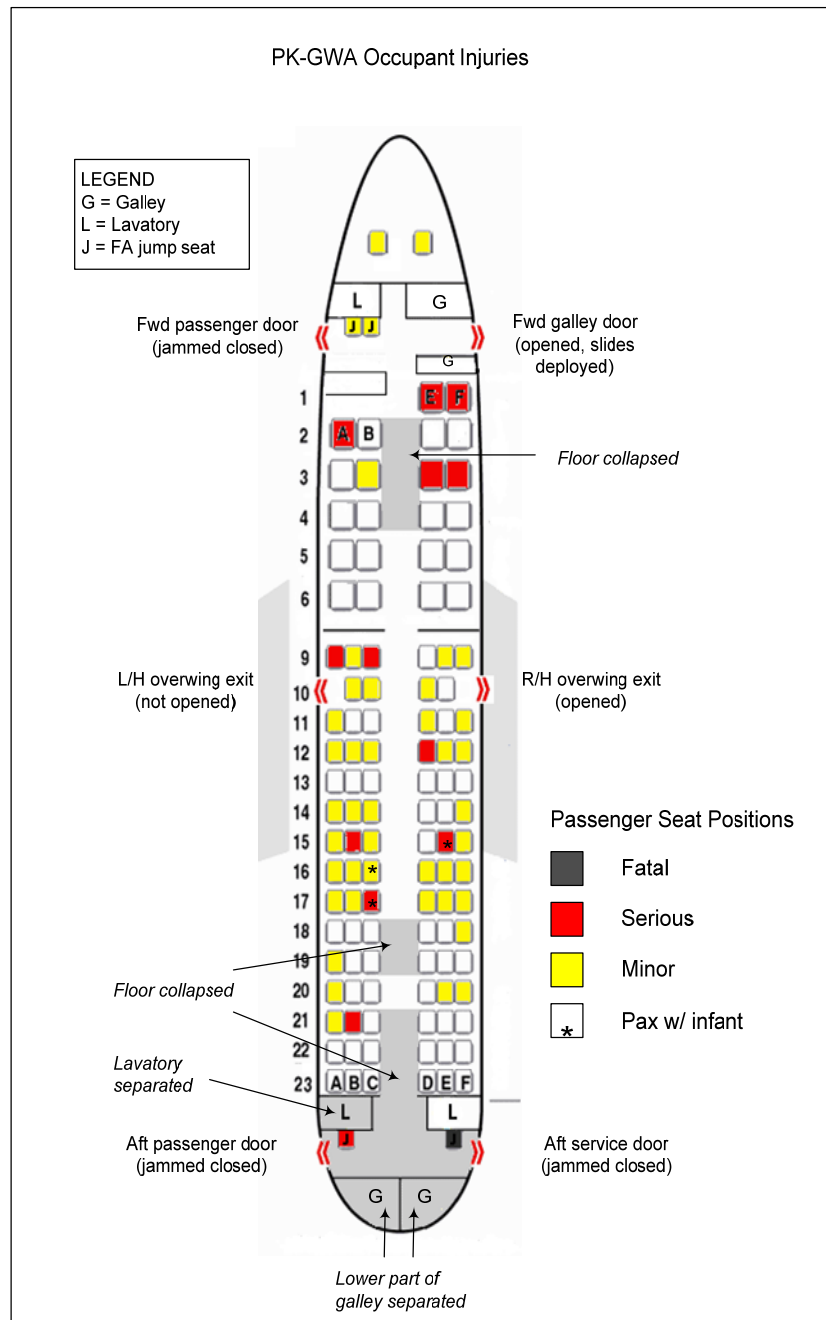
Figure 4 Interior Airplane Configurations and Occupant Injuries Map

Ditching the aircraft into the river was considered by the crew to be the safest option for a forced landing. Fifty three occupants were safely evacuated to the river bank. One flight attendant who was seated at the aft jump-seat was found severely wounded on the river, and one another flight attendant was found fatally injured on the river

The aircraft was configured with 104 passenger seats; 22 in business class and 82 in economy class. An aft-facing, double-occupancy flight attendant jump-seat was located by the forward passenger door; an aft-facing, single occupancy flight attendant jump-seat was mounted behind the right-hand and left-hand aft lavatory. Figure 4 It shows the interior airplane configuration and the injuries sustained by the passengers and crewmembers according to the seat location.

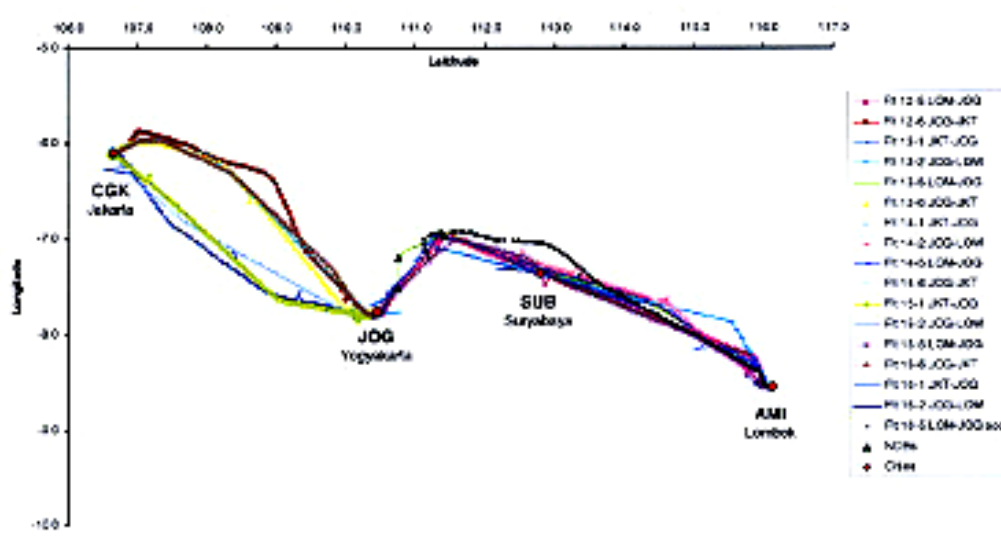
Figure 5 Typical flight paths of previous flights

On the radar screen (at Yogyakarta APP) since the target appeared around 09.08 UTC the track of GIA-421 was normal, i.e. West bound. Starting at 09.20 UTC it went South bound. At 09.22 UTC it still showed a label of GIA-421F200S390, meaning that it was on FL200 descending by a ground speed of 390 knots. Then at 09.24 UTC the speed increased up to 410 knots, before the SSR target disappeared and faded out.

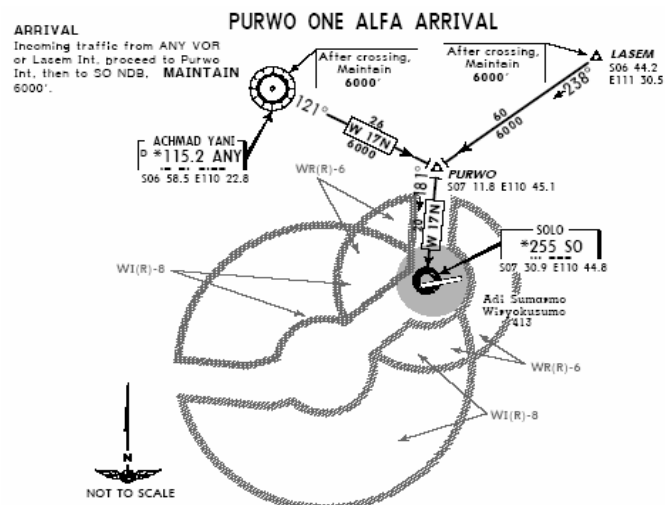
Figure 11 Purwo one alfa arrivals

PURWO ONE ALFA ARRIVAL shows the airway from Lasem (W 16) to Purwo W17N and WR (R) -6 as Military Restricted Area

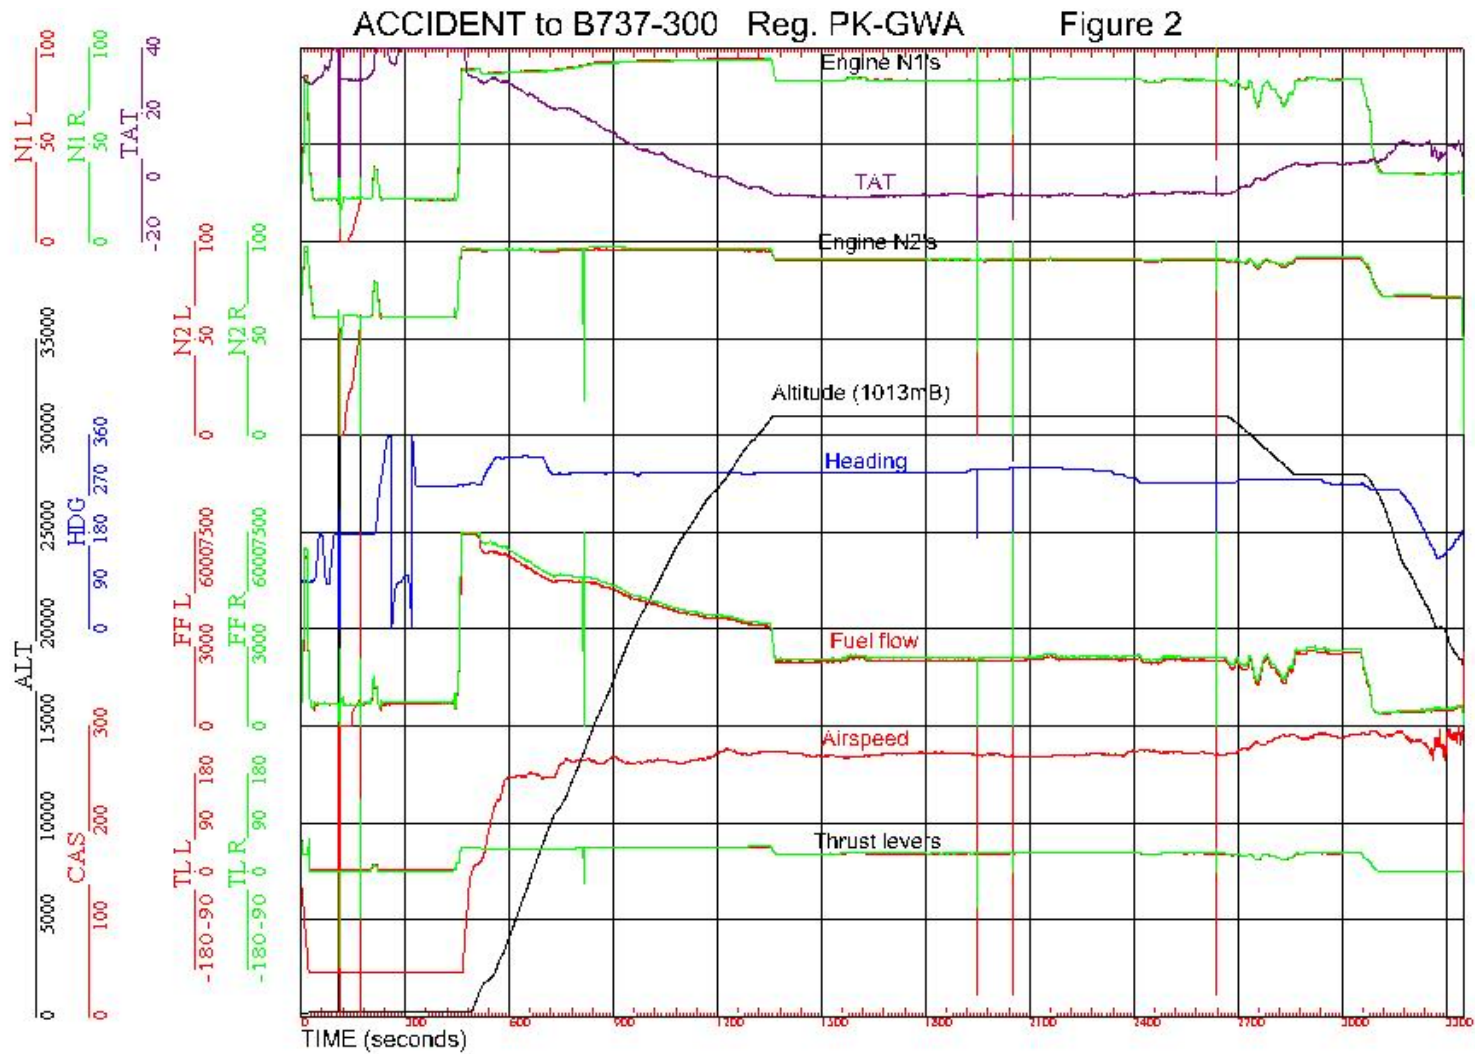
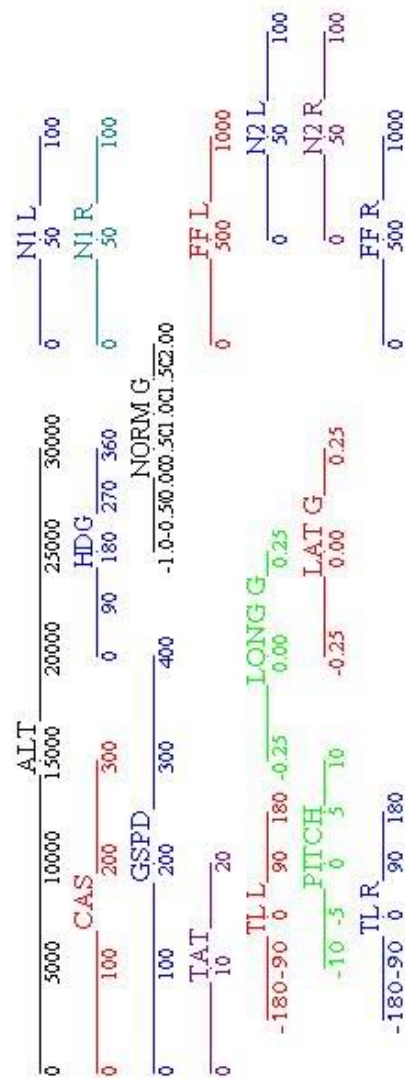
Figure 4

The data plots and listing for the last 250 seconds of the records are shown in Figure 4. The main points are:
