FINAL REPORT

BOEING B777-200 REGISTRATION OE-LPC COLLISION WITH AN AEROBRIDGE AT SINGAPORE CHANGI AIRPORT ON 17 JANUARY 2006

AIB/AAI/CAS.031

**Air Accident Investigation Bureau of Singapore
Ministry of Transport
Singapore**

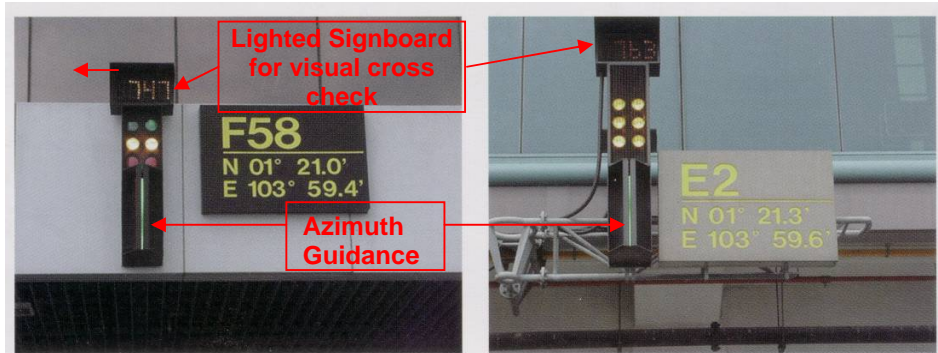
1.9.2 The manual types of ADGS used in Terminal 2 were Robert Louis Gaugenmaier (RLG) Type B (Figure 5a) and RLG Type C (Figure 5b). RLG Type B had one pair each of green, amber and red lights. RLG Type C was similar to Type B except that it had three pairs of amber lights instead of just one. Correspondingly, on Type B's console panel, the rotary knob used to select the lights had one amber light detent whereas on Type C's control panel, the rotary knob had three amber detents (for selecting one, two or three pairs of amber lights).

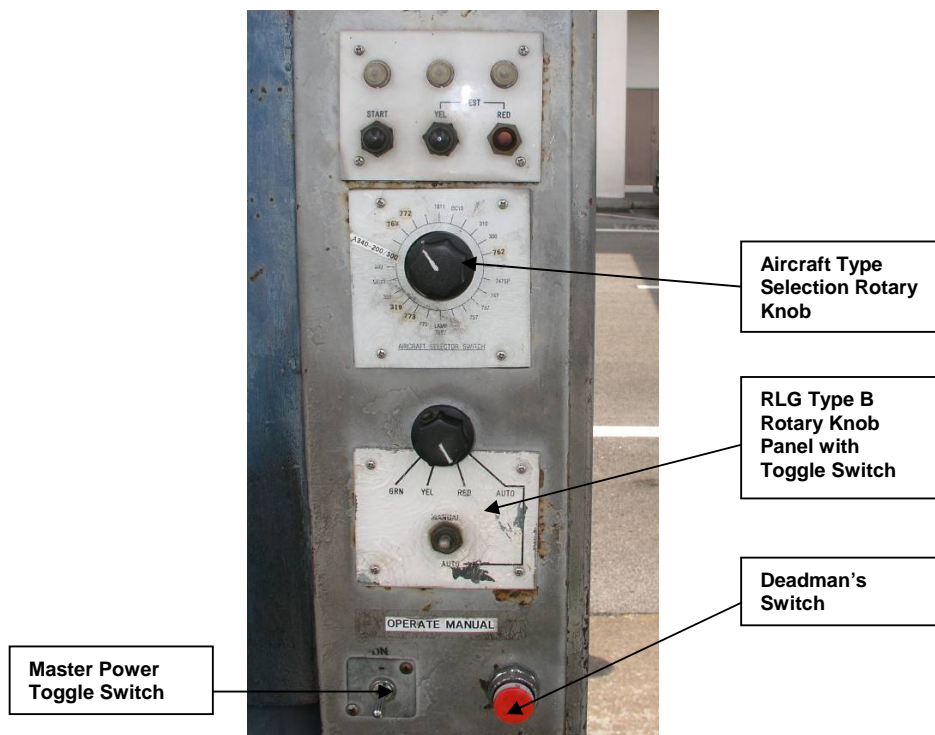
Figure 8. Bay F58 ADGS control panel

- 1.9.7 All three types of ADGS were equipped with a deadman's switch. In order for the ADGS to work and provide guidance instructions the ADGS operator had to keep the deadman's switch depressed at all times. If the deadman's switch was released the ADGS would give an emergency stop indication to the flight crew.
- 1.9.8 The normal stop indication was a steady red light which was turned on when the aircraft had reached the correct parking position. The emergency stop indication was identical to the normal stop indication.
- 1.9.9 Bay F58 was equipped with a RLG Type B ADGS. The ADGS console panel at F58 is shown below (Figure 8).

2.2.1 The position of the RLG Type B and Type C ADGS control panel was not conducive to the ADGS operator's task of monitoring the aircraft's taxi in and of ensuring that the correct indications were displayed on the ADGS. This was because the operator had to turn his body more than 90° to look at the aircraft and only half of the pairs of lights could be observed from the position of the ADGS control panel.
