**Report on the accident to
Fokker F27 Mk 500 Friendship, G-CEXF
At Jersey Airport, Channel Islands
on 5 June 2001**

AIRCRAFT ACCIDENT REPORT 4/2004

Air Accidents Investigation Branch

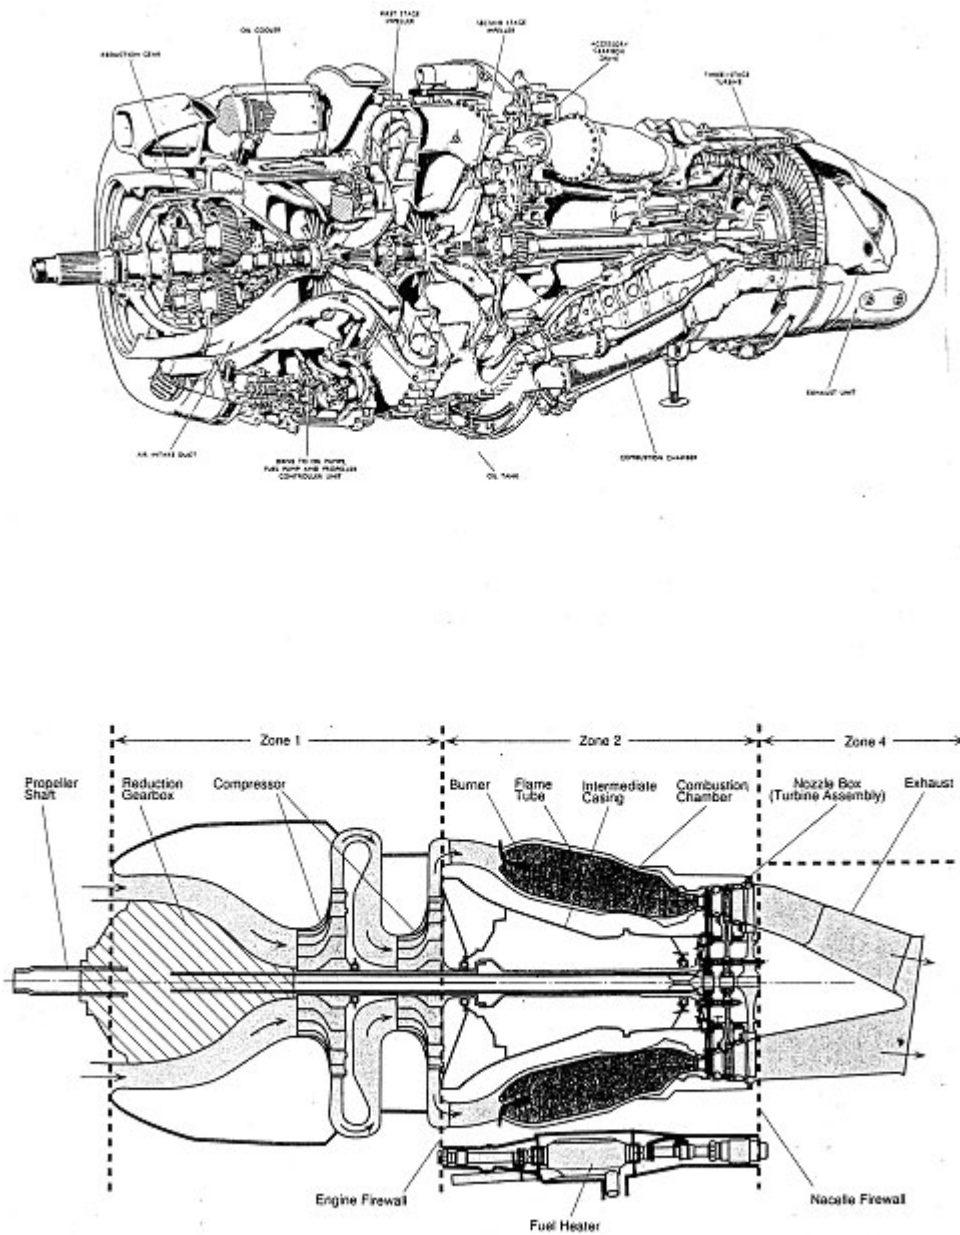
Figure 3 RR Dart Engine - Cutaway and schematic views

The general layout of the Dart Mark 532-7 is shown in Figure 3. The main structure consists of, from front to rear, a reduction gear, compressor, intermediate and nozzle box casings and exhaust. Take-off power rating is listed as 15,000 rpm spool speed with a maximum allowable Turbine Gas Temperature (TGT) of 810°C (dry) and 860°C (wet), limited to 5 minutes. These limits were also specified, for an unrestricted period, for Max Continuous and Intermediate Contingency ratings respectively but were to be used only in emergency situations and/or for limited crew training. Permissible overspeed was listed as 17,000 rpm for 20 seconds and maximum overtemperature as greater than 860°C, but less than 950°C, for less than five seconds.

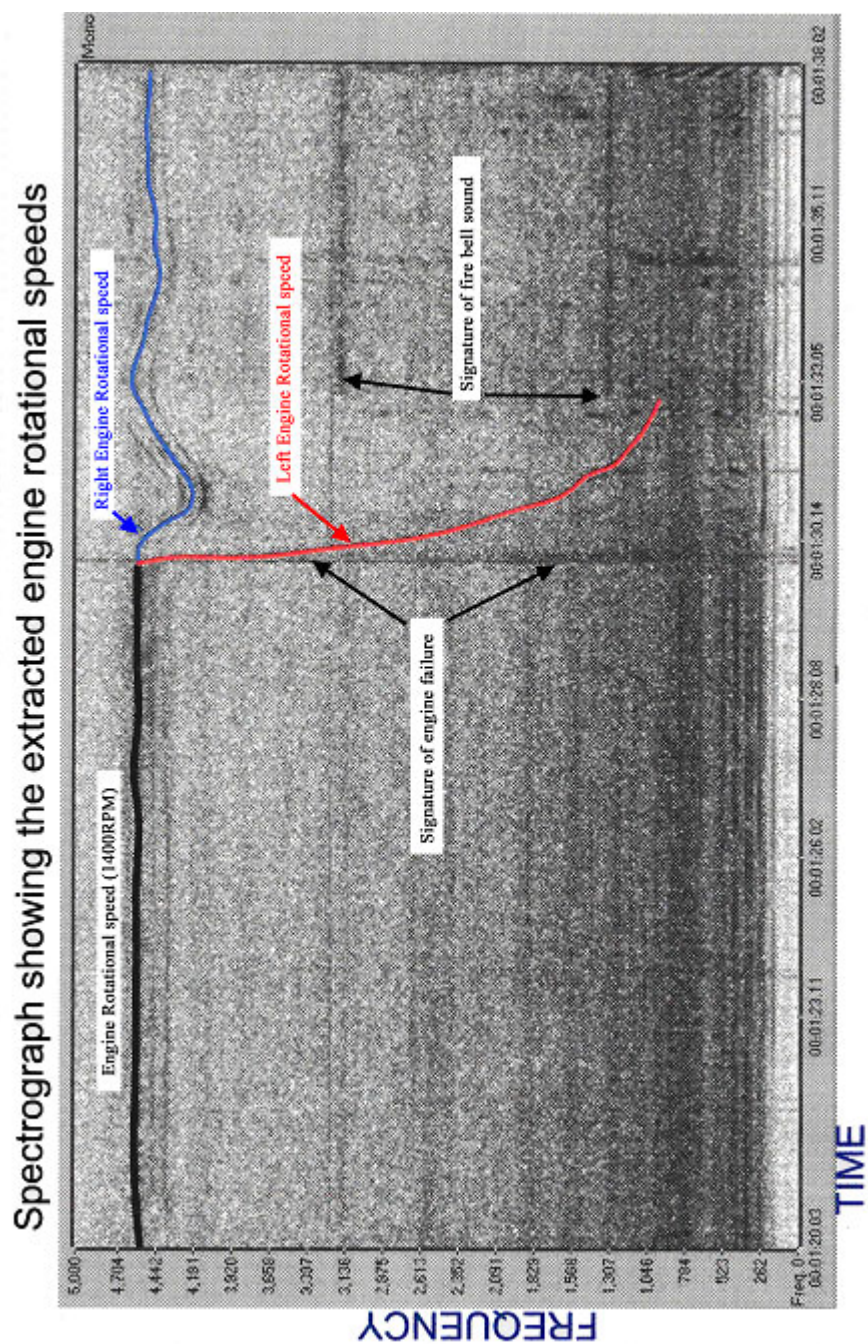
Figure 5 Spectrograph showing the extracted engine rotational speeds

The aircraft was equipped with a Fairchild A-100A CVR and the recording consisted of three channels of good quality audio information. The recorded channels were the Captain's and the First Officer's hot microphone channels and the cockpit area microphone. The recording started while the aircraft was on the ground in Jersey as the crew were in the cockpit preparing for the flight to Bournemouth, and ended when electrical power was removed from the aircraft subsequent to its landing back at Jersey. The CVR recording was subjected to a spectrographic audio analysis and this enabled a time history of the rpm of both engines/propellers to be extracted, Figure 5. These were examined for any abnormalities, but none were found.

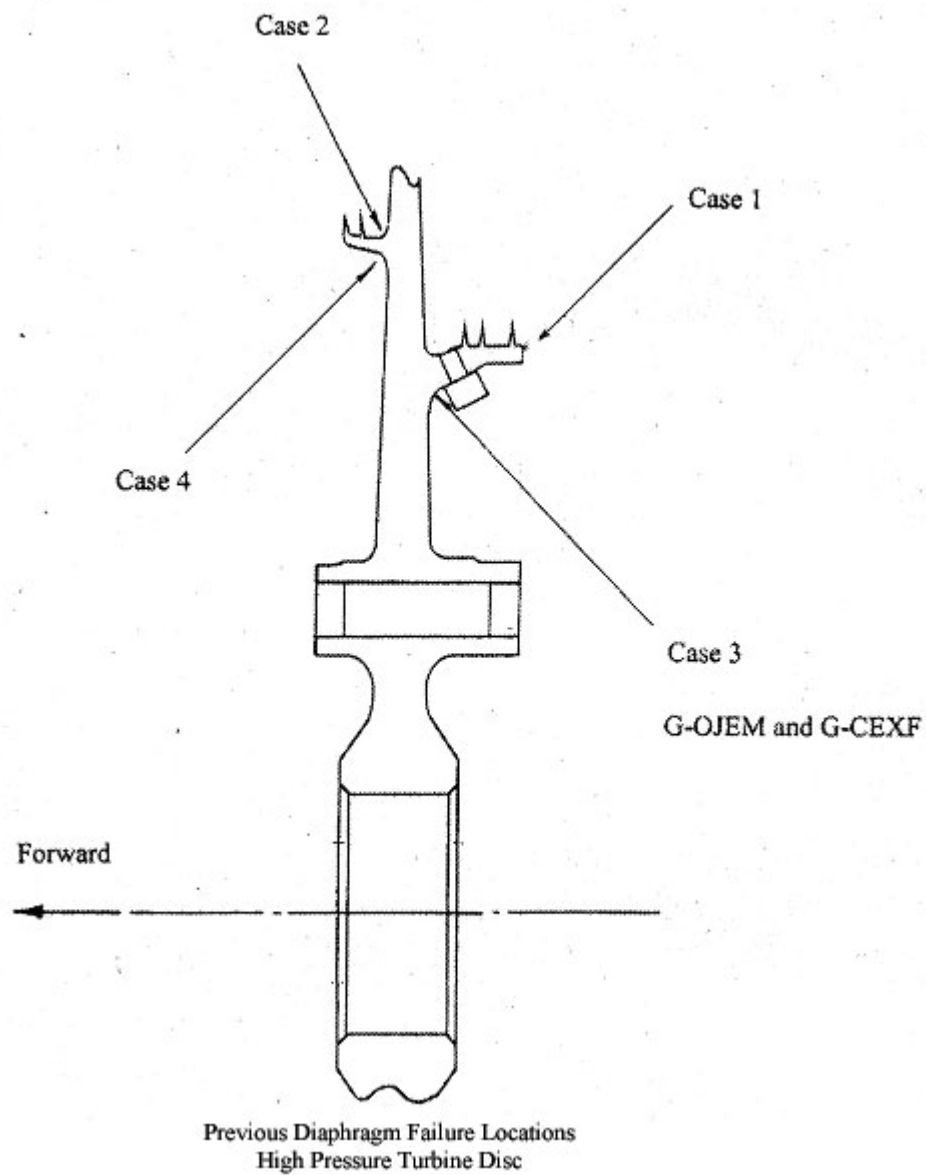
Figure 9 Previous diaphragm failure locations - high pressure turbine

1.18.4.5 Diaphragm Failure Case Summary, Figure 9

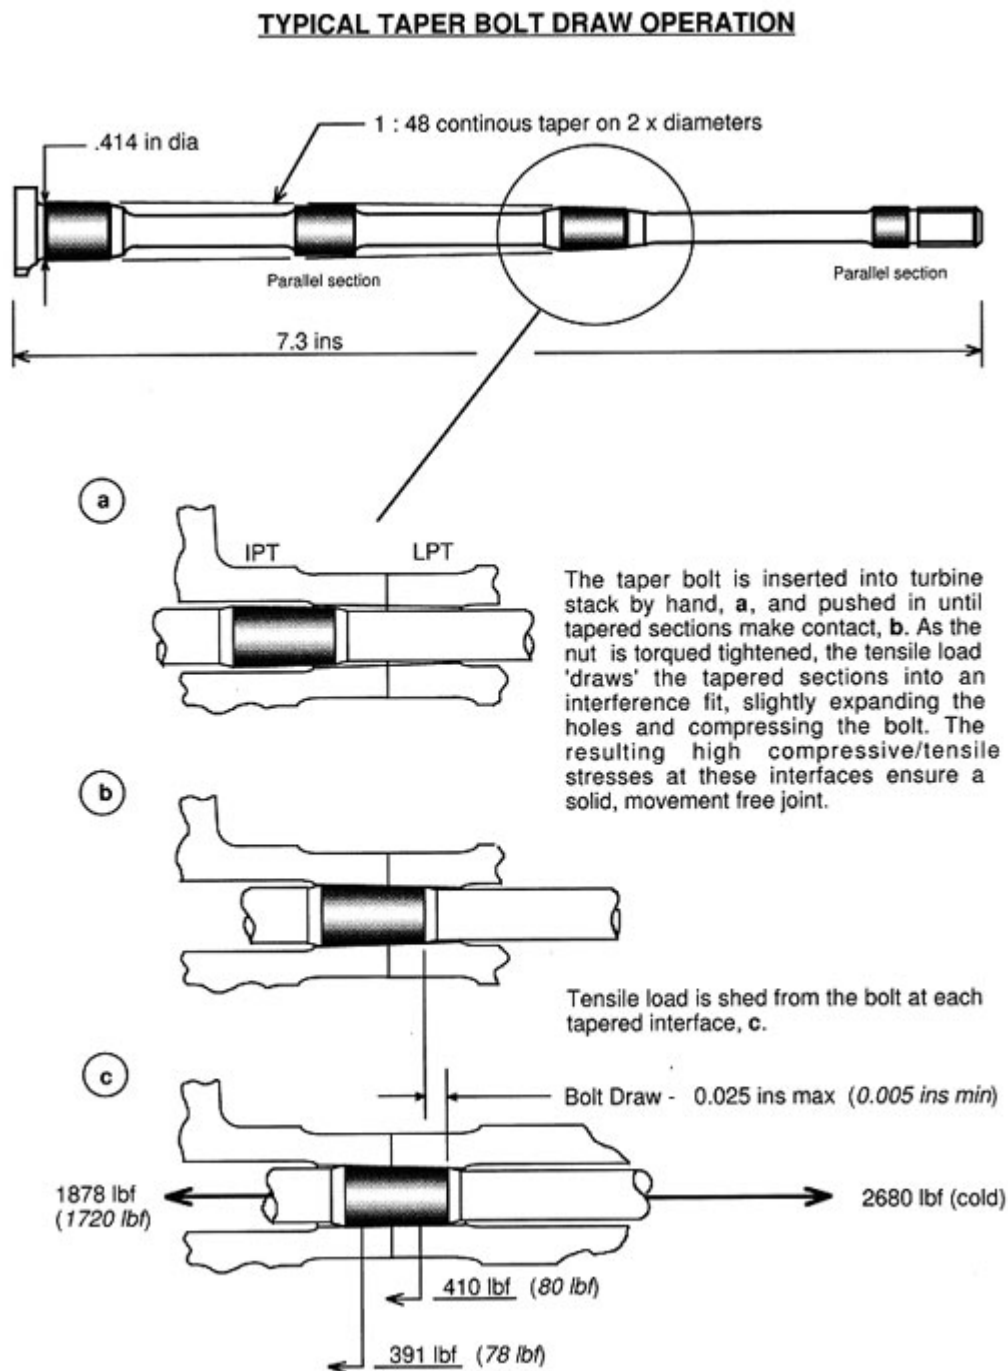
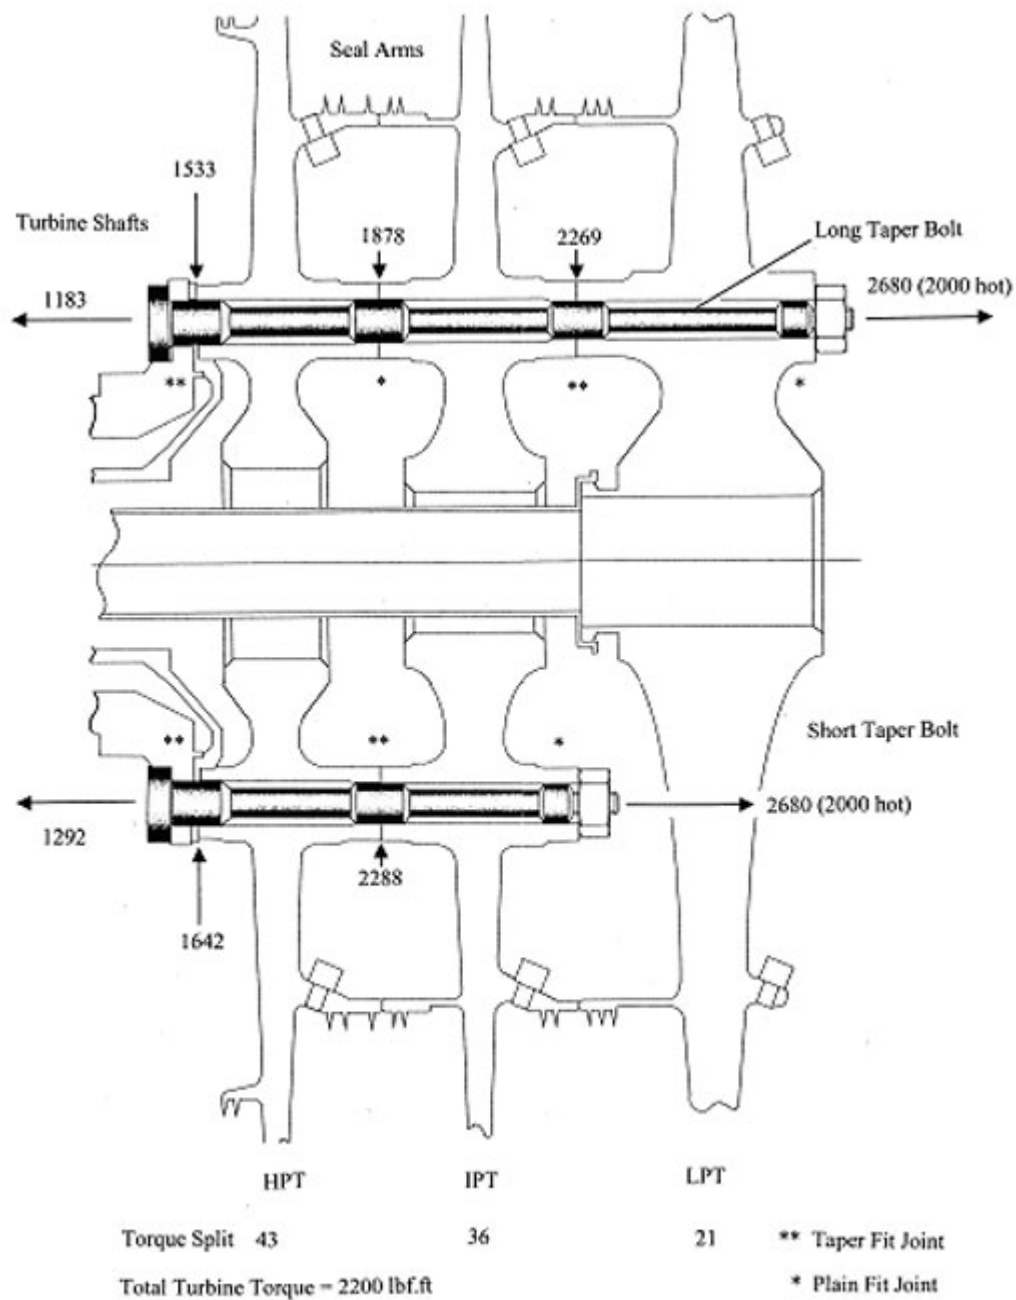
The total torque to be transmitted by the turbine is 2,200 lbf.ft and the torque split between the HP, IP and LP turbines is estimated in the ratio of 43:36:21. An analysis of this model of Dart engine indicated that these torque levels could not be transmitted by friction alone between the faces of the mating bosses, so the tapered sections of the bolts would experience shear forces at the disc interfaces. Diagrams illustrating the location and principle of the tapered sections, and a theoretical loads analysis for a turbine stack, are shown in Figures 10 and 11.
