Accident
Investigation Board
Norway

Issued March 2010

SL 2010/05

**REPORT ON SERIOUS AVIATION INCIDENT AT
SANDEFJORD AIRPORT TORP 26 MARCH 2006
INVOLVING AIRBUS A321 OY-VKA OPERATED BY
MY TRAVEL AIRWAYS SCANDINAVIA**

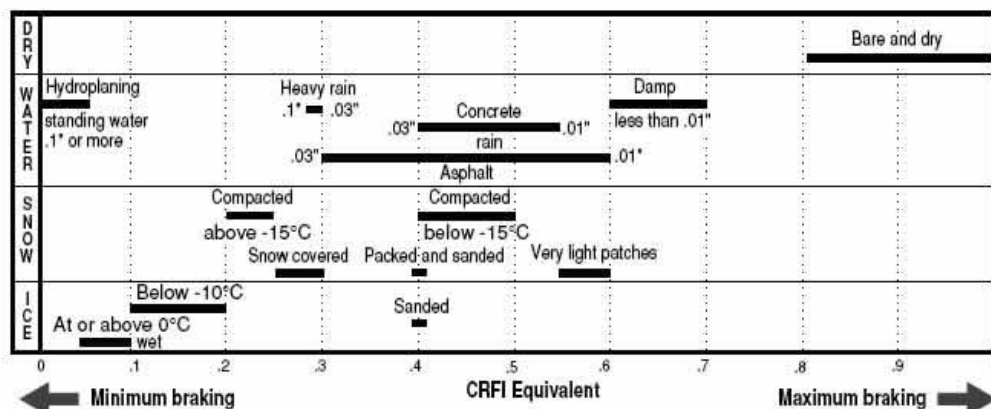
AIBN's investigations also shown there to be moist conditions with dewpoint spread (the difference between air temperature and dewpoint) of < 3 K, even at frost degrees (when the temp. is below minus Celsius). This is illustrated in Figure 1 which shows a big difference in friction for compacted snow at temperatures above and below minus 15°C. Figure 1 is taken from Transport Canada and demonstrates some of the uncertainties that befall friction measurements on contaminated surfaces.

Figure 1. Uncertainty of friction measurements on contaminated surfaces (Transport Canada 2004)

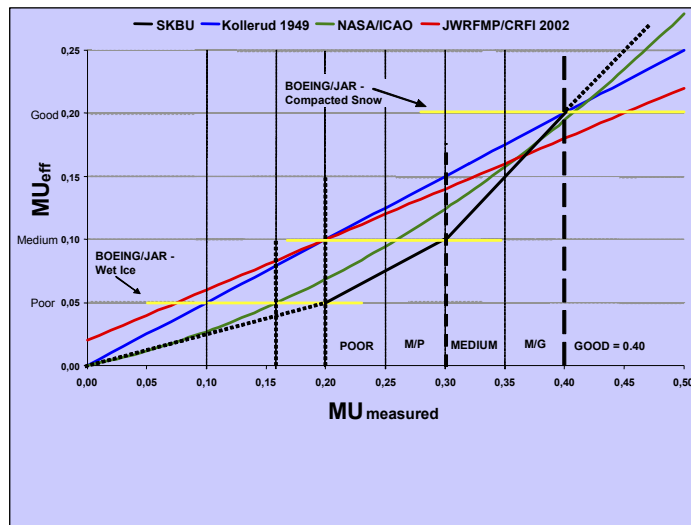
1.18.9.2 Figure 1 in Appendix L shows different correlation curves between measured (reported) friction figures and "*airplane effective μ* " (or ABC). We see there is little difference between Kollerud's correlation curve and the Canadian curve. Roughly speaking, the effective friction coefficient is half of the measured and reported one. The figure also shows the ICAO-recommended correlation curve (green) and the Norwegian approved curve (black). The latter is the most conservative, and the one that has proven the most practical over several years on contaminated Norwegian winter runways.

Figure 1. Correlation between measured μ and effective μ . (Norheim, Avinor 2006).

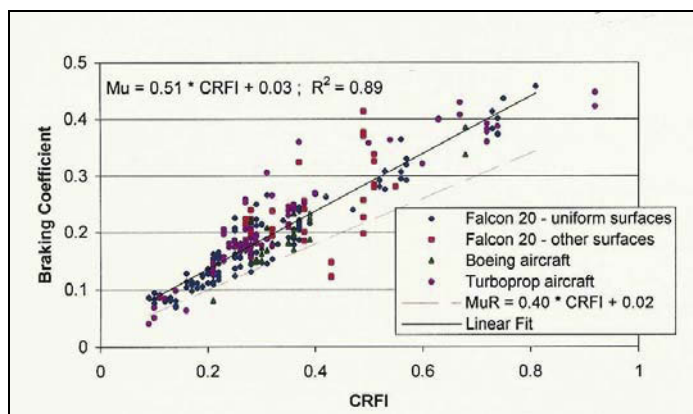
1.18.9.1 Over the past 50 years there have been many attempts to correlate the measured friction figures with the airplanes' effective brake coefficients. Airport manager O. Kollerud started the first tests at Oslo Airport Fornebu in the late 1940s. Kollerud (1953) concluded that the airplanes' "*efficient μ* " ("*airplane braking coefficient*", ABC) was 50% of the measured values. The latest correlation tests were conducted in Canada as part of the Joint Winter Runway Friction Measurement Program (JWRFMP 2004), a winter program stretching over several years up to 2004. Figure 2 in Appendix L shows the ABC vs CRFI.

Figure 2. Airplane Braking Coefficient vs Canadian Runway Friction Index (CRFI, TC 2004).
