**AIR ACCIDENT INVESTIGATION
& AVIATION SAFETY BOARD
(AAIASB)**

AIRCRAFT ACCIDENT REPORT

**HELIOS AIRWAYS FLIGHT HCY522
BOEING 737-31S
AT GRAMMATIKO, HELLAS
ON 14 AUGUST 2005**

Accident of the a/c 5B-DBY of Helios Airways,
Flight HCY522 on August 14, 2005,
in the area of Grammatiko, Attikis,
33 km Northwest Of Athens International Airport

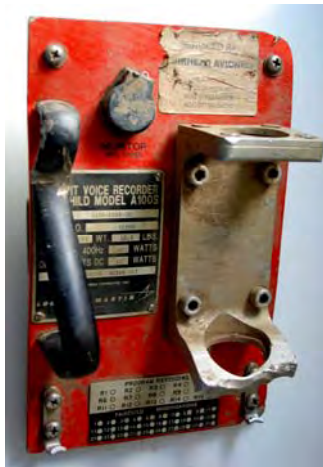
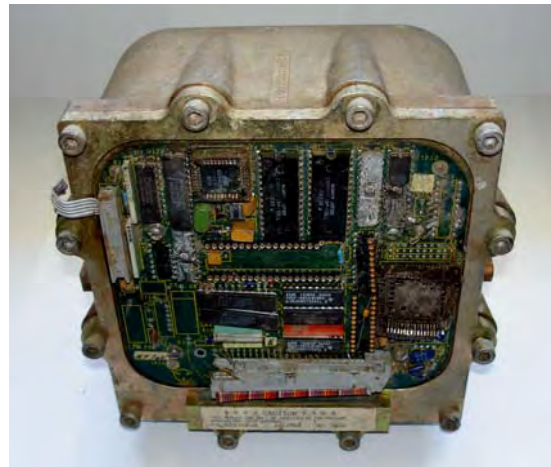
Photo – CVR

The CVR was taken to be transcribed at BEA (Bureau d’ Enquêtes et d’ Analyses) in France. The Flash Card Survivable Store Unit (FCSSU) was opened and the memory board was extracted. The memory board was connected to the acquisition part of the Solid State CVR by a cable from the FCSSU (memory-protected module). The cable was found in good condition; a new connector was plugged into the cable, which was then connected to BEA’S A100S unit, which was used as a reader. After the data extraction was completed, the last 30 minutes of the recording was obtained.

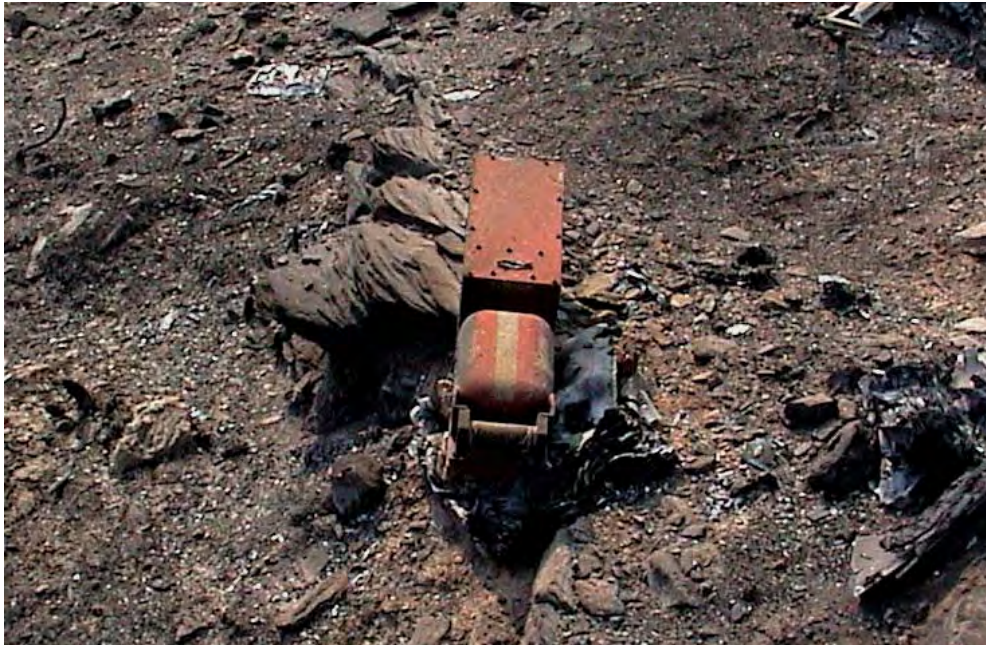
Photo - FDR

The FDR was found near the right aft service door and was recovered from the accident site on 14 August 2005, the day of the accident (Photo – FDR). It was taken to the readout facilities of BEA and the read out began on 17 August 2005. The recorder was in good condition, with no evidence of impact damage. However, the outside casing, including the outside of the acquisition unit, was blackened by fire expose and the paint was melted. Since it bore signs of fire exposure, the protected unit was removed from the FDR and connected to a new acquisition unit. It was then connected to the readout equipment, in order to download the raw data file. The data file was synchronized using BEA software.

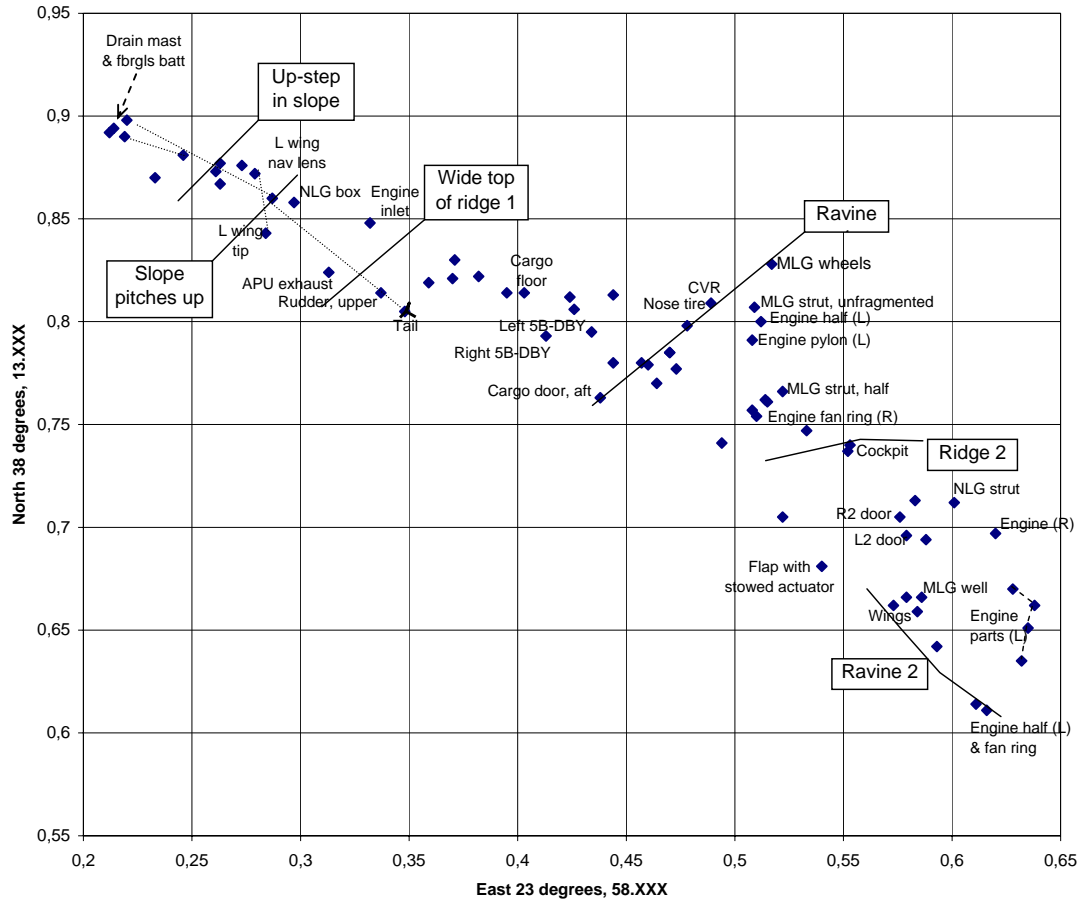
Diagram – Wreckage Distribution Map

The wreckage was distributed generally from west to east, over two rocky hills for a straight-line distance of about 800 m (Diagram - Wreckage Distribution Map and in Appendices the Wreckage Distribution Position Data). The first component found was a drain mast where the fuselage first impacted the ground. Tufts of fiberglass thermal-acoustic insulation batting were in the immediate area.

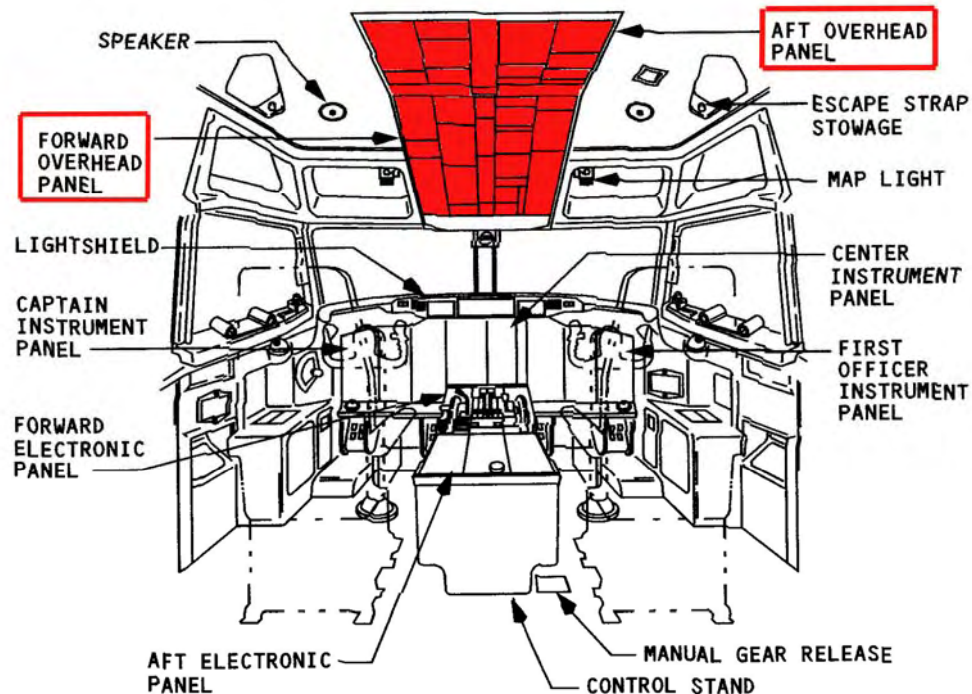
Diagram – Position of overhead P5 panel (marked in red)

The forward overhead P5 panel was located in the area of the cockpit within the wreckage at the accident site. The panel was accessed by removing the surrounding wreckage. Once the panel was located, low air pressure was used to remove the accumulated dirt, dust and light debris in order to visually examine the controls. The entire P5 panel was photographed and the position of the controls (toggle switches, selectors, switches, and indicators) were visually examined and documented. The controls were not activated.

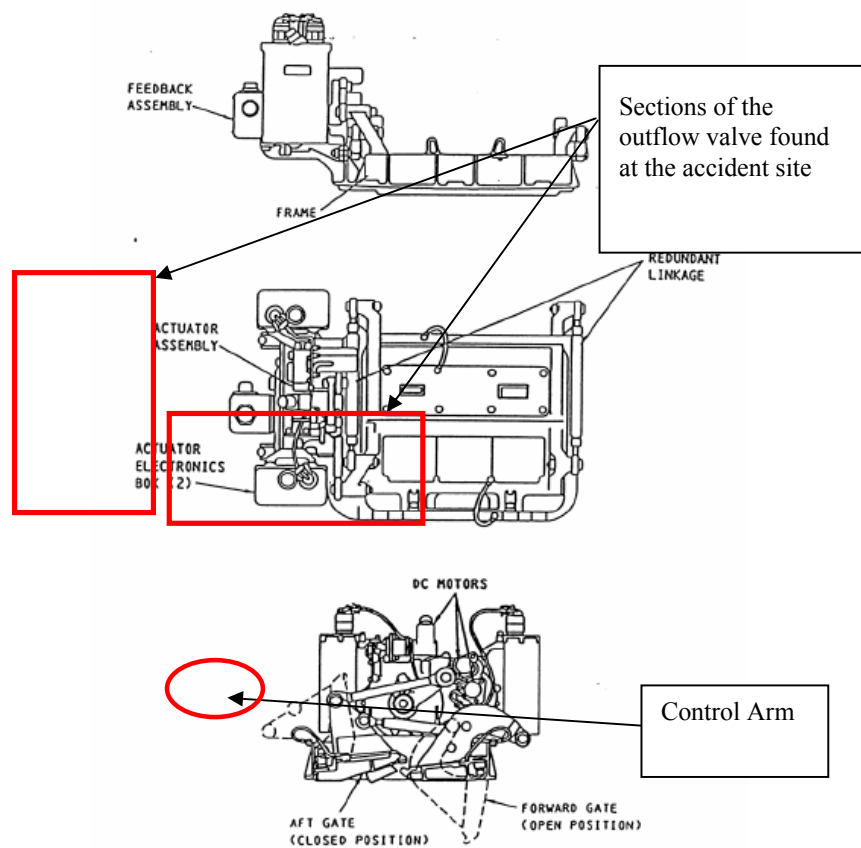
Diagram - Aft Outflow Valve

The actuator/motor assembly and both the forward and aft door gates of the aft outflow valve (AOV) were found at the accident site (see diagram and photos below and next page). The actuator/motor assembly was separated from each of the door gates. The condition of the actuator/motor assembly was documented and photographed at the accident site. The control arm and position indicator remained attached to the motor assembly. Using hand pressure, a small force was applied to the control arm; it was physically locked in place and not able to rotate freely. At the storage facility, a measurement was taken between the closed position stop and the control arm position lever; the distance between the two was 8.0 mm (see photo in the next page).

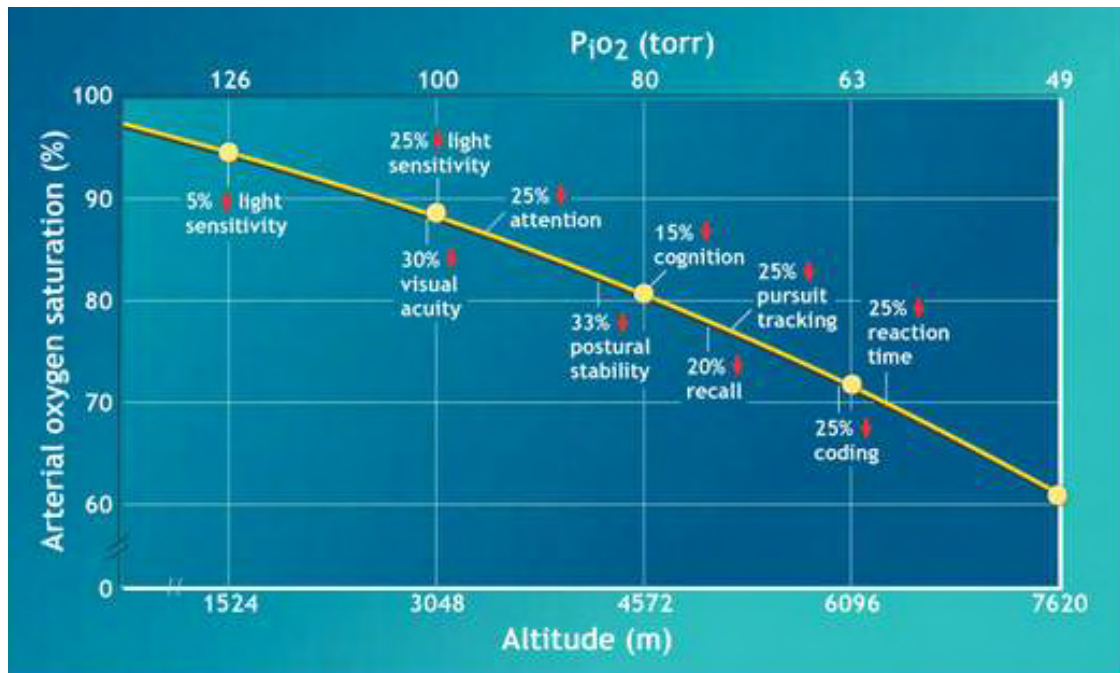
The decrease in SaO_2 leads to both physical and mental performance degradation. In aircraft operations, where muscle work is not the major requirement, the decrements in mental capabilities are most important for the flight crew in relation to safe aircraft guidance. The diagram of Haemoglobin Oxygen Saturation and Performance shows a collection of corresponding findings.

Diagram - Haemoglobin Oxygen Saturation and Performance (McArdle, 2001)
