ATSB TRANSPORT SAFETY REPORT
Occurrence Investigation Report AO-2007-070
Final

Leading edge device failure
Norfolk Island
29 December 2007
VH-OBN, Boeing 737-229

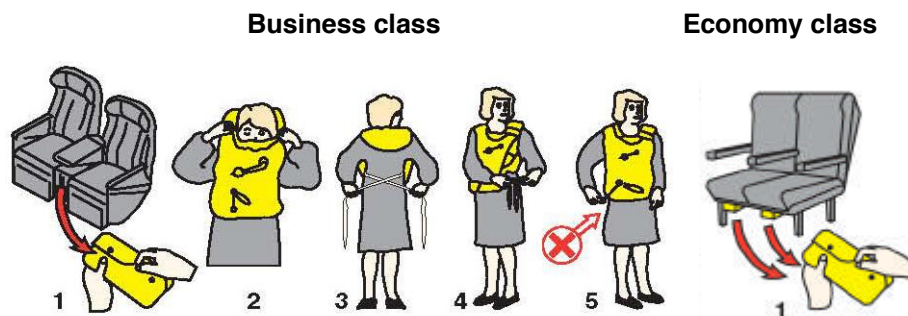
Figure 7: Lifejacket instructions from the business class passenger safety card (left) and step 1 from the economy class safety card (right)

The cabin crew reported that a number of passengers found it difficult to locate their lifejackets under their seat or armrest, and that some passengers in business class (rows one and two) needed assistance locating them. It was noted that in business class, the lifejackets were at floor level under the armrest, which may have contributed to them being difficult to find (Figure 7).

It was also reported that some passengers were surprised that the lifejackets were wrapped in a container when they found them, and that may have also contributed to some passengers finding it difficult to locate them.

There were a number of passengers that put on their lifejackets incorrectly, but that were subsequently corrected by the cabin crew. The most common problems were putting them on backwards, or tying the cord over the top of the jackets instead of under them (see Figure 7, business class diagram number 4). Tying the cord over the top of a jacket would restrict or modify its inflation.

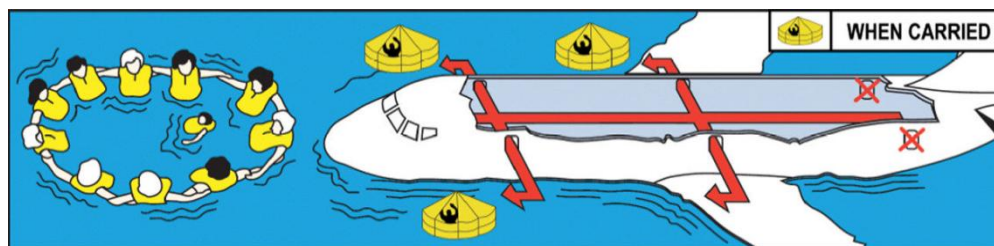
Figure A1: Excerpt from the passenger safety card directing passengers not to use the rear exits and to alight the wing in the forward direction.

The passenger safety card indicated that, once the aircraft landed on the water, only the forward and over-wing exits were to be used, and that passengers should leave the aircraft in the forward direction from the wings (Figure A1).

The majority of respondents did not know which direction they should have exited the wing (68%). Only 8% indicated they should exit in the forward direction. One respondent indicated that, although they were advised which exits to use, they were not told which direction to alight from the wing. Of the three passengers sitting in the over-wing exit row who responded, two indicated they did not know which direction to move off the wing, while the third indicated they should exit rearwards.

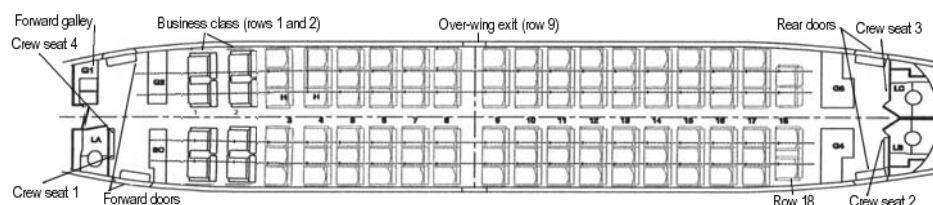
Figure A2: Cabin configuration

Three respondents indicated that they moved seats before the descent into Nouméa. A male passenger replaced a female passenger in the over-wing exit row (row 9), and a woman who was travelling with her daughter moved out of row 18 so that another passenger, who did not have to look after a child, could occupy the rear exit row seats (Figure A2).
