ATSB TRANSPORT SAFETY REPORT

Aviation Occurrence Investigation AO-2008-033

**Operational non-compliance
Perth Airport, WA
9 May 2008
PK-GEF
Boeing Company 737-8CX**

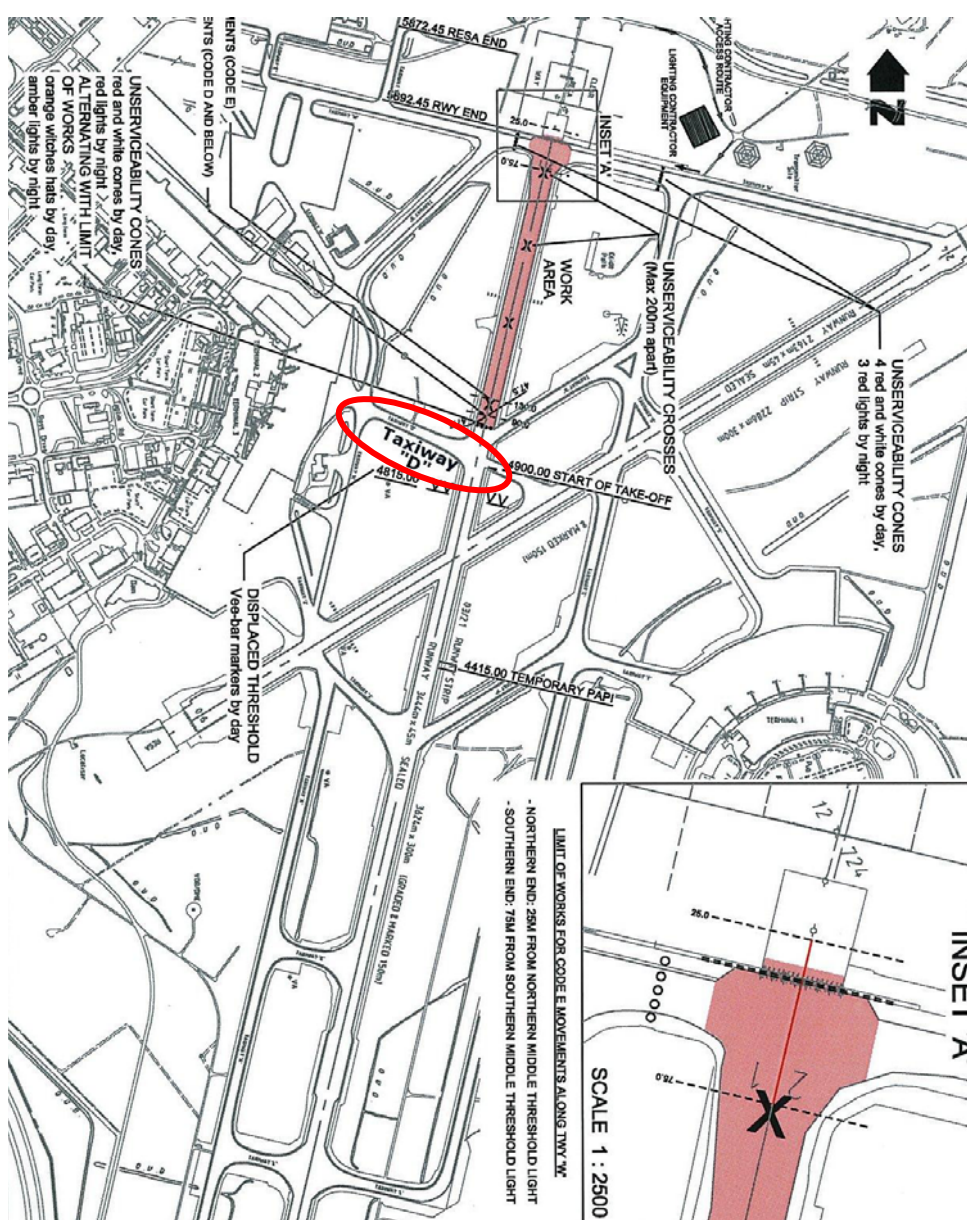
Figure 2: Part of the MOWP showing the stage 2 runway works area

plan view of the works (Figure 2) and a number of draft NOTAMs for promulgation at the appropriate stage of the works. There was no indication in the MWOP or draft NOTAMs of the consideration of the effect of those works on the final approach profile to the displaced threshold from the MDA of the runway 21 LLZ approach.

The aircraft operator's Perth office recalled receiving a copy of the MOWP, which was retained in Perth for reference by flight crew. The MOWP was not forwarded to the operator's flight operations department in Indonesia. The aircraft operator reported that, had they received a copy of the MOWP, they would have issued a notice to their flight crew.

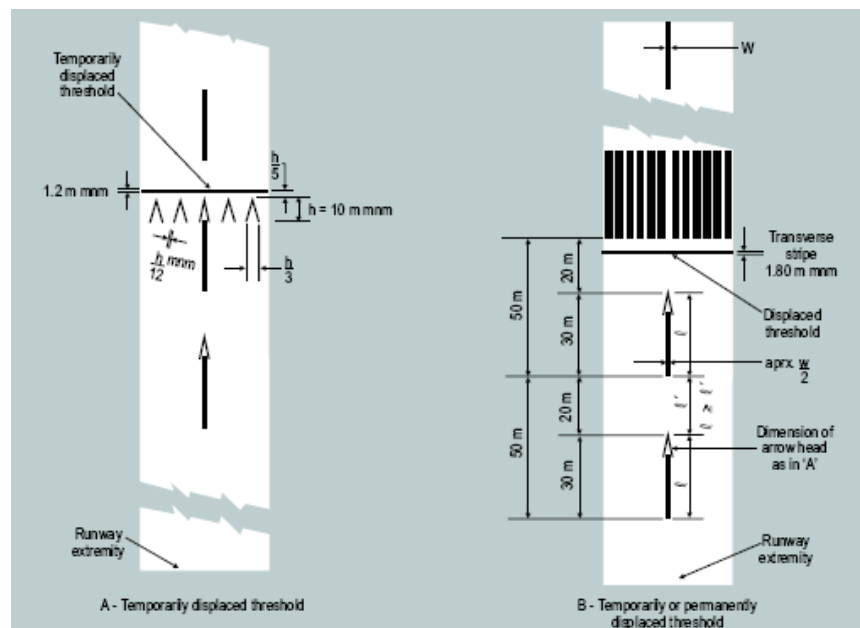
Figure 3: ICAO-recommended displaced threshold markings

5.2.4.10 When a runway threshold is temporarily displaced from the normal position it shall be marked as shown in figure 2 (A) or 2 (B) and all markings prior to the displaced threshold shall be obscured except the runway centre line marking, which shall be converted to arrows [Figure 3 below].

Despite the relevant Australian requirements allowing for the permanent runway 21 markings to be left in view, the obscuration of those markings, as recommended by ICAO, would have increased the likelihood that the crew would identify the displaced threshold. It was possible in this instance that, had the flight crew not noticed the vehicles on the runway during the initial landing approach, they may have landed within the runway works area.

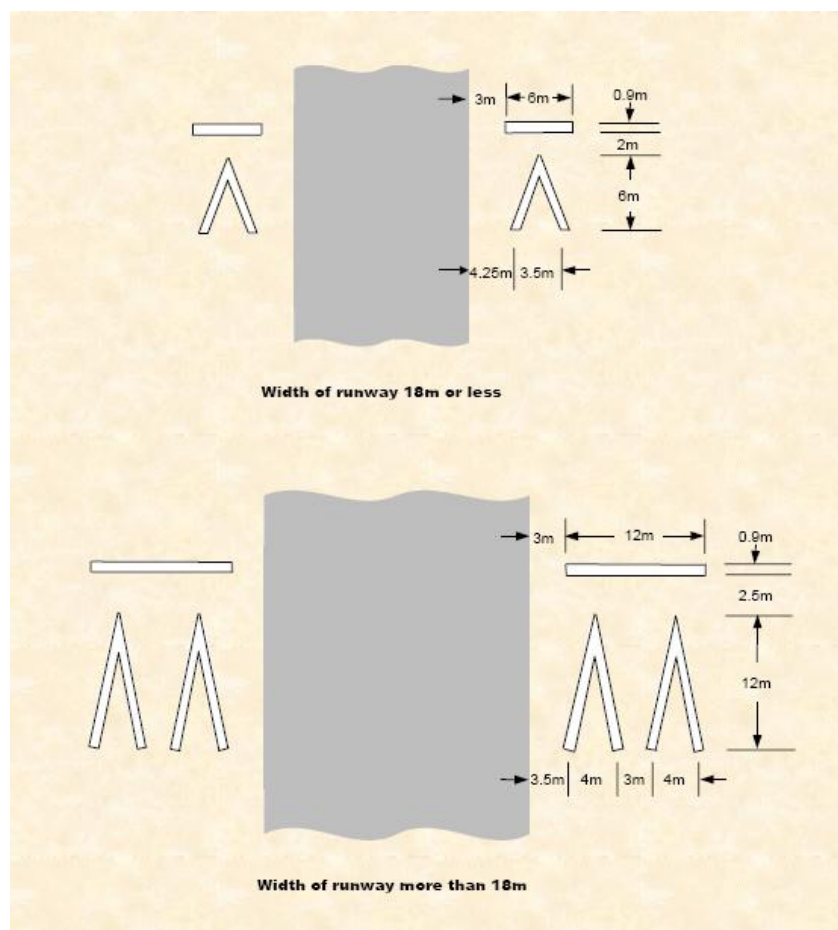
Figure 5: Australian temporarily displaced threshold markings (less than 5 days)

8.3.9.8 When a threshold at an air traffic controlled aerodrome is to be temporarily displaced for 5 days or less, and the displacement is more than 450 m, the new threshold location is to be indicated by the above markings [Figure 5 below] but the permanent threshold markings may be retained.

The Australian requirements for marking runway thresholds that were displaced for 30 days or less differed from those recommended by the International Civil Aviation Organization (ICAO). When compared with the likely visibility of the ICAO-recommended 36 m closed runway markings, the Australian 6 m markings, as used in this case, increased the difficulty for the crews in locating the precise location of the displaced threshold. As a result, there was an increased risk of a flight crew conducting a visual approach to the permanent threshold/touch-down area. The use of the larger-sized crosses, as specified in *ICAO Annex 14 Aerodromes*, would have been visible to the flight crew much earlier during their approach, allowing additional time for the identification of the closed runway area and displaced threshold. That would have allowed an early adjustment to their approach path, ensuring a stabilised approach and landing.

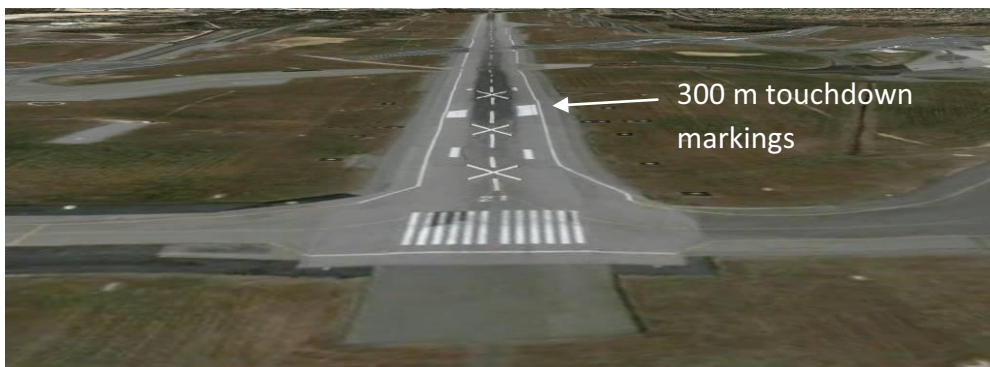
Figure 9: 36 m closed runway markings

Simulated views of the 6 m and 36 m closed runway markings are at Figures 8 and 9 respectively. Those markings are indicative of the final approach to a runway as viewed by the flight crew just prior to touchdown. Note the 300 m touchdown marking as normally used by this type of aircraft.
