AIR ACCIDENTS INVESTIGATION  
INSTITUTE OF CZECH REPUBLIC  
Beranových 130  
199 01 PRAHA 99

**CZ-10-229**

# **FINAL REPORT**

**Air accident involving  
Airbus A321-131, registration mark D-AIRT  
And  
Boeing B737-8BK, registration mark TC-SNM,  
On 18<sup>th</sup> June 2010 at LKPR.**

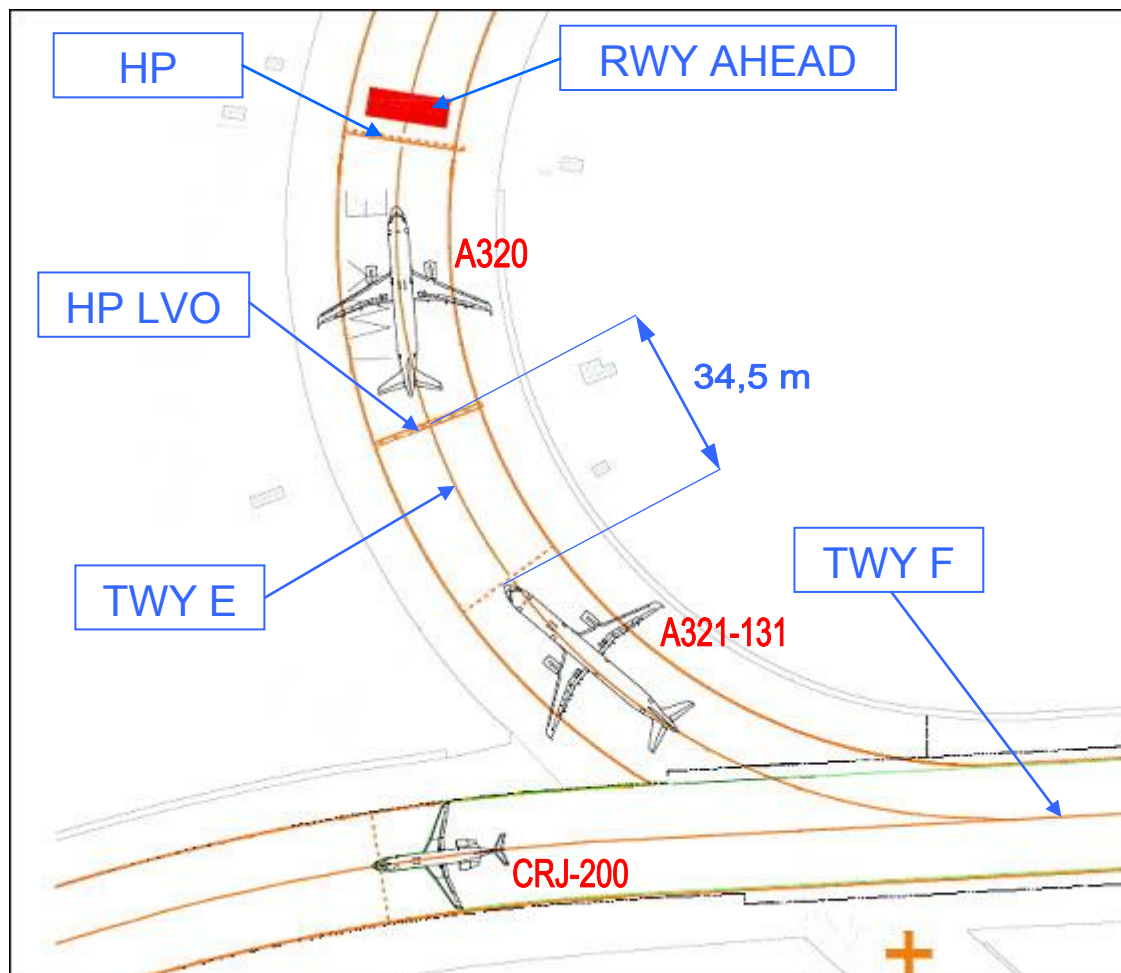
Scheme 1

At 08:28:50 the B737-8BK crew on stand 2 asked for taxiing clearance. TWR-GEC cleared taxiing on TWYs A1, Z, H, and F to RWY 06 holding point.

At 08:37:04 the B737-8BK crew reported it could start from RWY 06 / TWY E intersection and stopped at TWY F on TWY FF level. TWR-GEC issued an instruction, for operational reasons, "continue to the end please". At 08:37:40 the B737-8BK crew continued its further taxiing on TWY F toward THR RWY 06. During this taxiing the B737-8BK right winglet struck the stabiliser of the A321-131 standing on TWY E (see Scheme 2). After the collision the B737-8BK crew stopped. At 08:38:23 the B737-8BK crew reported the event over the TWR-GEC frequency.

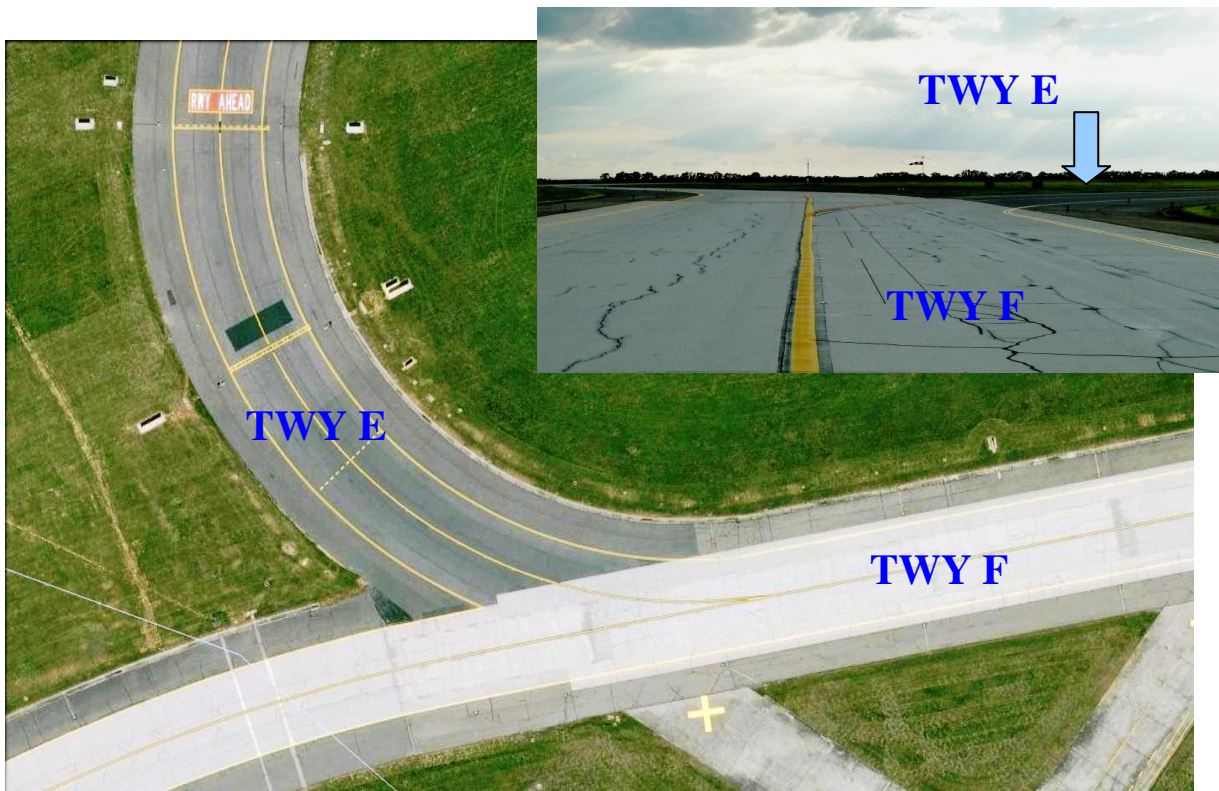
On TWY E are designated two holding points. One is standard at a distance of 90 m (HP) and the other for operation under LVO condition at a distance of 150 m from RWY 06/24 centre line (HP LVO).

On TWY F and TWY E are designated intermediate holding points to identify TWY strip.

Fig. 1 The place of accident – horizontal marking.

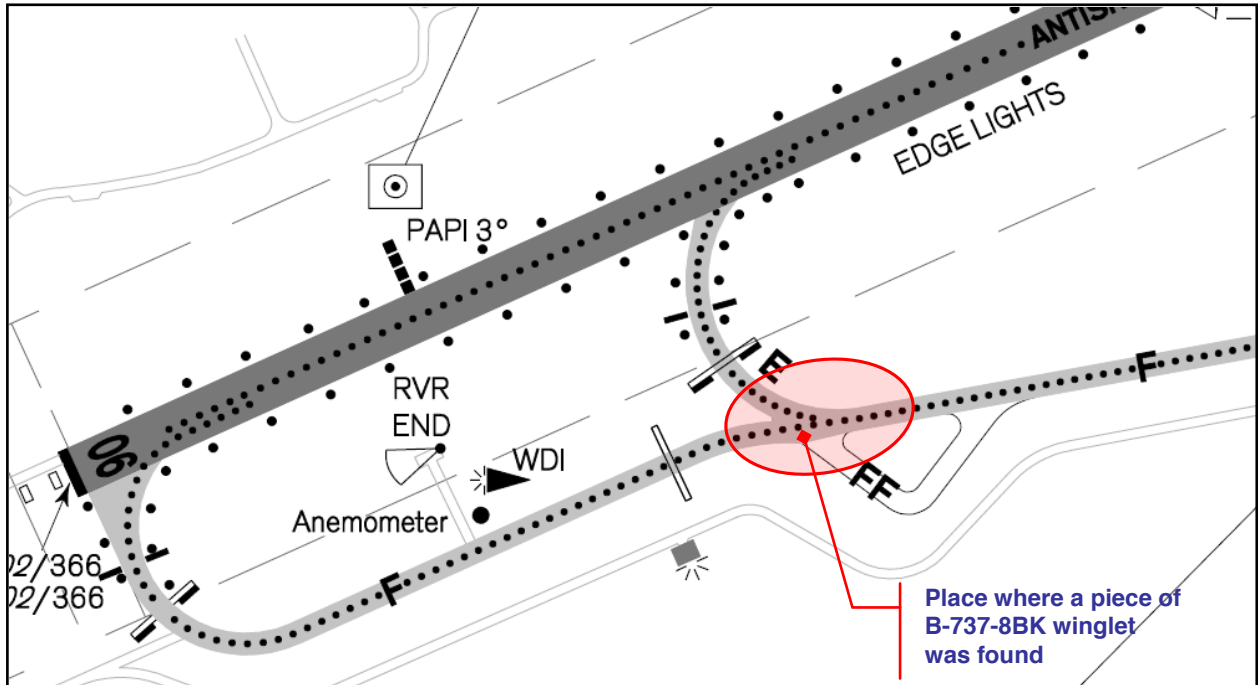
Scheme 3

Intersection where TWY E branches off TWY F. (see Scheme 3)

An exact position of the aircraft was not drawn and documented on the scene. Both the planes went back to the apron stand after the collision. See Chapter 1.1 Scheme 2 for a reconstructed position of the aircraft at the time of the accident.
