Crash During Approach to Landing  
Empire Airlines Flight 8284  
Avions de Transport Régional  
Aérospatiale Alenia ATR 42-320, N902FX  
Lubbock, Texas  
January 27, 2009

**NTSB/AAR-11/02  
PB2011-910402**

# Aircraft Accident Report

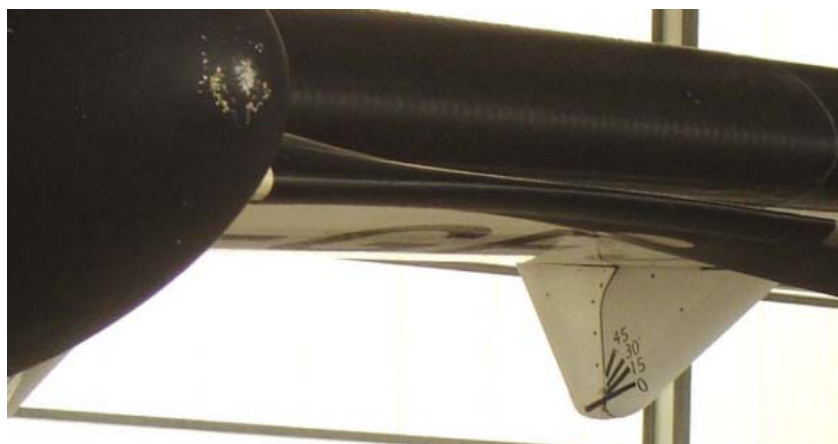
In addition to the cockpit flap position indicator, exterior flap position fairings mounted on the wings (one per wing) are visible to each flight crewmember through their respective side windows. These fairings are also marked with lines and numbers for the four flap positions, providing flight crews with a visual indication of the actual position of each flap. Figure 3 shows the exterior flap position fairing. The wing flap position fairings are illuminated by the wing lights during nighttime use. If a flap asymmetry occurs, the actual positions of the right and left flaps will be indicated on the respective flap position fairings.

**Figure 3.** Exterior flap position fairing.

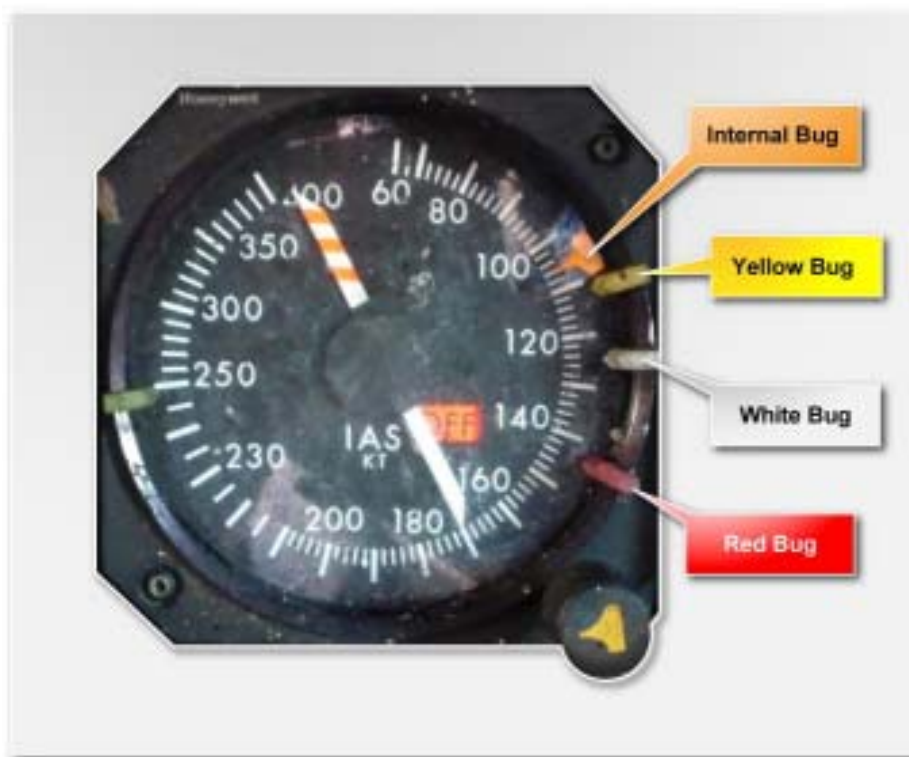
The other three indices, which are located on the outside of the glass face of the airspeed indicator, are color coded for use in referencing certain airspeeds during takeoff or landing and are manually positioned by the pilot. Unlike the internal bug's function, the pilot's positioning of these three indices (yellow, white, and red) does not affect any other systems or displays. The ATR 42 pilot handbook states that, for an approach, the yellow bug should be set to reference  $V_{ga}$ , which is the approach airspeed for 30° flaps plus 5 kts (not corrected for wind effect).<sup>25</sup> Similarly, the white bug should be set to reference  $V_{mLB0}$  normal, which is the minimum airspeed for an approach with 0° flaps in nonicing conditions, and the red bug should be set to reference  $V_{mLB0}$  icing, which is the minimum airspeed for an approach with 0° flaps in icing conditions. Figure 4 is an airspeed indicator showing the needle pointer; selector knob; and internal, yellow, white, and red bugs.

**Figure 4.** Airspeed indicator showing needle pointer; selector knob; and internal, yellow, white, and red bugs.

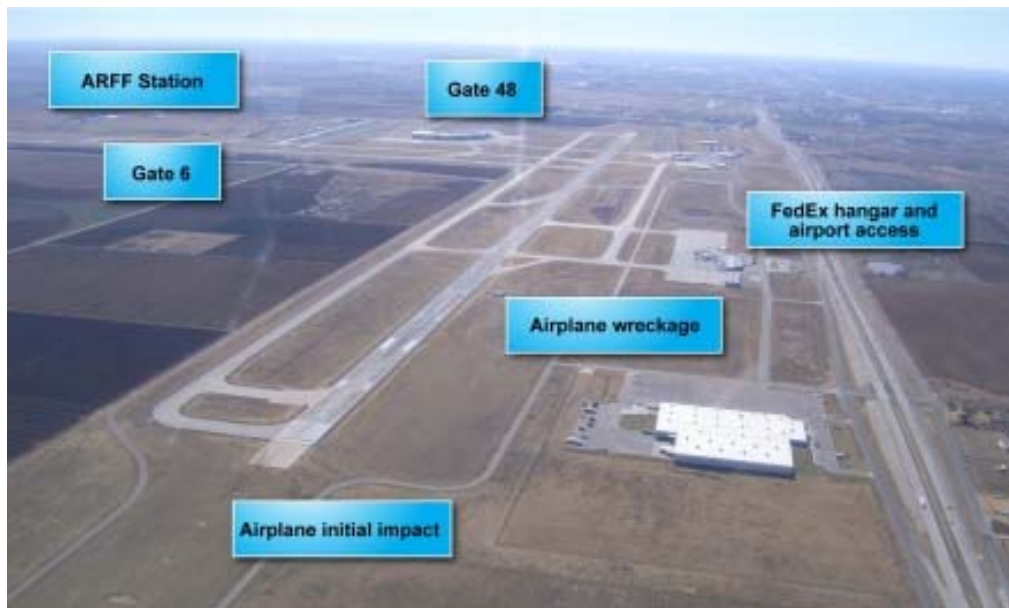
As directed, one engine from Station 2 responded to Gate 48, which is an electronically controlled gate operated by a drive chain. The engine team was unable to enter the airport property at Gate 48 because the gate had ice in its operating mechanism and would not open. The Station 2 engine then drove to the ARFF station to proceed from that point. All other responding Lubbock Fire Department units were informed that the wreckage was closest to the FedEx hangar and were rerouted to respond to that site. A FedEx employee who opened the gate near the FedEx hangar for the Station 2 team, Station 5 engine, and emergency medical service (EMS) personnel informed them that the pilots were at the hangar; the EMS units proceeded to the hangar. Figure 5 is a view of the airport showing the relative locations of airport access gates and the accident site.

**Figure 5.** View of airport showing relative locations of airport access gates and accident site.
