Aviation Occurrence Report

TransAsia Airways Flight GE222

ATR72-212A, B-22810

**Impacted Terrain and Collided with a
Residential Area**

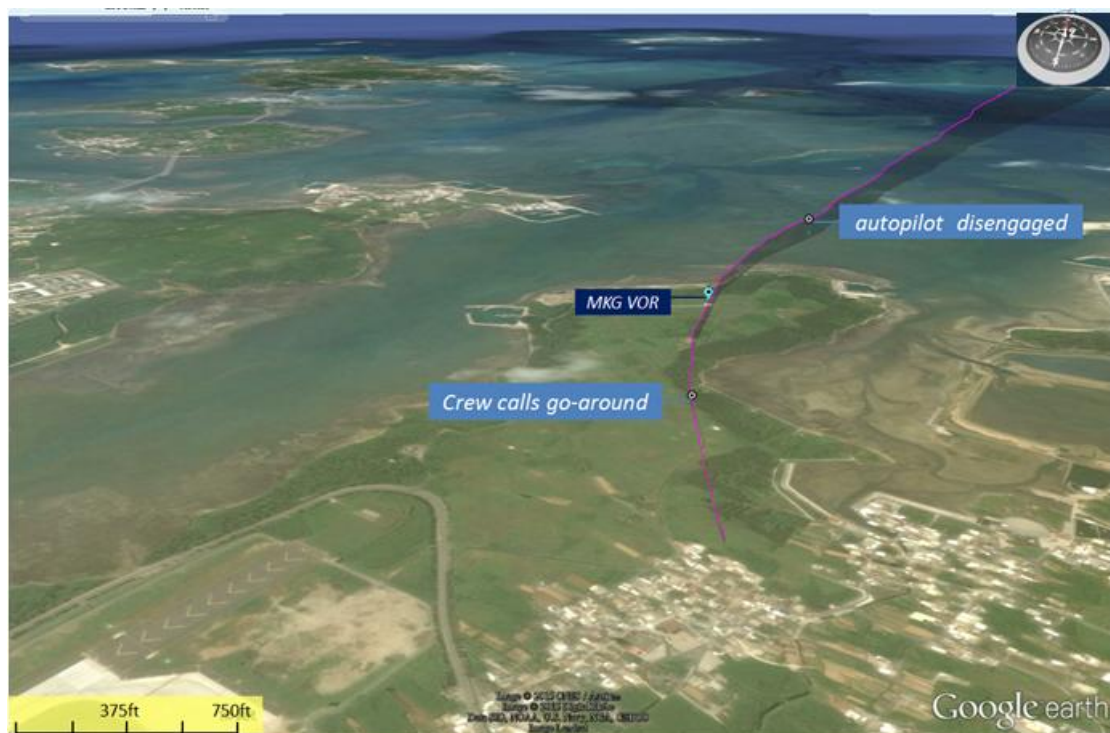
Figure 1.1-1 Final approach track

aircraft started to conspicuously deviate from the intended settings (see Figure 1.1-1), but there was no conversation between the flight crew regarding the aircraft entering an undesired state.

At 1906:11, both pilots called “go around” at 72 feet and both engine power levers were advanced. Two seconds later, the aircraft hit the foliage 850 meters northeast of the runway 20 threshold. The aircraft sustained significant damage and consequently collided with a residential area. Due to the high impact forces and post-impact fire, the aircraft was totally destroyed.

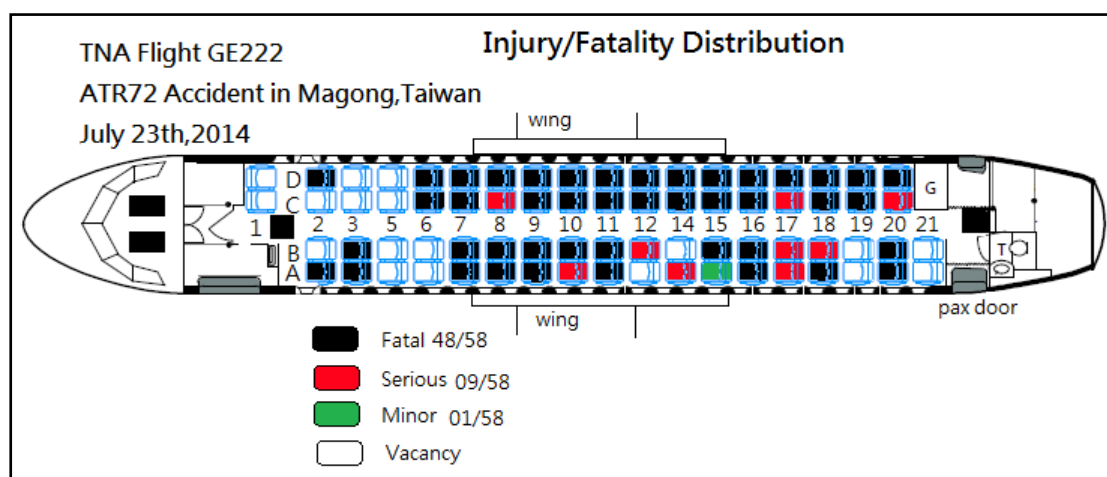
Figure 1.2-1 Injury and fatality distribution

Figure 1.2-1 shows the injury and fatality distribution via seat location. The passenger seating positions were based on the airline seating plan and interviews with the surviving passengers.

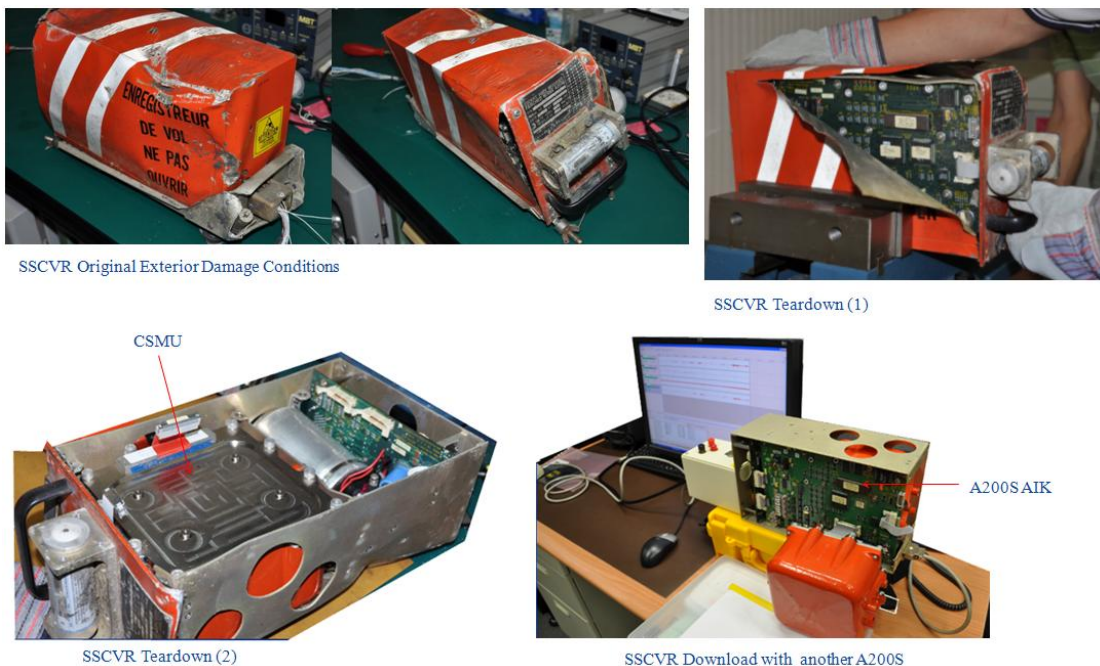
Figure 1.11-1 (a) Damaged SSCVR exterior view and its teardown; (b)

Raw data download as suggested in the A200S AIK

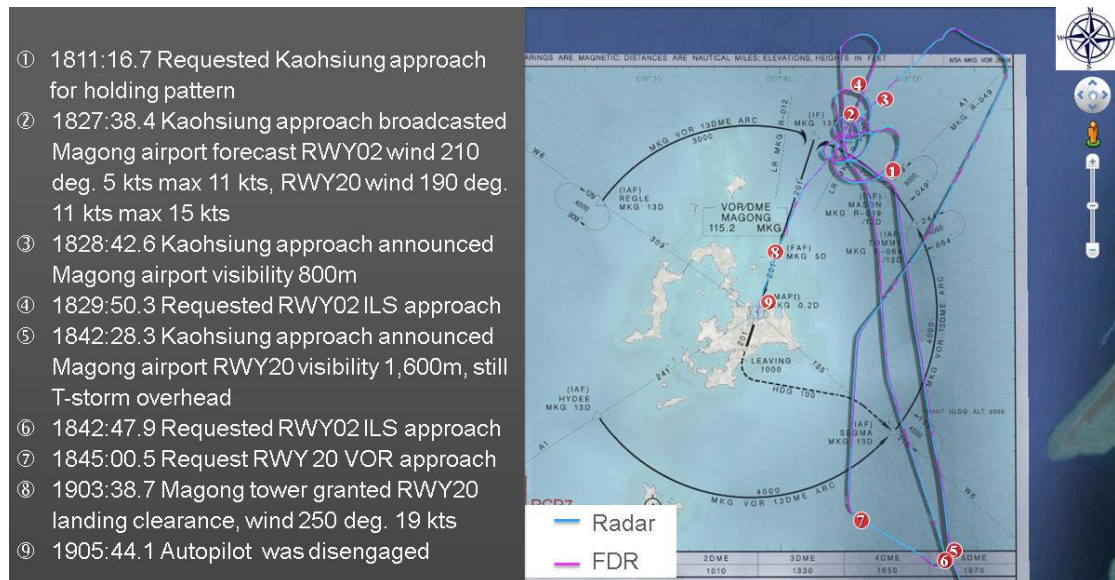
Figure 1.11-8 Superimposed GE222 flight path and VOR chart

the acceleration data recorded by the FDR, the position of the aircraft at every second was calculated, which enabled a reconstruction of the occurrence flight path. At 1906:18.9, the aircraft's last recorded position was N23°35'08.2", E119°38'21.1". Figure 1.11-8 displays key points along the occurrence flight path with the radar track superimposed with the Magong runway 20 VOR chart. Figure 1.11-9 presents the occurrence aircraft's trajectory during the last 40 seconds overlaid on a satellite image of the area.

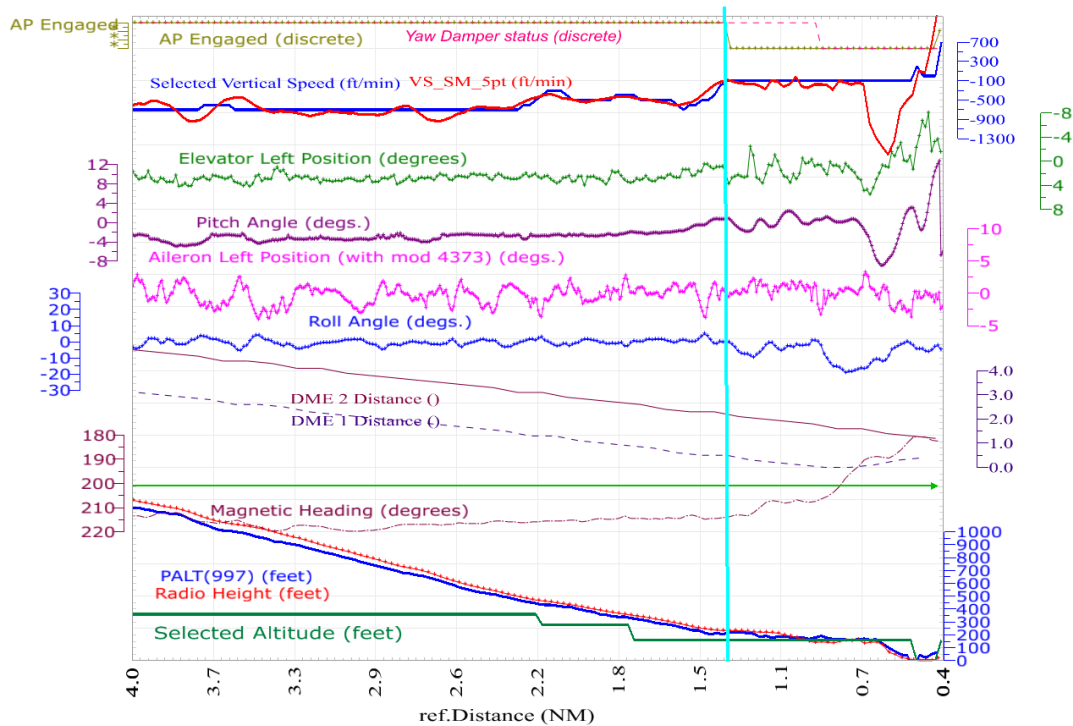
Figure 1.11-10 Calculated reference distance and vertical speed

The distance between the aircraft and the runway 20 threshold was calculated and presented as "ref. Distance". Parameters in Figure 1.11-10 include: autopilot engaged status, selected vertical speed, derived vertical speed⁴¹ (presented as "VS_SM_5pt"), left elevator position (positive value: pitch surface down and nose down), pitch attitude, left aileron position (positive value: left aileron down and right bank), roll attitude, rudder position (positive value: rudder to left), magnetic heading, selected altitude, radio height and pressure altitude.

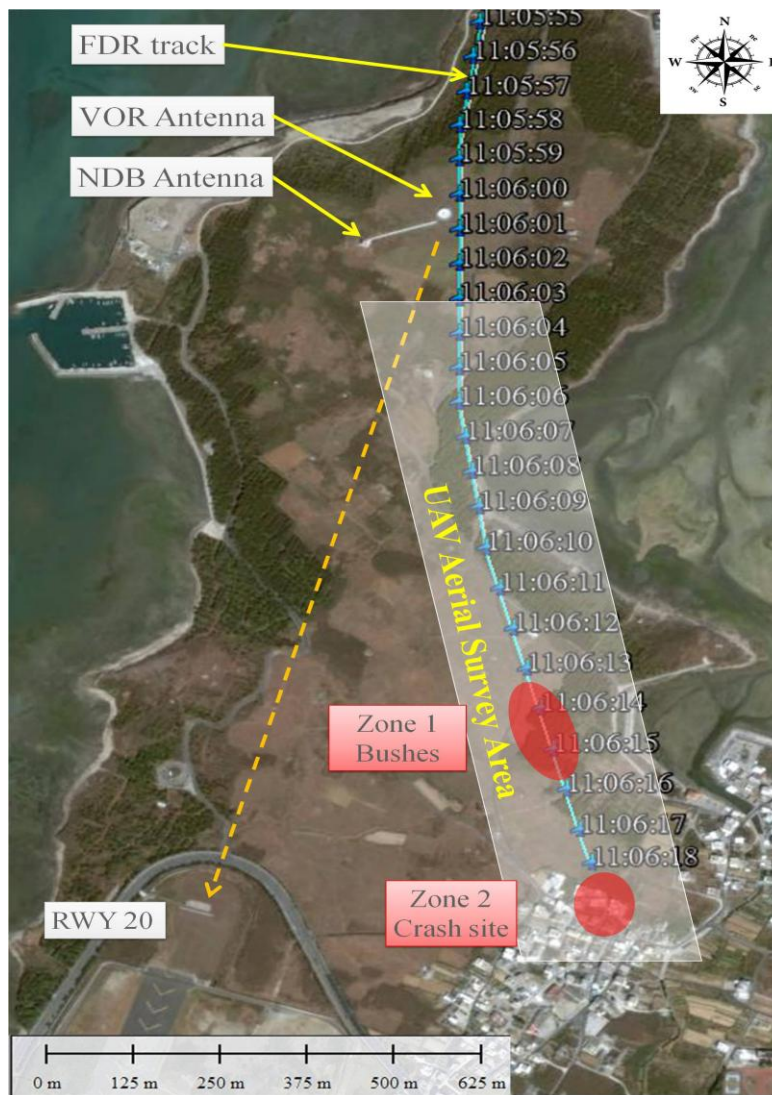
Figure 1.12-2 Superimposed GE222 flight path with time marks and wreckage zones

The UAV aerial survey generated a geo-reference map and 3D terrain model (DSM⁴³) of the occurrence area. Figure 1.12-2 shows the UAV area of operations superimposed on the occurrence flight path with timings and wreckage zones.

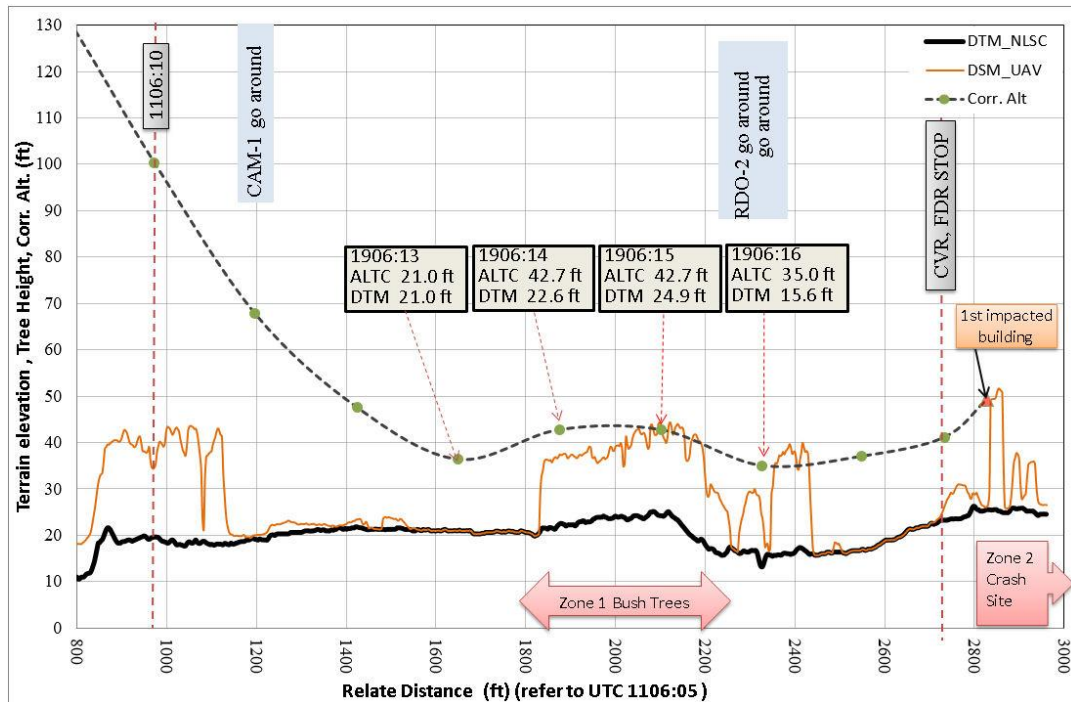
Figure 1.12-3 Comparison of terrain profiles

A set of terrain data (DTM⁴⁴) from the National Land Survey and Mapping Center (NLSC) was obtained to compare with the UAV survey results. The results are shown in Figure 1.12-3. The comparative terrain profiles are depicted for the last 9 seconds of the occurrence flight and extend a further 200 meters to ensure coverage of the wreckage display and associated collateral damage.

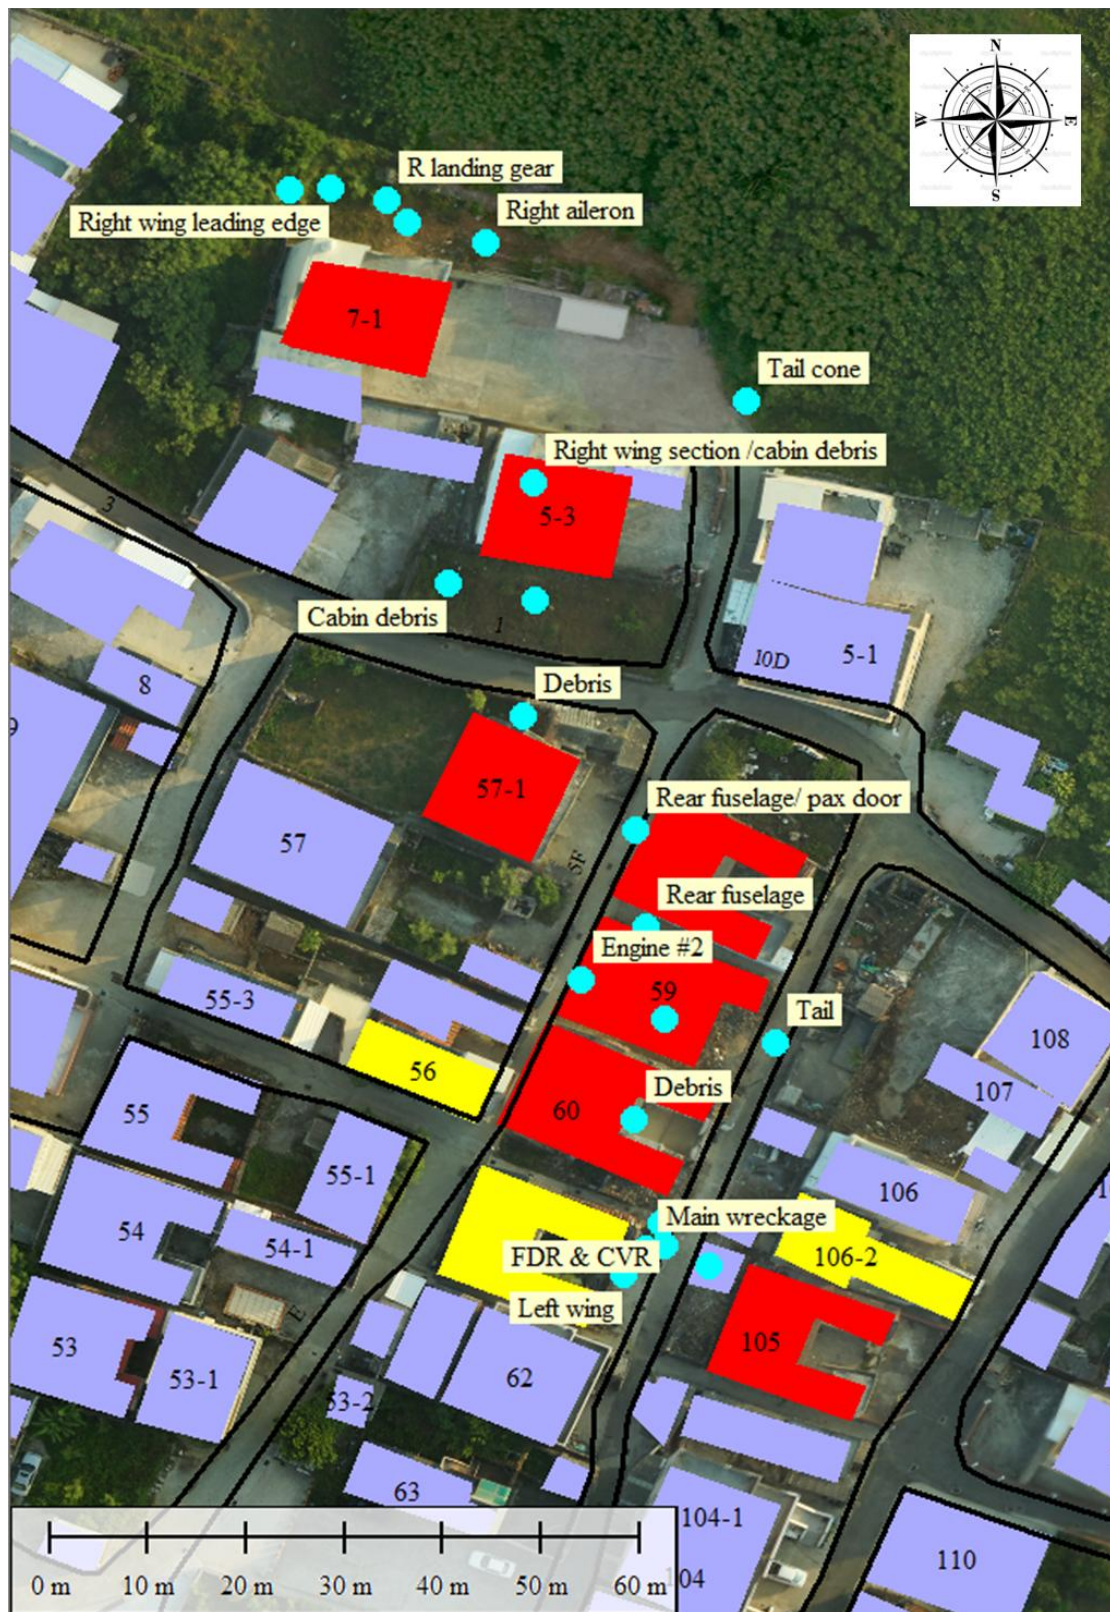
Figure 1.12-7 Wreckages distribution overlaid on Xixi village street map

Some aircraft wreckage was found along the swathe through the foliage. Those pieces of wreckage were identified as: nose landing gear aft doors, radome, left-hand heat exchanger, ram air inlet, ram air check valve, left-hand main landing gear door, belly fairing inspection doors, and belly fairing panels. The superimposed aircraft wreckage distribution and identified components on the UAV's orthogonal image⁴⁵ is shown in figure 1.12-6.

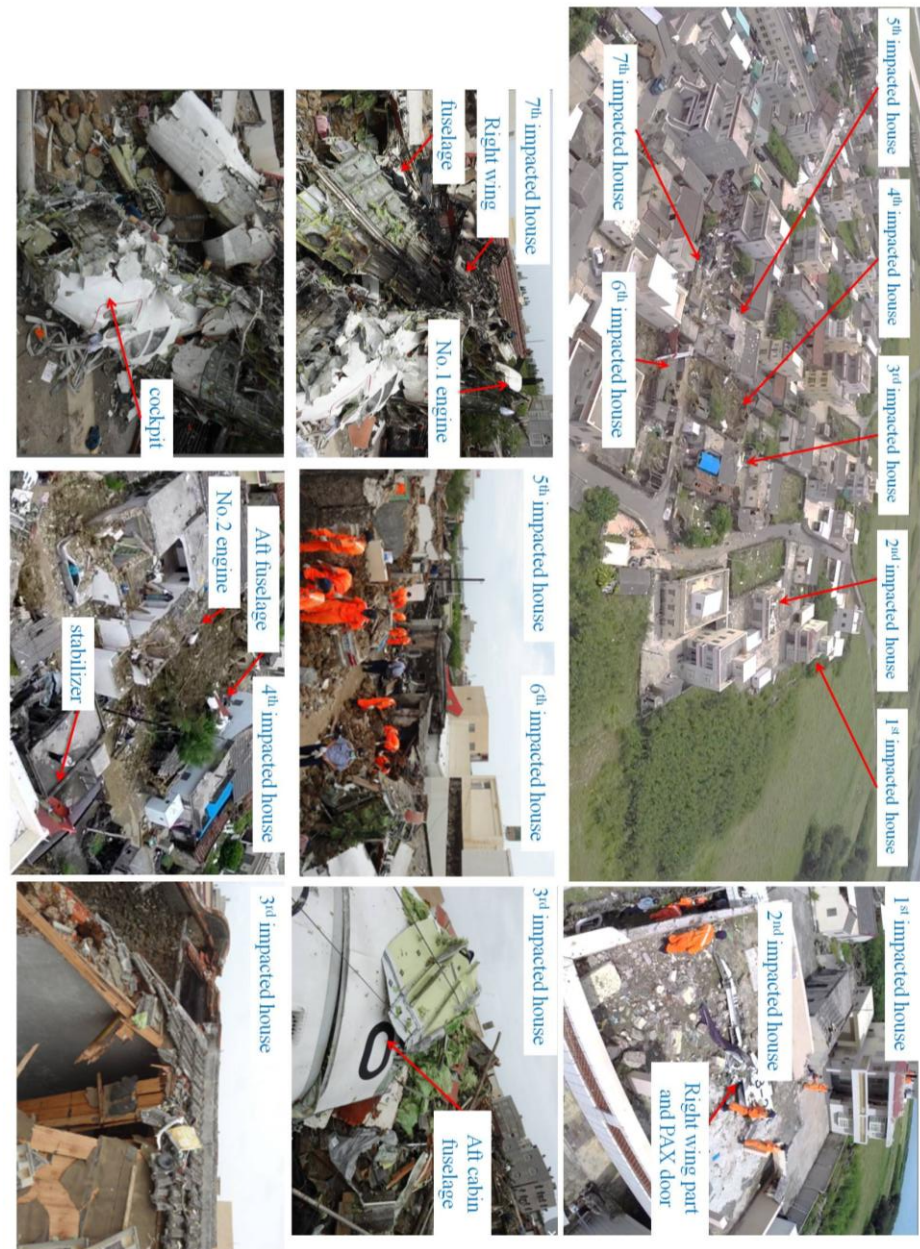
Figure 1.12-8 Aircraft main wreckage distribution and damaged buildings

Building no. 7-1 was the first building that the aircraft collided with. It exhibited impact damage primarily on its northern wall. One window on the second floor was shattered and the wall was pushed in. The iron bars reinforcing the wall structure were damaged in the direction of aircraft movement.

The damage on the second floor was consistent with a main landing gear impact. The northeastern corner of the roof exhibited rubber traces from either the tires or wing deicing boots. Five parallel, almost evenly

distributed, witness marks were visible on the top of the roof. Those marks were consistent with contact from the right side propellers. There was also a long prominent mark almost as wide as the wall, at the top of the northern side of the building. It continued on to the western wall. The mark was close to horizontal (approximately 10 to 15 degrees). That damage was consistent with right-wing impact. Figure 1.12-9 depicts the relevant aircraft impact marks, propeller marks, rubber marks and cracks at no. 7-1 building.

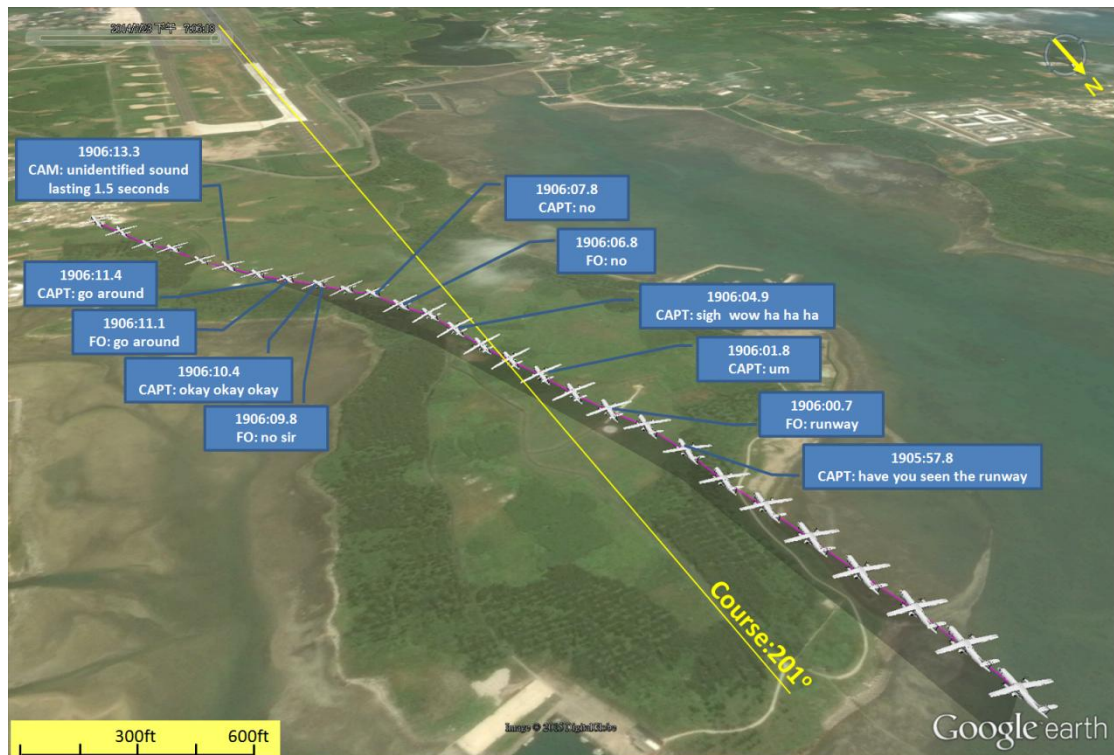
Figure 2.2-2 Aircraft track and altitude deviations as flight crew attempted to visually locate the runway.

recorder (FDR) data (see Table 2.2-4 and Figure 2.2-2) indicated that the aircraft's heading changed from 207° to 188° as a result of the bank angle changing from approximately wings level to 19° left and then decreasing to 4° left, which was consistent with the aircraft commencing a left turn away from the required approach course. The aircraft also commenced a descent from previously maintained altitude of 200 feet. The aircraft pitch angle decreased from 0.4° nose up to 9° nose down then returned to 5.4° nose down which produced a reduction altitude from 179 feet to 72 feet.

The combination of the captain's left control wheel input and strong right crosswind (32 to 34 kts from 252°) had turned the aircraft to the left, which consequently resulted in the aircraft's deviating from the required instrument approach course. In addition, the combination of the captain's forward control column input and the possible effects of moderate turbulence pitched the aircraft nose down with a subsequent loss of altitude below the previously maintained altitude of 200 feet.

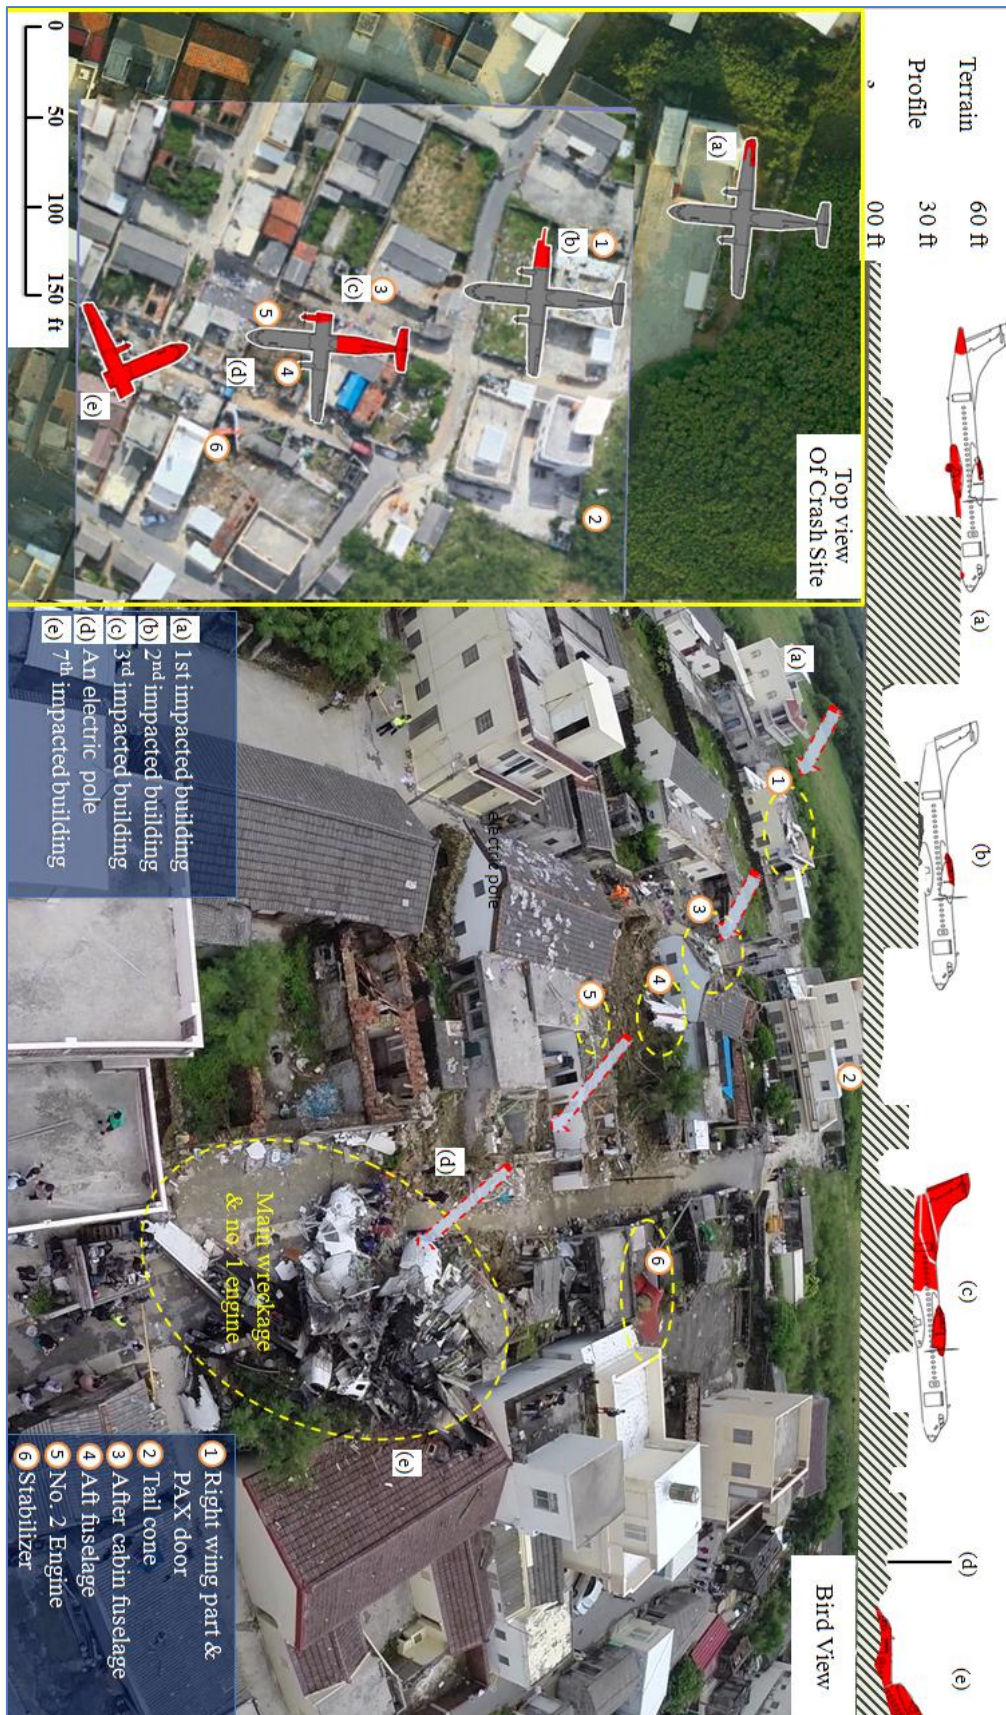
Figure 2.2-3 Aerial image of occurrence site superimposed with the main wreckage and final flight trajectory

The aircraft's right wing also collided with the northern wall of the first impacted building. After the first impact, the aircraft's direction of movement was altered to about 170 degrees and it then collided with several other buildings before it finally came to rest. Figure 2.2-3 shows an aerial image of occurrence site superimposed with the main wreckage and final flight trajectory.

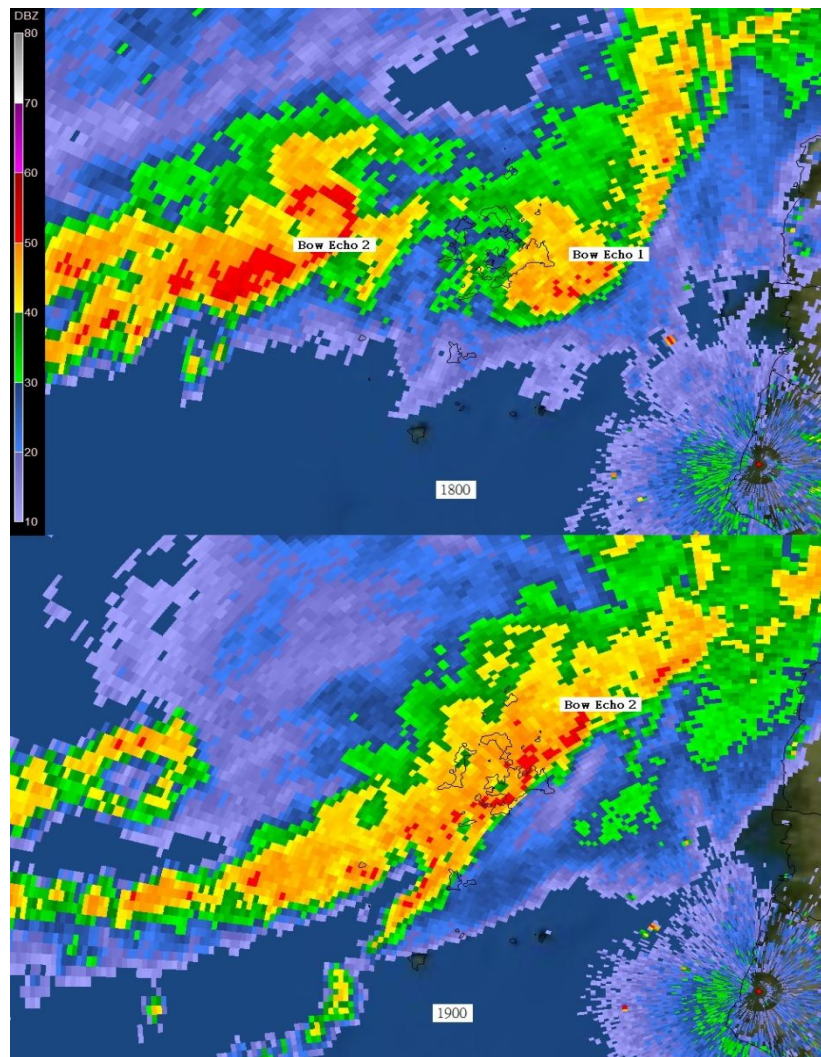
Figure 2.8-1 Rainband activity at Magong before the occurrence.

Magong Airport was affected by the outer rainbands of Typhoon Matmo at the time of the occurrence. The automated weather observation system (AWOS) and radar data showed that these rainbands were similar to squall lines. The radar images (see Figure 2.8-1) indicated that two waves of rainband passed through Magong Airport before and during the occurrence. The first bow echo affected Magong Airport from 1738 to 1803; the second echo was from 1901 to 1945. These bow echoes may cause significant changes in wind speed and wind direction with associated heavy rain showers.

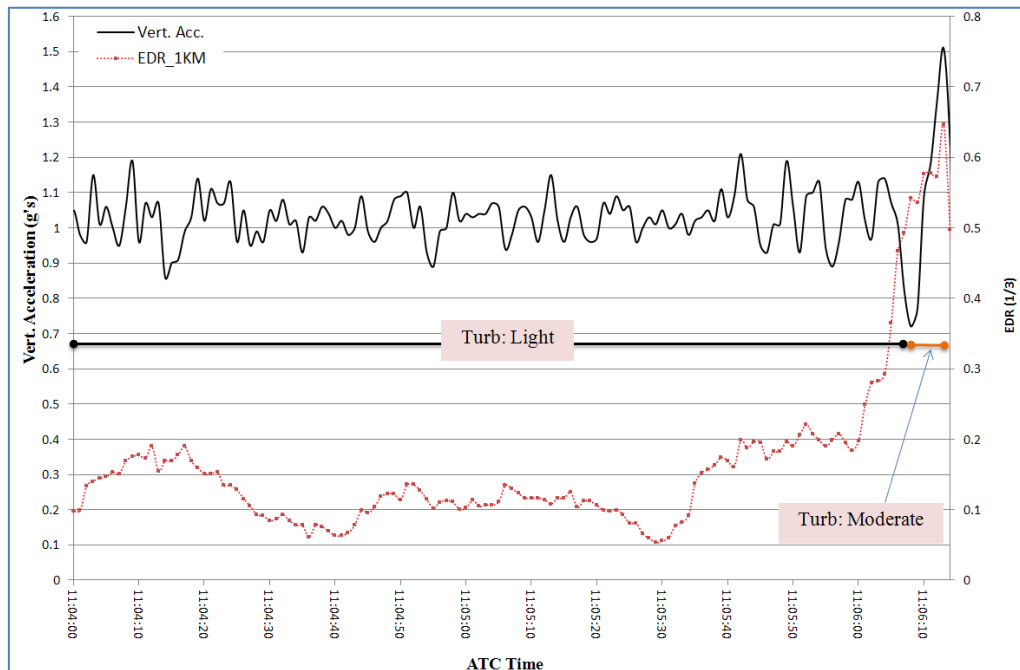
Figure 2.9-2 GE 222 vertical acceleration and calculated EDR (last two minutes)

Based on the FDR data, the vertical acceleration for the last two minutes of the occurrence flight is shown in Figure 2.9-2. The plot indicated that the vertical acceleration fluctuated between 0.8 and 1.2 g's until 1906:08, the vertical acceleration reached the minimum value of 0.72g's. The decrease of the vertical acceleration probably had a relationship with the pitch down maneuvers of the aircraft. The vertical acceleration then started to increase when the flight crew decided to go around. The vertical acceleration reached the maximum of 1.51 g's at 1906:13, when the aircraft hit the trees.

Stated in the ICAO Annex 3, the EDR is an aircraft-independent measure of turbulence. The relationship between the EDR value and the perception of turbulence is a function of aircraft type, and the mass, altitude, configuration and airspeed of the aircraft. The EDR values of the occurrence flight were calculated and shown in Figure 2.9-2. Similar to the vertical acceleration, the EDR values were less than 0.2 most of the time during the last two minutes of the flight. About 1906:00, the EDR value started to increase and reached the maximum of 0.65 just before the aircraft contacted with the trees.

Compare with the FDR data, between 1906:00 and the end of the flight, the occurrence aircraft had large amount of pitch and roll angle changes. The increased vertical acceleration and EDR values probably are cause by the combination of the turbulence and the aircraft maneuver. Based on the values, the turbulence strength of the occurrence flight during the last 2 minutes could be classified as “light to moderate” level.

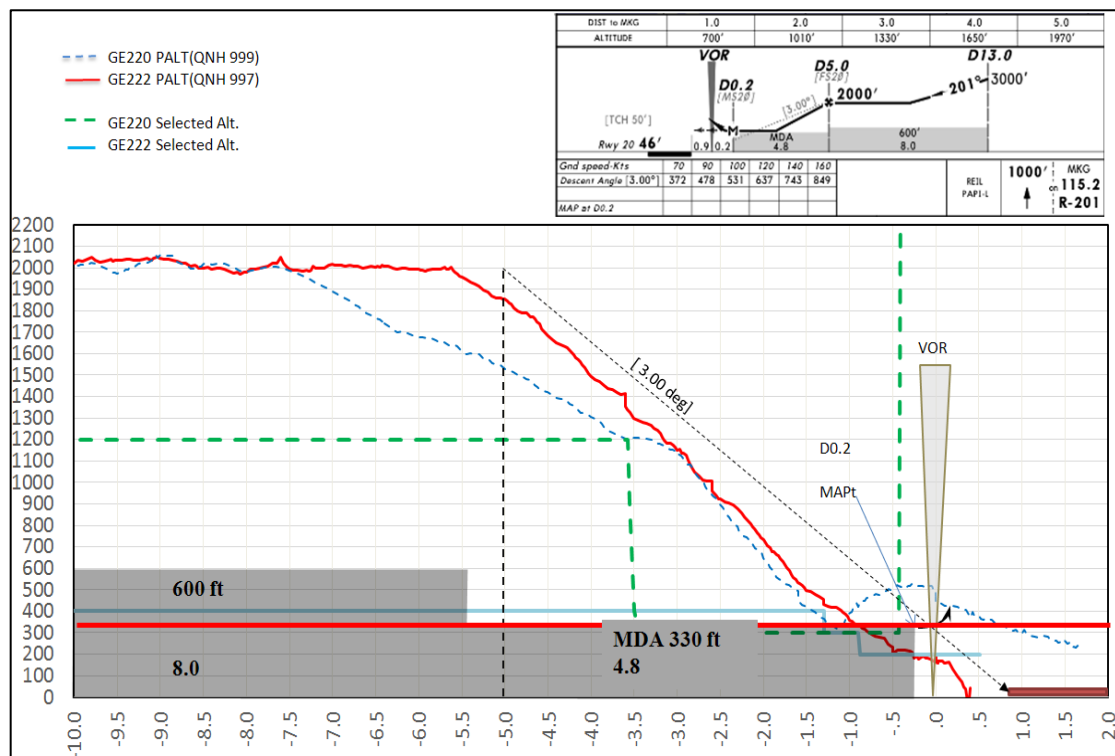
Figure 2.11-1 GE222 and GE220 flight profiles

The parameters and threshold values setting of the TNA FOQA program were in accordance with the manufacturer's suggestions. Based on the airline's FOQA system, on the day of occurrence, flight GE 220 triggered three red events: altitude below 500 feet - heading deviation greater than 20 degrees, GPWS warning triggered 24 seconds and level off below 1,400 feet above field elevation (AFE) exceeded 10 seconds. The occurrence flight GE222 triggered two red events: excessive bank angle on final approach below 100 feet AFE, and high rate of descent on approach between 500 and 50 Feet AFE. See Figure 2.11-1 for GE222 and GE220 flight profiles.

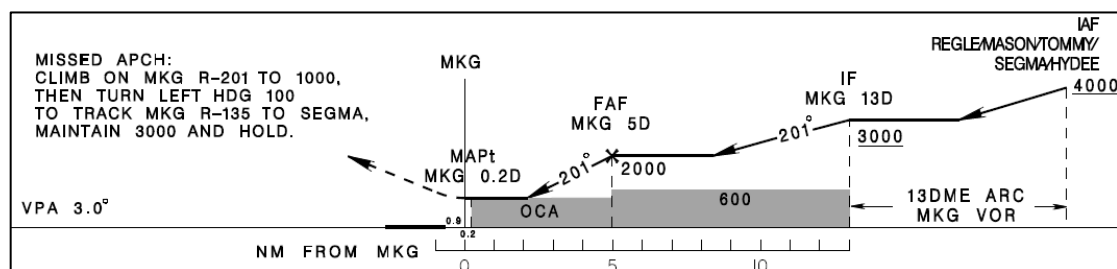
Figure 2.12-2 Magong MAPt location and runway 20 VOR approach procedure

According to the AIP, the distance from the runway 20 VOR missed approach point (MAPt) to the runway 20 threshold is 1.1 nautical miles (2,037.2 meters) (see Figure 2.12-2). The distance is longer than the published visibility landing minima of 1,600 meter.

The CAA used the PANS_OPS Designer software to calculate the OCA for the runway 20 VOR approach. The CAA advised that the calculations indicated if the MAPt was located at the threshold, the OCA would be 394 feet. If the MAPt was at 1.1 nm from the threshold, the OCA could be lowered to 328 feet. The investigation team asked the CAA to re-calculate the OCA for the runway 20 VOR approach by moving the MAPt to different locations toward the threshold. The results indicated that moving the MAPt to 0.8 nm (1,460 meters) from the threshold, the OCA was 328 feet.

With the same OCA, if the MAPt was set closer to the runway threshold, it would have increased the likelihood of crews being able to visually identify the runway in the future.
