FINAL
KNKT.11.12.30.04

NATIONAL TRANSPORTATION SAFETY COMMITTEE

Aircraft Accident Investigation Report
PT. Sriwijaya Air
PK-CKM
Boeing 737-300
Adisutjipto International Airport, Yogyakarta
Republic of Indonesia

20 December 2011

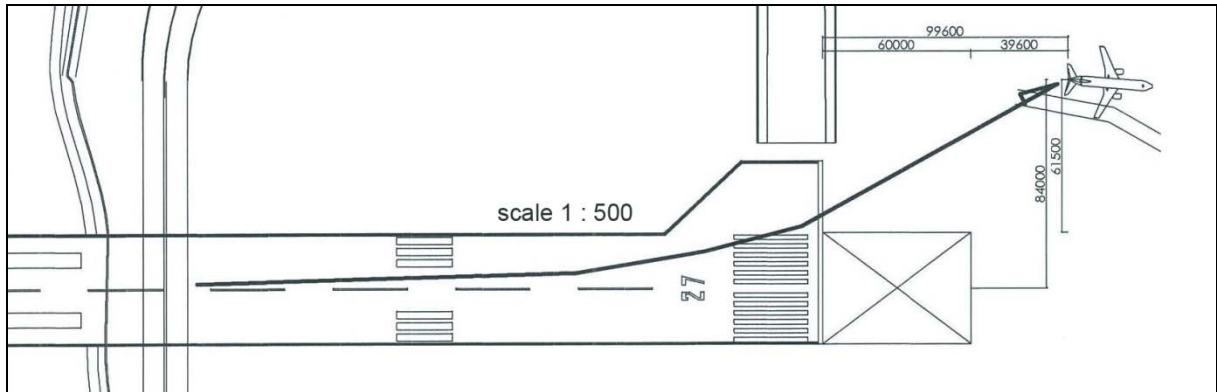
Figure 7: Location (source from AP I)

The aircraft stopped at left side of runway.

Aircraft tail position was 75 meters from the end of runway and 54 meters left side of runway centreline.
