# **Final Report of the Federal Aircraft Accidents Inquiry Board**

concerning the Accident of the aircraft DC-9-32, ALITALIA, Flight No AZ 404, I-ATJA  
on the Stadlerberg, Weiach/ZH, of 14 November 1990

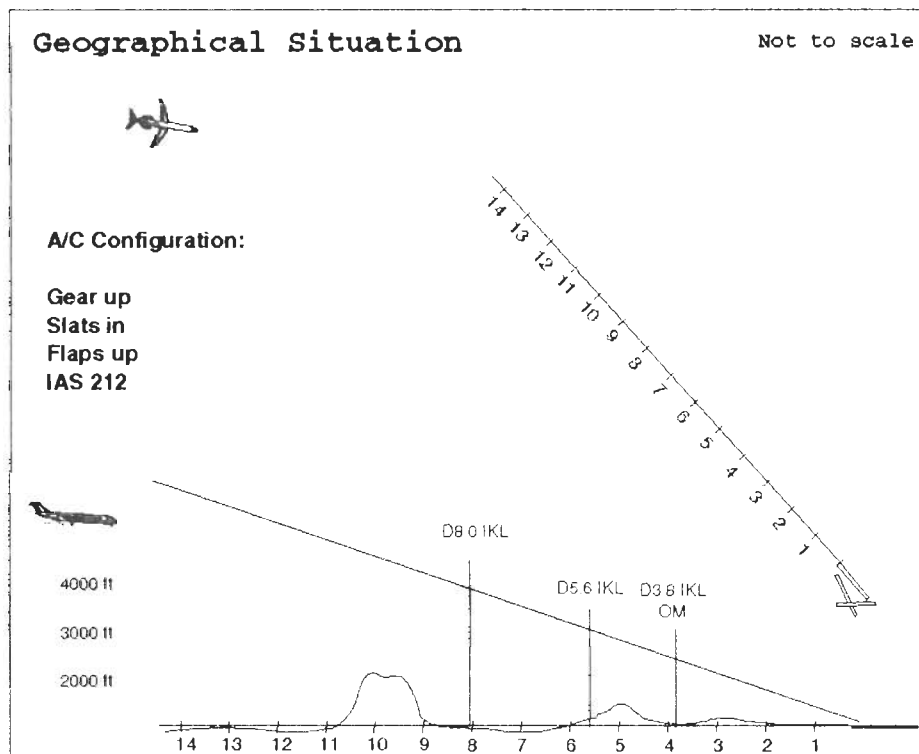
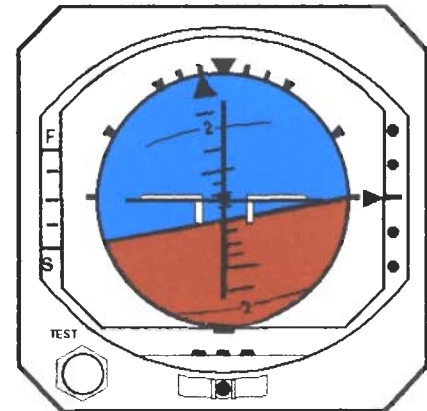
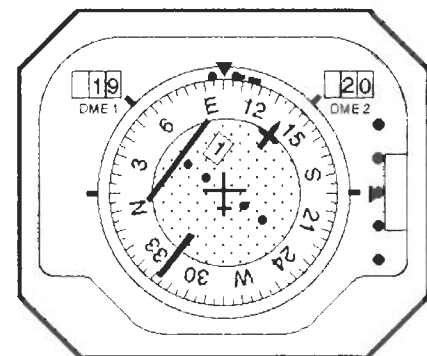
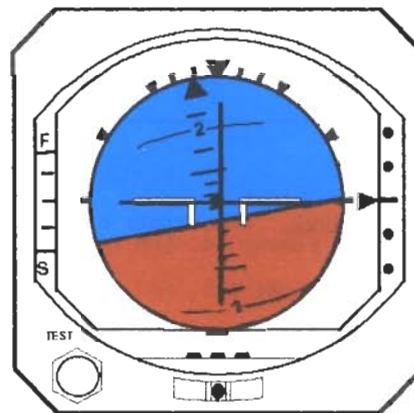
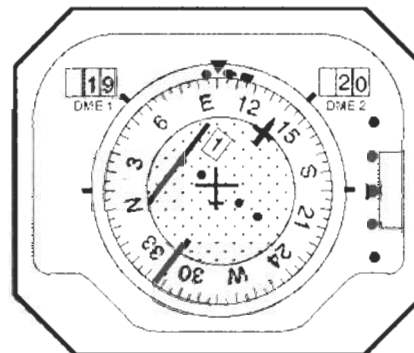
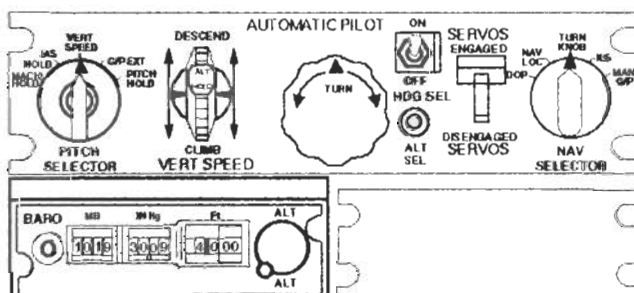
Figure 1

Fig. 1: In the Radio Selector position 1 the relative position to the localiser (LOC) and glidepath (GP) is shown on all four instruments (ADI 1 and 2, HSI 1 and 2), supplied by VHF- NAV 1 (108.30 MHz/ILS 14).

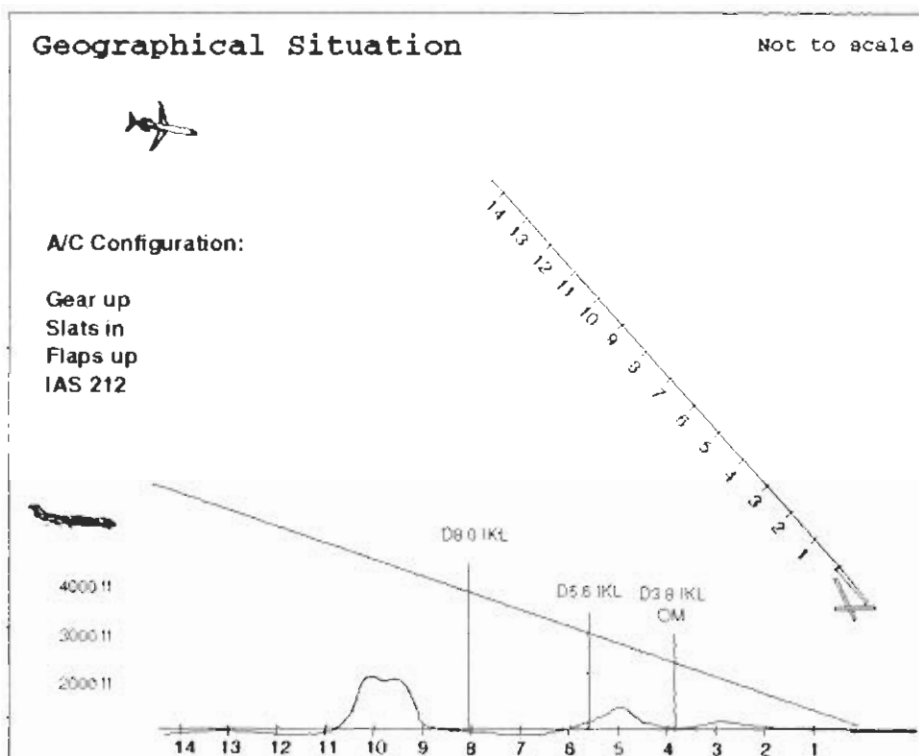
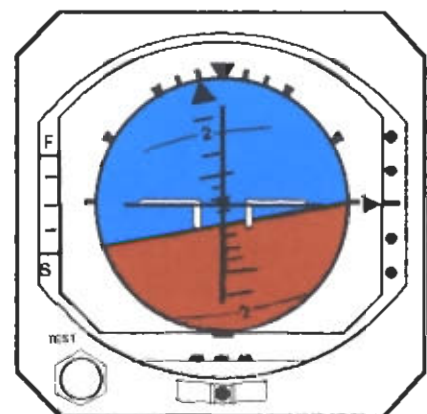
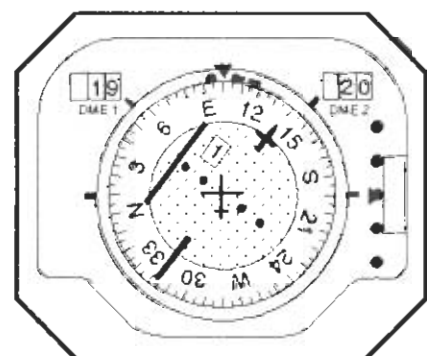
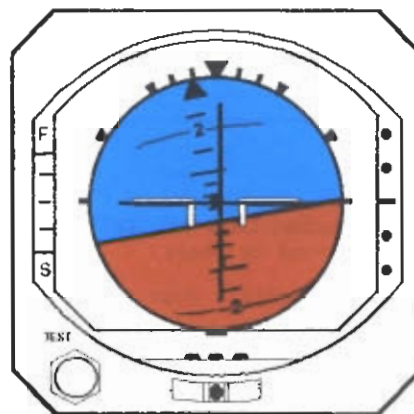
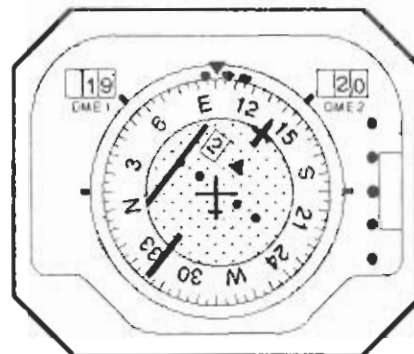
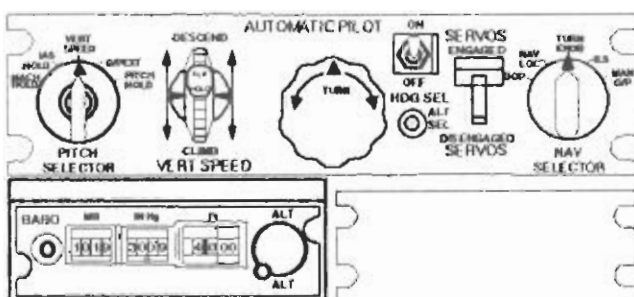
Figure 2

Fig. 2: The Radio Selector was on RADIO 2. All four instruments showed the position relative to the misleading course 138 on KLO-VOR (VHF-NAV 2).

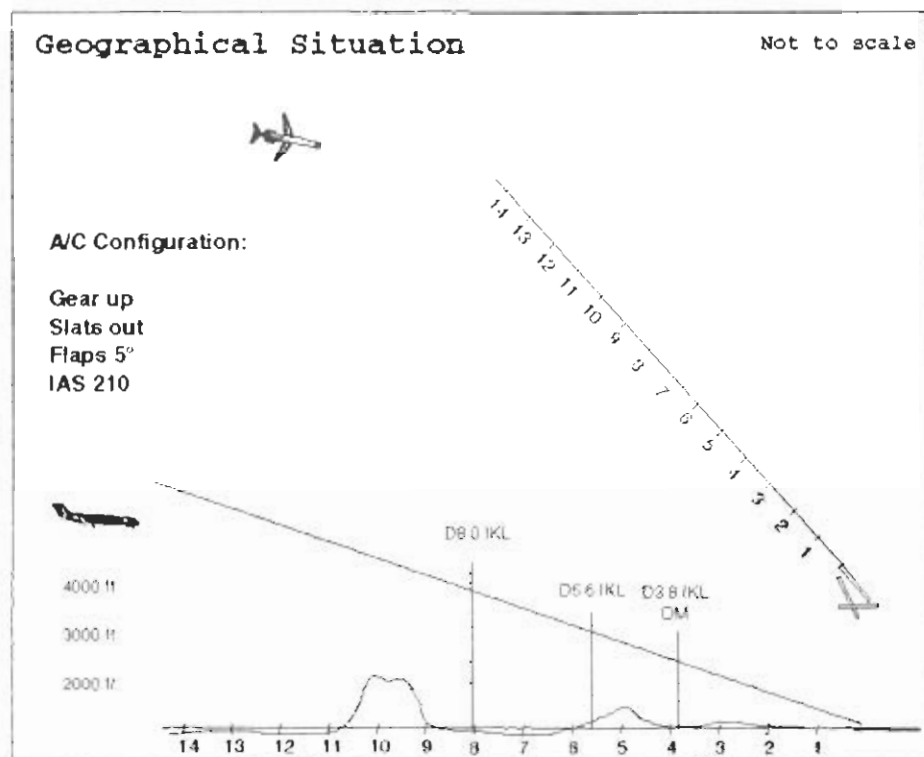
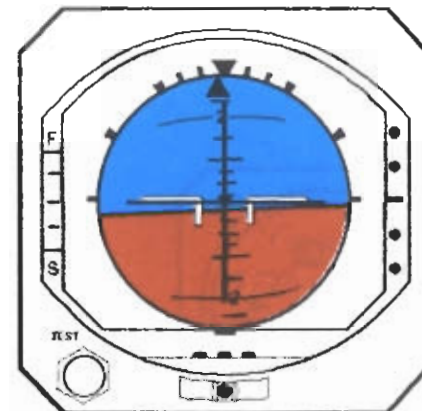
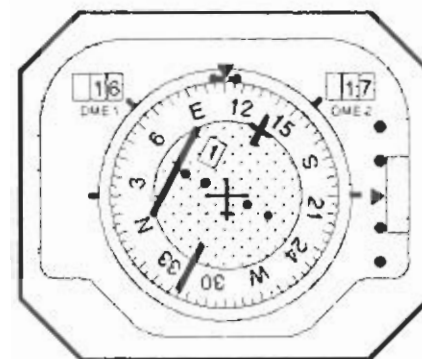
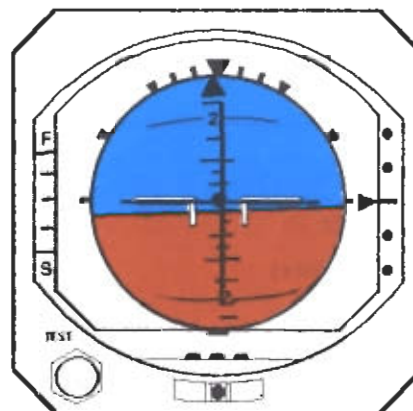
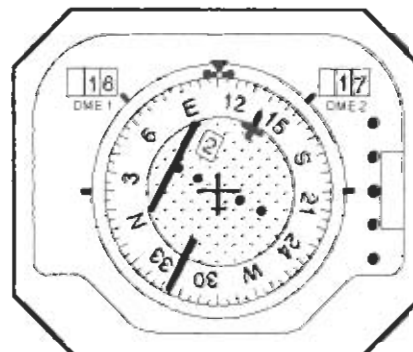
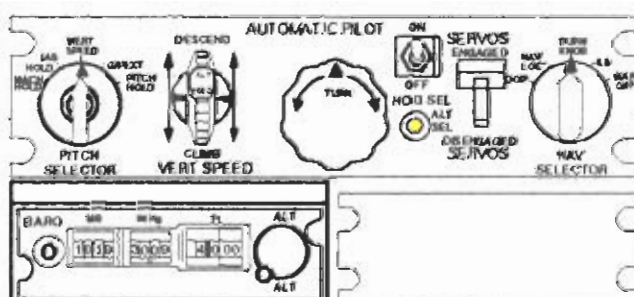
Figure 3

- 19.07.25: Fig. 3: The crew selected RADIO APP on the Radio Selector. By switching to RADIO APP, VHF-NAV 2 internally automatically tuned the ILS frequency 108.30 MHz of VHF-NAV 1. The selected frequency of 116.40 MHz on VHF-NAV 2 remained visible and available for DME 2 receiver. Accordingly, DME 2 showed the distance to KLO-DME. DME 1 showed the value from ILS-DME 14. The signal from VHF-NAV 1 receiver was displayed on HSI 1. Due to the fault in the GP receiver 1 a Null (zero) Signal was sent which led to an apparently correct centred GP indication on HSI 1. ADI 2 takes the LOC and GP information of HSI 1. HSI 2 received information from VHF-NAV 2 receiver which was functioning correctly. ADI 1 received the LOC and GP information of HSI 2. The actual position was way below the nominal glidepath. Accordingly the pointers in HSI 2 and ADI 1 were in the upper limit position and as designed not in view. The OFF FLAG was not in view because the GP signal was being received.

Comparator LOC on,  
then off  
Comparator GP on

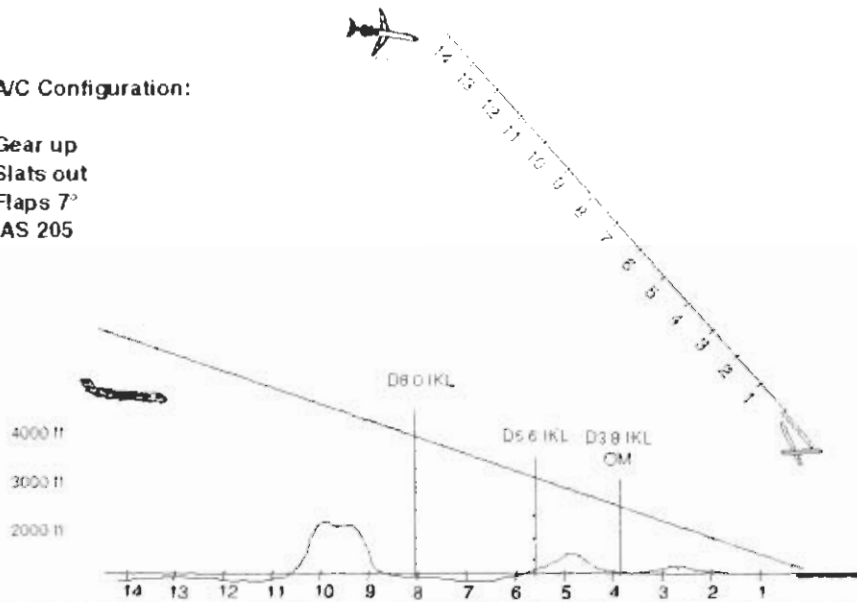
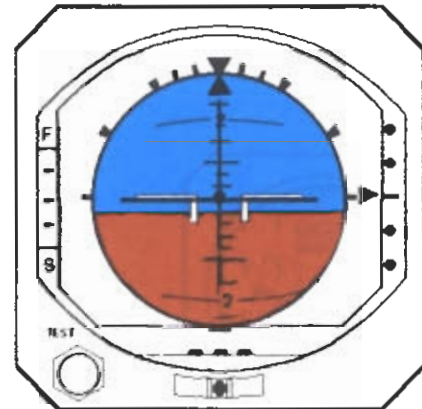
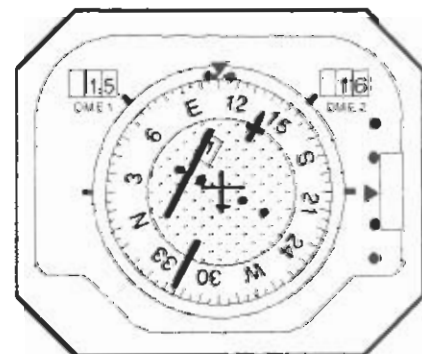
Figure 5

- 19.08.00: Fig. 5: At 19.07.59 hrs the PIC decided: "Good, let's do it on 1", whereby the COPI ordered "RADIO 1".

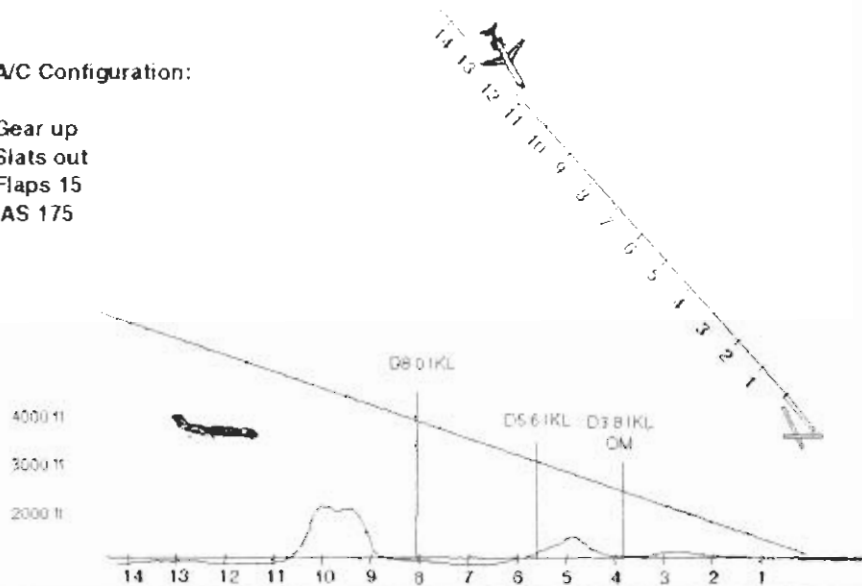
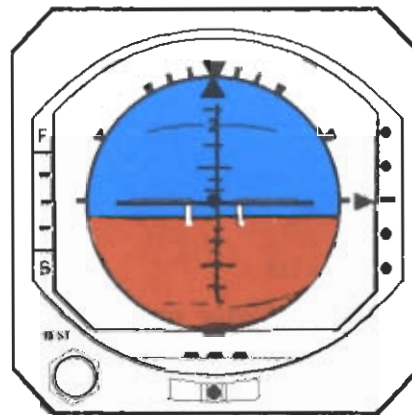
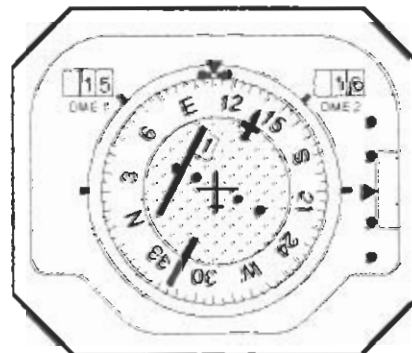
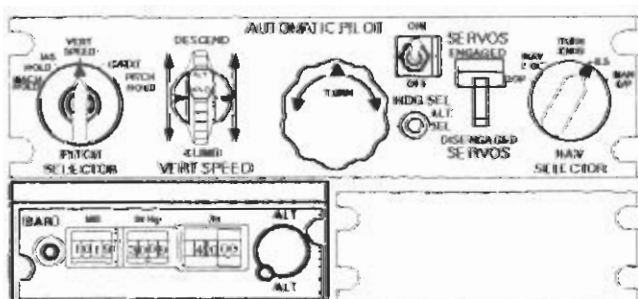
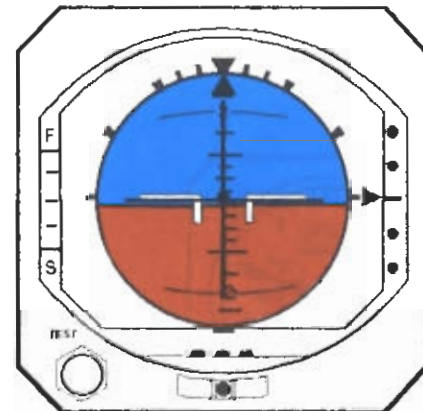
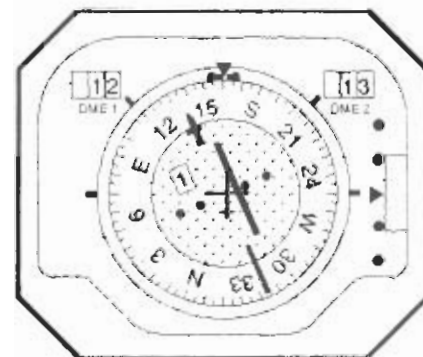
Figure 6

- 19.08.47: Fig. 6: The aircraft was slightly East of the LOC at about 4000 ft QNH where, although both Flight Directors and the Autopilot were following the LOC and GP. In the case of the GP it was the Null Signal from VHF-NAV 1 receiver. Here the aircraft was already 1200 ft below the nominal glidepath and still 12 NM from touch-down. This finding is supported because at 19.08.47 hrs the PIC confirmed "... capture LOC capture Glide path capture, so we are on the beam a little off track but ...".

1908.07 F/P Flaps...  
1908.20 A/P Reduce the speed a little  
TAPPING NOISE (perhaps indicating/showing something)  
AFF AZA 404 reduce to 160 knots  
1908.35 404 Reducing 160  
1908.47 A/P ...capture LOC capture Glide path capture.  
so we are on the beam a little off track  
but...

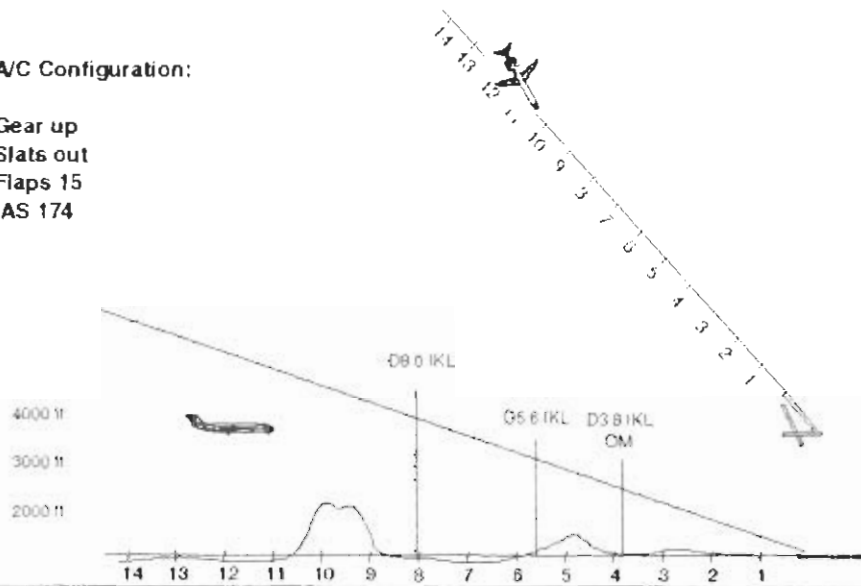
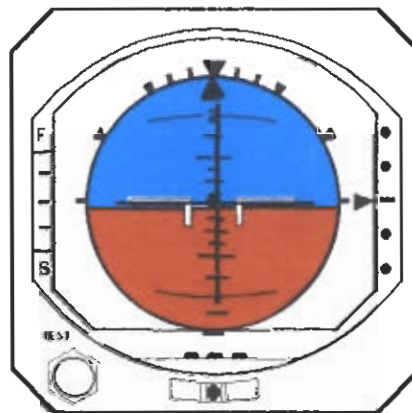
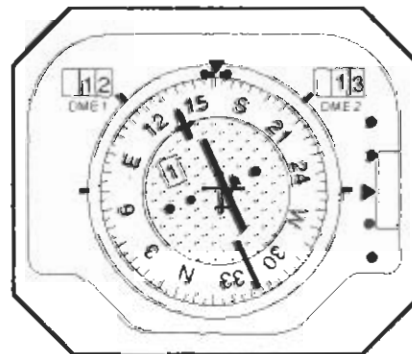
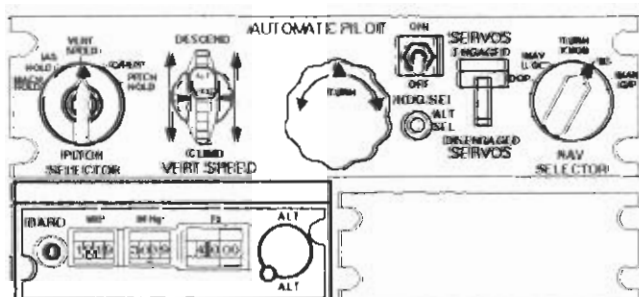
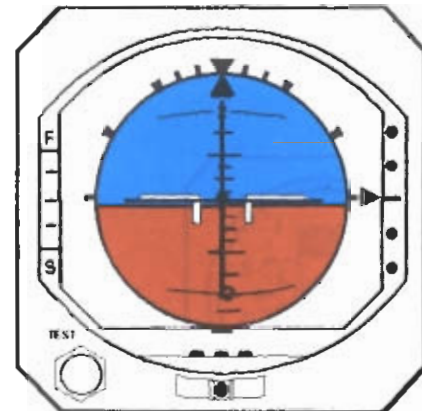
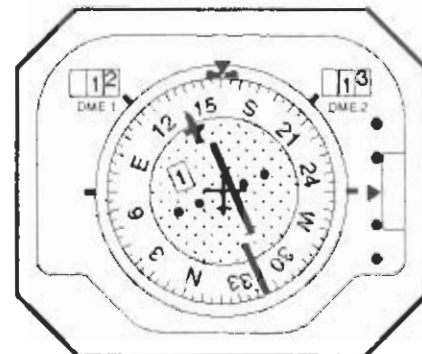
Figure 7

- 19.08.53: Fig. 7: Descent through 4000 ft is confirmed by the COPI "970 for me too", as he also set his altimeter to 970 hPa QFE.
- 19.08.57: Fig. 8: The aircraft passed 3700 ft as the Altitude Exit Warning sounded. This was armed to the selected altitude of 4000 ft QNH on the Altitude Preselect System.

1908.53 F/P 370 for me too

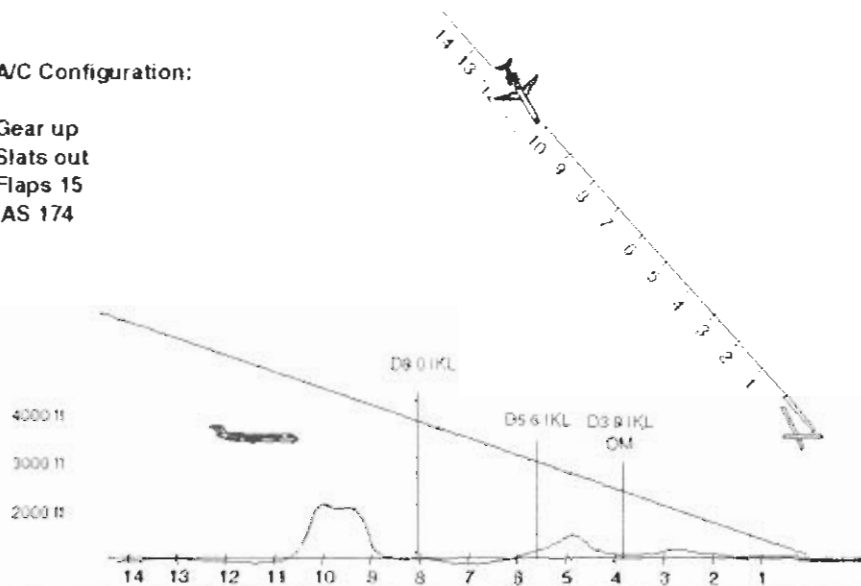
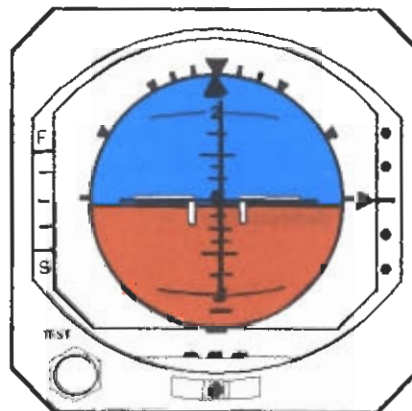
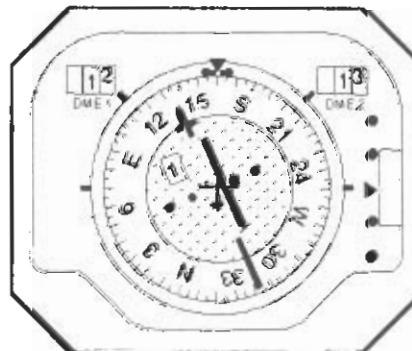
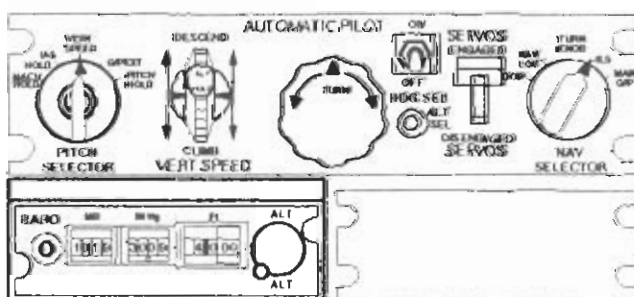
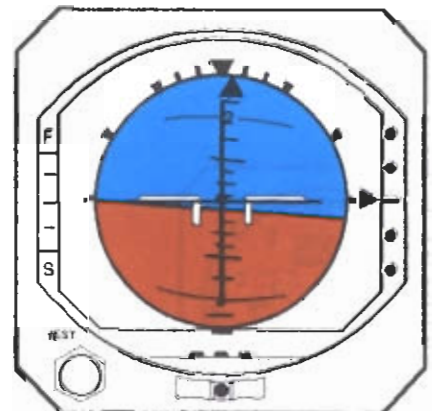
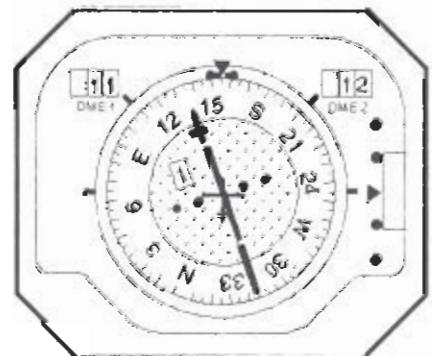
Figure 8

1908.58 - ALTITUDE ALERT SOUNDS (3700' descending) -

**ALTITUDE EXIT ALERT  
(VISUAL & AURAL)**

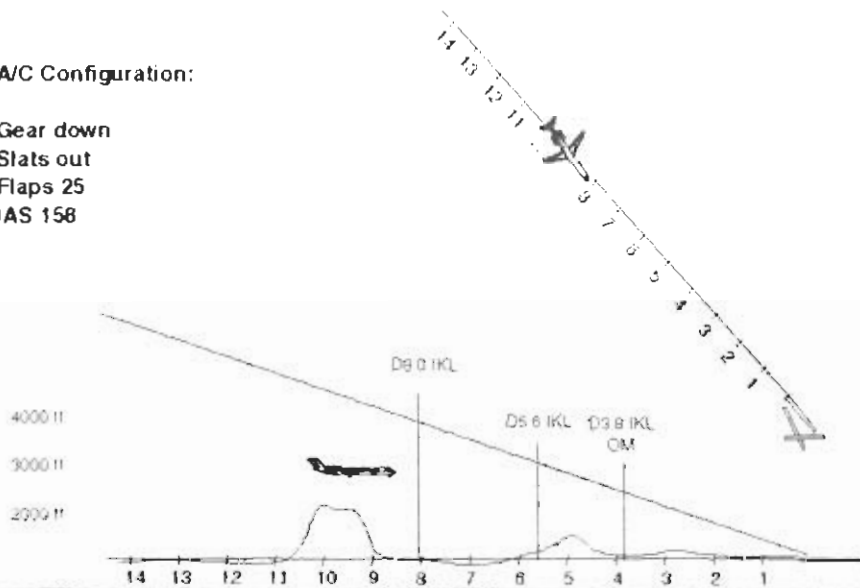
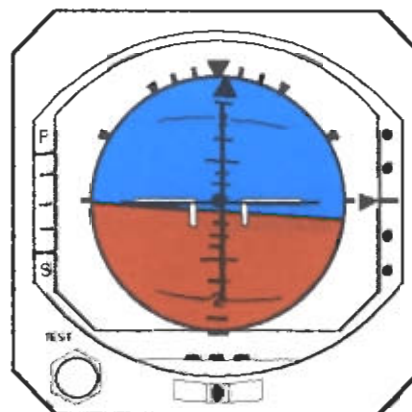
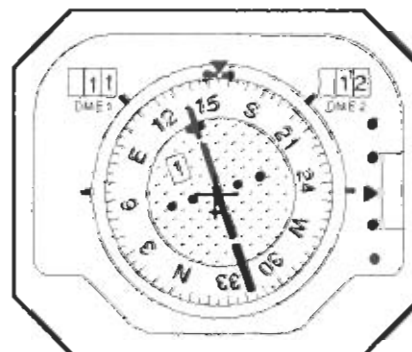
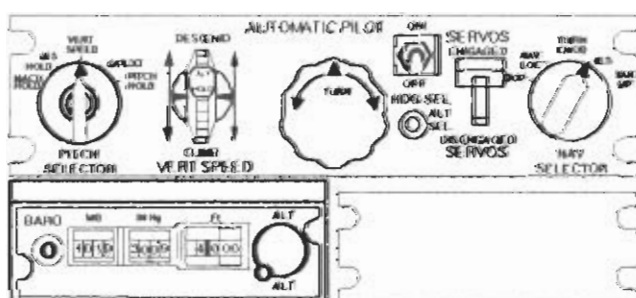
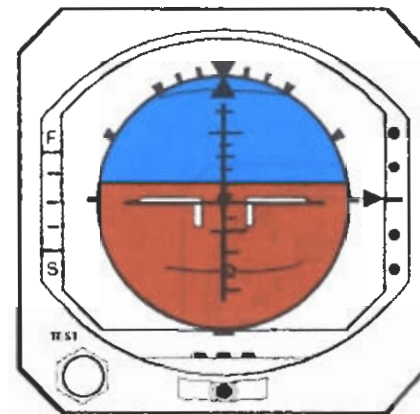
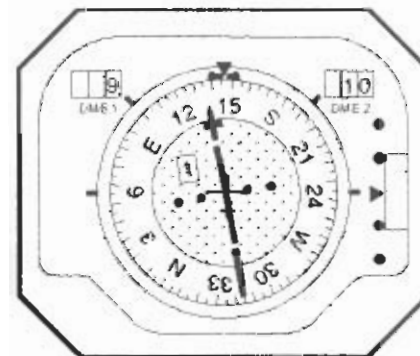
Figure 9

- 19.09.43: Fig. 9: Convinced that he was established on the ILS, the PIC said at 19.09.09 hrs: "I cancel and set 5000", referring to Altitude Preselect System. At this point the Landing Gear was probably extended, as during setting of the Flaps to 25 (19.09.41 hrs) no Gear Warning Horn was heard. At 19.09.18 hrs the PIC urged the COPI to reduce the speed further as he feared they were closing too near to the preceding aircraft. At 19.09.47 hrs the PIC stated "The outer marker check is at 1250 ft (QFE)". The altitude was now 1600 ft QFE and the distance from touchdown about 9 NM. As before, the aircraft was about 1200 ft below the nominal GP.

1908.58 - ALTITUDE ALERT SOUNDS (3700' descending) -  
 1909.01 A/P 160  
 1909.09 A/P I cancel and insert 5000'  
 - change of noise heard (could indicate gear extension) -  
 1909.13 A/P There is another one in front quite close. you can reduce even further to 150 otherwise we'll end up with a 'go around'.  
 1909.33 F/F Is there some icing?  
 1909.35 A/P No no, in fact we have 10 degrees and 10 degrees on the ground.  
 1909.41 F/F Flaps twenty five  
 A/P Flaps twenty five (No gear warning)  
 1909.47 A/P Outer Marker check is at 1250'  
 F/F Flaps fifty let's set...123  
 1909.52 A/P Bravo  
 - Switching is heard (could be the final check) -

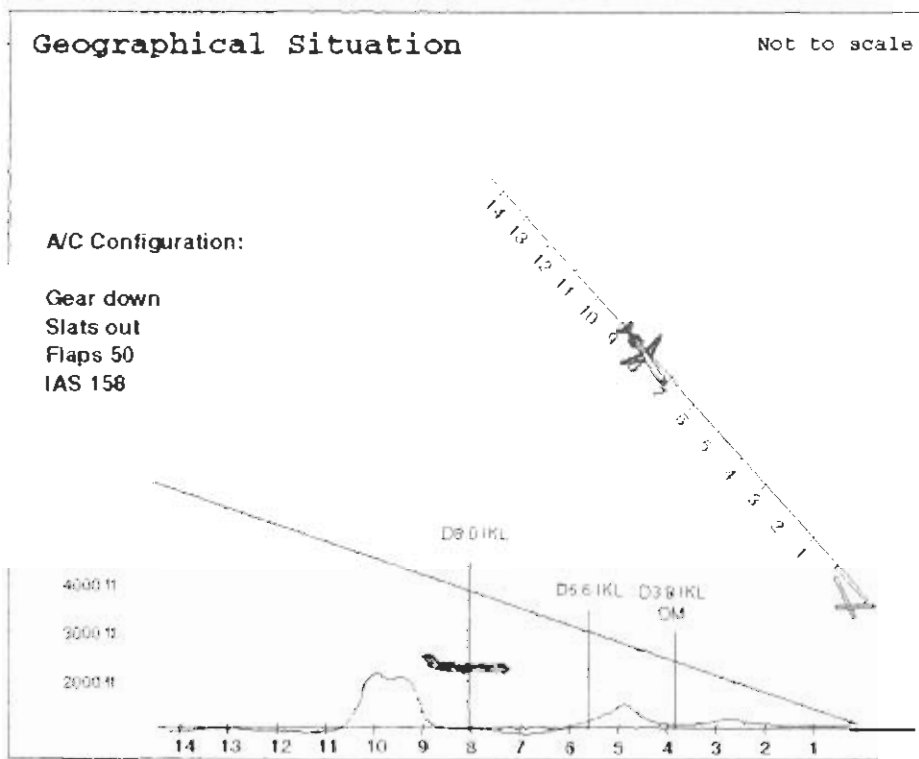
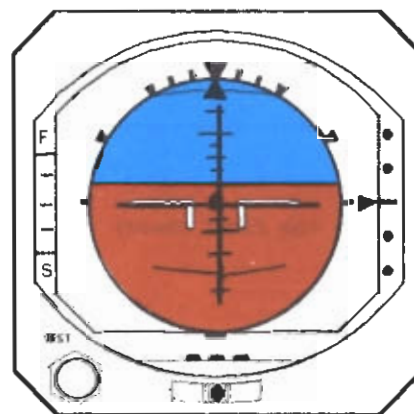
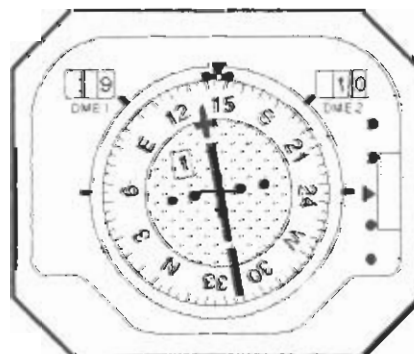
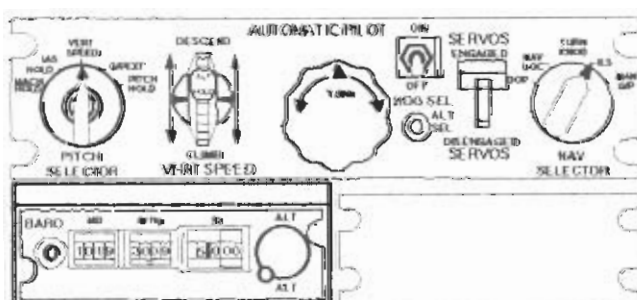
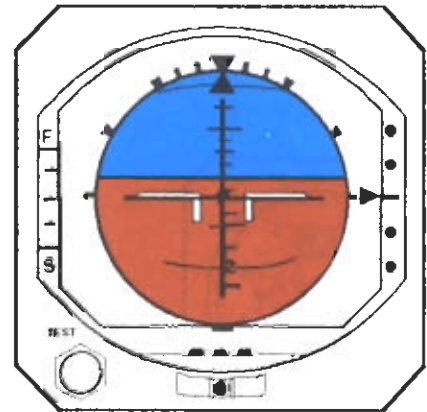
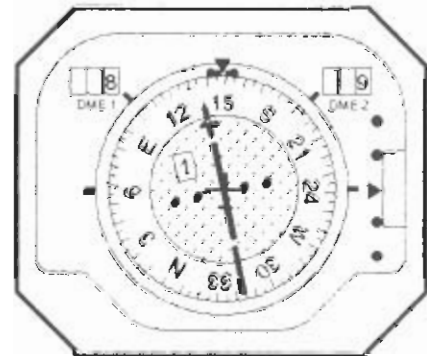
Figure 10

- 19.10.12: Fig. 10: At 8 NM IKL, the altitude on the GP should have been 4000 ft/QNH or 2598 ft/QFE. As the PIC remarked "3.8 almost 4 miles", the actual height was 1100 ft/QFE (outer marker height 1248 ft/QFE). These distance figures referred to the ILS-DME distance to the Outer Marker. At 19.10.27 hrs the COPI asked whether they had already passed the Outer Marker. At 19.10.39 hrs he repeated this question once again. The PIC responded "No, no, it hasn't changed yet ...." It is not clear what this answer meant.

| 1910.39 | F/P | Didn't we pass the outer marker? |
| | A/P | No no it hasn't changed yet... |

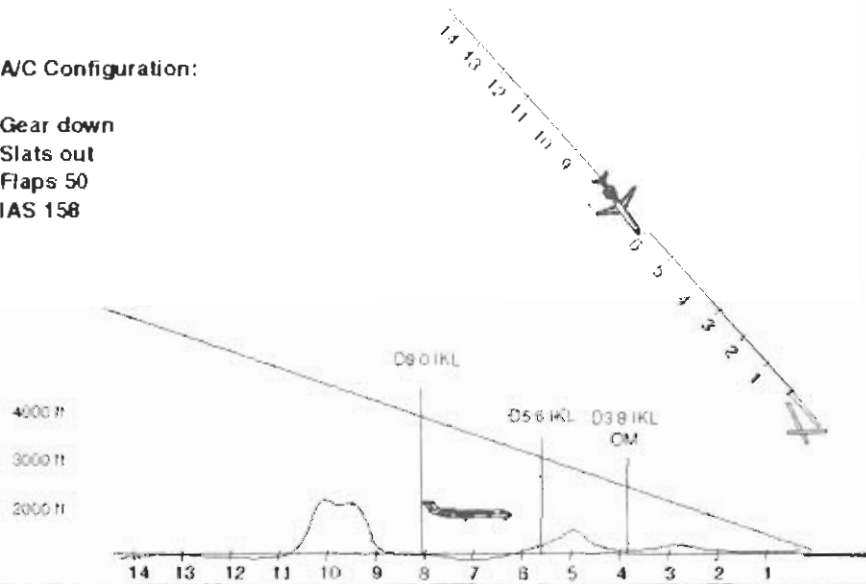
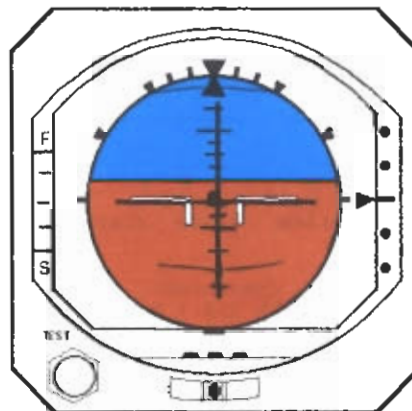
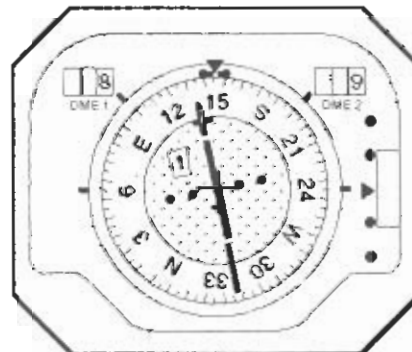
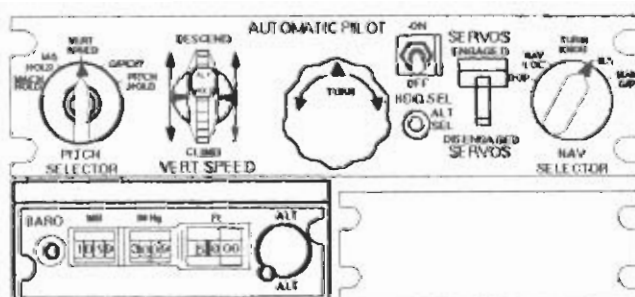
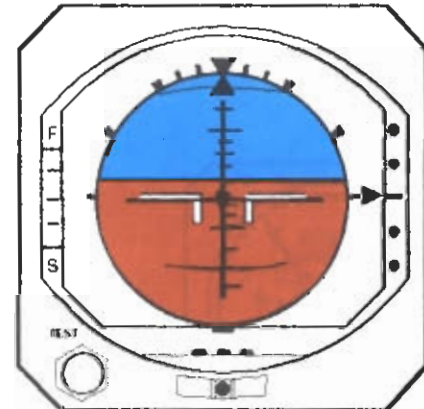
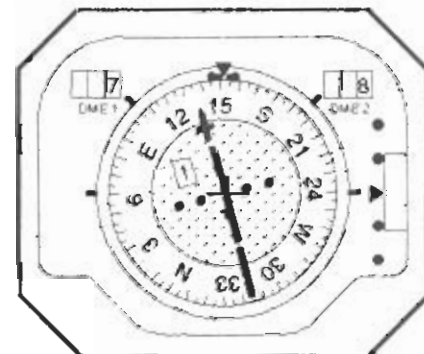
Figure 11

- 19.10.43: Fig 11: The PIC remarked that the ILS-DME showed 7 NM and possibly began an analysis of the position. His thoughts were interrupted by the order from ZRH APP to change to ZRH TWR on frequency 118,10 MHz. The instruction to change frequency with an indication of the relative position to the prelying airplane and the clearance that there were no more speed restrictions did not give the crew any reason to analyse their position. At 19.10.56 hrs the Captain's uncertainty was heard "That doesn't make sense to me ...", the COPI responded "... nor to me ...".

1910.43 A/P Oh it shows 7 (Miles, maybe starting a cross check)  
APP AZA 404 speed now as convenient, 4 miles behind a DC-9, contact TWR 118.1 Good night.  
1910.50 404 118.1 Good bye  
1910.56 F/P ...That doesn't make sense to me...  
A/P Not to me...

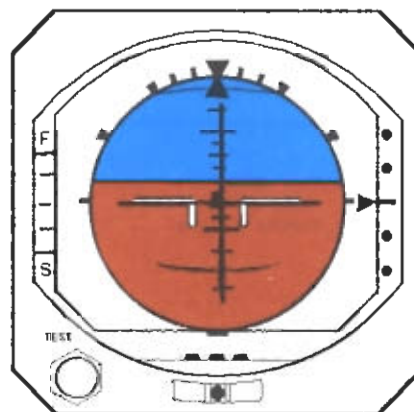
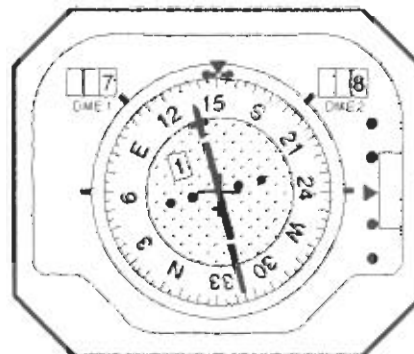
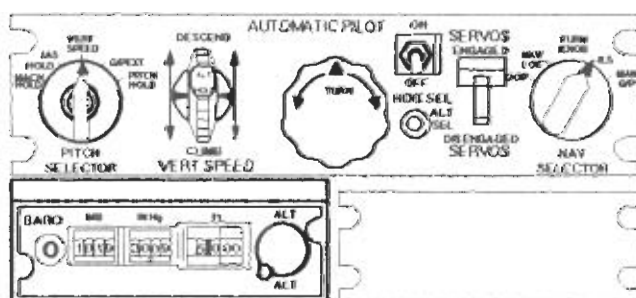
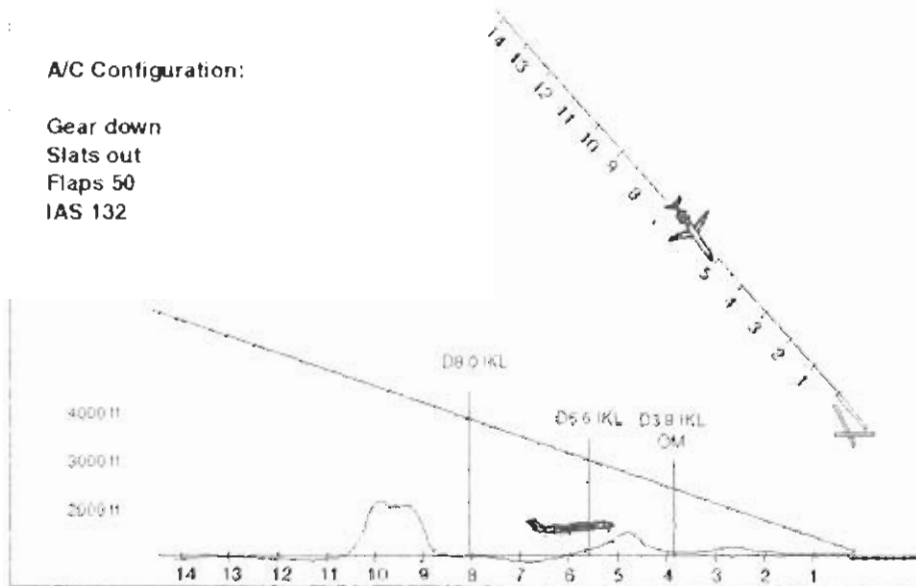
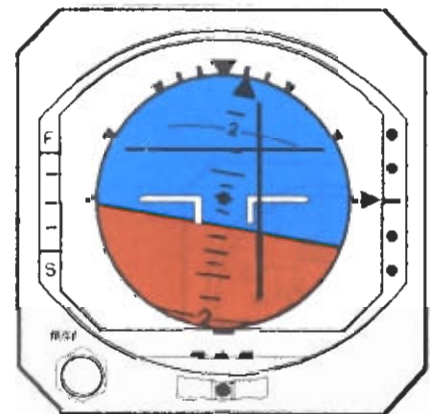
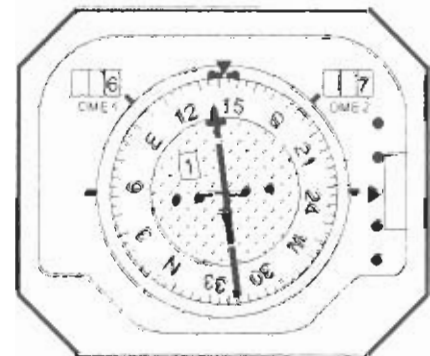
Figure 12

19.10.59: Fig. 12: At 19.10.57 hrs the PIC called out "Pull, pull, pull, pull" upon which disconnection of the Autopilot is heard. The PIC, due to misreading the altimeter, was obviously of the opinion that they were still at 1300 ft/QFE. Possibly the PIC wanted the COPI to fly the aircraft level until they reached the Outer Marker. The COPI probably interpreted the altimeter correctly and read a height of 300 ft/QFE. This caused him to commence a missed approach with the order "Go Around" (position about 6 NM from touchdown).

1910.56 F/P: ...that doesn't make sense to me...  
A/P: Not to me...  
1910.57 A/P: Pull, pull, pull, pull!  
- Click of Auto-pilot disengage is heard  
1910.58 F/P: ... AROUND

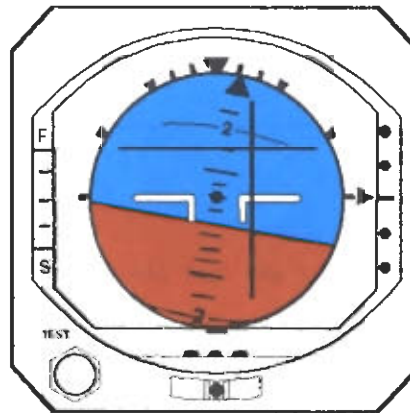
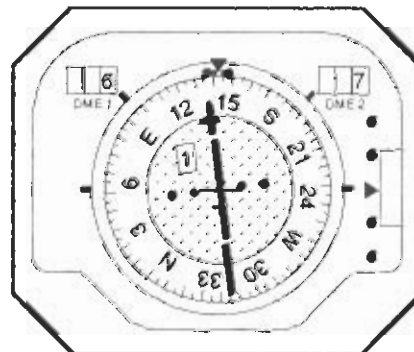
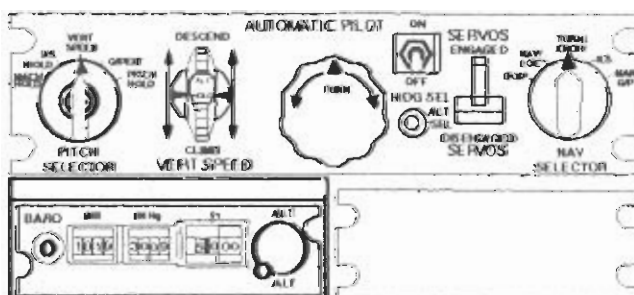
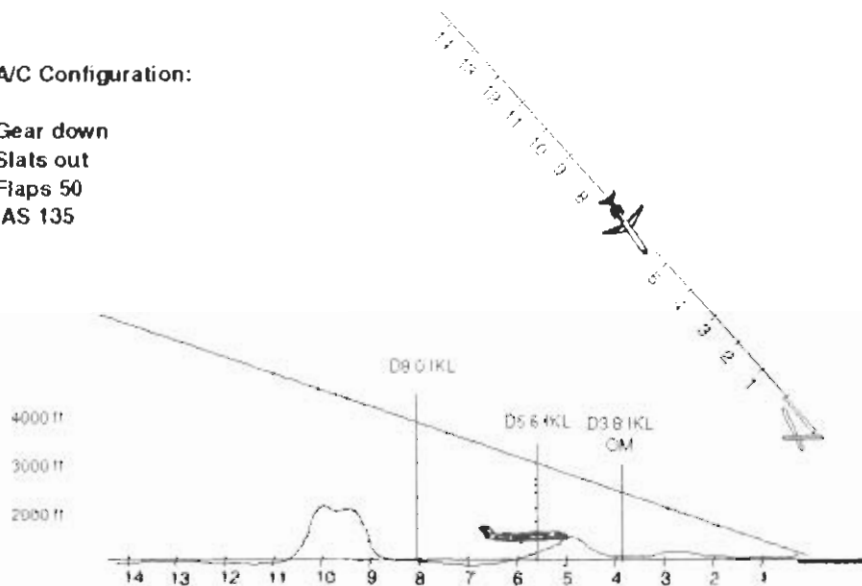
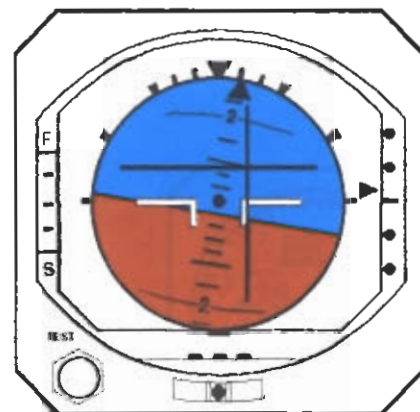
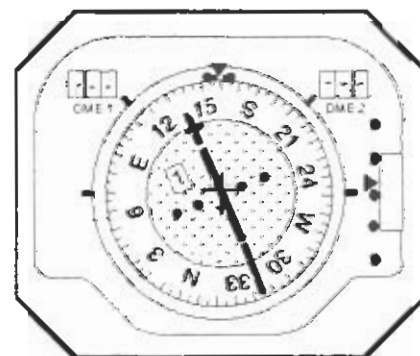
### Figure 13

19.11.17: Fig 13: At 19.10.59 hrs, the beginning of the Go Around manoeuvre is clearly recognisable. Immediately (19.11.00 hrs) after the COPI's "Go Around" order the PIC intervened as follows: "No, no, no, no ... catch glide". Italian expression "fattiti" (phonetic).

1910.59 F/P G: AROUND  
1911.00 A/P No no no no ... [hold / ask for] the glide  
1911.11 A/P Can you hold it?  
1911.13 F/P Yes  
1911.14 - pip pip pip pip pip pip (radio altimeter passing 200')  
1911.16 A/P Hold on let's try to put on...  
1911.18 - Crash sounds heard -

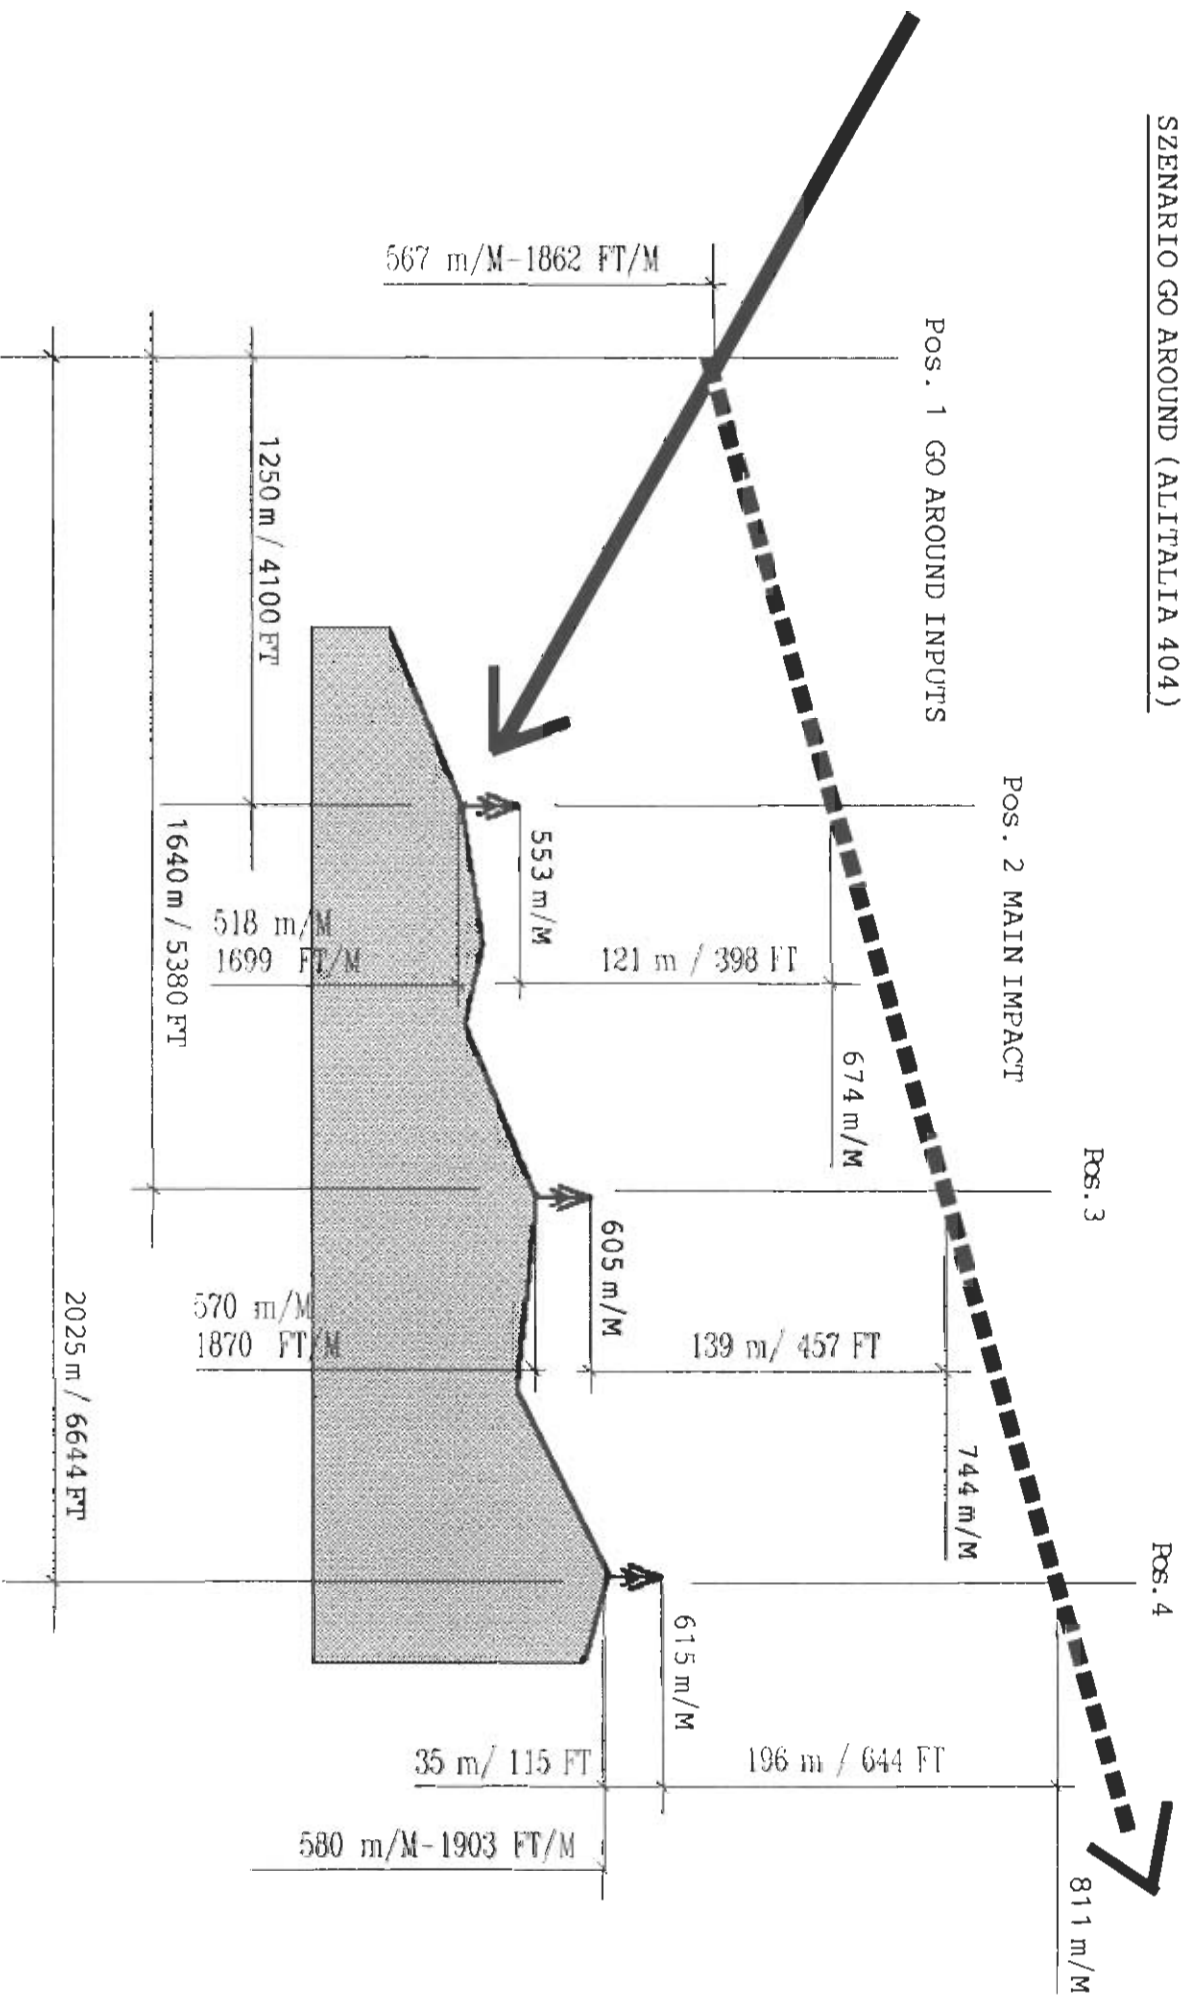
**Grafical flight path presentation of AZ 404 with continued go around after time 19:10:59**
