# AIRCRAFT ACCIDENT REPORT AND EXECUTIVE SUMMARY

Reference:	CA18/2/3/9257	
<b>Aircraft Registration</b>	G-BNLL	<b>Date of Accident</b>	22 December 2013		<b>Time of Accident</b>	20:43Z
<b>Type of Aircraft</b>	Boeing 747- 400		<b>Type of Operation</b>		Air Transportation	
<b>Pilot-in-command Licence Type</b>		ATPL	<b>Age</b>	57	<b>Licence Valid</b>	Yes
<b>Co-pilot Licence Type</b>		ATPL	<b>Age</b>	51	<b>Licence Valid</b>	Yes
<b>Pilot-in-command Flying Experience</b>		Total Flying Hours	±20 050,00		Hours on Type	±12 500,00
<b>Co-pilot Flying Experience</b>		Total Flying Hours	± 5700,00		Hours on Type	± 1400,00
<b>Last point of departure</b>		OR Tambo International Airport (FAOR) at Gauteng in Republic of South Africa.				
<b>Next point of intended landing</b>		Heathrow International Airport (EGLL) at London in United Kingdom.				
<b>Location of the accident site with reference to easily defined geographical points (GPS readings if possible)</b>

**AIRCRAFT ACCIDENT INTERIM REPORT**

**Name of Owner** : British Airways PLC  
**Name of Operator** : British Airways  
**Manufacturer** : Boeing Company  
**Model** : B747- 400  
**Nationality** : United Kingdom  
**Registration Marks** : G

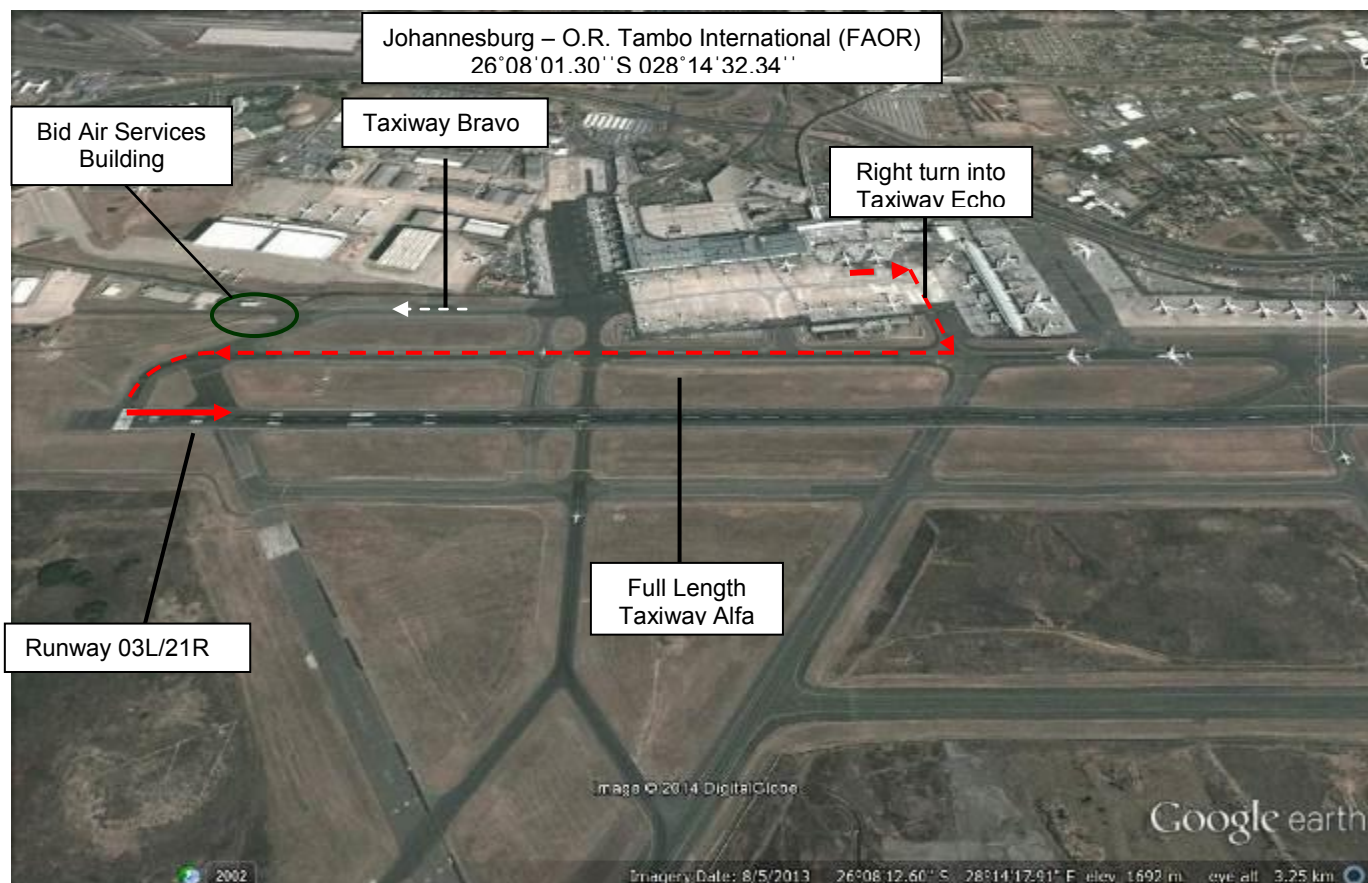
Figure 1 The expected taxi route which the flight crew discussed during the taxi and take-off briefing session

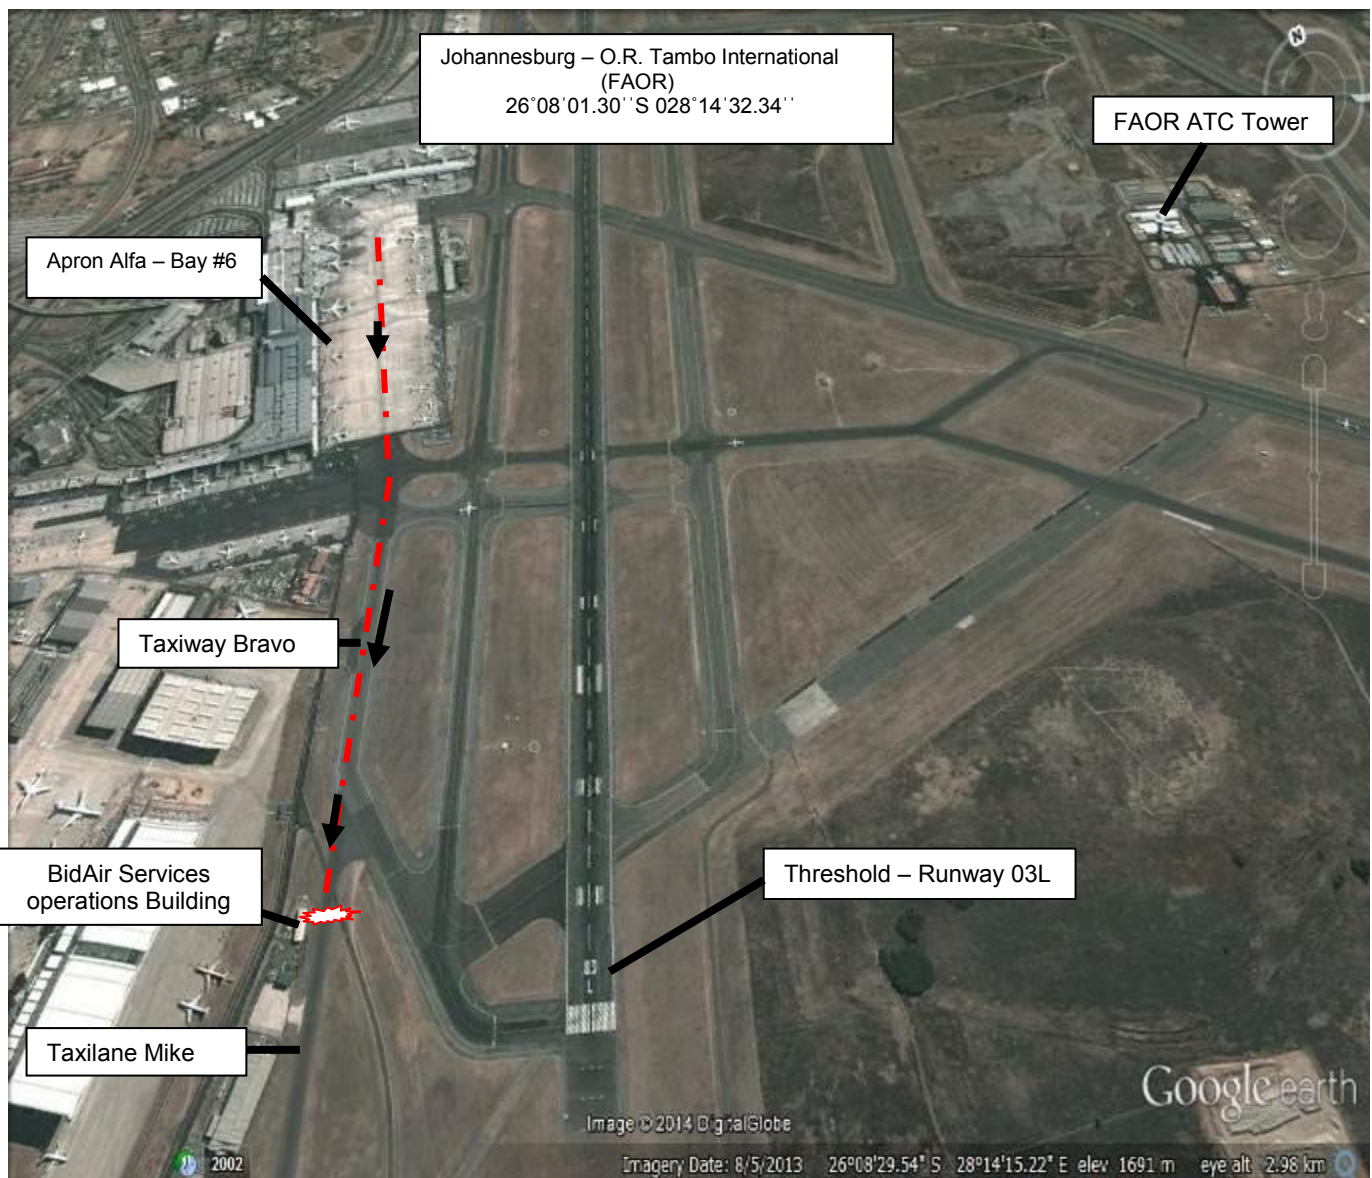
1.1.21 The actual route followed by the crew after it had been confirmed, but not followed as instructed by ATC, is shown below:

Figure 2 Actual taxi route which the pilots followed before the collision with the Bid Air Services Building

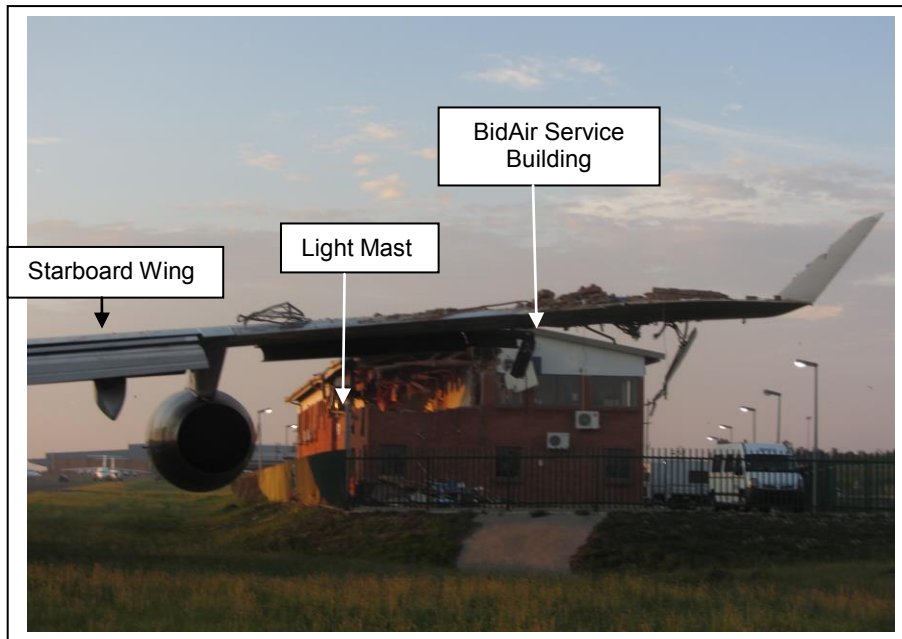
1.4.1.2 The investigation determined that the aircraft taxied facing south using taxiway Bravo and crossed the intersection straight onto Mike. The aircraft then taxied on Mike, where the starboard wing of the aircraft impacted the eastern side of the second floor of the BidAir Services building. The magnitude of the impact caused substantial damage to the building and facilities, as follows:

1.4.1.2.1 The first point of impact was determined to be a light mast installed next to the eastern side perimeter fence of the building. The light mast was cut at the same height as where the wing sliced through the hall. The remaining piece of the light mast was found standing at a distance of  $\pm 5$  to 10 meters from the building.

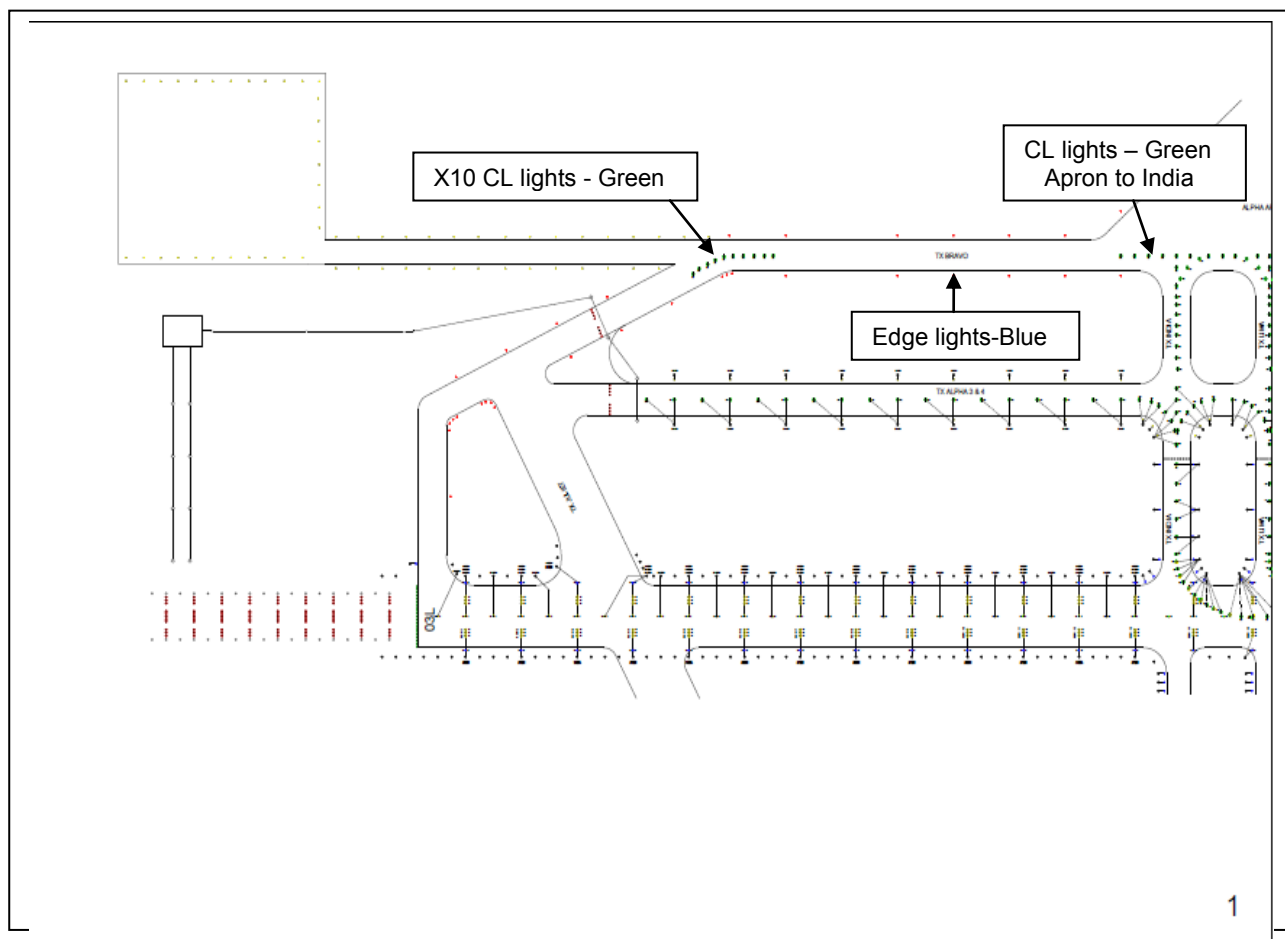
- The evidence of the above information from ACSA supports what the crew observed:
  - The taxiway edge lights illuminated in a continuous straight line, with no signage indicating the change of the taxiway Bravo and Mike.
  - Also, that some of the green centre line lights on taxiway Bravo were not illuminated in sequence.

Figure 15 Centreline lights installed on Bravo in the area of the intersection/junction

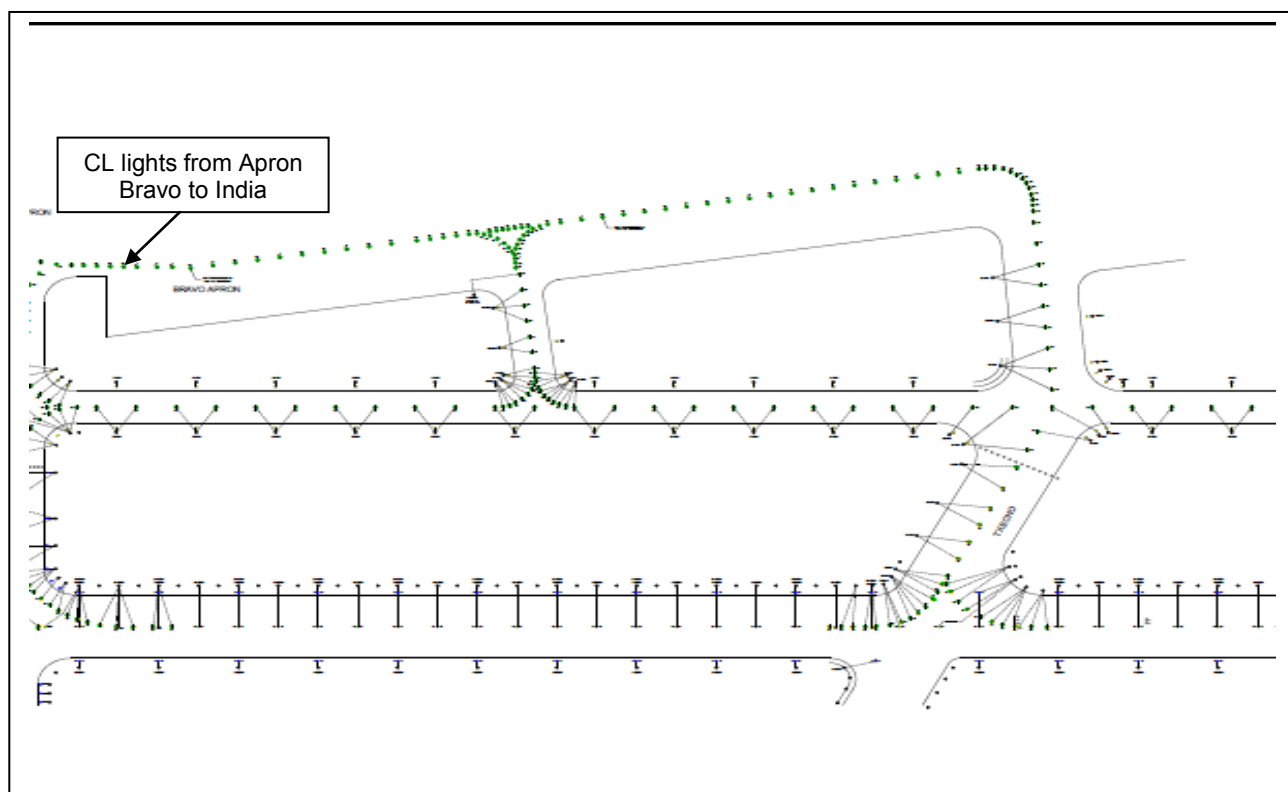
Figure 16 Centreline lights installed on taxiway Bravo from apron Bravo

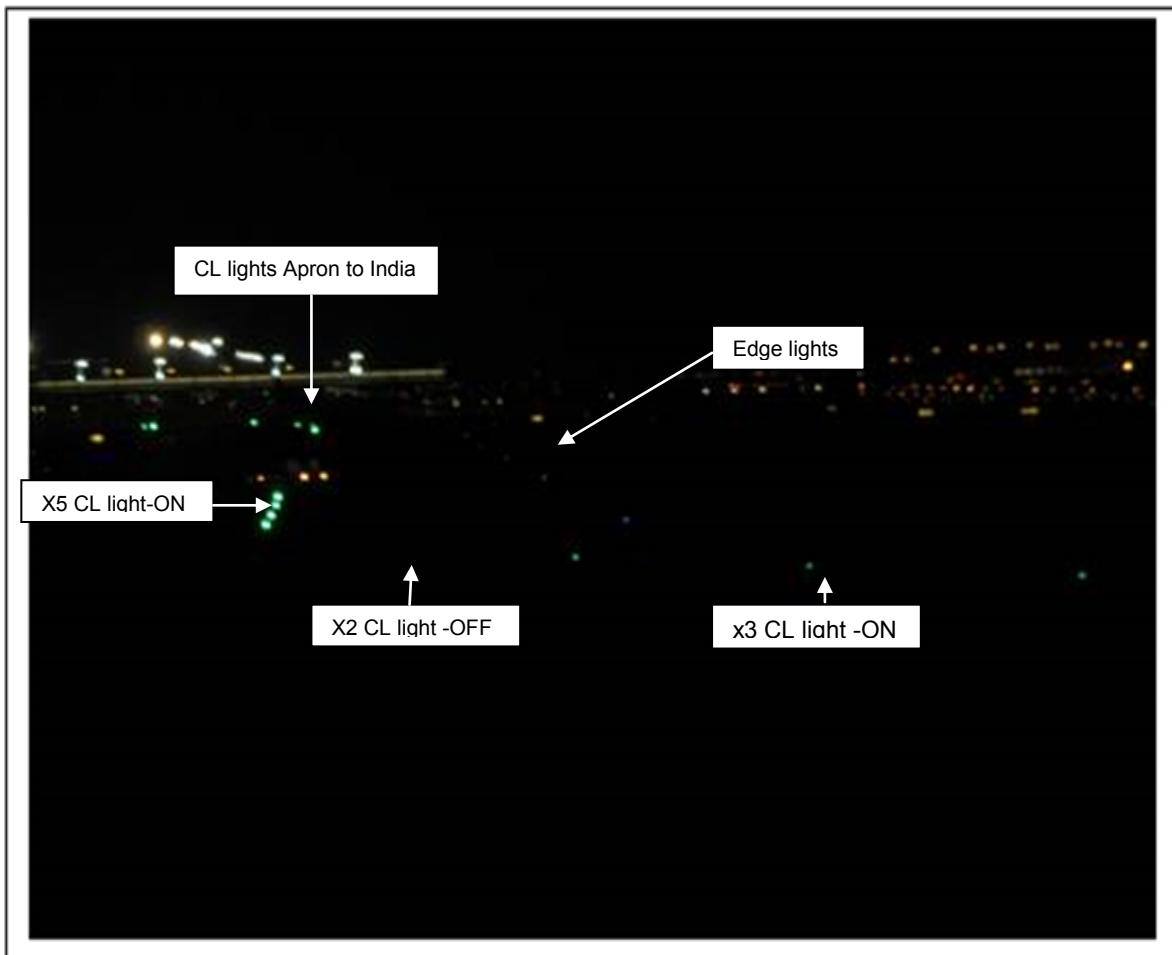
- The investigation determined the taxiway centreline lighting situation as follows:
  - The investigation did find centreline lights installed on taxiway Bravo.
  - A total of 15 centreline lights were counted and switched on (serviceable). Below is a picture taken on the night in question.
  - The picture was taken from the intersection area of Bravo and Mike showing the 15 green centreline lights installed on Bravo.

Figure 17 Green centreline and blue edge lights illuminating on taxiway Bravo

- Below are short descriptions of the condition of centreline lights installed:
  - There were 3 centreline lights switched on when leaving the apron;
  - There were 4 centreline lights switched on at the intersections of Bravo, Lima and India;
  - There were 5 lights centreline lights switched on in the straight line prior to the split between Bravo and Mike;
  - There were 3 centreline lights switched on in the straight line leading to the Category 2 holding point.

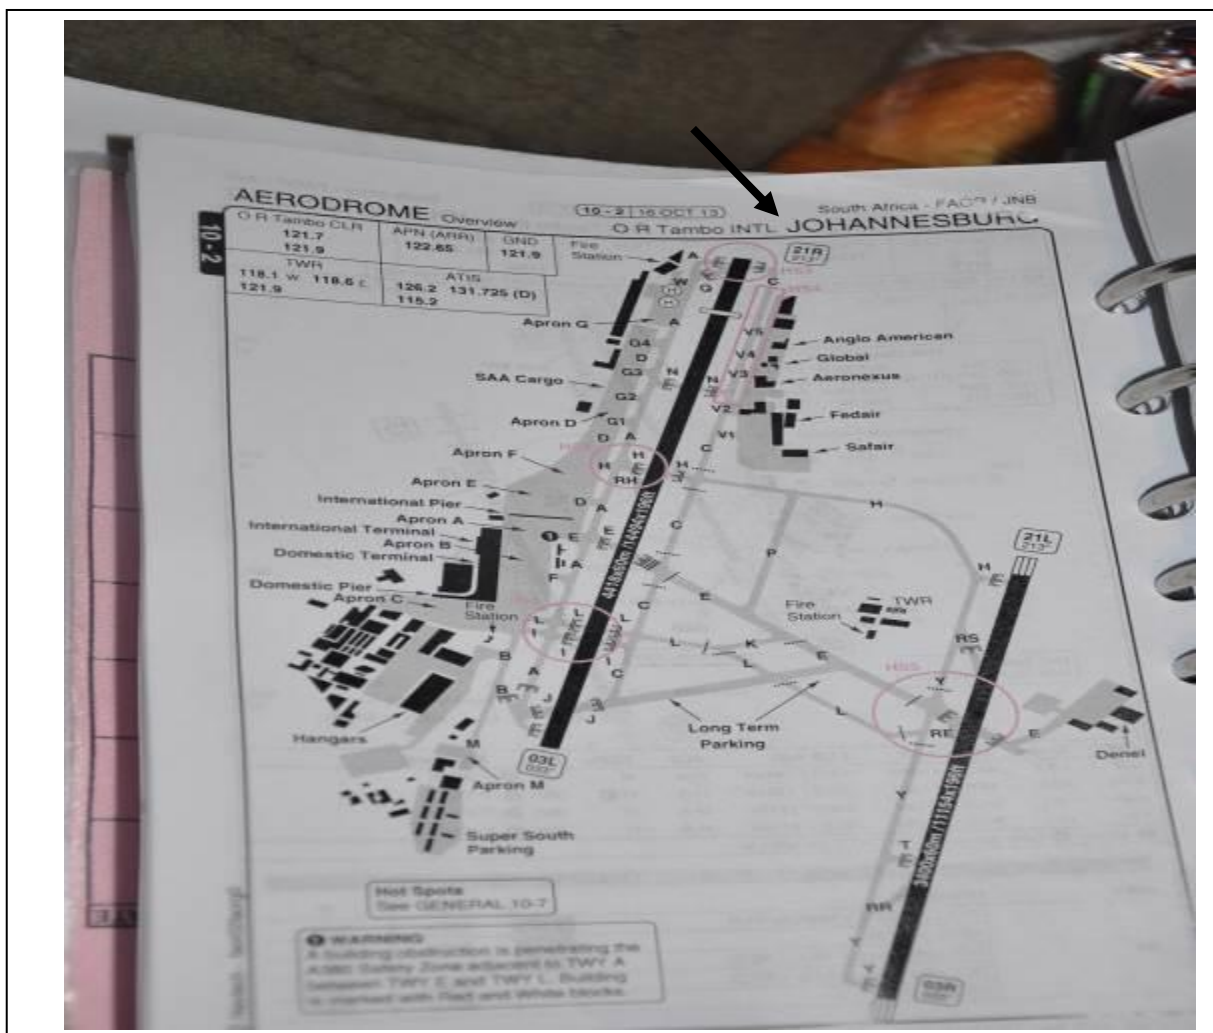
Figure 20 Navtech Aerodrome Overview Chart 10-2

1.10.4.4 The Navtech Chart 10-2 information was reviewed against that published in the South African AIP (e.g. Chart AD-02 eff. 12 DEC 13). The evidence was that the wording of the Navtech Chart had not been revised/updated to the latest revision of the South African AIP.

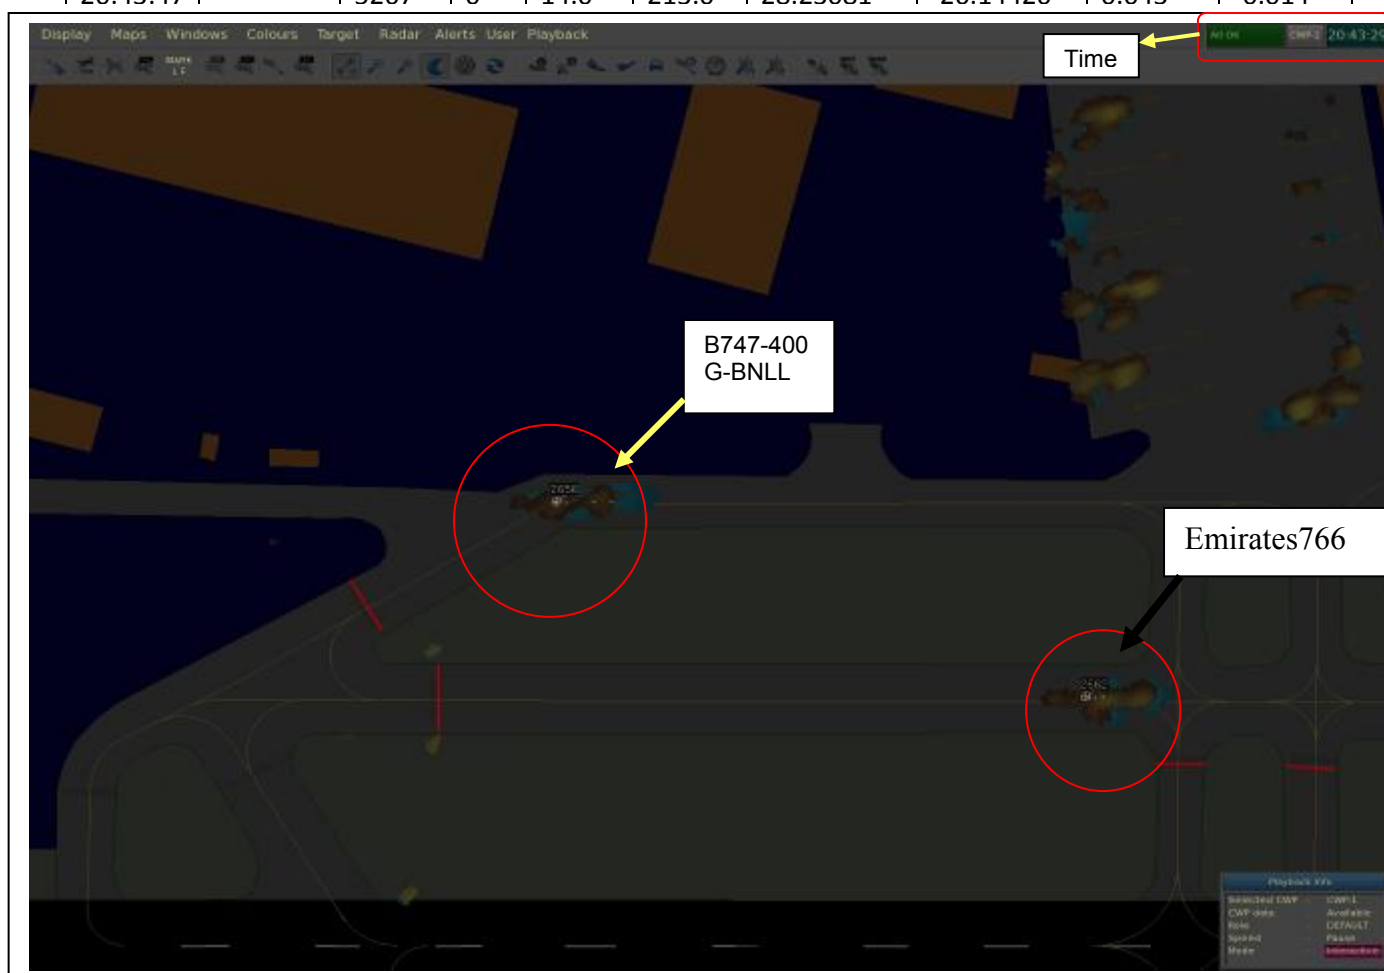
Figure 29 A-SMGCS image of BA034 at intersection of Bravo and Mike

- 1.11.4.7 The FDR and A-SMGCS show that at 20.43:29 UTC (22.43:29 local time), BA034 was taxiing (GSPD: 14.3 kts), reaching the intersection of Bravo and Mike (GPS reading: E28.23149 S26.14289), southbound (heading 213.3 degrees). At this time, there was no report of any defect, malfunction or anomaly and the situation was still uneventful.
- 1.11.4.8 On taxiway Alfa, the Emirates766 aircraft was also taxiing southbound toward Cat 1 holding point en route to Runway 03L/21R.
- 1.11.4.9 There is no evidence of any communication on between BA034 and Tower (ATC), communication was among the crew (pilots). Nothing was said that is considered relevant to the accident at this time.

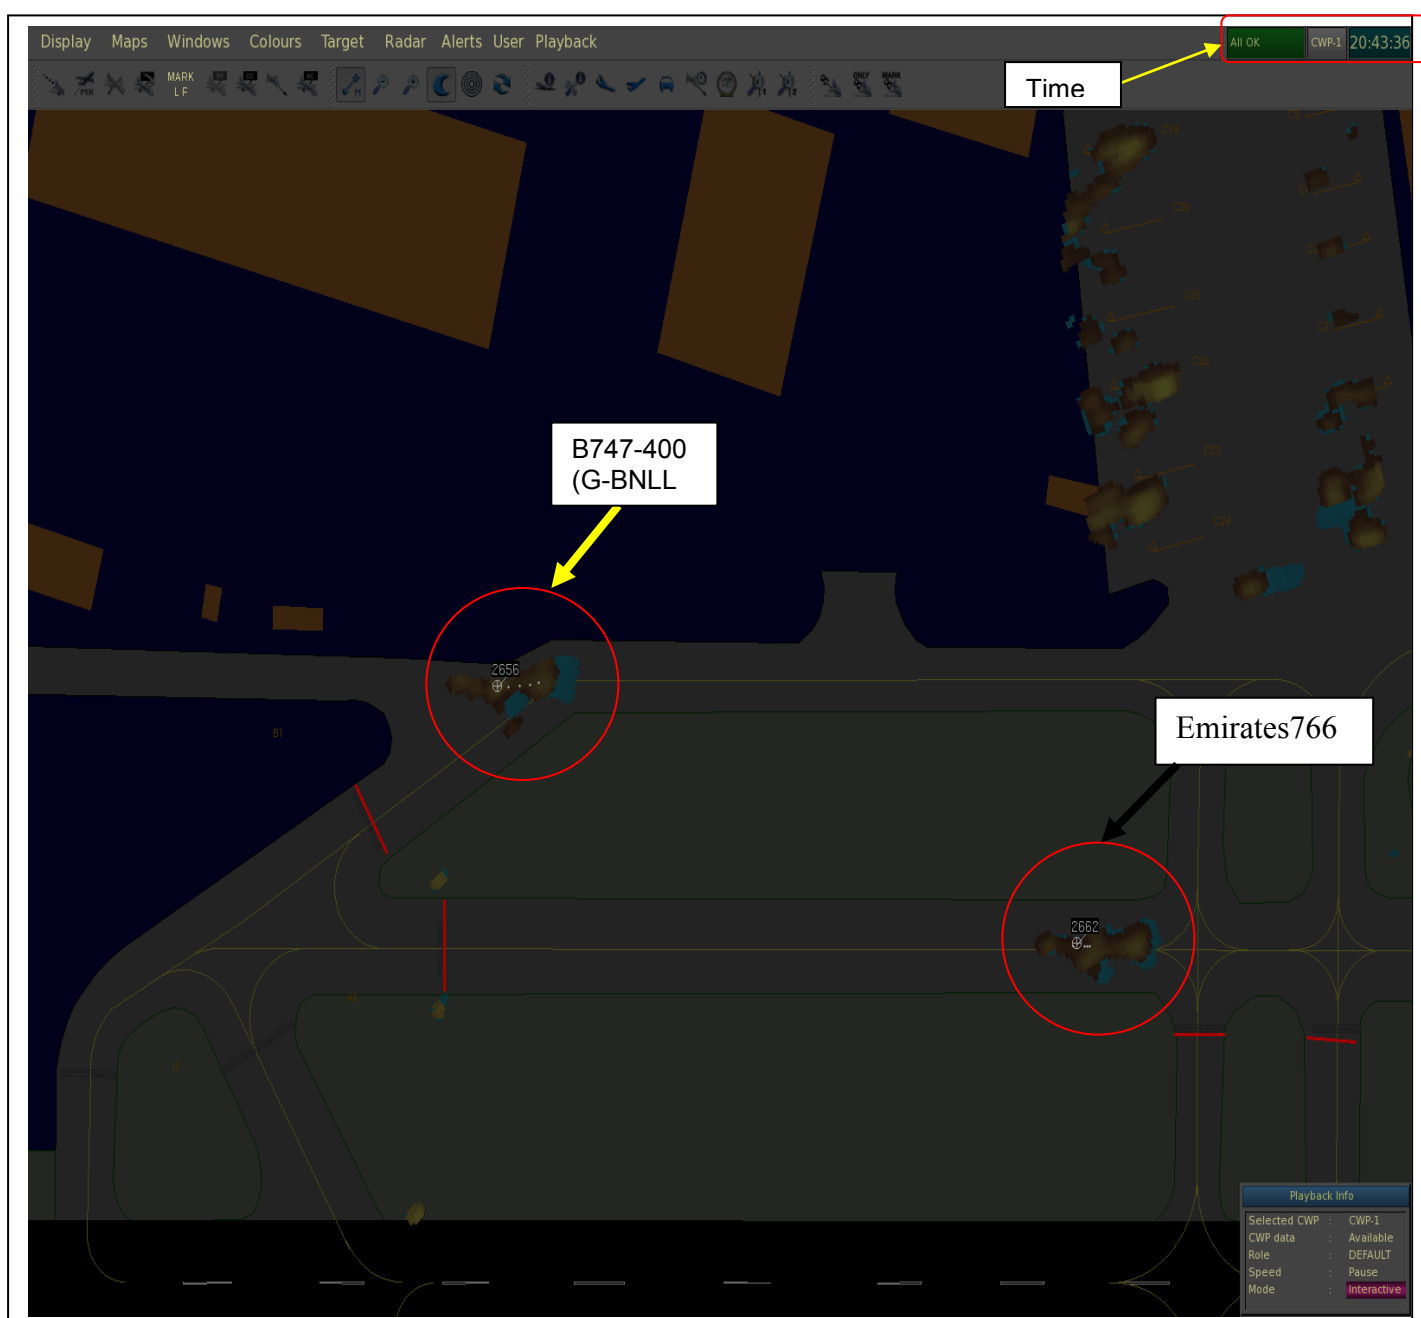
Figure 30 A-SMGCS image of BA034 proceeding onto Mike

1.11.4.10 The FDR and A-SMGCS show that at 20.43:36 UTC (22.43:36 local time), the BA034 aircraft was taxiing (ground speed 14.3 kts), turning slightly to the left ( $\pm 0.5$  degrees).

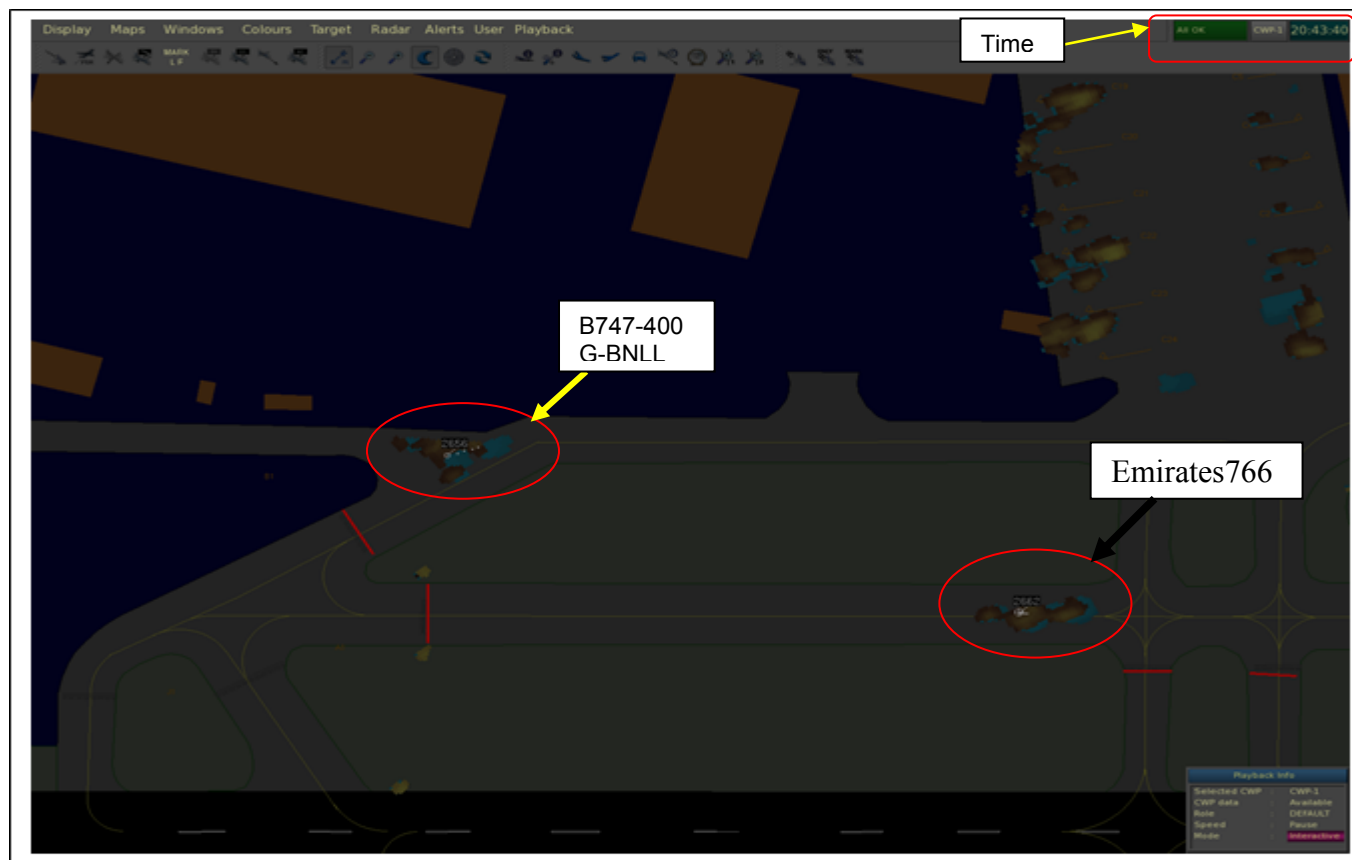
1.11.4.11 The A-SMGCS images below show the sequence of events that followed when the B747-400 aircraft crossed the intersection/junction of Bravo and Mike, intending to go straight ahead.

Figure 32 A-SMGCS image of BA034 proceeding to Mike

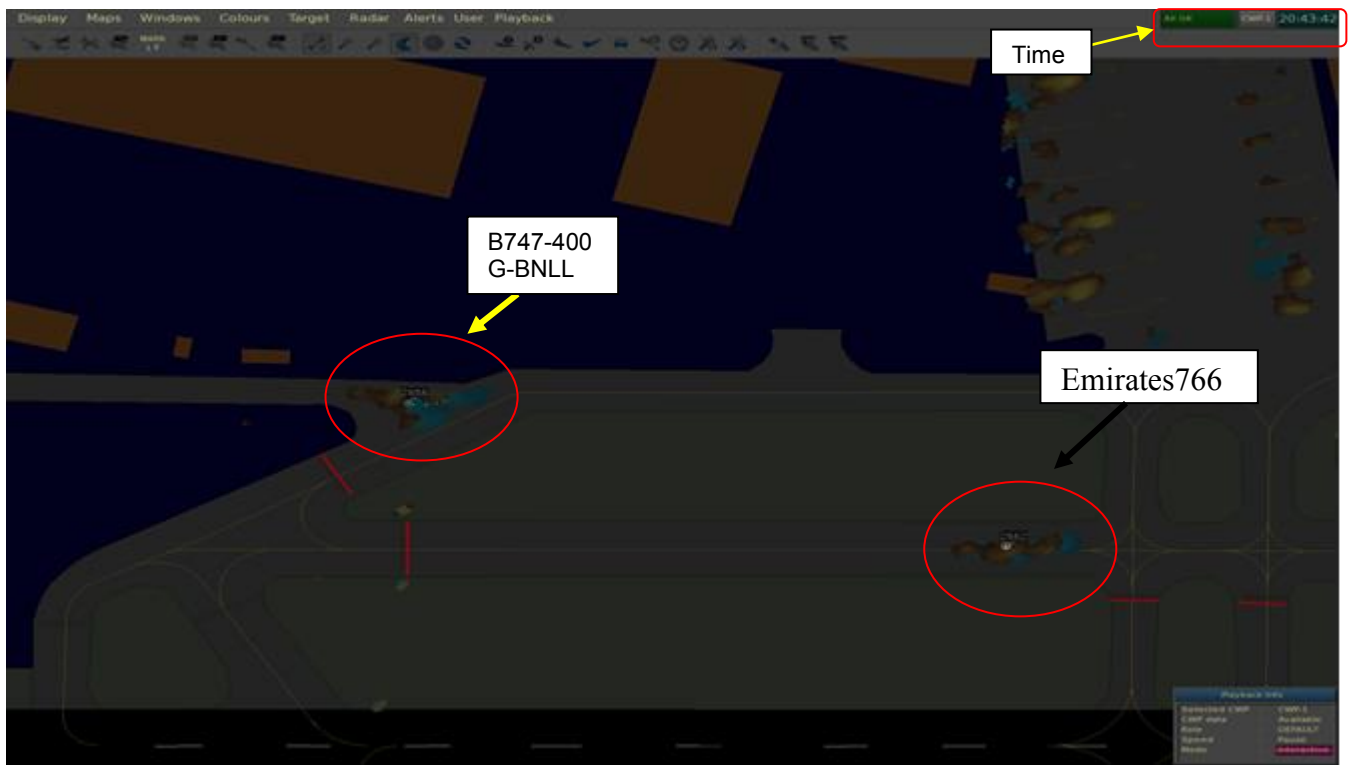
Figure 33 A-SMGCS image of BA034 proceeding to Mike

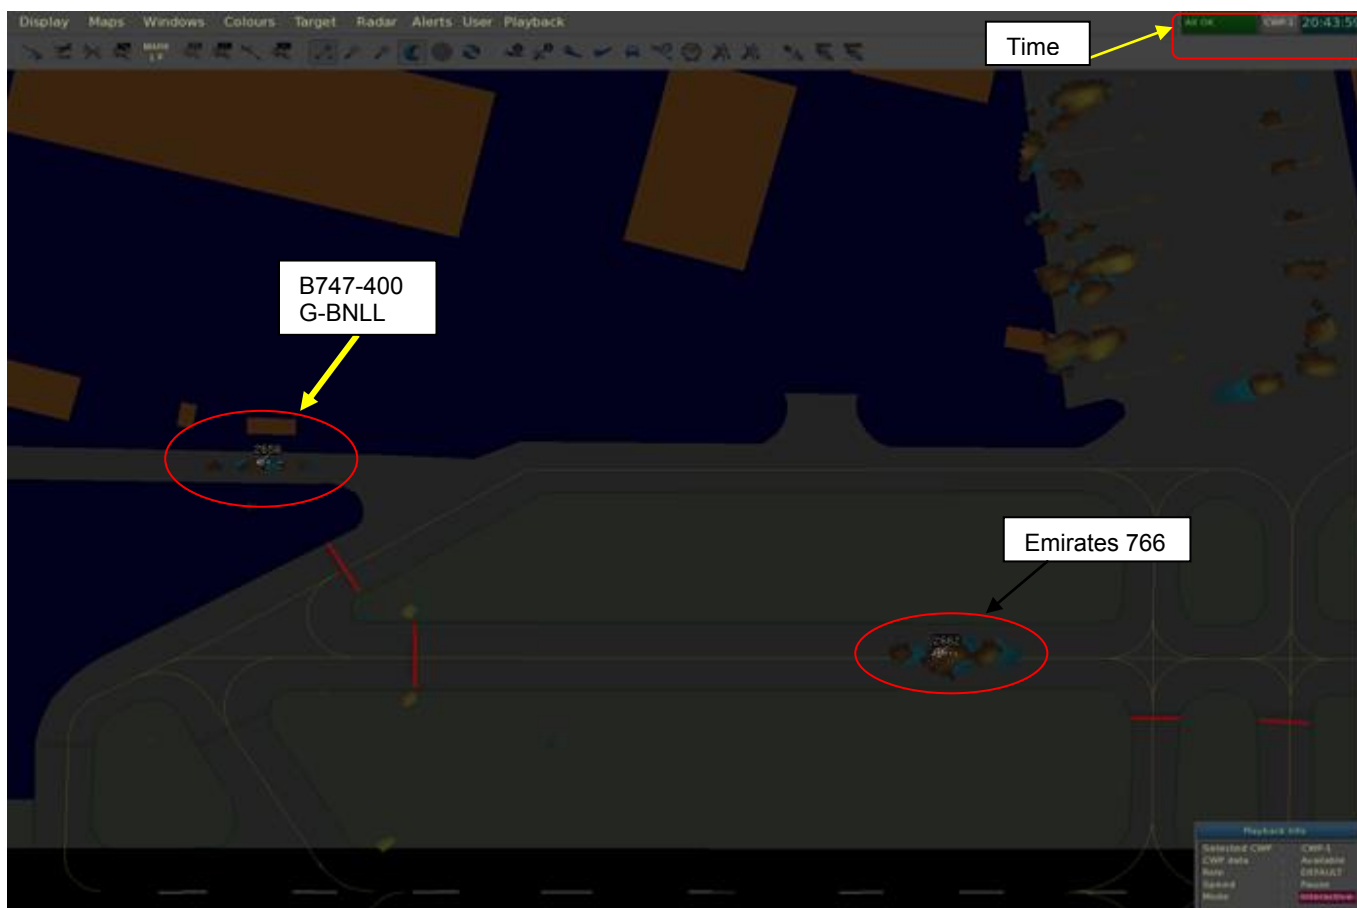
Figure 37 A-SMGCS image of BA034 involved in accident

- 1.11.4.14 The FDR and A-SMGCS show that at 20:43:59 UTC (22:43:59 local time), BA034 was taxiing on taxiway Mike. The aircraft was then involved in a collision with Bid Air Services Building (GPS reading: E28.23081 S26.14426). The heading was 214.4 degrees. At this point in time, as a result of the impact the aircraft ground speed dropped to 1.3 kts.

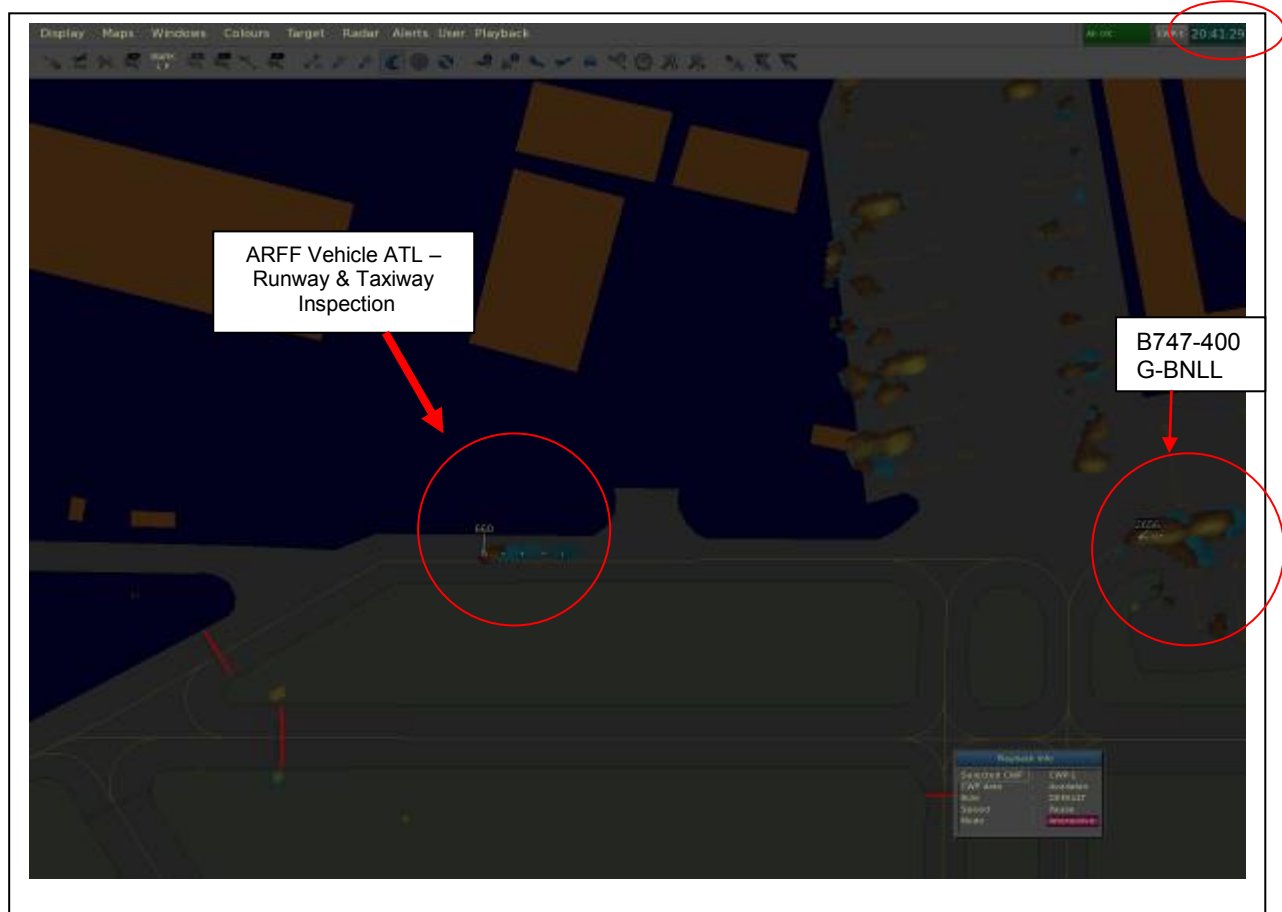
Figure 38 A-SMGCS image of ARFF vehicle (FTL) near intersection of Bravo and Mike

1.11.5.2 Below the A-SMGCS shows the ARFF vehicle (FTL) heading toward the intersection/junction of Bravo and Mike, which is where the two green centreline lights were found not illuminating and not reported.

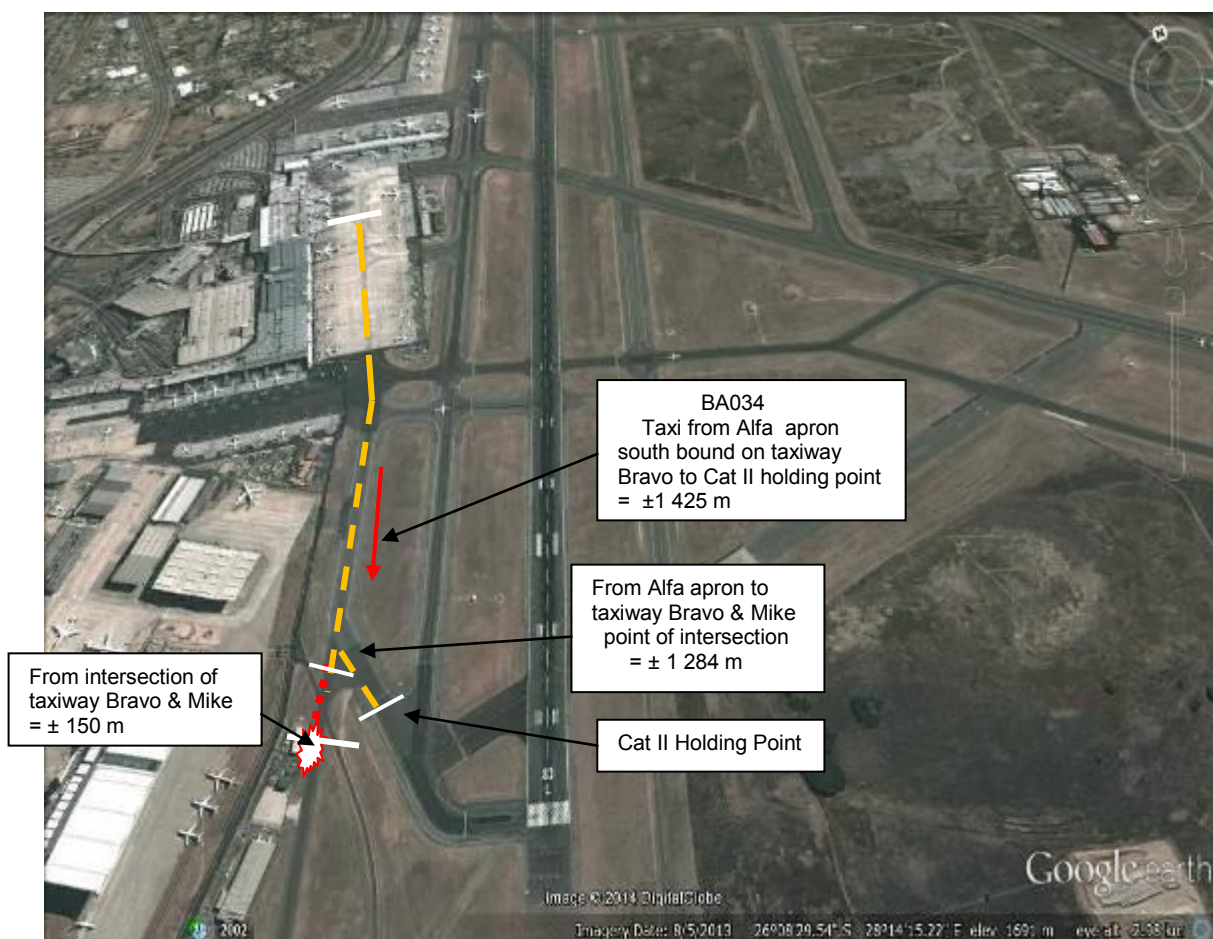
Figure 39 Google Earth ground map of taxi route

1.12.1.3 The aircraft proceeded straight onto taxiway Mike heading into the direction of Mike apron. On taxiway Mike, at a distance of approximately 150 metres from the intersection, the aircraft right wing collided with the BidAir Services Operations Office building.

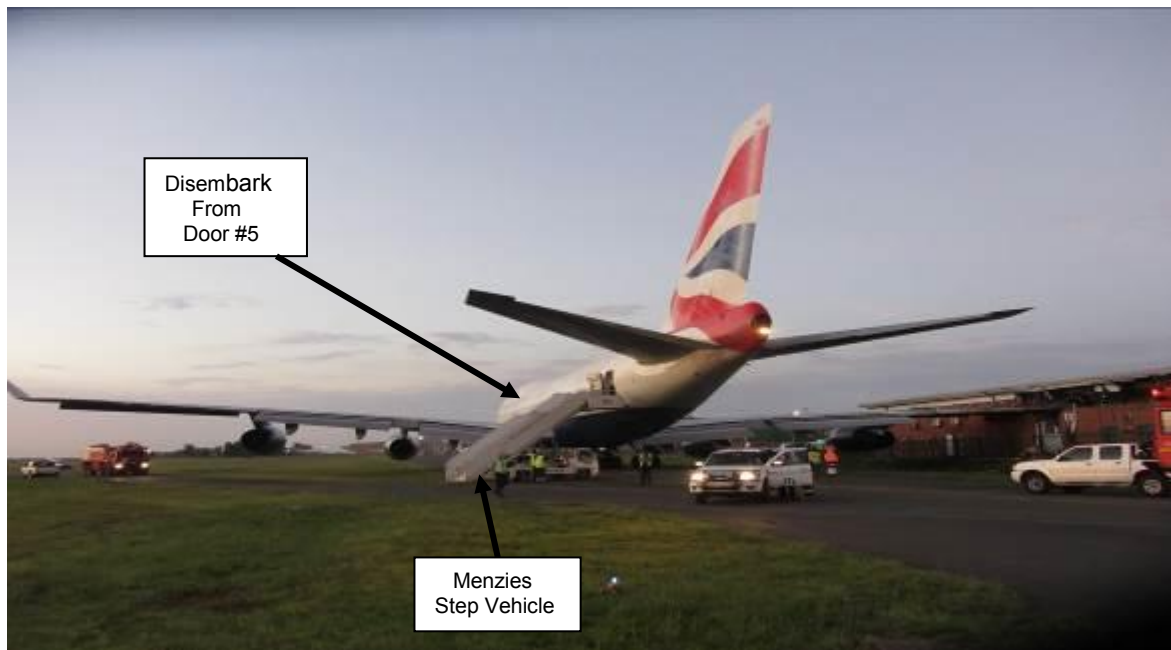
Figure 42 Door #5 and step vehicle used to disembark

- (i) At 21.15:00 UTC (23.15:00 local time), a step vehicle and two buses from Menzies Handling Company arrived at BA034. The step vehicle first drove to Door #1 (left side) of the aircraft, as the initial decision was to do the evacuation from Door #1. However, the step vehicle had to drive off Mike into grass and got stuck in the soft grass. The step vehicle could not reach Door #1 and decided to use Door #5 (left side) instead. Eventually, at 21.20:00 UTC (23.20:00 local time, which was 5 minutes later), the step vehicle was properly positioned at Door #5 and the passengers started to disembark from the aircraft.

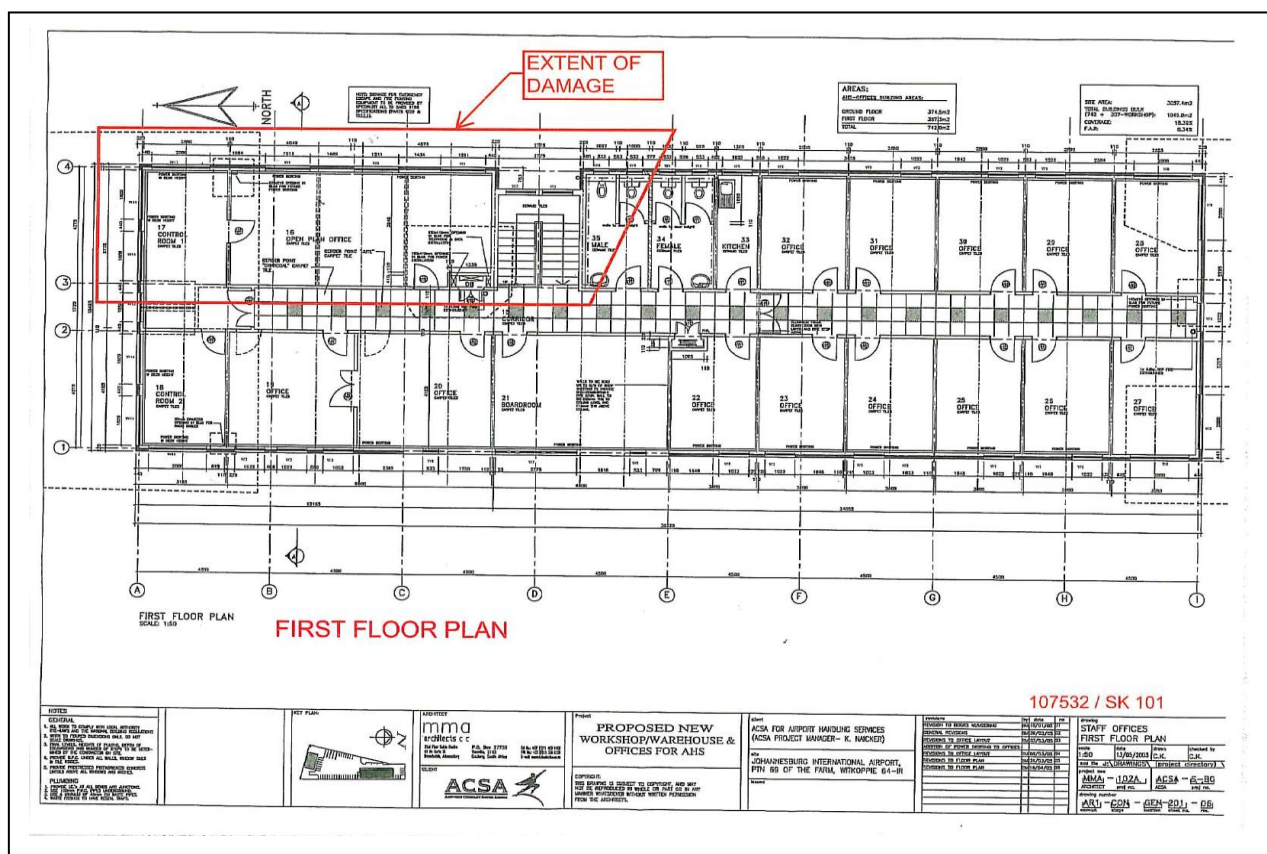
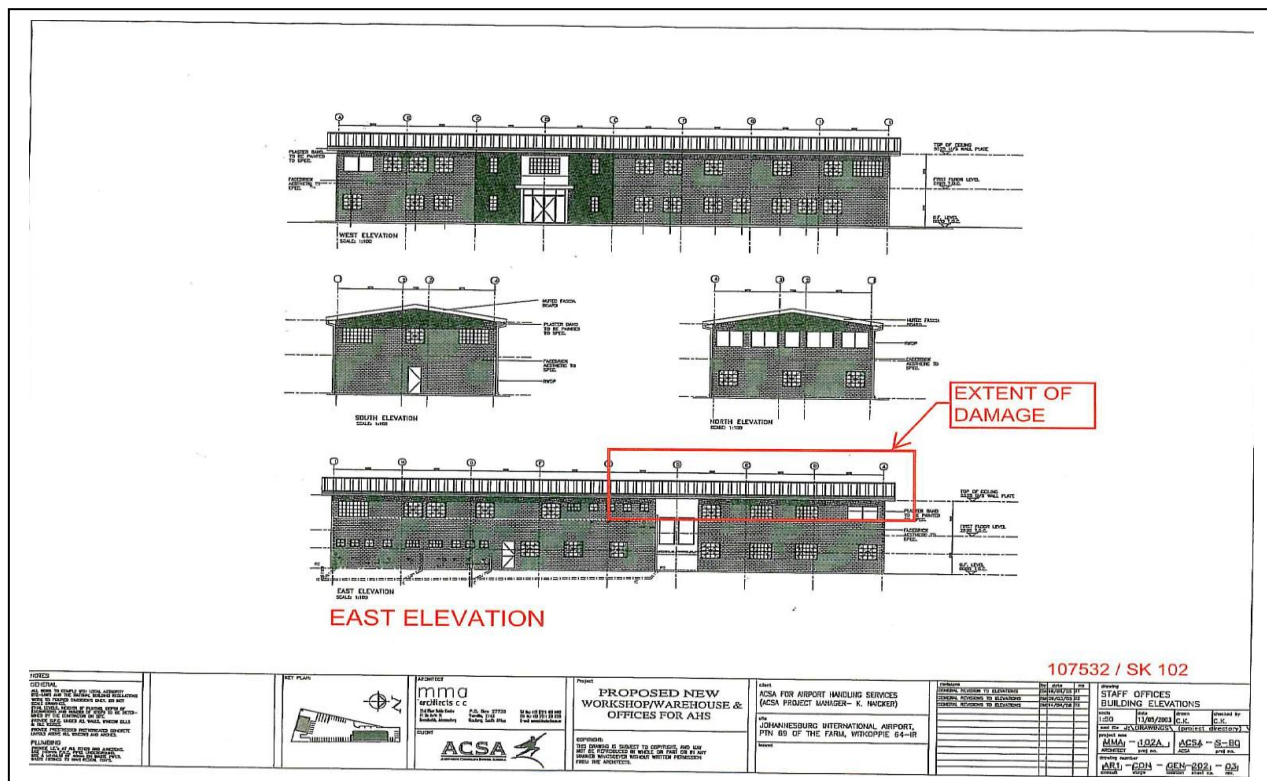
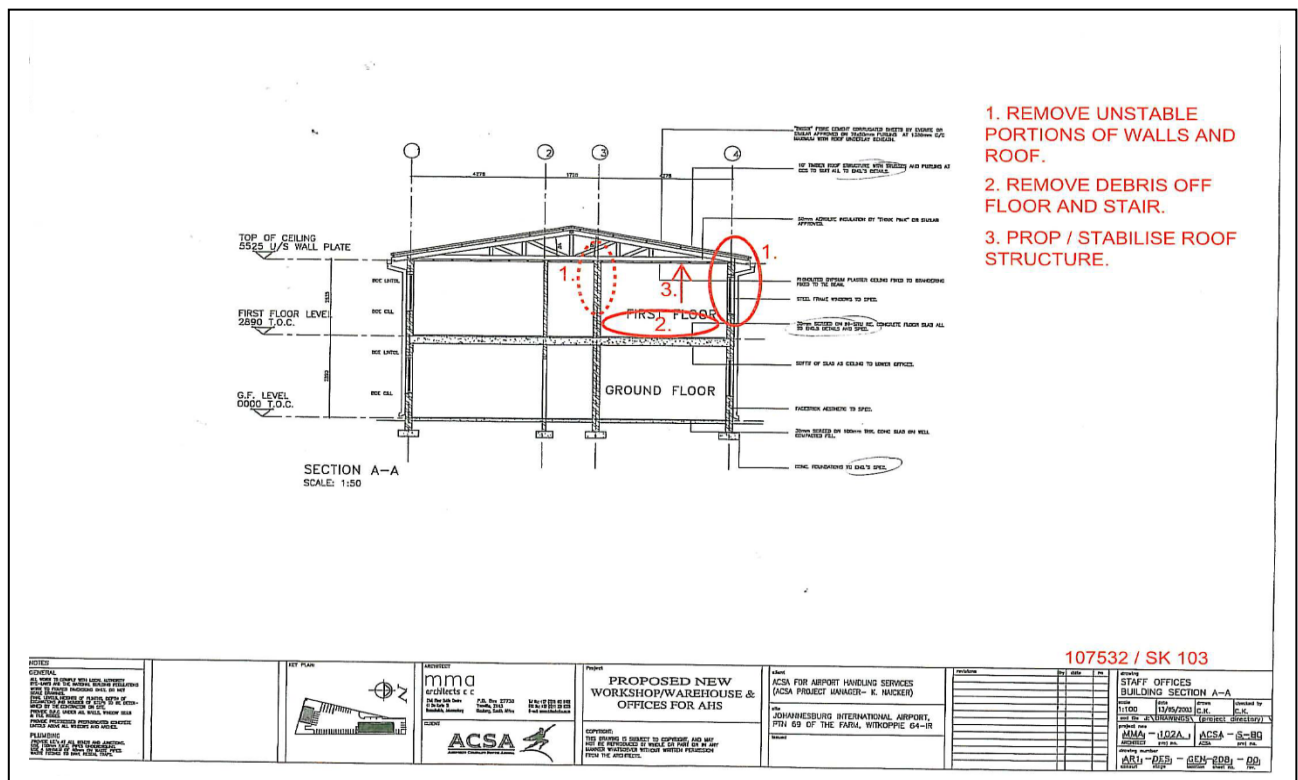
### Bird Air Service Building Structure Layout showing damage:

2.1.11.2 The damage to the electrical power supply in the BidAir Services building was substantial. The information shows that the eastern hall on the second floor was destroyed. There were electrical appliances and broken electrical wires hanging around still receiving electrical power. Also, a large quantity of fuel (Jet-A1) from BA034 had spilled inside and outside the building. A risk assessment of the situation, taking into consideration all factors, was required. This is exactly what the ARFF CFO did.
