TECHNICAL REPORT

A-068/1999

Accident of aircraft
Fokker MK-100,
registration I-ALPL,
at Barcelona Airport
(Barcelona), on 7
November 1999

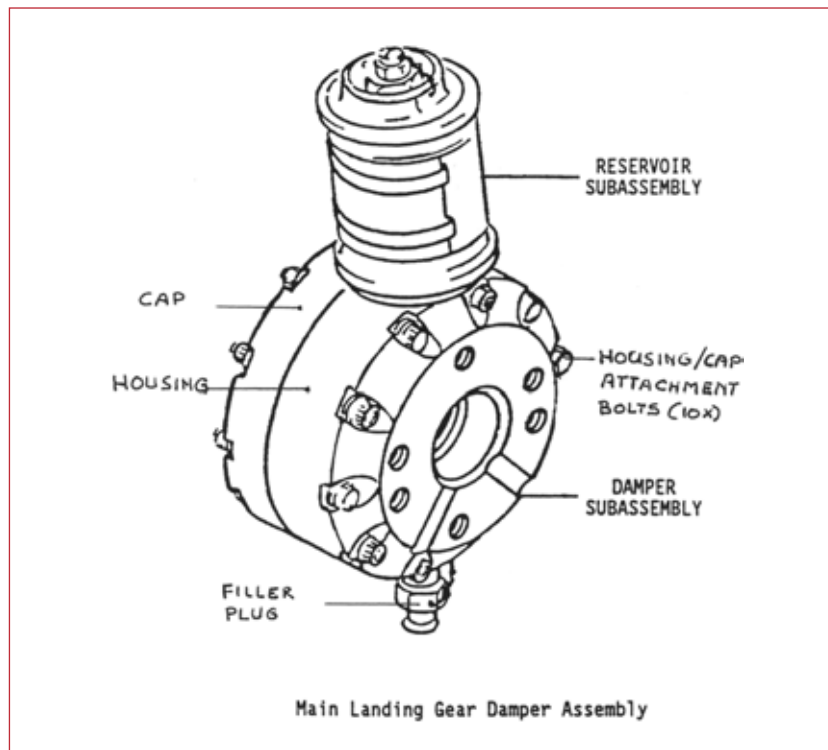
3. The vibration became unstable due to a functional failure of the shimmy damper.
4. The low damping capacity of the shimmy damper was due to the excessive thickness of a pack of shims between the housing and the cap which form the sleeve of the damper.

Figure C.4. Shimmy damper

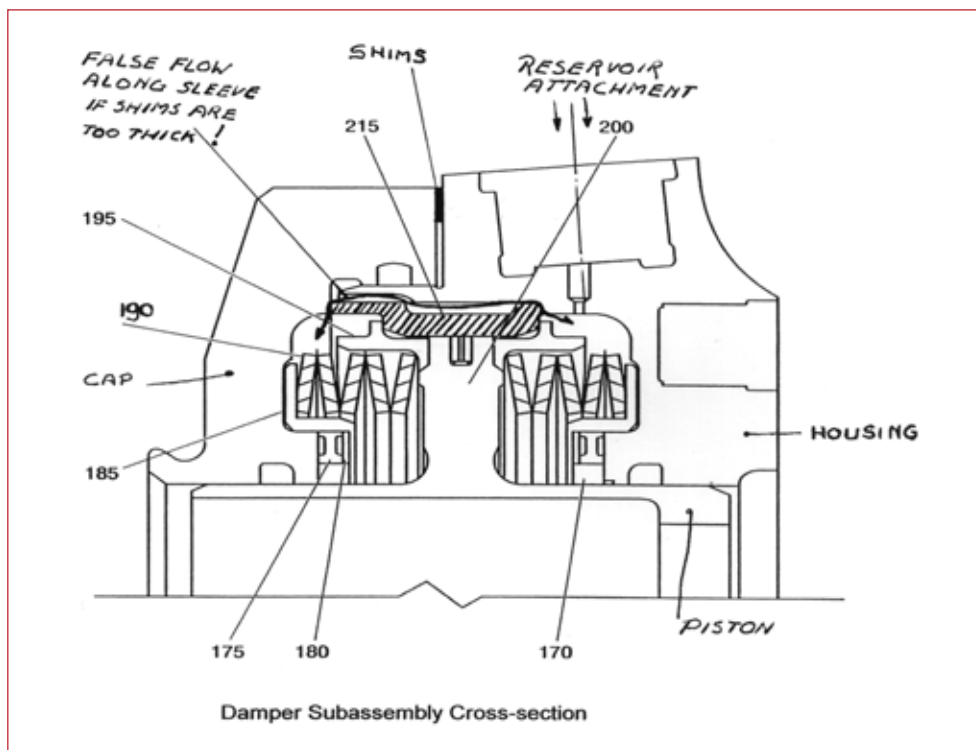
5. The defective assembly was not detected in a mandatory flow test on a hydraulic bench.
6. The existence of the shims themselves could have contributed to the assembly defect; it has been demonstrated that they have no functionality in the design.

Figure C.5. Cross-section of the damper (observe the shim pack and route of the false inner flow in the damper)

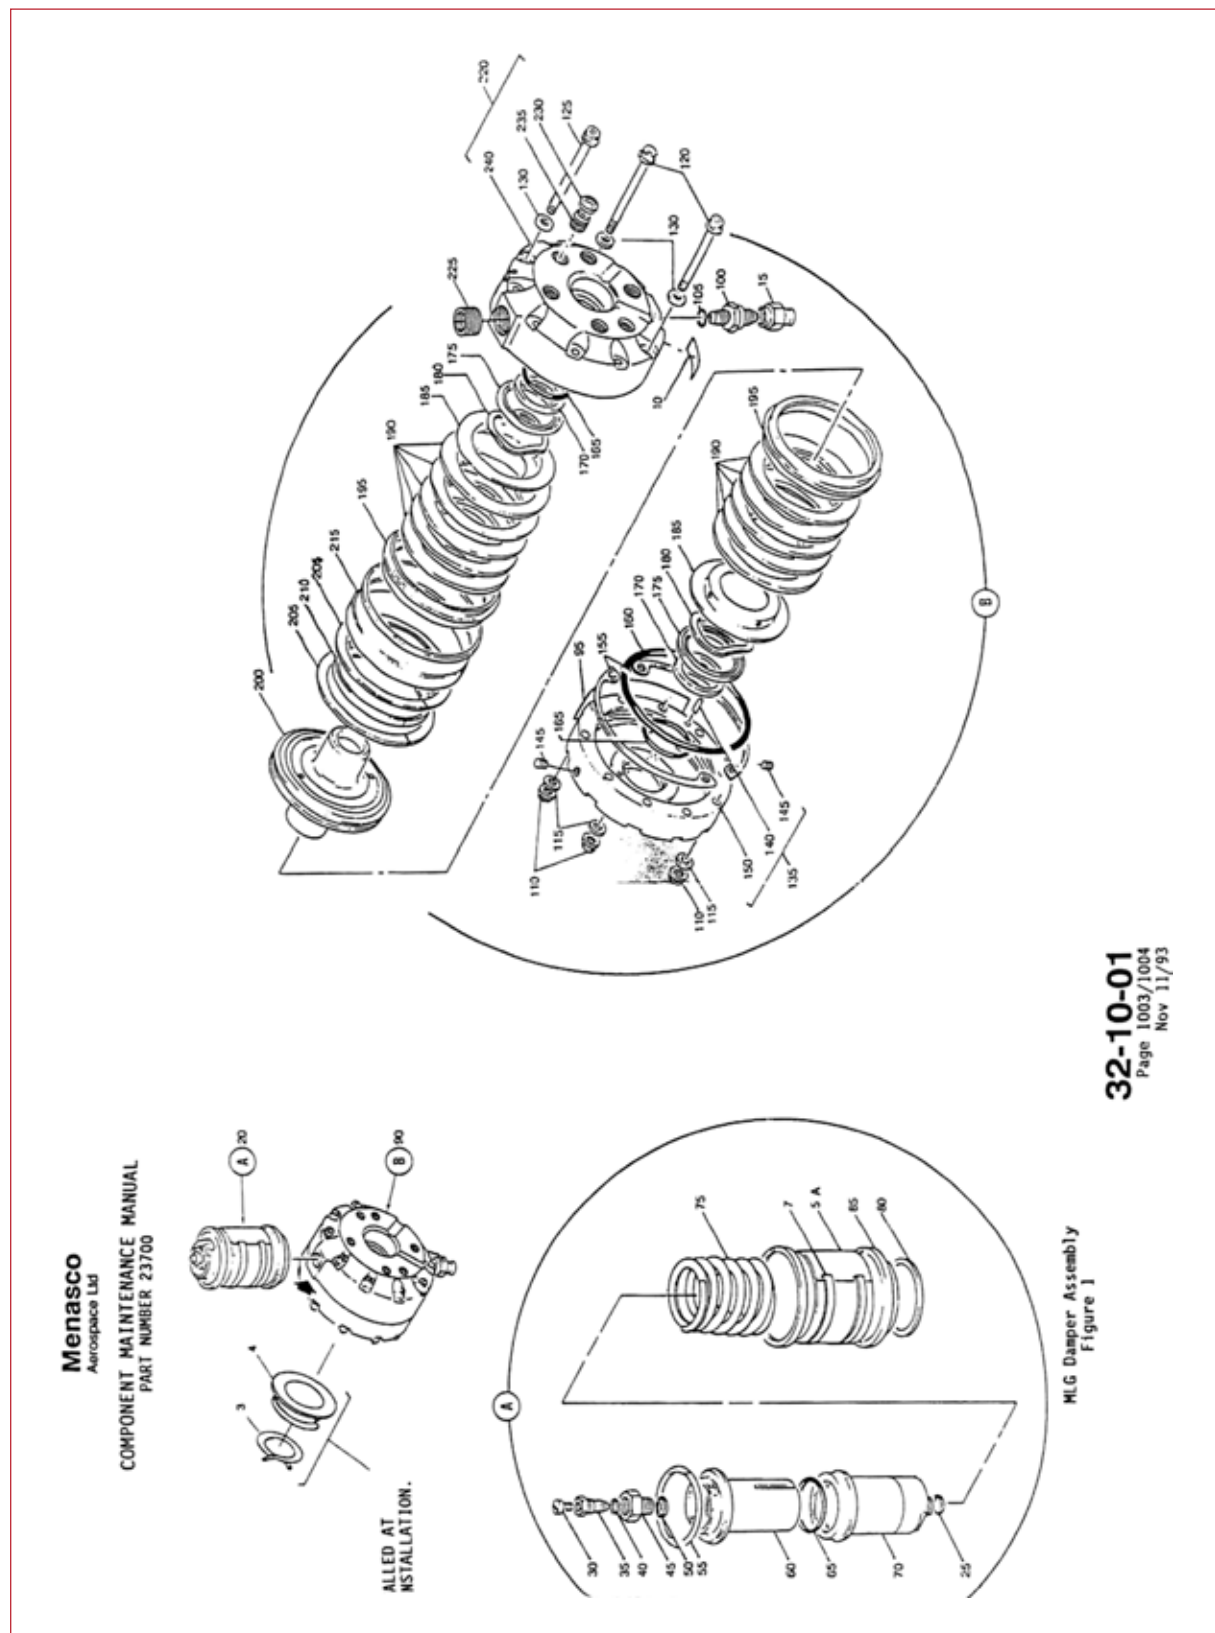
Figure C.6. Exploded diagram of the shimmy damper
