# **FINAL REPORT**

## **CONTACT BETWEEN AIRBUS A320 AND AEROBRIDGE**

**5 OCTOBER 2012**

**AIB/AAI/CAS.087**

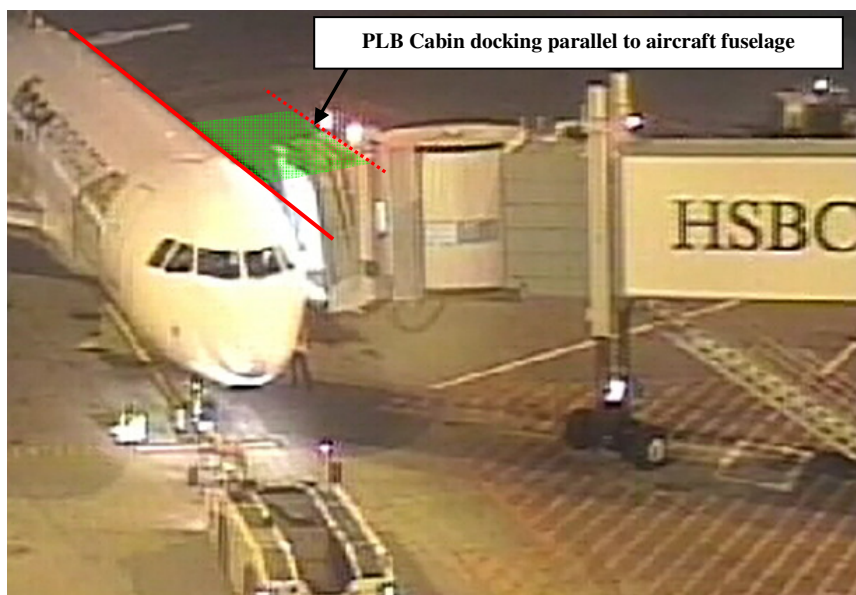
- 1.7.3 After the occurrence, another PLB operator re-docked the PLB to facilitate the disembarkation of passengers. At this instant, it was observed that the PLB cab was almost parallel to the aircraft fuselage prior to opening of the front cabin door (see **Figure 8**).

Figure 8: Docking position of PLB after occurrence (performed by another operator)

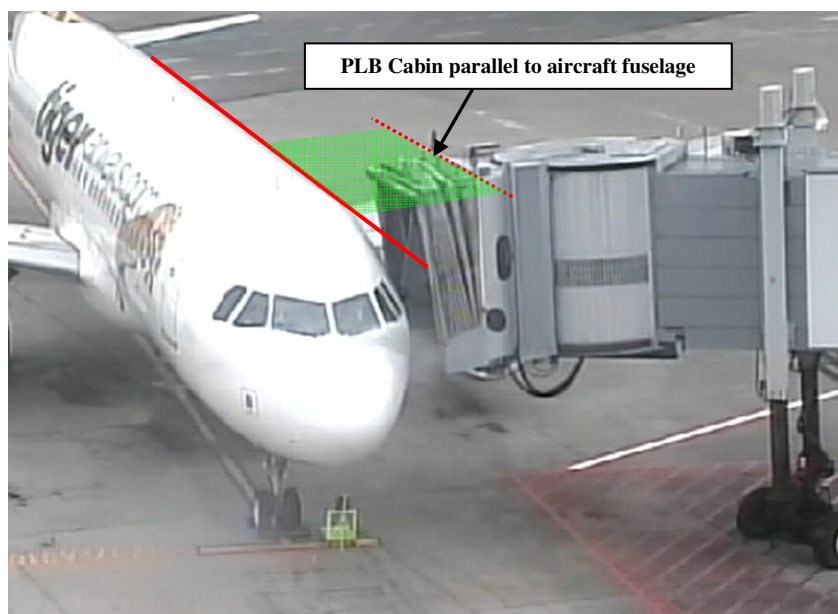
- 1.7.4 It was also observed that, during the first receipt of the aircraft at 1722 hours, the docking position of the PLB cab was almost parallel to the aircraft fuselage prior to opening of the front cabin door (see **Figure 9**).

Figure 9: Docking position of PLB on first receipt of aircraft at Bay E7

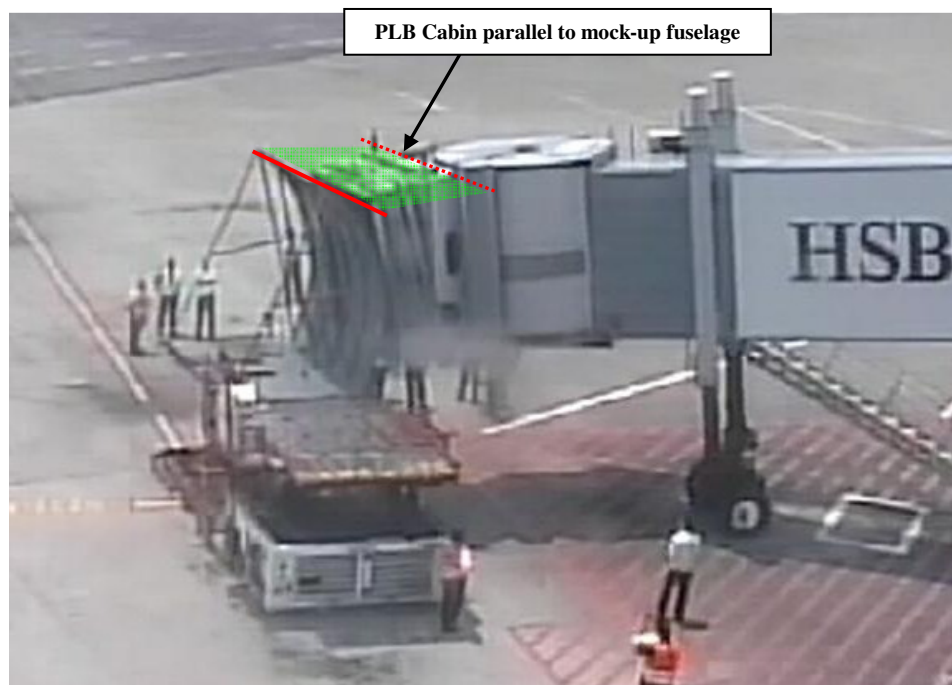
- 1.8.1.2 For the normal docking, the PLB cab was positioned parallel to the aircraft fuselage, and there was no contact between the PLB cab and the aircraft during the docking operation (see **Figure 10**).

Figure 10: Normal docking position of PLB during simulation

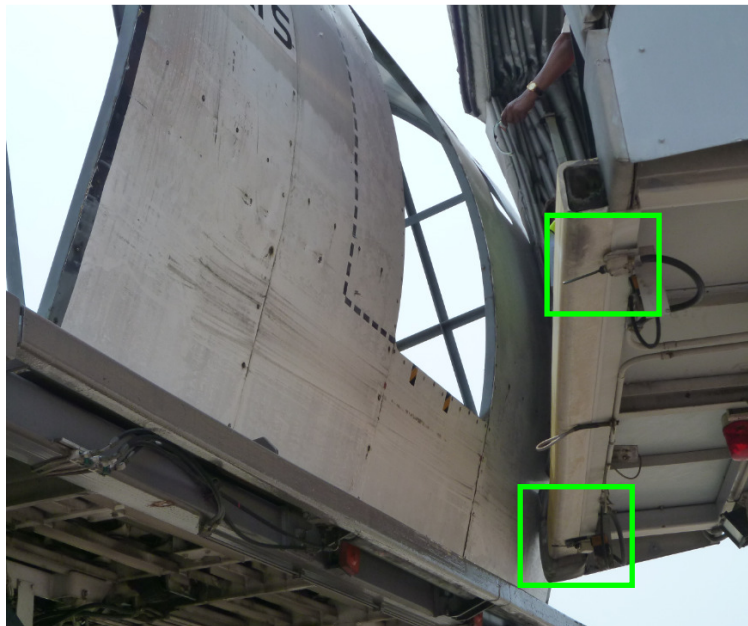
- 1.9.3.1 There are two safety-interlocking sensors under the PLB cab, one on the left and one on the right. They are installed to prevent the PLB from moving once the sensor rods have come into contact with an obstacle. The position of the two end sensors are shown in **Figure 17**.
- 1.9.3.2 It is noted that in the non-parallel docking scenario when the PLB cab's right padding had already contacted the aircraft fuselage, the end sensor closest to the fuselage (i.e. the one on the right) was not touching the fuselage and was therefore not activated as shown in **Figure 18**. Thus the PLB cab could still be manoeuvred further forward towards the aircraft fuselage.

Figure 17: Position of the two safety-interlocking sensors under the PLB cab

- 2.1 Evidence from the CCTV footage shows that the PLB made contact with the aircraft during the re-docking process. The contact is also evidenced from the debris fragments found on the PLB cab's damaged right padding.
- 2.2 The safety-interlocking sensors under the PLB cab were designed to work when the PLB is relatively parallel to the aircraft fuselage. In a PLB non-parallel position, the sensor rod would be much farther from the fuselage and would not have prevented the PLB cab from contacting the fuselage.
- 2.3 Thus, as the non-parallel PLB cab was approaching the aircraft fuselage, the effectiveness of the PLB's safety-interlocking sensors was compromised. The sensor on the right side was unable to detect the closing in of the PLB onto the aircraft fuselage.

- 4.1 Following the incident, the airport ground handling provider has taken the following safety actions:
- Amending the PLB training manual to include a warning to PLB operators that highlights the importance of ensuring that the PLB cab is parallel to the aircraft fuselage, particularly when making adjustments when the bridge is 1.5 m and 0.5 m away from the aircraft. The amendment includes also a warning that non-parallel docking can cause damage to the aircraft fuselage.
