INTERIM REPORT

Accident
on 24 July 2014
in the region of Gossi in Mali
to the MD-83 registered EC-LTV
operated by Swiftair S.A.

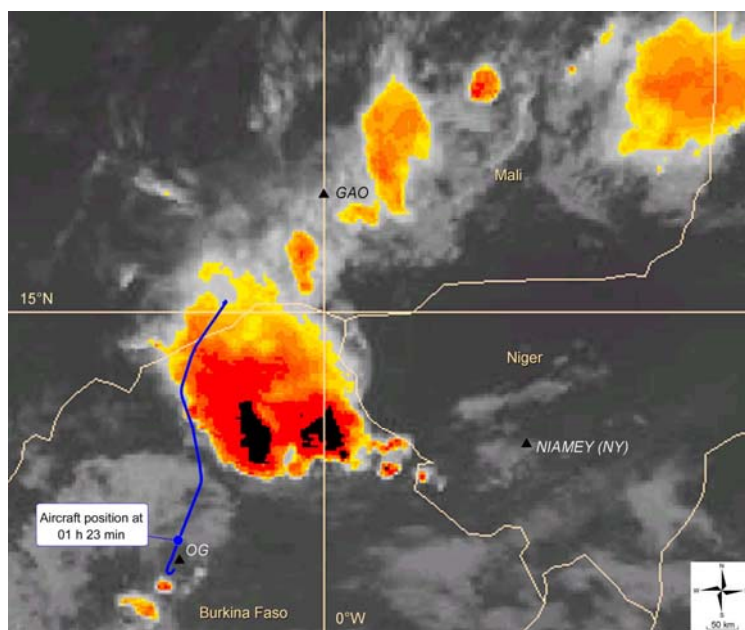
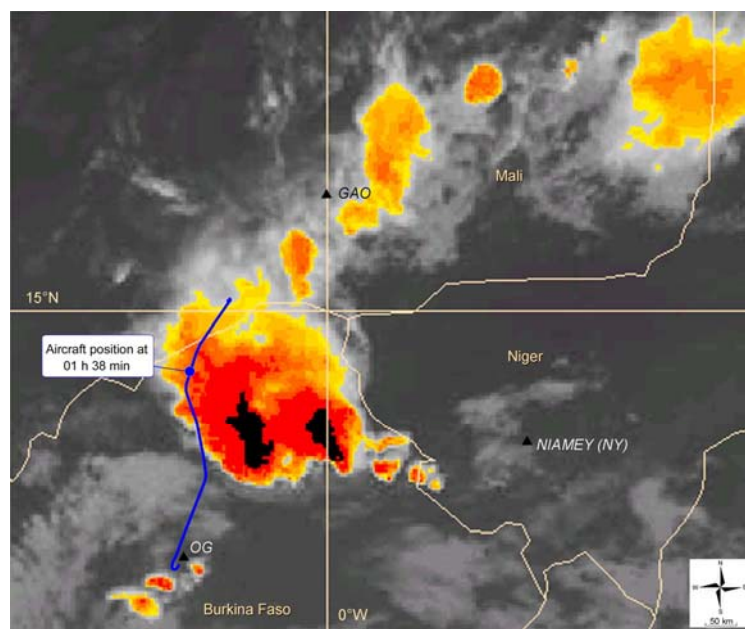
Satellite observations of the night of July 23 to 24 showed a convection zone that grew from 20 h 00 over northern Burkina Faso as it moved to the southwest. On the following image, two black areas can be seen representing the two coldest zones which are therefore the highest and most dynamic. They culminate well above the level of FL 400. The highest number of lightning strikes occurs in these zones.

After takeoff from Ouagadougou, the crew changed heading. The aeroplane passed along the western edge of the convection zone. From 1 h 30 to 1 h 45 the aeroplane was flying in a saturated environment, probably in the cloud layer between 24,000ft and 31,000ft.

Infrared images and overlaid flight path

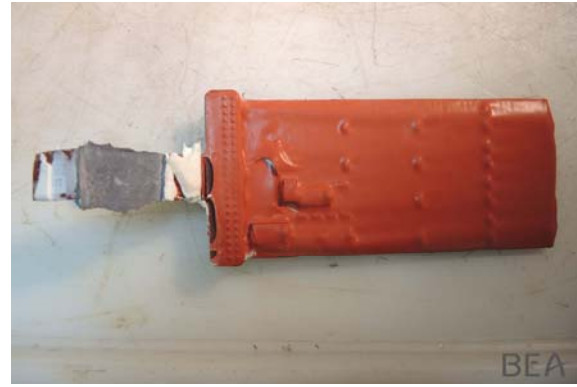
Electronic card with the protective layer

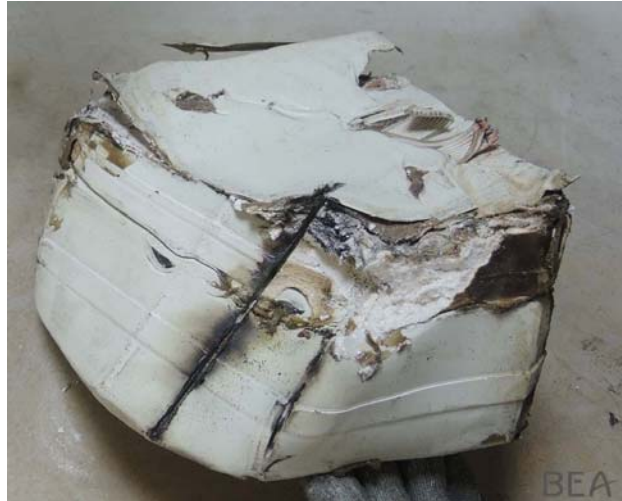
Heat protection of the data media

After removing the heat shield, it was noted that the tape mechanism had been destroyed and the tape was damaged. It was broken in several places.

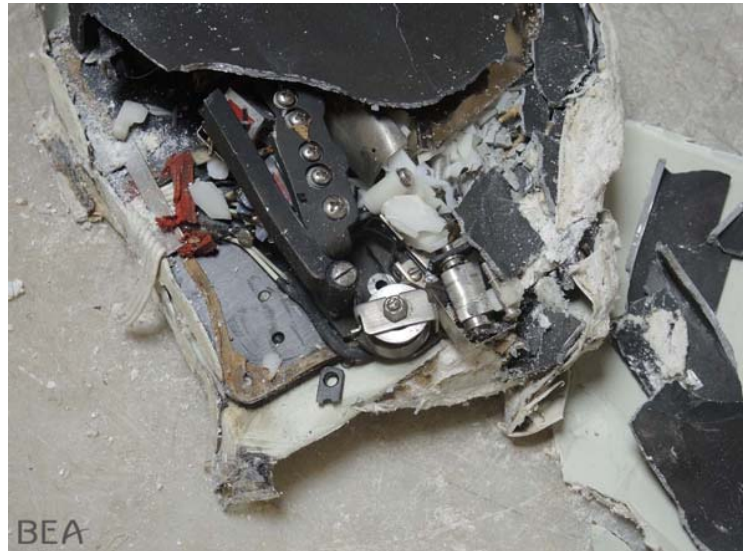
Zoom - Magnetic tape drive mechanism

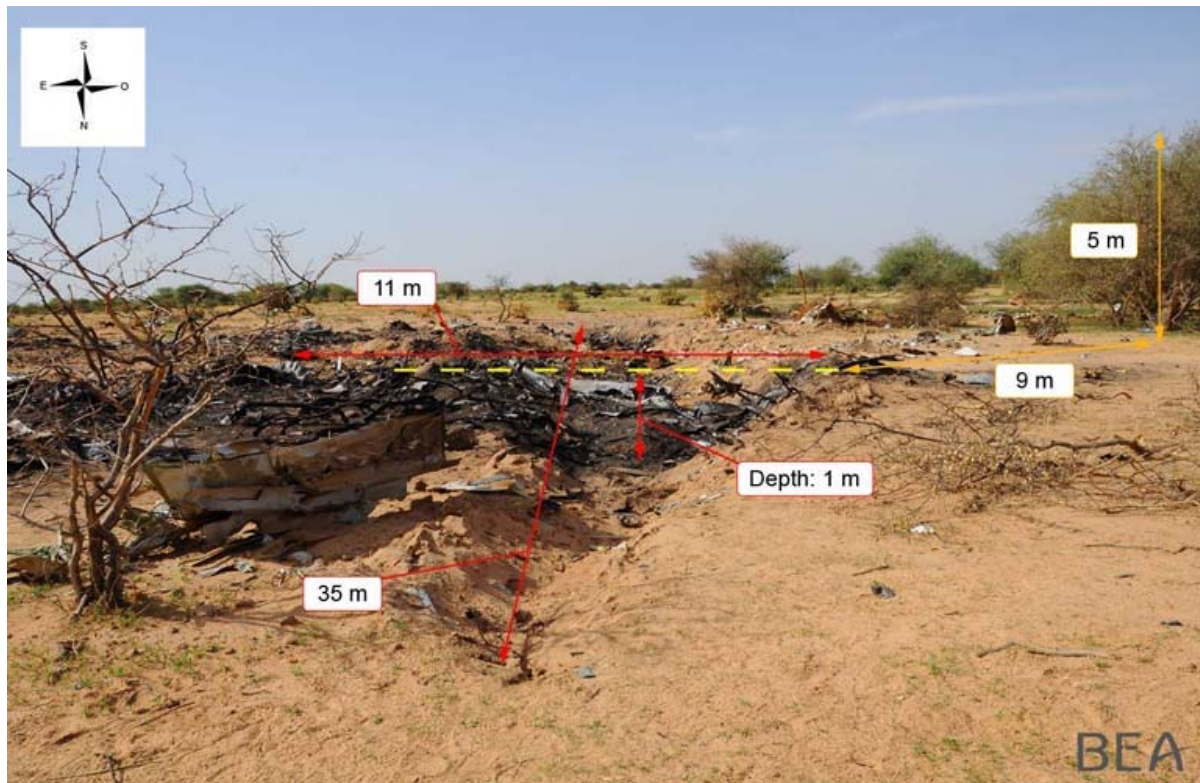
Trees, about 5 m high and located about ten metres before the impact point, were not cut off. A few elements of the tail section, as well as the rear door and the tail skid, were discovered near these trees.

Side view of the crater
